Municipality of Brockton Greenock Structure No. 0002

Schedule 'B' EA Project File (Version 1)

GMBP File: 212326

October 22, 2020

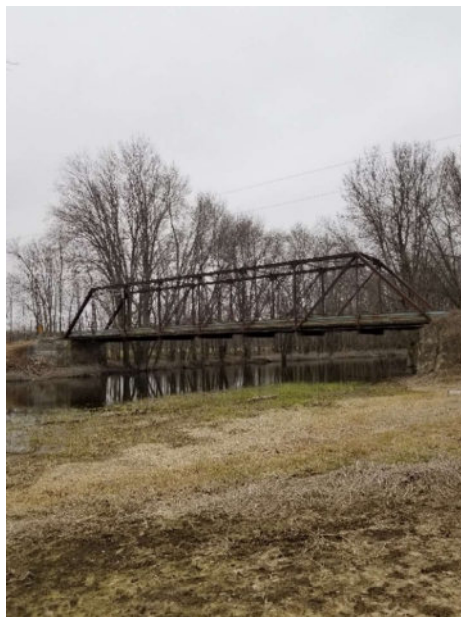
Photo 1: Image showing the steel rivet-connected Pratt through-truss bridge.

The subject single-lane bridge was reportedly built in the early 1900's. The structure is an 8-panel rivet-connected Pratt through-truss bridge with steel floor beams and stringers supporting a laminated timber deck. Although it is not known how the existing structure is founded (i.e. piles or spread footings), the bridge is supported by cast-in-place concrete abutments and wingwalls with an overall span of 37.1 meters. The overall width of the existing structure is approximately 4.25m with flex beam guiderails on each side (refer to **Photo 4**). The flex beams are fastened directly to the steel truss. The available clear roadway width is approximately ± 4.0 meters which accommodates one lane of traffic. There are no deck drains.

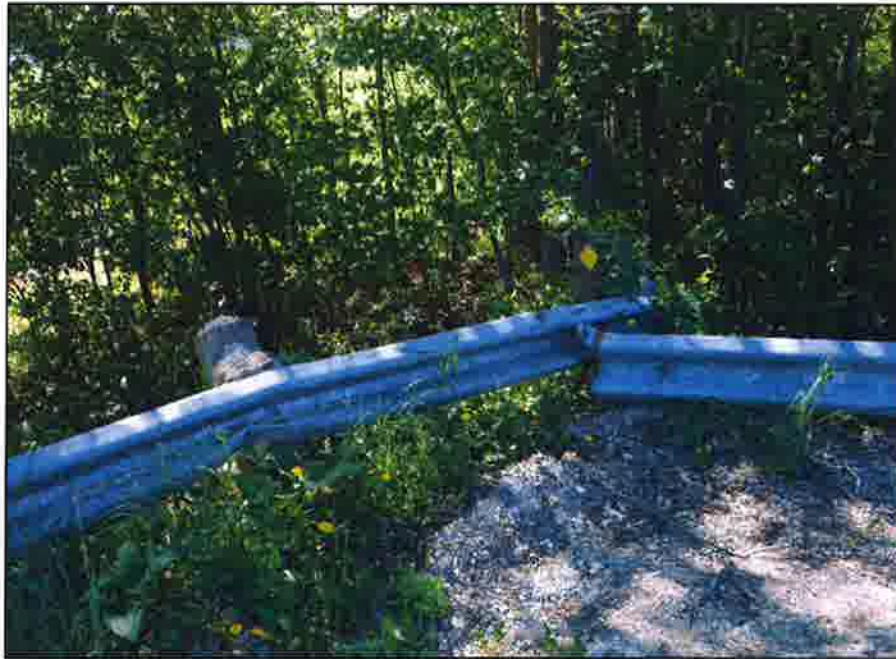
Photo 3 - View of damaged guiderail at southeast.

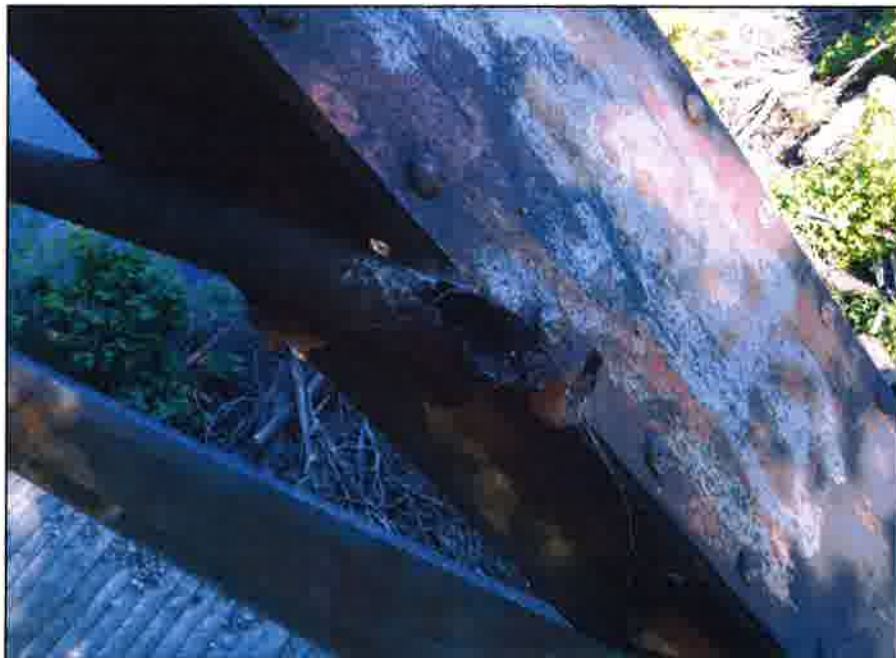
Photo 4 - View of northeast railing with severe corrosion.

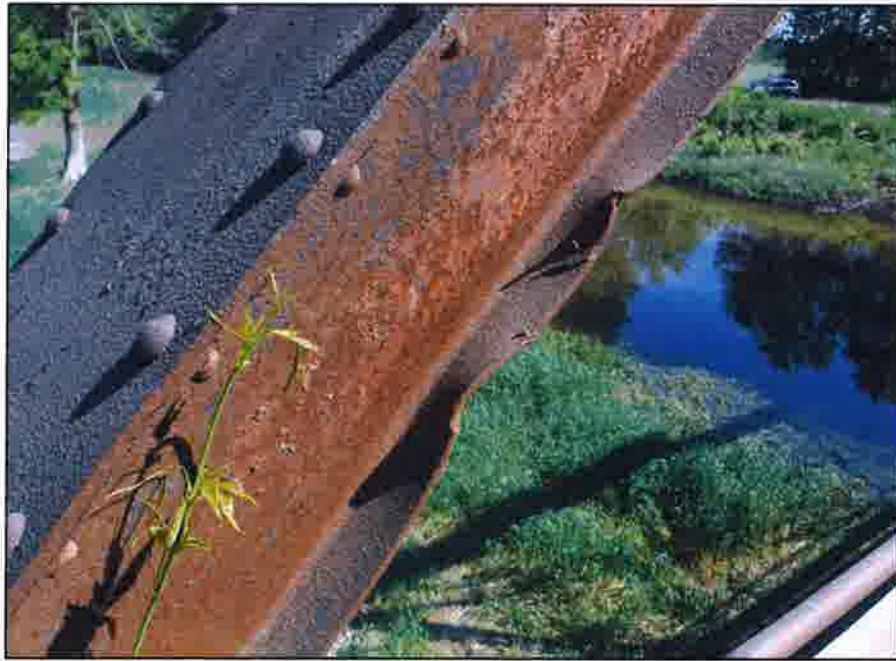
Photo 5 - View of damaged top chord at northwest.

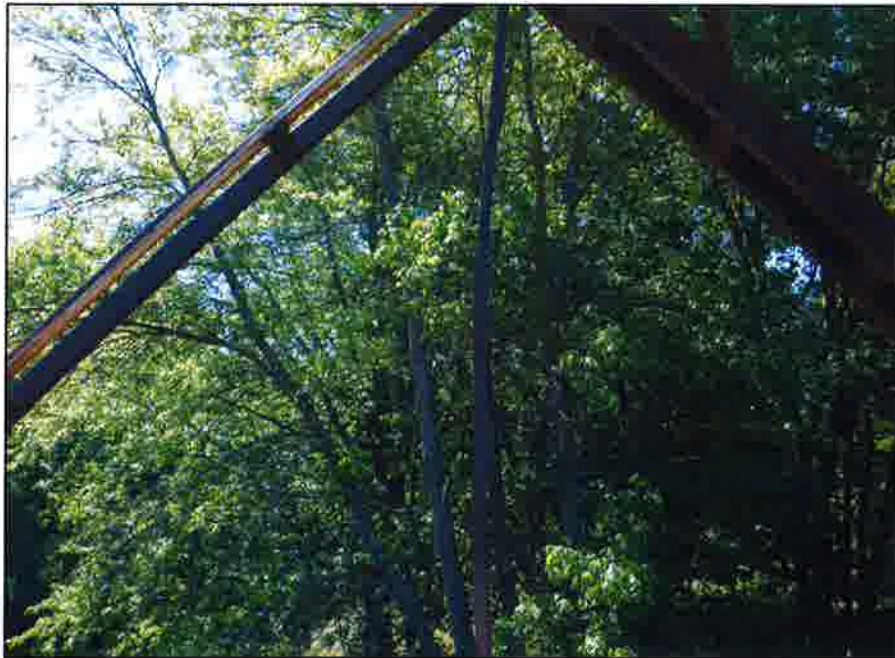
Photo 6 - View of damaged vertical member at southwest.

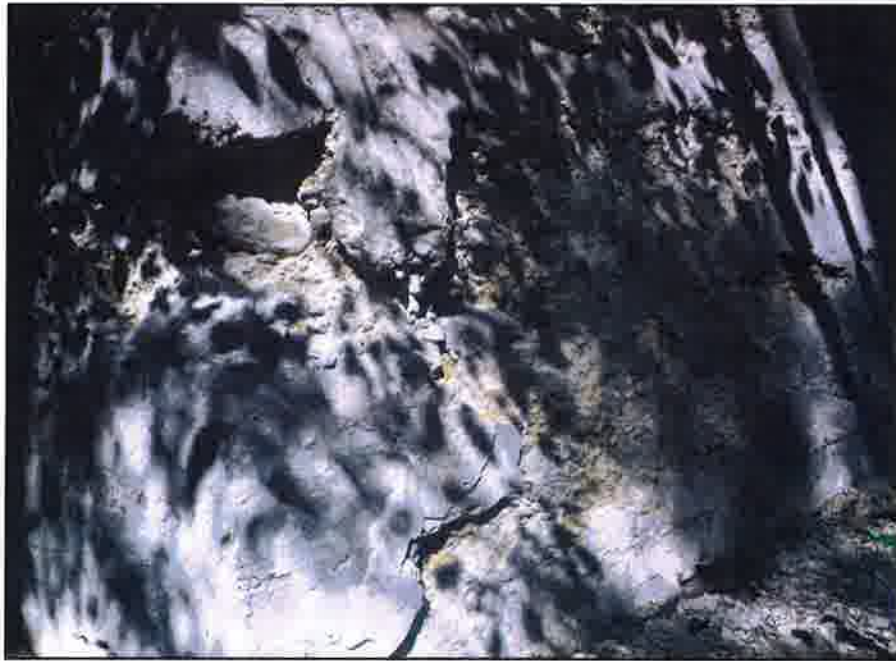
Photo 7 - View of severe scaling and spalling at west abutment.

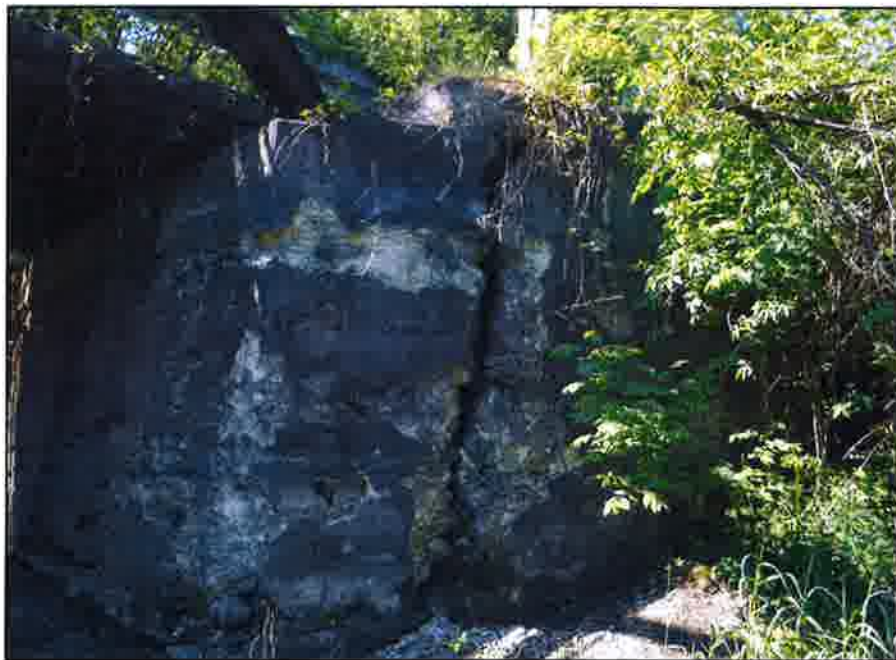
Photo 8- View of wide vertical crack at northwest wingwall.

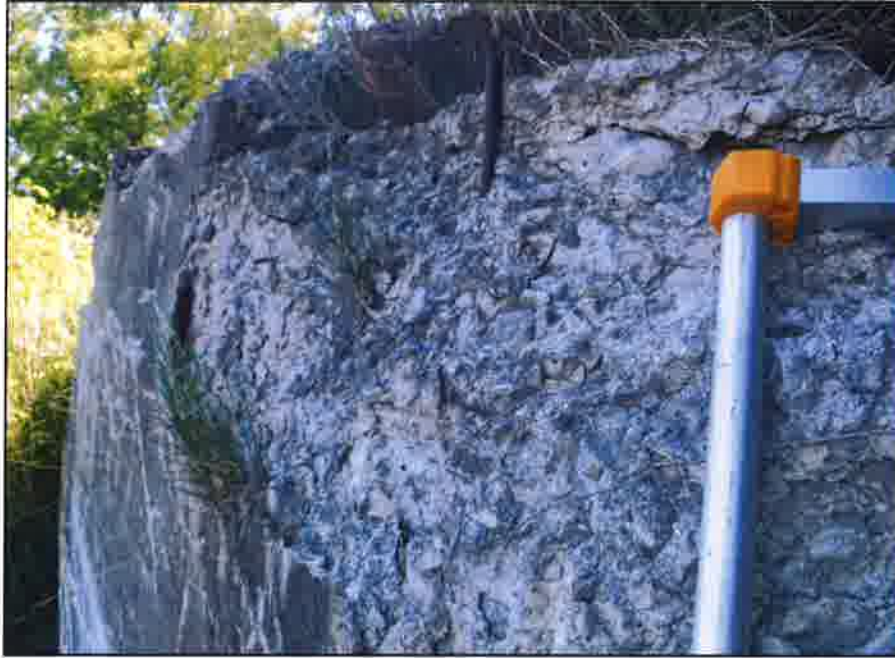
Photo 9- View of severe scaling and spalling on top of abutment wall.

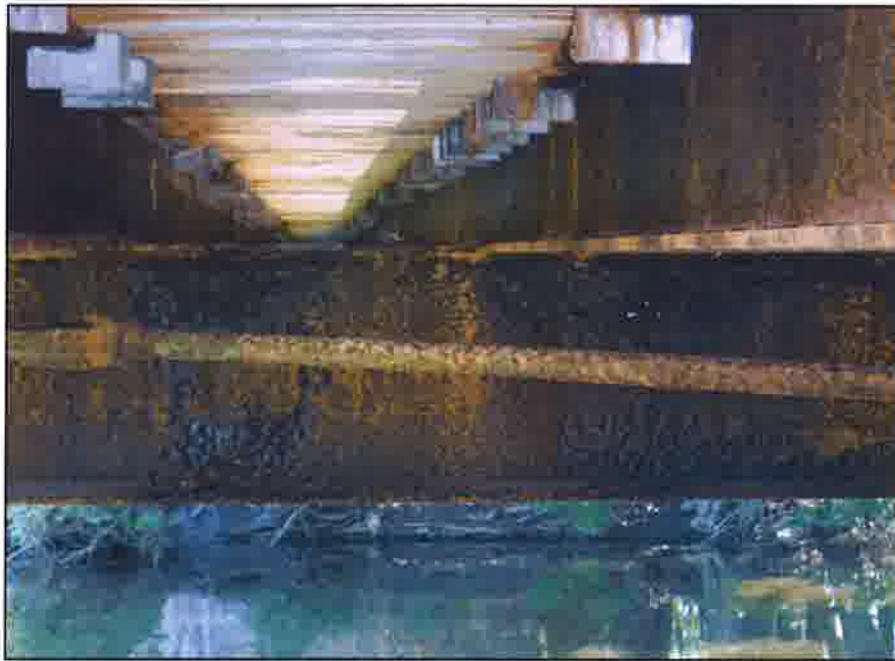
Photo 11- View of severe corrosion in western most floor beam.

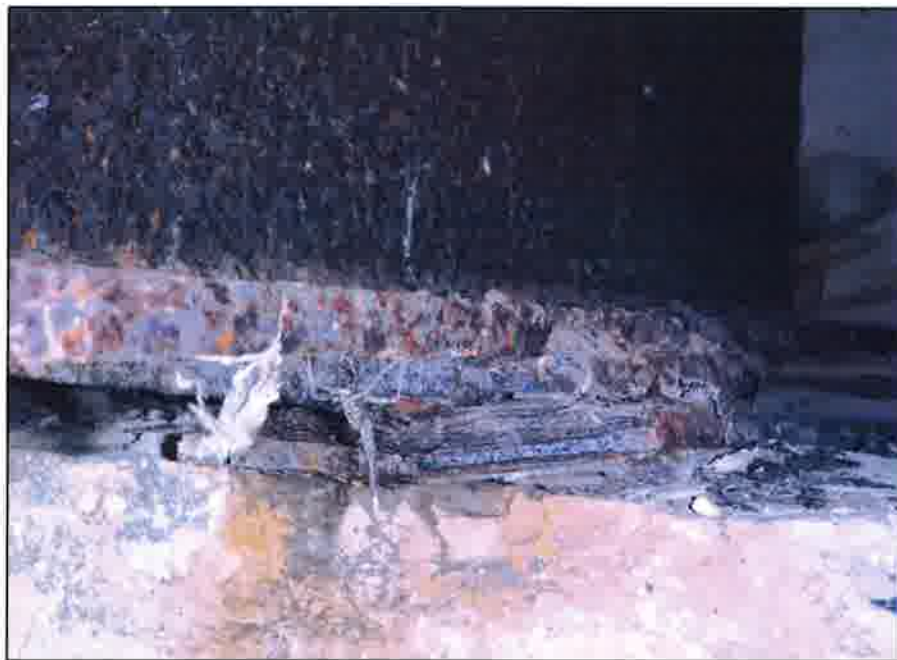
Photo 12 - View of severely corroded bearing bad.

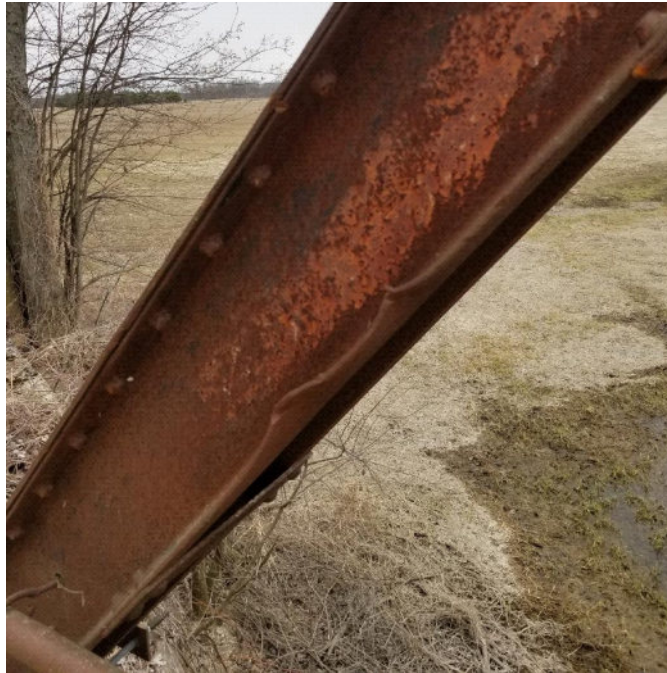
Impact damage on top chord at southeast.

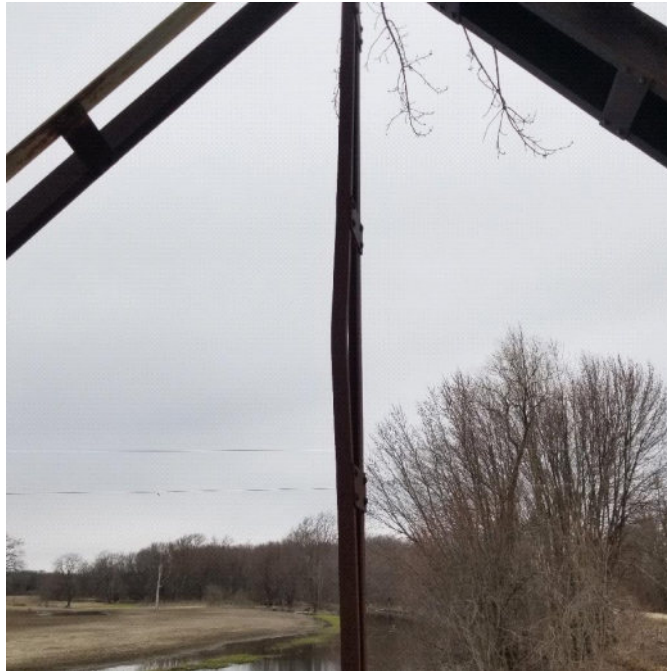
Permanent deformation of vertical web at northeast.

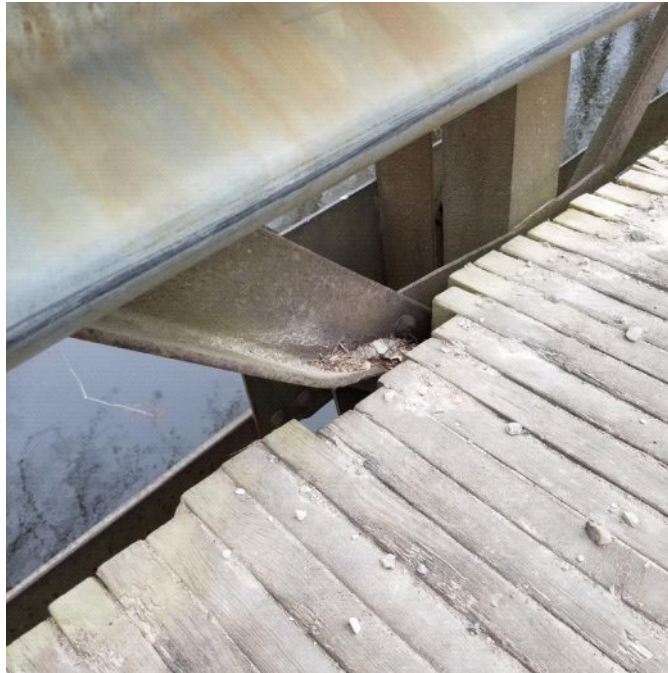
Impact damage on diagonal brace at southeast.

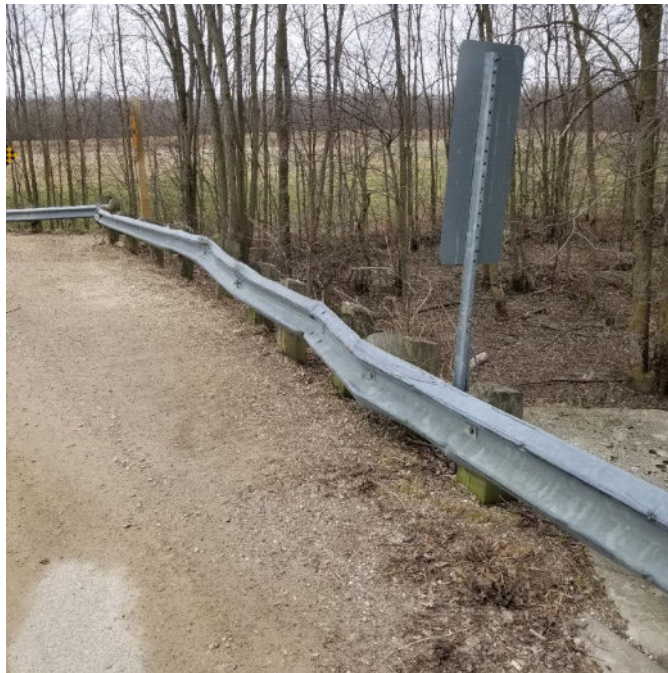
Impact damage and rotation of southeast guide rail.

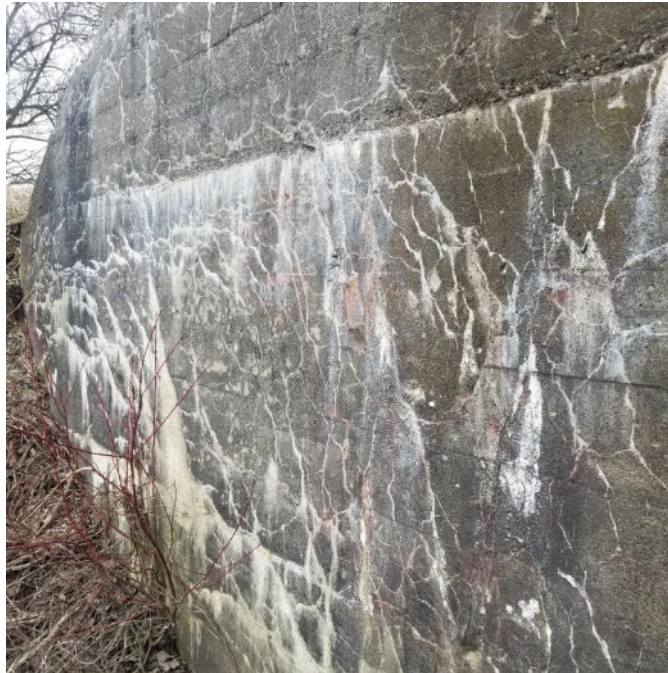
Map cracking with efflorescence at northeast wingwall.

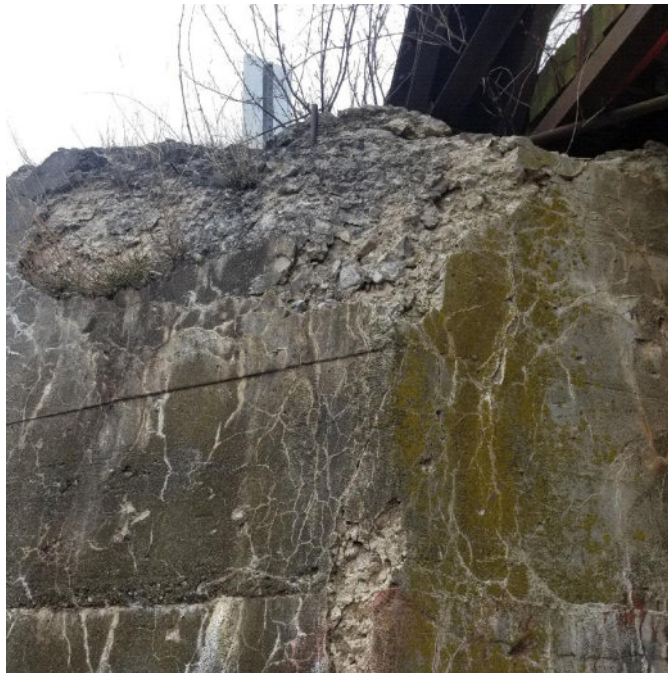
Severe spalling at northeast bearing seat.

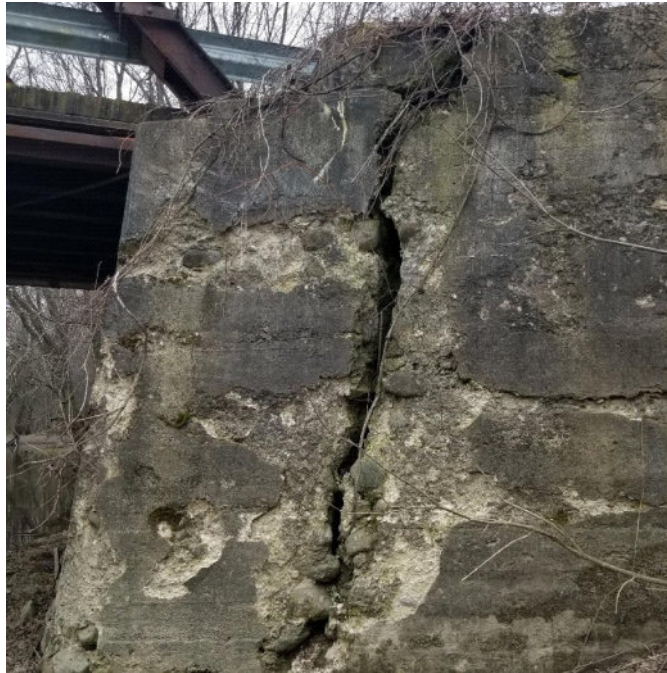
Wide vertical crack with daylight at northwest wingwall.

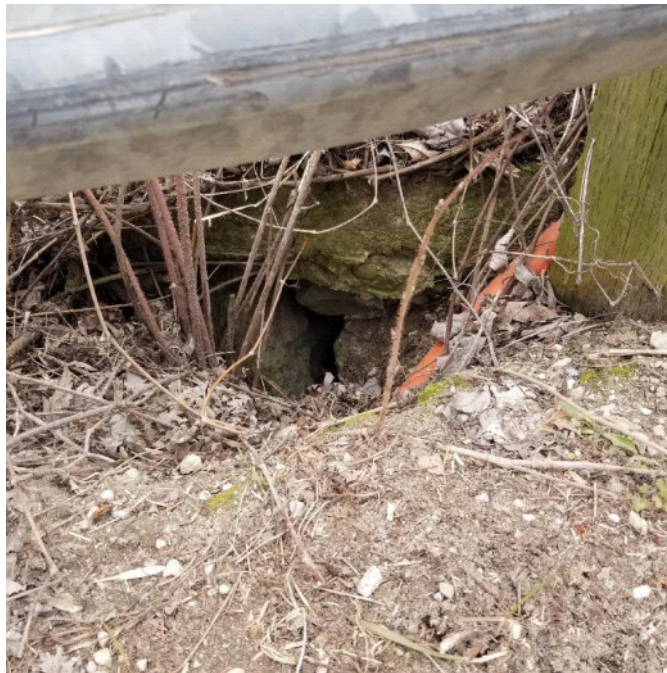
Void in approach at northwest due to wingwall crack.

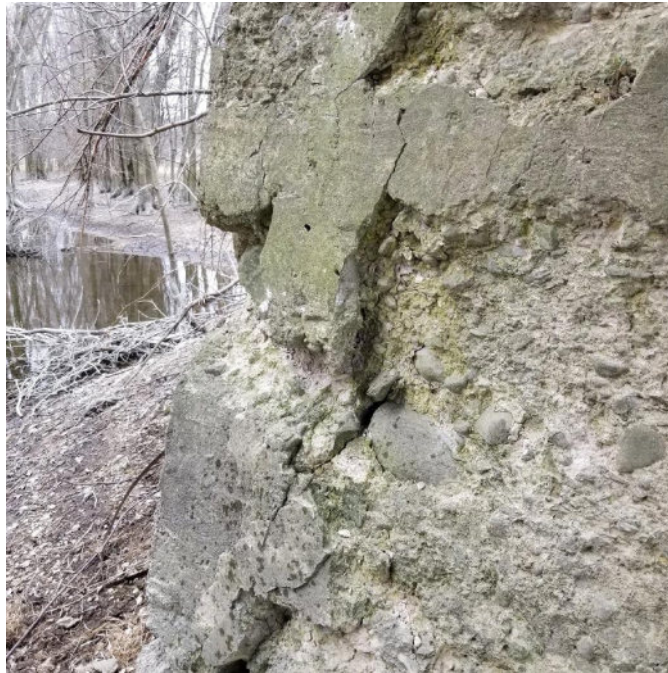
Wide vertical crack at southwest wingwall.

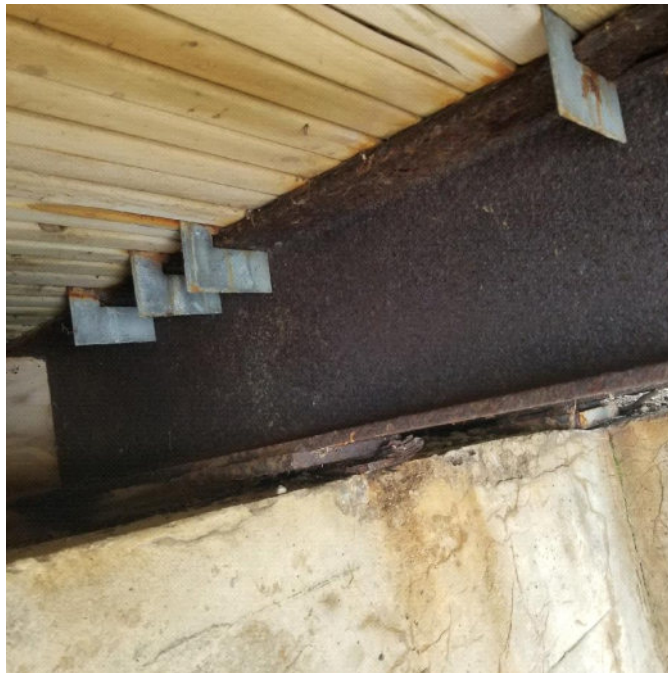
Severe corrosion and section loss of east bearing pad.

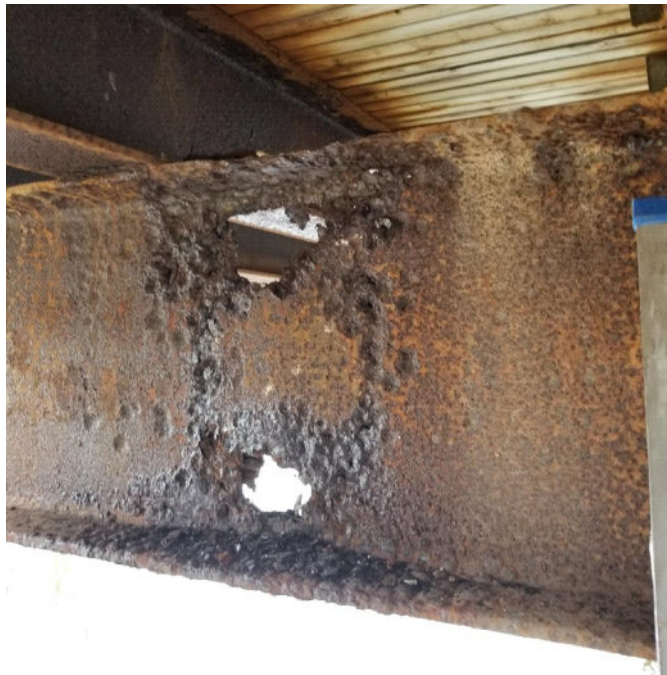
Severe section loss and large perforations at west stringer.

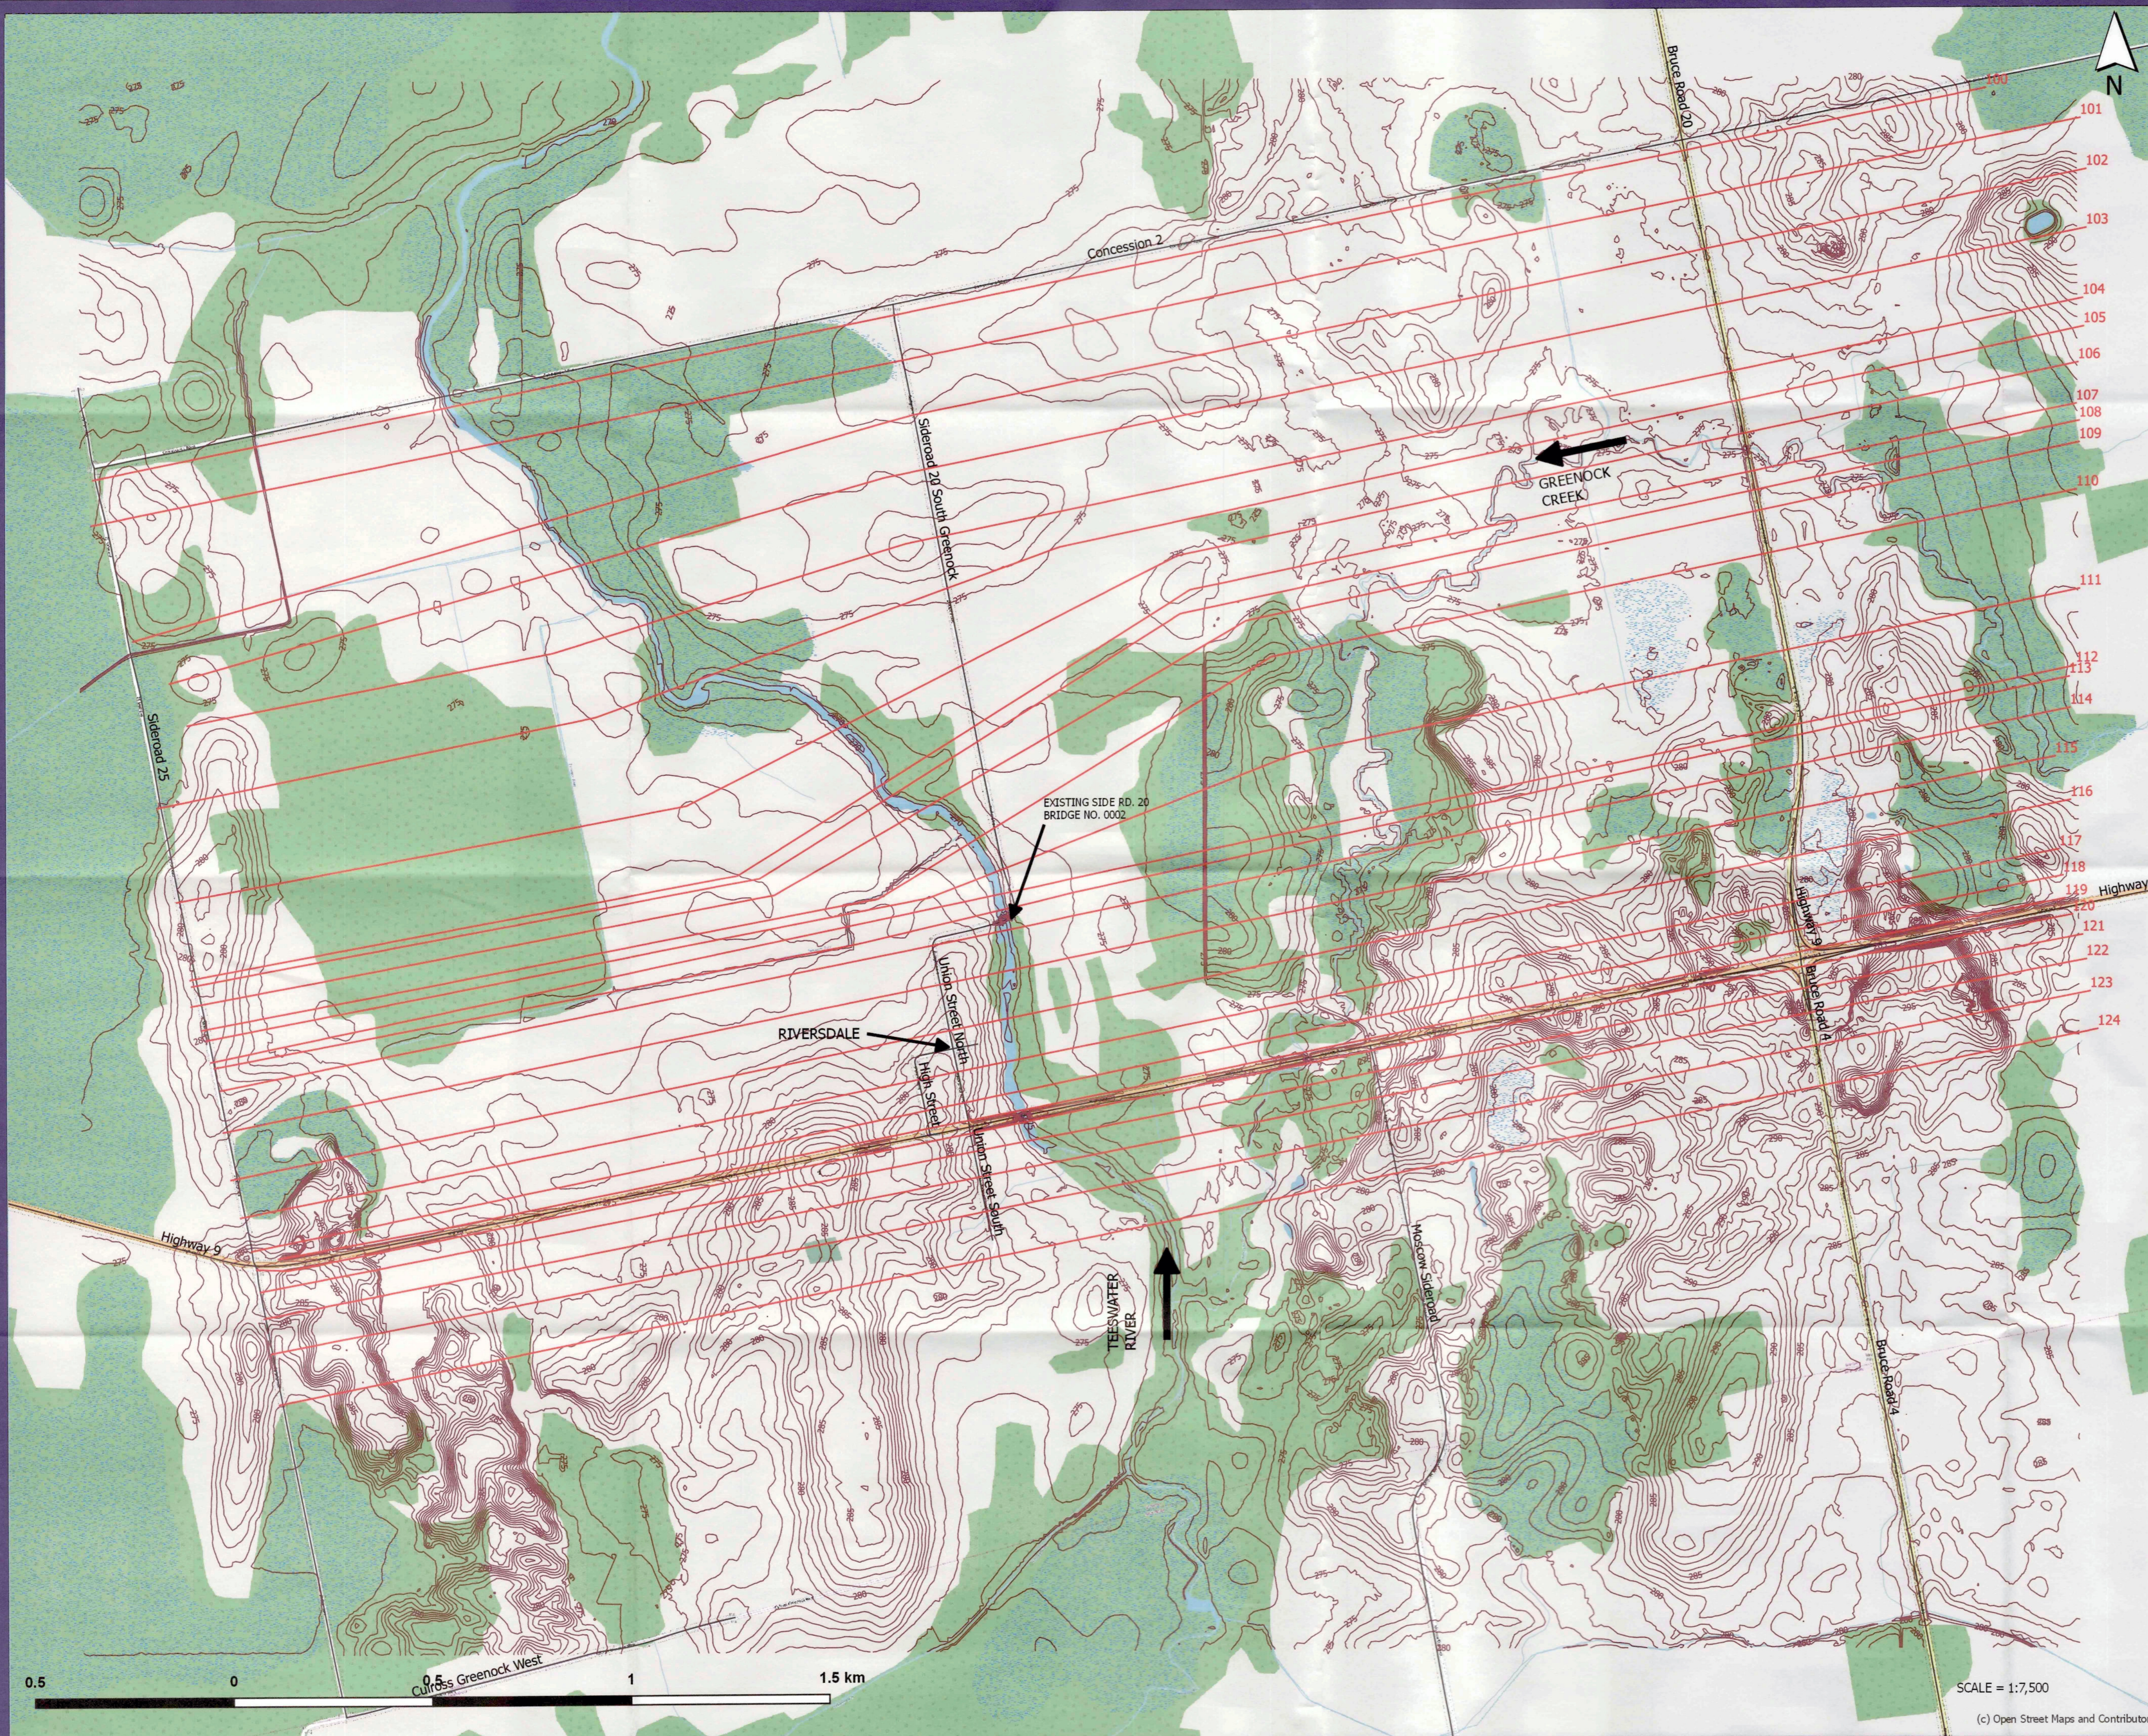
Figure 3 - Flood Model Cross-Section Location Plan

- 124 Flood Model (HEC-RAS) Cross-section
- 1m Elevation Contours
- Roads
- Forest / Woodlands

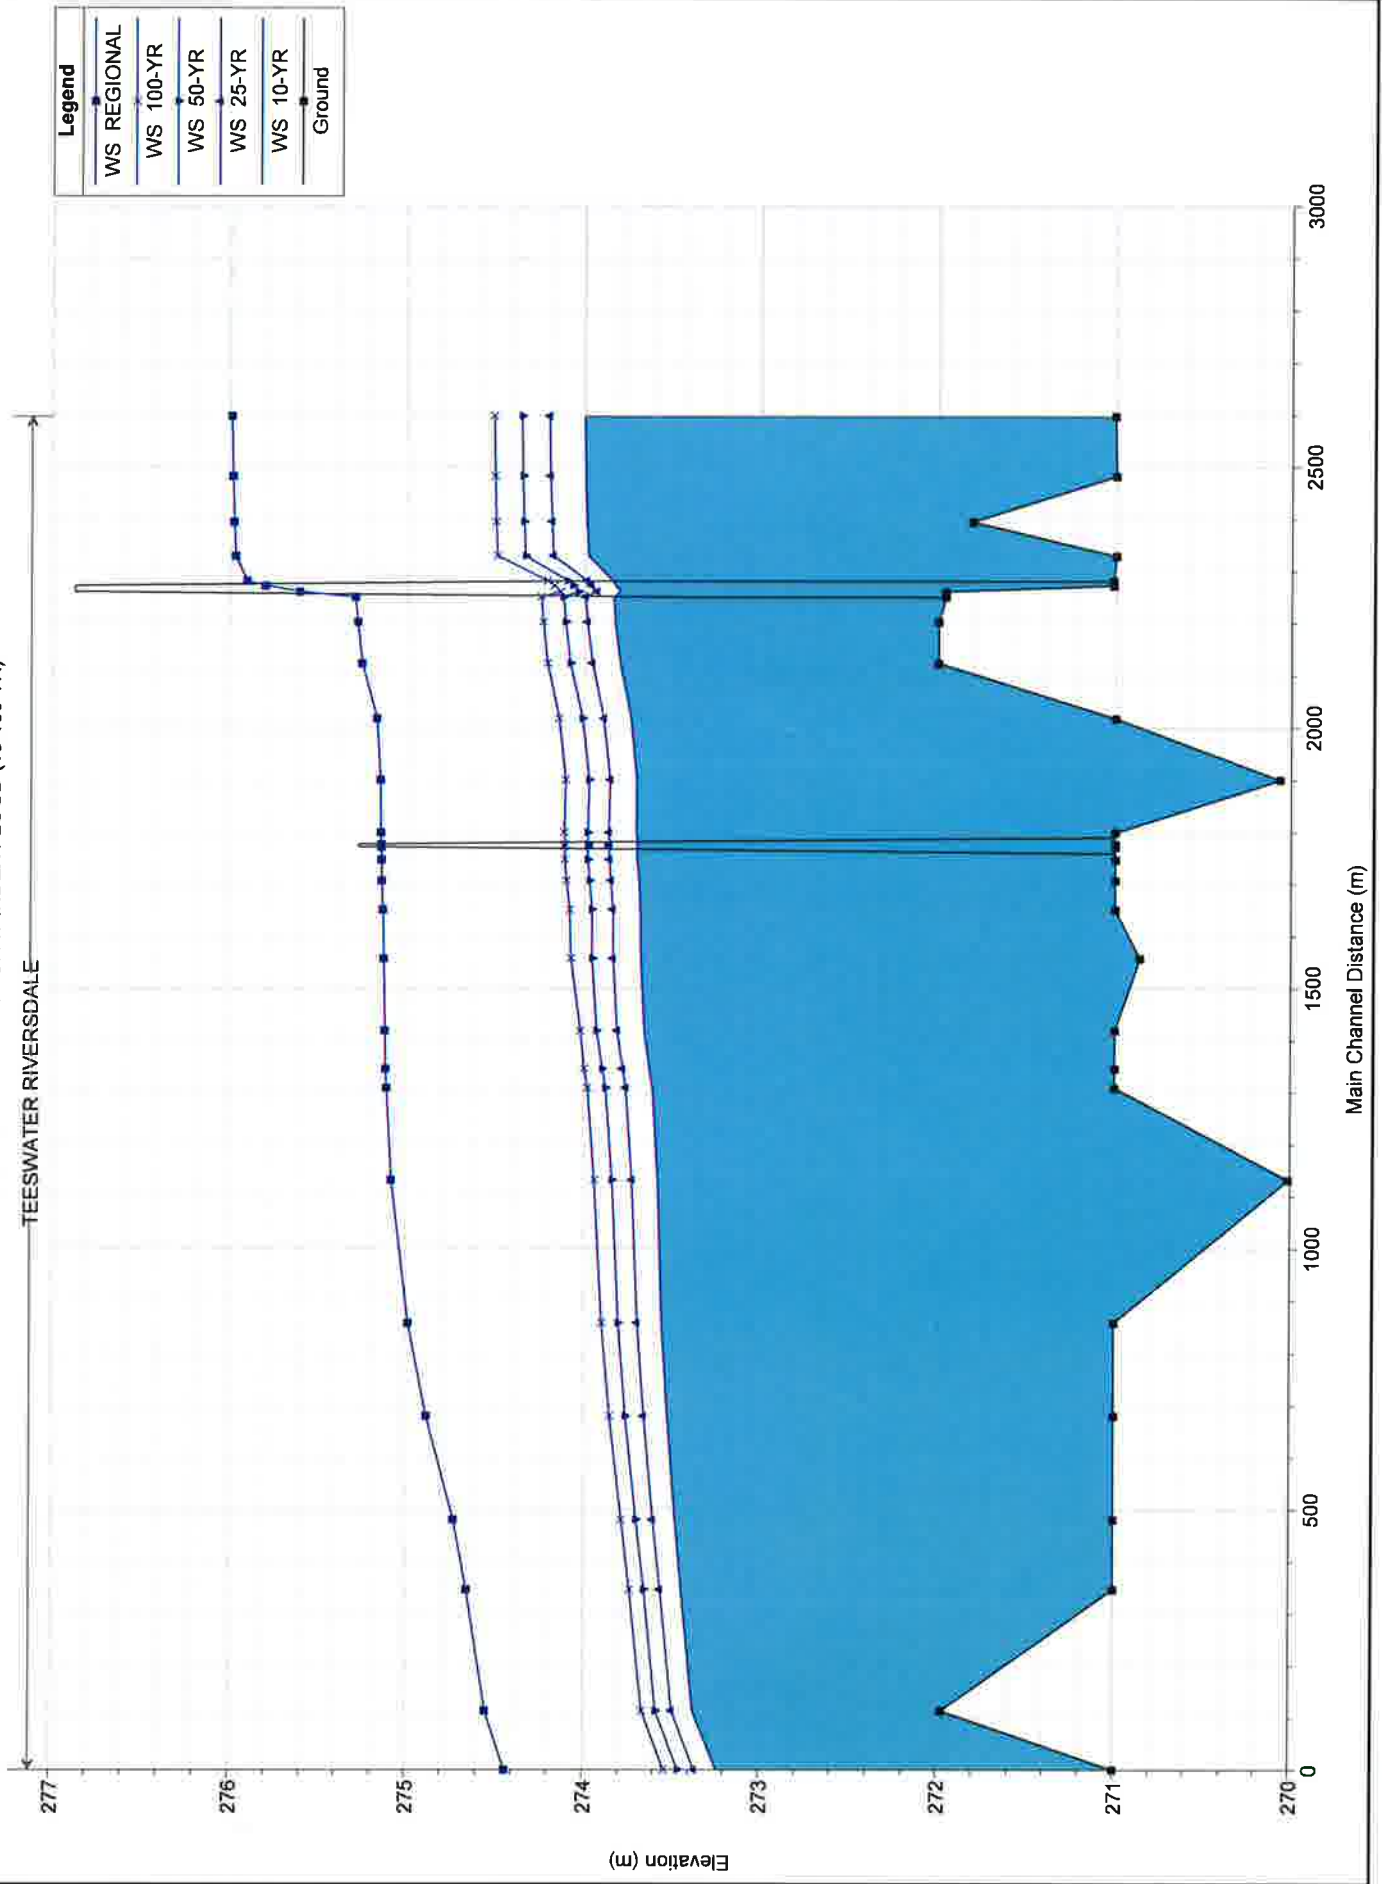
RIVERSDALE Plan: EX - OFAT INDEX 1/23/2018
Geom: EXISTING Flow: OFAT INDEX FLOOD (10-100 YR)

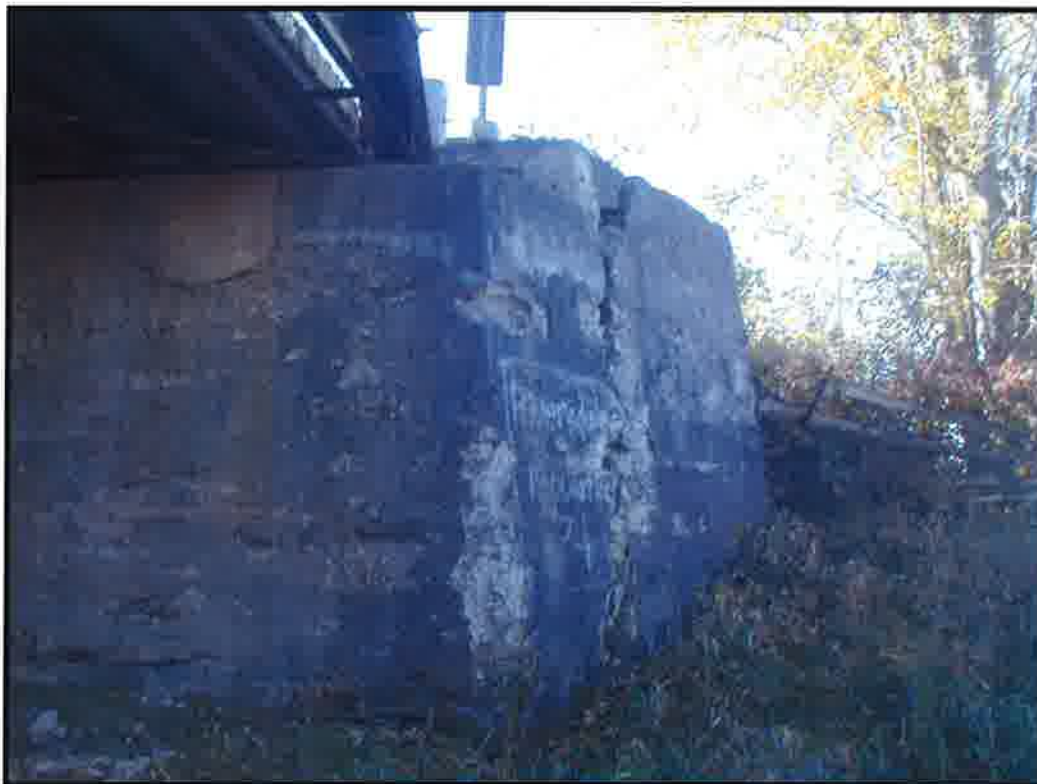
Plate 3 – Large crack in north-east wingwall

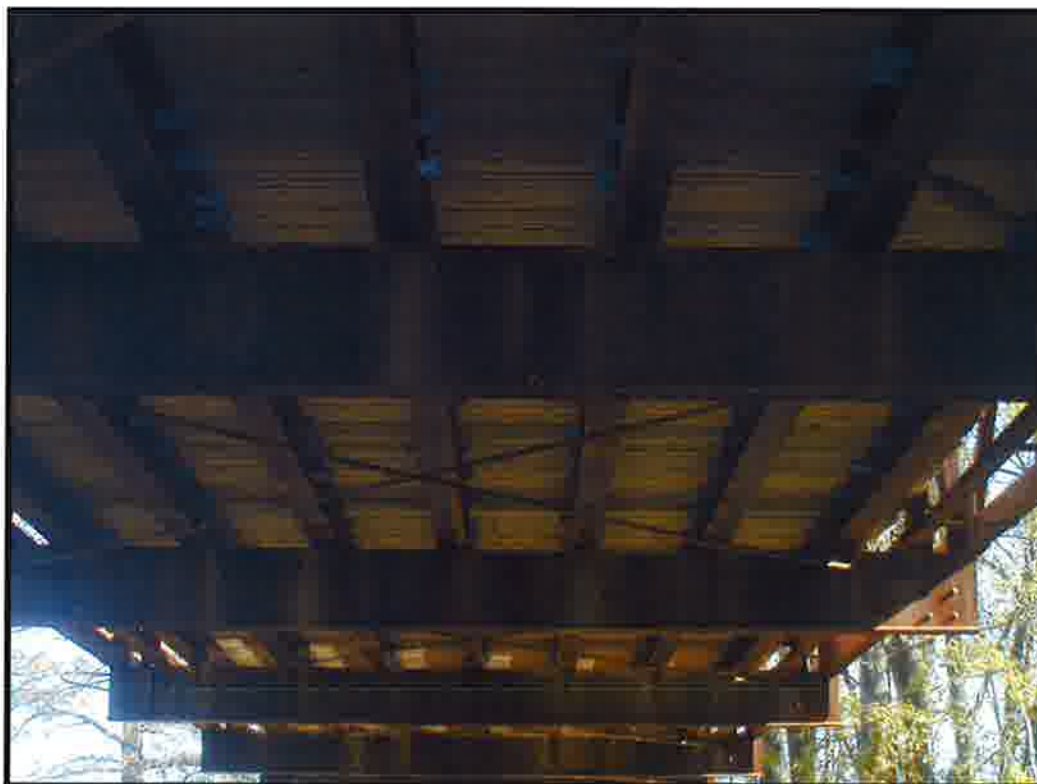
Plate 4 – Cross beams are heavily corroded on underside of deck

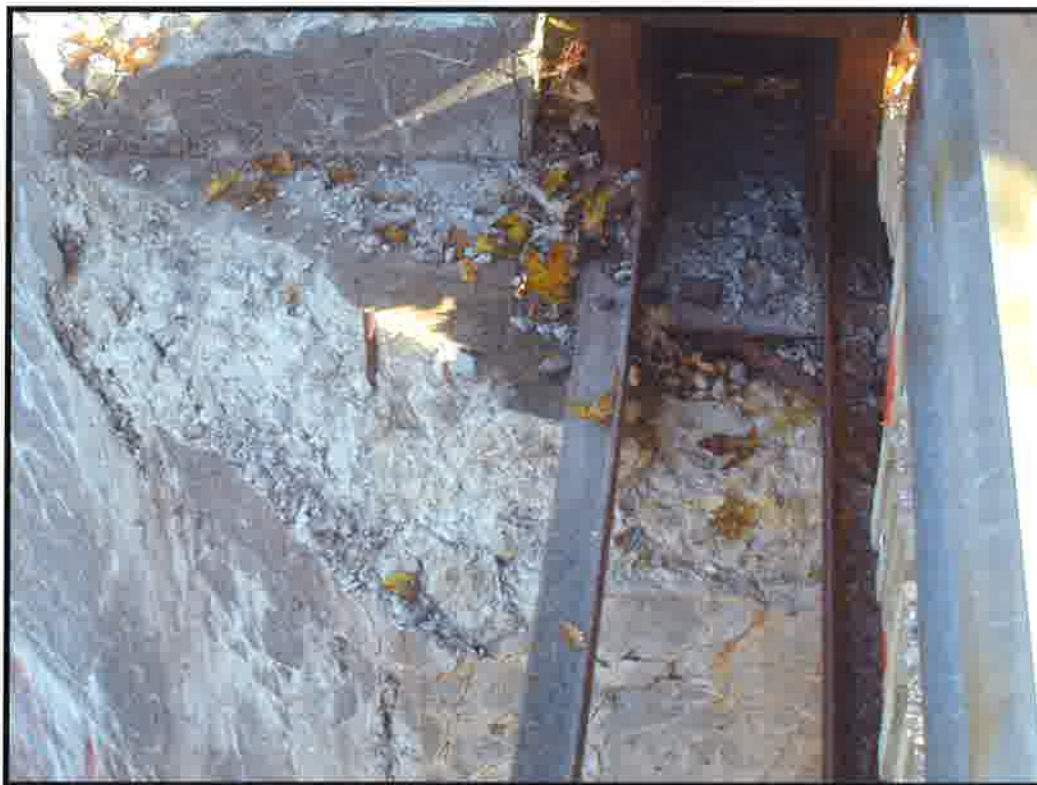
Plate 5 – Wingwall has spalled exposing reinforcing steel.

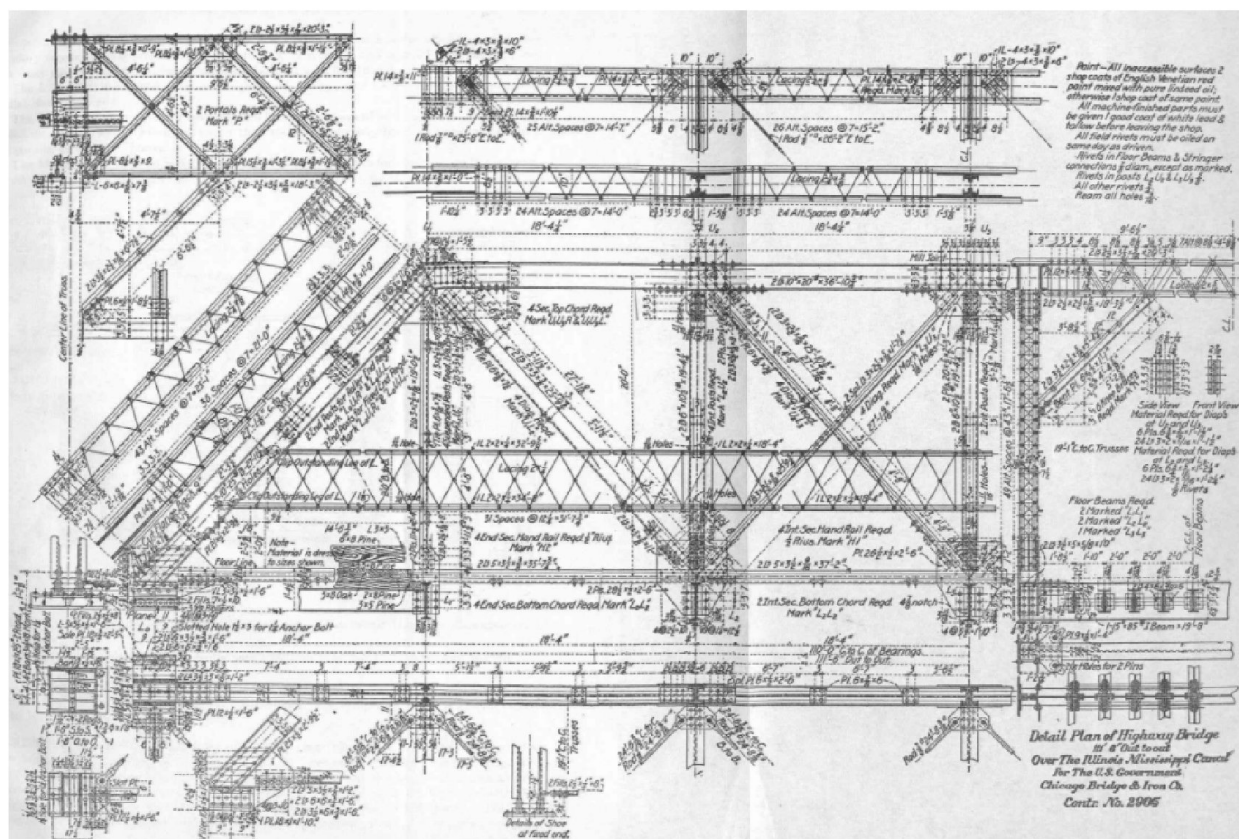
Figure 7: Details of a 111' 6" Through Span
 (http://okbridges.wkinsler.com/technology/truss.html)

The earlier bridge was replaced in the twentieth century, most probably in 1905, by a 125-foot (~38 metres) “riveted Pratt truss steel bridge” constructed by the Hunter Bridge & Boiler Company for the sum of \$1,925.00 (Gateman 1981: 96). A truss design bridge did not require any intermediate piers, which would have been subject to the ravages of regular flooding and ice jams in the river. While Hunter Bridge and Boiler Company built the superstructure of the bridge, it is likely (although no records have been found as yet to support this supposition) that the abutments were built by another company.

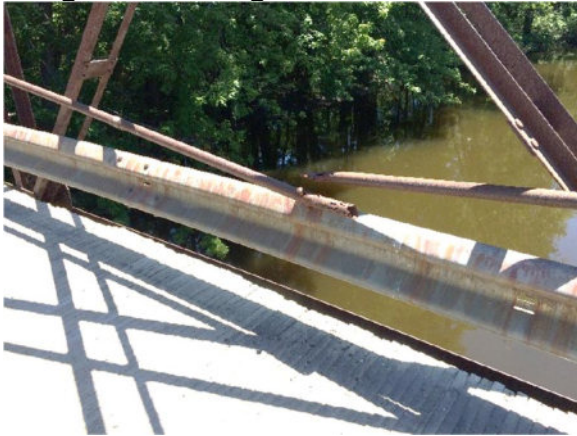
Image 17: Repair Work on Upper Framework, East End

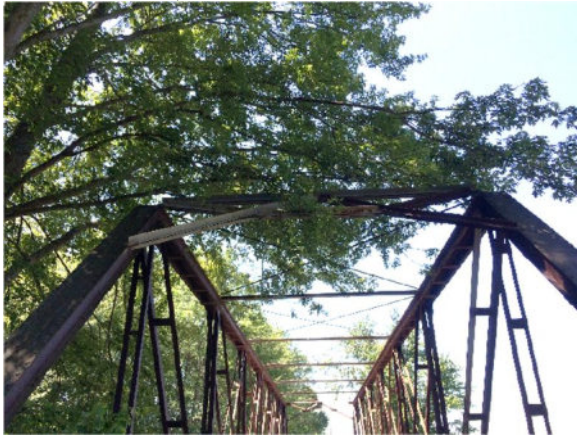
Image 18: Riveted Connection Showing Inclined End Post, Top Chord, Vertical Post

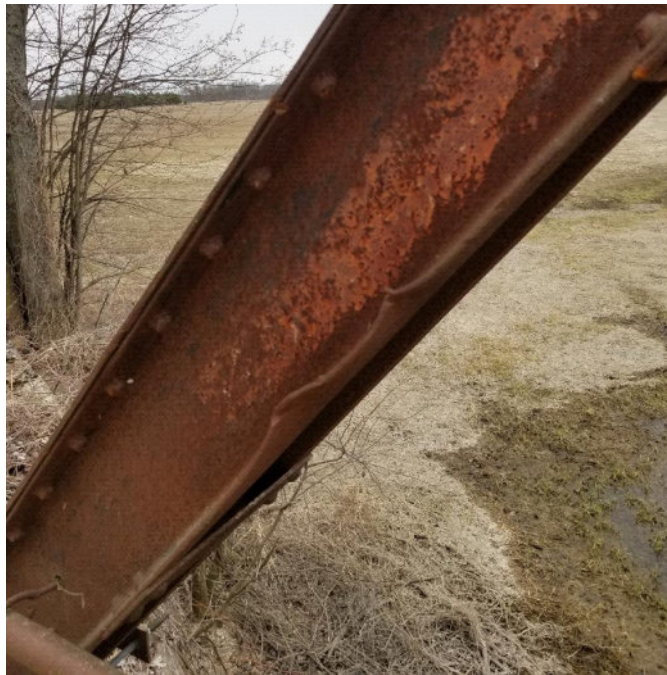
Impact damage on top chord at southeast.

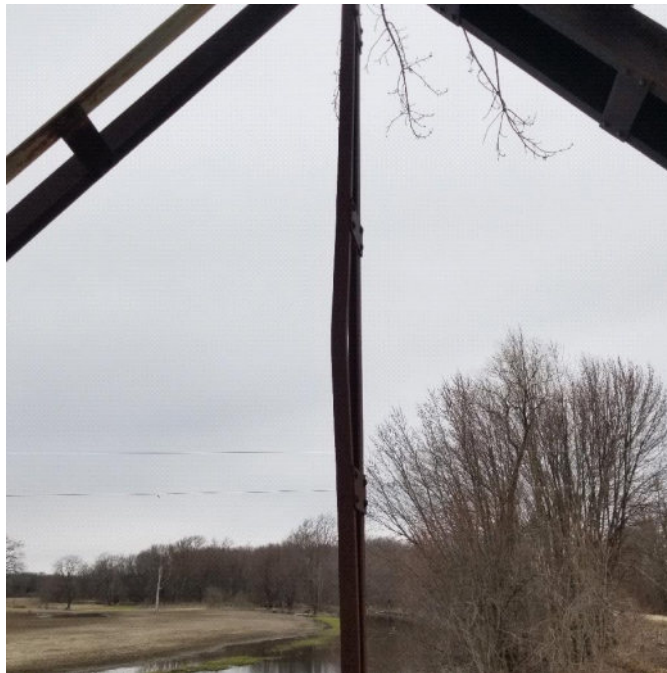
Permanent deformation of vertical web at northeast.

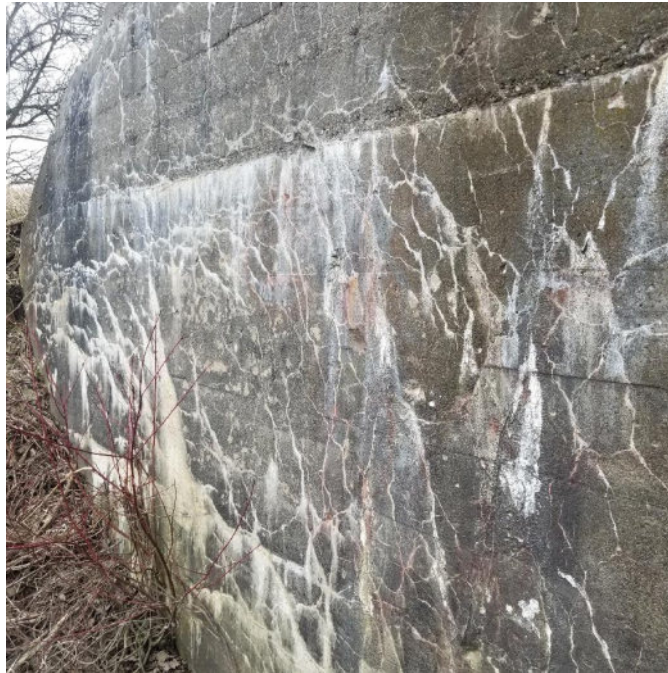
Map cracking with efflorescence at northeast wingwall.
