Municipality of Brockton Greenock Structure No. 0002

Schedule 'B' EA Project File (Version 1)

GMBP File: 212326

October 22, 2020

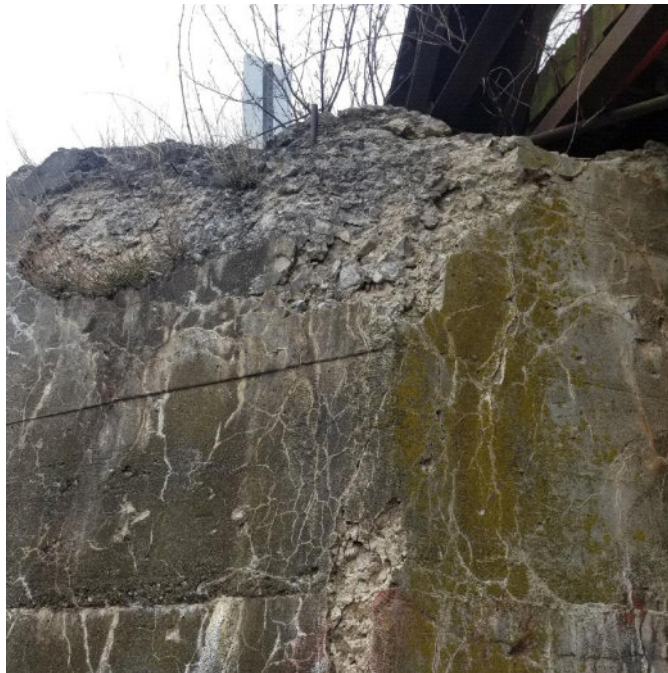
Severe spalling at northeast bearing seat.

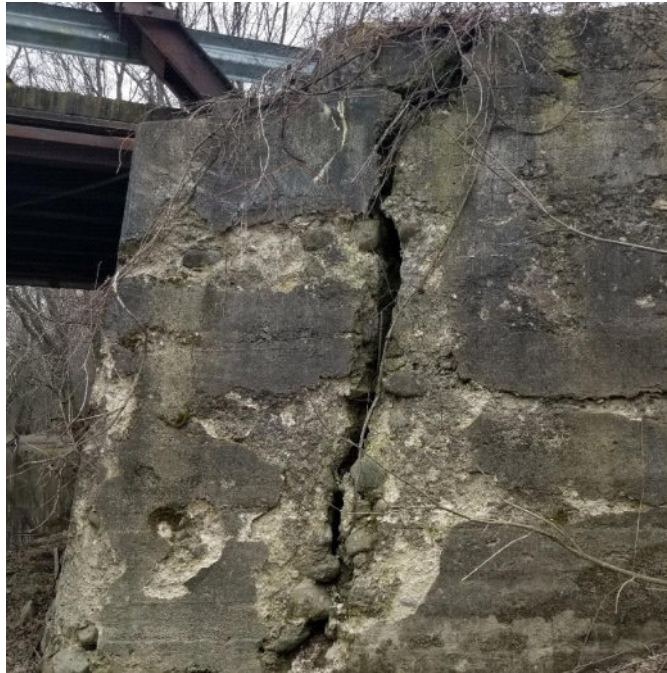
Wide vertical crack with daylight at northwest wingwall.

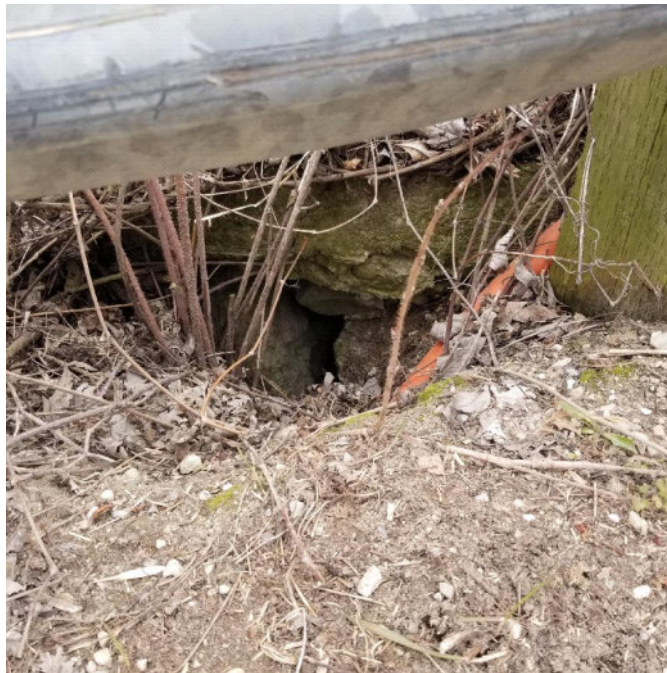
Void in approach at northwest due to wingwall crack.

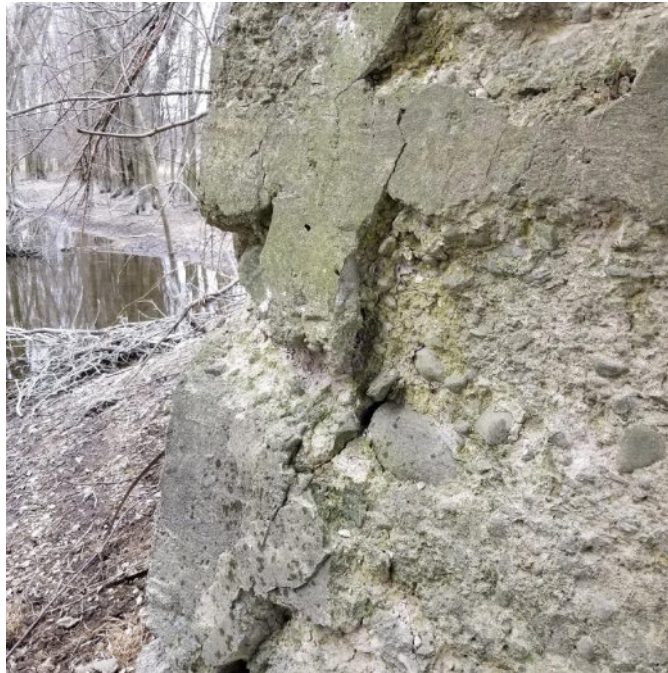
Wide vertical crack at southwest wingwall.

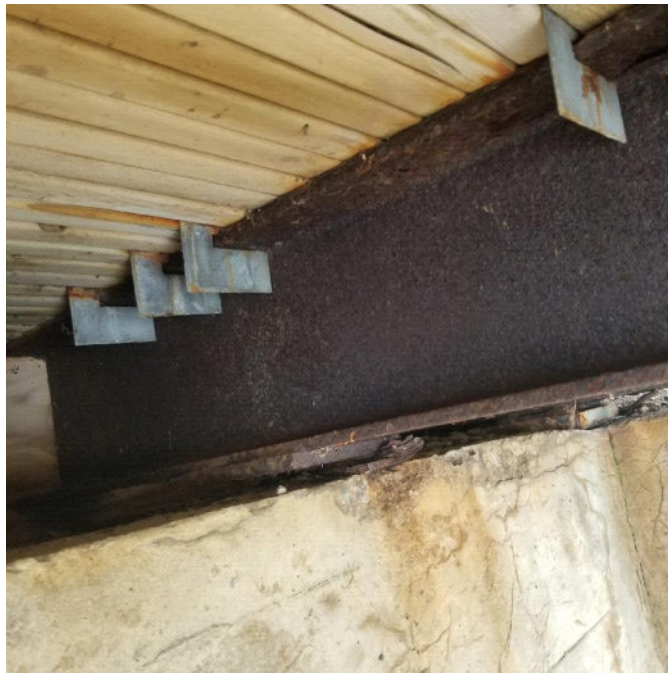
Severe corrosion and section loss of east bearing pad.

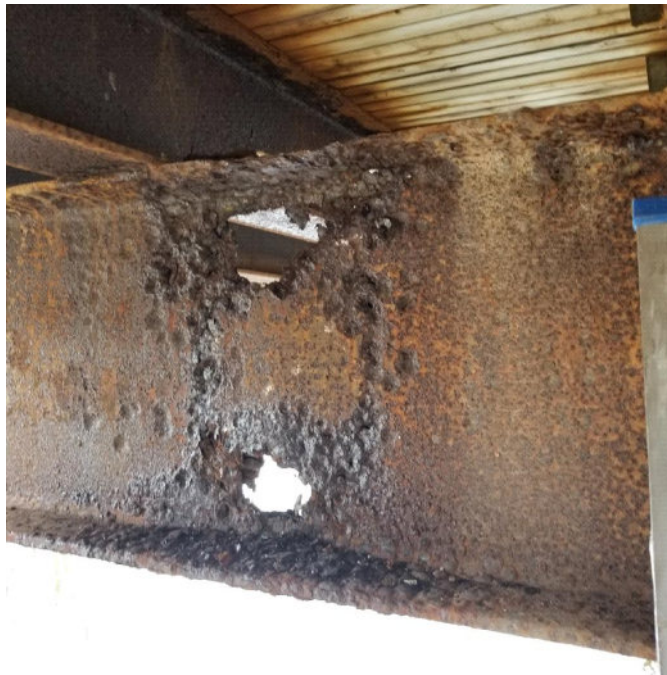
Severe section loss and large perforations at west stringer.
