Keldon Bridge

(Hooker Bridge)
(ELGV Bridge #1)

General Information	Physical Details
Bridge No. GV1	Type: Concrete Bowstring Arch
Ownership: Town of Grand Valley	Span: Single
Construction Date: 1929	Dimensions: 16.4m x 5.5m (LxW)
Water Crossing: Mud Creek	Materials: Reinforced Concrete

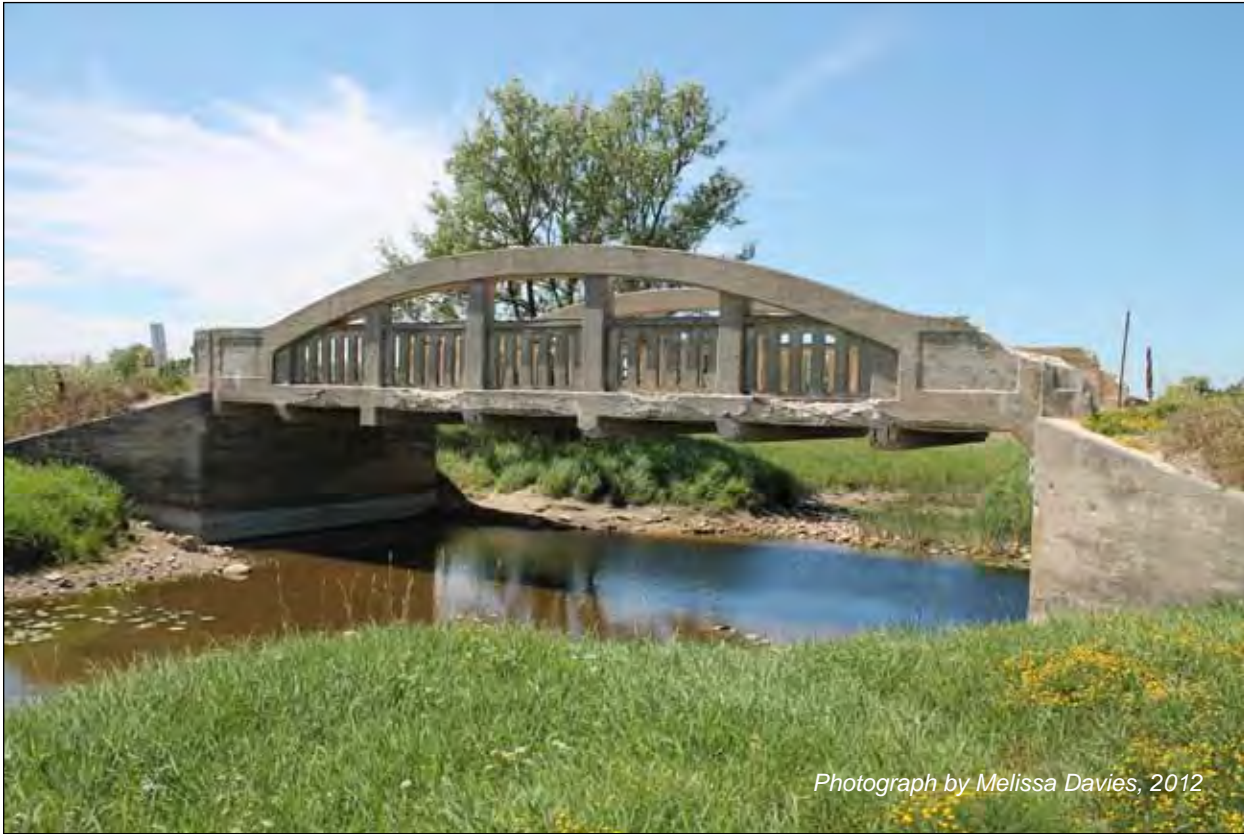
Photograph by Melissa Davies, 2012

While of a basic type, there is considerable variety among bowstring truss structures. The concrete trusses on the Keldon Bridge are shallow and thick. Solid railing walls merge into the arch and display decorative embossed squares and a slightly protruding capped end post. Due to damage, only the southwest end post remains. The railings located in the centre of the arch are open balustrades that span between each stringer. The thin board finish is still visible in the concrete.
