County of Elgin

# Meeks Bridge Replacement Municipal Class Environmental Assessment

Project File Report

September 2020

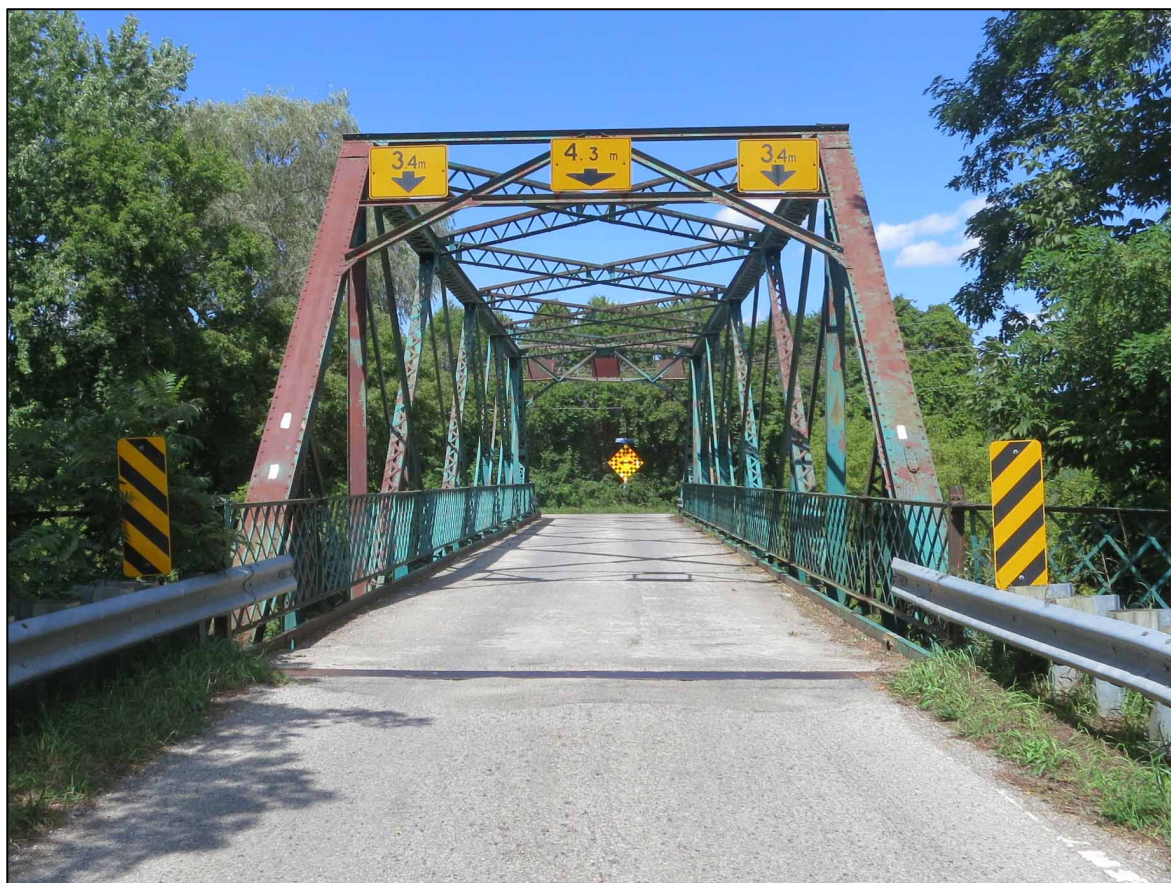
The single span Meeks Bridge, County No. B-24, over Kettle Creek in the Township of Southwold is classified as a through steel truss, double-intersection Warren truss (**Figure 4**). The abutments are constructed of cast-in-place concrete. The steel truss was fabricated in 1900 and the connections are rivetted.

Figure 4. View looking north on Sparta Line CR 27 to the south portal of Meeks Bridge located in the Township of Southwold, County of Elgin, Ontario.

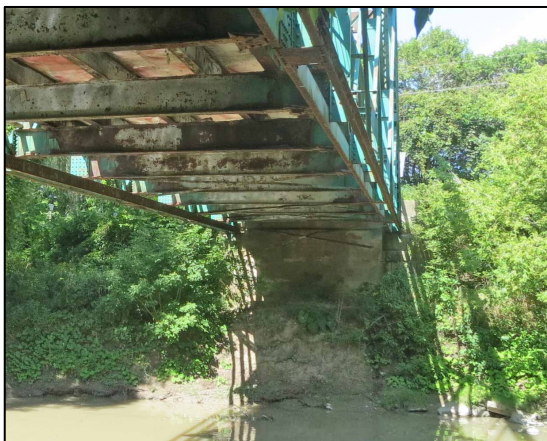
North bridge abutment.

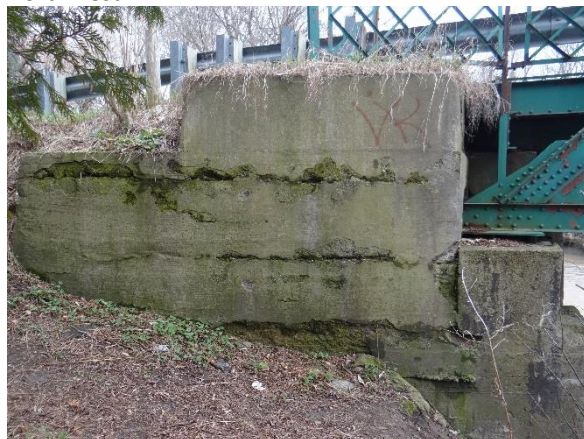
Plate 6: East face of south abutment, looking west.

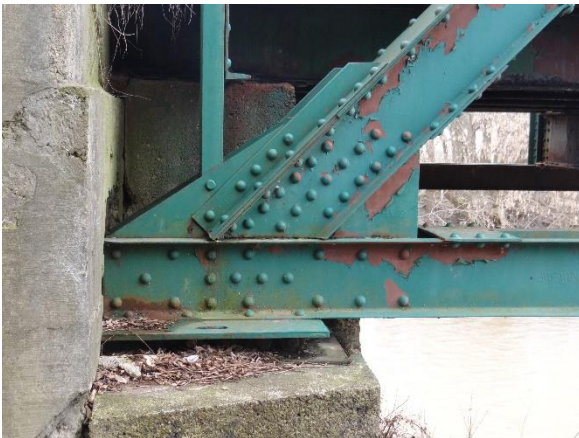
Plate 7: Detail of the bearing on southeast corner of the structure, looking west.

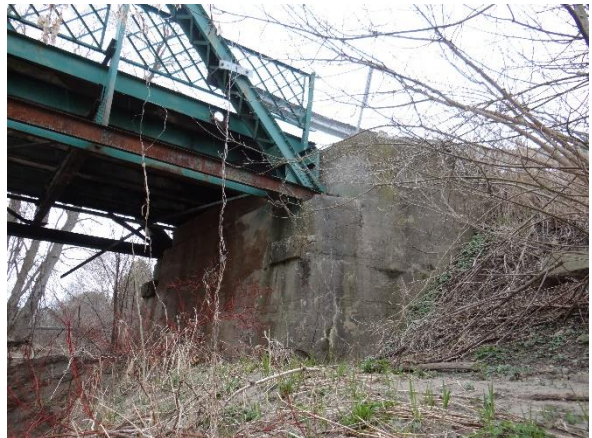
Plate 8: North abutment, looking northwest.

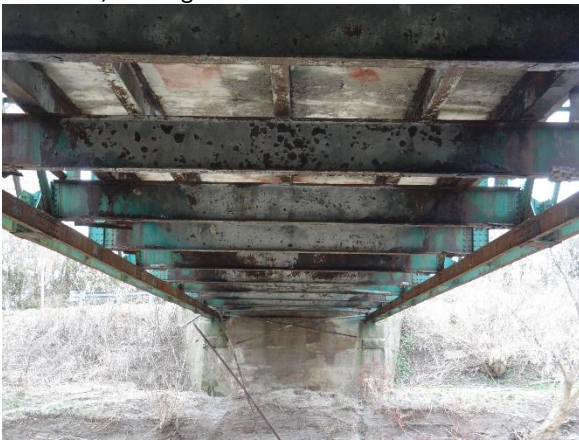
Plate 9: Deck soffit and floor beams, looking north towards the north abutment.

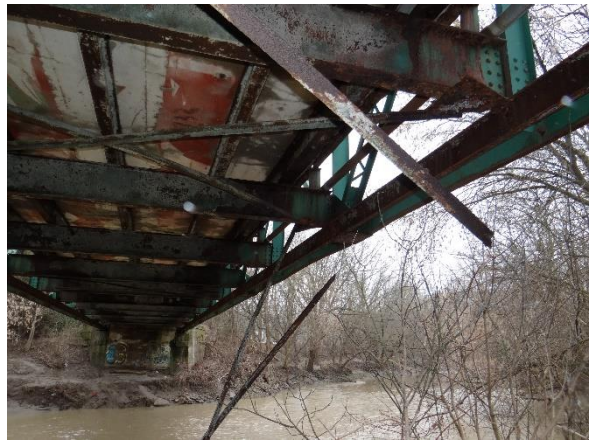
Plate 10: Damaged bracing supporting floor beams in the north portion of the structure, looking southwest

- The bridge currently has a load posting of 8 tonnes due to the structural capacity of truss bottom chords (2- C230 X 20) and transverse beams (W460 X 67);
- Underside bracing has fallen off on numerous panels and the remainder is corroded;
- Existing deck is cast-in-place concrete, and existing abutments are sitting on spread footings; and
- The 2019 inspection report recommended rehabilitation in 1-5 years and replacement in 6-10 years.

- Steel truss structure's bottom chords (2xC230) and floor beams (W460x67) exhibit section loss due to rusting and deterioration. Most floor system cross bracing members have fallen off on numerous panels and also have section loss;
- Typically, steel manufactured circa 1900 has a significantly lower yield strength than modern steels. The specified yield strength is most likely 180 MPa compared to 350 MPa minimum required strength and this dramatically affects the structural capacity of the bridge;
- Concrete deck exhibits spalling, cracking and severe scaling;
- Abutment condition and age of concrete used on the substructure creates a challenge for rehabilitation. Based on the year the bridge was built, the substructure concrete would not have been air-entrained and is prone to spalling and scaling due to corrosion of reinforcing bars and freeze thaw action.

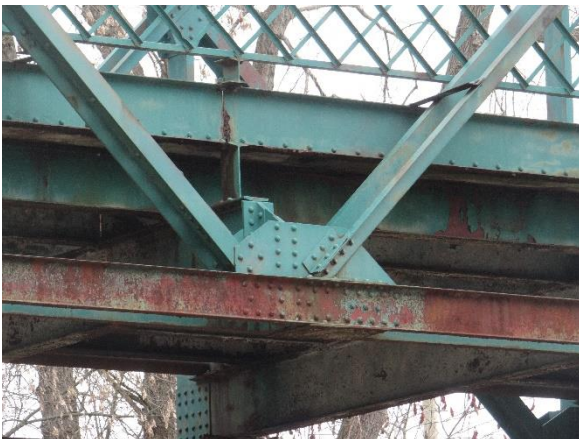
Plate 11: Representative gusset plate with riveted connections to truss diagonals on the east elevation, looking west.

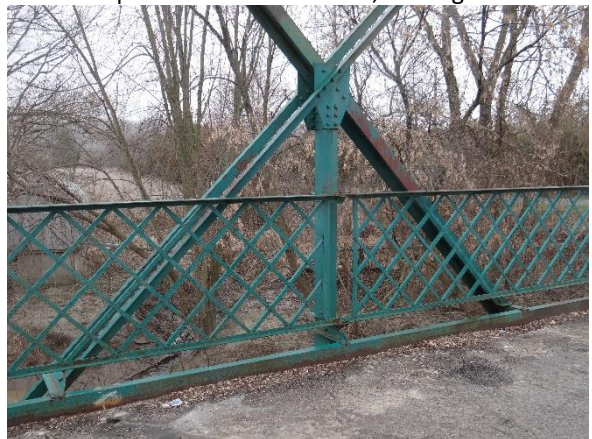
Plate 12: Representative metal lattice railing at deck level.

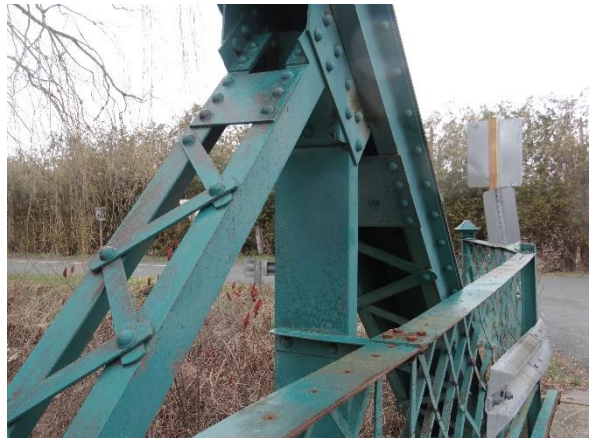
Plate 14: Detail of components in end post on the northwest corner of the bridge, looking northwest.

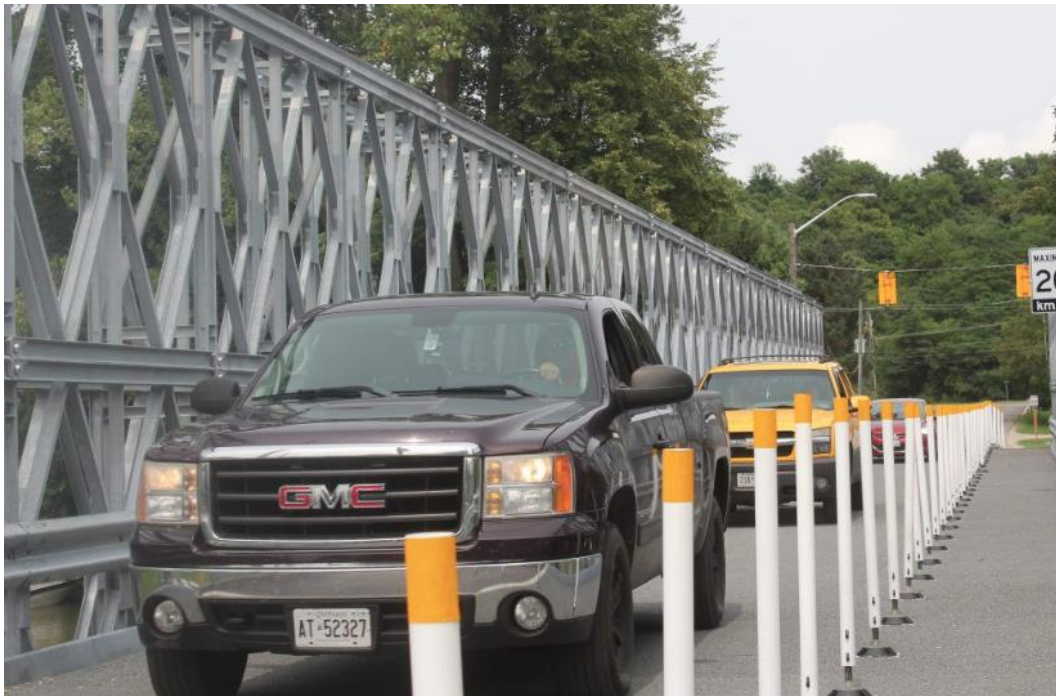
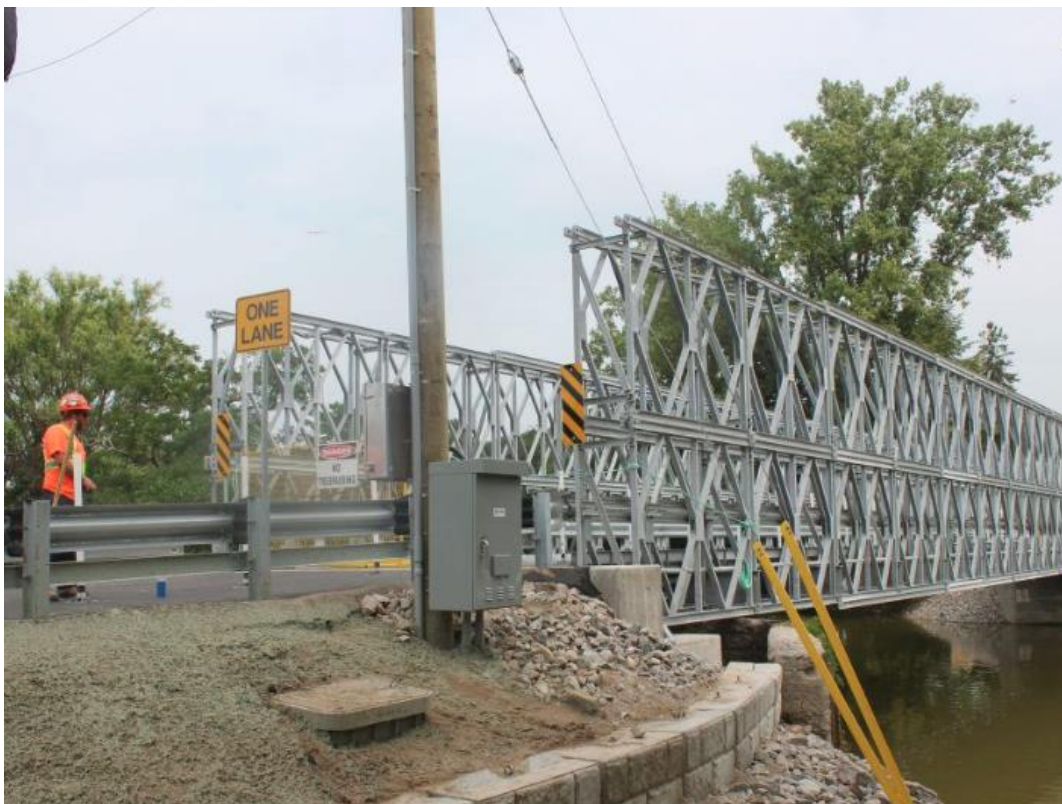
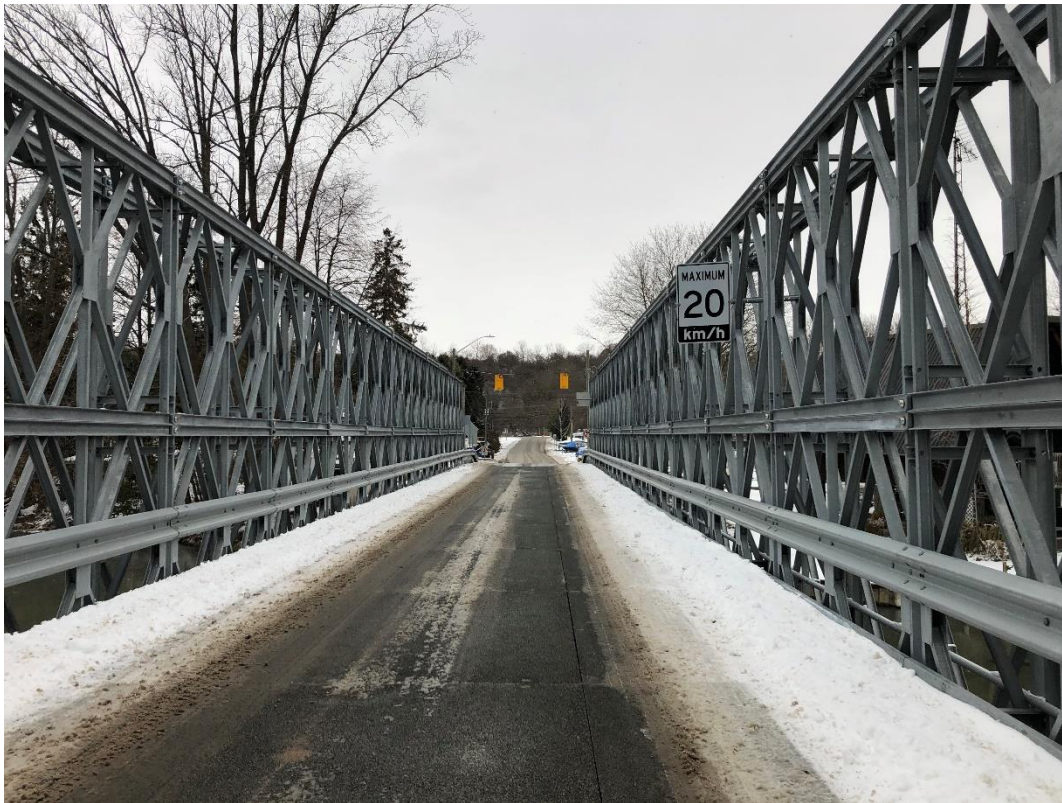
Figure 4: Modular panel bridge in Port Bruce that is anticipated to replace the Meeks Bridge, shown carrying traffic in Port Bruce (Broadley, August 20, et al. 2018)

Figure 5: Modular panel bridge in Port Bruce that is anticipated to replace the Meeks Bridge, shown carrying traffic in Port Bruce (Broadley, August 15, et al. 2018)

Figure 6: Modular panel bridge in Port Bruce that is anticipated to replace the Meeks Bridge  
(Photo courtesy of CIMA+)

It is proposed to use the existing Acrow Port Bruce temporary modular bridge as the replacement structure for Meeks Bridge (if Alternative 3 is selected as preferred) given that a new structure is currently being constructed at Port Bruce and the temporary modular bridge is a suitable structure for the Meeks Bridge location. The Port Bruce temporary modular bridge's length and width can be adjusted to provide various lane widths for traffic and shoulder width for pedestrians. The modular bridge is available in 10-foot increments. Two options for the span of the Meeks Bridge replacement were considered:
