Engineering News-Record

Design of Great International Suspension Bridge Over Detroit River

Unusual Anchorages—Unloaded Backstays on 1,850-Ft. Span—Towers, Lacking Full-Height Stability Before Placing Cables, Are Braced by Approach

BY JONATHAN JONES

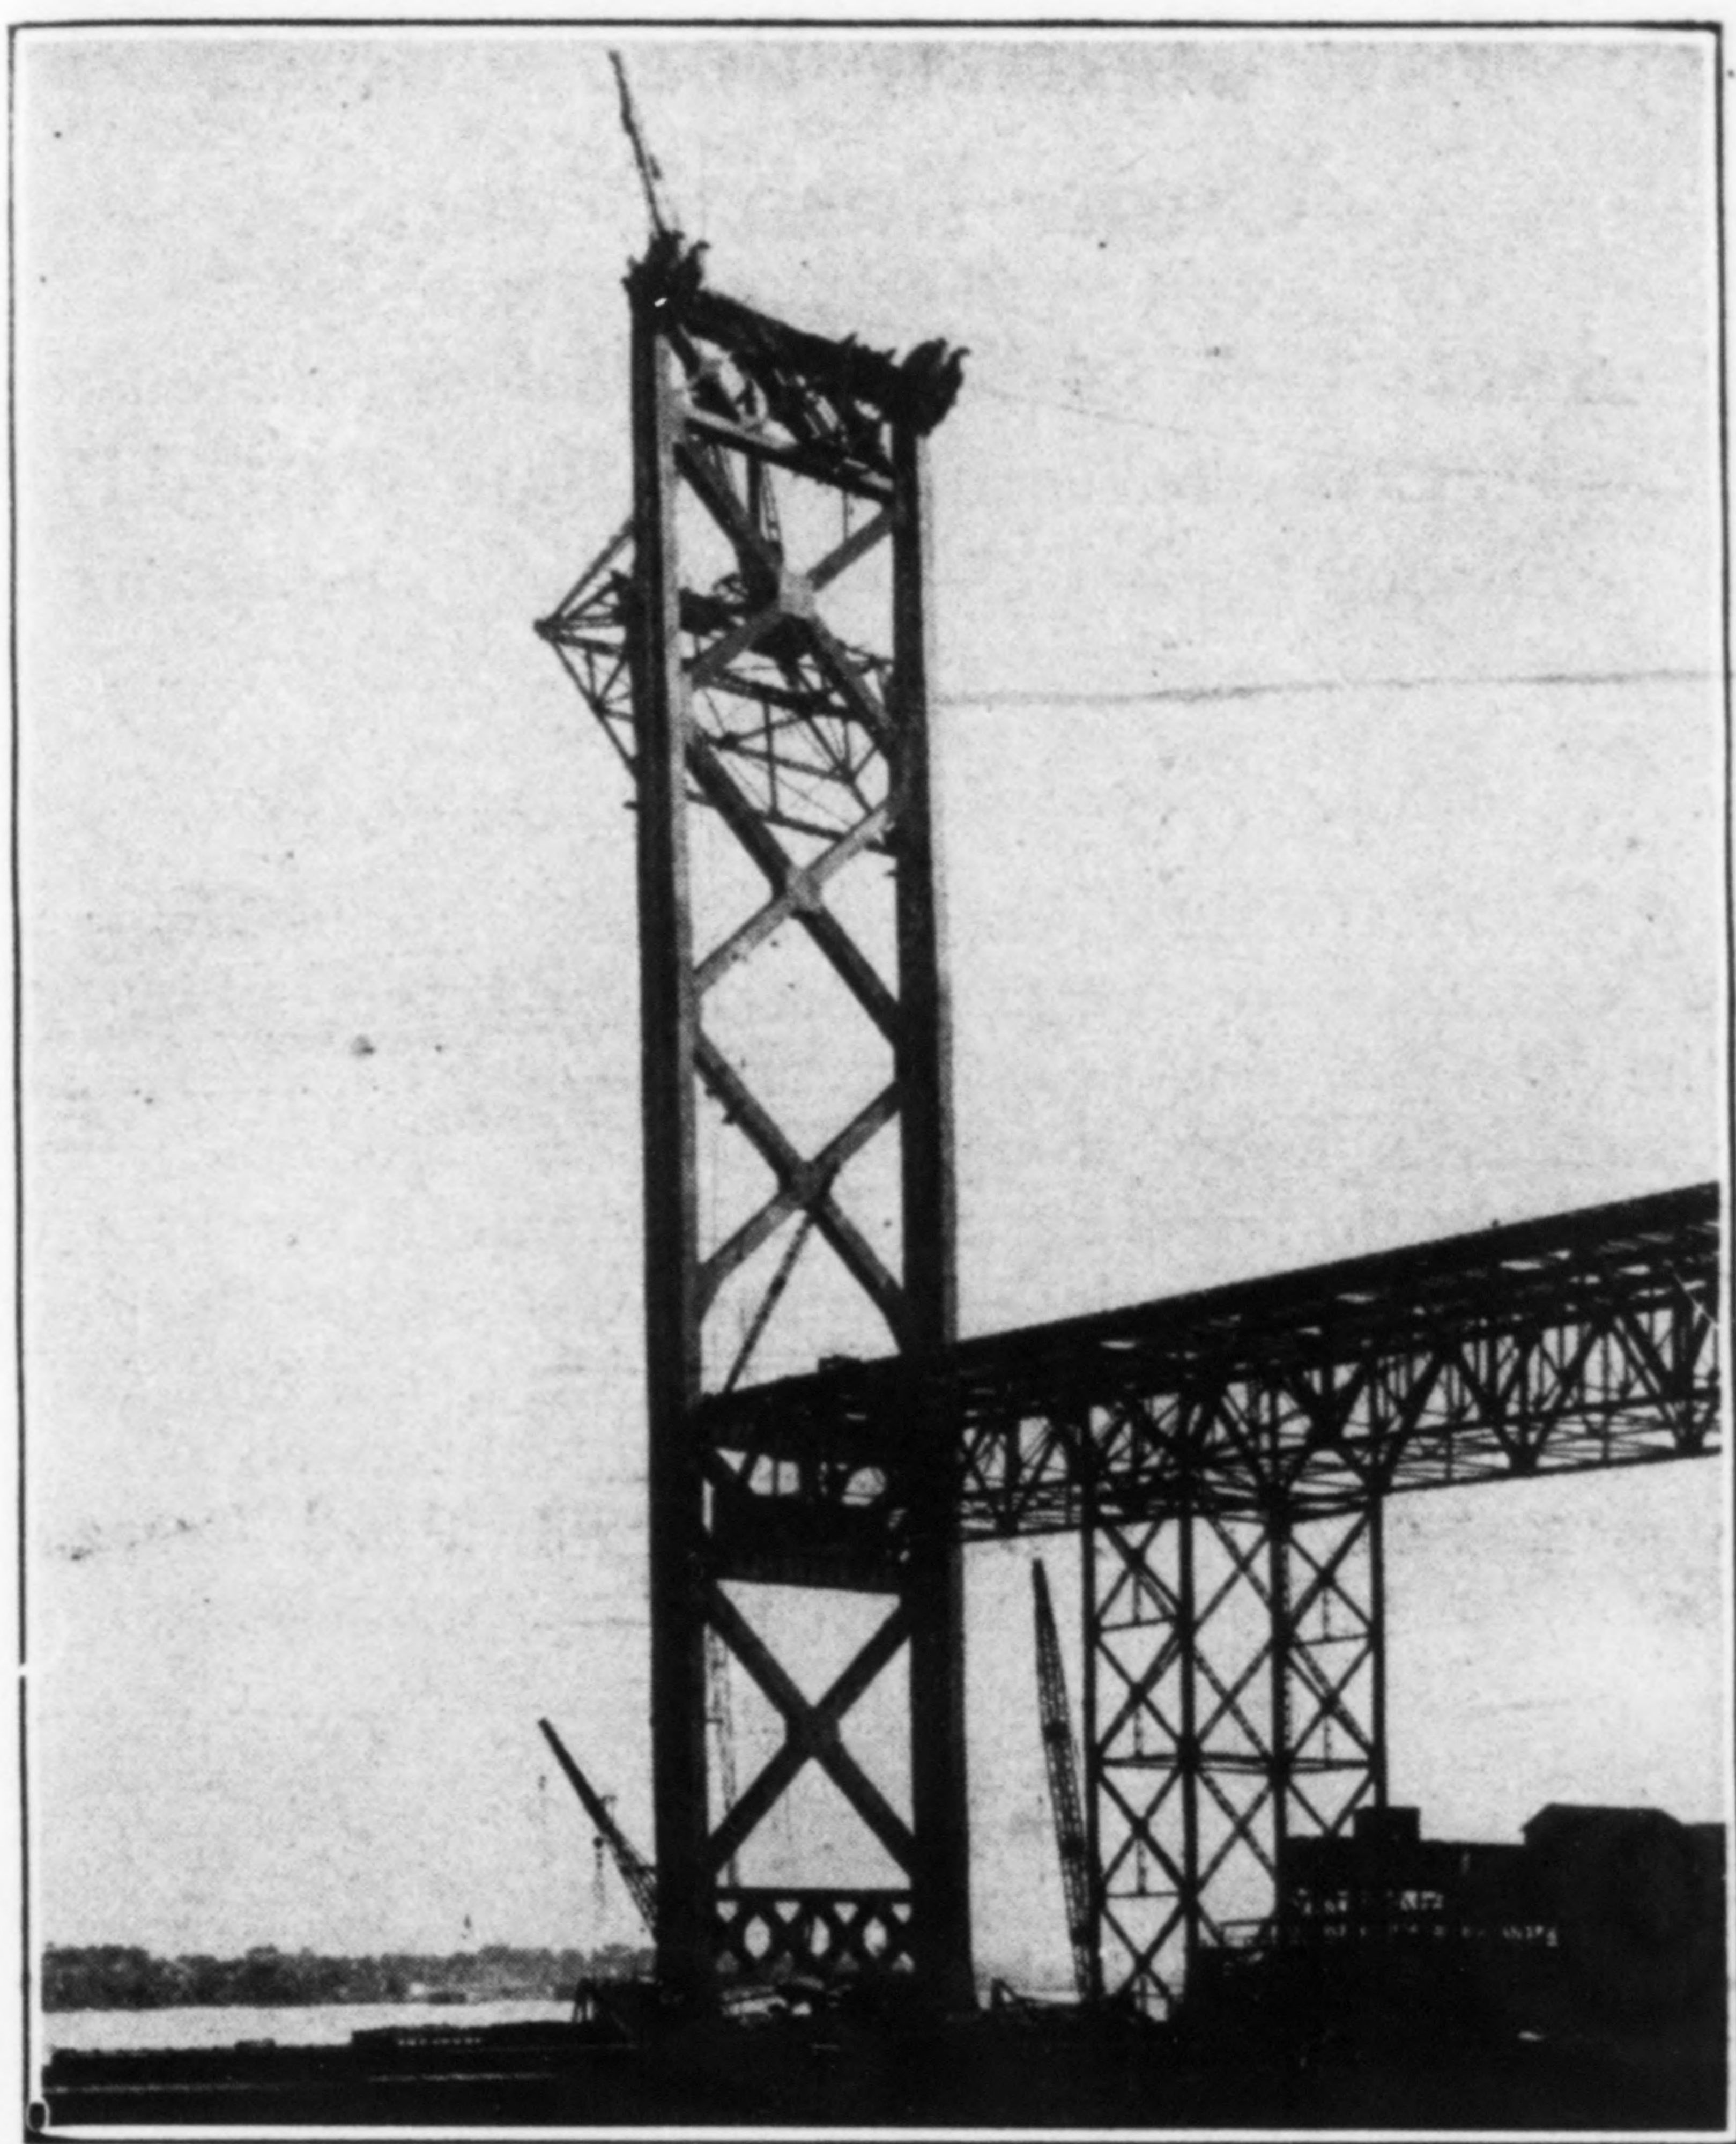
FIG. 8—UNITED STATES TOWER COMPLETE WITH FOOTWALK CABLES IN PLACE

The second tower was completely erected 11½ months after the contract went into effect and the footwalk ropes were hoisted to place on Aug. 8.

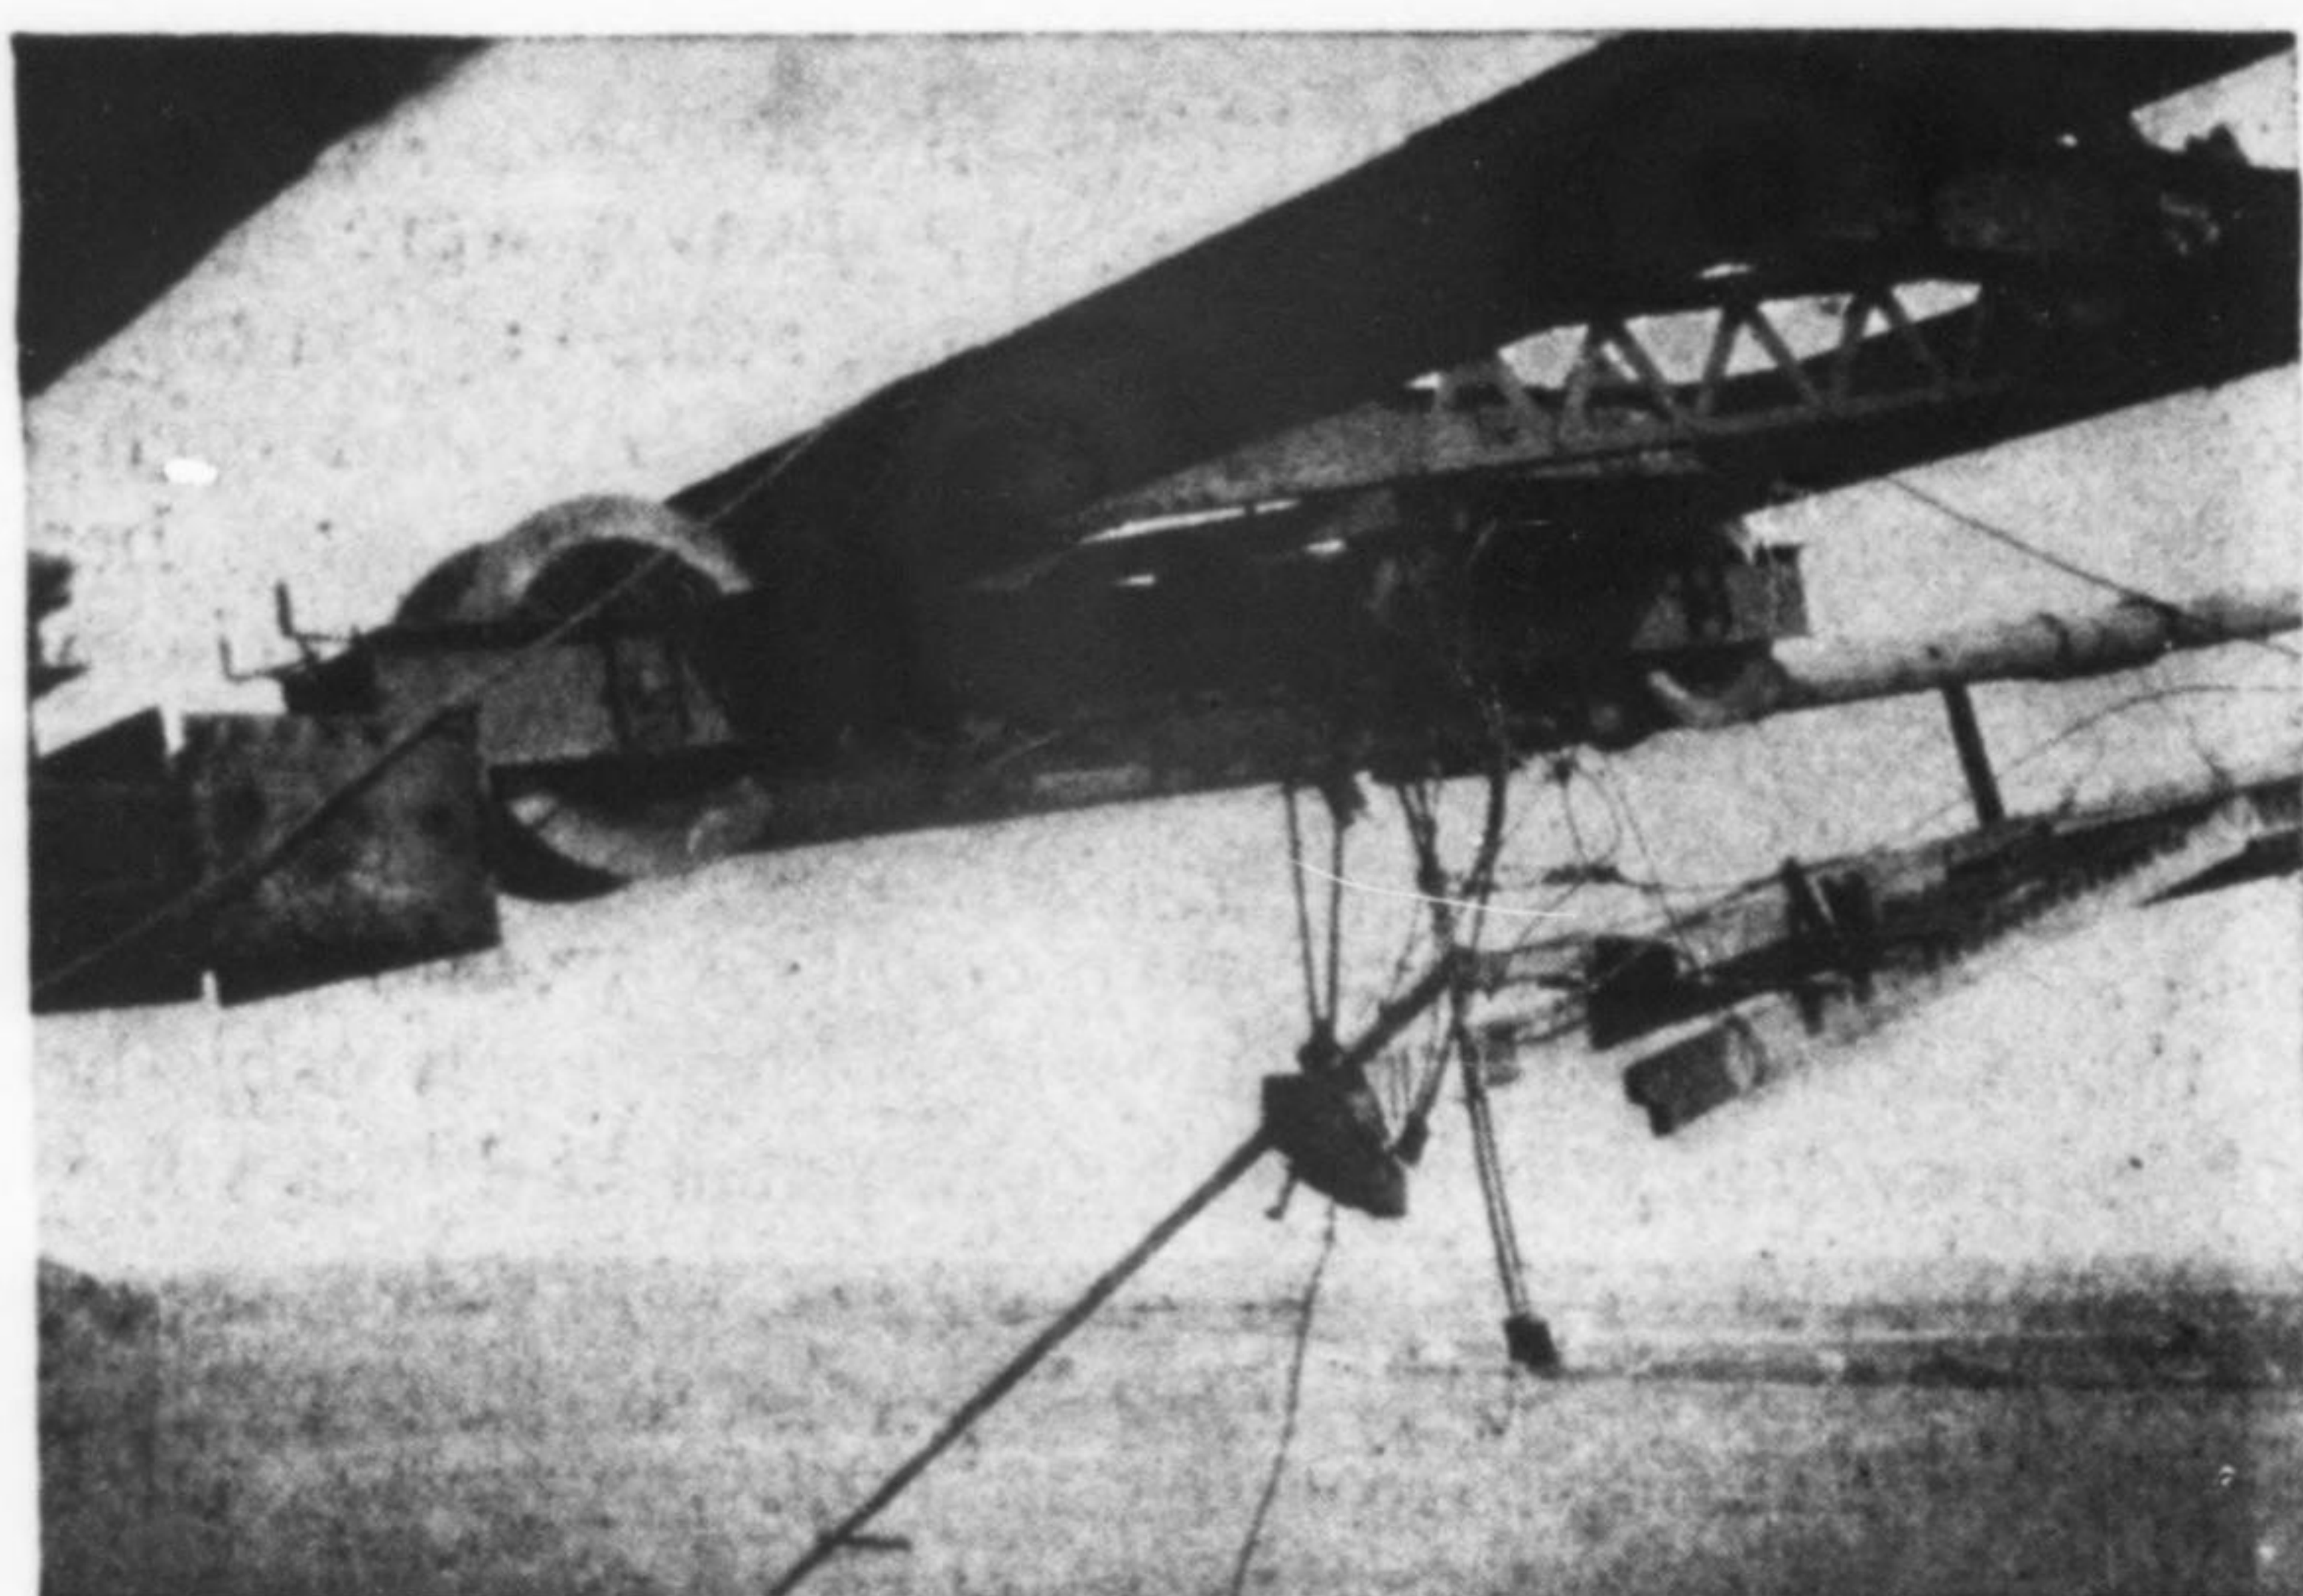
FIG. 5—TRAVELERS AT MOUNT HOPE DESIGNED TO RUN ON CABLES

Dismantling Travelers—With only one of the backstay holdbacks in place, further failures in the cable wire ceased; the contractor then discontinued the preventive work and concentrated all efforts on dismantling. The usual procedure for removing rivets was either to cut off the heads with a pneumatic chisel or to knock them off with blunt-nosed tools. The shafts of the rivets could then be punched from the holes and replaced with bolts. The smallest possible number of bolts was used in general only enough to steady the steel in the wind.

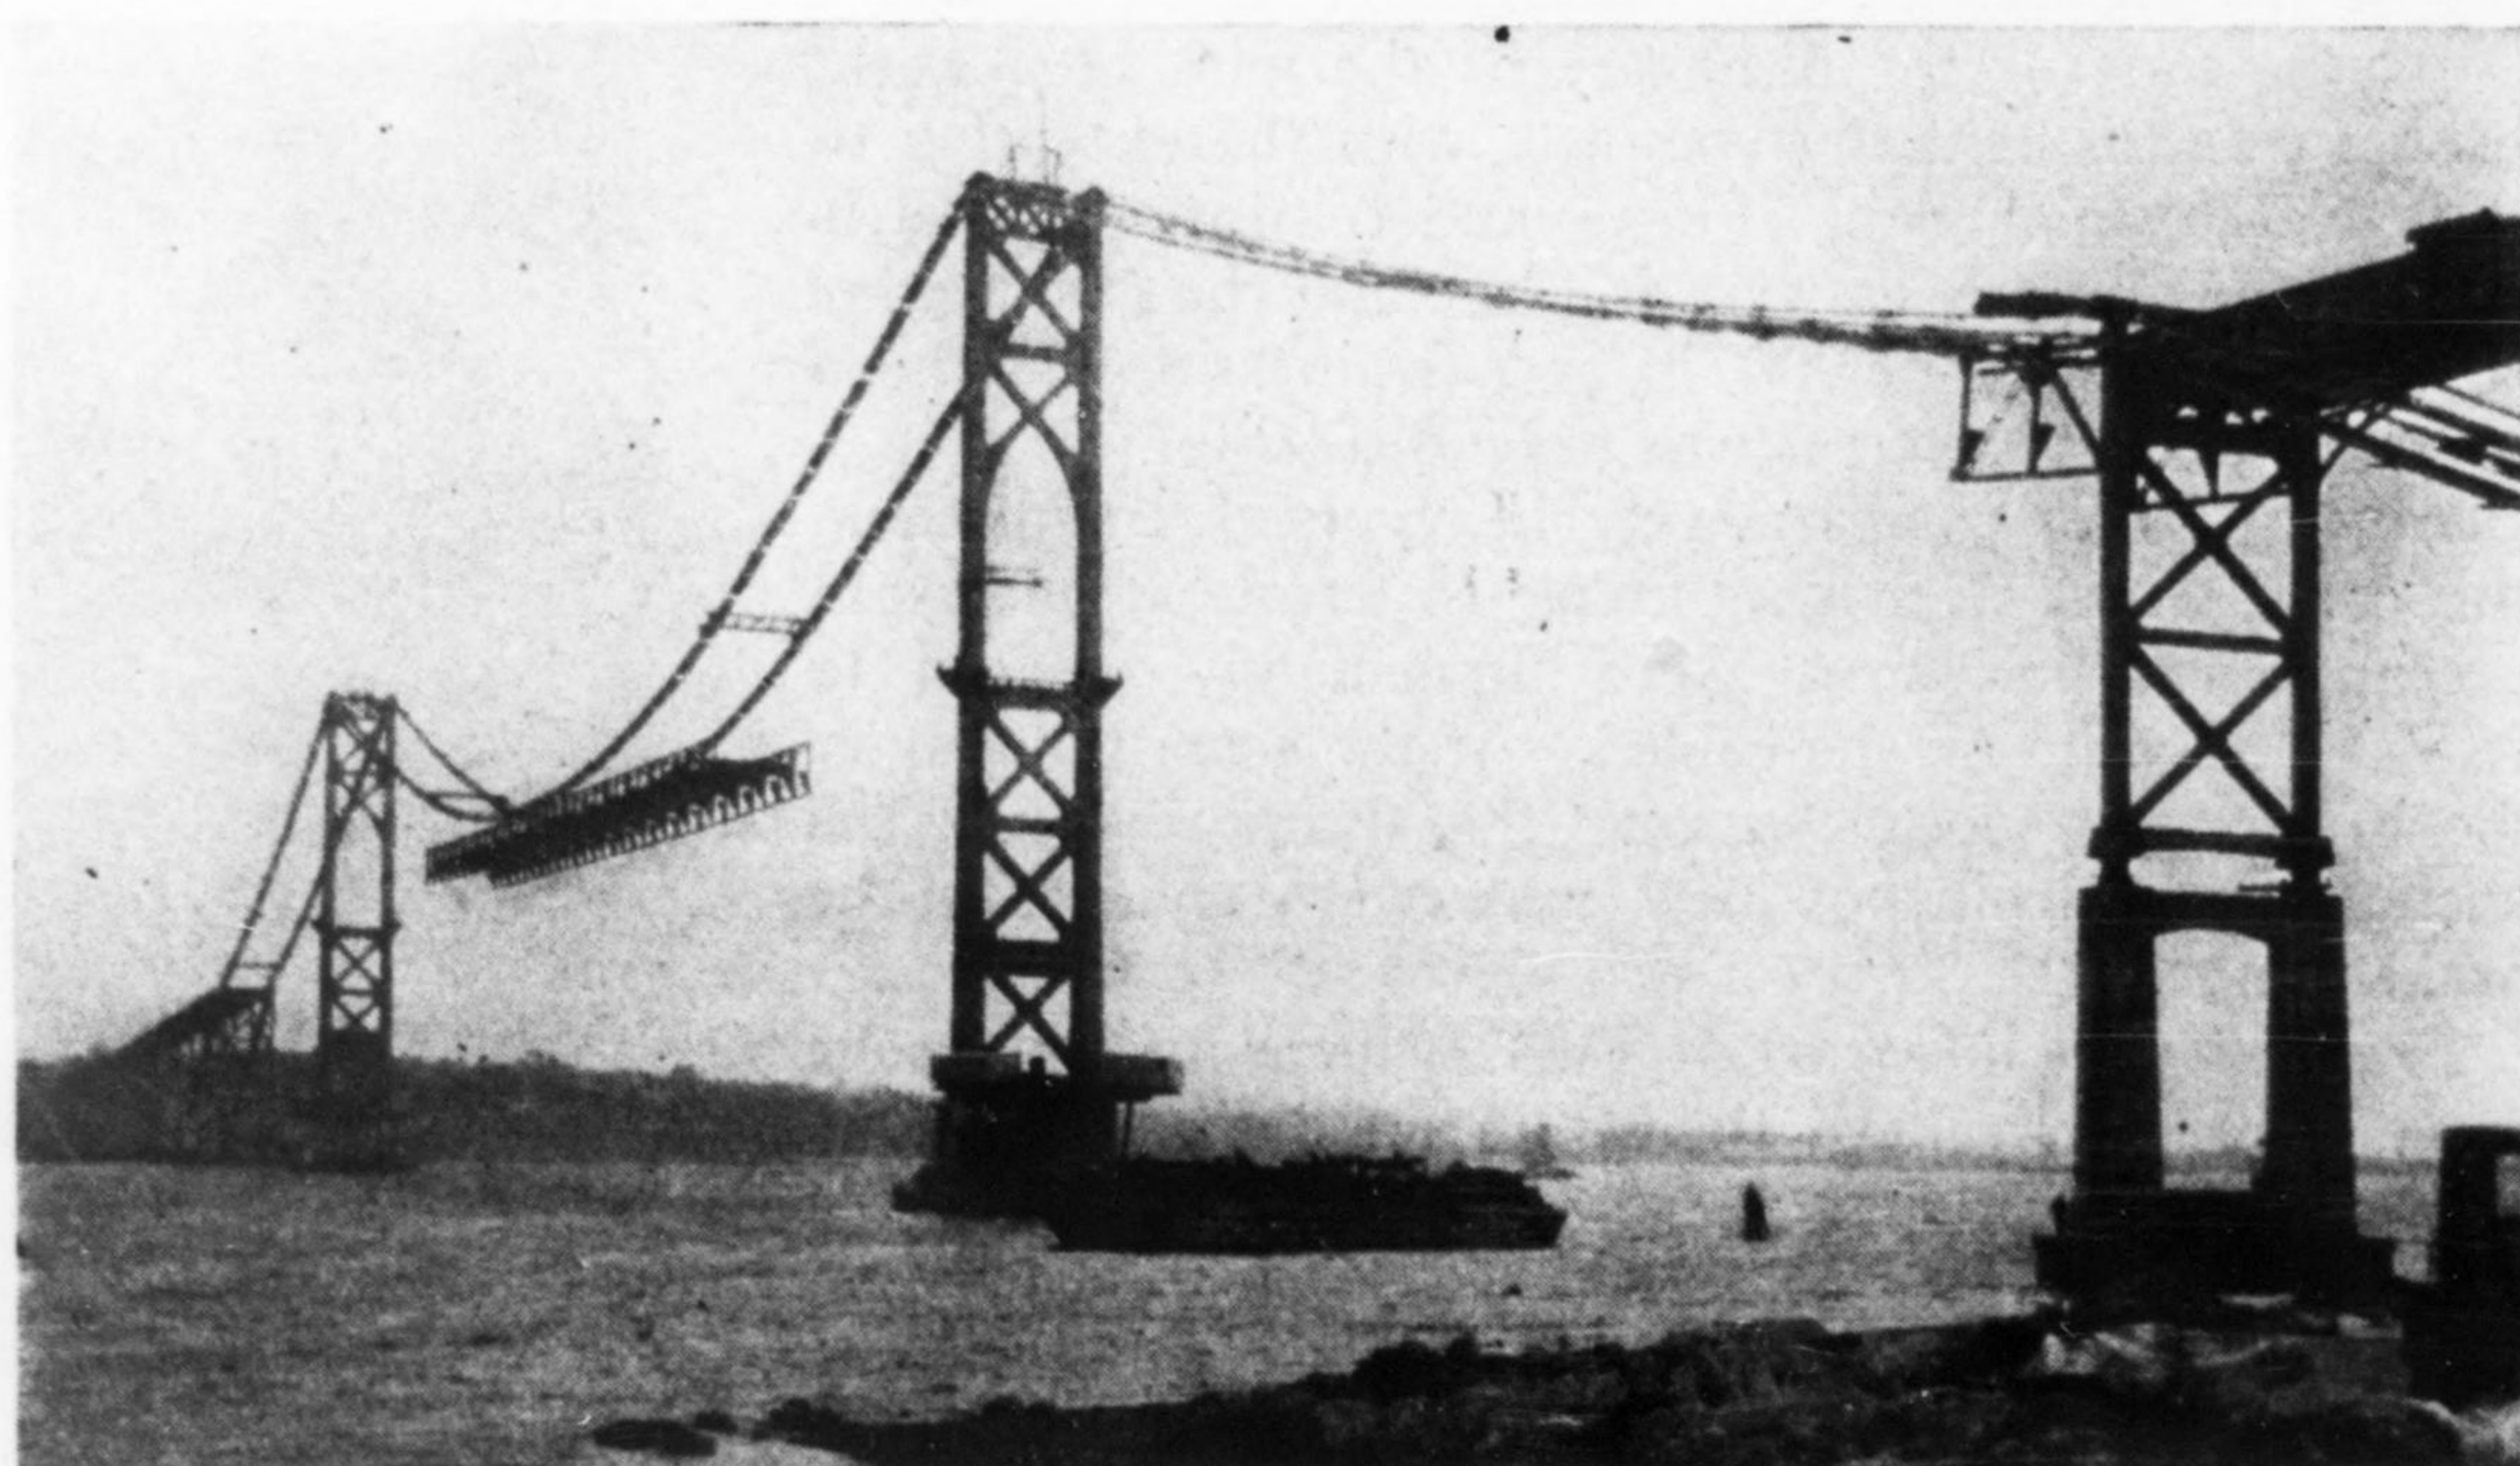
FIG. 6—DISMANTLING TRAVELERS WORKING AWAY FROM MAIN TOWERS, MOUNT HOPE

Note that side spans are down except for one panel. Before the last ten panels in main span could be removed, the main tower saddles had to be jacked shoreward 10 in. to maintain the system in balance.

The stringers and laterals, as well as the floorbeams at stiffening-truss splices (alternate floorbeams), were removed on the first pass of the travelers, followed by the stiffening trusses and the remainder of the floorbeams on the second pass. For the first operation, the side-span travelers started at the cable-bent towers, whereas the main span travelers started at the center of the span, all working toward the main towers. When all had arrived at the main towers, there remained the stiffening trusses and the alternate floorbeams at the suspenders to dismantle; this steel was lowered as all of the travelers worked away from the main towers. By

trusses having been previously taken down as shown in Fig. 6) the saddles on the towers had to be jacked back 10 in. toward the anchorages—the reverse of the operation performed during erection. Graphite had been spread on the base plate when the saddles were erected, so that two 25-ton screwjacks easily moved them the required distance (Fig. 8). After these ten sections of stiffening trusses had been lowered, jacking was continued for 10½ in. more in order to restore the towers to a plumb position.

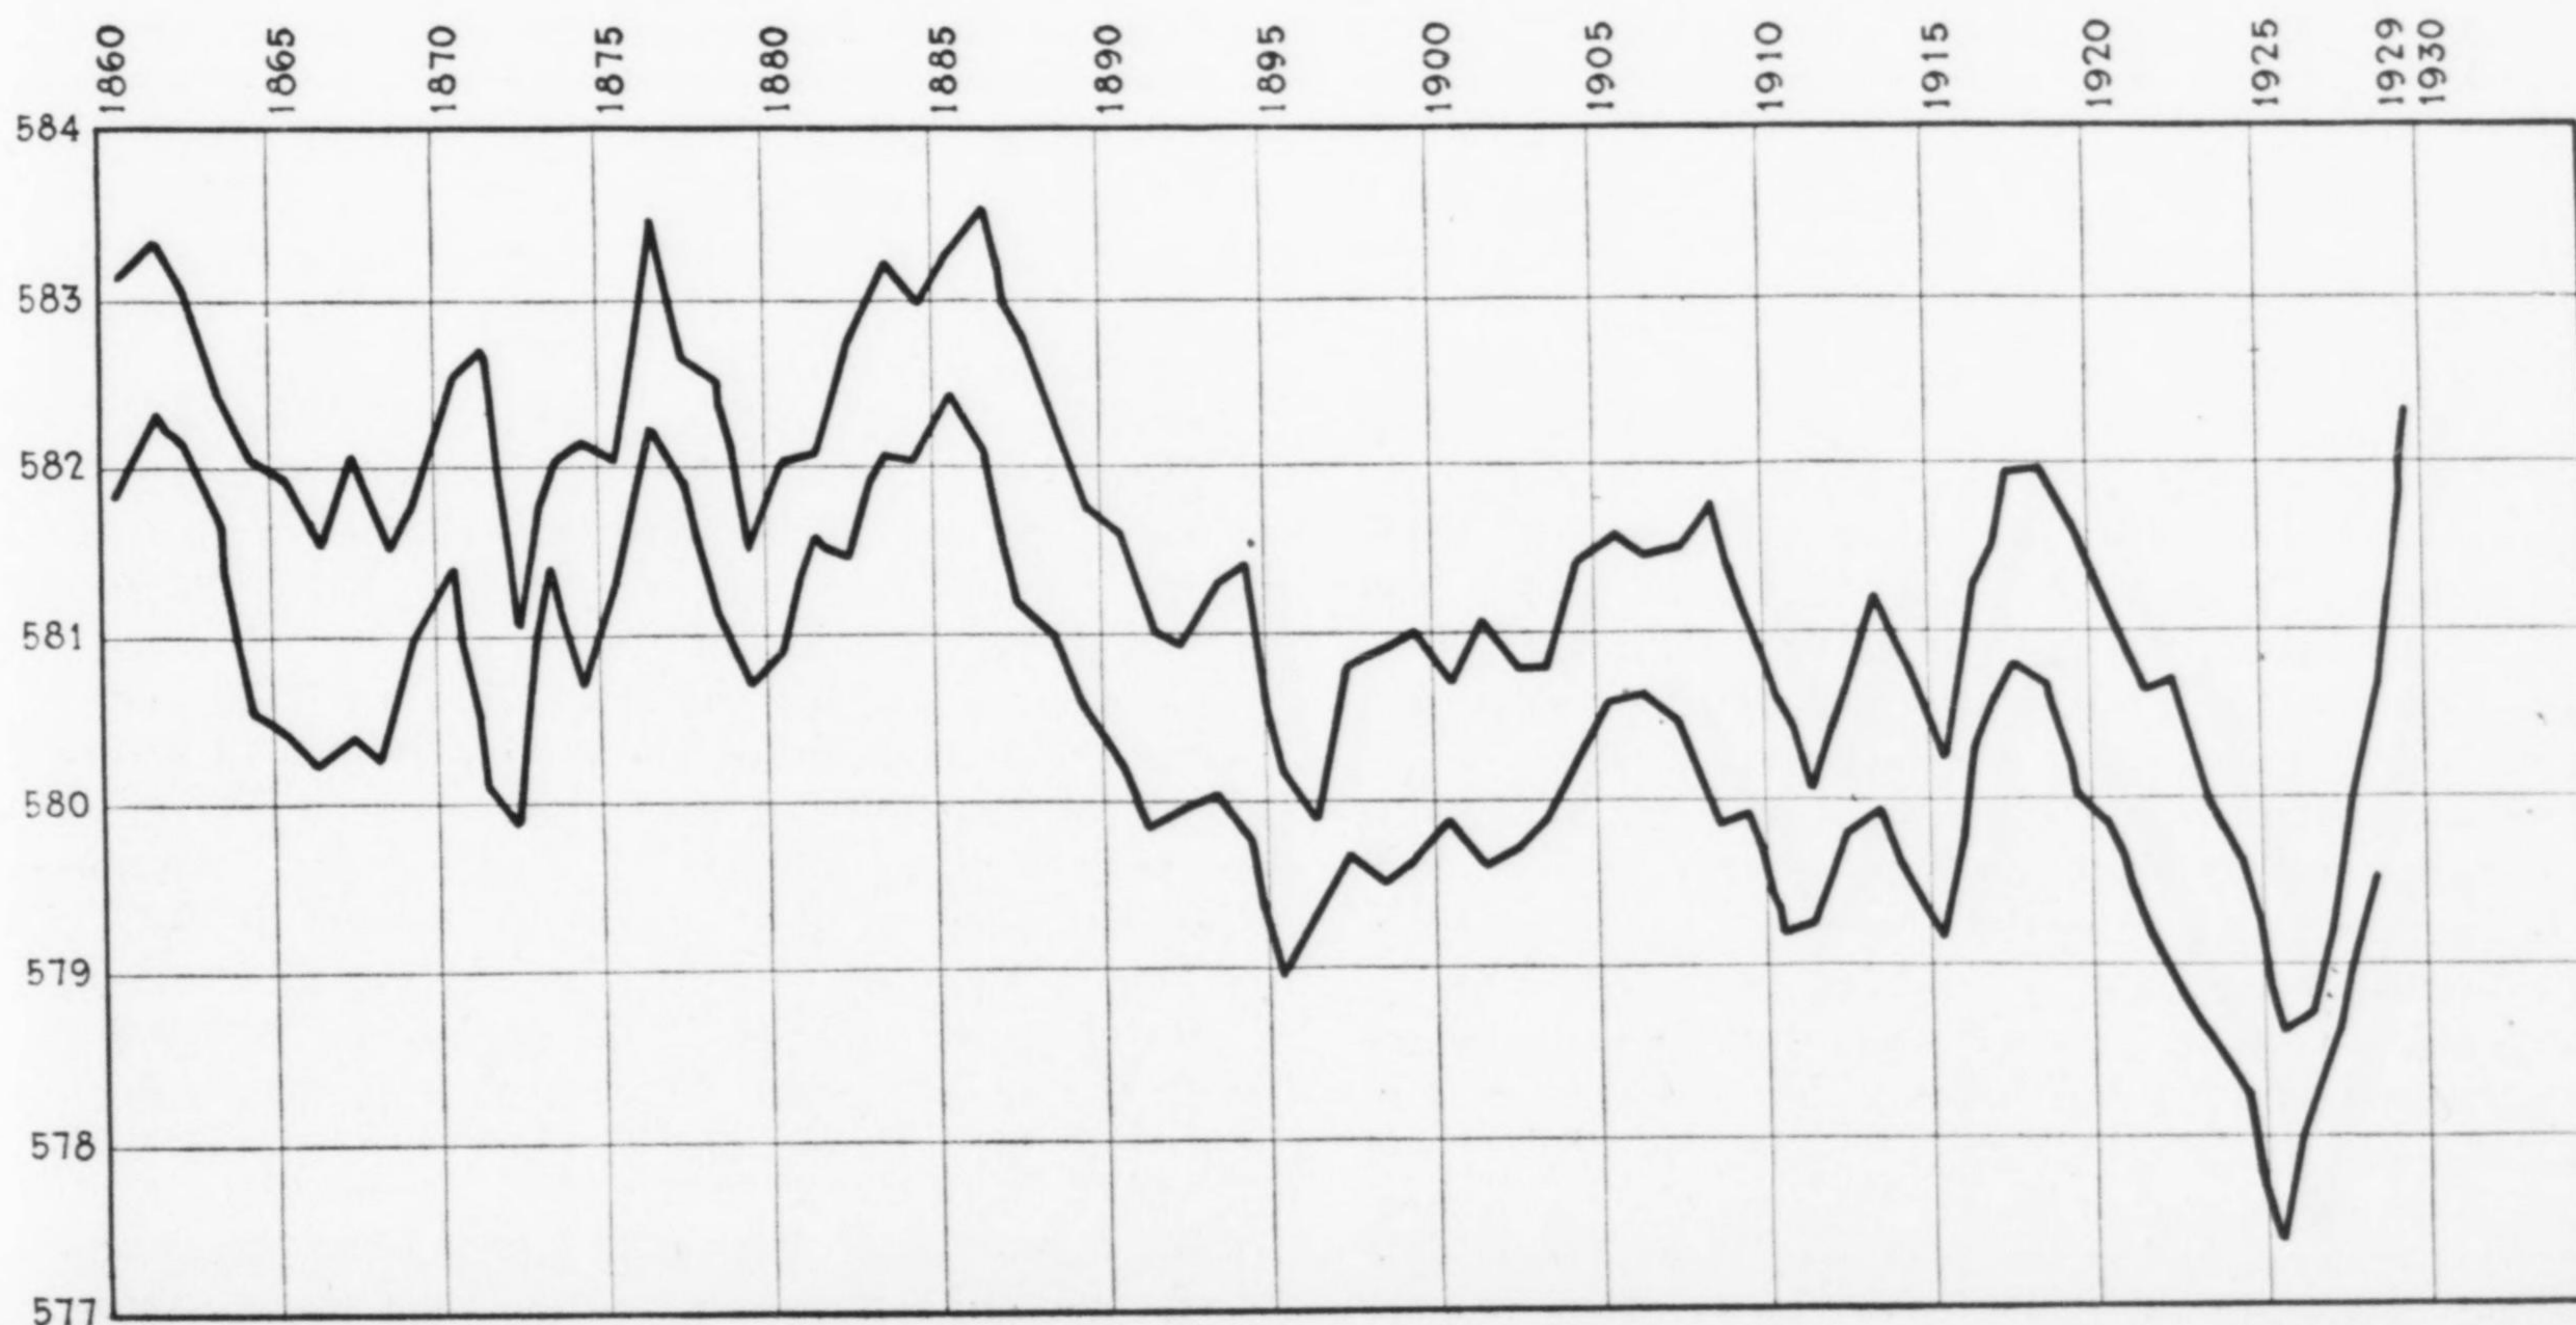
ELEVATION OF LAKE MICHIGAN, 1860 TO 1929
Showing maximum and minimum stages of monthly means.
