REHABILITATION FEASIBILITY STUDY

**DOTTER ROAD BRIDGE PROJECT
T-522 OVER MILL CREEK
ROCKLAND TOWNSHIP, VENANGO COUNTY,
PENNSYLVANIA**

ER# 2007-6071-121

February 2011

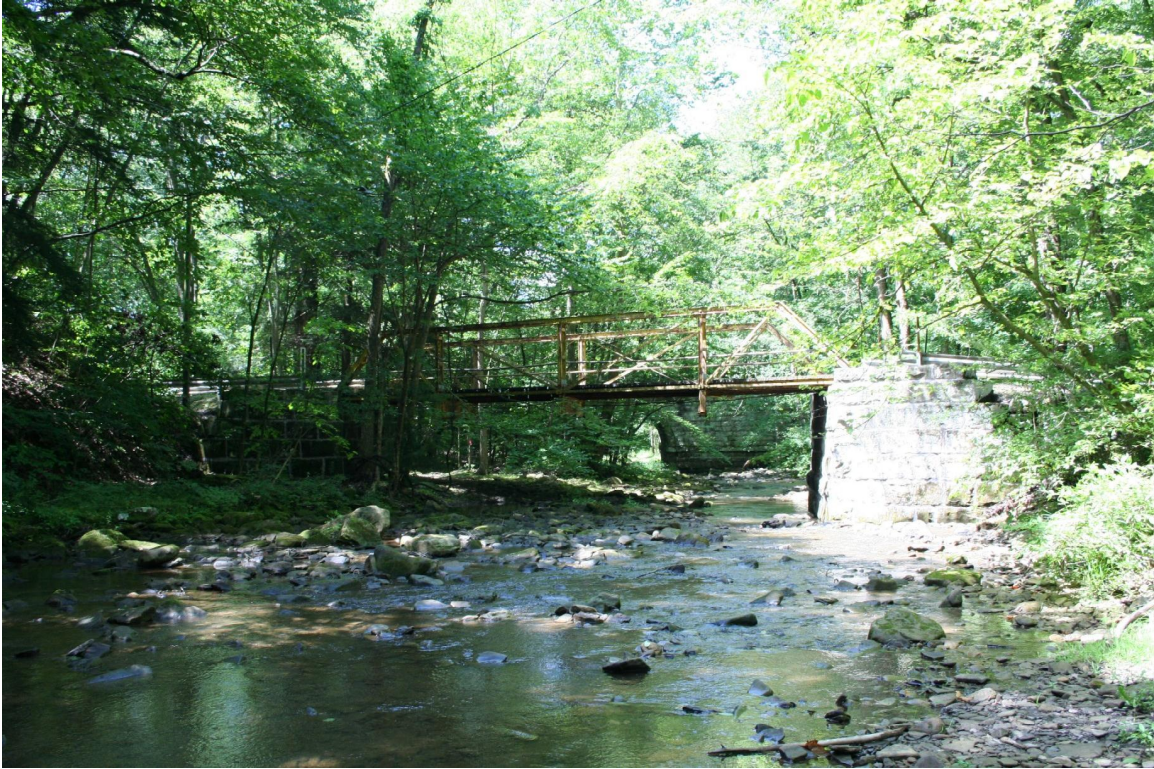
PHOTO 1: EAST ELEVATION, LOOKING WEST

Dotter Road Bridge was constructed ca. 1885 by the Smith Bridge Company of Toledo, Ohio. This single-lane, single-span, pin-connected Pratt pony truss is 62 feet long and 16.1 feet wide and the alignment is skewed. The trusses have built-up upper chords, end posts, and verticals. The lower chords and diagonals are eye bars. The end posts are inclined. The steel superstructure rests on ashlar abutments with flared wingwalls. The original pole

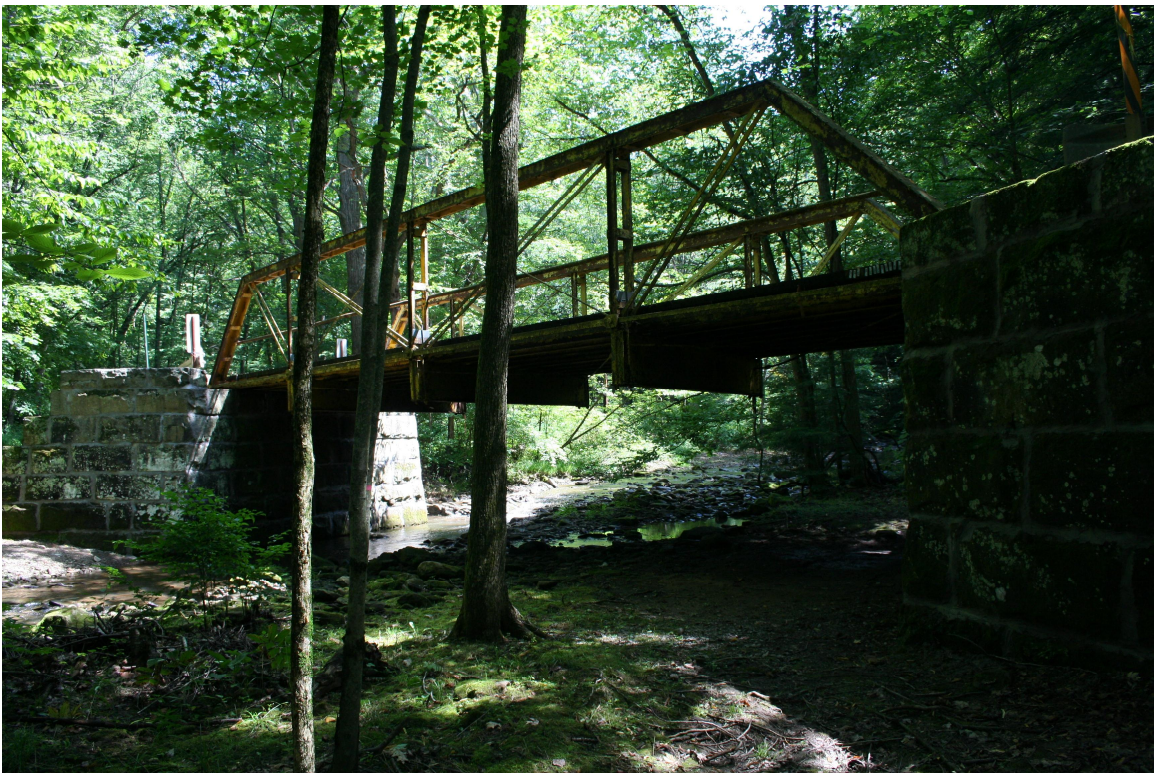
PHOTO 2: WEST ELEVATION, LOOKING EAST

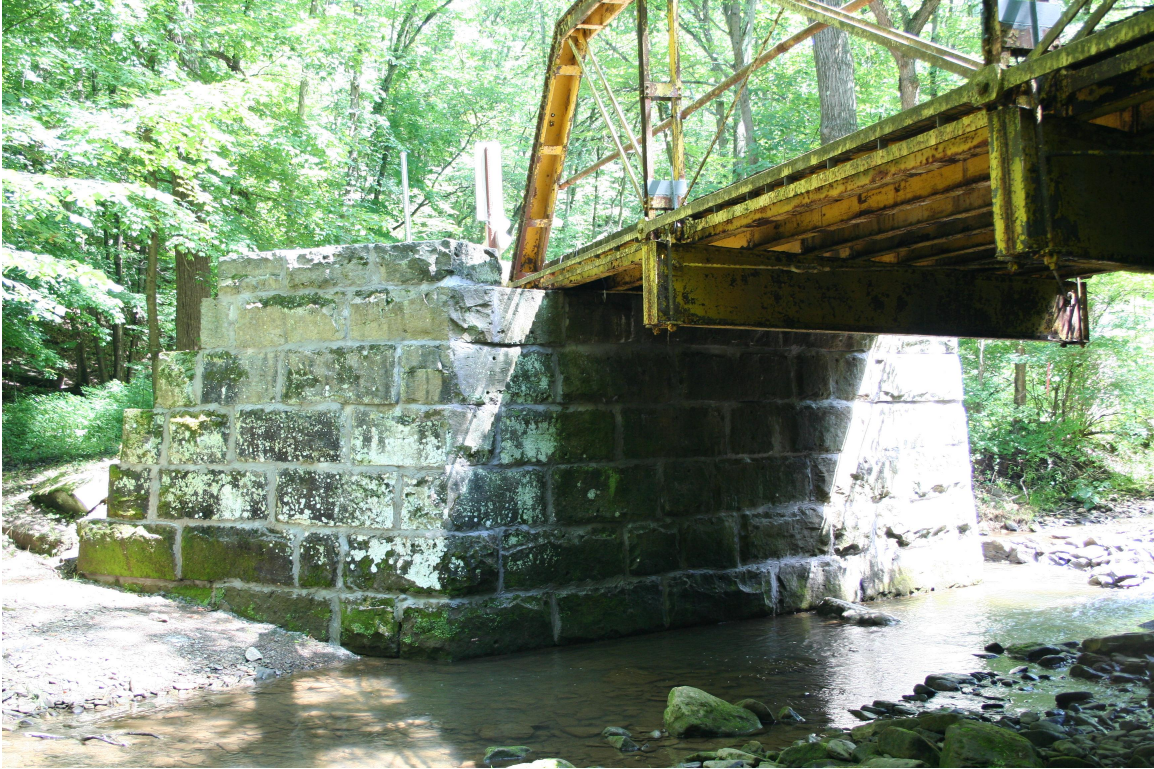
PHOTO 5: FLOORBEAMS, STRINGERS, DIAGNAL BRACING

The superstructure is in serious condition. It was given a Condition Rating of 3 during the NBIS inspection completed in 2010. The floorbeams all have 75% of their surface covered with surface rust. The floorbeam hanger bottom plates all show significant deflection at all locations. Floorbeam 1 has the top pushed toward the near abutment and the bottom toward the far (out of plumb 2+). Floorbeams 2 and 3 have the top toward the far and the bottom toward the near out of plumb 2+. Approximately 75% of the area of each stringer was covered with surface rust. They had moderate build-up of scale rust to the lower webs and pitting of the lower flanges.

The bottom chords and diagonals around the bottom pins have 50% section loss. All diagonals and bottom sway bracing have scattered light rust and are loose and bent downward. All pins appear frozen due to rust. The paint system is in poor condition with loose and peeling paint.

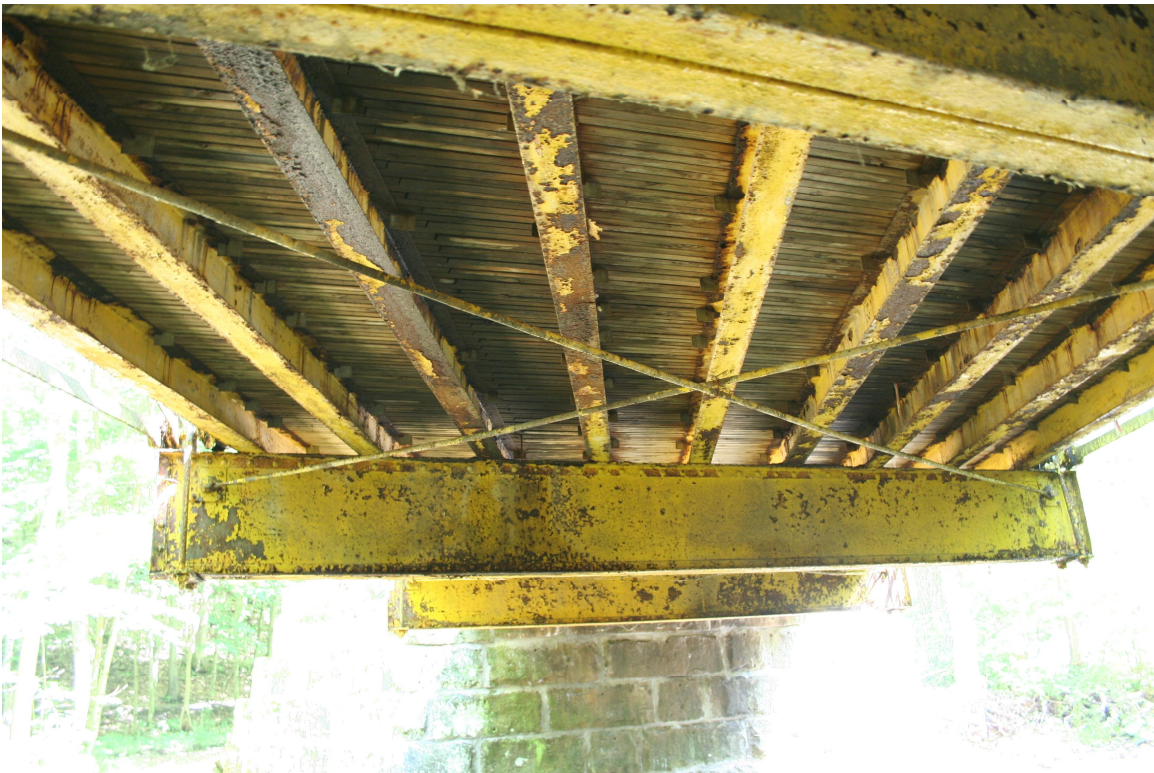
PHOTO 6: FLOORBEAMS AND HANGERS, NORTH BBUTMENT

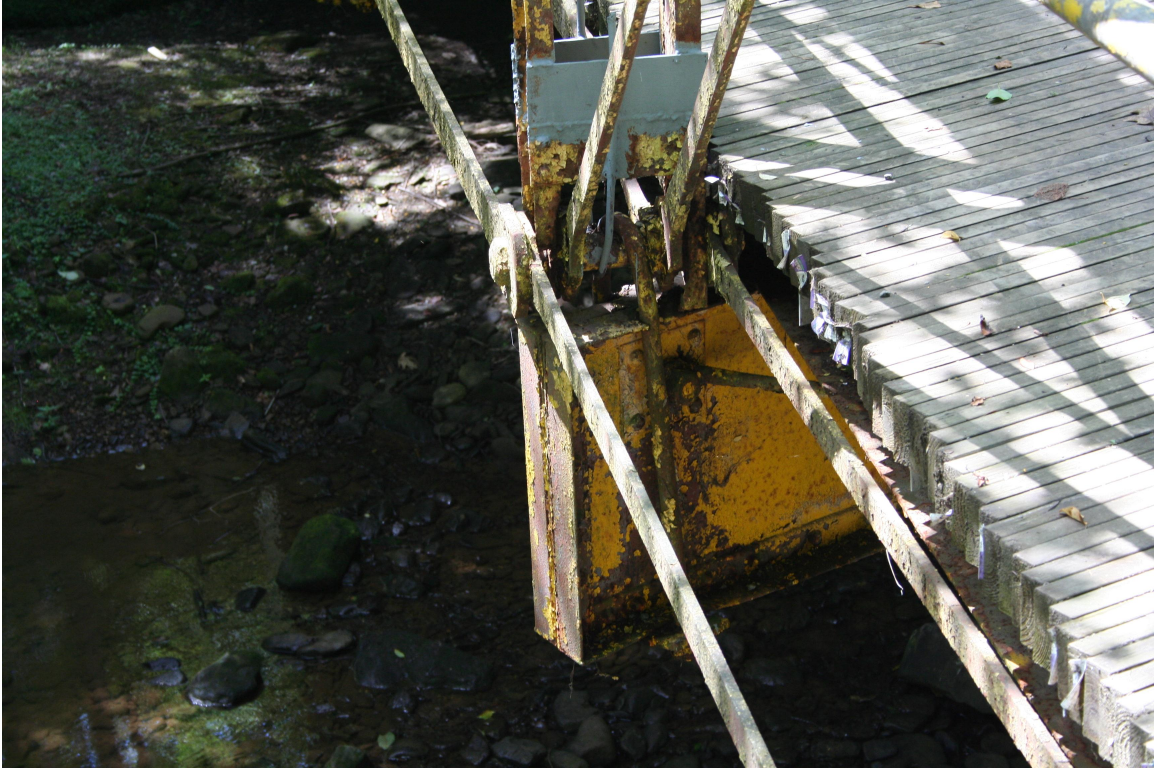
PHOTO 7: PIN CONNECTION, HANGER PLATE, SOME REPAIR WORK

Due to the age of the structure (111 years old), any rehabilitation option should replace all of the floorbeam hangers as well as all pins in the truss. Based on the current ratings of the existing truss members, the heavier deck and bridge barrier would require the replacement or rehabilitation of a minimum of 60% of the truss members (24 out of 40) in order for each member to rate above the targeted 15 tons.
