Sixty-Year-Old Trusses of Cast Iron Still in Service

Pennsylvania structures contain interesting details including unusual connection castings

By Harry K. Ellis
County Engineer, Chester County,
West Chester, Pa.

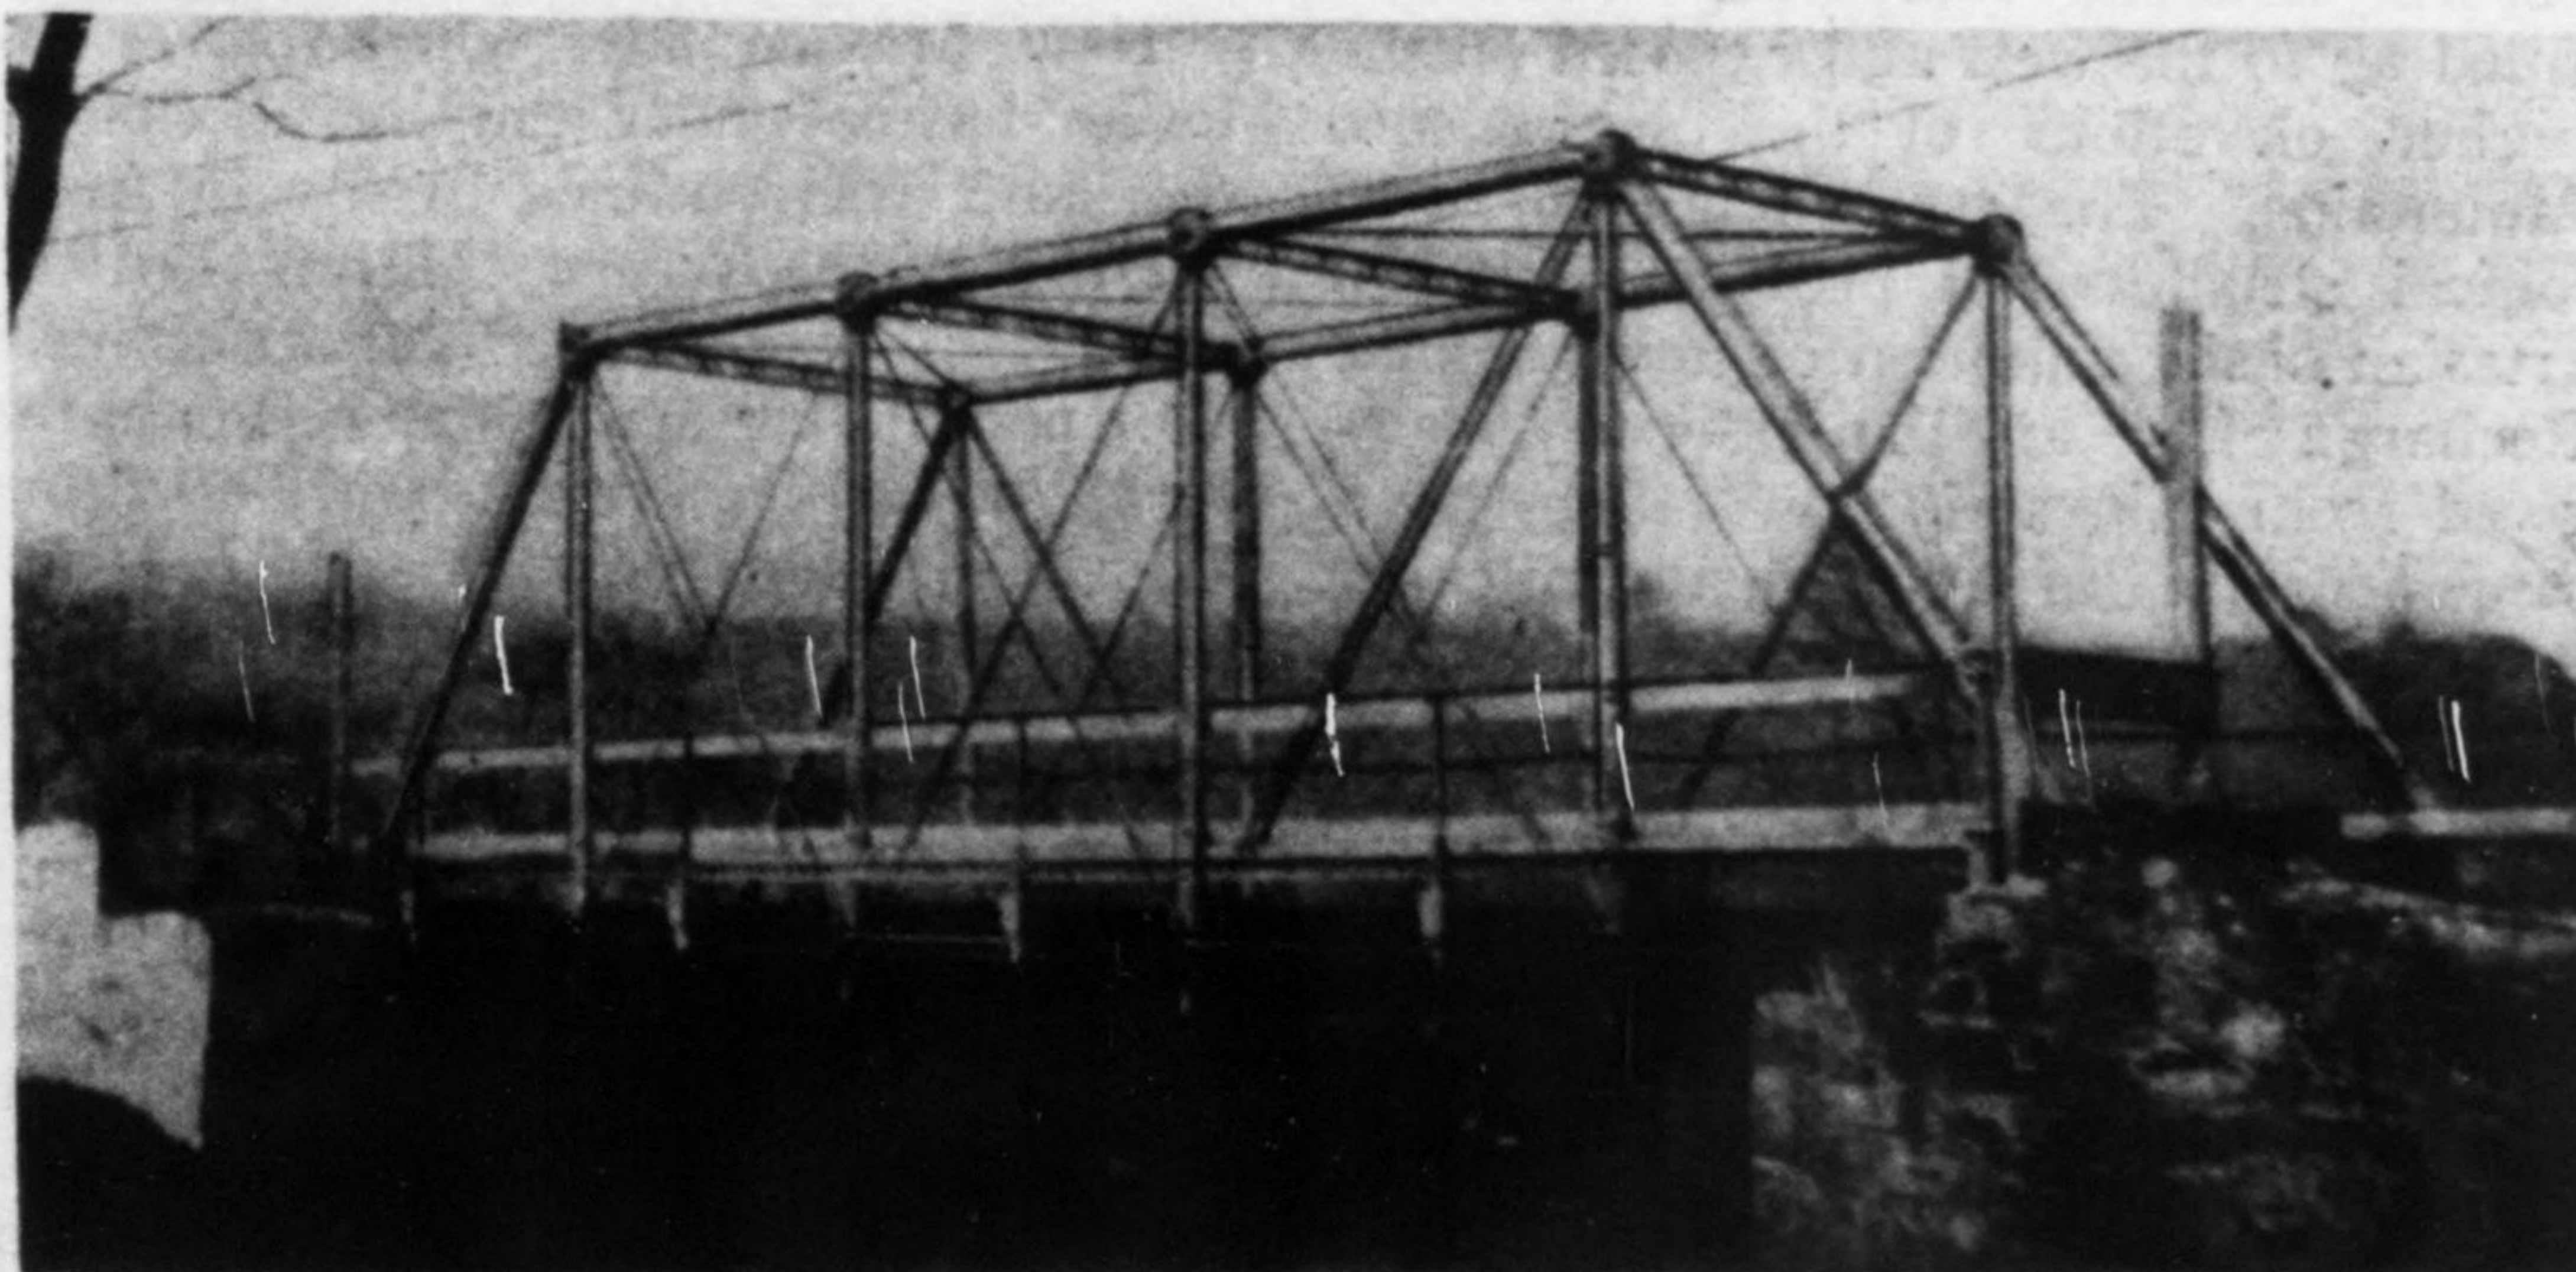
Fig. 1—Cast-iron truss bridge of 55-ft. span at Hellertown, Pa. Top chords and verticals are circular.

TWO BRIDGES built almost entirely of cast iron are still in service over Saucon Creek, near Bethlehem, Pa. One of them (Fig. 1), is located on Walnut St., Hellertown, and is a through-truss span of 55 ft. 5 in. center to center of bearings. It

The trusses are 12 ft. on centers and 14 ft. 8 in. deep. They are built with all compression members of cast iron. The top chords and end posts are circular in section and taper from a maximum outside diameter of 7 in. near the middle to a lesser diameter at the ends. The posts are similar in section but with a maximum diameter of 5 in.

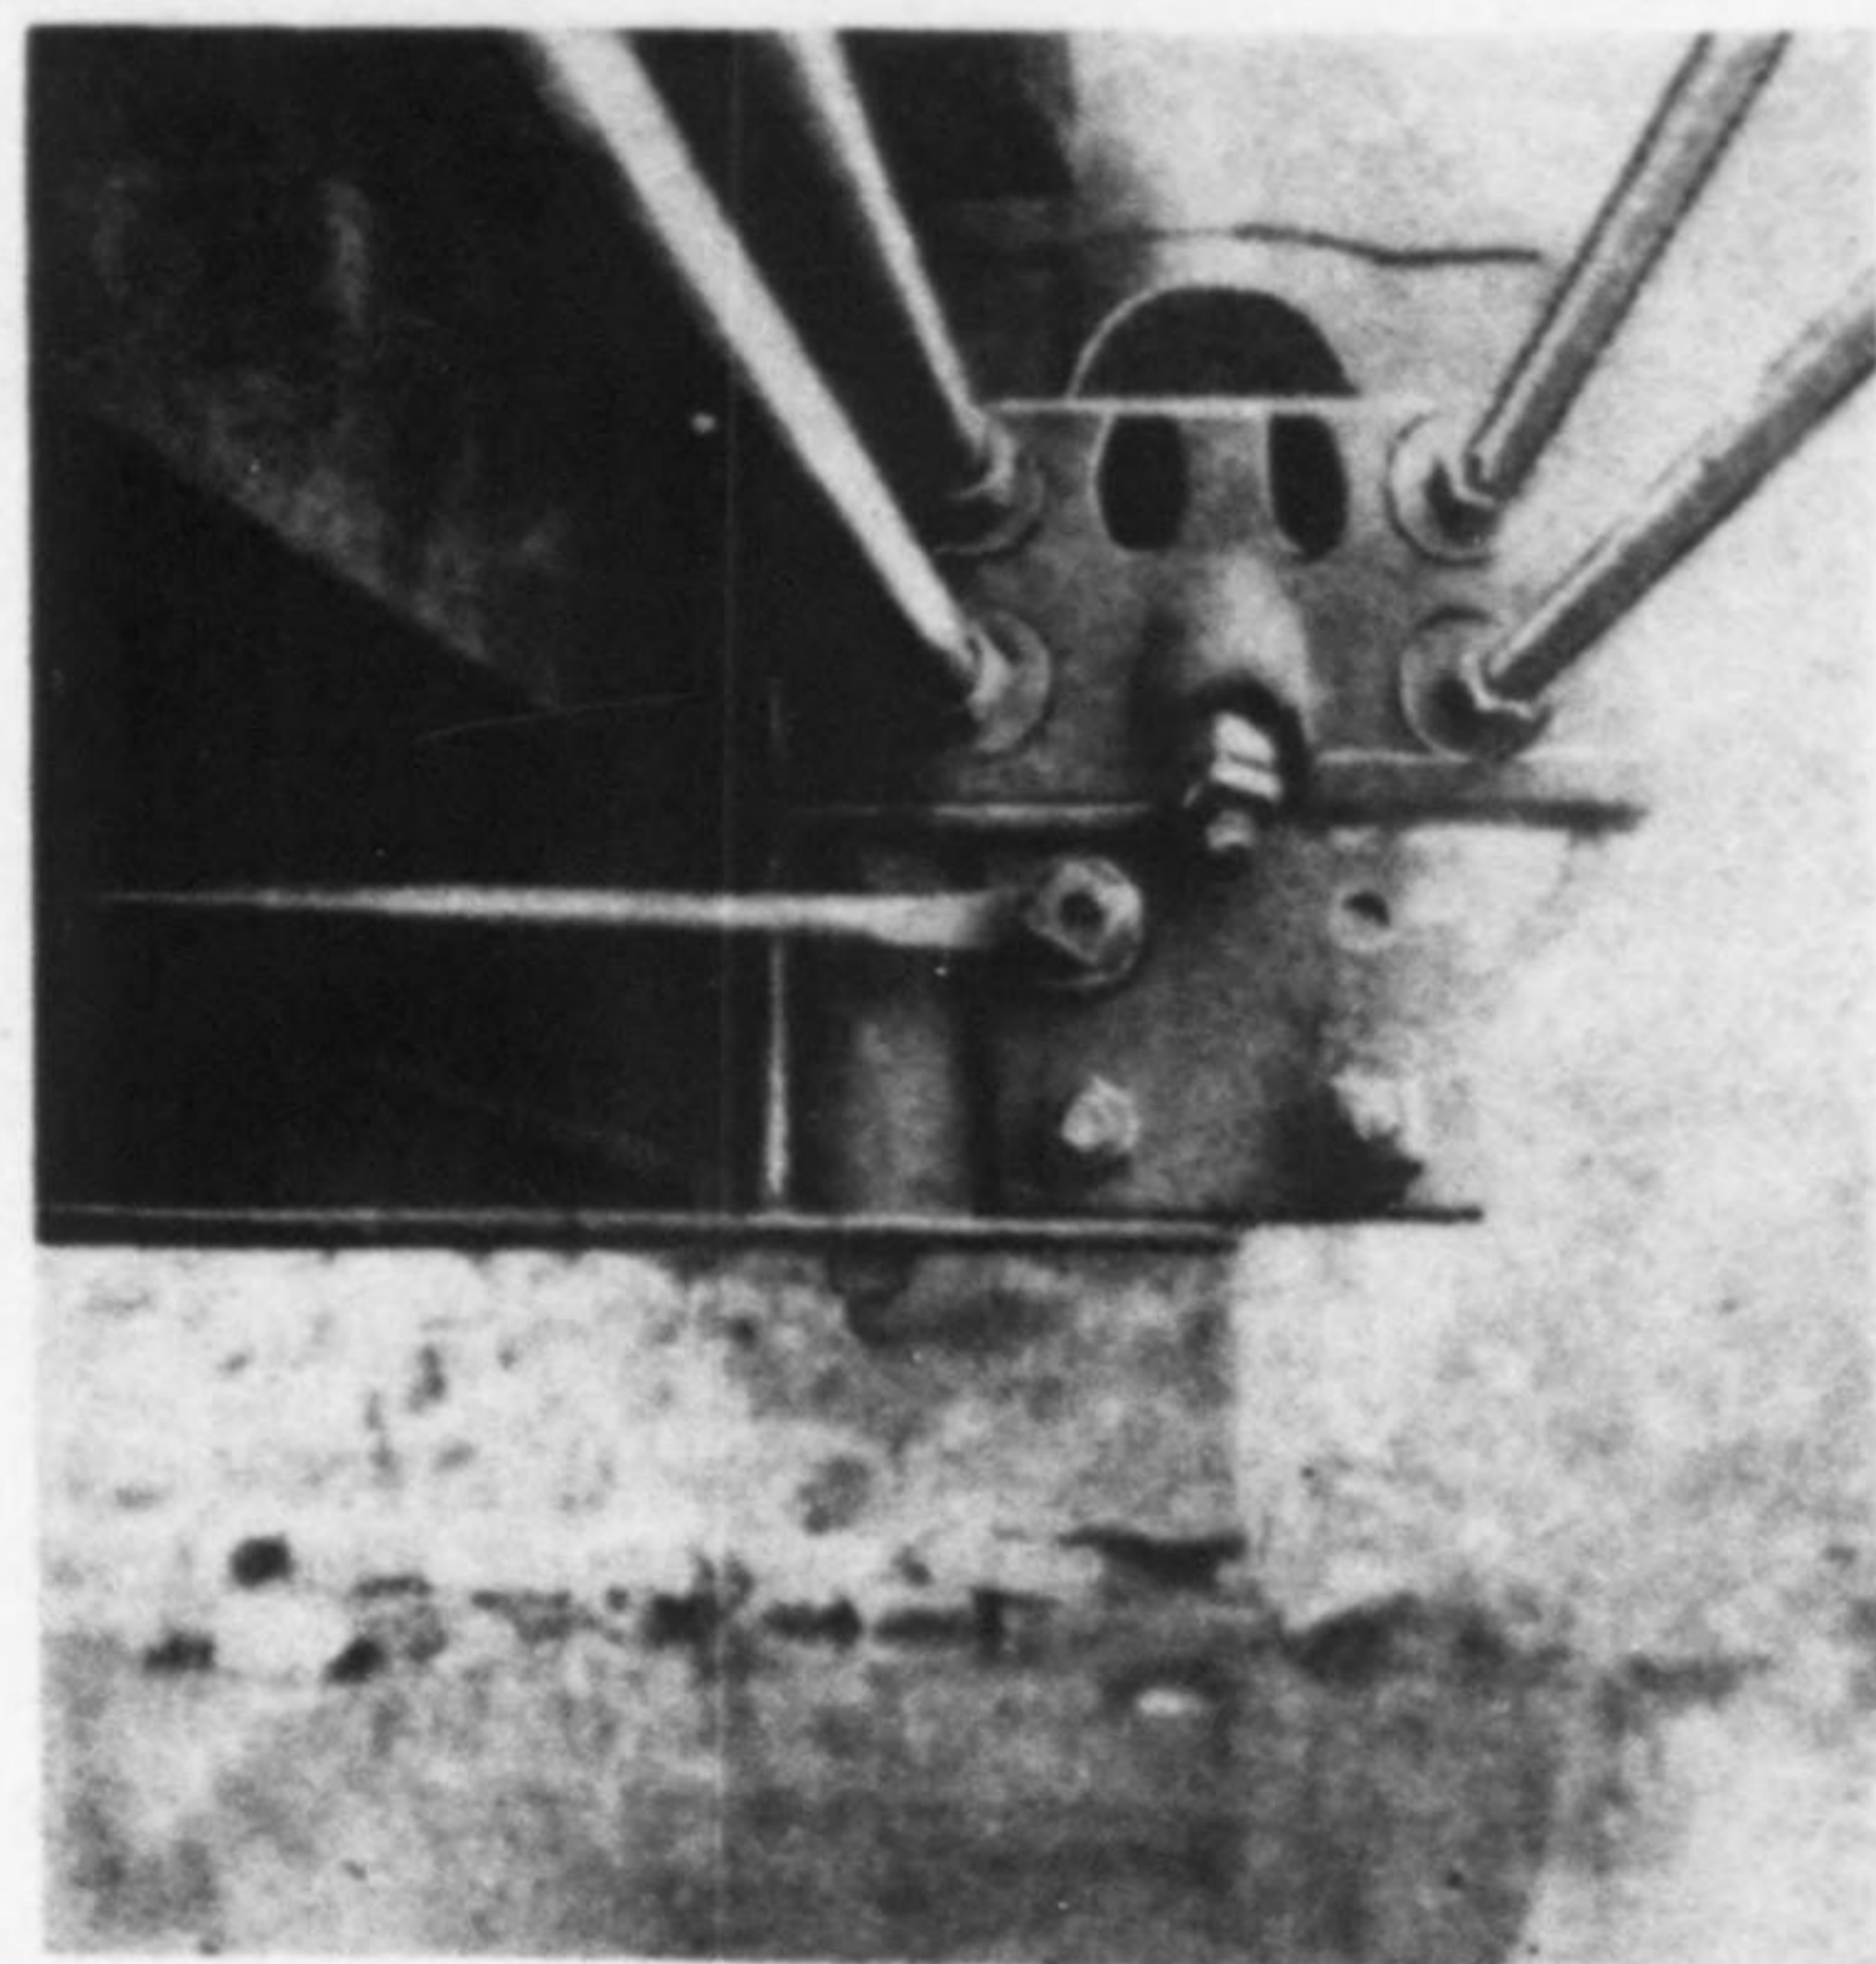
Fig. 2—Bottom panel-point casting on Hellertown bridge providing connection for diagonals, chords and floor beams.

Diagonal web members are rods of 1 and 1½ in. diameter, not upset. Connections are made by passing the rods through the ends of the cast-iron vertical posts and fastening them with a nut on each end. This is shown in Fig. 2. The lower chords consist of four rods of 1-in. diameter in the end panels and 1½-in. in the center panel. The smaller rods are upset but the larger ones are not. They are spliced together with a sleeve nut just outside the center panel. This may be seen in Fig. 2.

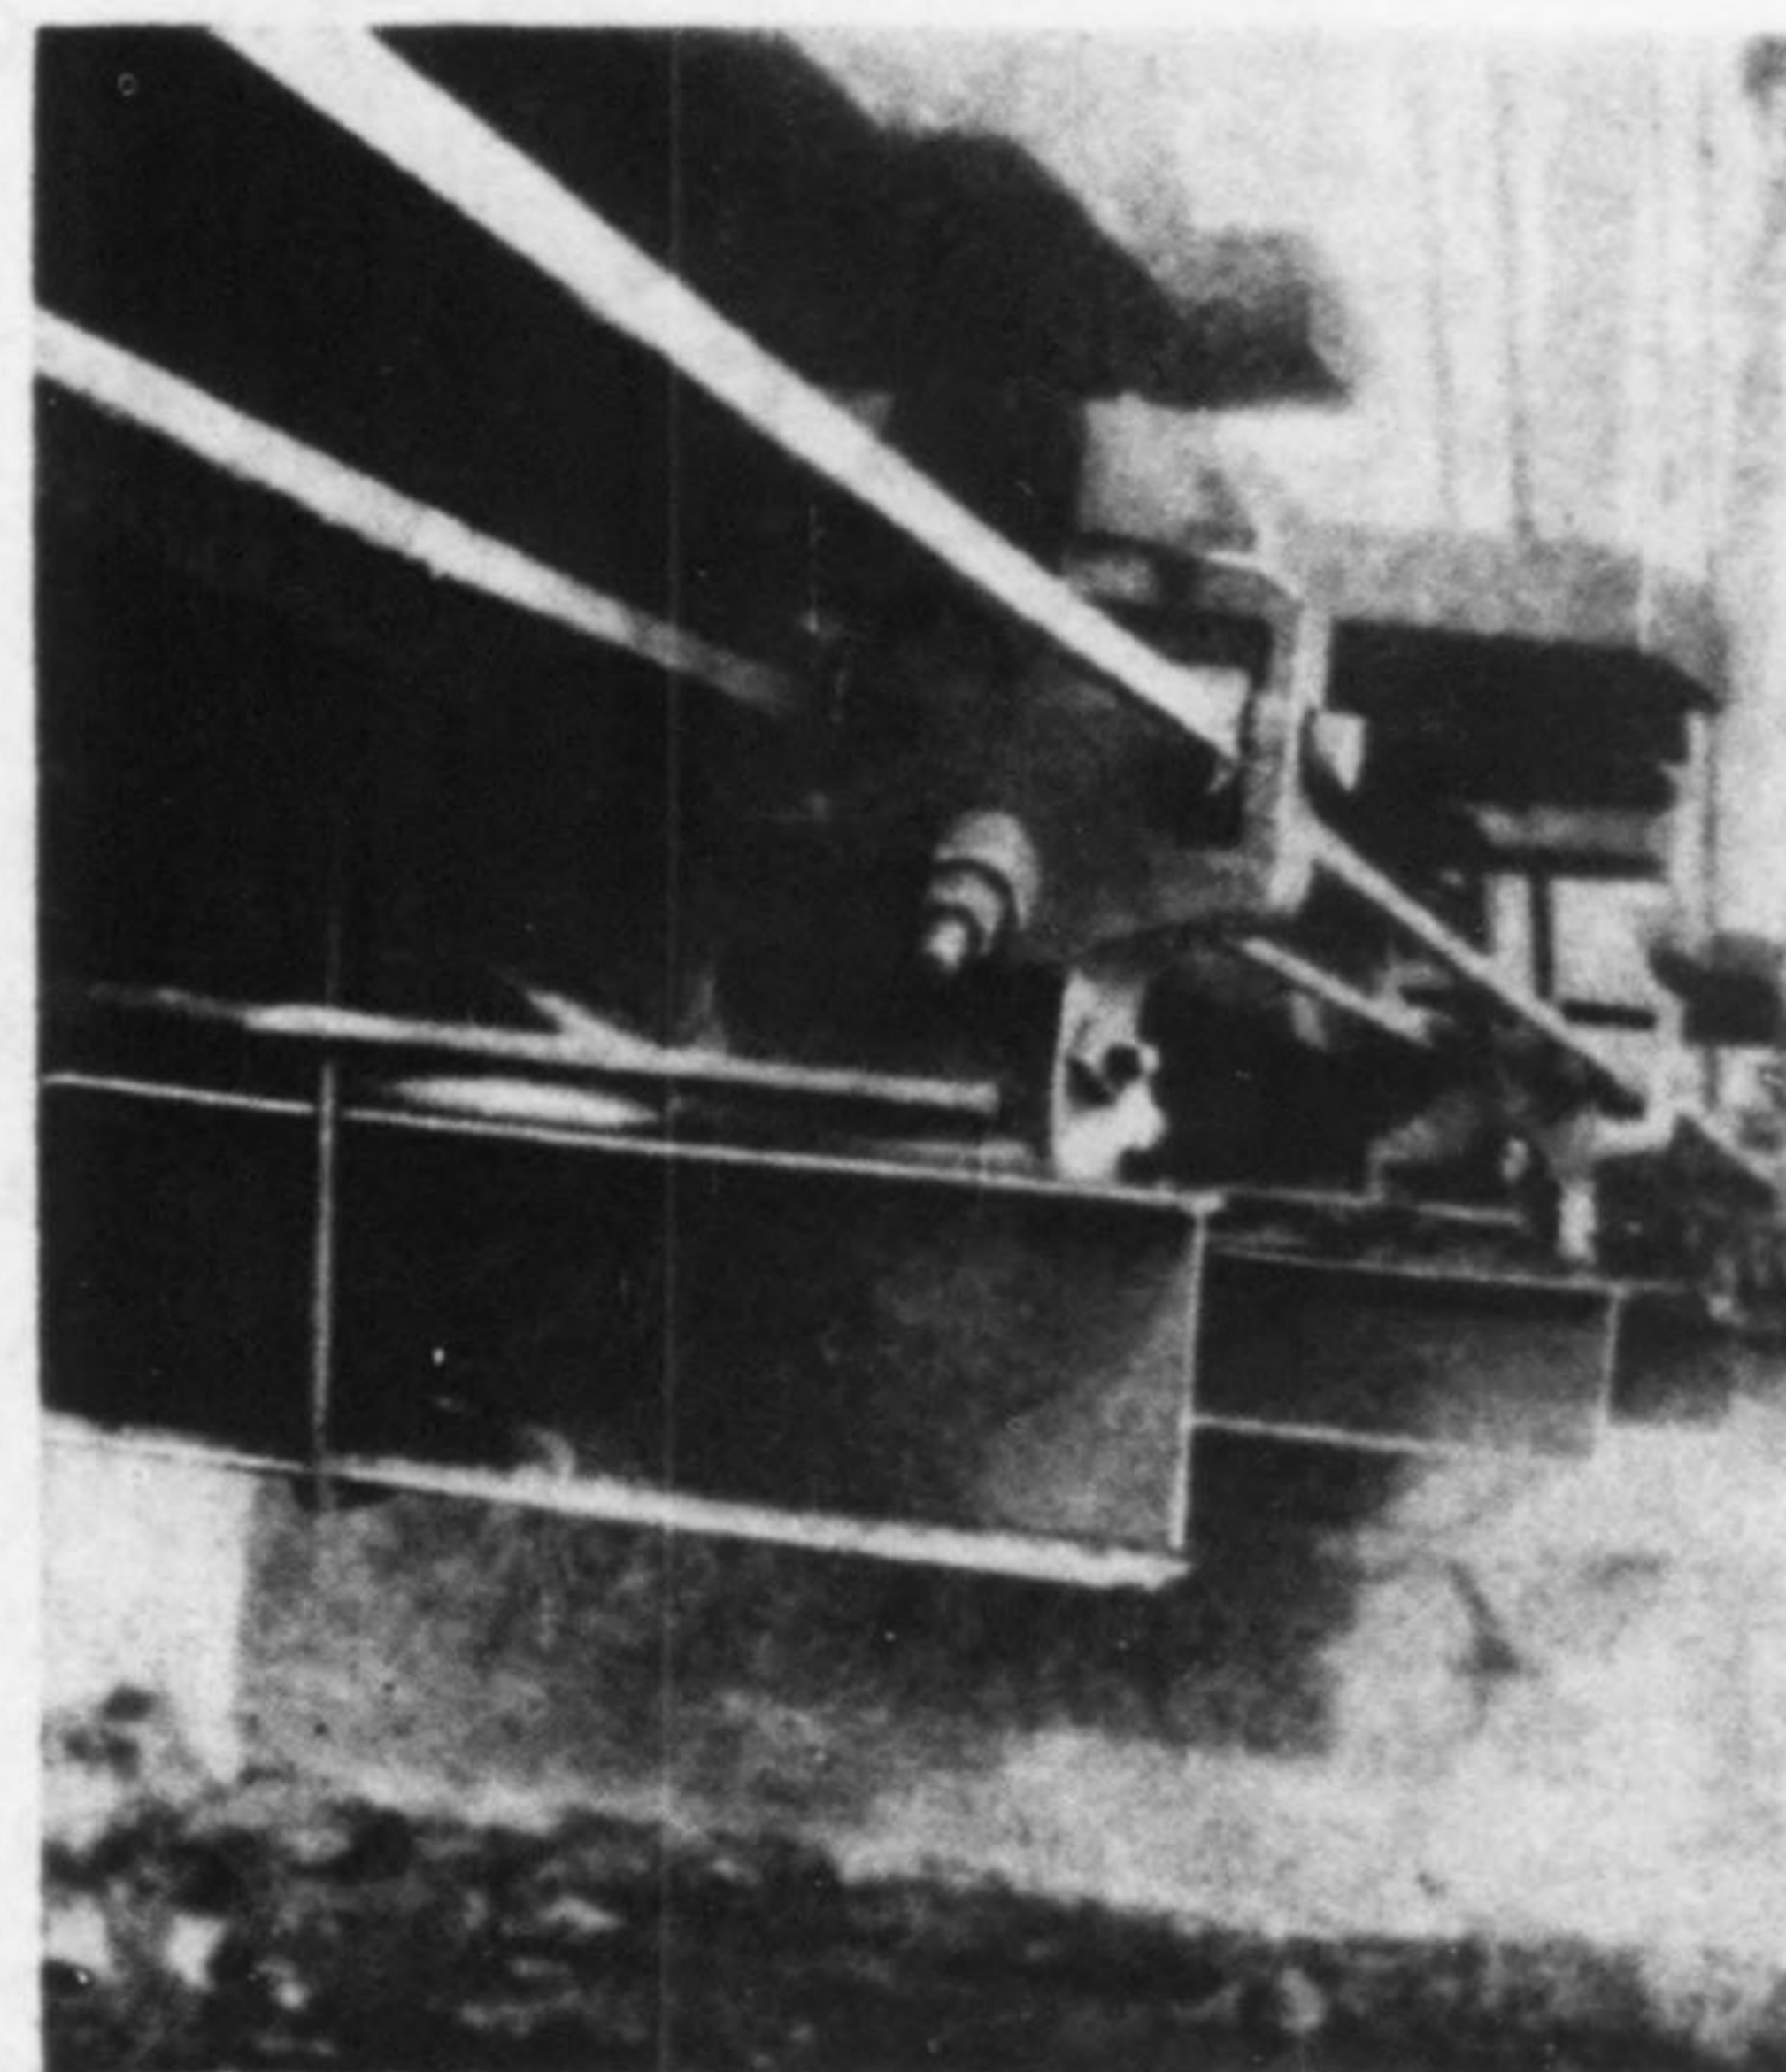
Fig. 3—Bottom panel-point detail of continuous-type cast-iron bridge. Note steel I-beams used to reinforce old cast-iron floor beams.

The floor beams are of cast iron, 10 in. deep and similar in construction to those used in the Walnut St. bridge. One of them has broken, and all of them have been reinforced by fastening steel I-beams beneath them. Horizontal rod bracing forms the lower lateral system.

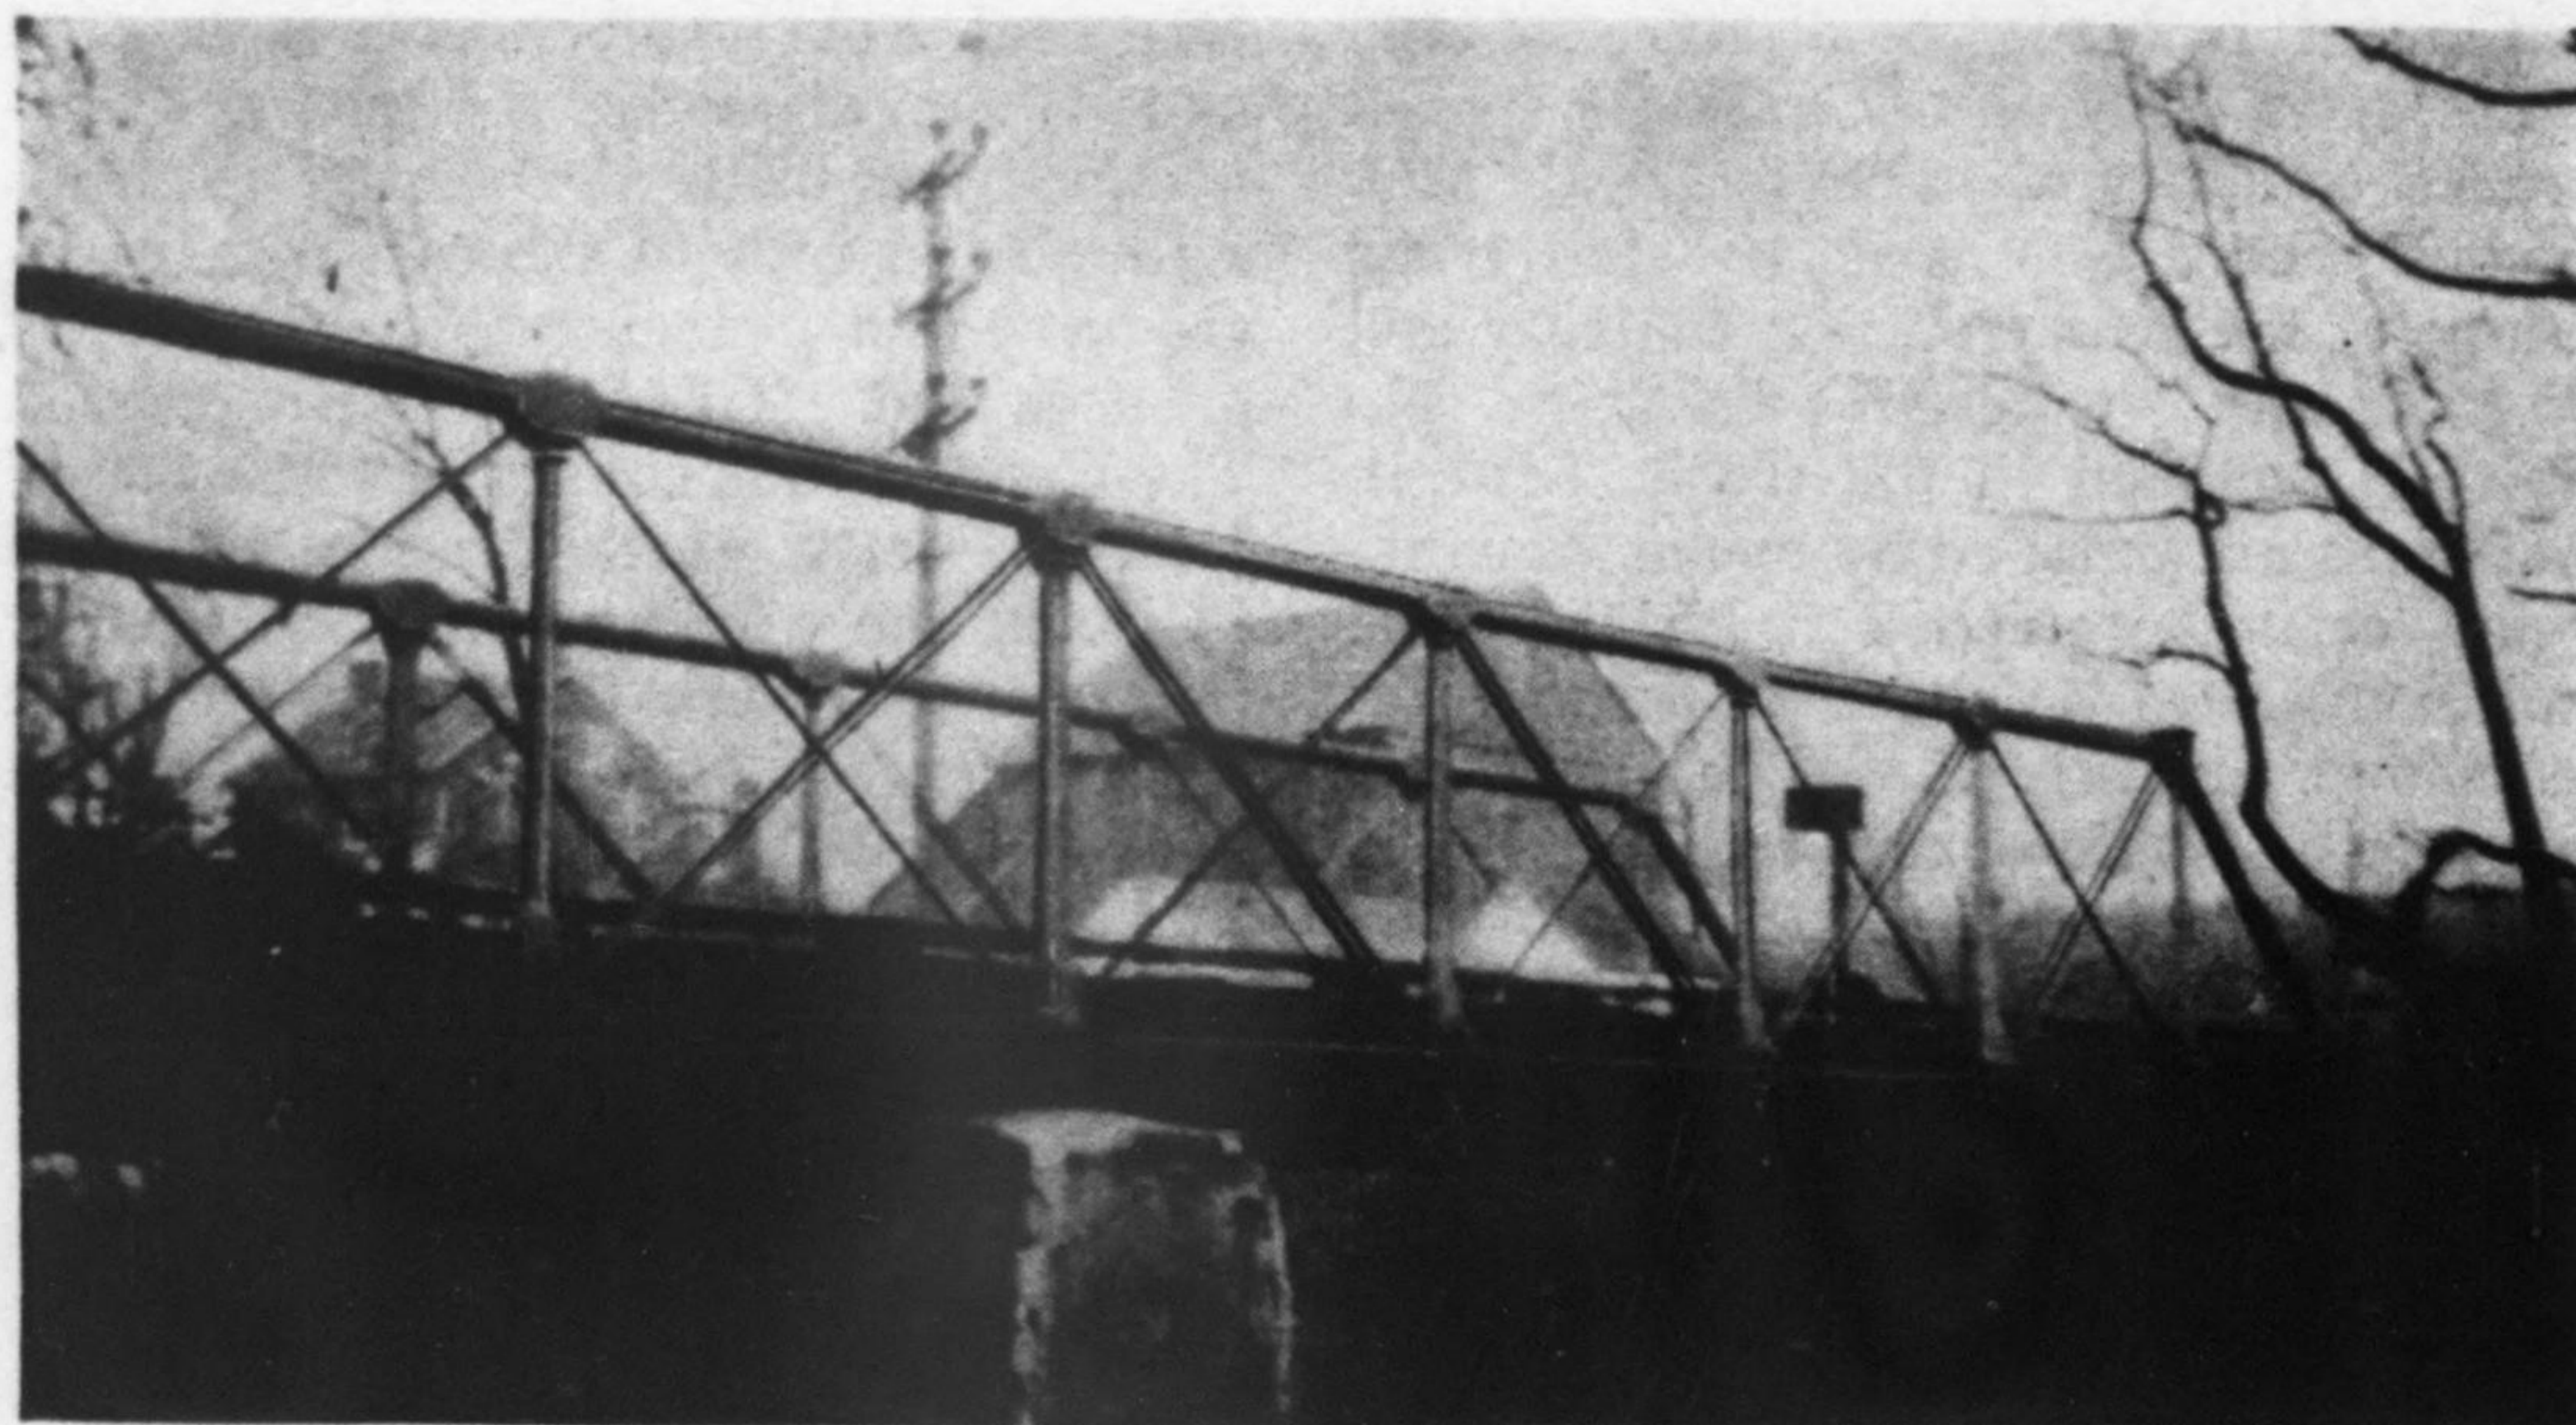
Fig. 4—Continuous-type truss bridge of cast iron in two spans of 52 ft.

of bearings, and the trusses are 15 ft. on centers and 7 ft. 10 in. deep. All compression members are octagonal in shape, the top chords and end posts being 6 in. in short diameter and the vertical posts 4½ in. All diagonals are of rods which pass through the truss castings. The upper ends of the rods are formed into a round rivet head, and

The lower chords are square eyebars connected to the panel points with pins. The trusses are not truly continuous, for the lower chord is a tension member in all panels. Probably the designer had continuity in mind, however, for the diagonals in the middle panel of each span consist of two 1-in.-diameter rods

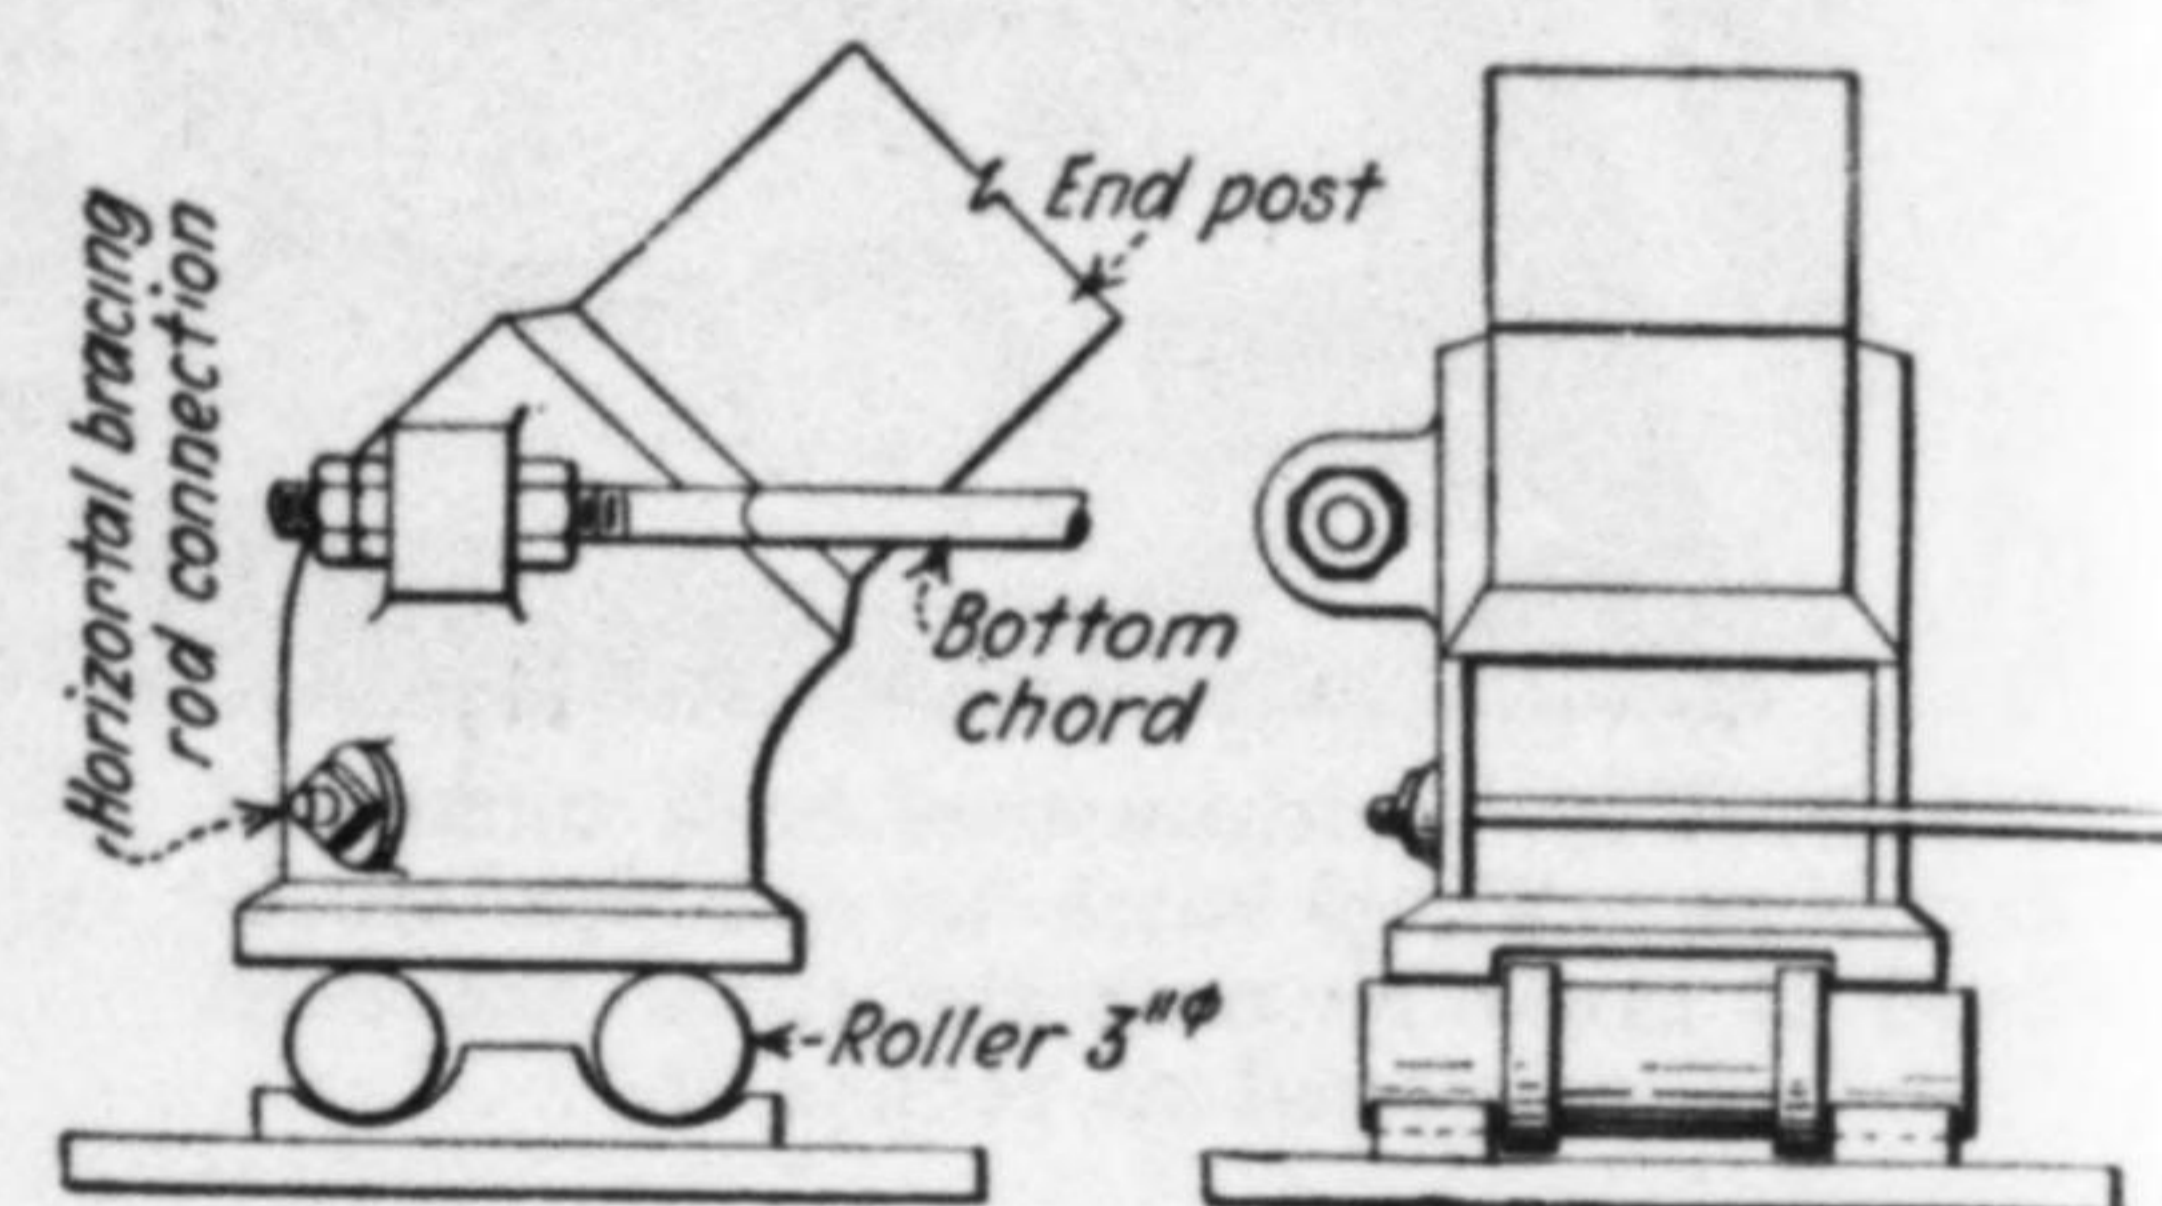
Fig. 5—Sketch of cast-iron expansion bearing on continuous-type bridge.

The expansion bearings of this bridge consist of a cast bed plate upon which

rest two 3-in.-diameter rollers. The upper surface of the bed plate is rounded as shown in Fig. 5. Except that the truss casting does not rest centrally upon the rollers, the bearings are in excellent condition.
