JERSEY BRIDGE - 1882

Jersey Bridge, near Drake Well, outside Titusville, in Venango County

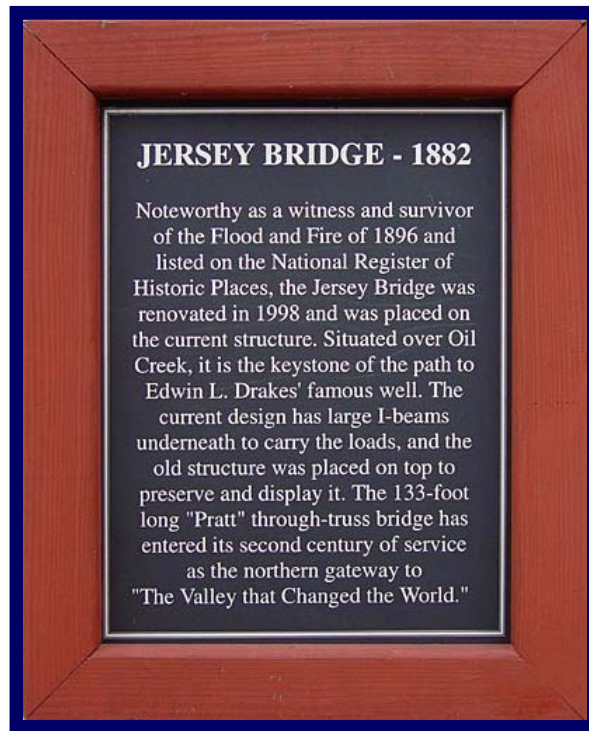
Plaque Mounted Near The Jersey Bridge
photo copyright © 2002 Daniel Alward

Noteworthy as a witness and survivor of the Flood and Fire of 1896 and listed on the **National Register of Historic Places**, the Jersey Bridge was renovated in 1998 and was placed on the current structure. Situated over Oil Creek, it is the keystone of the path to Edwin L. Drake's famous well. The current design has large I-beams underneath to carry the loads, and the old structure was placed on top to preserve and display it. The 133-foot long "Pratt" through-truss bridge has entered its second century of service as the northern gateway to "The Valley that Changed the World."

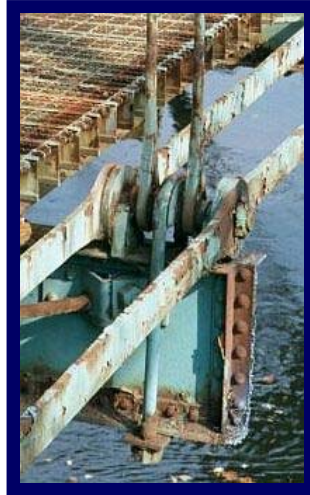
Detail of floor system connecting to truss on the old **Utica Bridge** while destruction was in progress.
photo copyright © 2001 Daniel Alward

I just don't think that the preservation model applied to this bridge is one of the better ones available. With this preservation model, the entire flooring system was lost. The pin connections and hangers that fastened the flooring system to the trusses were lost. If the old bridge couldn't have been rehabilitated to carry traffic, a more beneficial preservation scheme would have been one where the entire old bridge could have been incorporated into the new bridge.

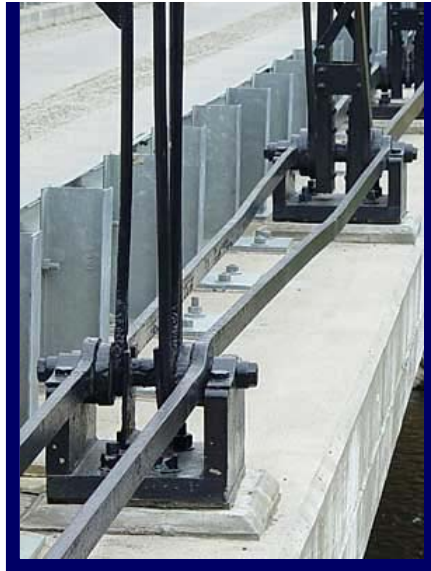
Major rehabilitation was recently done to this 19th century Pratt through truss bridge. Well - maybe "major" and "rehabilitation" aren't exactly the right words to use in this case. Only a portion of the old bridge remains today. The trusses were saved, the flooring system was discarded.

The abutments are concrete with a finish that looks like cut stone if you don't look too closely.

The Relationship Of Old and New Bridges
photo copyright © 2002 Daniel Alward
