DETERMINATION OF EFFECT REPORT

S.R. 2069, Section 001 Bridge Rehabilitation Project

Moreland Township Road over Little Muncy Creek

ER #2003-6155-081

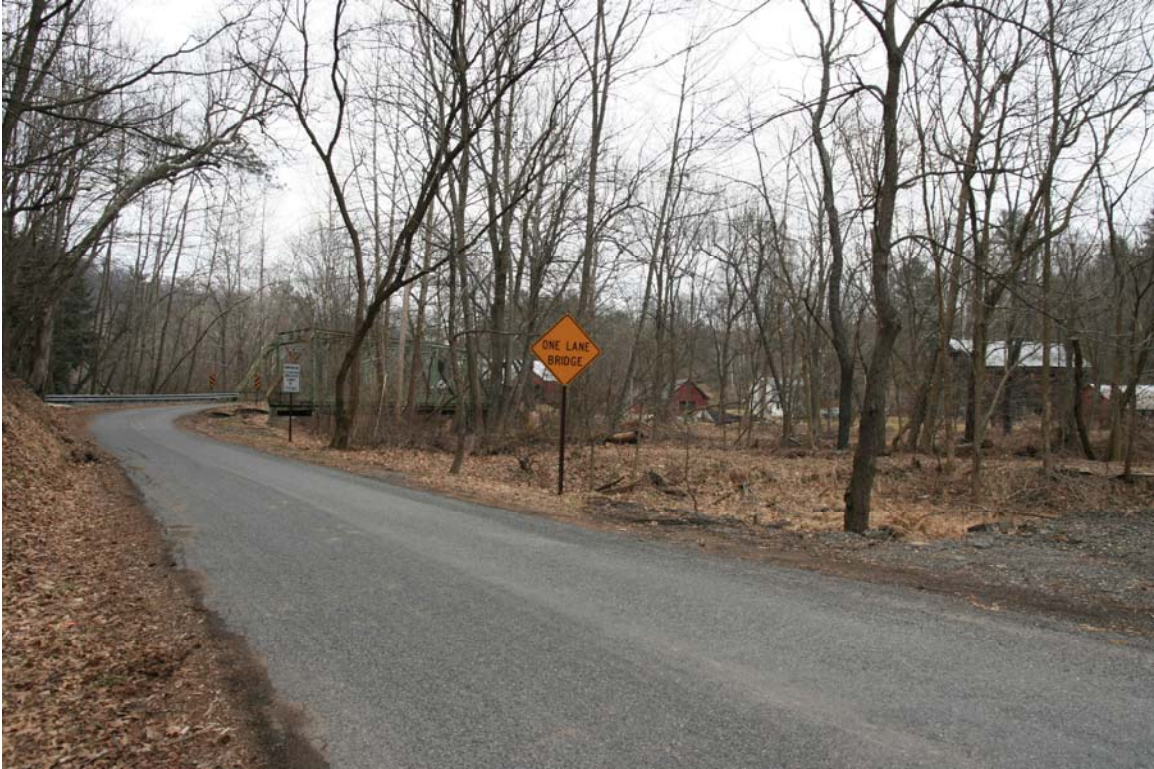
Photograph 1: View of the project area looking northeast, showing the S.R. 2069-001 bridge (in background, just left of center) and wooded surroundings (January 2012).

The proposed project is located in the rural area of central Moreland Township, Lycoming County (Figure 1). The S.R. 2069-001 bridge is a contributing resource to the Smith/Wallis Gristmill Historic District, which is primarily located to the east of the bridge. The district includes approximately 14 buildings that date from ca. 1796 to 1953, as well as two bridges and one well. The area surrounding the bridge and district generally consists of farmland interspersed with swaths of trees (Photographs 1 to 4).

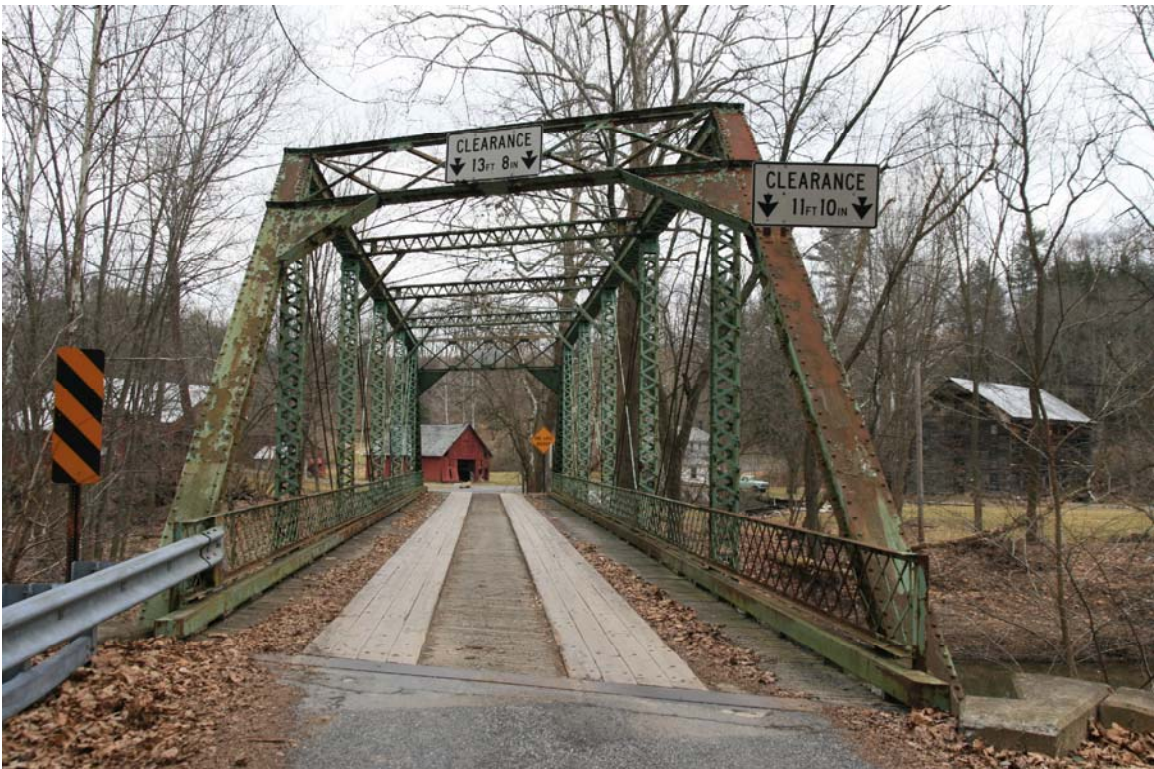
Photograph 4: View looking east toward the west portal of the S.R. 2069-001 bridge. Buildings within the Smith/Wallis Gristmill Historic District are visible in the background (January 2012).

The existing S.R. 2069-001 bridge (built in 1904) is a single-lane, single-span, 113-foot long steel Pratt through truss that carries S.R. 2069 (Moreland Township Road) over Little Muncy Creek (Photographs 4 to 6). The structure has a curb-to-curb width of 16 feet and is in poor condition. The steel members of the bridge are held together by iron pins, a popular construction technique that enabled the bridge to be prefabricated in the workshop and erected on-site. The bridge rests on stone abutments with flared wingwalls. The timber deck, which was previously replaced, is in poor condition (Photographs 6 to 8). The trusses are composed with built-up box section upper chords, vertical members with lacing, and diagonals and lower chords composed of eye bars. The steel floor beams are suspended by pin plates that are framed into both the ends of the floor beams and the bottoms of the verticals. To compensate for deterioration at the lower ends of the verticals, U-shaped hangers over a batten plate at the bottom of the verticals were added at an unknown date. The hangers were replaced in-kind in 1995 (A.G. Lichtenstein & Associates 2000). The lower chords have undergone section loss, which dictates the current 5-ton limit. The preferred ton limit, in order to accommodate township vehicles, school buses, and emergency vehicles, is 17 tons.

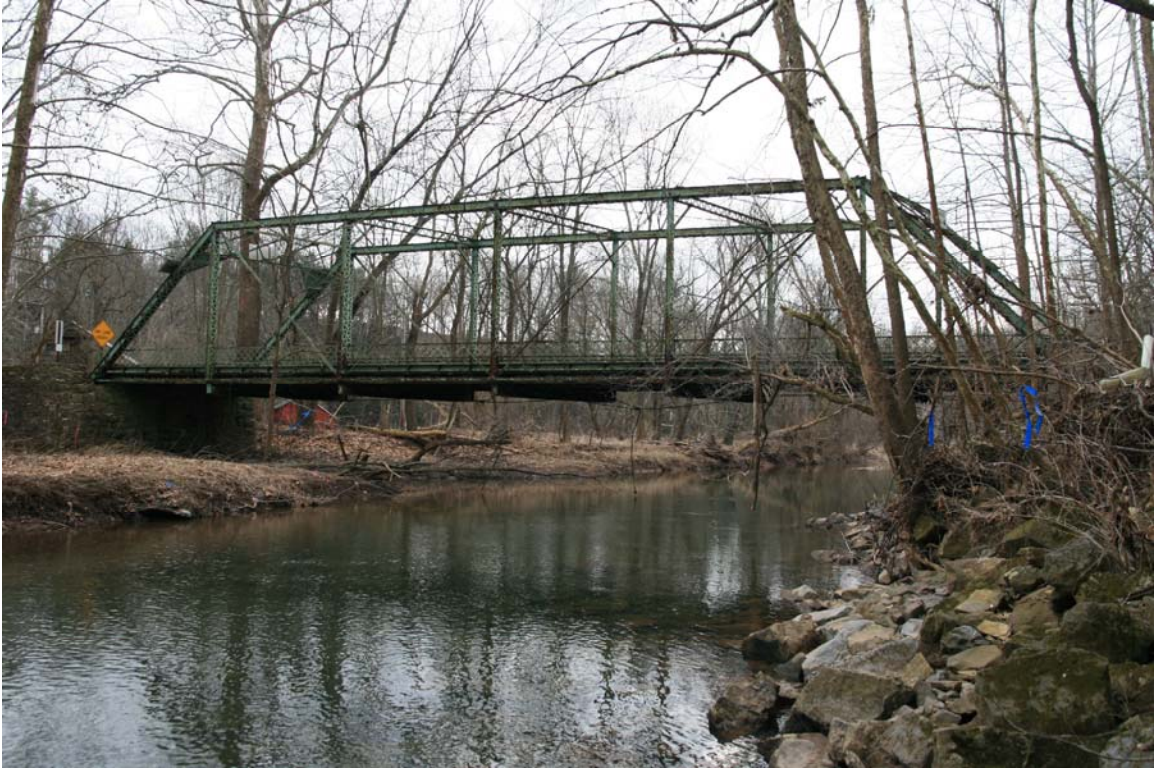
Photograph 5: Overview of S.R. 2069-001 bridge, looking southeast (January 2012).

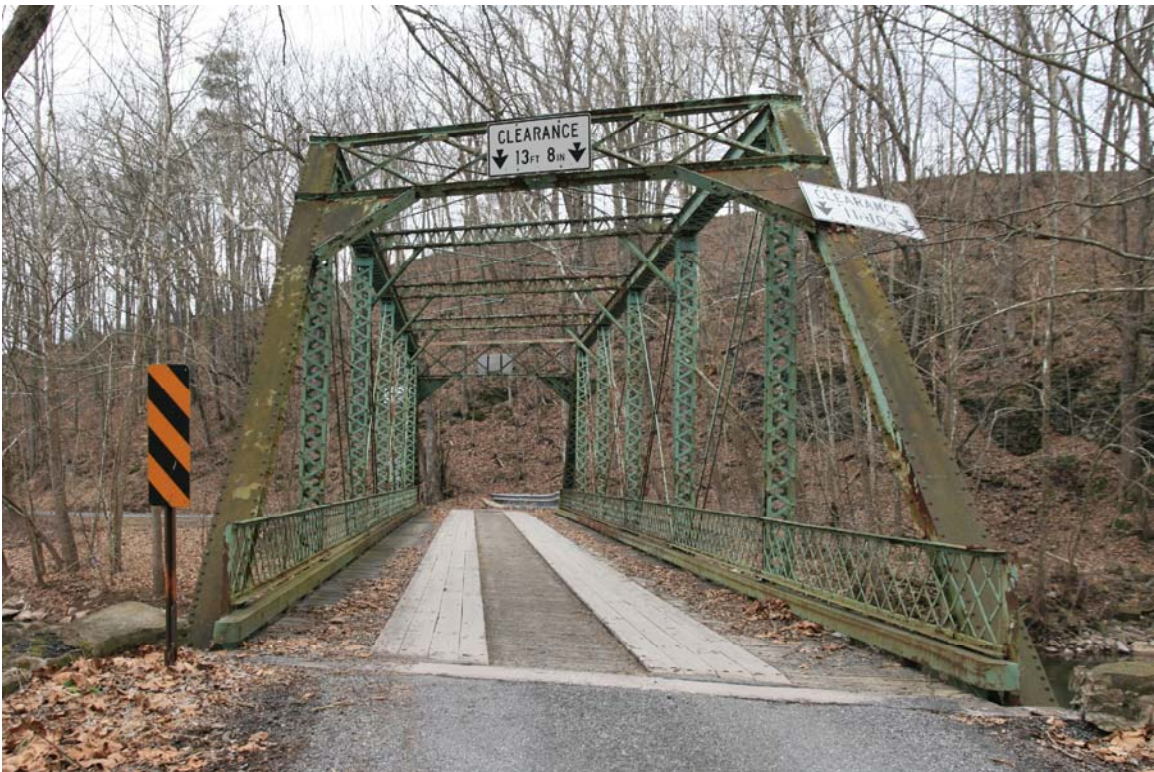
Photograph 6: View looking west toward the east portal of the S.R. 2069-001 bridge. The portal, top struts, and upper lateral bracing will be retained through minor repair work. The previously repaired timber deck will be replaced with a galvanized steel open deck (January 2012).

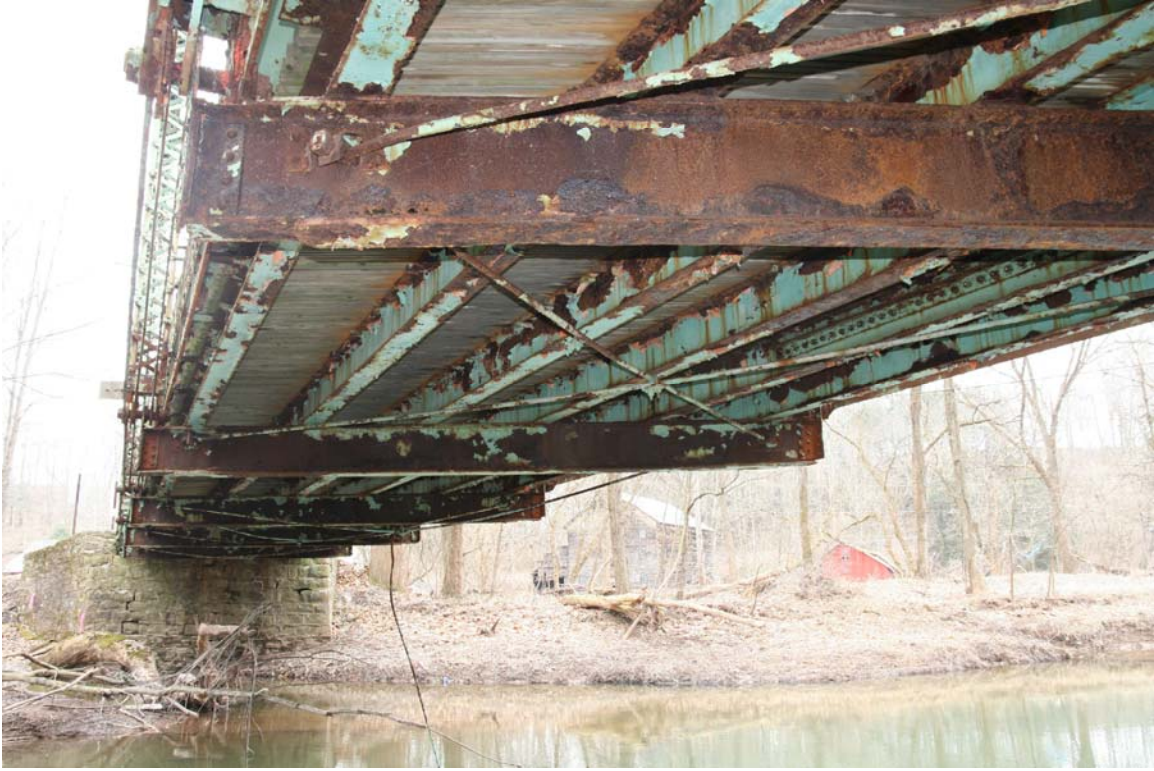
Photograph 7: View underneath the S.R. 2069-001 bridge, looking northeast, showing the deterioration of floor beams, stringers, and lower lateral bracing (January 2012).

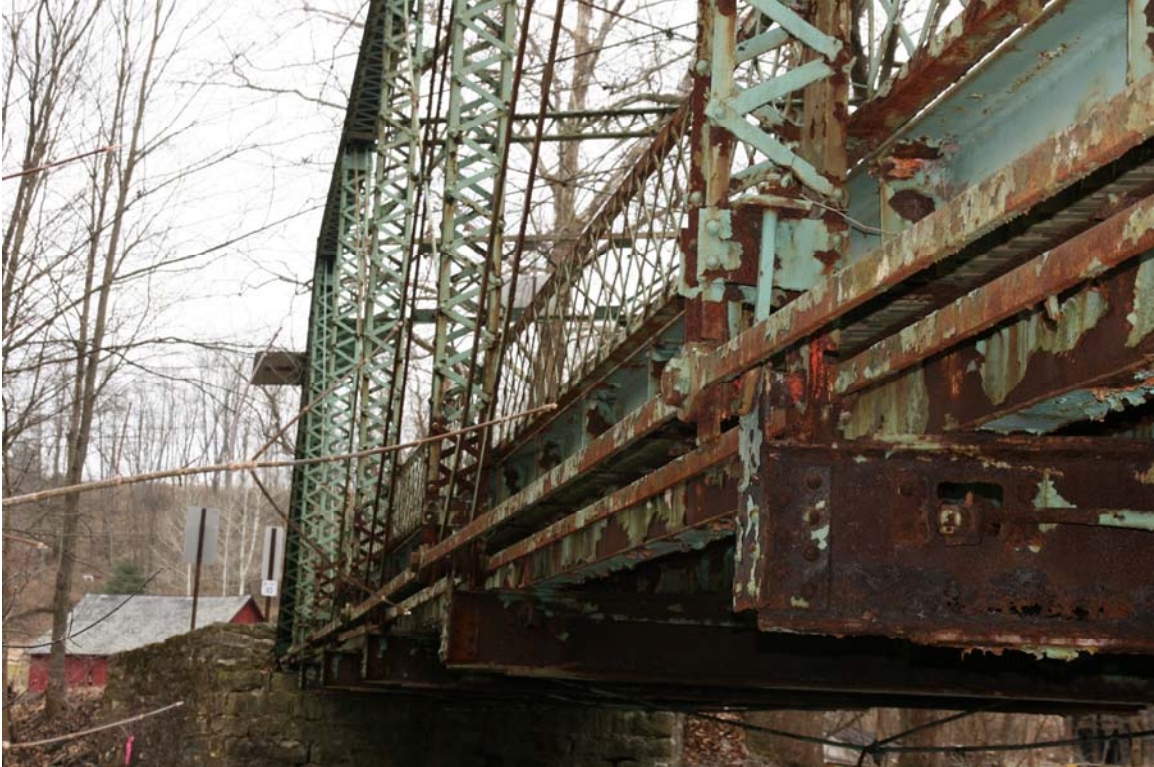
Photograph 8: Detail of the north side of the S.R. 2069-001 bridge, looking east, showing the deterioration of the floor beams, lower chord, and vertical and diagonal members (January 2012).

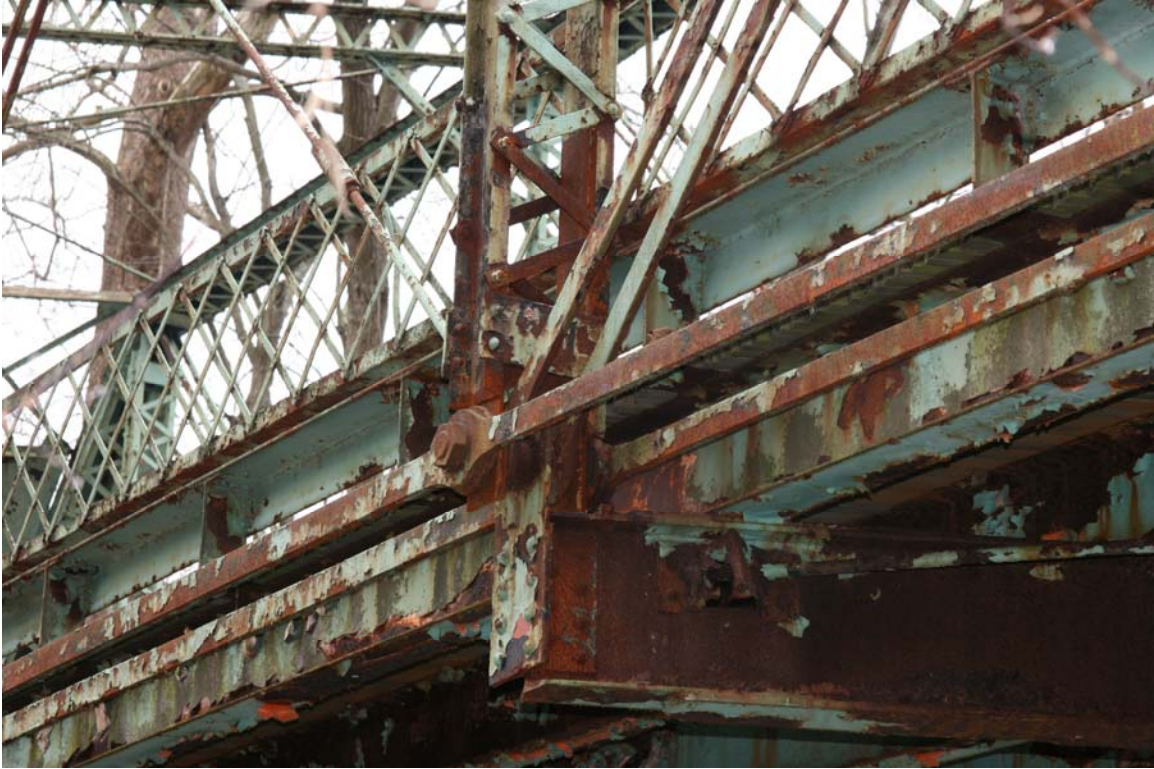
Photograph 9: Detail of the lower connection of vertical members and floor beam, looking southeast. The floor beams, lower chord, and vertical members will all be replaced. The eye bars will be replaced in-kind (January 2012).

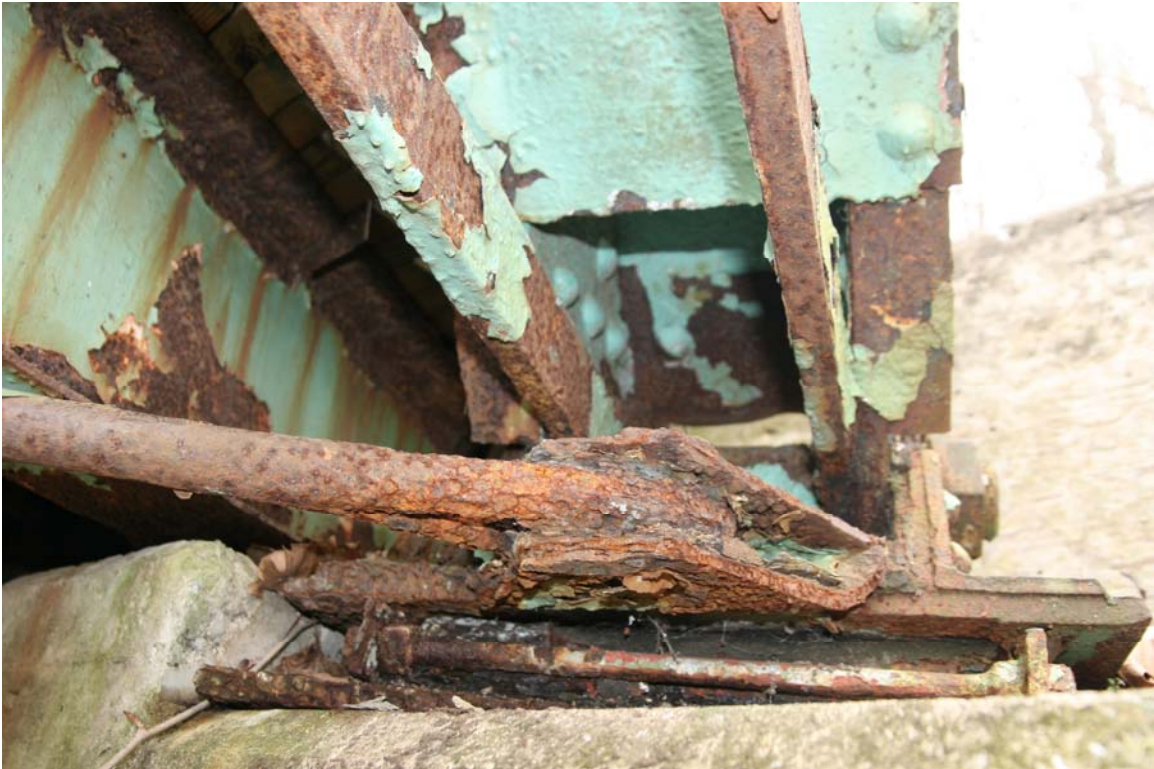
Photograph 10: Detail of the deterioration at the connection of the lower chord, lower lateral bracing, and east portal of the S.R. 2069-001 bridge, looking southwest (January 2012).

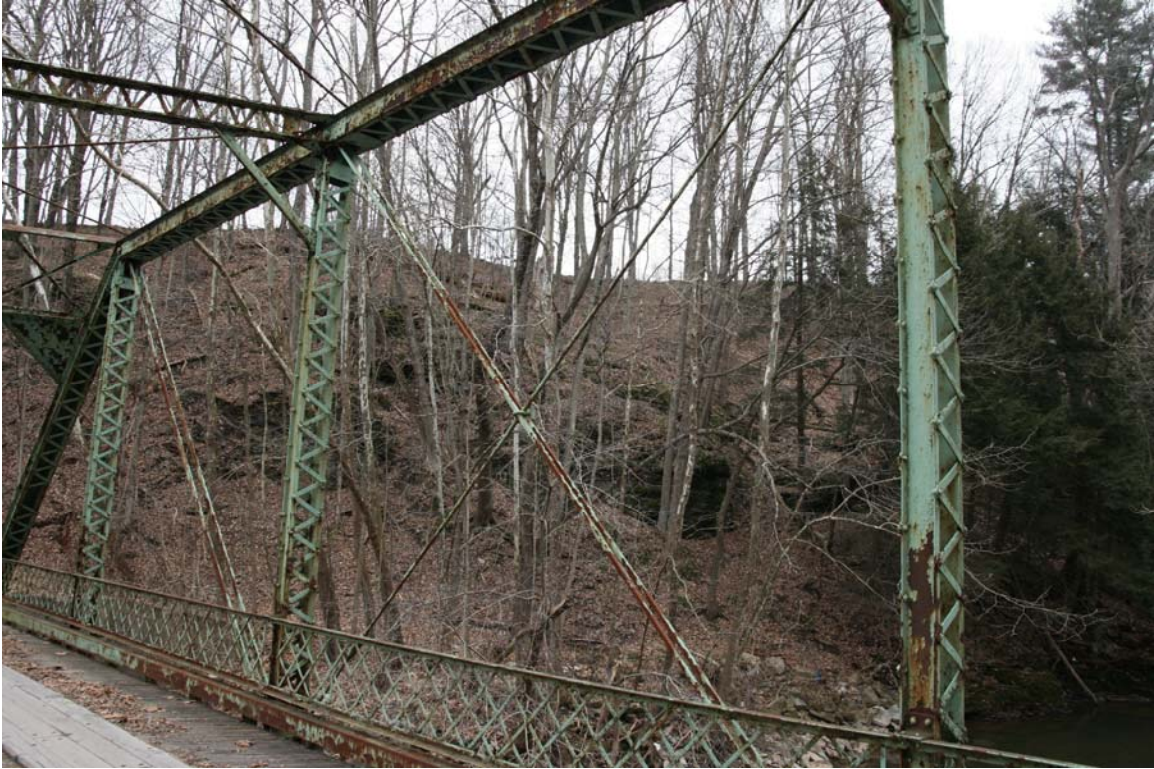
Photograph 11: Detail of the north side of the S.R. 2069-001 bridge, looking northwest, showing the deteriorated vertical and diagonal members, which will be replaced (January 2012).

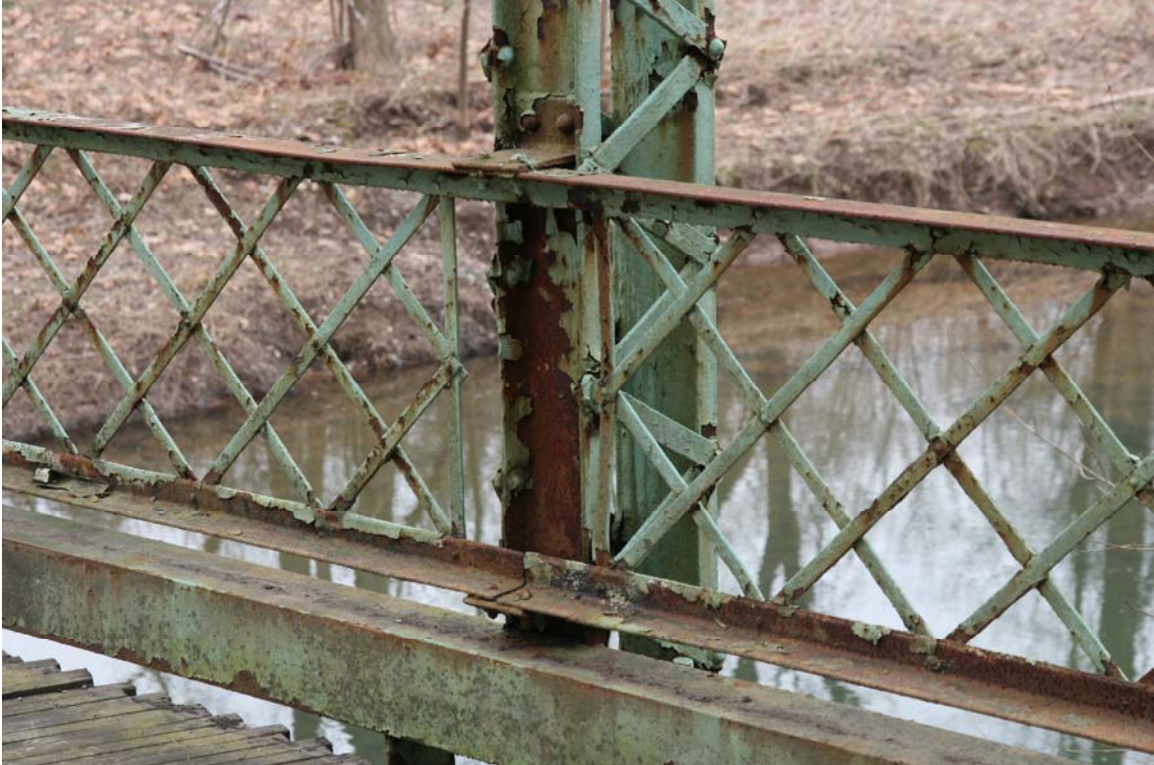
Photograph 12: Detail of the vertical member and railing, looking southeast. The vertical members will all be replaced, and the railing will be replaced in-kind with a new W-beam railing (January 2012).

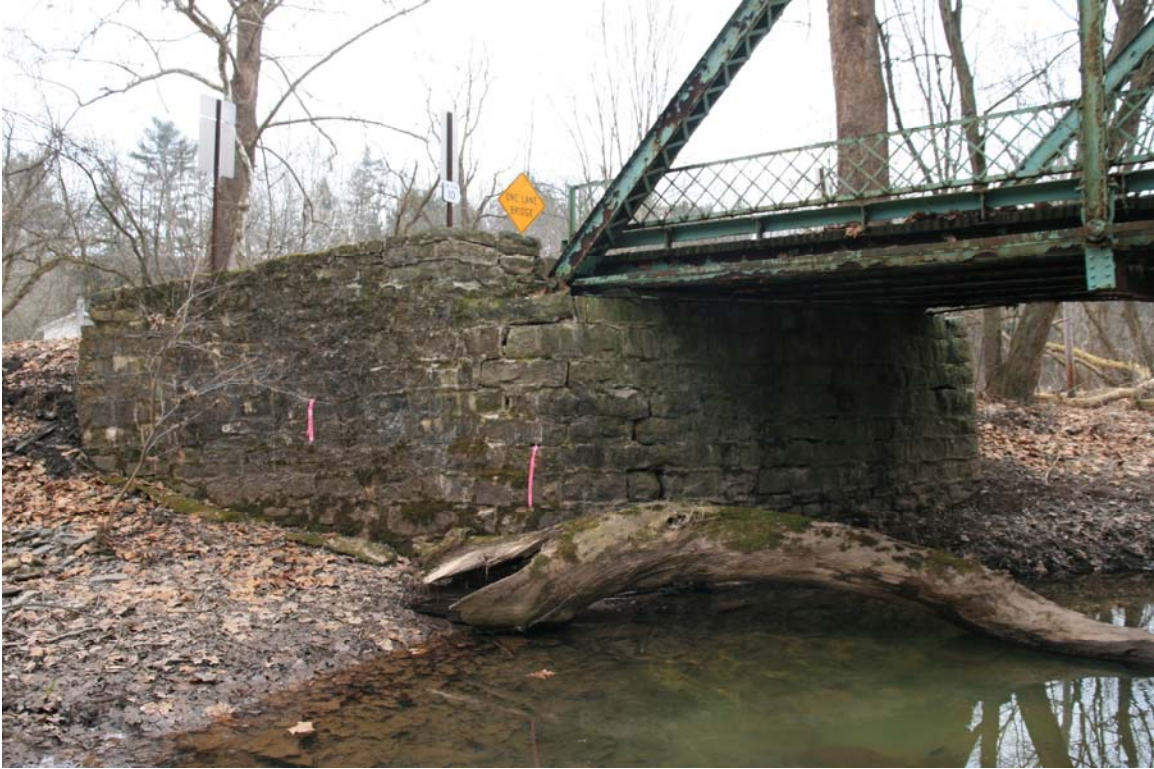
Photograph 13: Detail of the east abutment, which will be retained, looking southeast. The stone will be repointed, drainage will be placed behind the abutment, and a new concrete cap will be applied (January 2012).

New bearings will be placed. The lower lateral bracing will be replaced with new rods of similar size. The portals, built-up sway struts, and steel upper lateral bracing will be retained through minor repair work. A new W-beam railing will be installed that replicates the previous railing. The east abutment will be retained through the placement of drainage behind the abutment, repointing of the existing stone masonry, and application of a new concrete cap (Photograph 13). The west abutment, which was replaced in 1975, will be retained (Photograph 14).

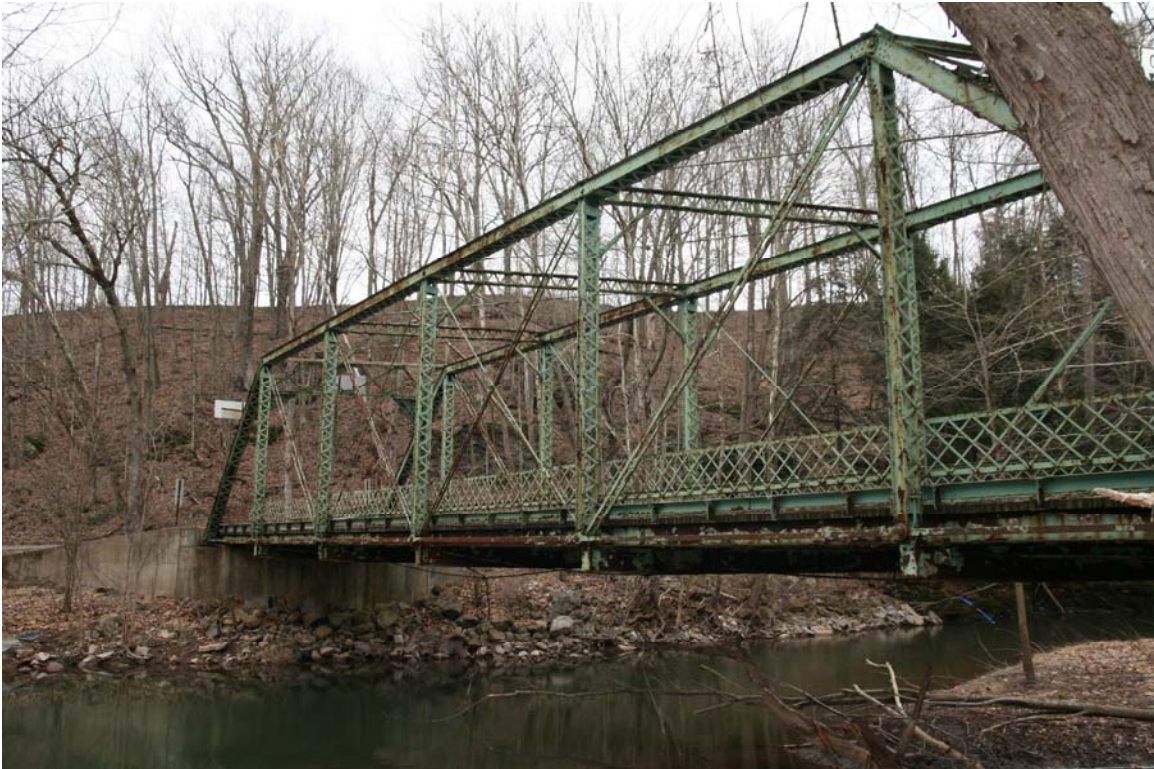
Photograph 14: Overview of the S.R. 2069-001 bridge, looking northwest. The west abutment was replaced in 1975 and will be retained (January 2012).
