SITUATION SKETCH of Bluestone River bridge at time the center span failed during erection.

Probe cause of W. Va. bridge failure

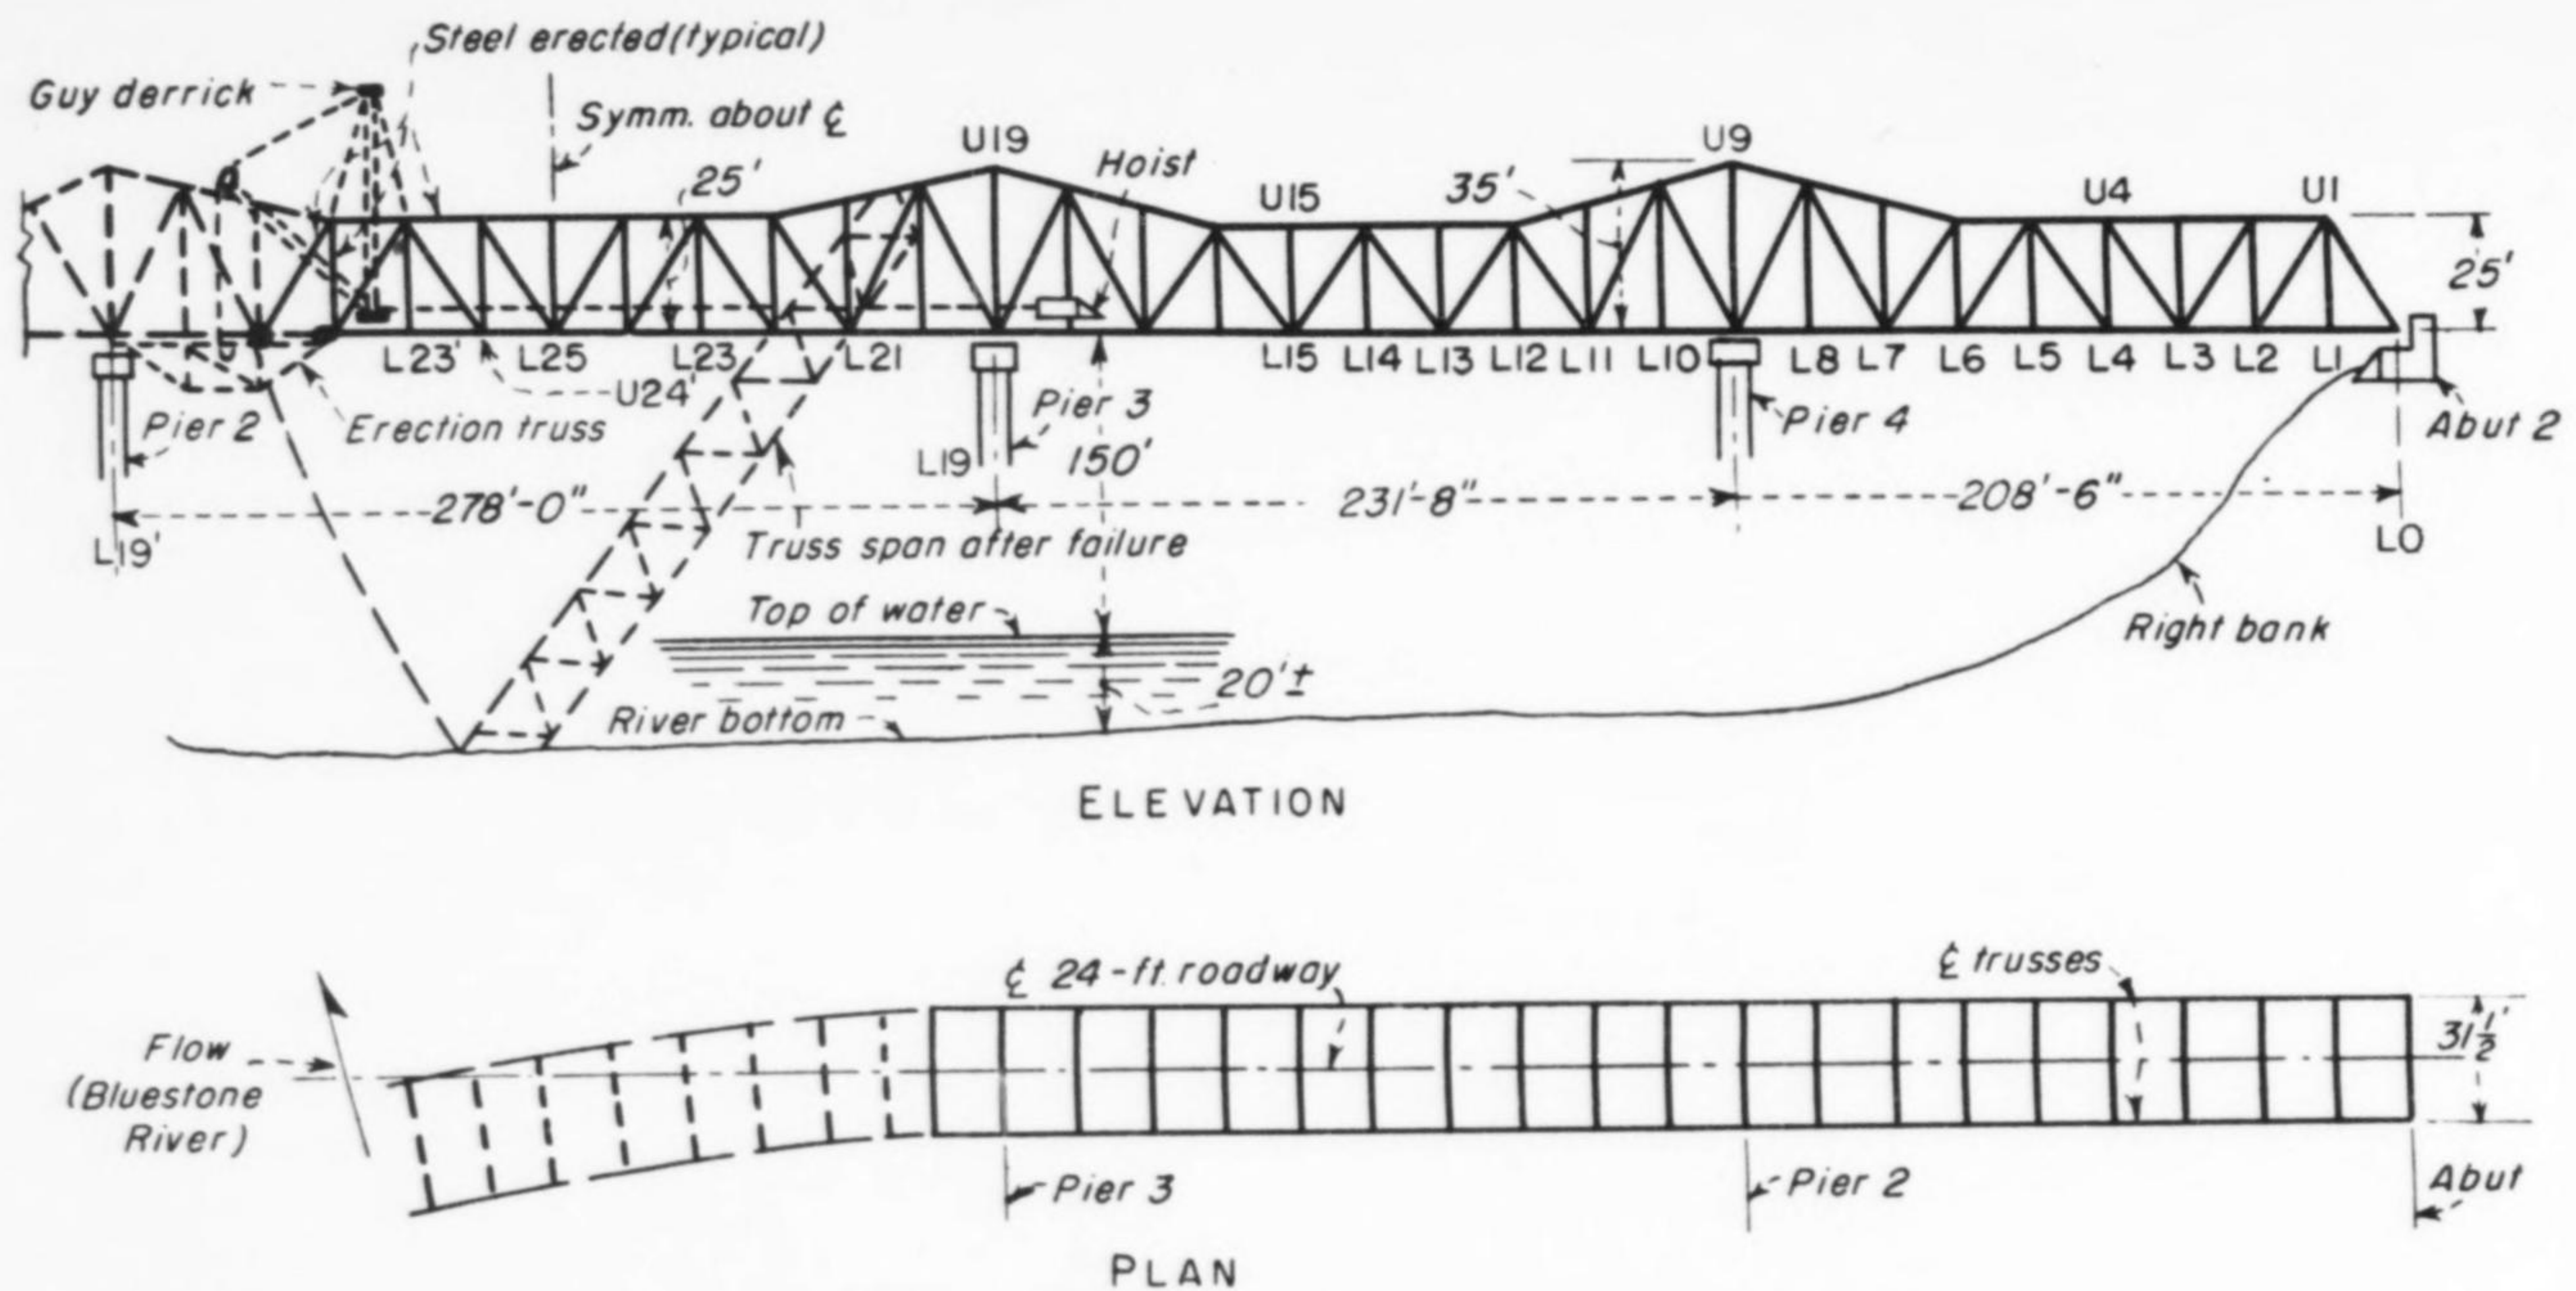
Failure occurred when ten panels of the 278-ft. center span of the five span bridge had been cantilevered 231 ft. 8 in. from pier 3 toward pier 2. The riverward end of the extension dropped into the stream leaving the shoreward end hanging precariously, supported by twisted truss members in the first and second panels adjacent to pier 3.

When the sudden failure occurred (five steel erectors were killed and four others injured) the downstream top chord snapped in two at the second panel point from pier 3. The upstream top chord bent, but did not break. This caused the end of the cantilever to drift about 15 ft. upstream as it fell. Workmen reported they heard only a single, sharp popping sound, but it could not be determined if this occurred before or after the actual failure.

Located two miles upstream from Bluestone Dam, near this village, Bluestone Bridge is to be a 1,158-ft. riveted five-span cantilever highway bridge as shown in the accompanying sketch. All panel lengths are 23 ft. 2 in. Spans 2 and 4 are anchor spans for spans 1, 3 and 5. They are continuous over, and extend 3 panels beyond their supporting piers to form cantilever arms for supporting a 6-panel suspended span at the ends of

spans 1 and 5 and in the center of span 3.
