# THE GOLDEN GATE BRIDGE

REPORT OF THE GENERAL MANAGER

GOLDEN GATE BRIDGE AND HIGHWAY DISTRICT

# A SYMPOSIUM ON STRUCTURAL DESIGN AND STABILITY OF THE GOLDEN GATE BRIDGE

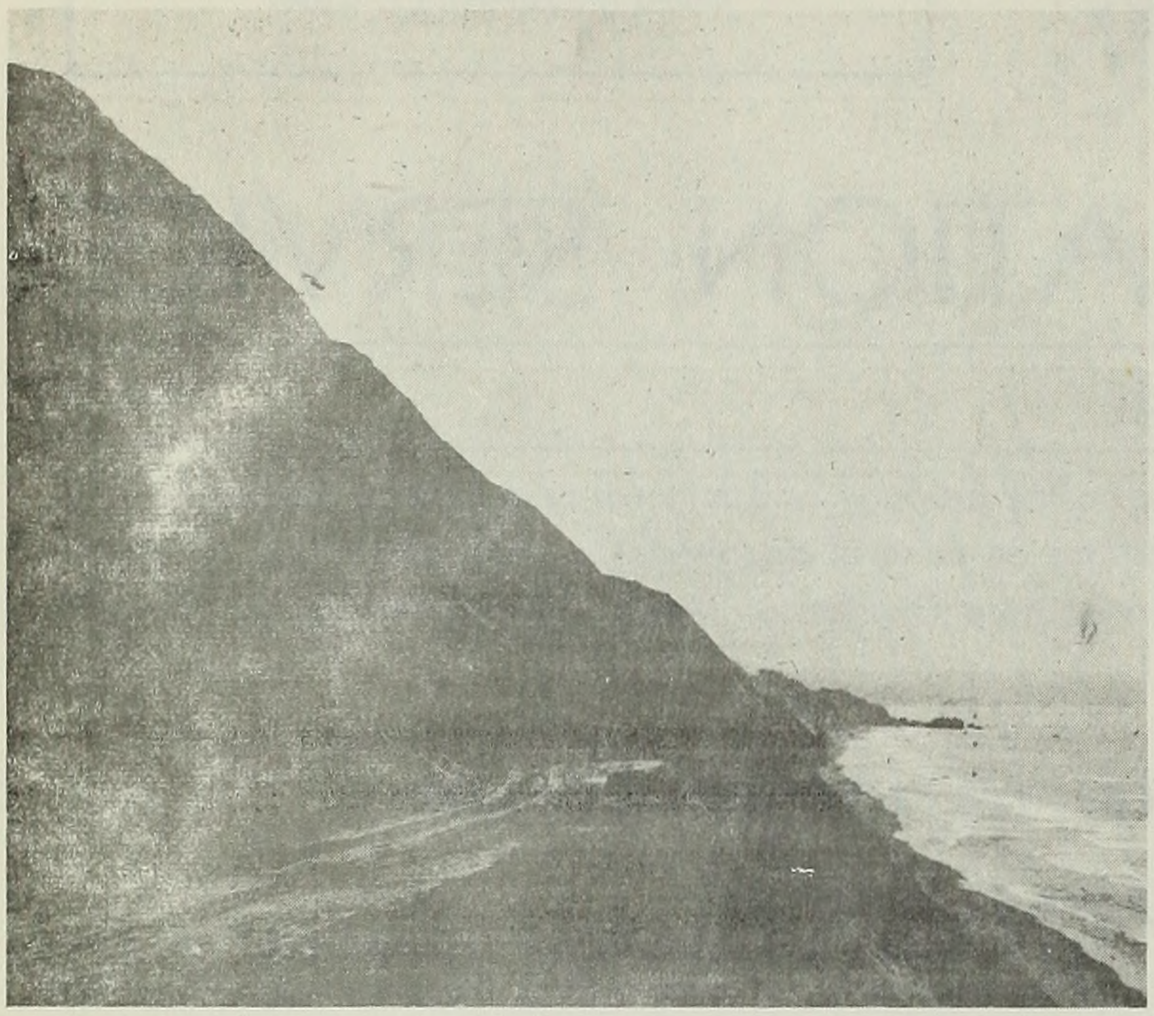
Landslide near Mussel Rock, State Highway 1.

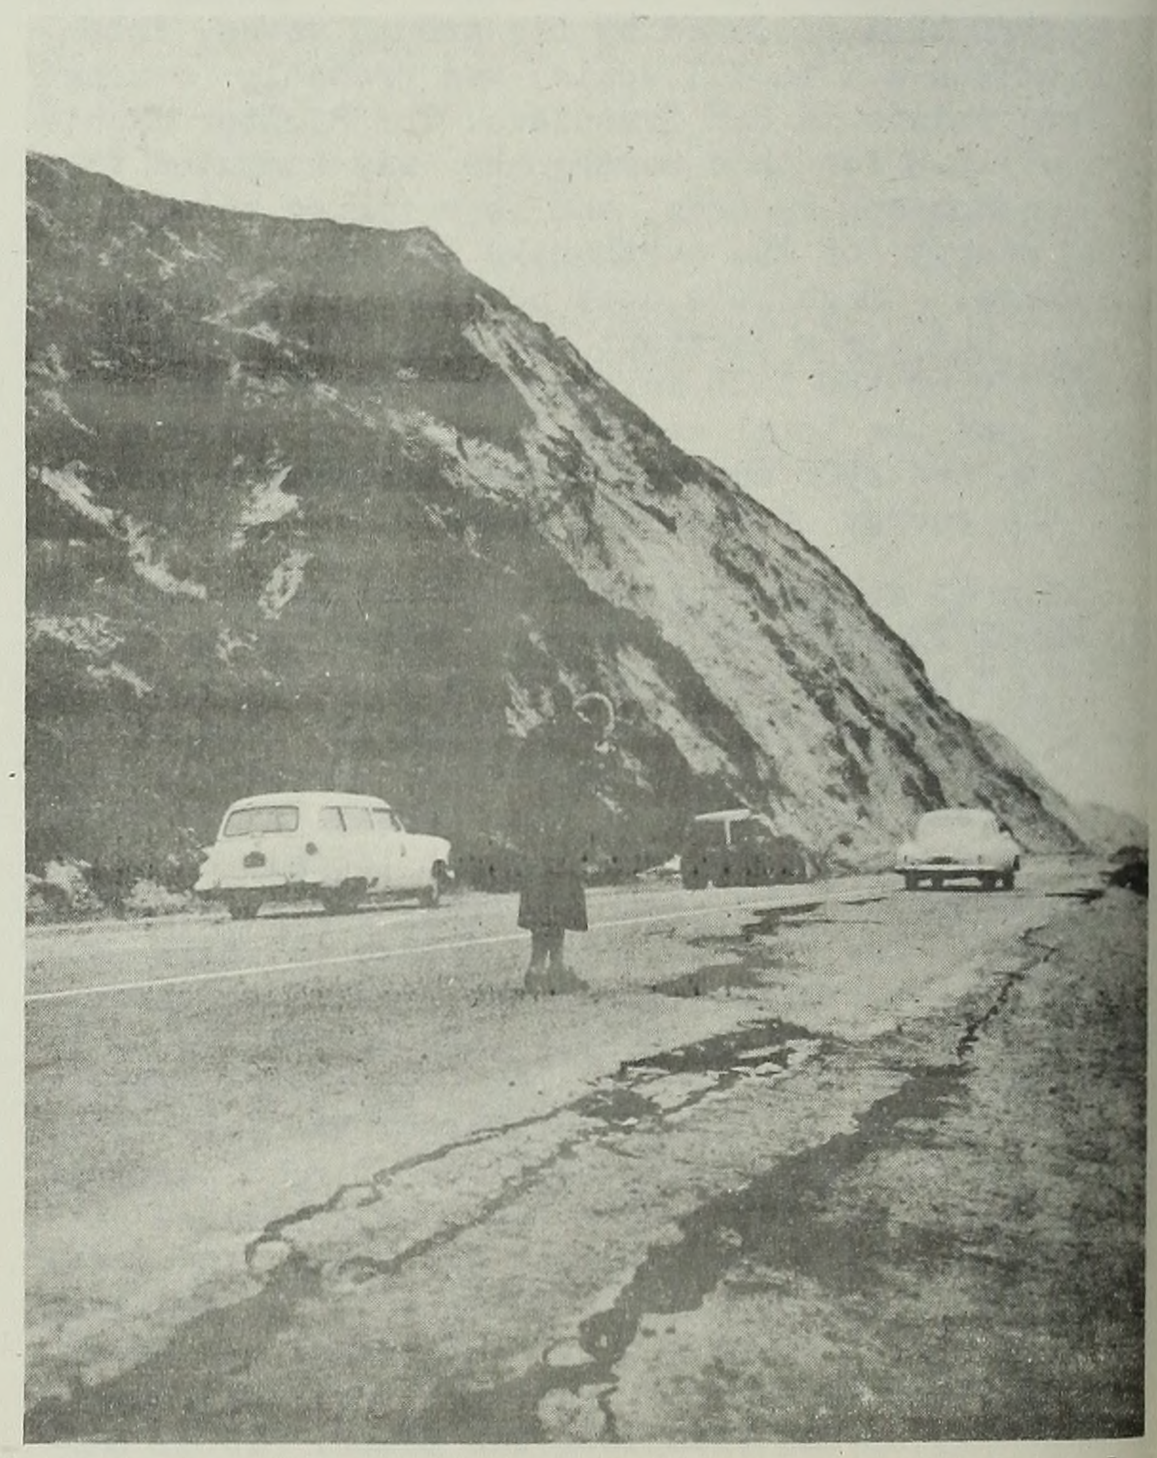
Cracks in roadbed and shoulder, State Highway 1 near Mussel Rock.

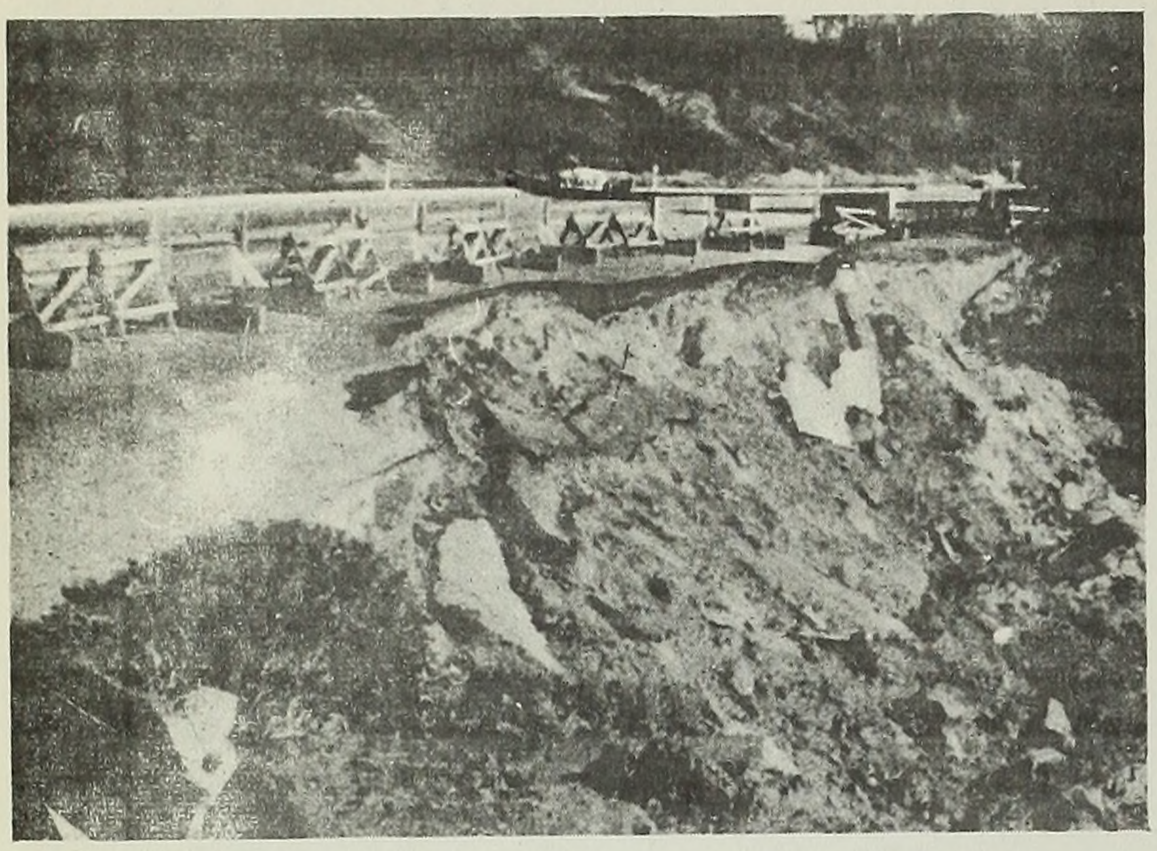
Road shoulder slump due to earthquake, Lake Merced, San Francisco.

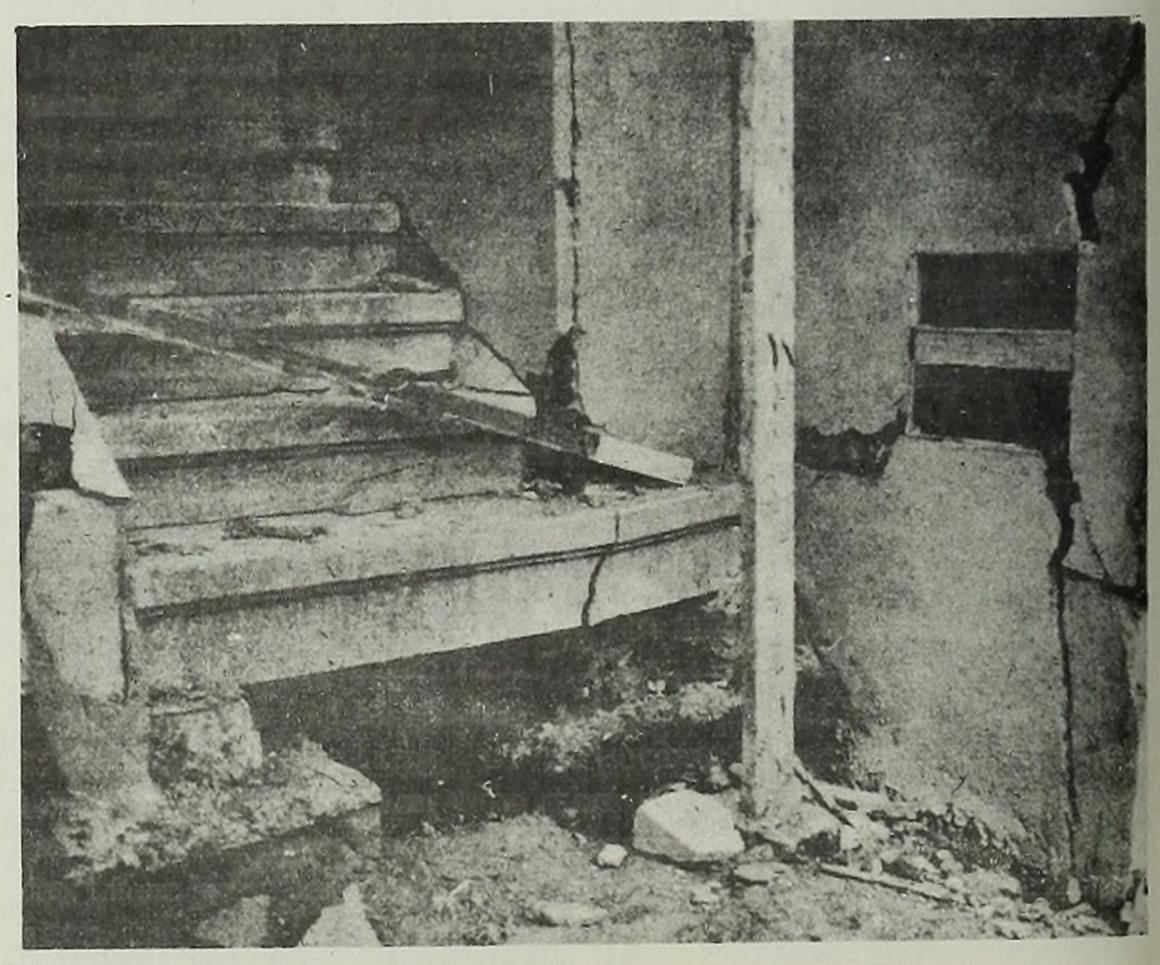
Building damage was strongest in the Westlake Palisades tract of Daly City which is located on a terrace several hundred feet in elevation along the Pacific Ocean. The tract comprises about 450 wood-frame dwellings, one and two stories high; all recently built. An estimated 50 percent of the houses in this tract were damaged, with the loss per dwelling estimated to average less than $200. Damage was generally confined to the exterior plaster of the first-story front wall (see photo).

Earthquake damage to exterior wall and steps by earthquake. Westlake-Palisades district, Daly City.

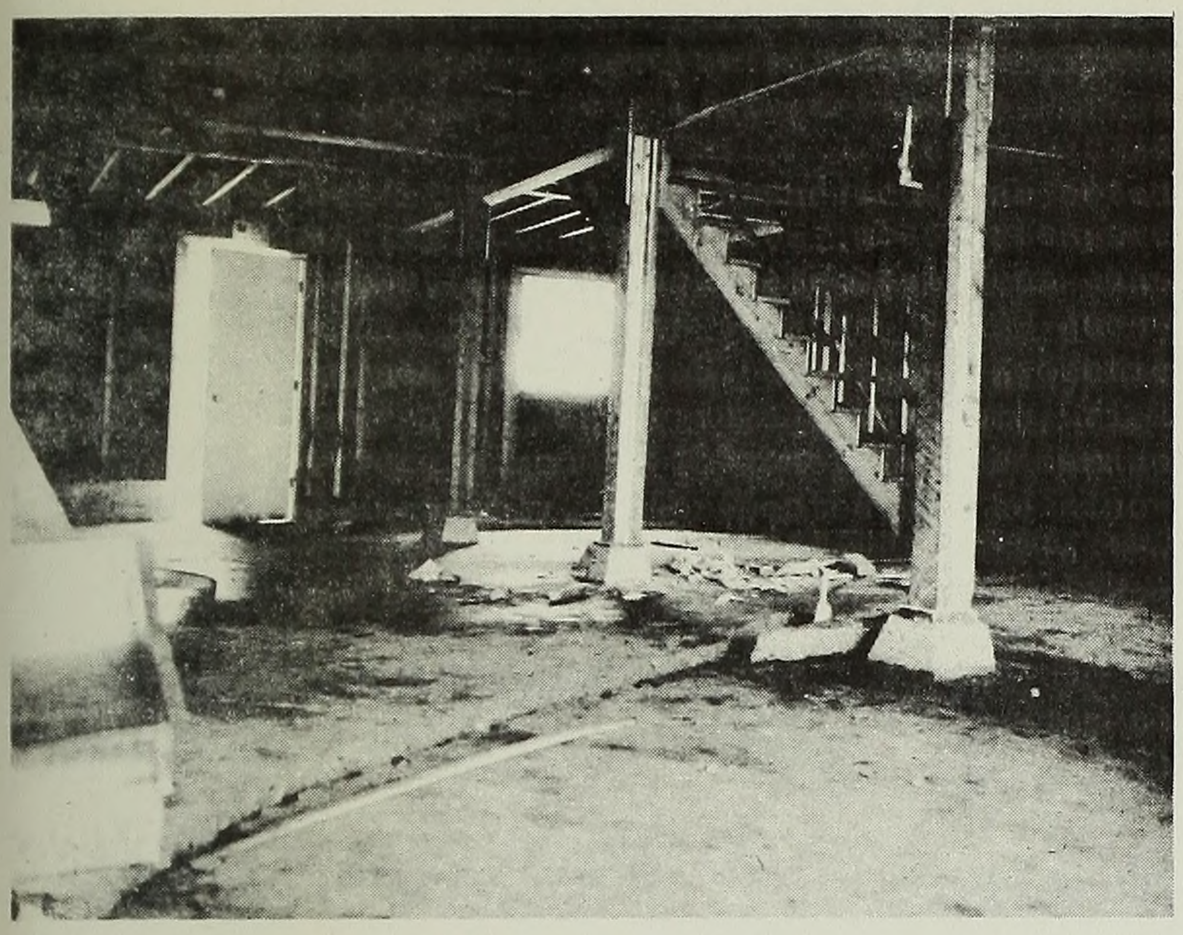
Crack in concrete floor of house caused earthquake. Westlake Palisades district, Daly City.

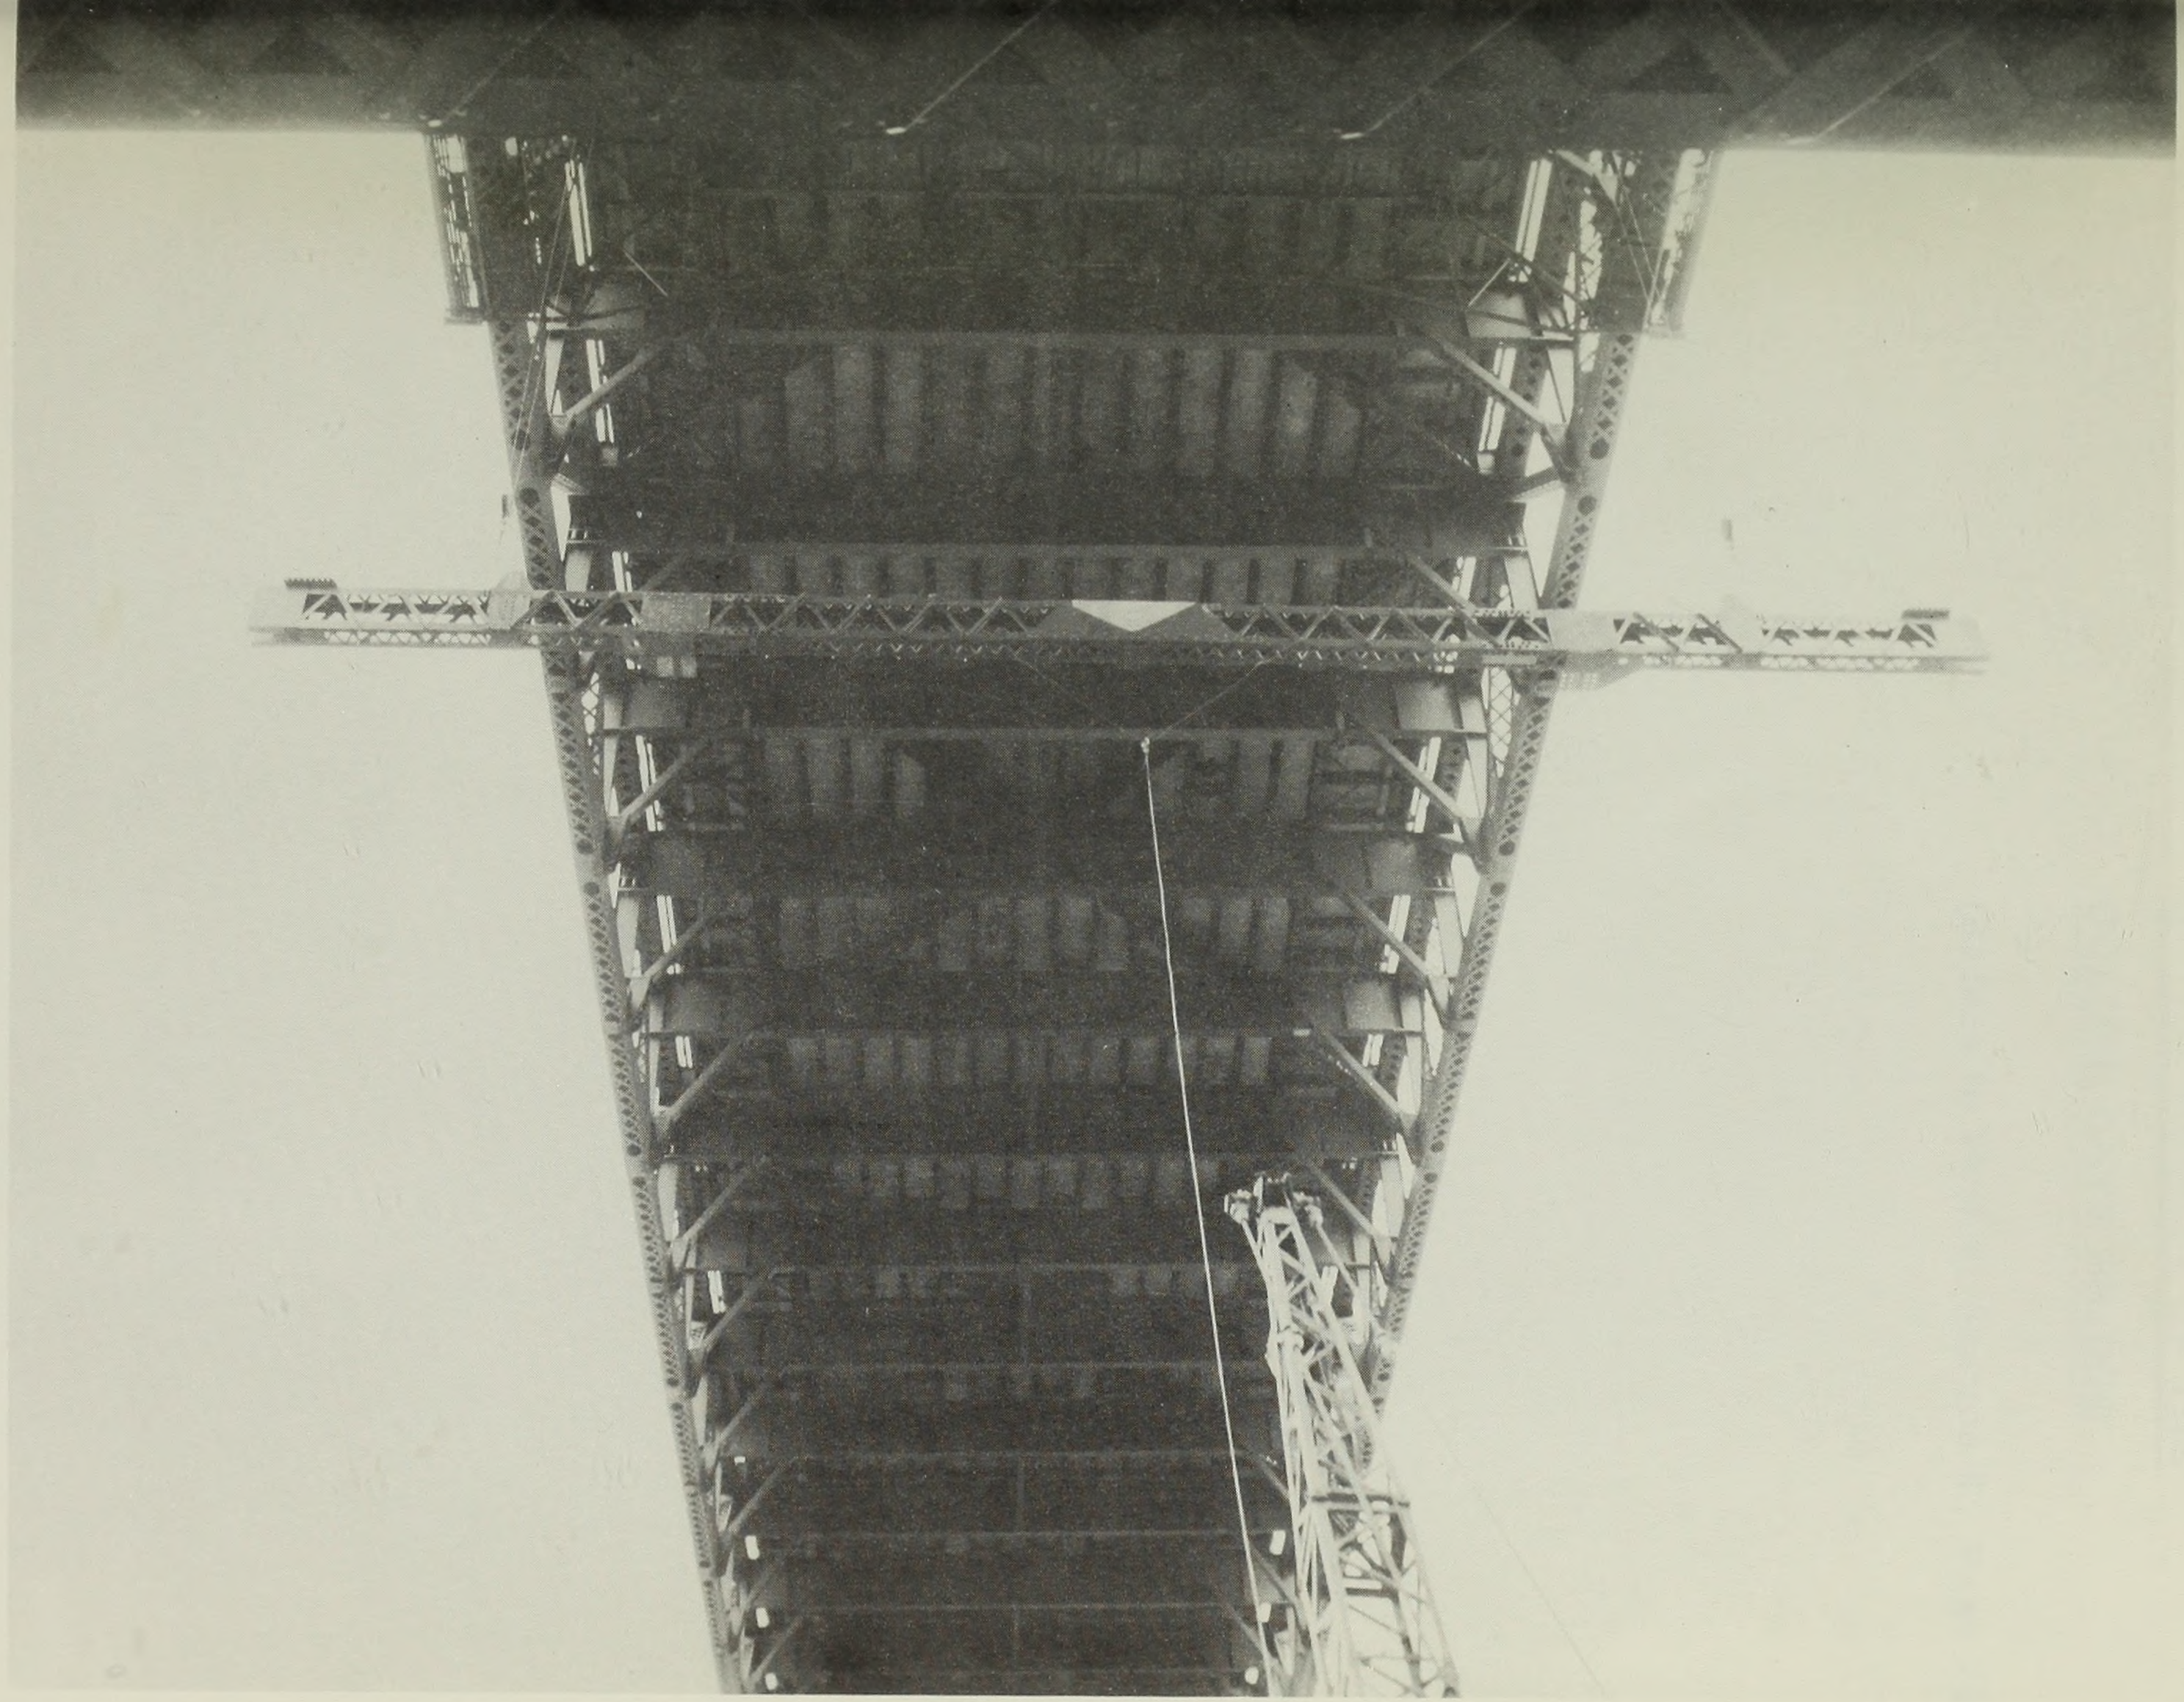
It was found that there had been no damage of any structural consequence, except at expansion joints where the lateral system of the center span connects with the towers. These joints were designed to absorb the stresses of such wind action by use of sliding blocks and bearing plates located beneath the roadway. To improve the mechanical design for future occasions, carbon steel was installed to replace the bronze shoes that had originally been used, with a re-design of moving parts to reduce the amount of dry friction between steel and bronze.

Underside of Bridge Deck Structure Prior to Installation of Bottom Lateral Bracing
