Paper No. 1335

### LITTLE ROCK JUNCTION RAILWAY BRIDGE,

### OVER THE ARKANSAS RIVER

### AT LITTLE ROCK, ARKANSAS, 1883-1914\*

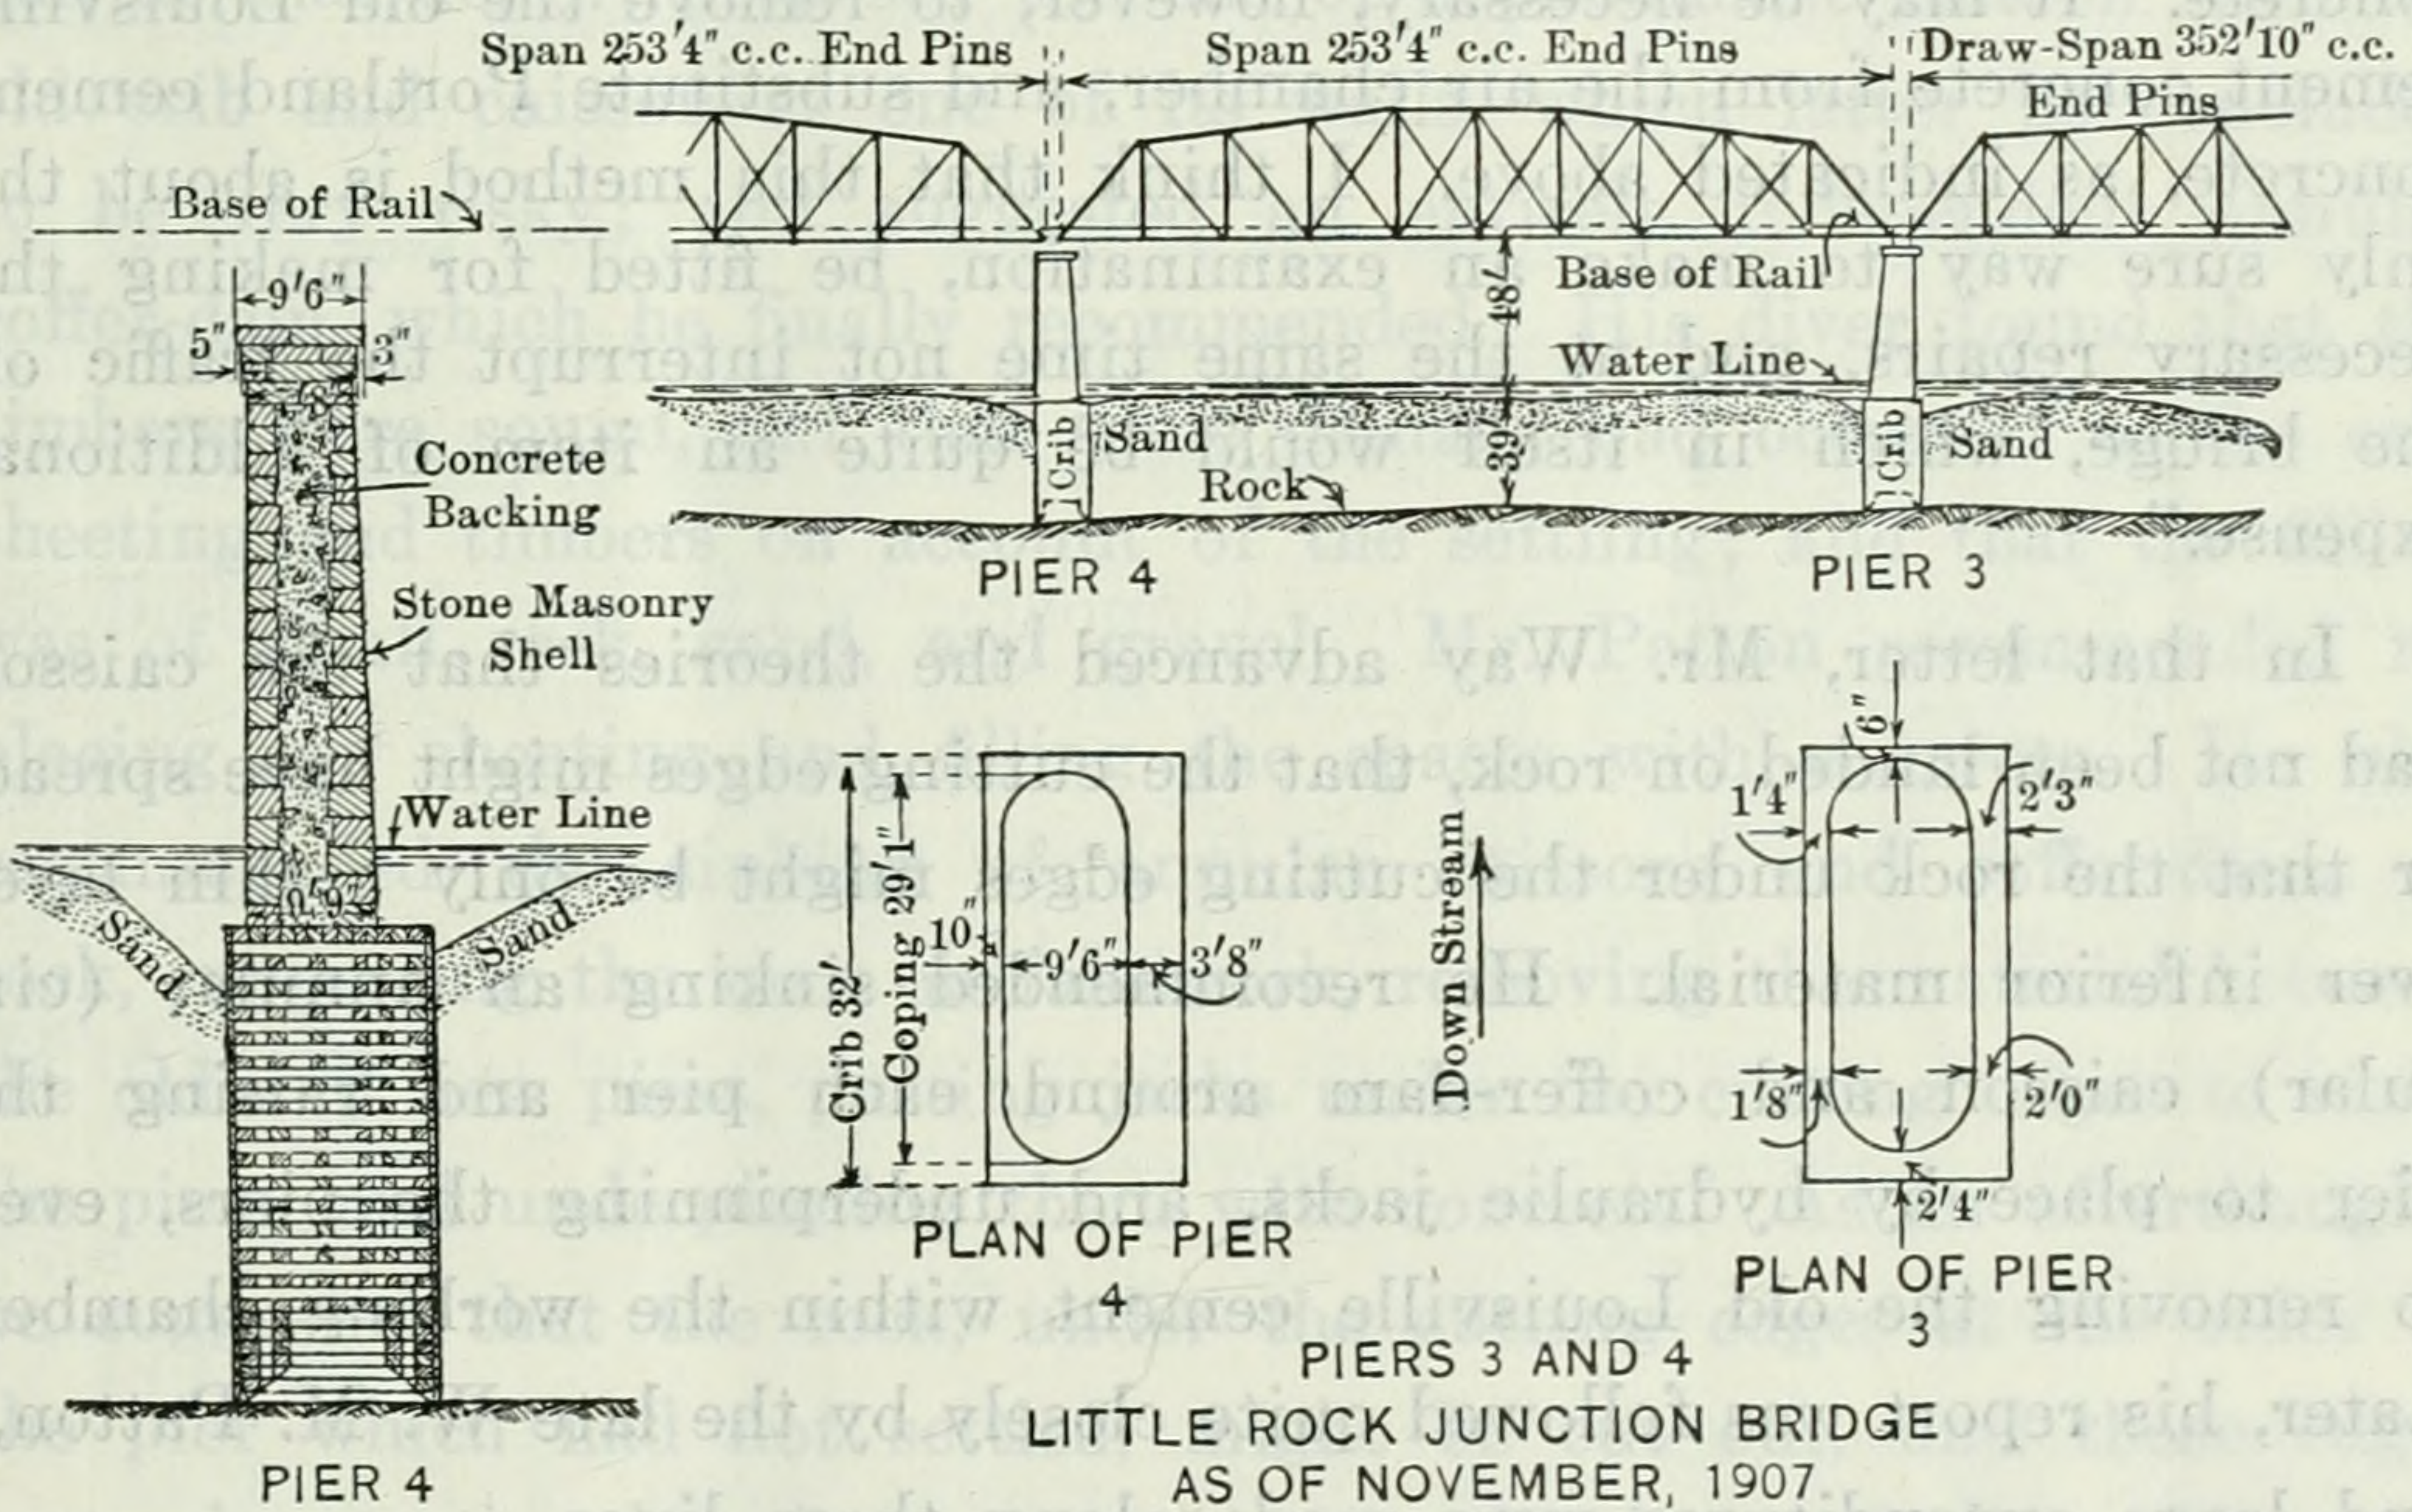
FIG. 4.

Fig. 4 shows the location of the footing courses of Piers 3 and 4 with reference to the tops of the cribs, the cross-section of Pier 4, and the location of the intermediate span from Pier 3 to Pier 4.

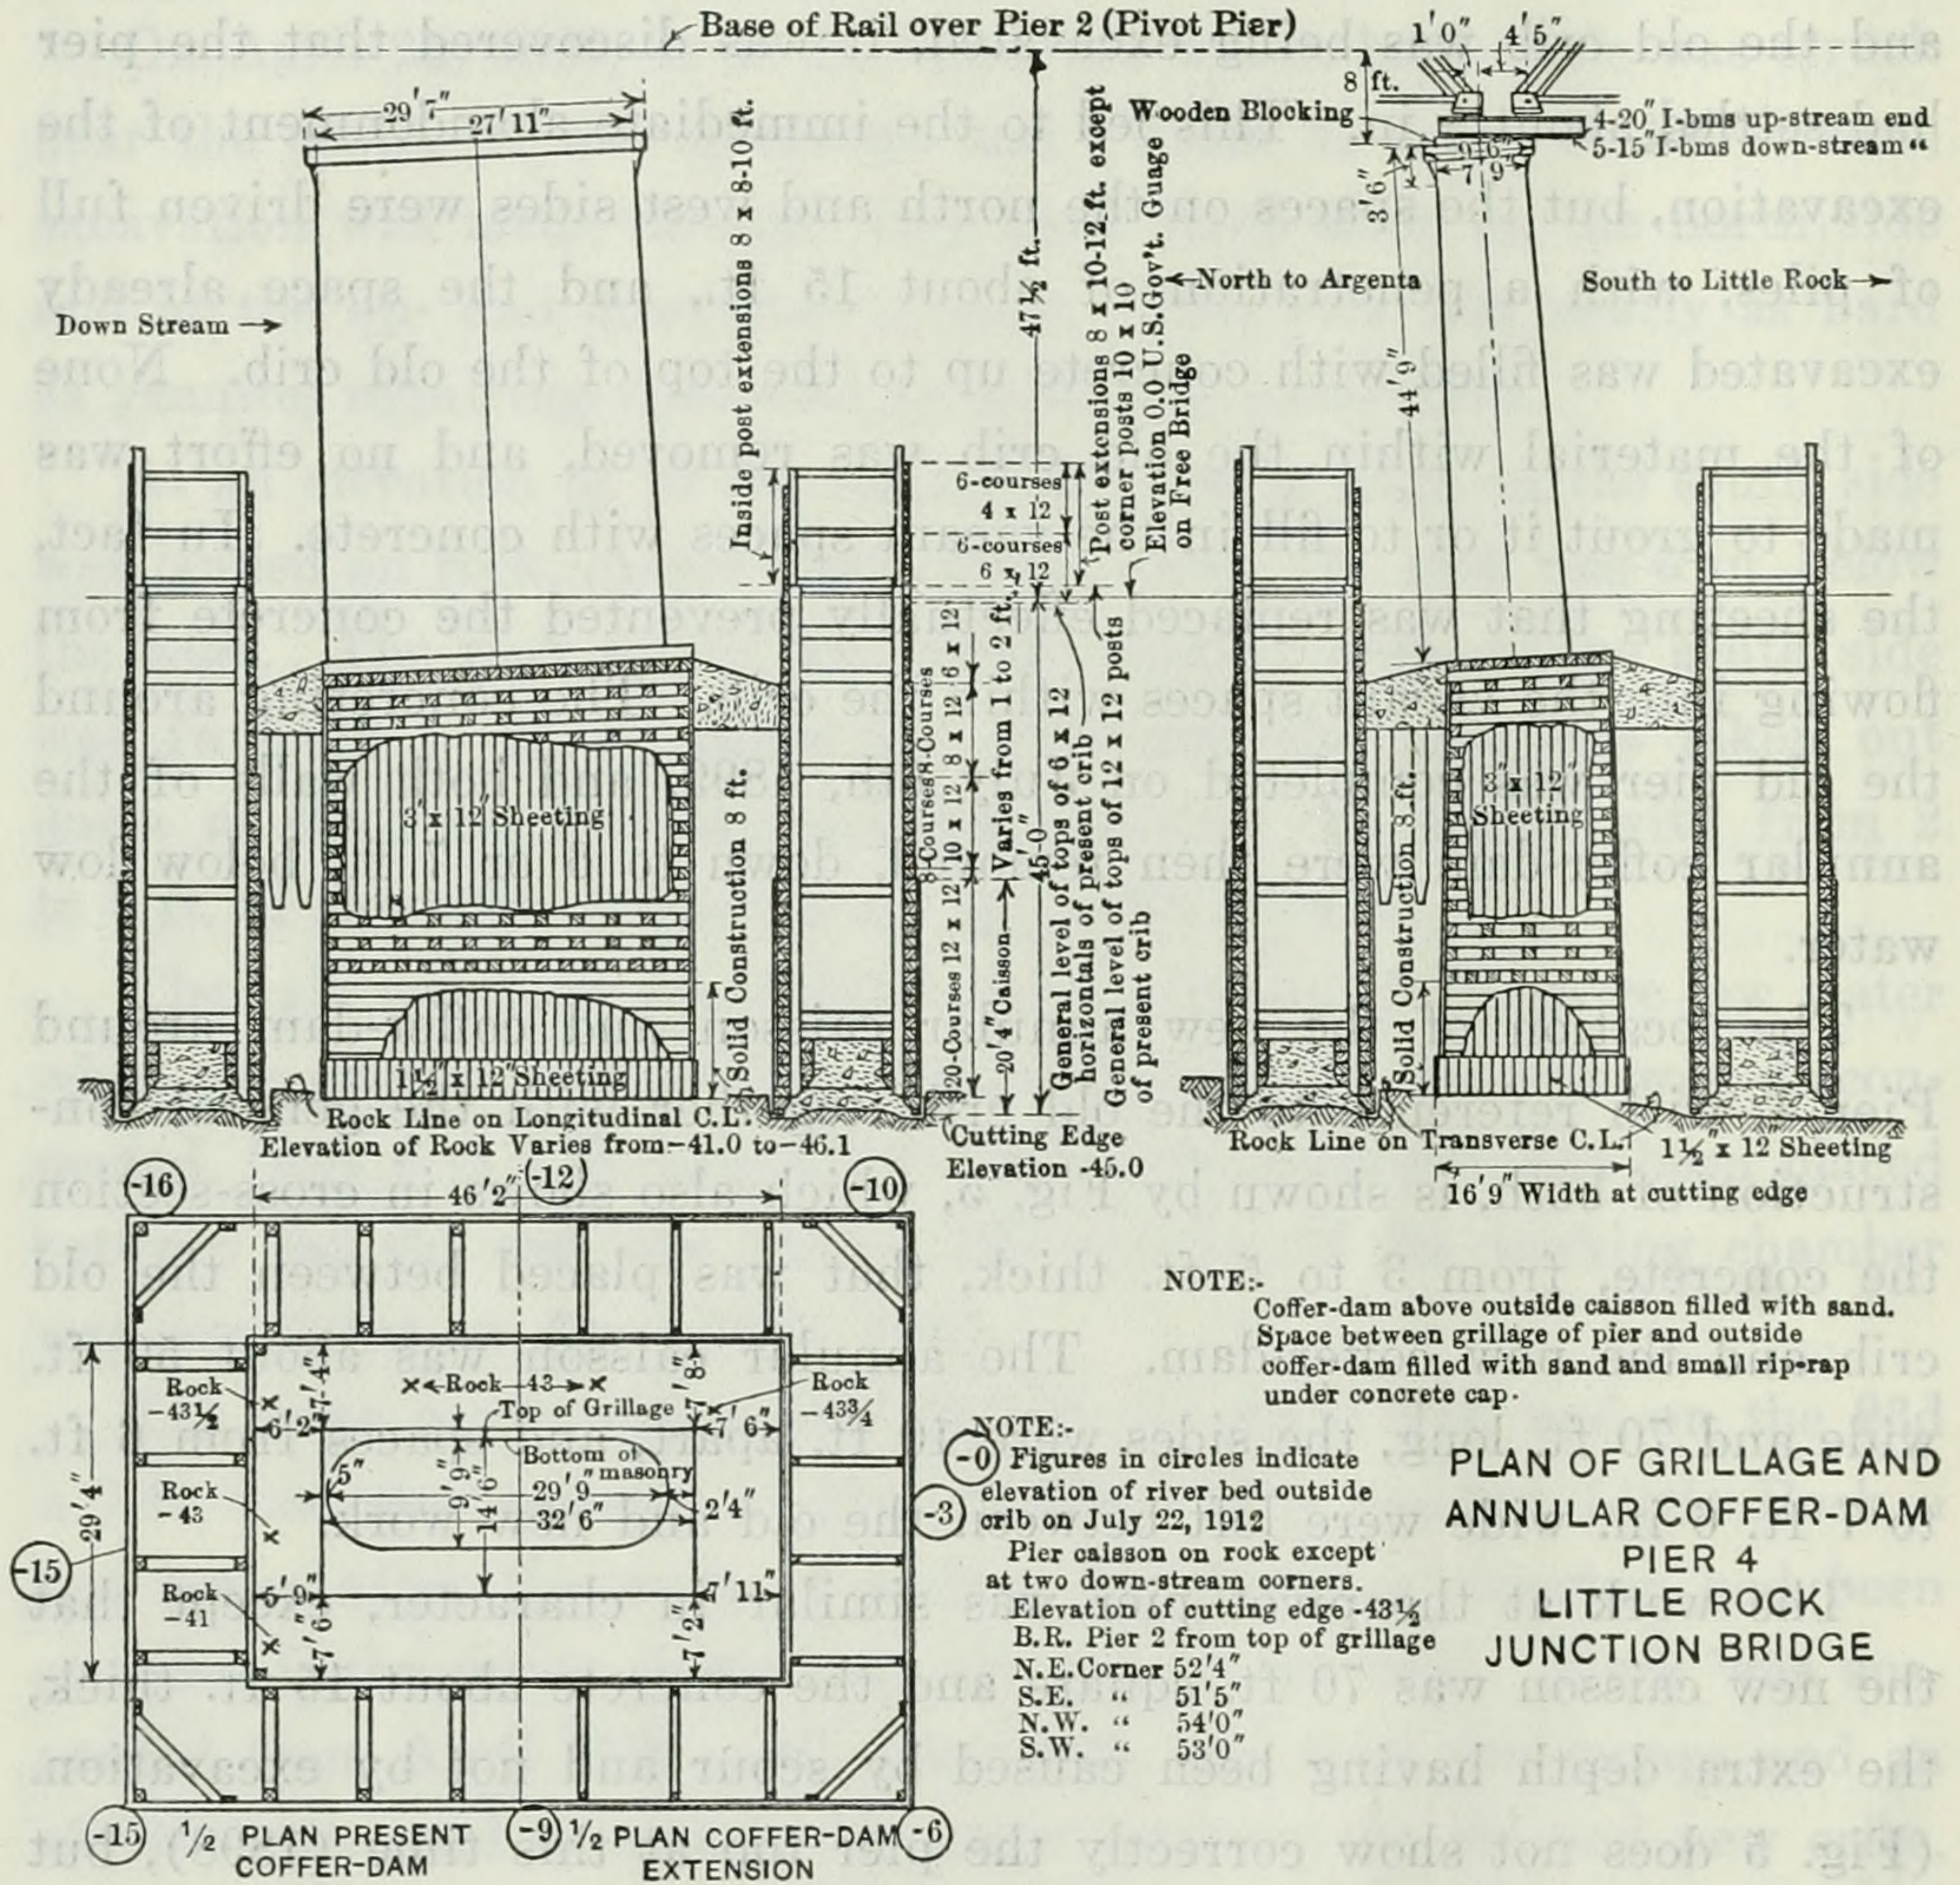
FIG. 5.

The work at the pivot pier was similar in character, except that the new caisson was 70 ft. square and the concrete about 15 ft. thick, the extra depth having been caused by scour and not by excavation. (Fig. 5 does not show correctly the pier top at this time (1898), but as it appeared several years later, after additional movement had taken place.)

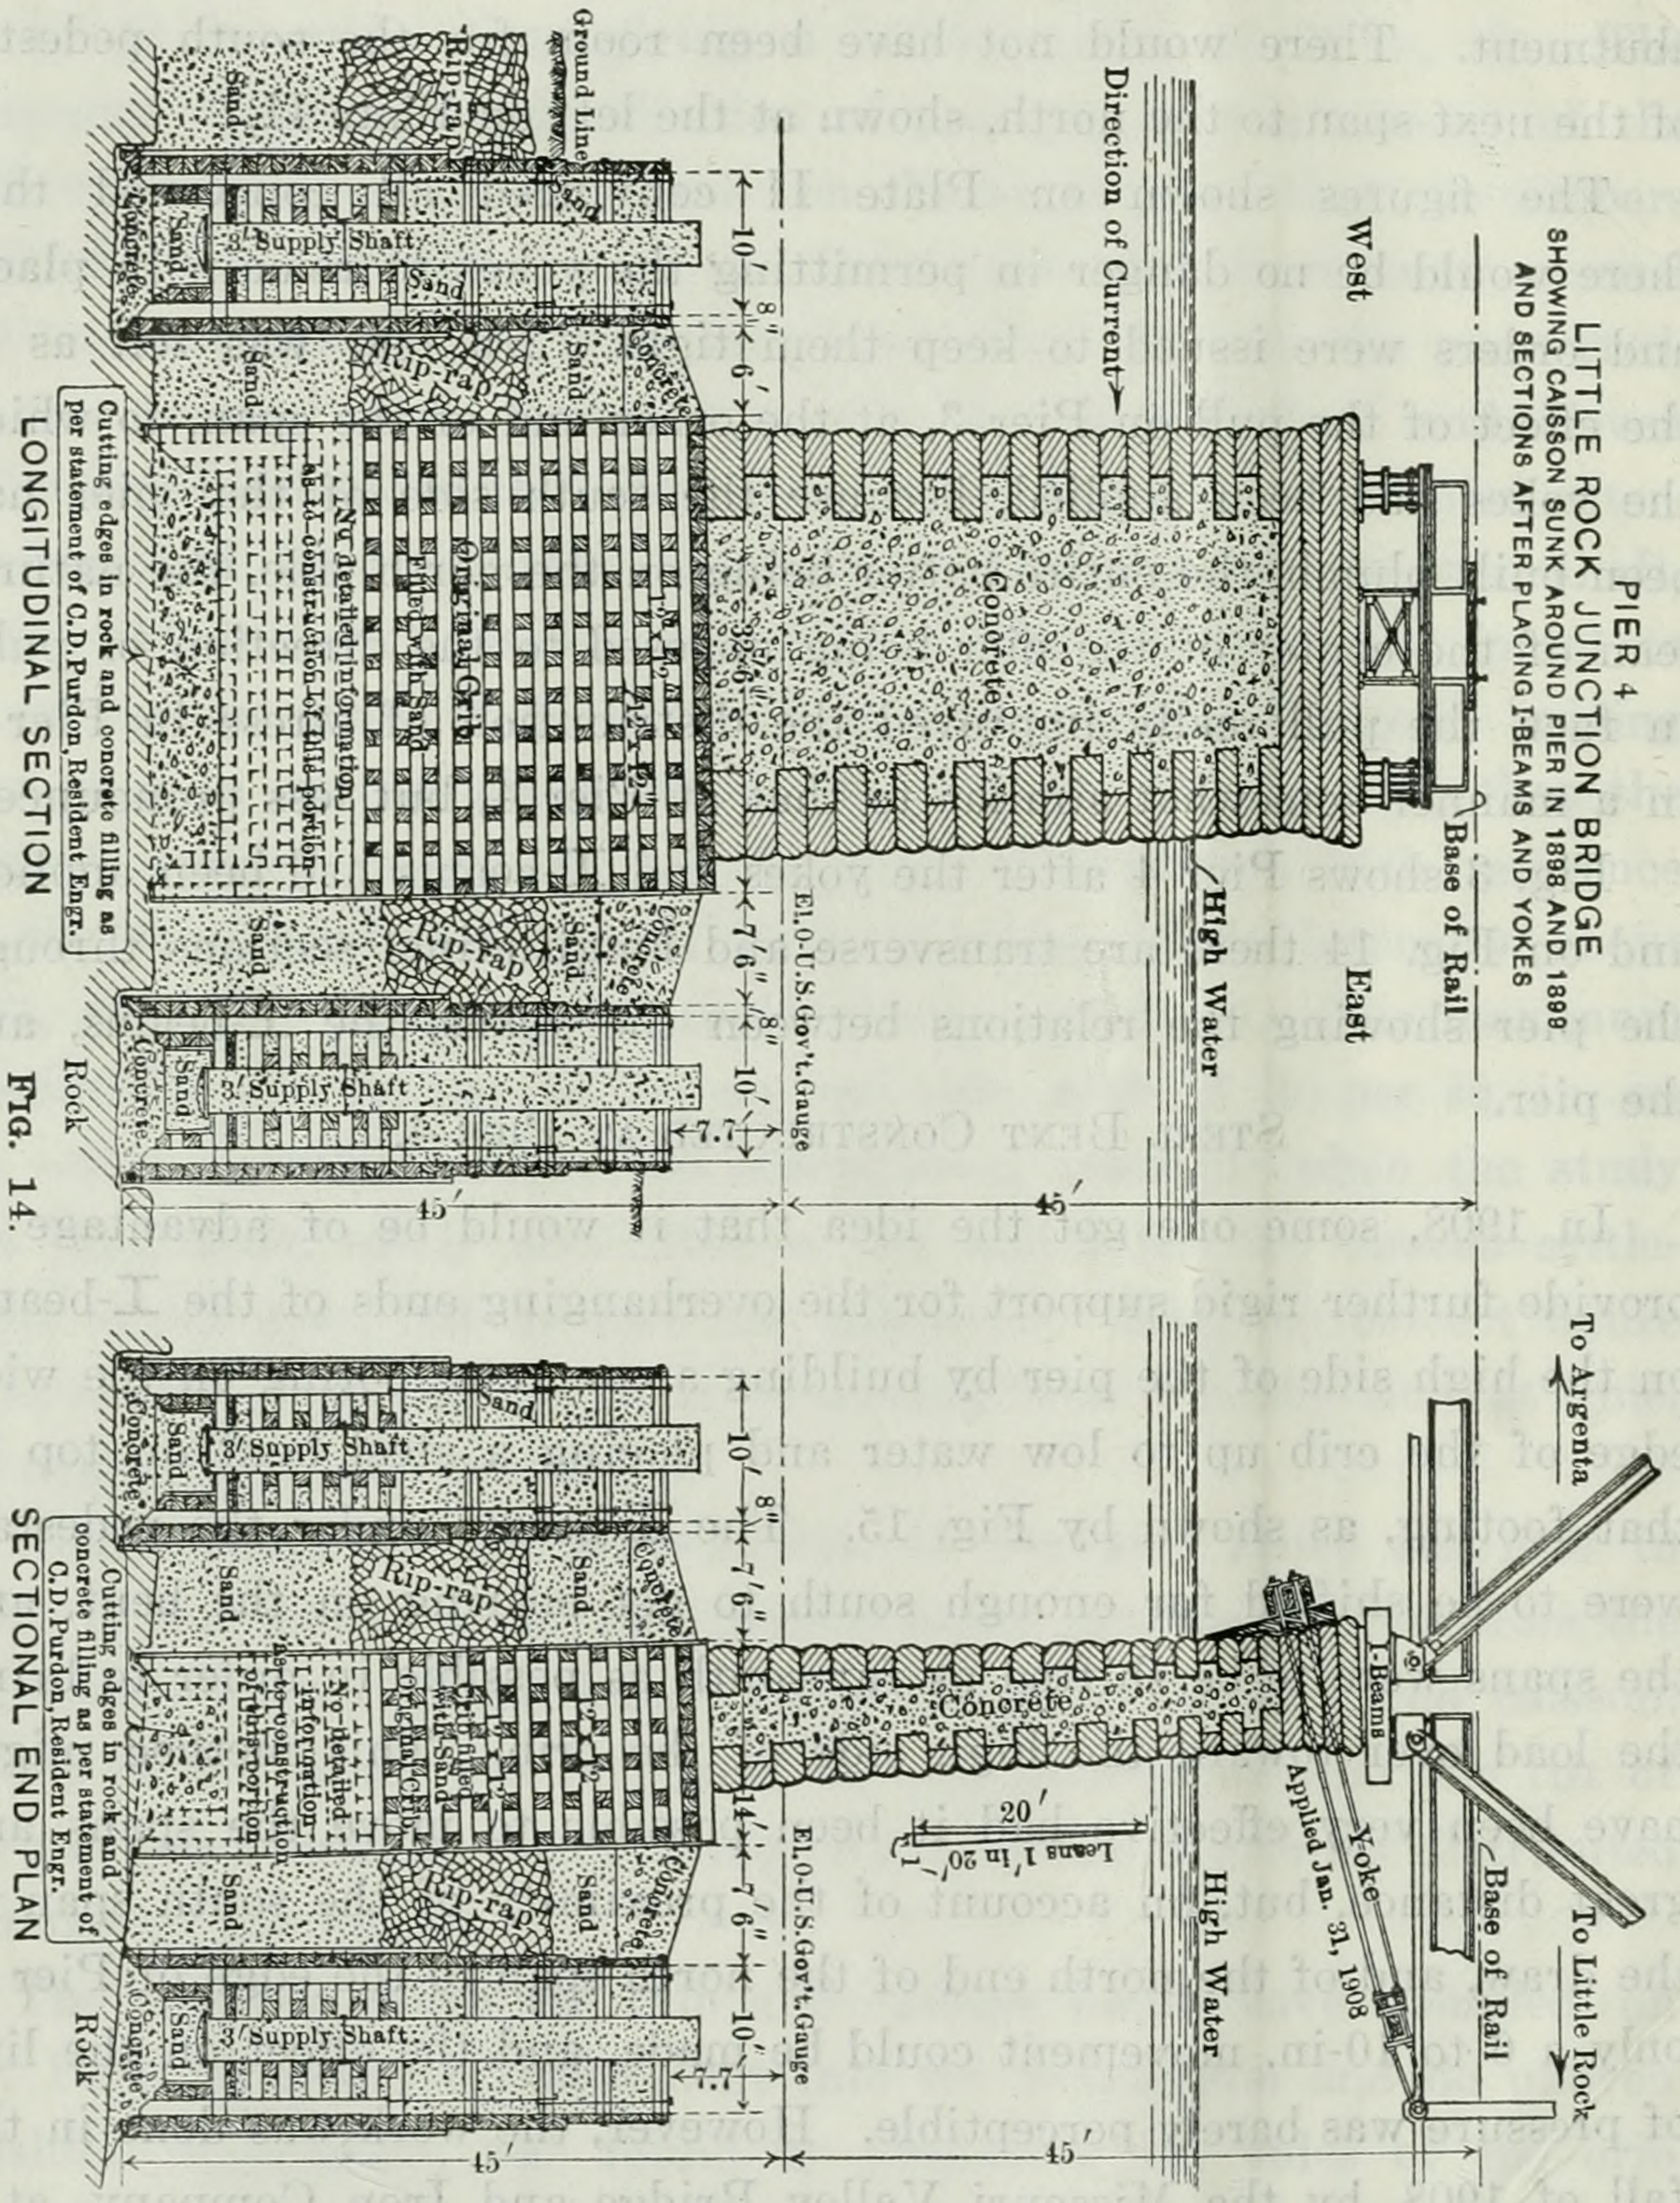
FIG. 14.

Fig. 3 shows Pier 4 after the yokes and **I**-beams had been applied, and on Fig. 14 there are transverse and longitudinal sections through the pier showing the relations between the yokes, the **I**-beams, and the pier.

PIER 4  
 LITTLE ROCK JUNCTION BRIDGE  
 SHOWING CAISSON SUNK AROUND PIER IN 1898 AND 1899  
 AND SECTIONS AFTER PLACING I-BEAMS AND YOKES

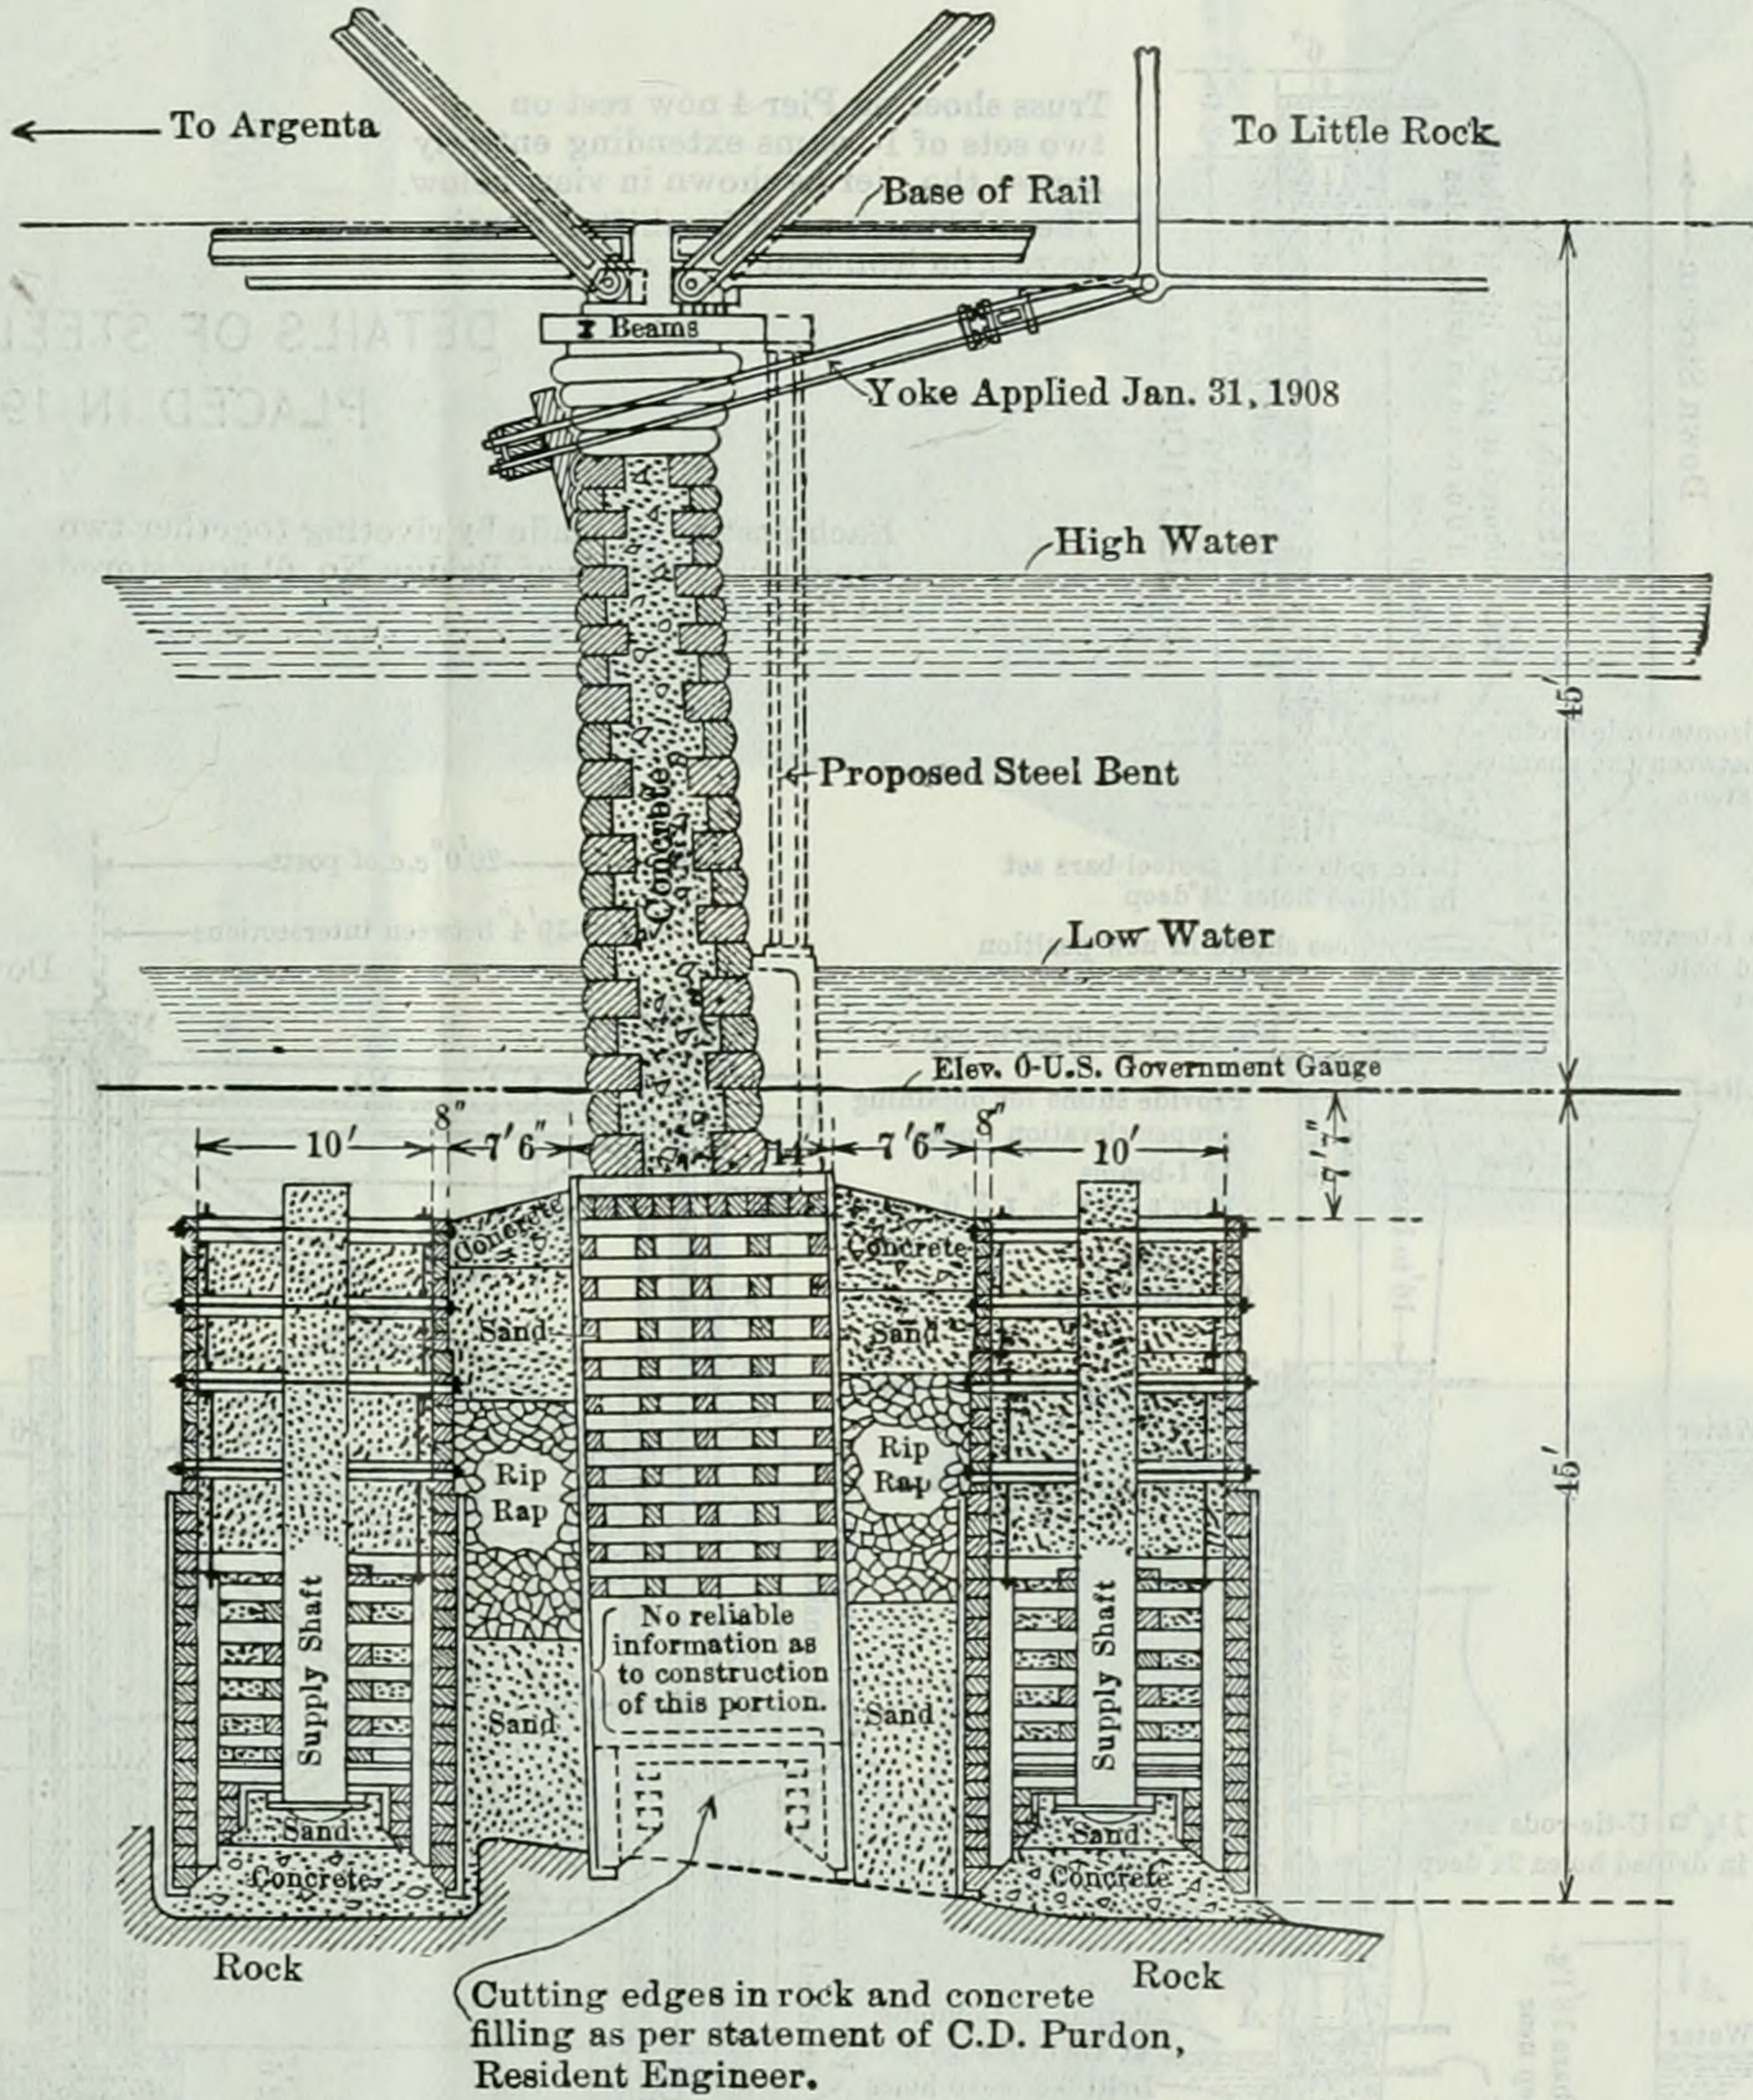
FIG. 15.

SECTIONAL END PLAN  
 PIER 4  
 LITTLE ROCK JUNCTION BRIDGE  
 SHOWING CAISSON SUNK AROUND PIER IN 1898 AND 1899.

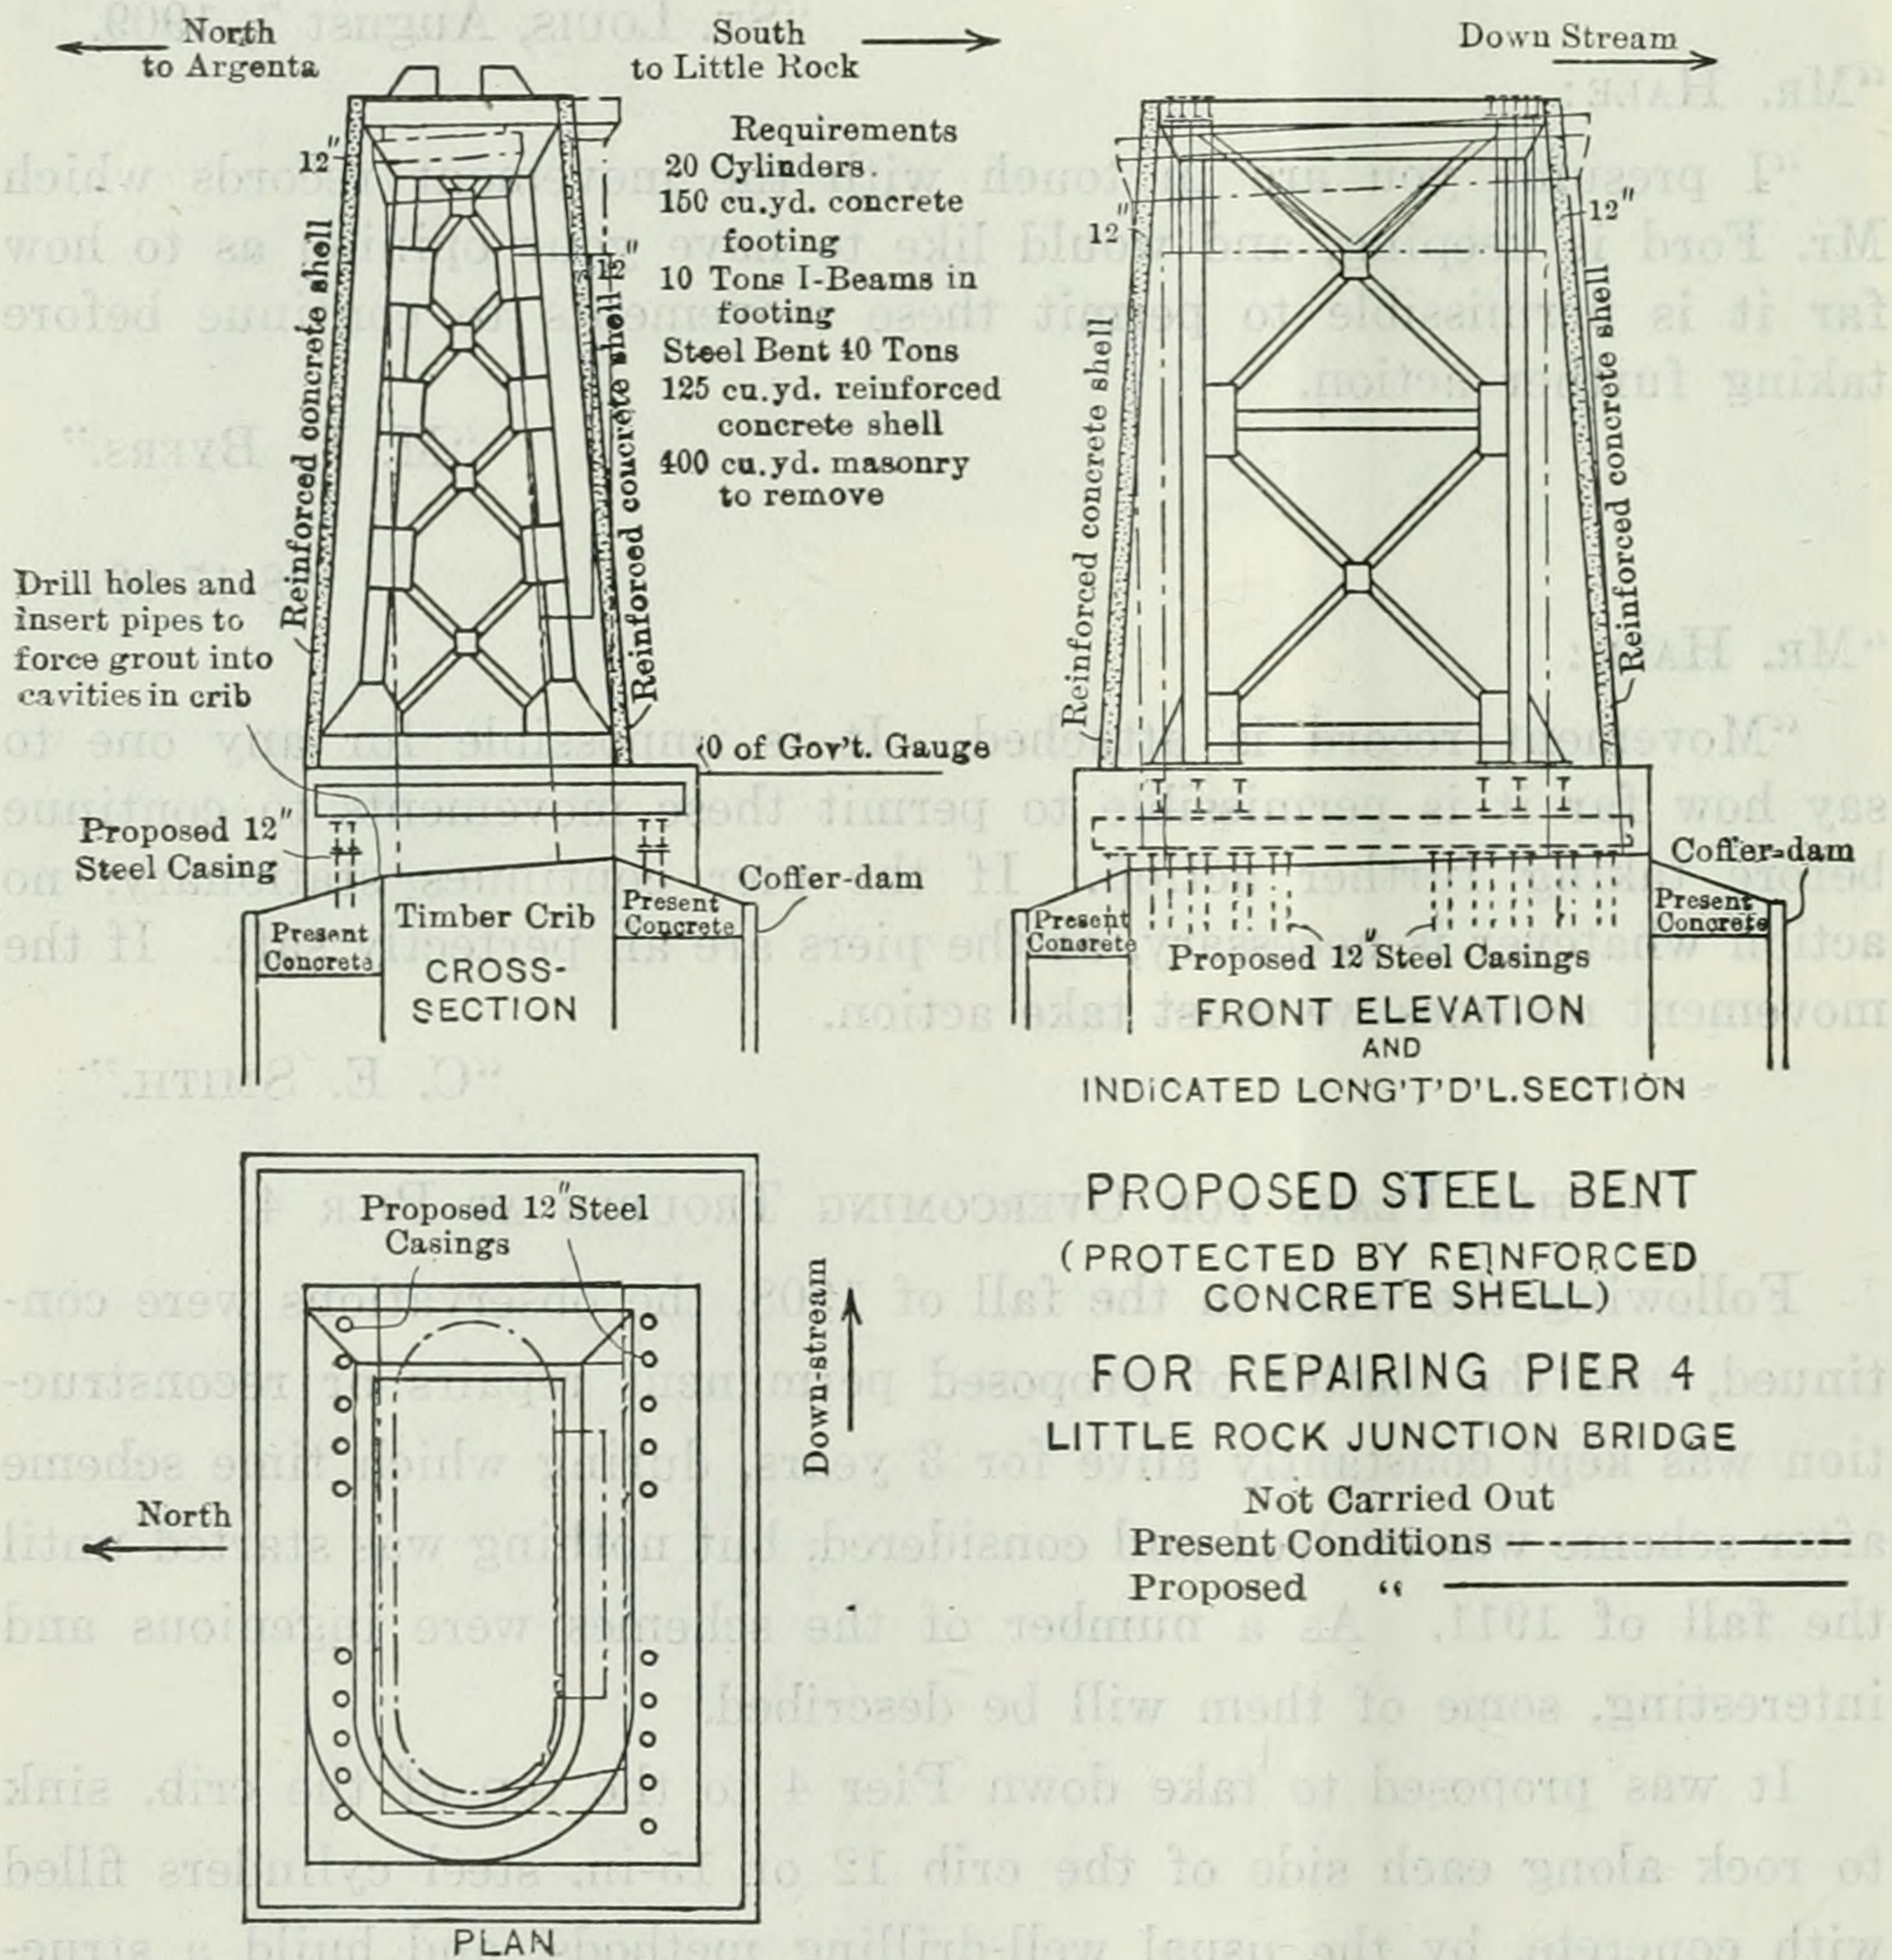
FIG. 19.

It was realized, however, that on account of the great stiffness of the cylinders and the steel tower, and the great elasticity of the crib, it would be impossible to control the distribution of load among the supports, and, in any event, most of the load would go to the cylinders. If the cylinders were made large and numerous enough and the steel tower strong enough to carry the entire load, the cost was estimated at \$43 200.

It was proposed to take down Pier 4 to the top of the crib, sink to rock along each side of the crib 12 or 15-in. steel cylinders filled with concrete, by the usual well-drilling methods, and build a structural steel tower on top of the cylinders and crib, as shown by Fig. 19.

This was first studied on the basis of having the load divided equally between the cylinders and the crib, which would have reduced the maximum pressure on the timbers from 555 to 150 lb. per sq. in., on which basis the estimated cost, including the falsework for supporting the spans and taking down the old pier, was \$32 200.
