Paper No. 1335

### LITTLE ROCK JUNCTION RAILWAY BRIDGE,

### OVER THE ARKANSAS RIVER

### AT LITTLE ROCK, ARKANSAS, 1883-1914\*

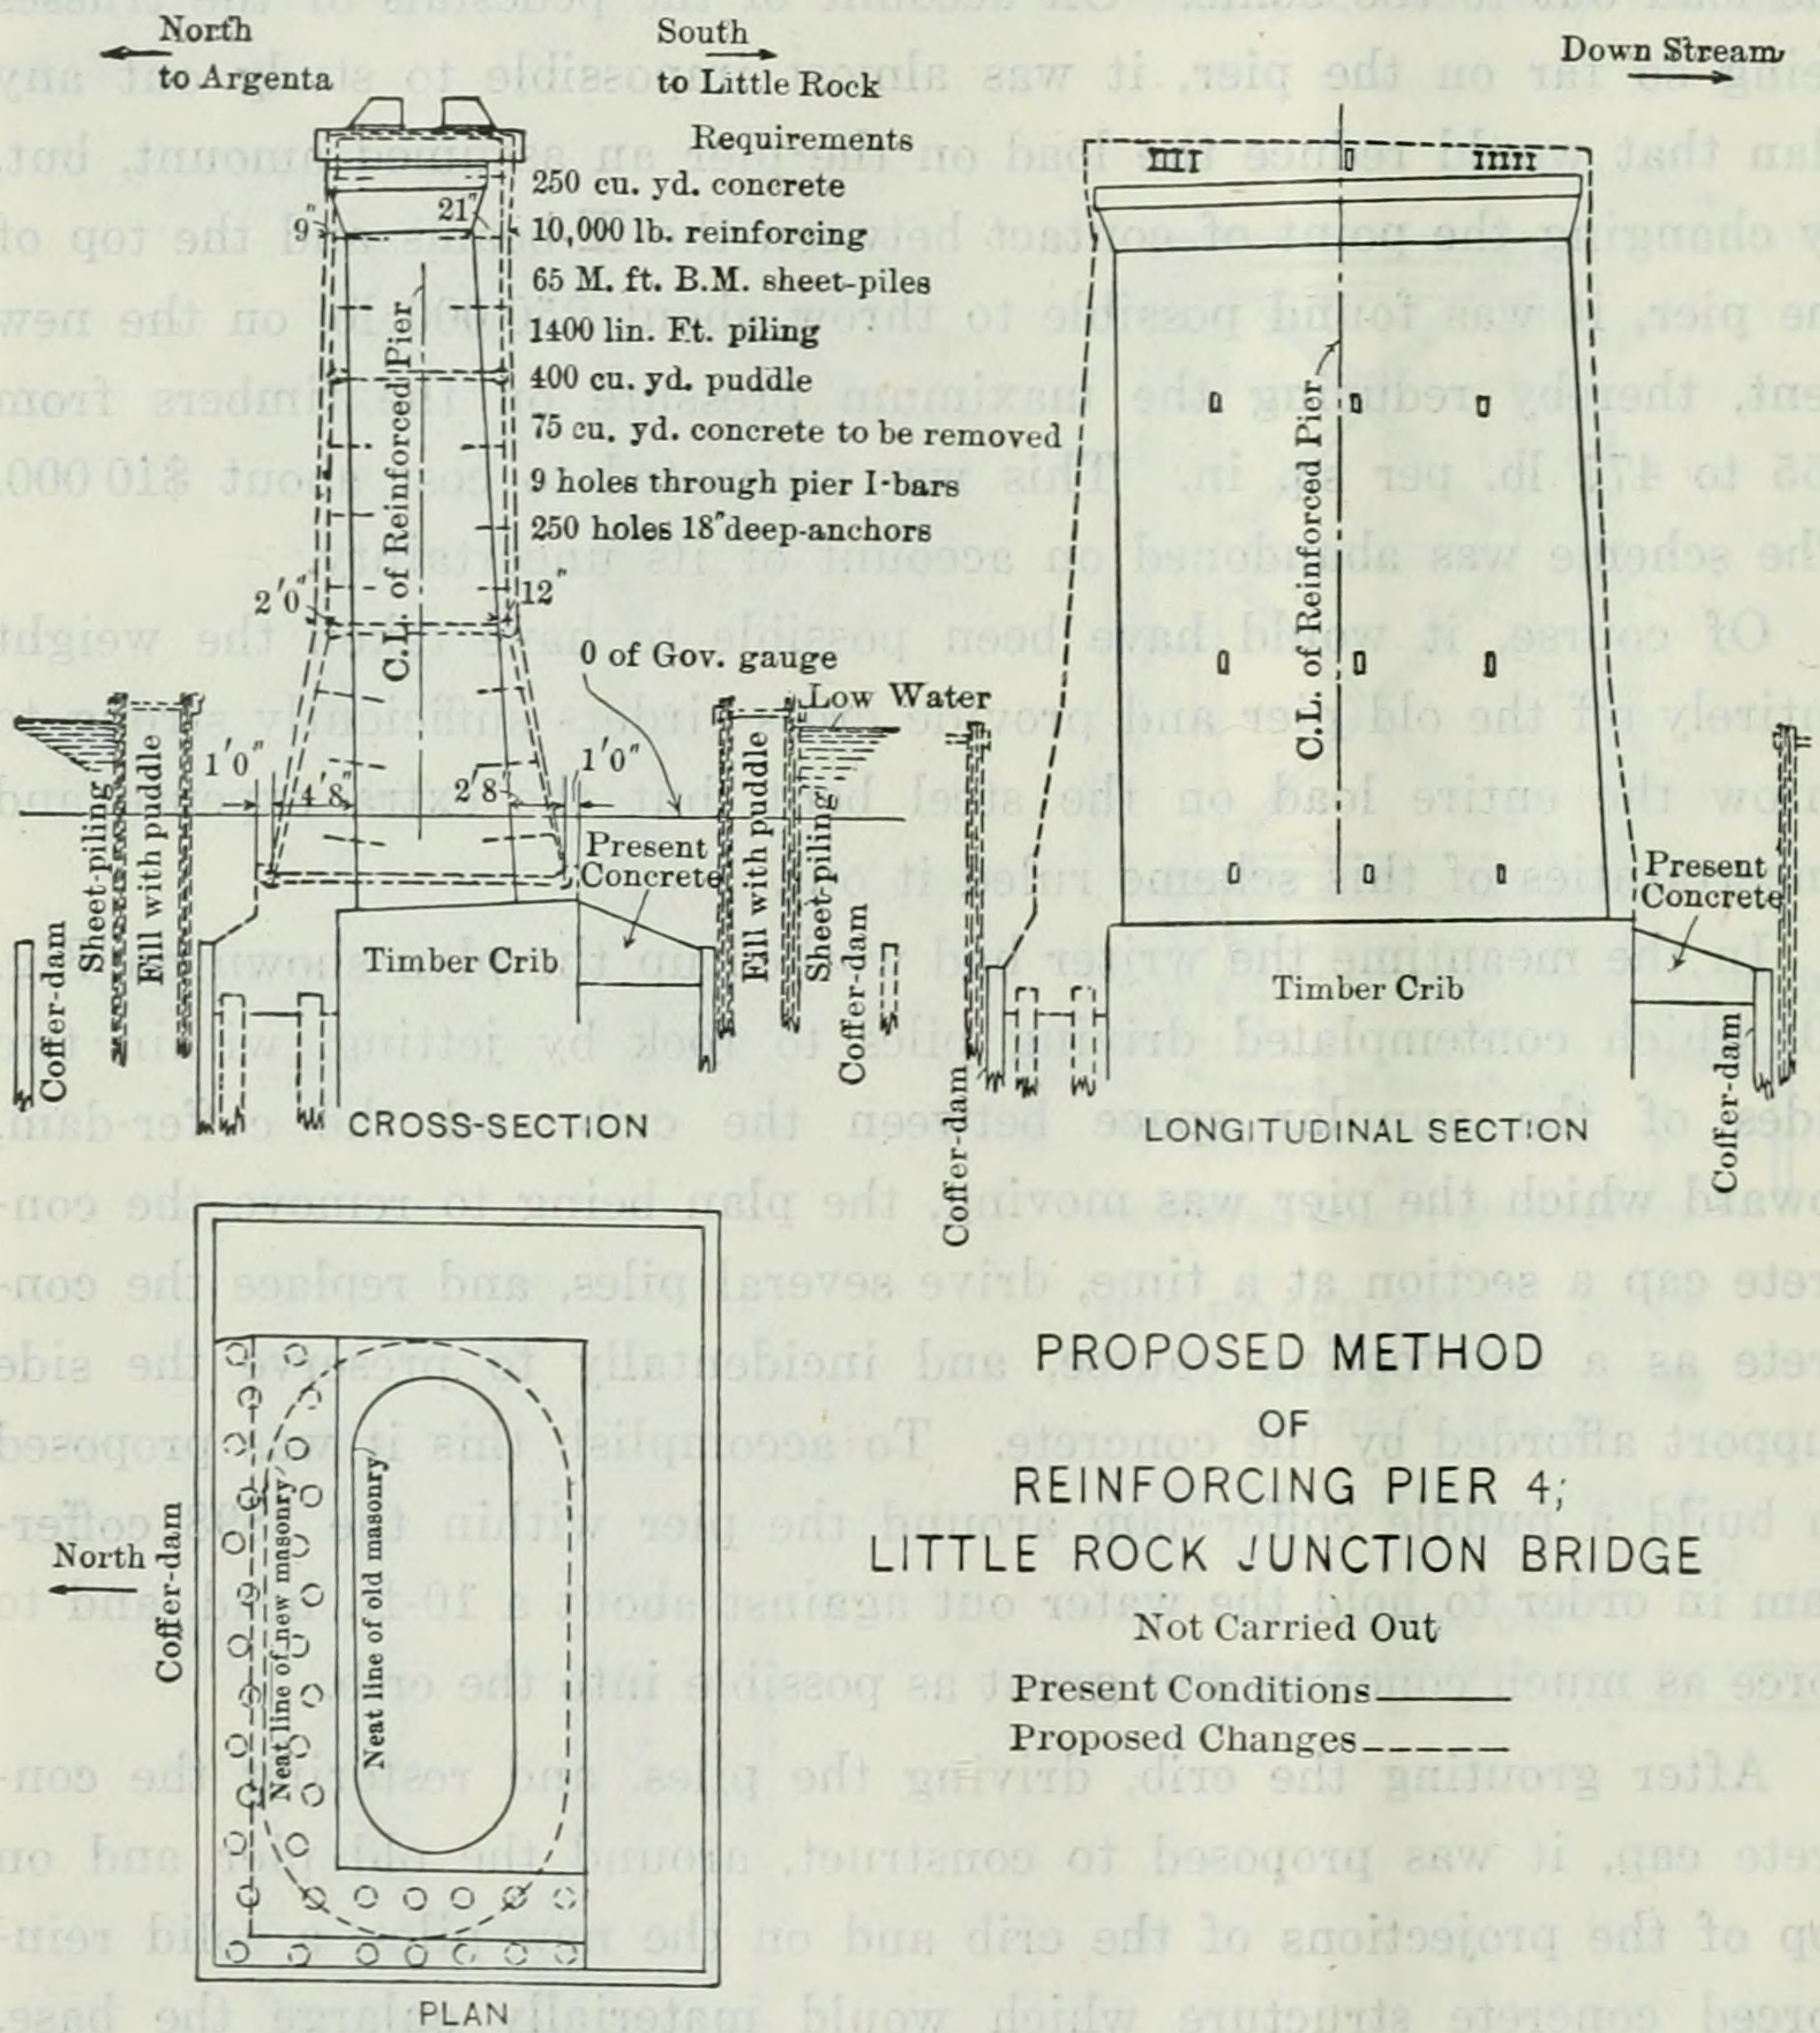
FIG. 20.

The writer has always felt that this method of repairing Pier 4 was the best that could have been devised, but so many objections were raised, as to the difficulty of extending the old coffer-dam up to make it water-tight, the danger to the pier of removing the concrete cap placed in 1899, the difficulty of driving the piles, and the possible damage to the pier by the adjacent pile-driving, the danger of

In the meantime the writer had worked up the plan shown on Fig. 20, which contemplated driving piles to rock by jetting, within two sides of the annular space between the crib and the coffer-dam, toward which the pier was moving, the plan being to remove the concrete cap a section at a time, drive several piles, and replace the concrete as a sub-footing course, and incidentally to preserve the side support afforded by the concrete. To accomplish this it was proposed to build a puddle coffer-dam around the pier within the 1898 coffer-dam in order to hold the water out against about a 10-ft. head, and to force as much concrete and grout as possible into the crib.

The rough rock-face and round ends of the pier made it particularly suited to encasement, but, in order to make the bond as intimate as possible, it was planned to drill through the body of the pier at several places near the bottom and place second-hand eye-bars through the pier, with suitable anchors at each end to be embedded in the con-

crete shell; also to curve the horizontal reinforcing rods continuously around the ends of the pier, and to replace the top by a new thick reinforced concrete cap. This plan had the advantage that no false-work would have been necessary, and it could have been carried out for \$12 000.

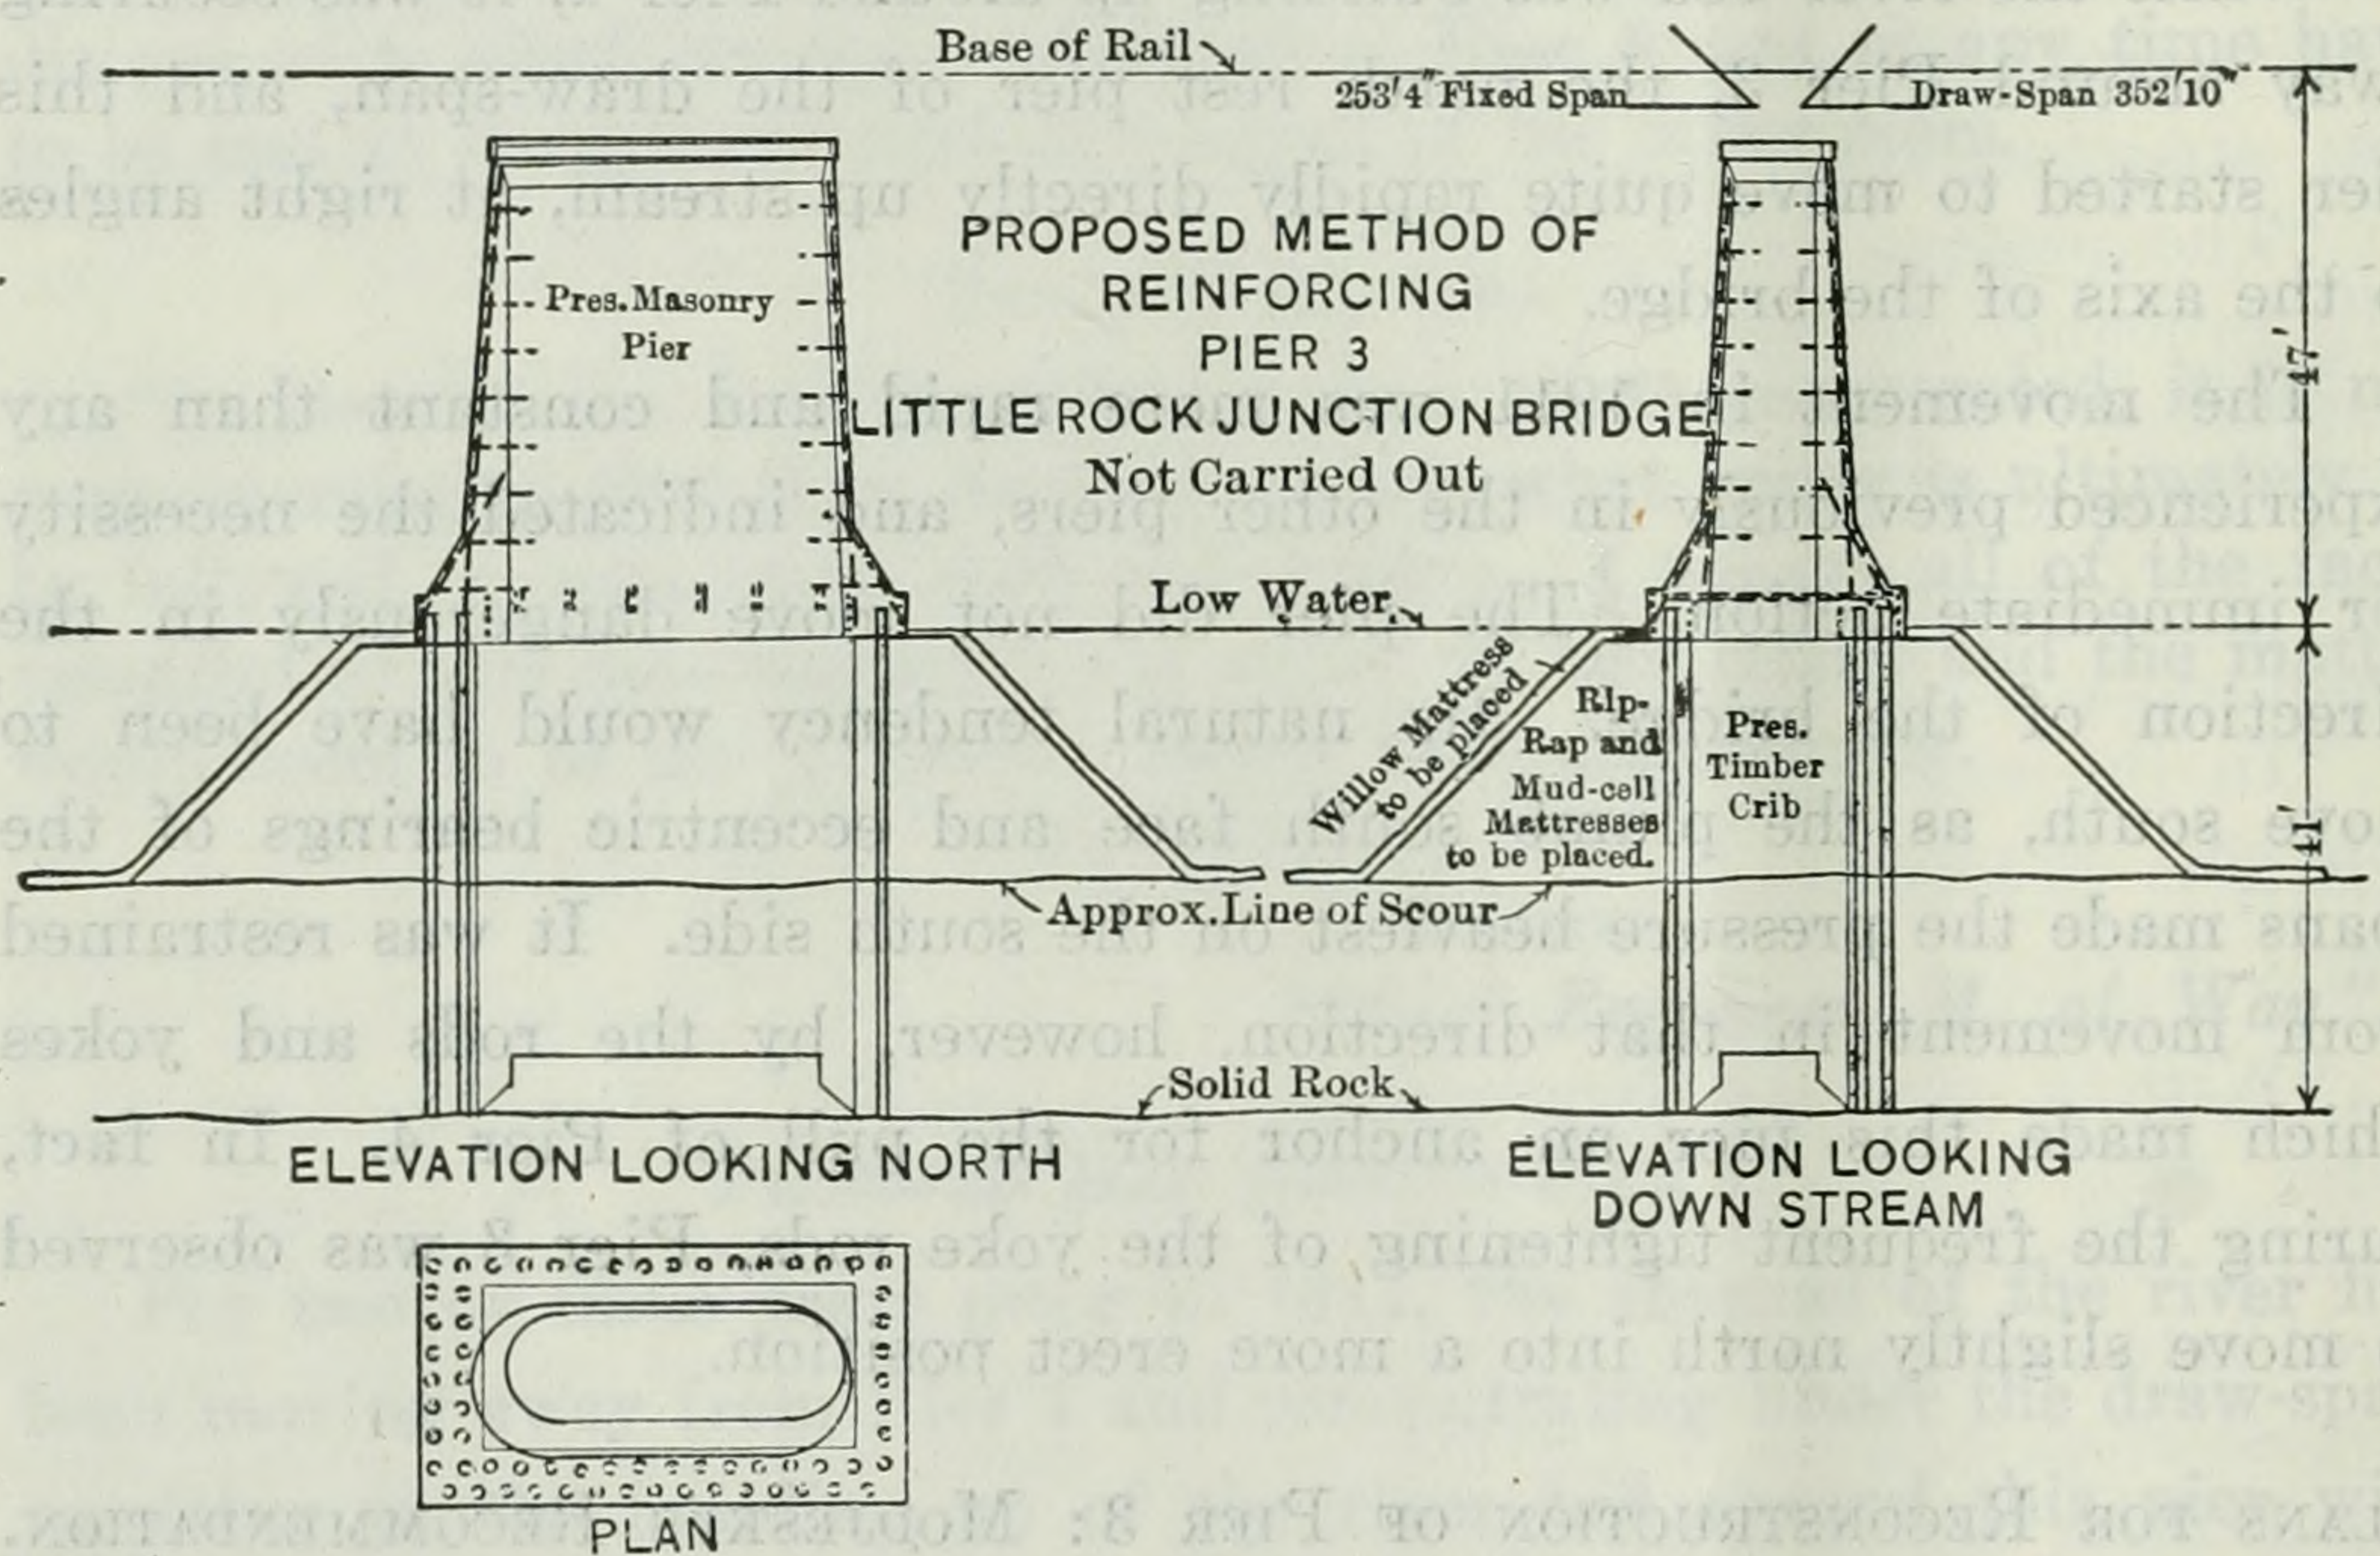
FIG. 22.

Mr. Modjeski was then requested to pass opinion on the writer's plan of driving piling around Pier 3 and resting on it a reinforced concrete encasement around the pier, protecting the piling with mud-cell mattresses and rip-rap, as shown by Fig. 22. This he objected to as somewhat uncertain as to results and the eventual stability of the pier.

It consisted of a reinforced concrete shell, tied to the old pier and resting on additional piles to be driven to rock around the old crib, as shown by Fig. 22. Here, however, there was no surrounding cofferdam, and it was deemed advisable to furnish protection for the piles and additional stability for the pier.

This was to be obtained by sinking around the pier mud-cell mattresses in layers about 4 ft. deep, with enough rip-rap in them to sink them. The result would be a building up of mattresses of

decreasing sizes and rock; sand sediment would immediately deposit until the top of the crib was nearly reached, when the entire mass would be covered by a heavy layer of rip-rap, the latter and the surrounding bed of the river would then be covered by another large protecting mattress. It was also the intention to bore holes in the crib and get in as much grout as possible. The writer believes this method of repair would have been entirely satisfactory; it also had the advantage of being very cheap. Five bids were received, the lowest (from an entirely reliable contractor) being about \$8 500, which, together with the extras and incidentals, would probably have made the total cost of the work \$10 000.
