Paper No. 1335

### LITTLE ROCK JUNCTION RAILWAY BRIDGE,

### OVER THE ARKANSAS RIVER

### AT LITTLE ROCK, ARKANSAS, 1883-1914\*

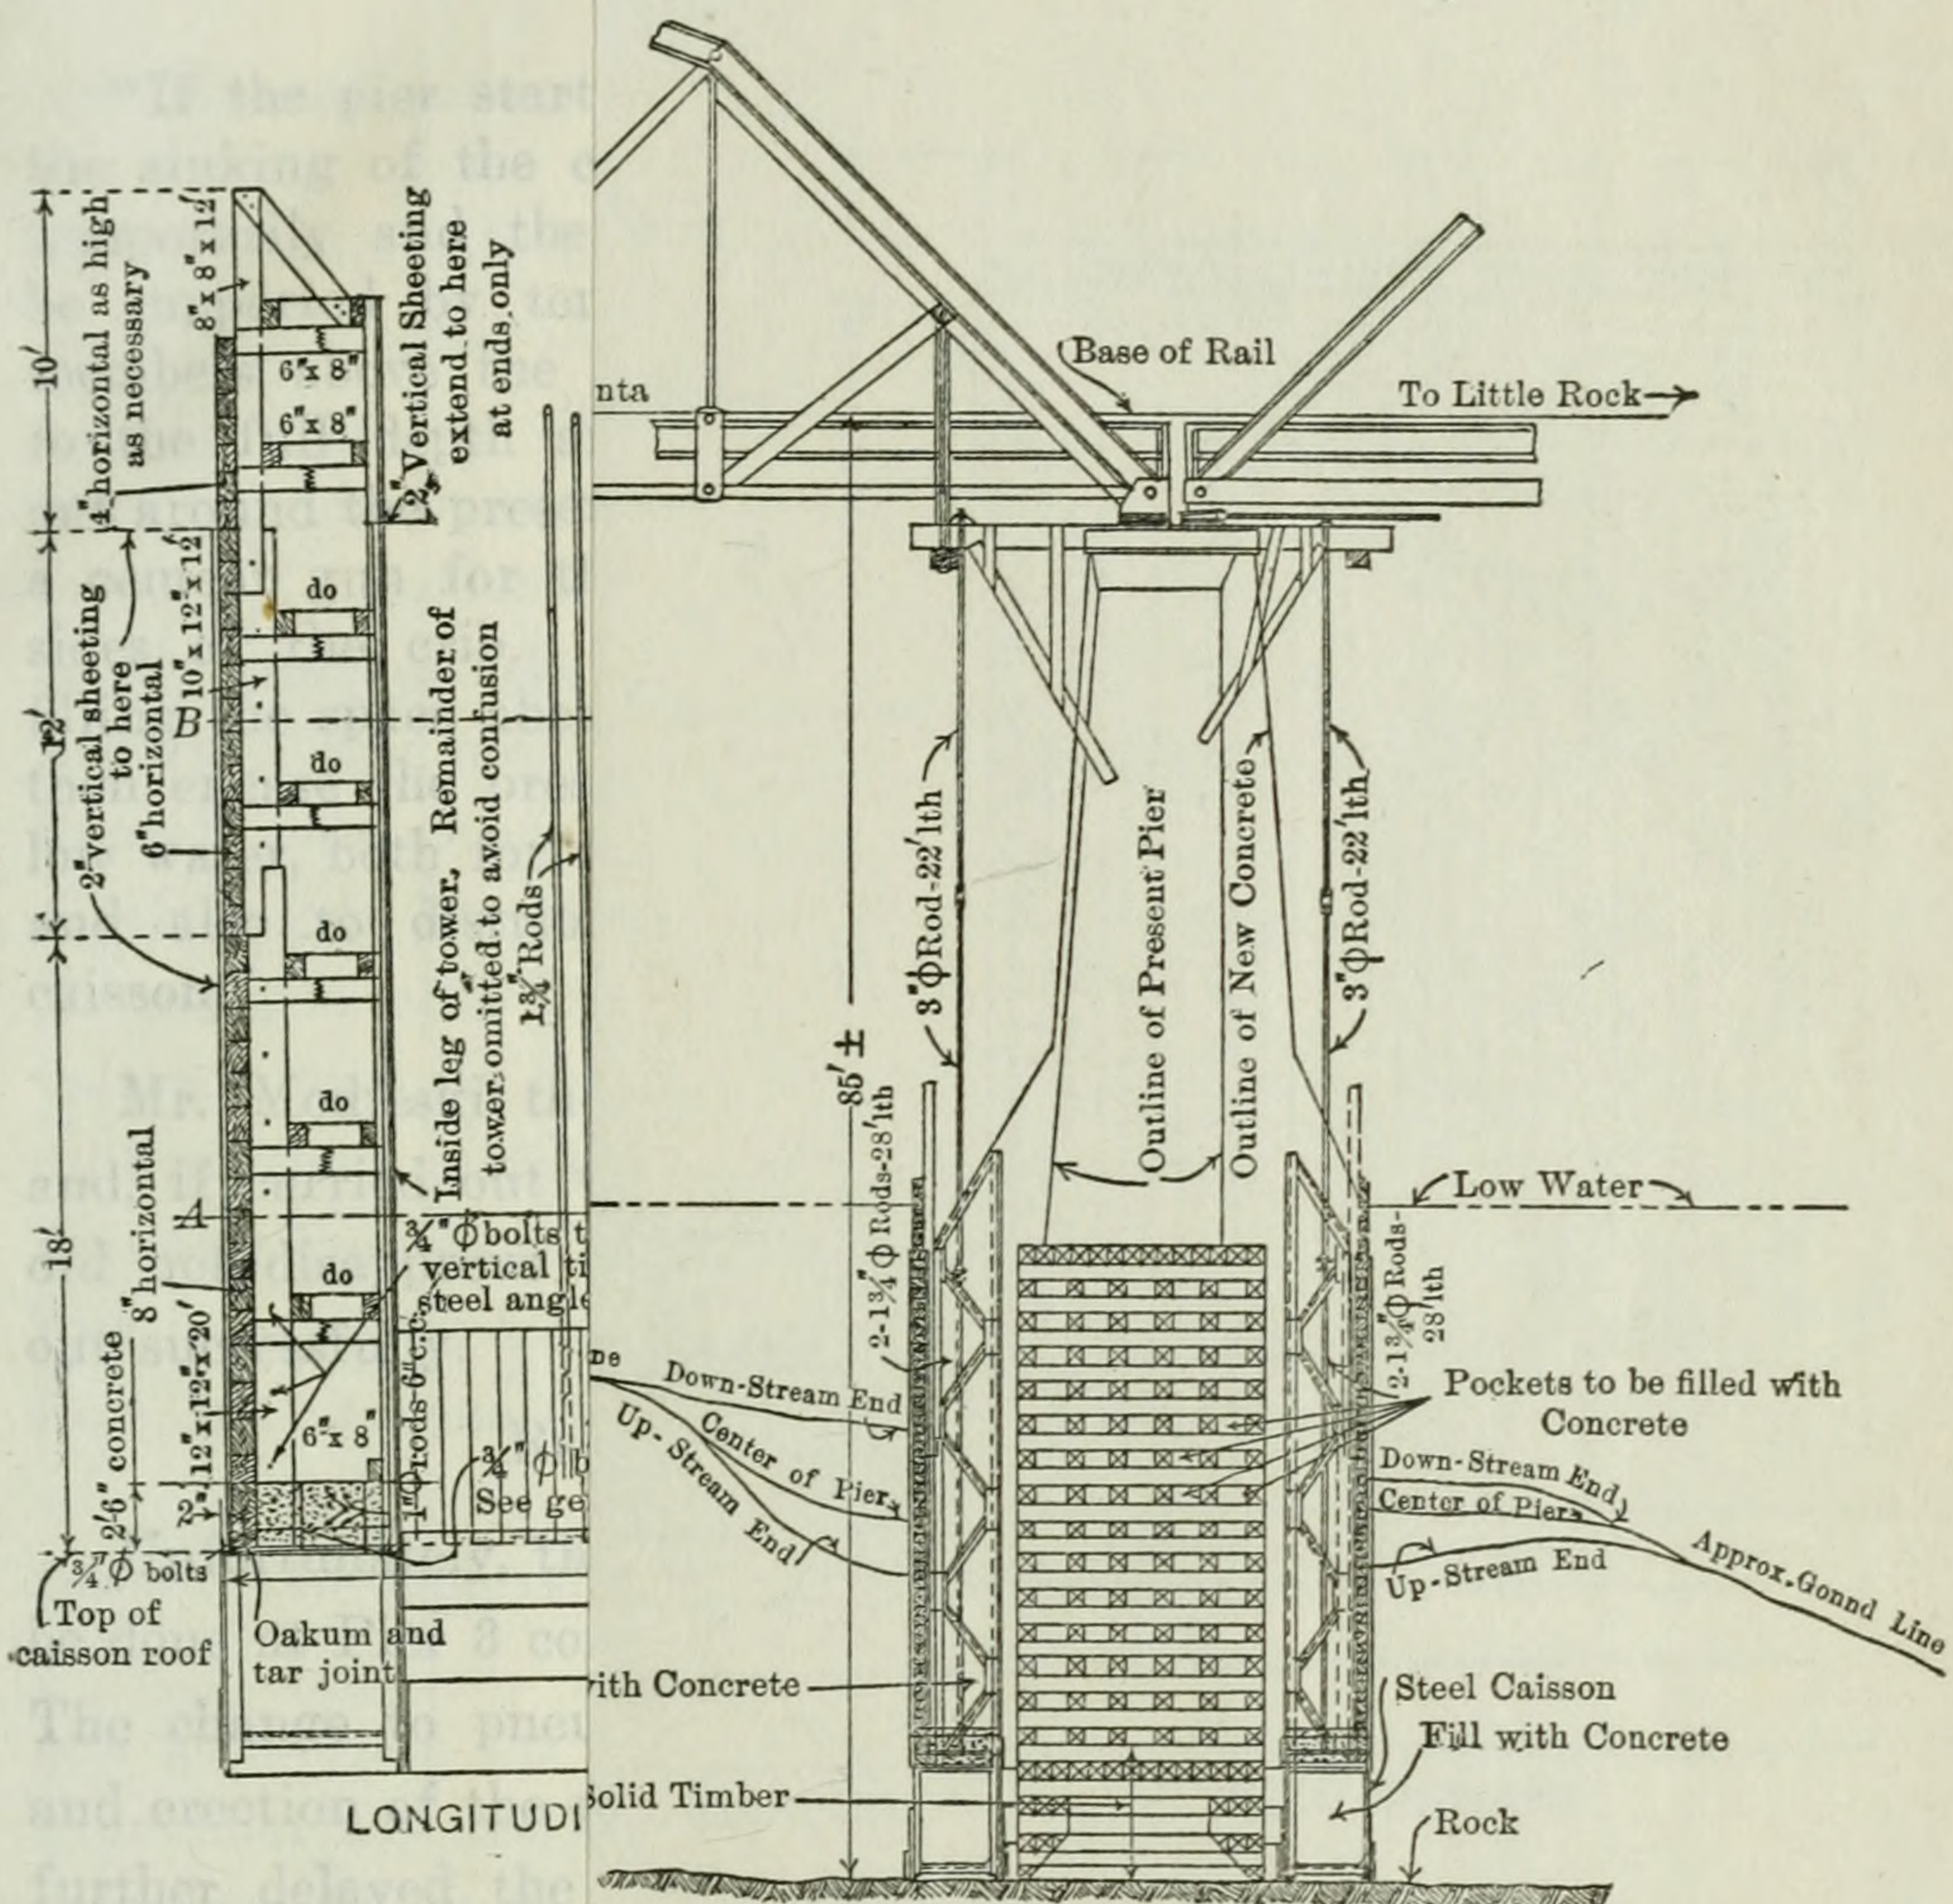
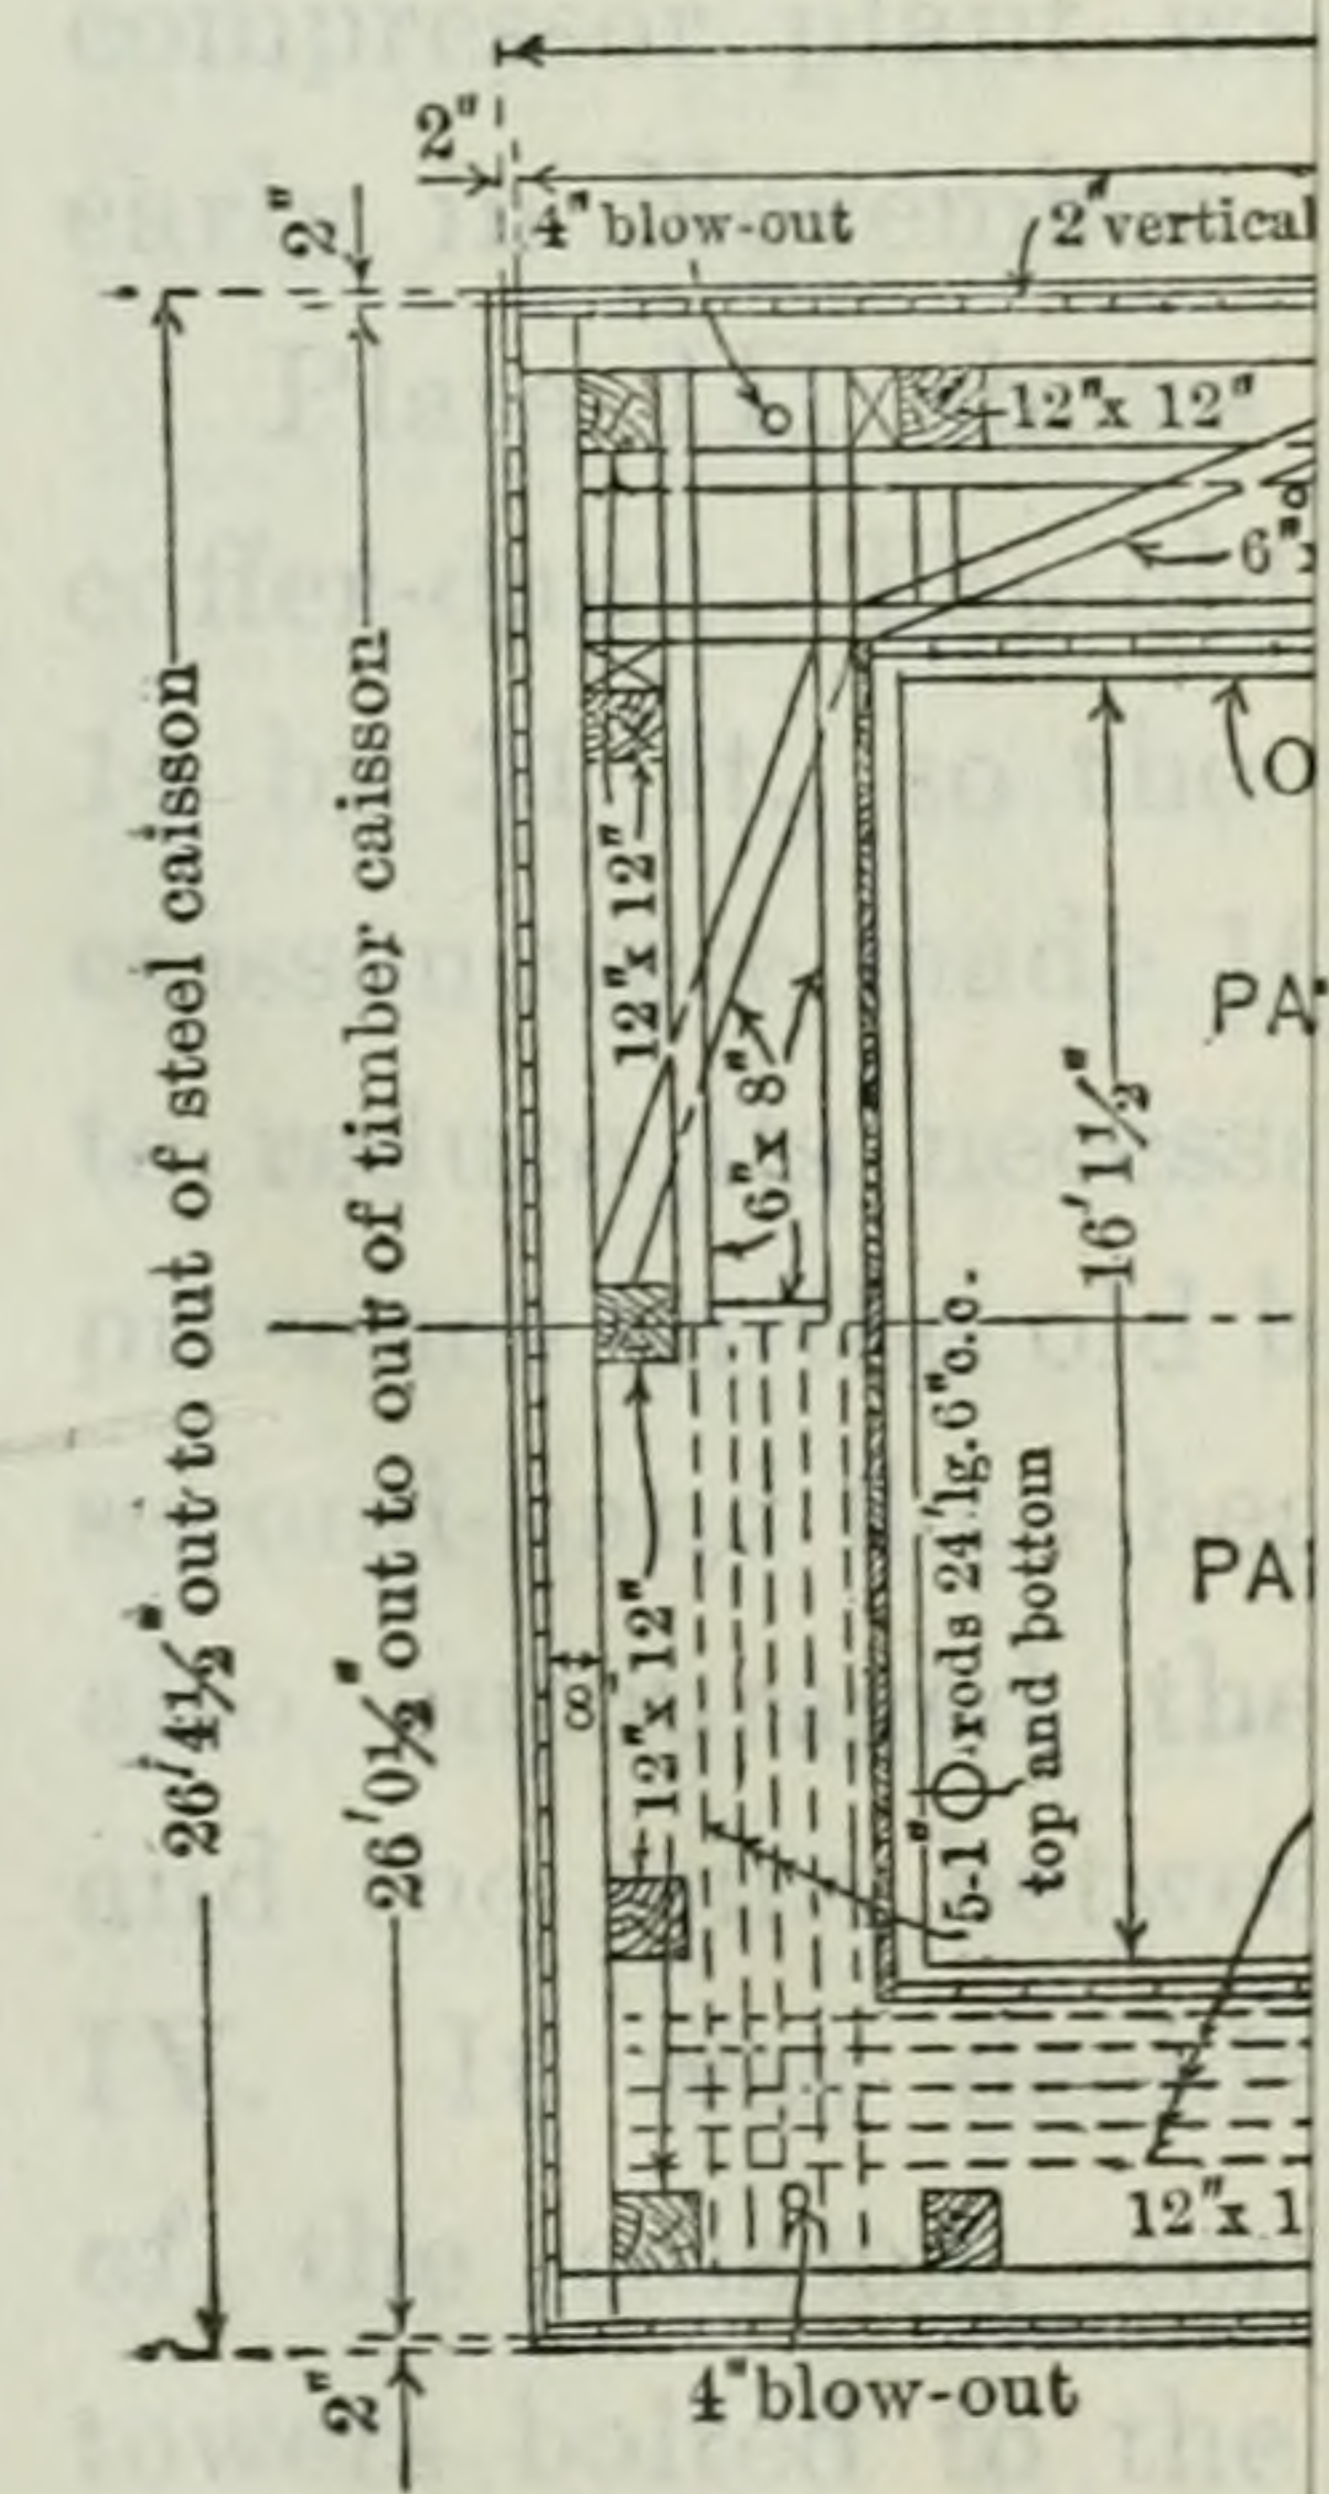
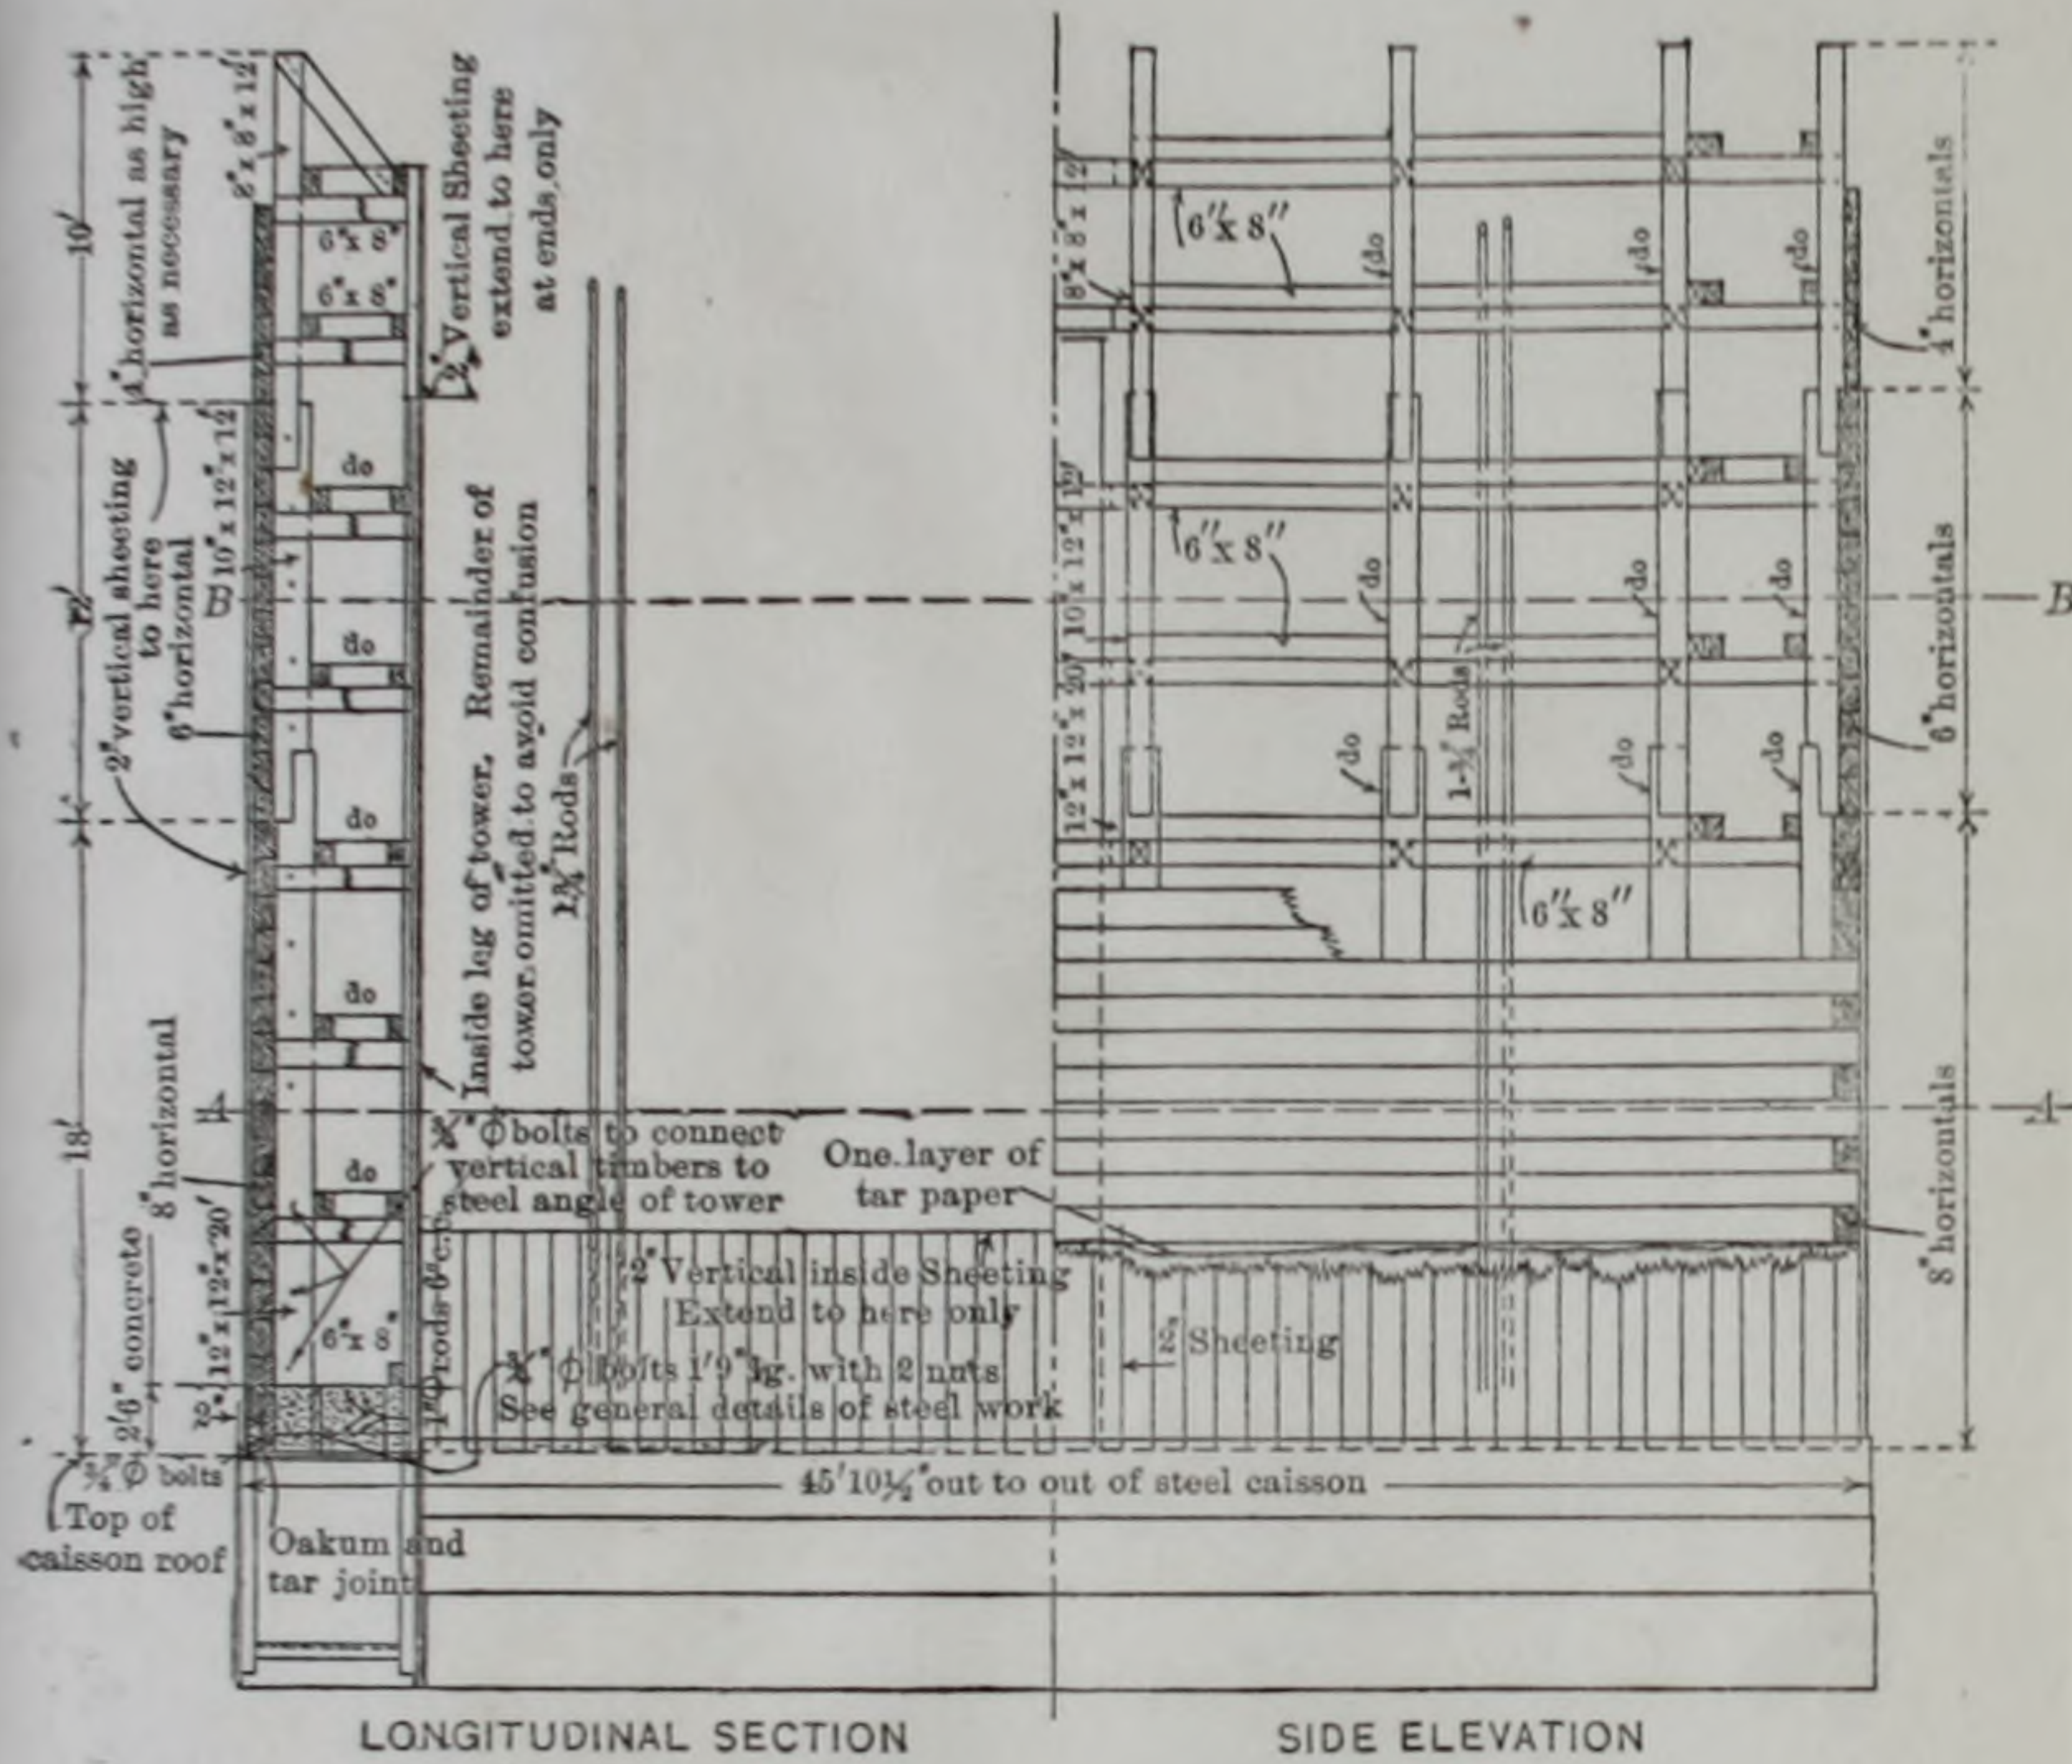
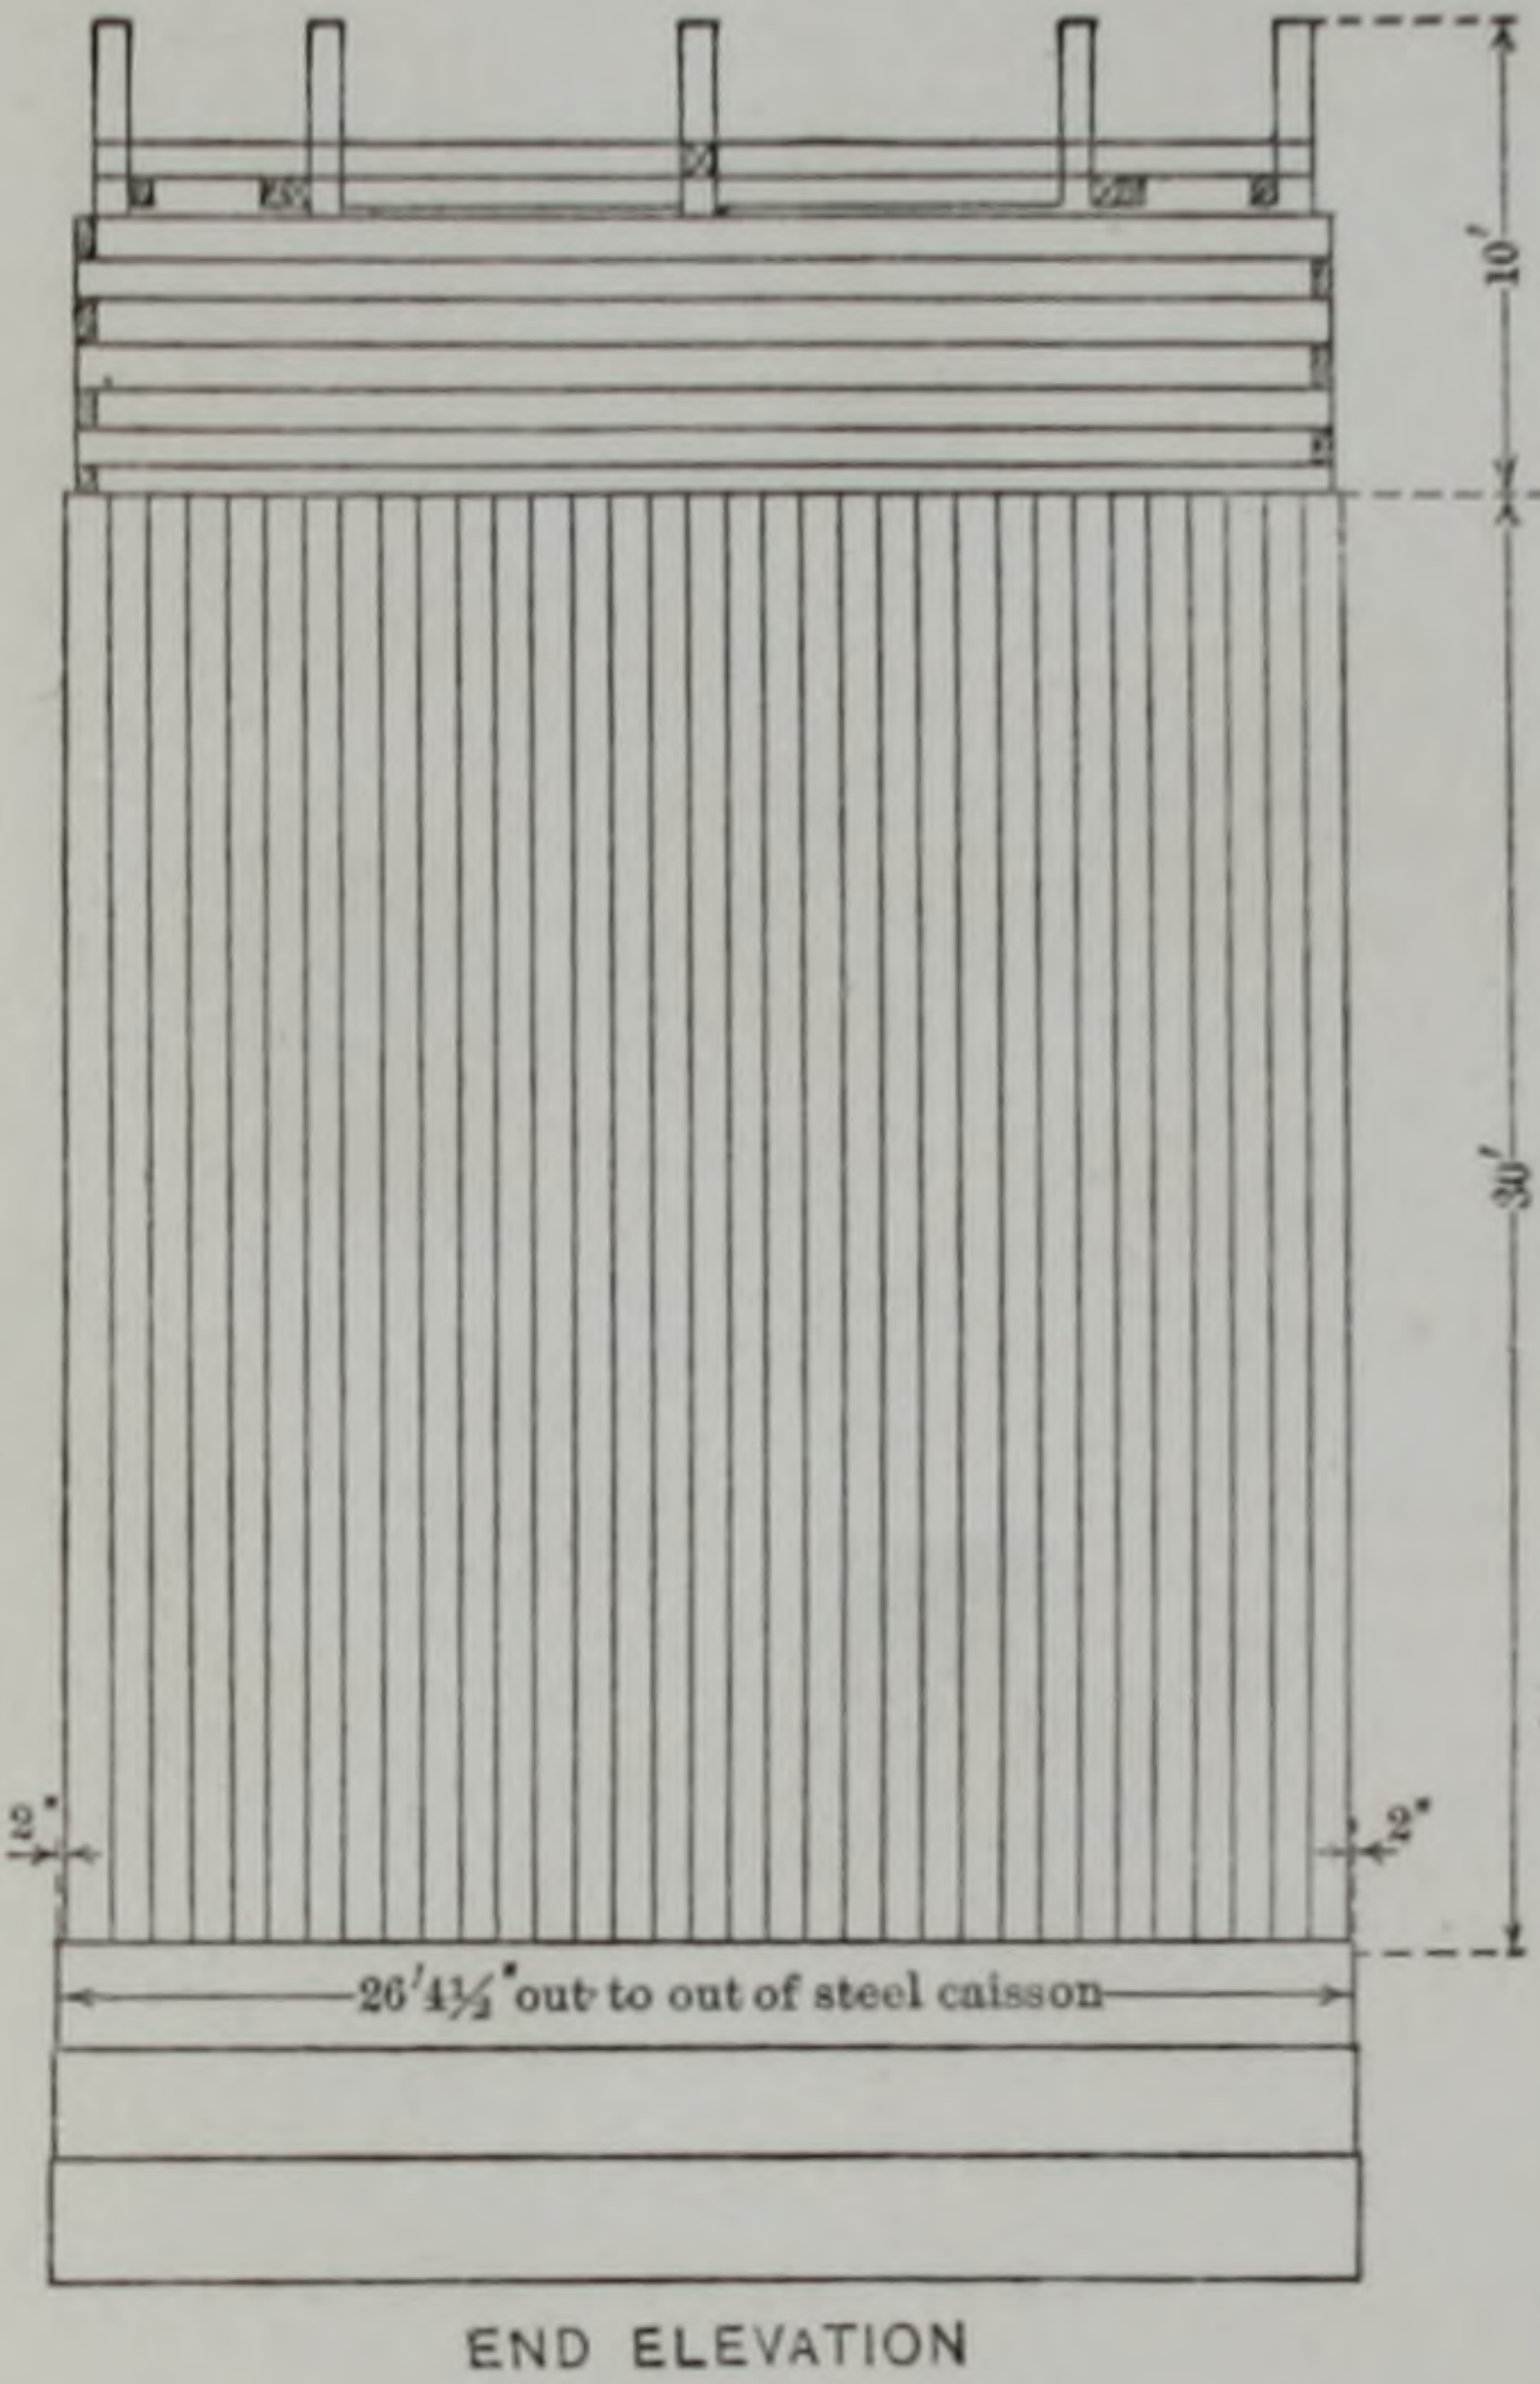
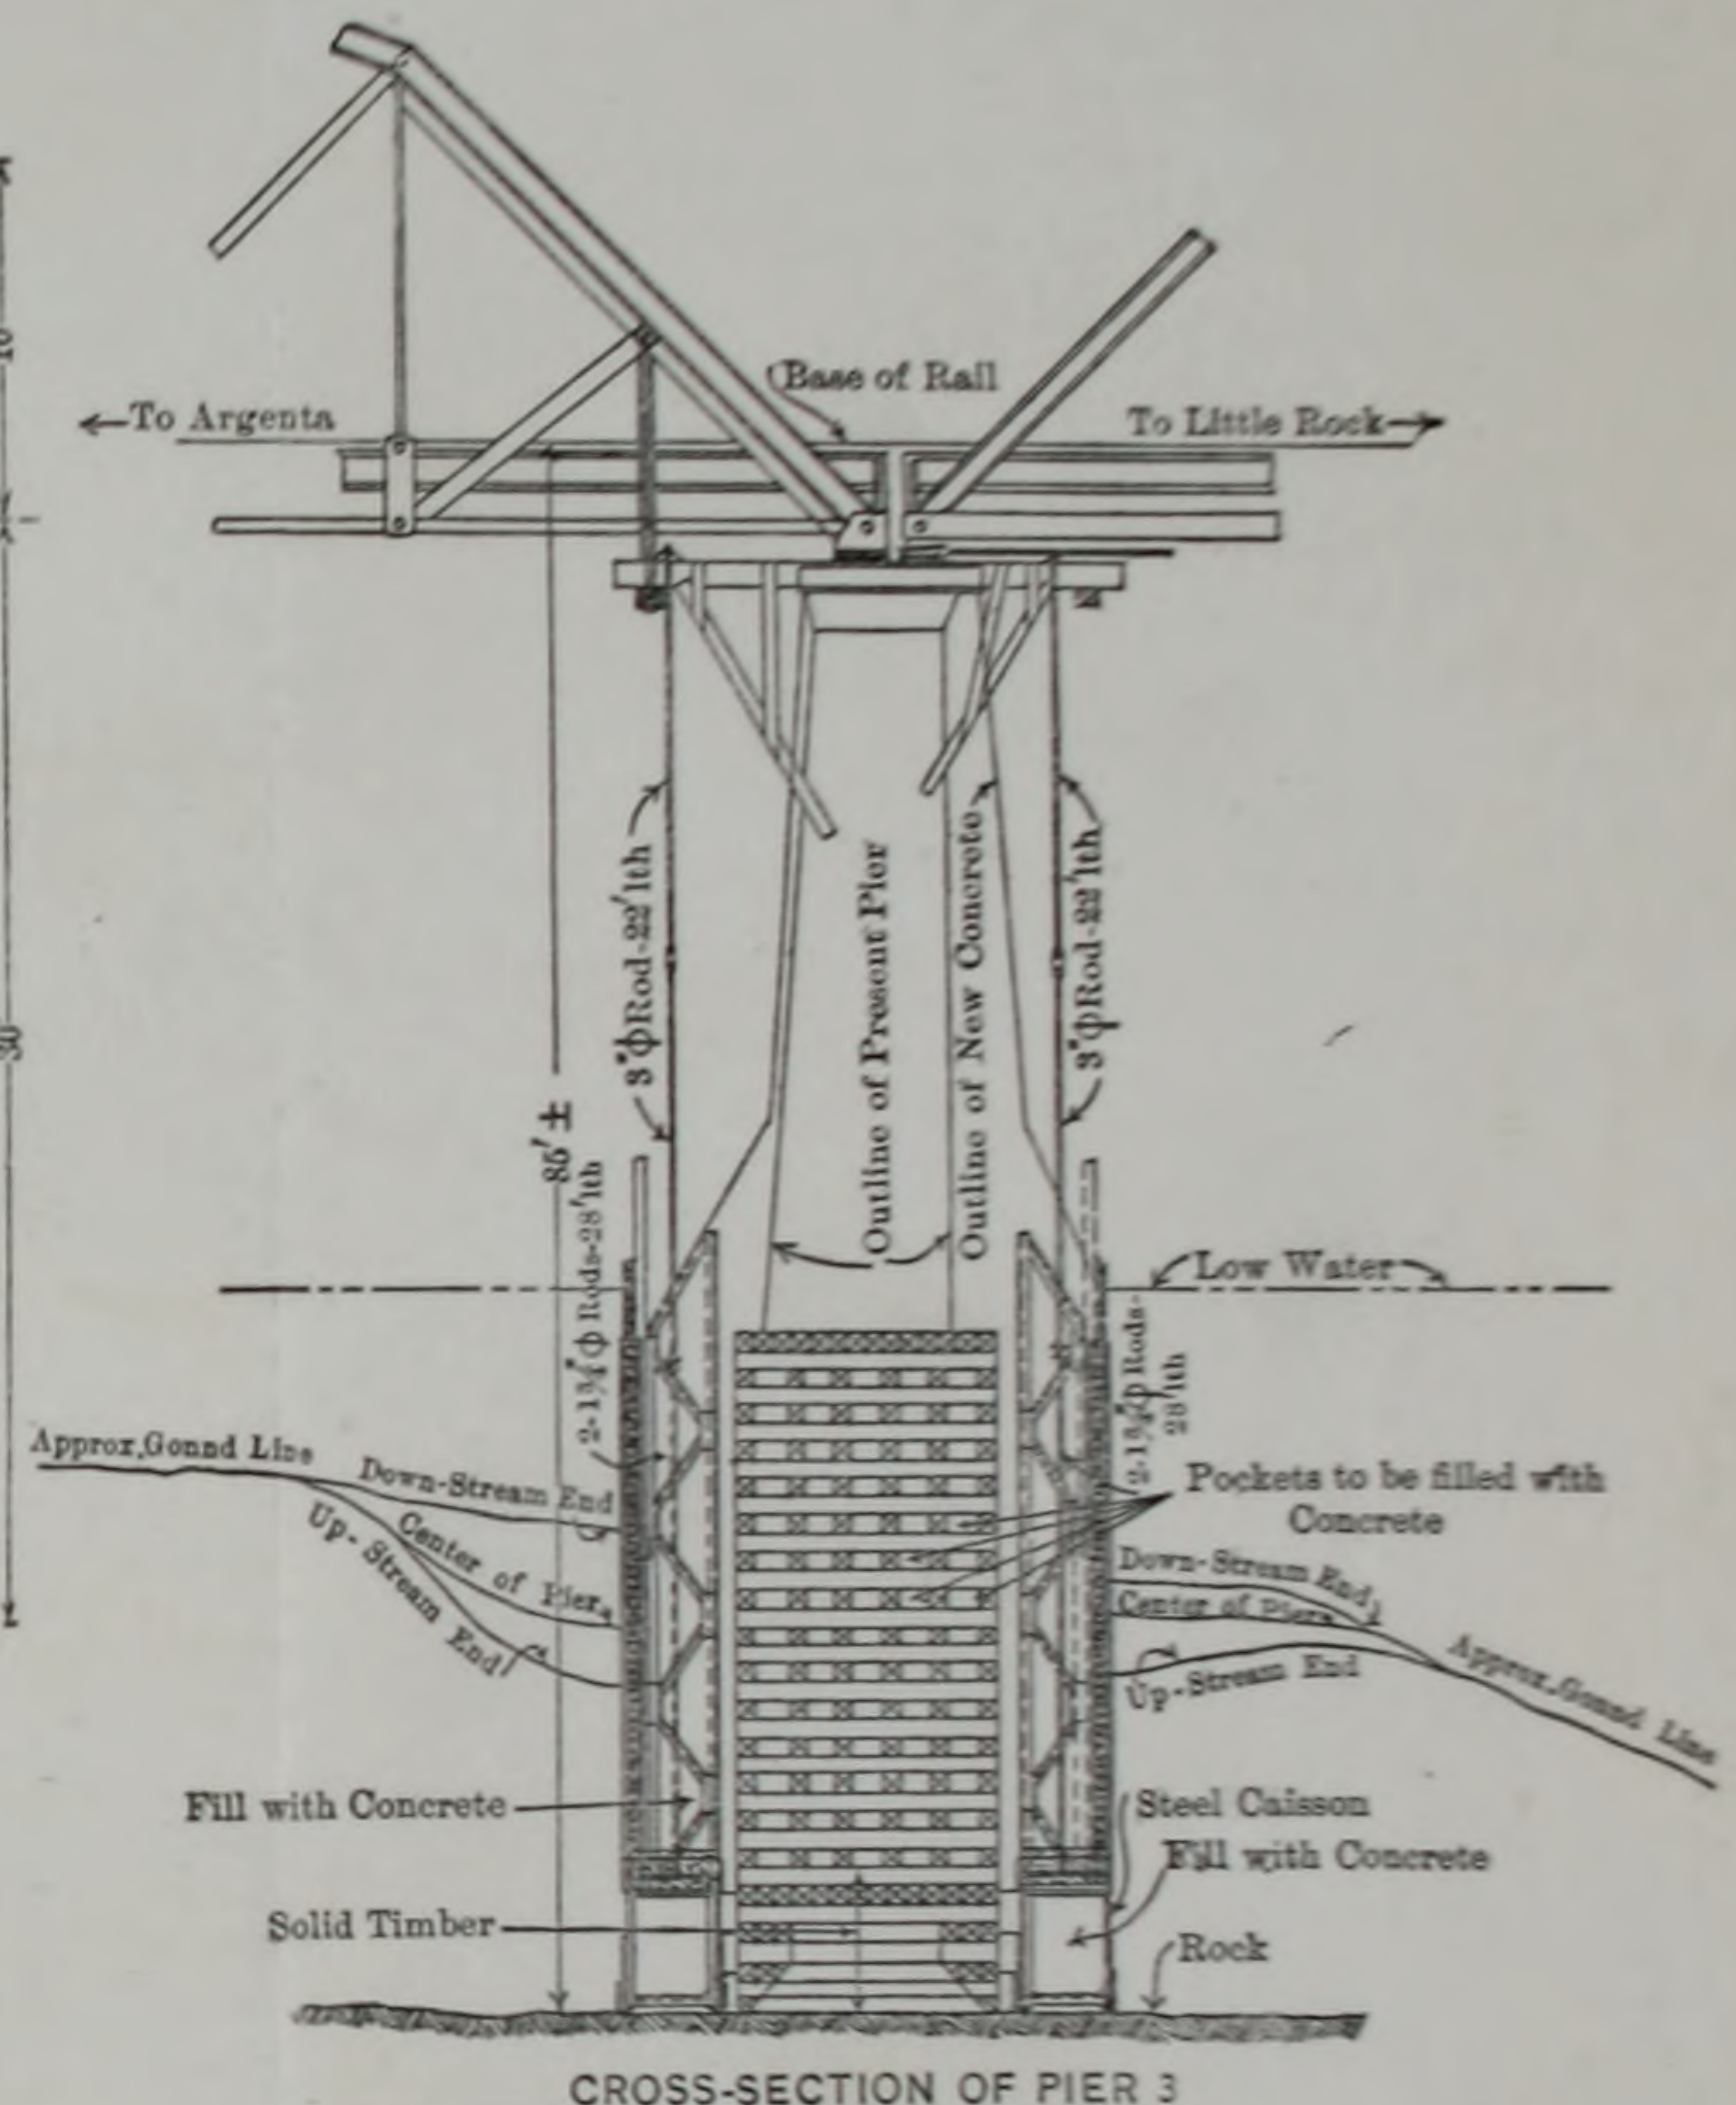
FOR USE IN REPAIRS TO PIER 3, L.R. J.C. BRIDGE

NOTE.  
 When Grillage under old Pier was uncovered it was found to be made up of 5 Longitudinal and 10 Transverse courses. (below the 2 top solid Courses)

Figures along sides show distance of cutting edge above rock. Figures at corners show distance of cutting edge below Base of Rail at Pier 3 which is 3 3/4" lower than Base of Rail at Pier 2 (Pivot Pier)  
 Spaces between cutting edge and rock packed with neat cement in bags  
 Caisson landed at final elevation Feb. 25, 1912  
 Caisson filled with concrete Feb. 29, 1912
