Paper No. 1335

### LITTLE ROCK JUNCTION RAILWAY BRIDGE,

### OVER THE ARKANSAS RIVER

### AT LITTLE ROCK, ARKANSAS, 1883-1914\*

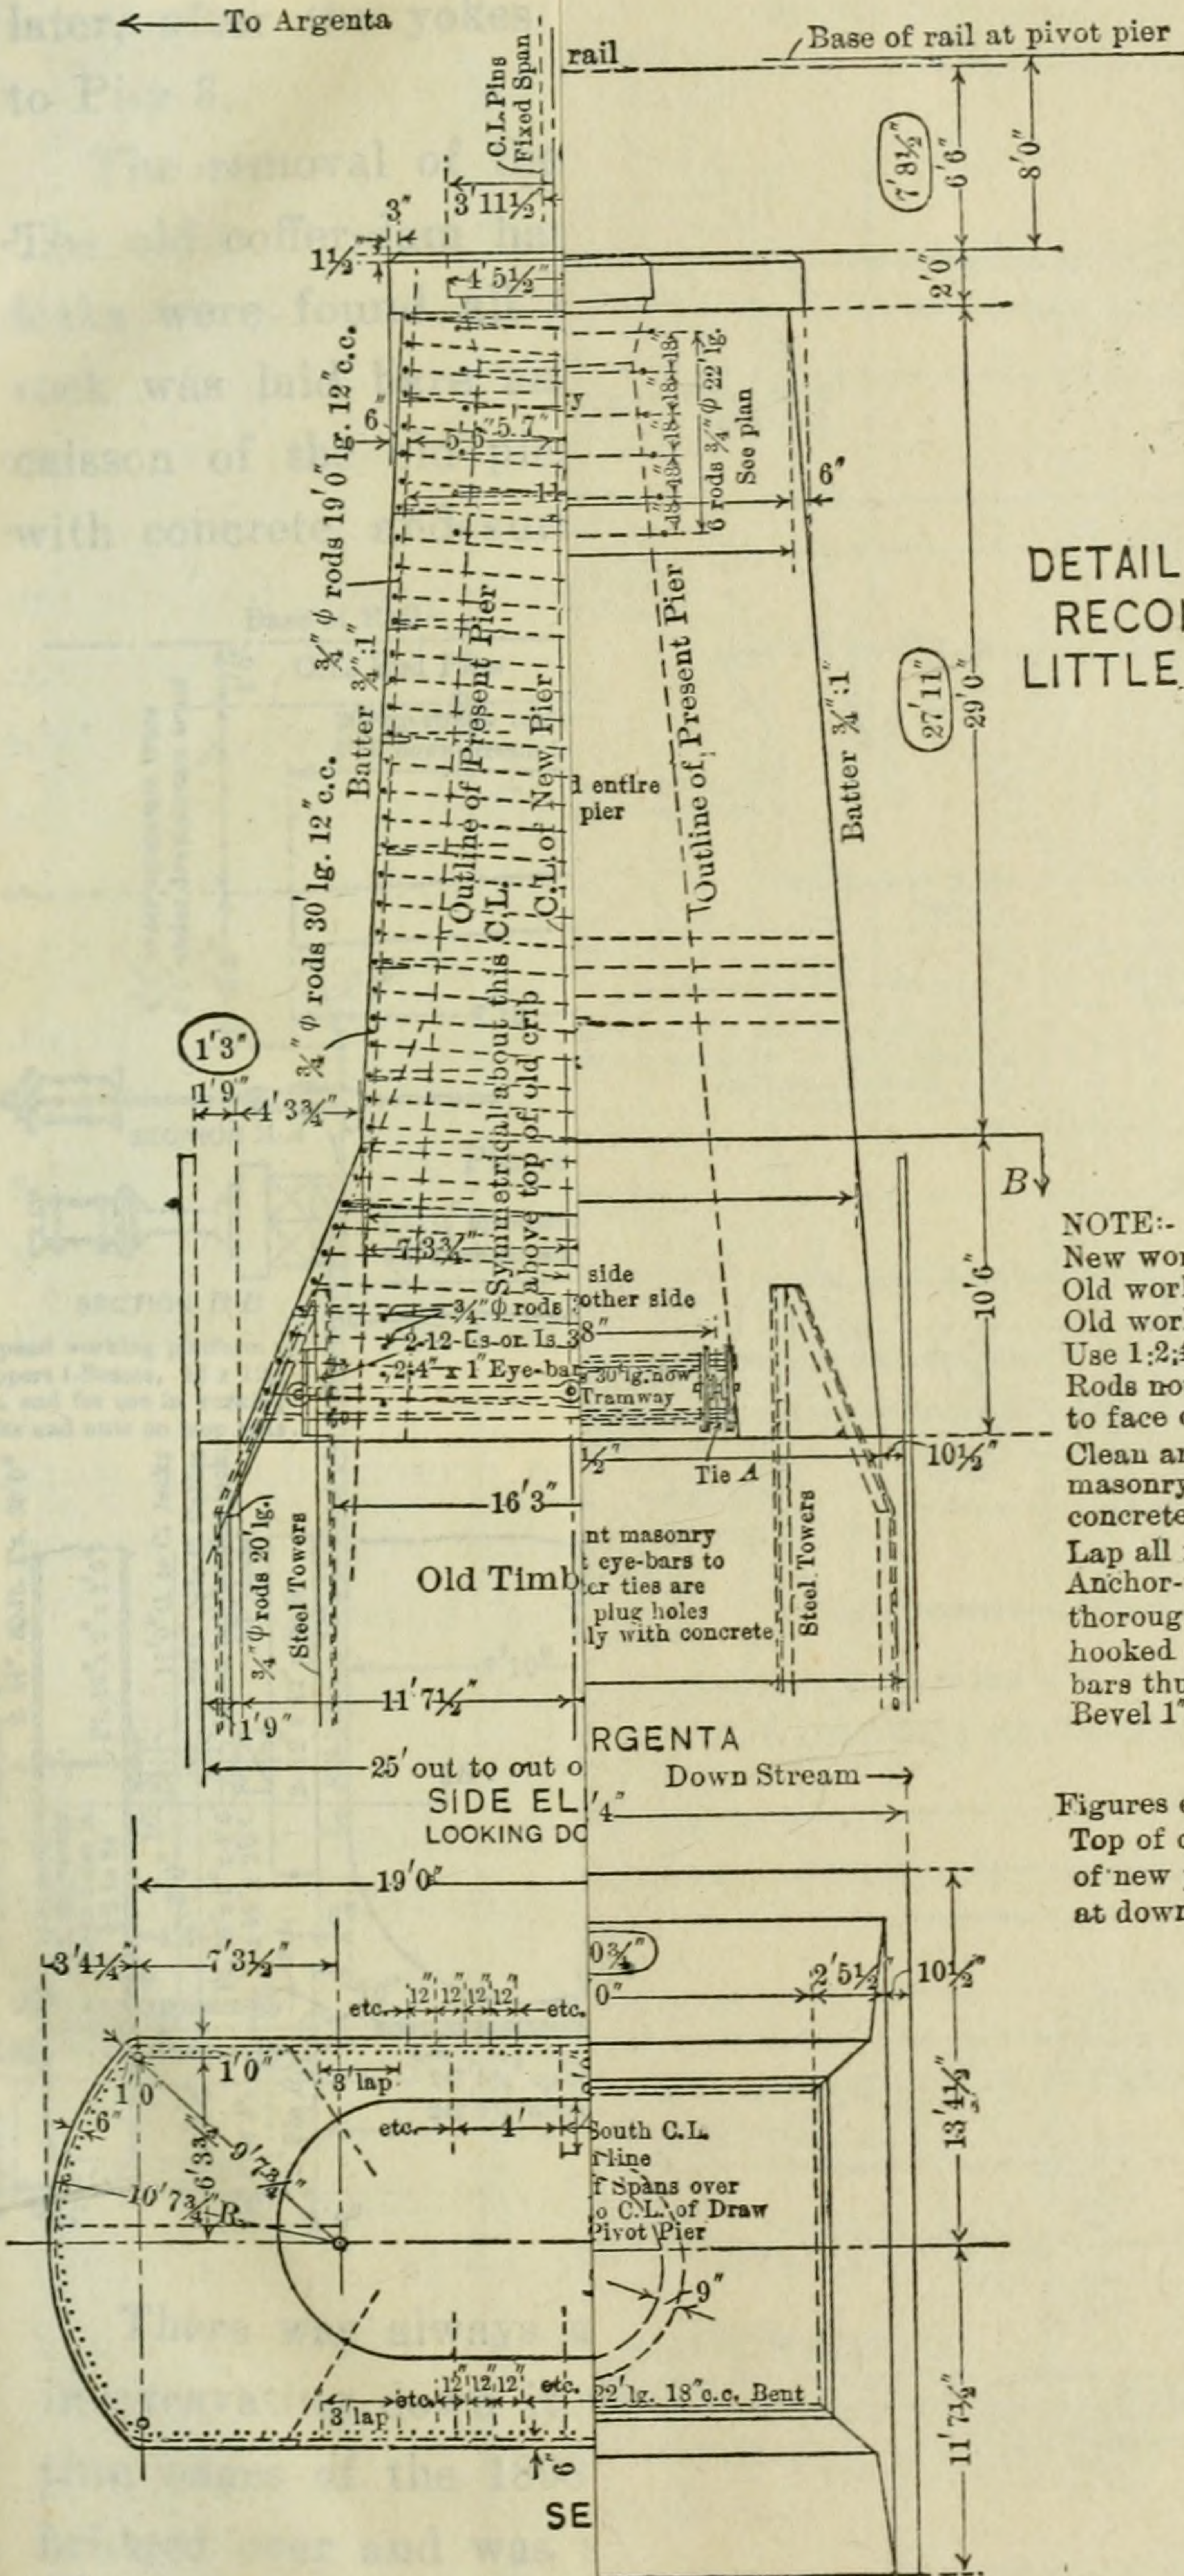
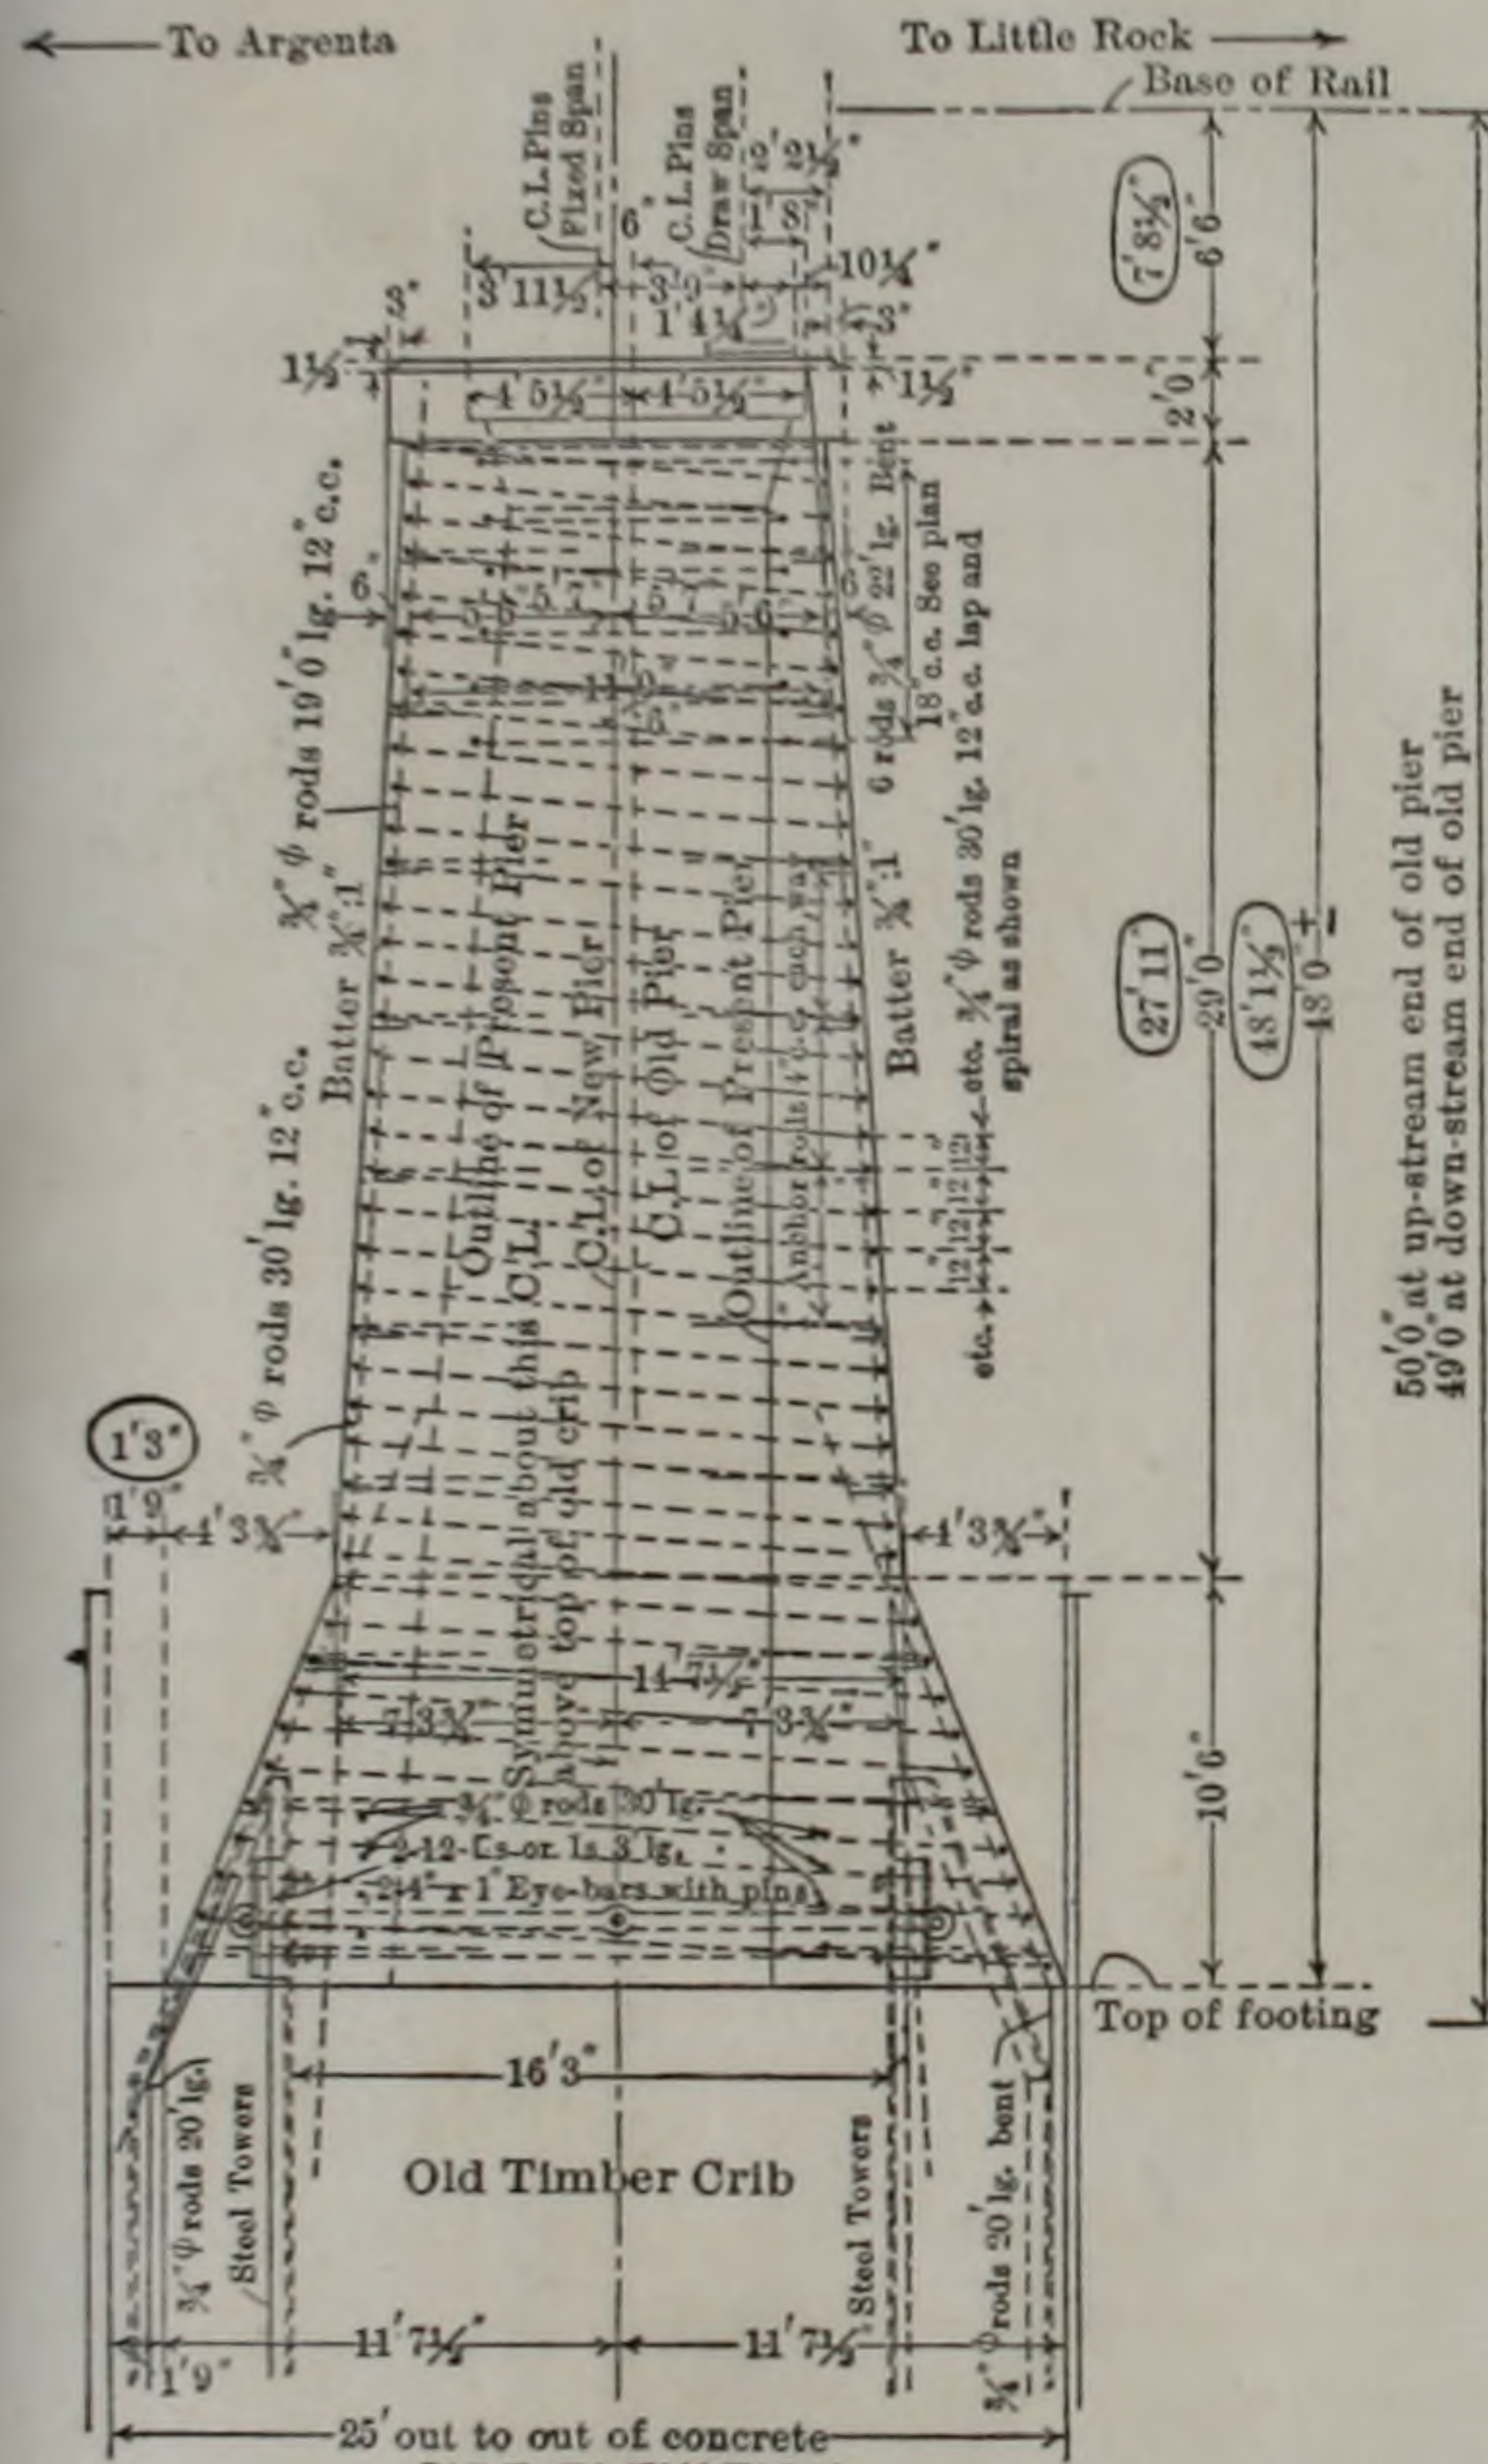
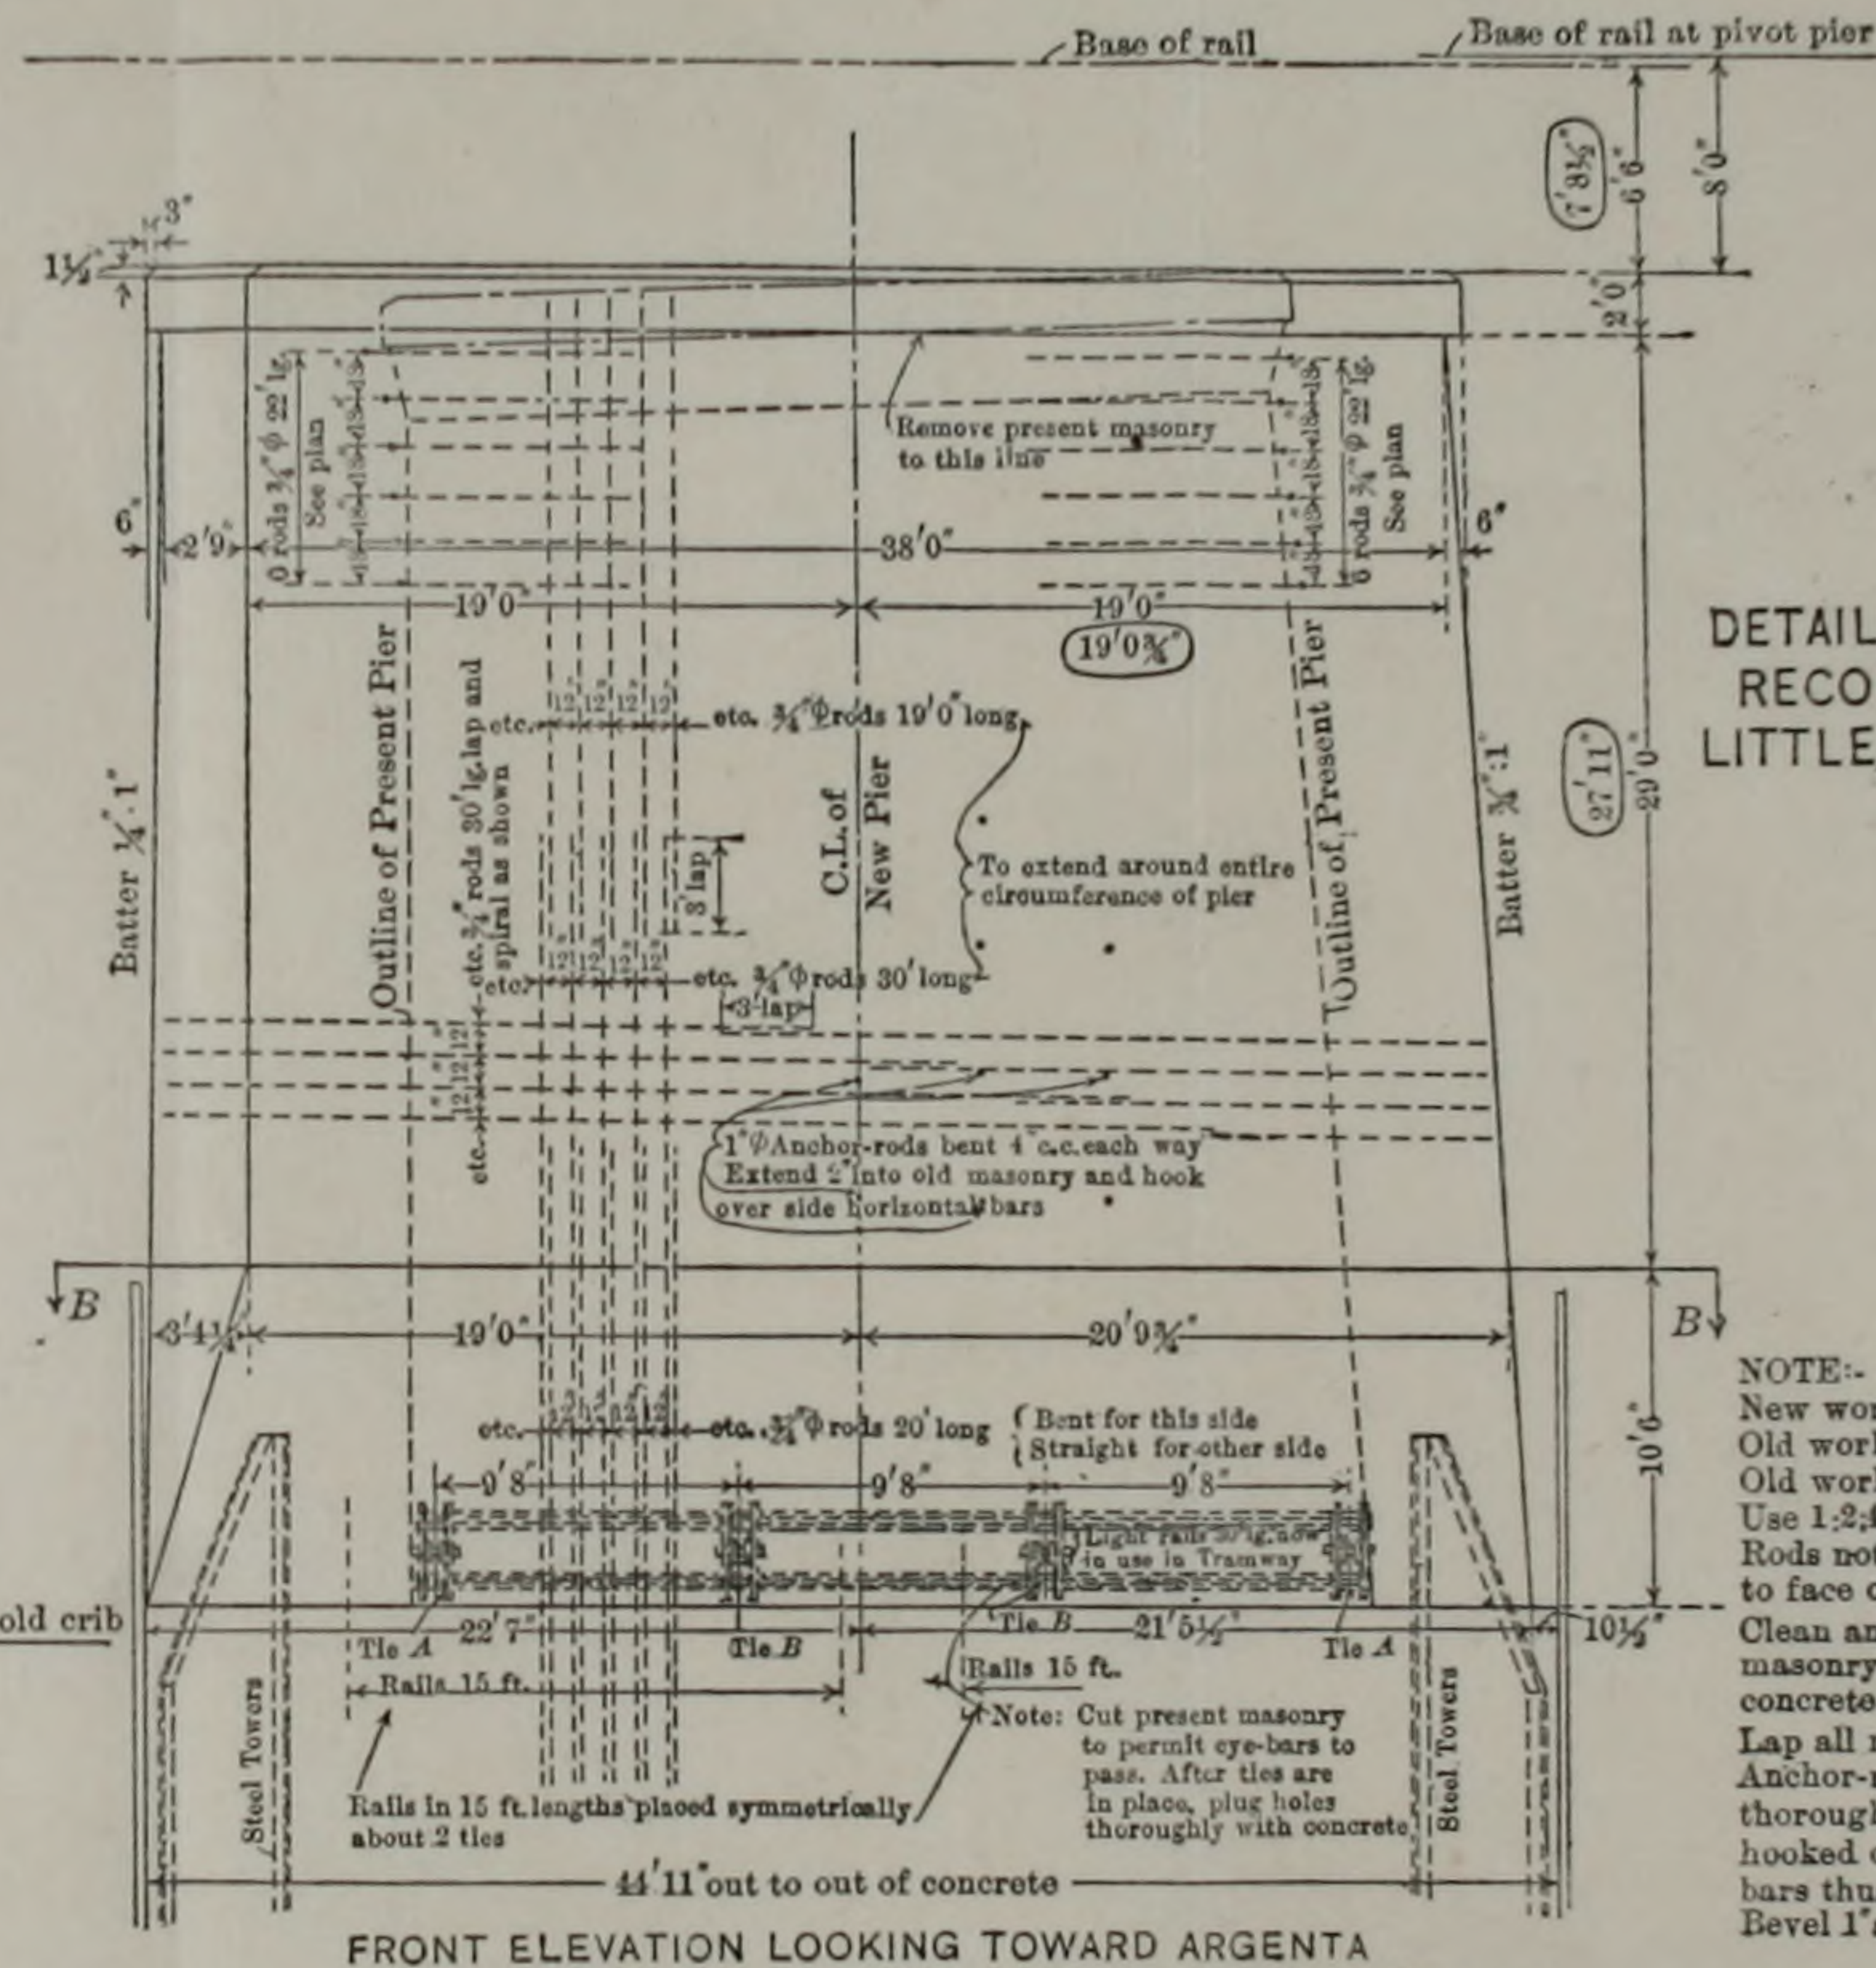
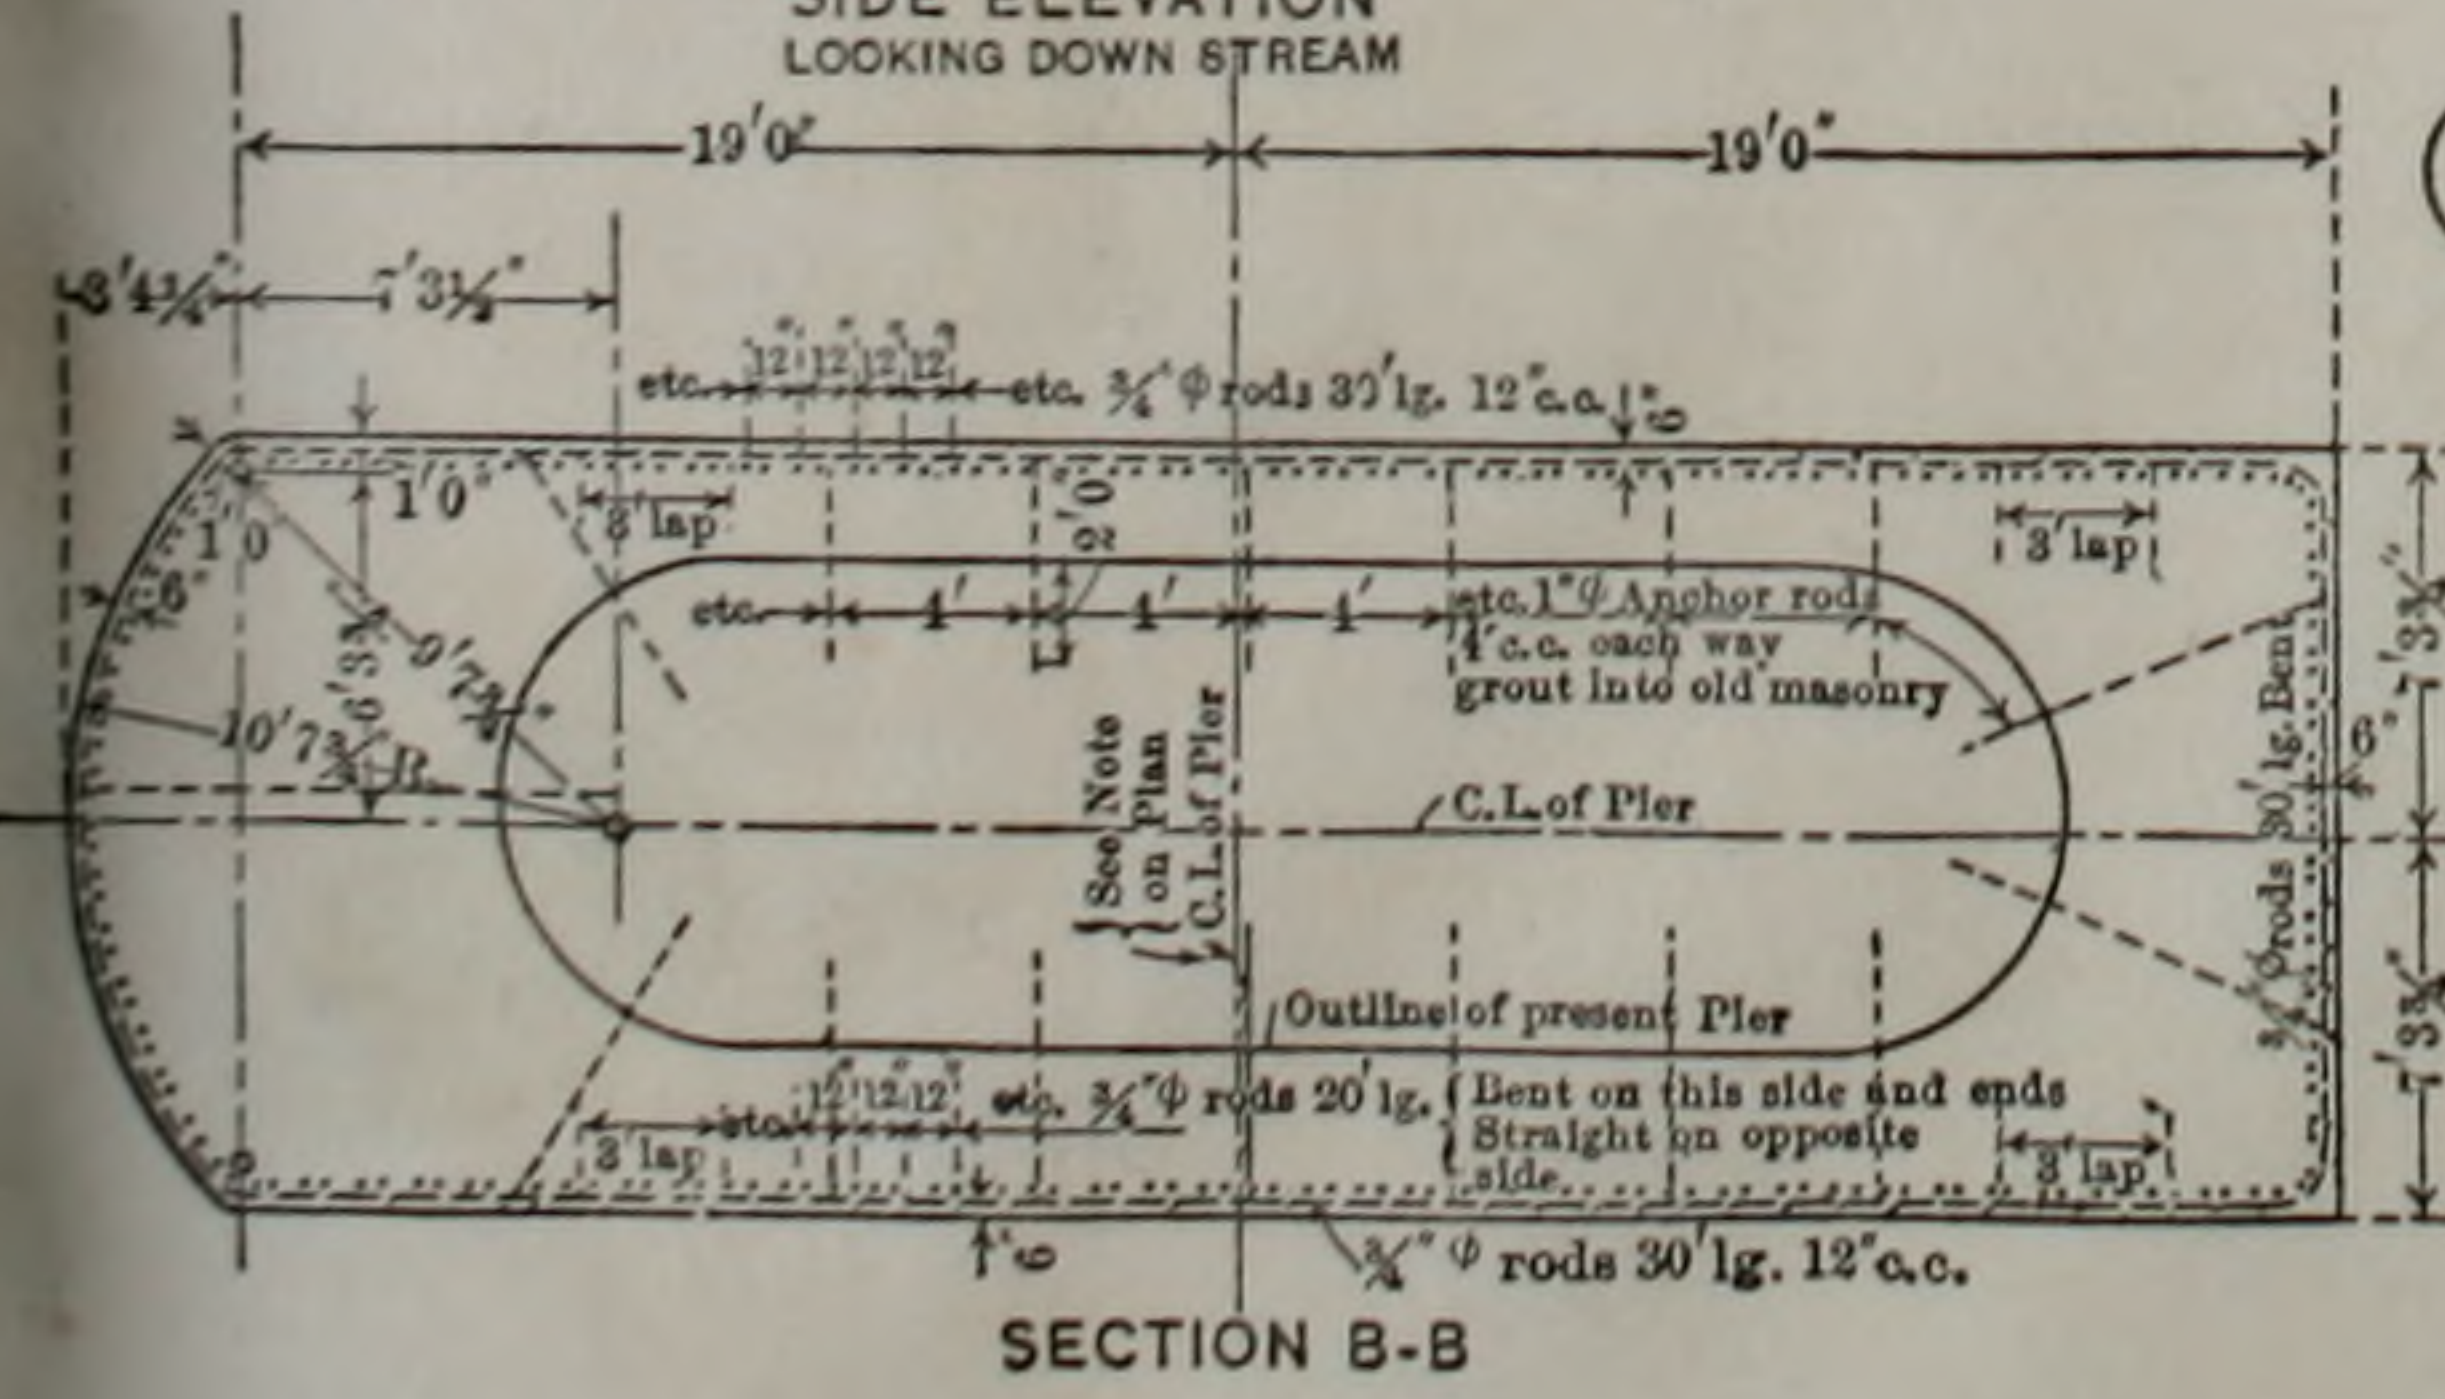
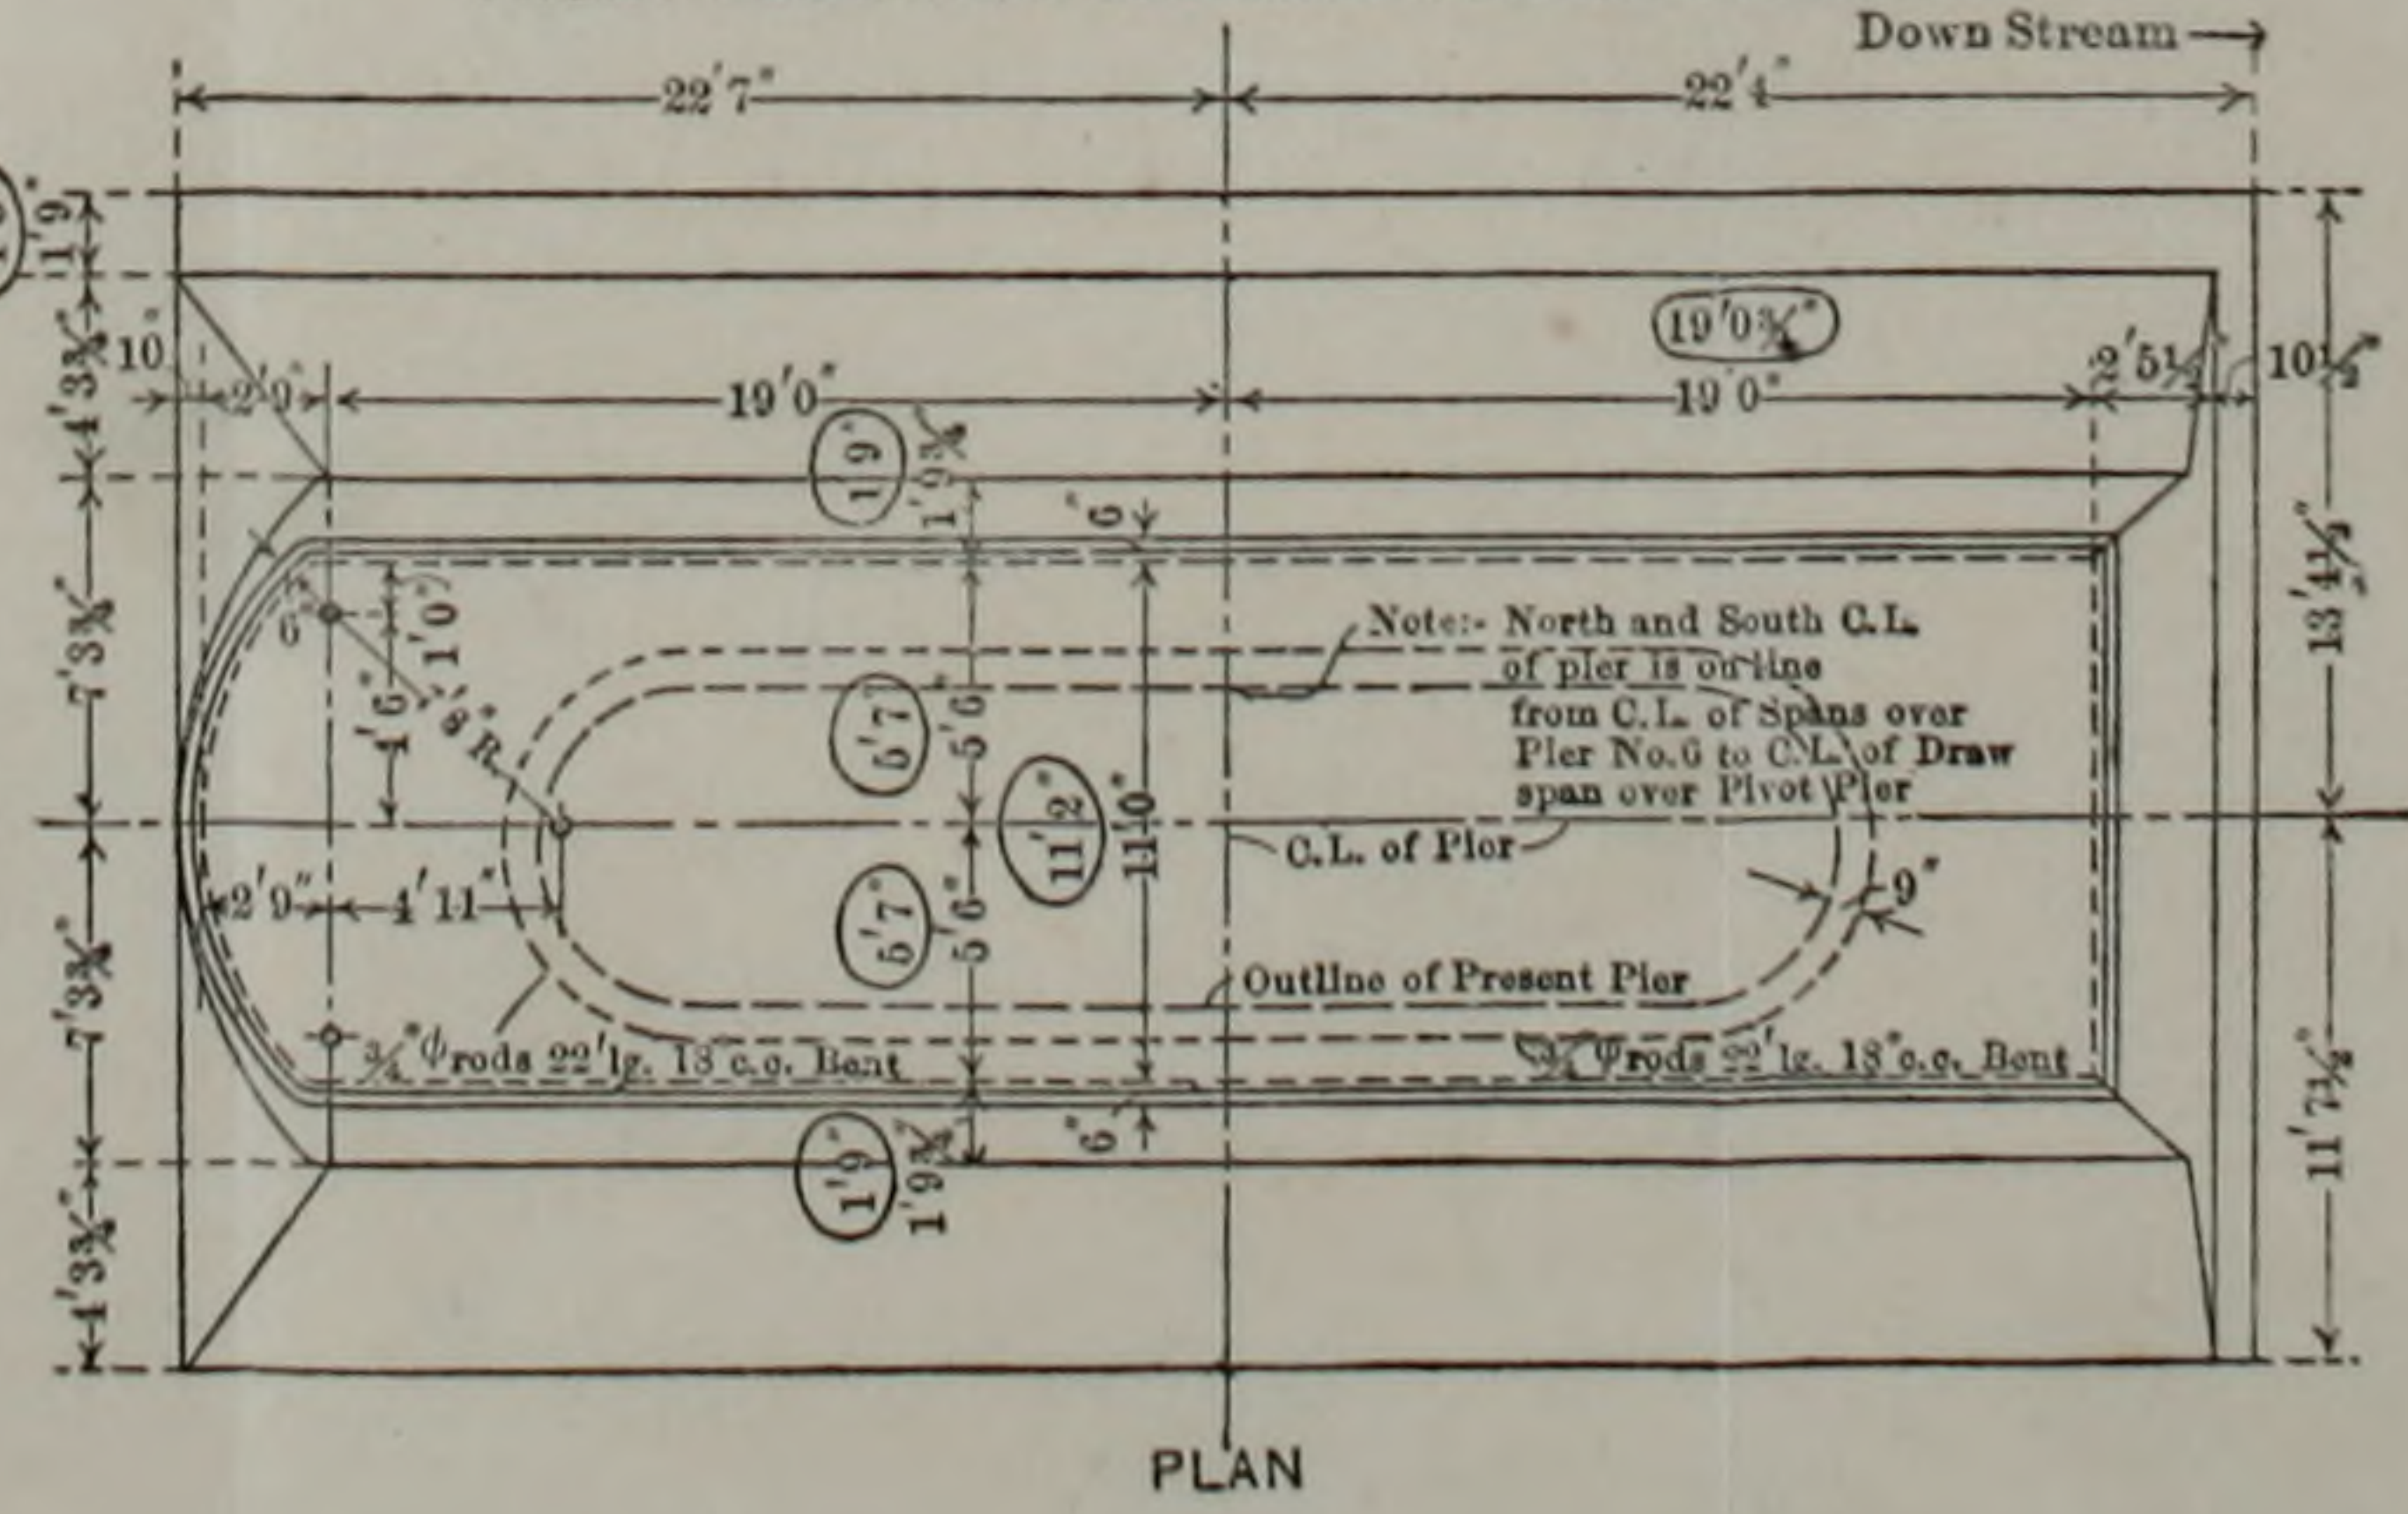
DETAILED MASONRY PLAN FOR  
 RECONSTRUCTION OF PIER 3  
 LITTLE ROCK JUNCTION BRIDGE

Figures enclosed thus (7'8 1/2") show pier as built.  
 Top of old pier projects above top  
 of new pier 4" at up-stream end and 9"  
 at down-stream end.

NOTE:-  
 New work shown thus —  
 Old work to be removed shown thus ---  
 Old work to remain in place " —"  
 Use 1:2:4 Concrete  
 Rods not to come nearer than 3"  
 to face of concrete  
 Clean and moisten thoroughly old  
 masonry where joined by new  
 concrete.  
 Lap all rods 3'0"  
 Anchor-rods, 1" Rd., must be grouted  
 thoroughly into old masonry and  
 hooked over outside horizontal  
 bars thus —  
 Bevel 1" all corners 90° or less

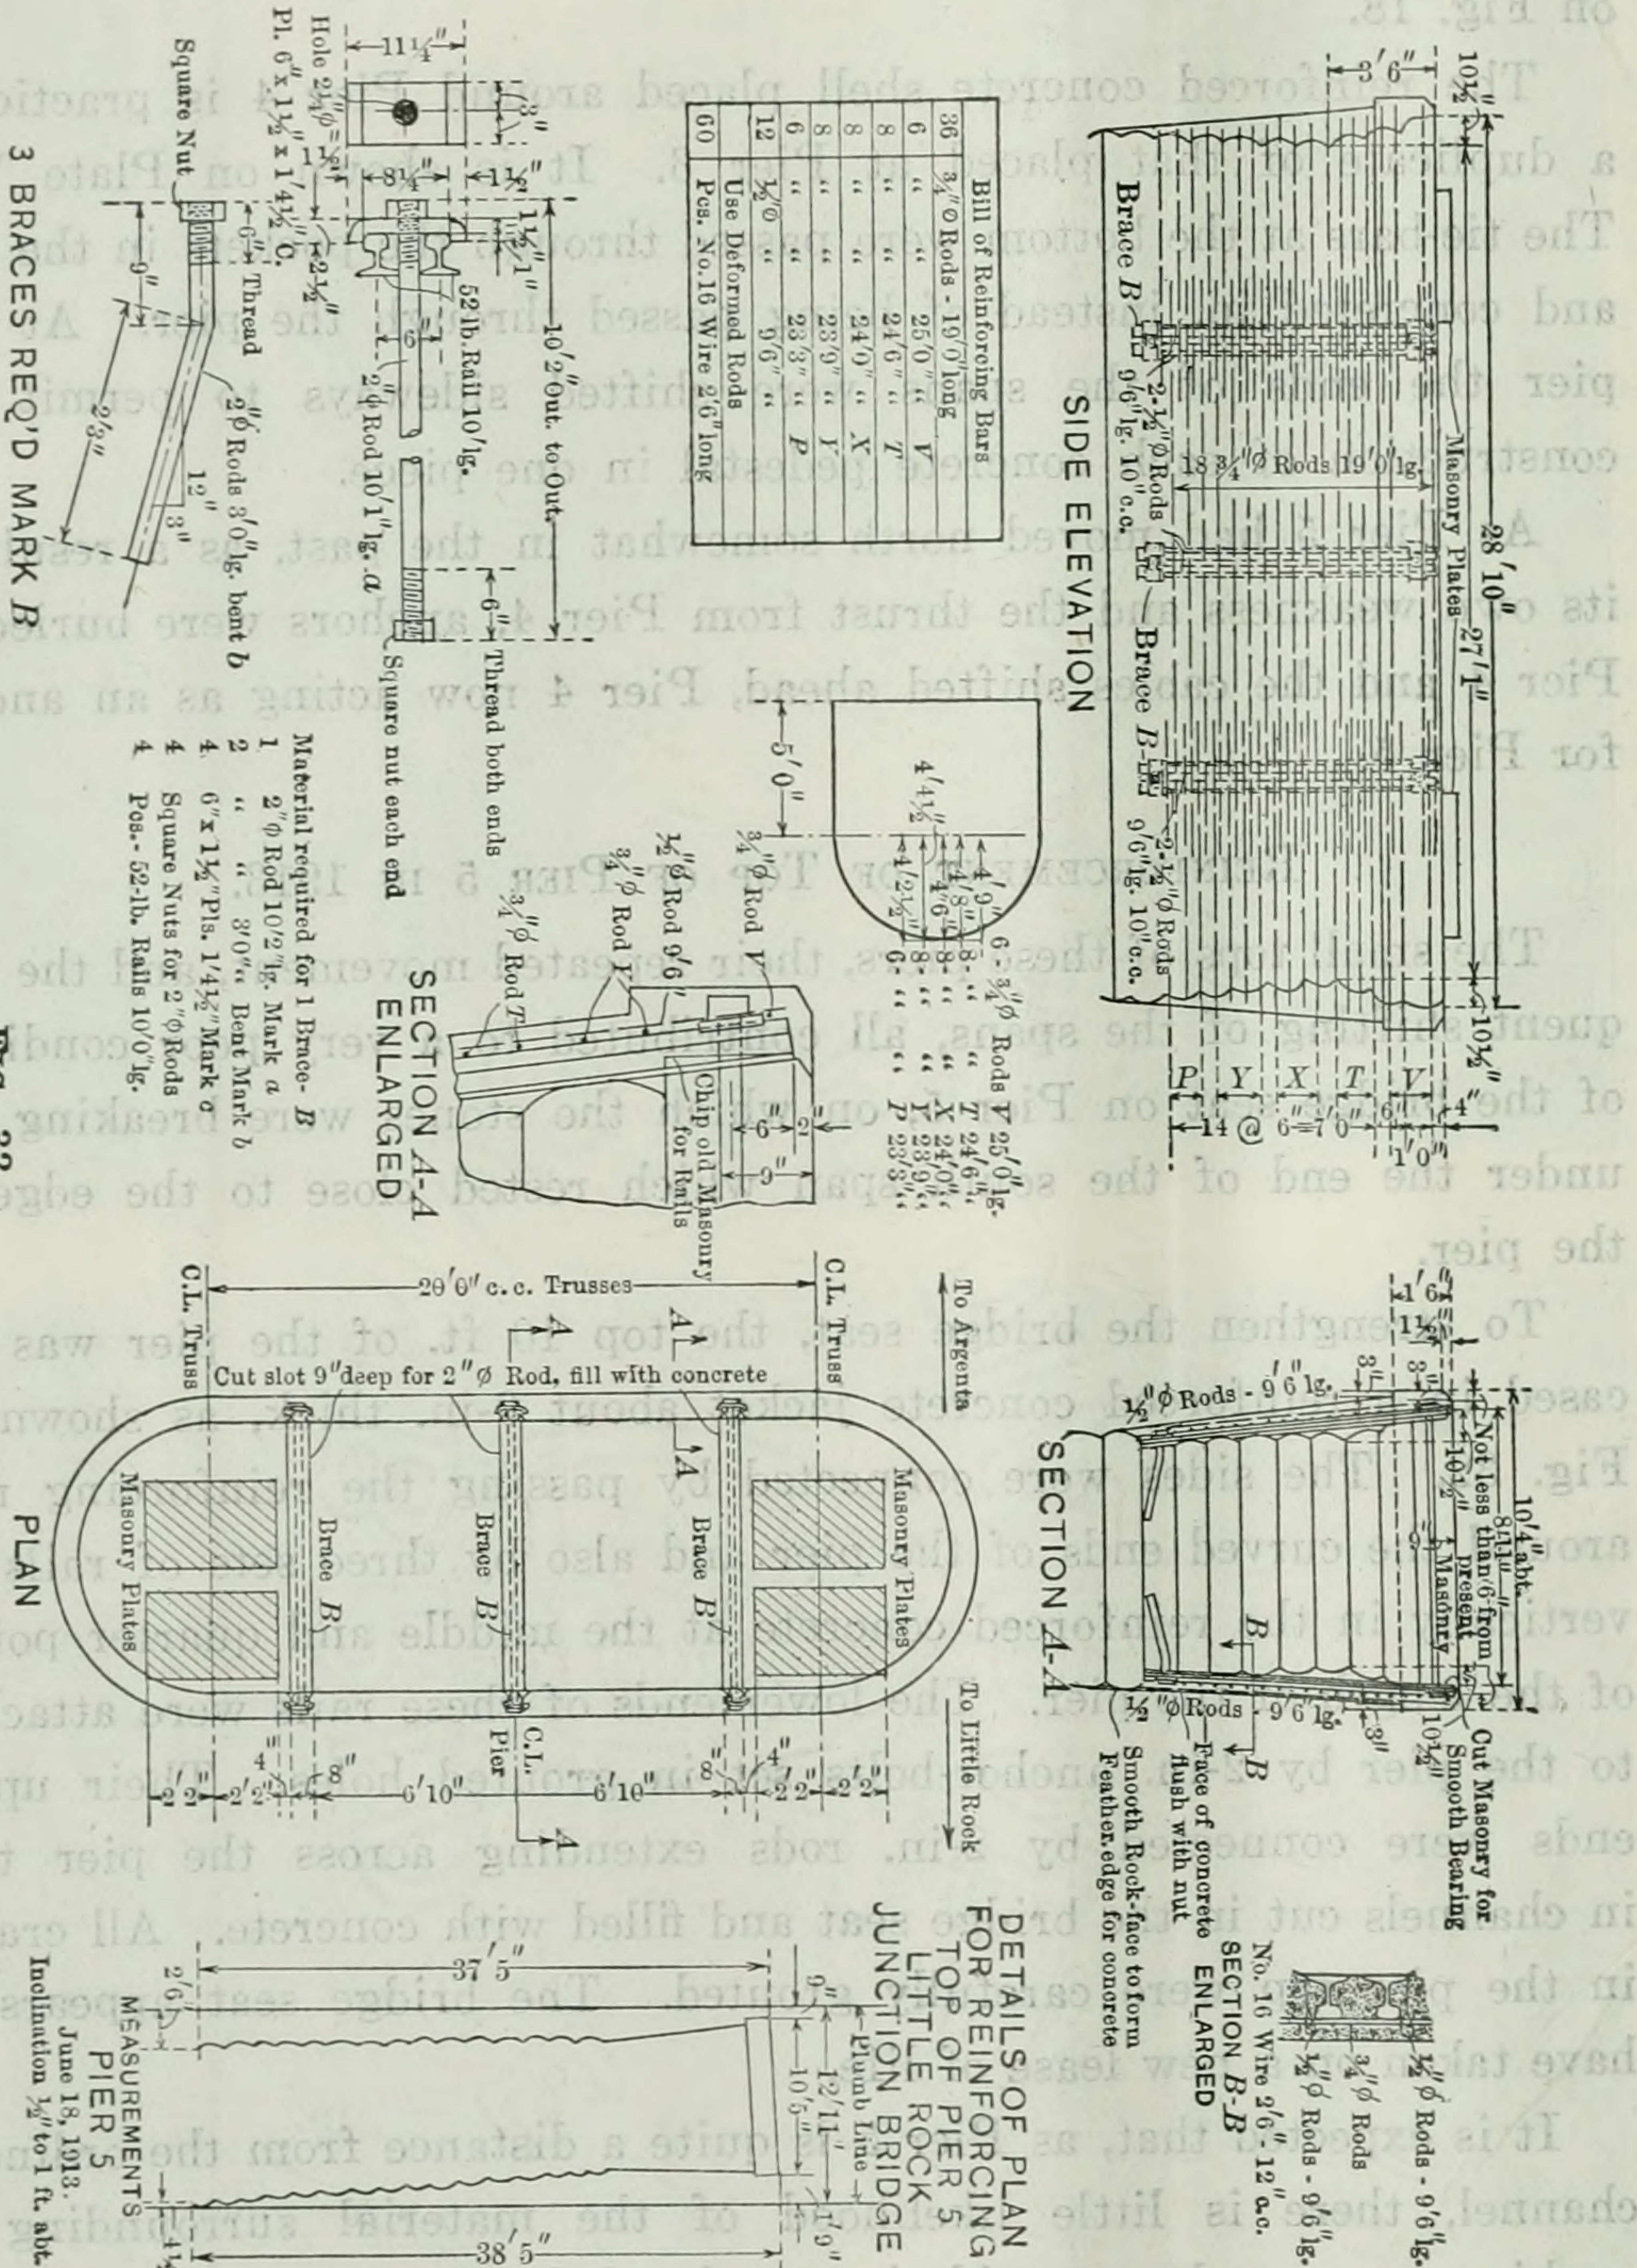
FIG. 32.

The small tops of these piers, their repeated movement, and the frequent shifting of the spans, all contributed to a very poor condition of the bridge seat on Pier 5, on which the stones were breaking out under the end of the south span which rested close to the edge of the pier.

To strengthen the bridge seat, the top 10 ft. of the pier was encased in a reinforced concrete jacket about 9-in. thick, as shown by Fig. 32. The sides were connected by passing the reinforcing rods around the curved ends of the pier and also by three sets of rails set vertically in the reinforced concrete at the middle and quarter points of the length of the pier. The lower ends of these rails were attached to the pier by 2-in. anchor-bolts set in grouted holes. Their upper ends were connected by 2-in. rods extending across the pier tops in channels cut in the bridge seat and filled with concrete. All cracks in the pier top were carefully grouted. The bridge seat appears to have taken on a new lease of life.
