Paper No. 1335

### LITTLE ROCK JUNCTION RAILWAY BRIDGE,

### OVER THE ARKANSAS RIVER

### AT LITTLE ROCK, ARKANSAS, 1883-1914\*

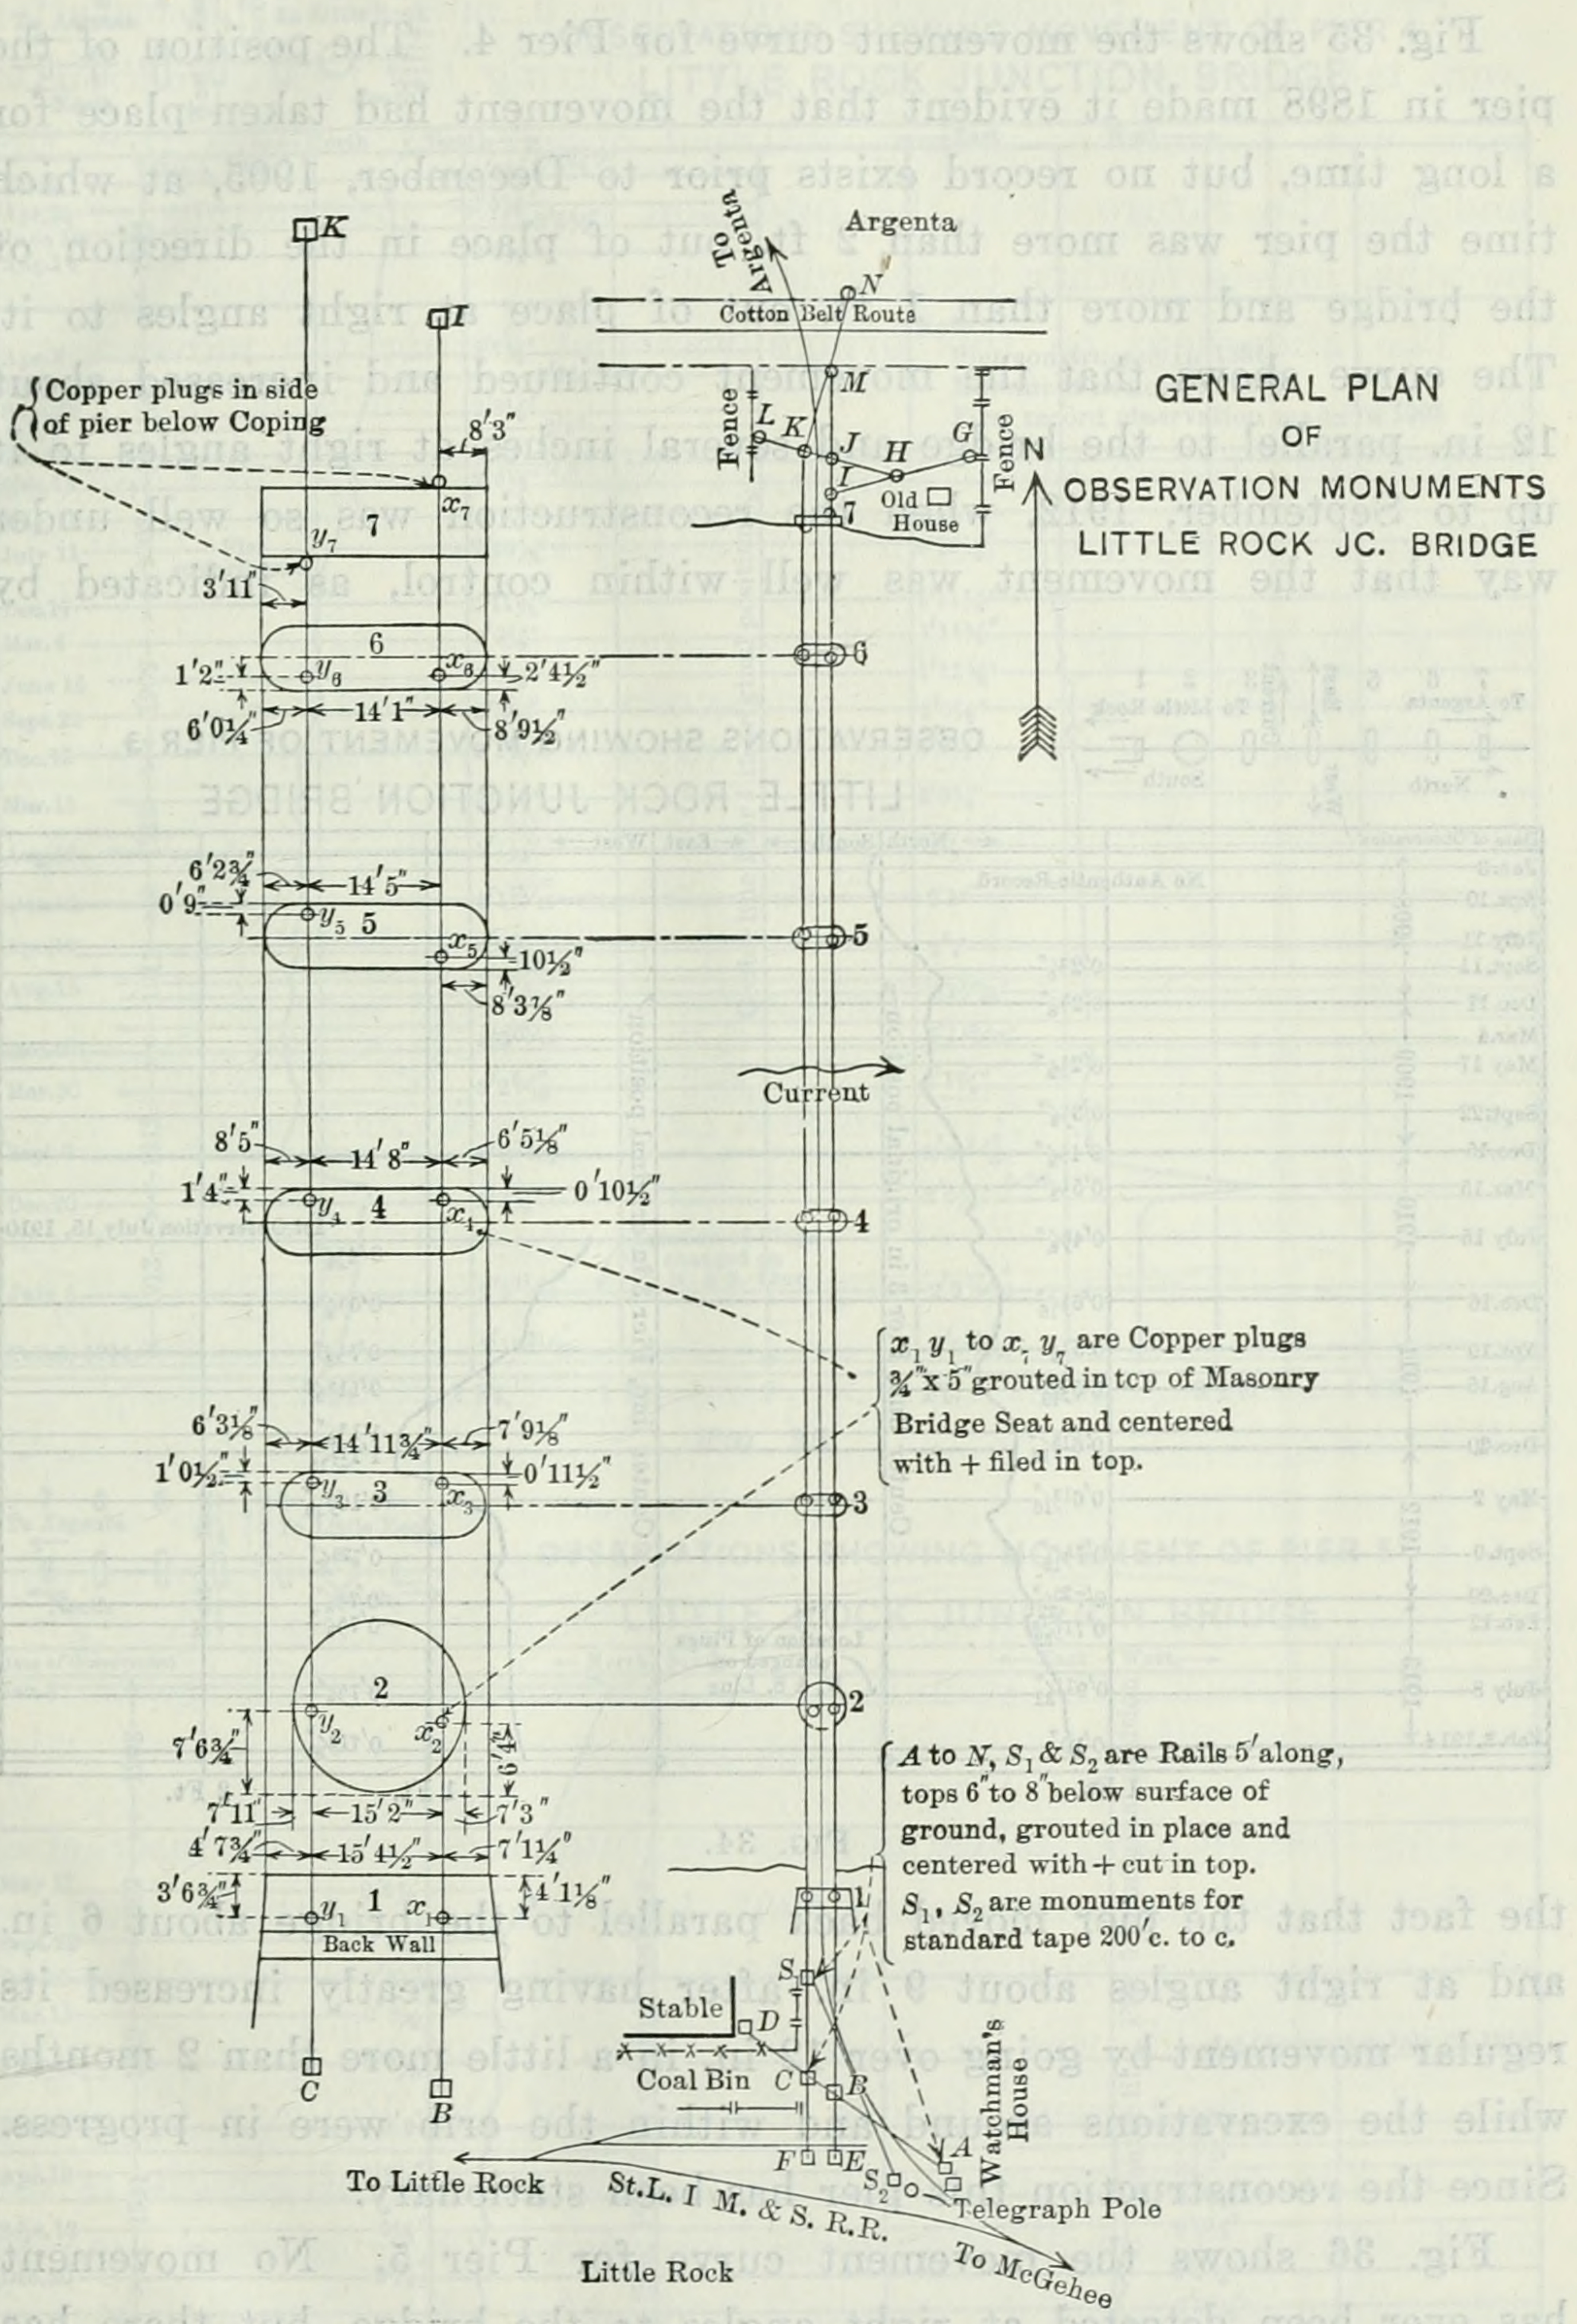
FIG. 33.

Fig. 33 shows the location of the base lines, points on pier, transit points, and other monuments. No movement has been detected in the pivot pier since the repairs in 1898; no movement has ever been detected in Piers 1, 6, and 7.

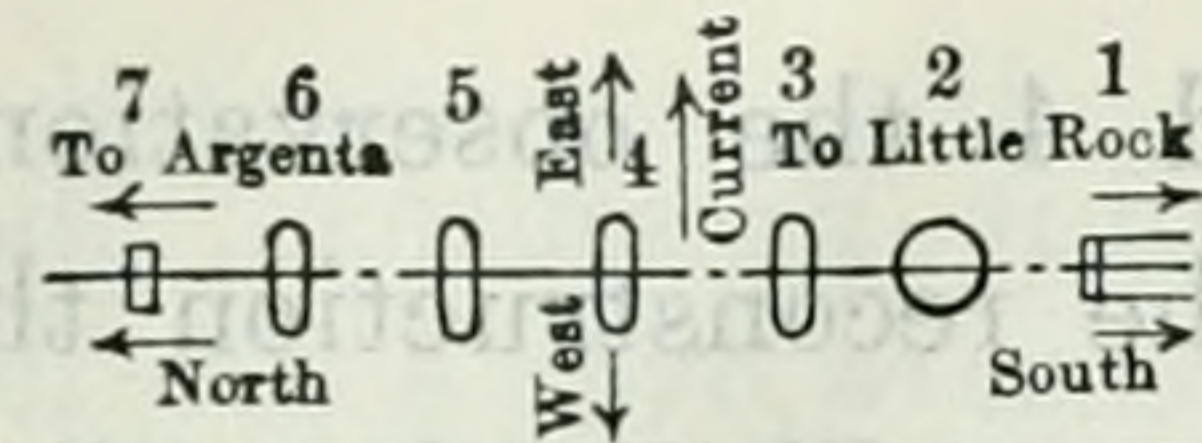
FIG. 35.

Fig. 35 shows the movement curve for Pier 4. The position of the pier in 1898 made it evident that the movement had taken place for a long time, but no record exists prior to December, 1905, at which time the pier was more than 2 ft. out of place in the direction of the bridge and more than 1 ft. out of place at right angles to it. The curve shows that the movement continued and increased about 12 in. parallel to the bridge and several inches at right angles to it up to September, 1912, when the reconstruction was so well under way that the movement was well within control, as indicated by

the fact that the pier moved back parallel to the bridge about 6 in. and at right angles about 9 in. after having greatly increased its regular movement by going over 12 in. in a little more than 2 months while the excavations around and within the crib were in progress. Since the reconstruction this pier has been stationary.

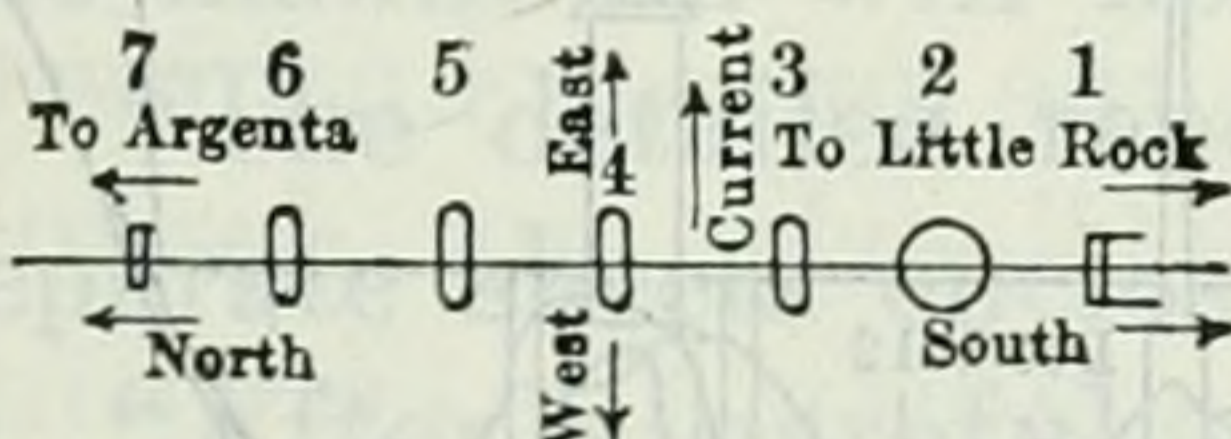
FIG. 36.

Fig. 36 shows the movement curve for Pier 5. No movement has ever been detected at right angles to the bridge, but there has been intermittent movement parallel with it. No movement has been detected since the application of the cables anchoring this pier to Pier 4, and no further movement is expected.
