**INSPECTION AND REHABILITATION
OF
THE JOHN A. ROEBLING BRIDGE
FORMERLY KNOWN AS
THE COVINGTON-CINCINNATI SUSPENSION BRIDGE**

ABSTRACT

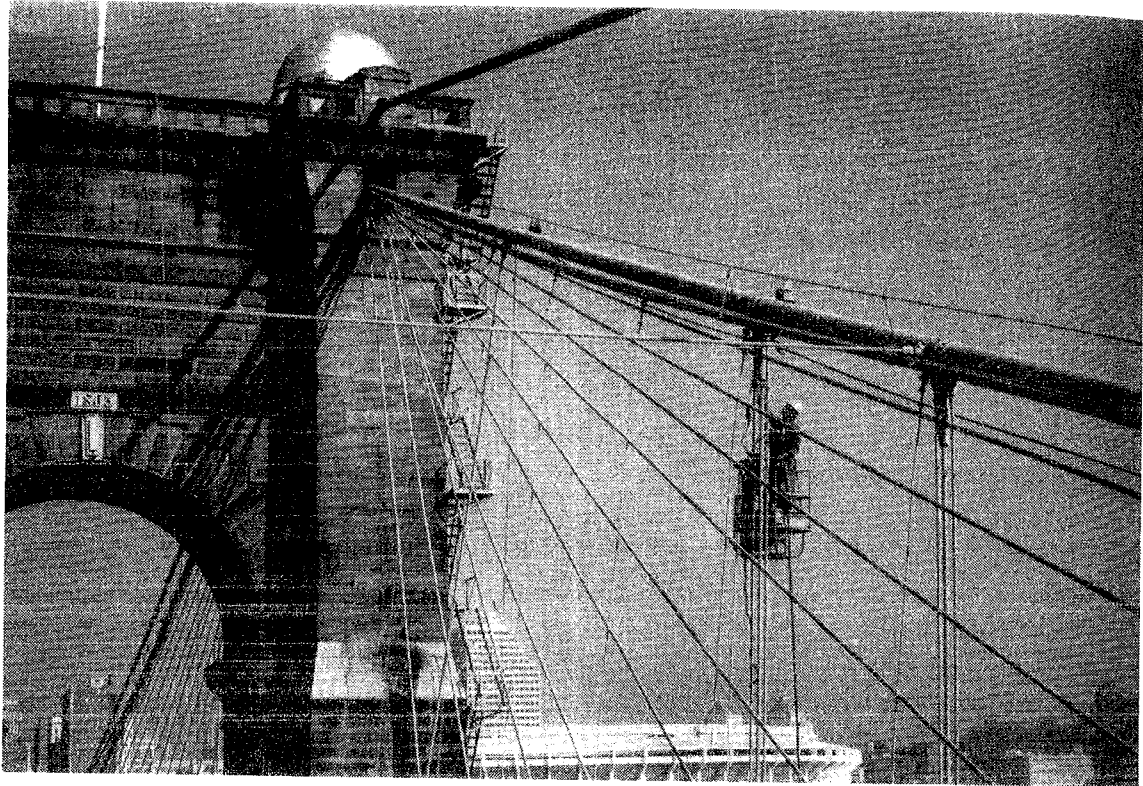
- Floor system of the approach spans
- Cable rigging for high level cable inspection shown in Figure 4
- Tower rigging for inspection of the upper exterior tower masonry

FIGURE 4. CABLE RIGGING FOR HIGH LEVEL CABLE INSPECTION

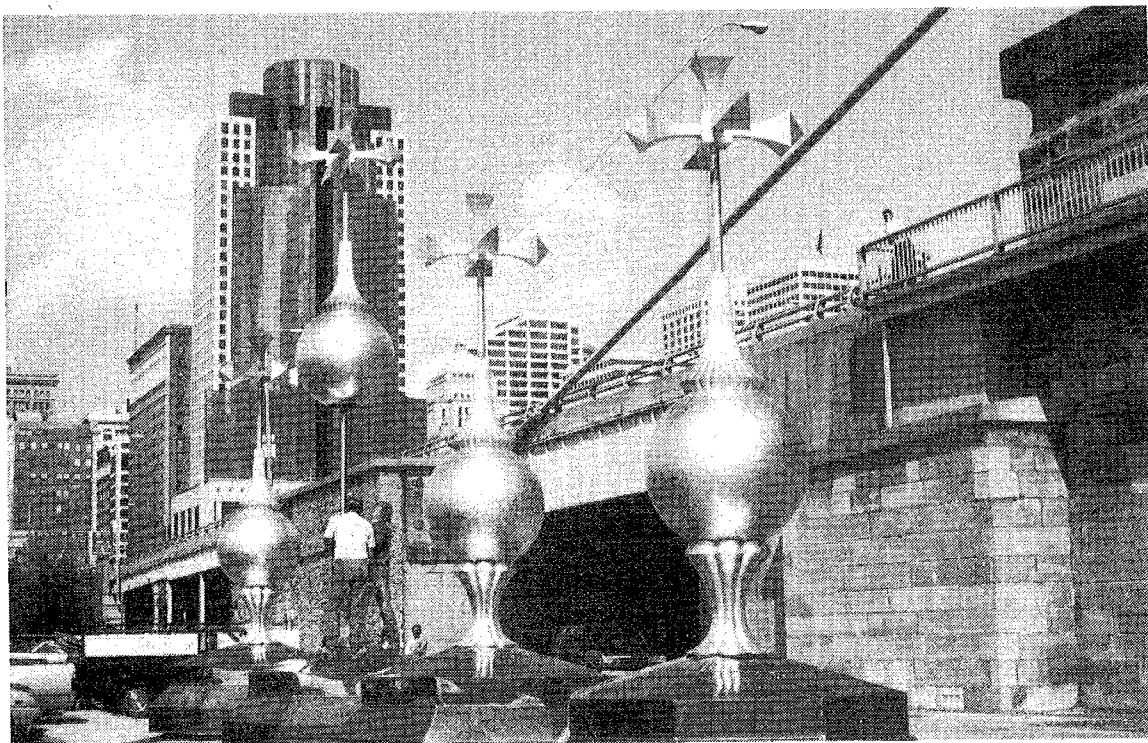
The contractor elected to fabricate and gild the ball and Greek cross as one unit in the shop. The octagonal steel frame bases clad in copper were also shop assembled. The individual units were trucked to the site, where the ornaments were mounted on the bases (Figure 11). Final touch-up gilding was done while the assemblies rested in the parking lot adjacent to the Ohio approach. The next day, March 7, 1992, the bridge was closed to traffic, and the ornament assemblies were lifted one by one using a heavy-duty helicopter and positioned on the finished turrets (Figure 12).

FIGURE 11. ATTACHING THE GILDED BALL AND GREEK CROSS
ORNAMENTS TO THE PEDESTALS

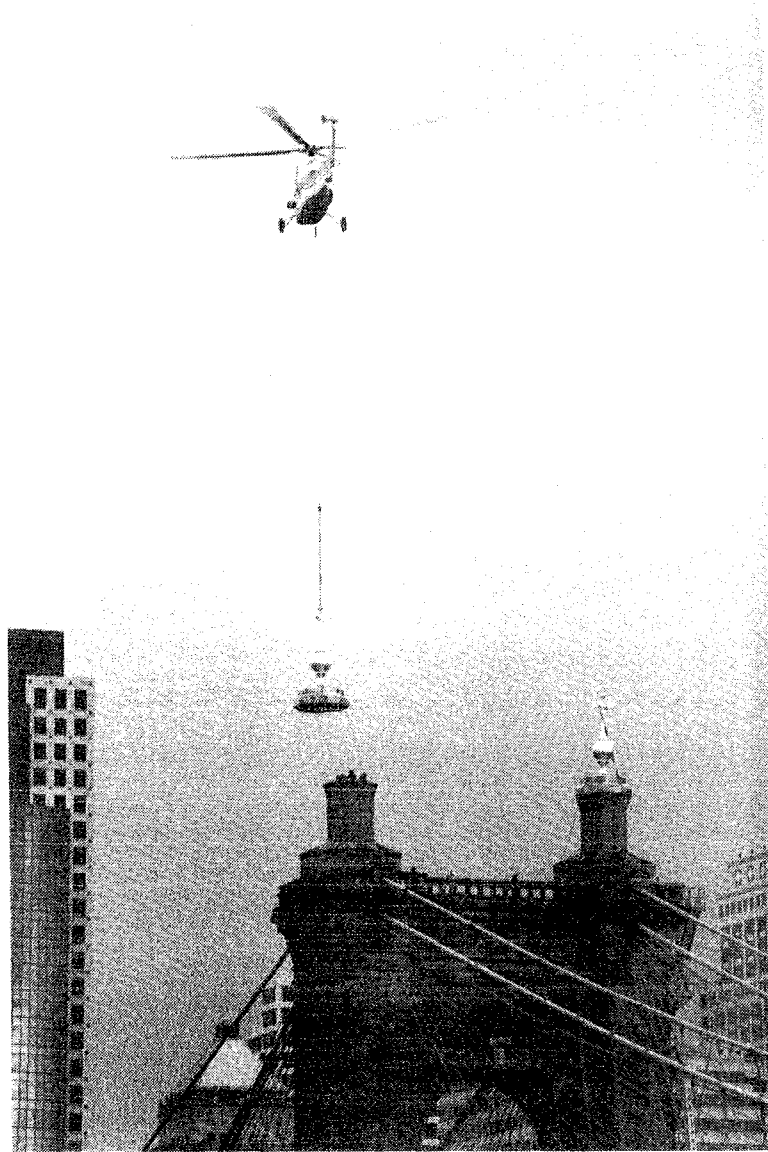
FIGURE 12. LIFTING THE ORNAMENTS IN PLACE BY HELICOPTER

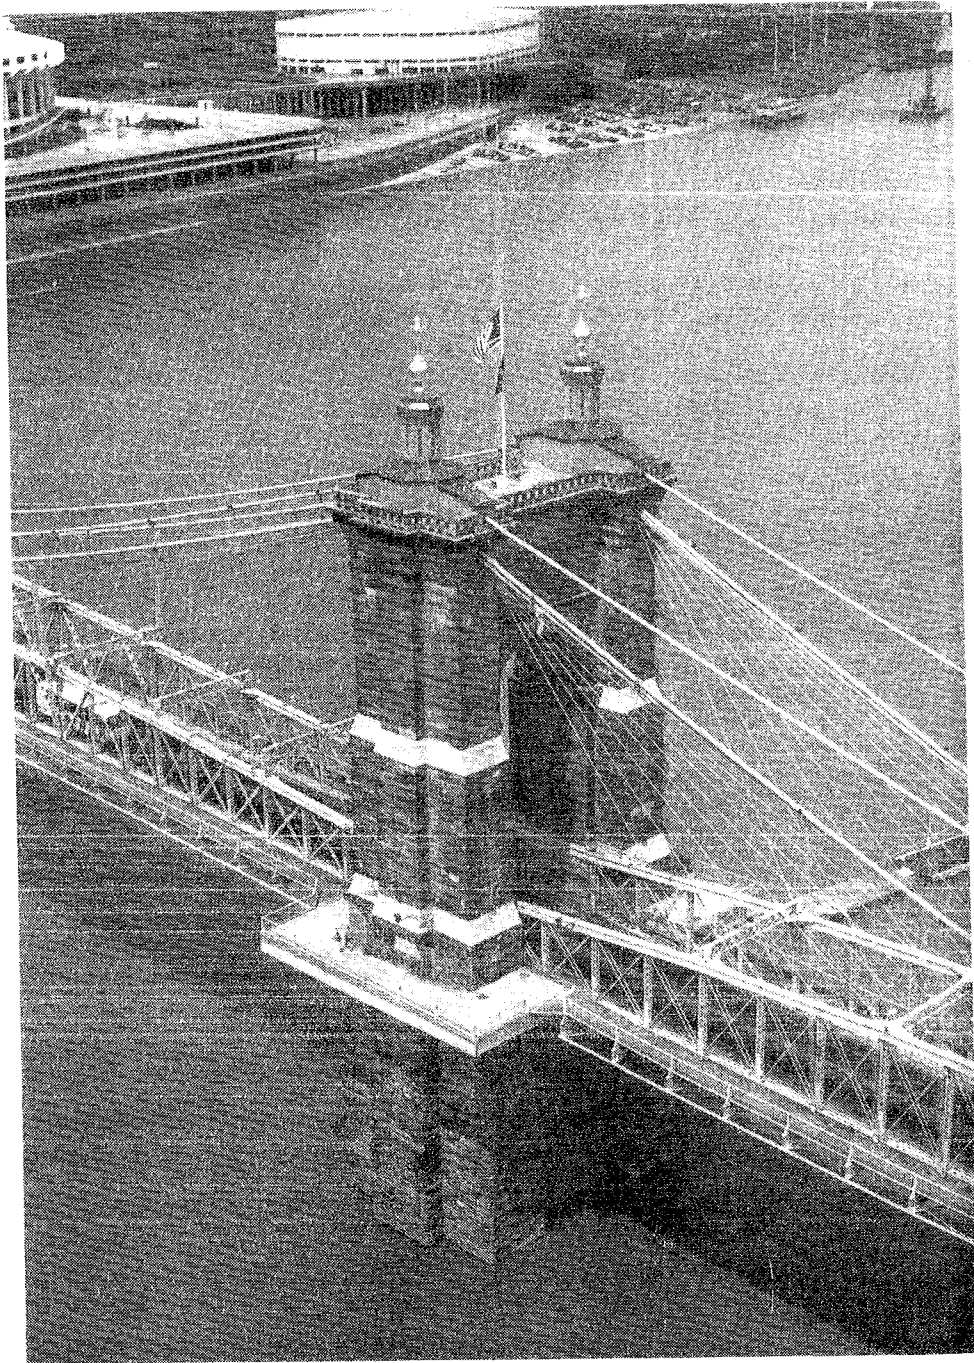
At the time of this writing, the Suspender Replacement Plans (Contract I and the Repair Plans (Contract II) are completed. The Masonry Restoration Plans (Contract III) is nearly finished (Figure 17); and the Anchorage Restoration Plans (Contract V) and Dramatic Lighting and Ornamental Fencing Plans Contract (Contract VI) are well underway. The second set of Repair Plans (Contract IV) will be bid in late summer.

FIGURE 17. AERIAL VIEW OF THE RESTORED COVINGTON TOWER,
JUNE 12, 1992
