County of Simcoe

**Replacement of Collingwood Street Bridge
(Structure No. 000141)
on Collingwood Street over the Mad River
Municipal Class Environmental Assessment
Study Completion Report**

AECOM

January 2012

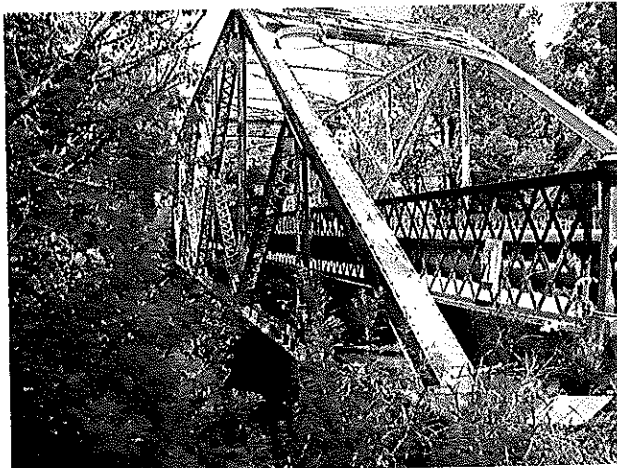
West Elevation.

Element Group:	Overall Structure				Length:	N/A	
Element Name:	Structure				Width:	N/A	
Location:	Single Element				Height:	N/A	
Material:	Any				Count:	N/A	
Element Type:	Bridge				Total Quantity:	1	
Environment:	Severe				Limited Inspection	<input type="checkbox"/>	
Protection System:	See Individual Elements					Performance Deficiencies	Maintenance Needs
Condition Data:	Units	Exc.	Good	Fair	Poor	01	17
	count	0	0.4	0.34	0.26		
Comments:	The structure is in partial poor condition and replacement is recommended. Replacement will also eliminate road constriction and load limitation.						
Urgency:	None <input type="checkbox"/>	6-10 years <input type="checkbox"/>	1-5 years <input type="checkbox"/>	< 1 year <input type="checkbox"/>	Urgent <input checked="" type="checkbox"/>		
Recommended Work:	Defer to Element Level

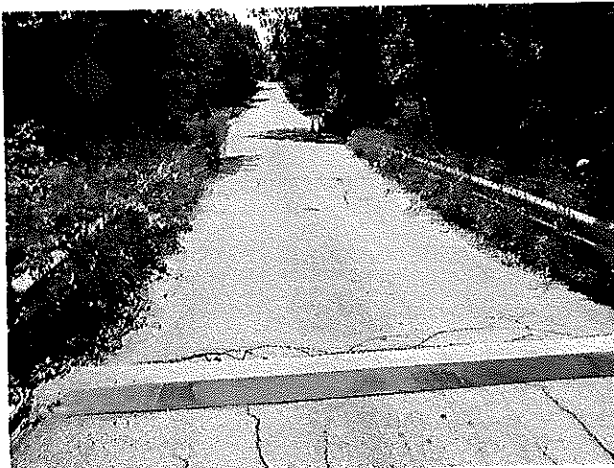
South Approach.

Element Group:	South Approach				Length:	N/A	
Element Name:	Approach				Width:	N/A	
Location:	Single Element				Height:	N/A	
Material:	Asphalt				Count:	N/A	
Element Type:	Primary Element				Total Quantity:	24	
Environment:	Severe				Limited Inspection	<input type="checkbox"/>	
Protection System:	None				Performance Deficiencies	Maintenance Needs	
Condition Data:	Units	Exc.	Good	Fair			
	tonnes	0	20.16	1.92	1.92	16	17
Comments:	Wearing surface will undergo ancillary replacement.						
Urgency :	None <input type="checkbox"/>	6-10 years <input type="checkbox"/>	1-5 years <input checked="" type="checkbox"/>	< 1 year <input type="checkbox"/>	Urgent <input type="checkbox"/>		
Recommended Work :	Ancillary Replacement				Estimated Cost: \$4,148

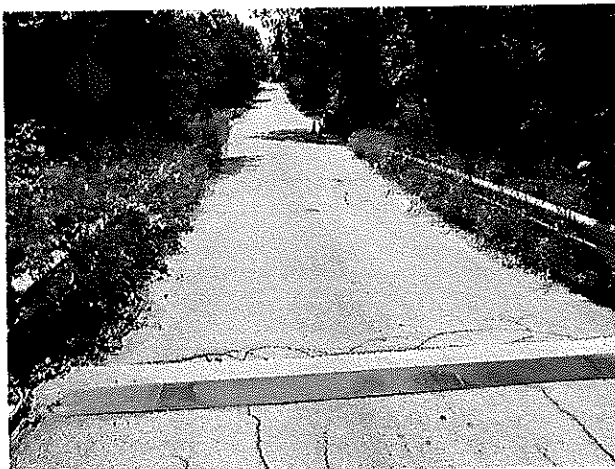
South Approach.

Element Group:	South Approach				Length:	6	
Element Name:	Slab				Width:	4.4	
Location:	Single Element				Height:	0.3	
Material:	Asphalt				Count:	1	
Element Type:	Any				Total Quantity:	26.4	
Environment:	Severe				Limited Inspection	<input checked="" type="checkbox"/>	
Protection System:	None				Performance Deficiencies	Maintenance Needs	
Condition Data:	Units	Exc.	Good	Fair			
	m2	0	26.4	0	0	00	00
Comments:	None						
Urgency:	None <input type="checkbox"/>	6-10 years <input checked="" type="checkbox"/>	1-5 years <input type="checkbox"/>	< 1 year <input type="checkbox"/>	Urgent <input type="checkbox"/>		
Recommended Work:	See Primary Element

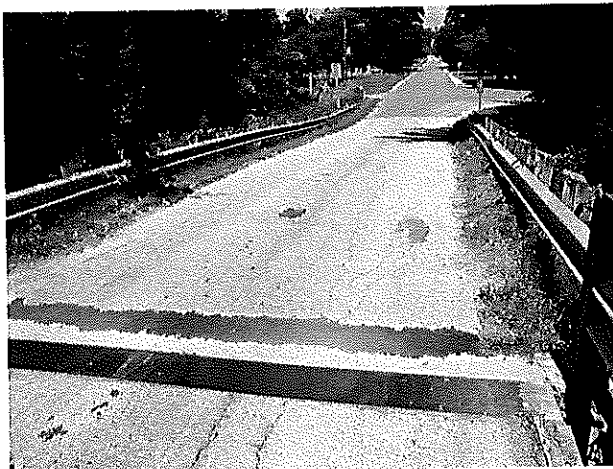
North Side.

Element Group:	North Approach				Length:	N/A	
Element Name:	Approach				Width:	N/A	
Location:	Single Element				Height:	N/A	
Material:	Asphalt				Count:	N/A	
Element Type:	Primary Element				Total Quantity:	24	
Environment:	Severe				Limited Inspection	<input type="checkbox"/>	
Protection System:	None				Performance Deficiencies	Maintenance Needs	
Condition Data:	Units	Exc.	Good	Fair			
	tonnes	0	15.6	8.4	0	16	17
Comments: Wearing surface will eventually need to be replaced.							
Urgency :	None <input type="checkbox"/>	6-10 years <input type="checkbox"/>	1-5 years <input checked="" type="checkbox"/>	< 1 year <input type="checkbox"/>	Urgent <input type="checkbox"/>		
Recommended Work :		Ancillary Replacement		Estimated Cost: \$4,148

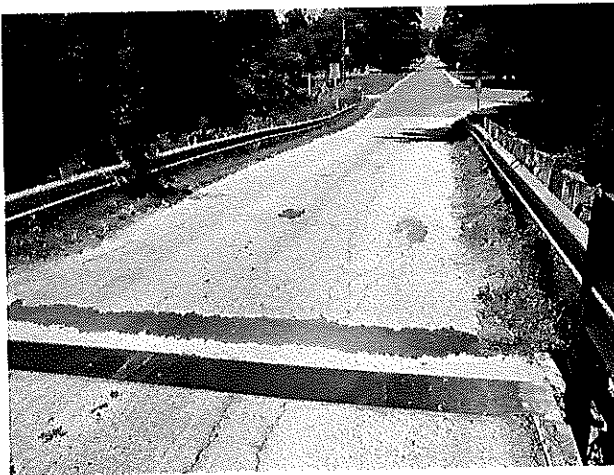
Element Group:	North Approach				Length:	6	
Element Name:	Slab				Width:	4.4	
Location:	Single Element				Height:	0.3	
Material:	Asphalt				Count:	1	
Element Type:	Any				Total Quantity:	26.4	
Environment:	Severe				Limited Inspection	<input checked="" type="checkbox"/>	
Protection System:	None				Performance Deficiencies	Maintenance Needs	
Condition Data:	Units	Exc.	Good	Fair			
	m2	0	26.4	0	0	00	00
Comments: None							
Urgency:	None <input type="checkbox"/>	6-10 years <input checked="" type="checkbox"/>	1-5 years <input type="checkbox"/>	< 1 year <input type="checkbox"/>	Urgent <input type="checkbox"/>		
Recommended Work: See Primary Element

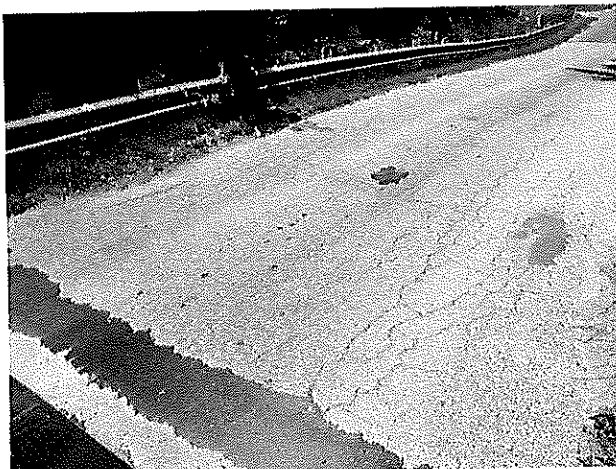
North Side.

Element Group:	North Approach				Length:	6	
Element Name:	Wearing Surface				Width:	4.4	
Location:	Single Element				Height:	0.08	
Material:	Asphalt				Count:	1	
Element Type:	Any				Total Quantity:	26.4	
Environment:	Severe				Limited Inspection	<input type="checkbox"/>	
Protection System:	None				Performance Deficiencies	Maintenance Needs	
Condition Data:	Units	Exc.	Good	Fair			
	m2	0	17.16	9.24	0	16	17
Comments:	Wearing surface will eventually need to be replaced.						
Urgency:	None <input type="checkbox"/>	6-10 years <input type="checkbox"/>	1-5 years <input checked="" type="checkbox"/>	< 1 year <input type="checkbox"/>	Urgent <input type="checkbox"/>		
Recommended Work:	See Primary Element

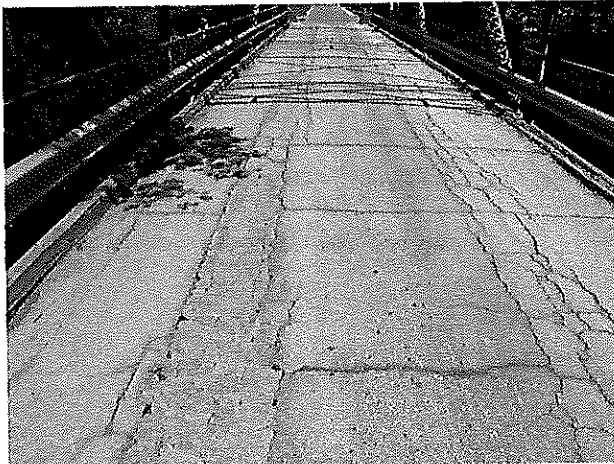
Overall View.

Element Group:	Wearing Surface				Length:	N/A	
Element Name:	Wearing Surface				Width:	N/A	
Location:	Single Element				Height:	N/A	
Material:	Asphalt				Count:	N/A	
Element Type:	Primary Element				Total Quantity:	25.5	
Environment:	Severe				Limited Inspection	<input type="checkbox"/>	
Protection System:	None				Performance Deficiencies	Maintenance Needs	
Condition Data:	Units	Exc.	Good	Fair	Poor	09	17
	tonnes	0	0	5.1	20.4		
Comments:	Wearing surface is in poor condition.						
Urgency:	None <input type="checkbox"/>	6-10 years <input type="checkbox"/>	1-5 years <input type="checkbox"/>	< 1 year <input type="checkbox"/>	Urgent <input checked="" type="checkbox"/>		
Recommended Work:	Replacement		Estimated Cost: \$15,706

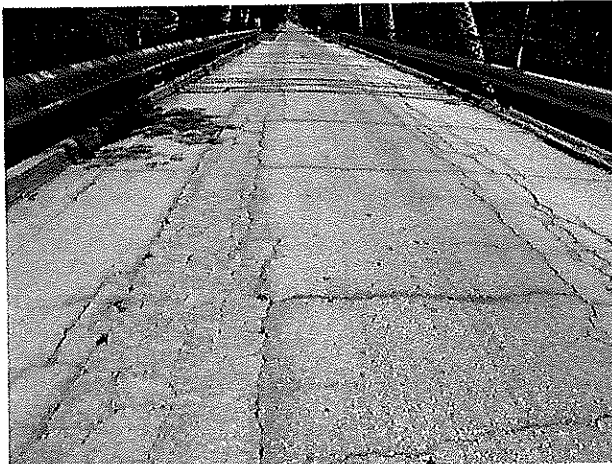
Element Group:	Wearing Surface				Length:	31.9	
Element Name:	Top Surface				Width:	4.4	
Location:	Single Element				Height:	0.08	
Material:	Asphalt				Count:	1	
Element Type:	Any				Total Quantity:	140.4	
Environment:	Severe				Limited Inspection	<input type="checkbox"/>	
Protection System:	None				Performance Deficiencies	Maintenance Needs	
Condition Data:	Units	Exc.	Good	Fair			
	m2	0	0	28.08	112.32	09	17
Comments:	Wearing surface is in poor condition.						
Urgency:	None <input type="checkbox"/>	6-10 years <input type="checkbox"/>	1-5 years <input type="checkbox"/>	< 1 year <input type="checkbox"/>	Urgent <input checked="" type="checkbox"/>		
Recommended Work:	See Primary Element

Top Surface. Showing poor condition.

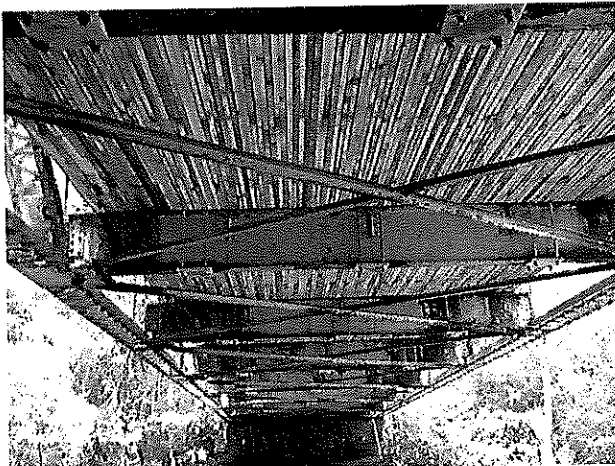
Underside View.

Element Group:	Deck				Length:	N/A	
Element Name:	Deck				Width:	N/A	
Location:	Single Element				Height:	N/A	
Material:	Timber				Count:	N/A	
Element Type:	Primary Element				Total Quantity:	20	
Environment:	Severe				Limited Inspection	<input type="checkbox"/>	
Protection System:	None				Performance Deficiencies	Maintenance Needs	
Condition Data:	Units	Exc.	Good	Fair			
	tonnes	0	20	0	0	00	00
Comments:	Taking into account the deterioration of the wearing surface the top of the deck may show some deterioration.						
Urgency :	None <input type="checkbox"/>	6-10 years <input checked="" type="checkbox"/>	1-5 years <input type="checkbox"/>	< 1 year <input type="checkbox"/>	Urgent <input type="checkbox"/>		
Recommended Work :	Ancillary Replacement				Estimated Cost: \$31,110

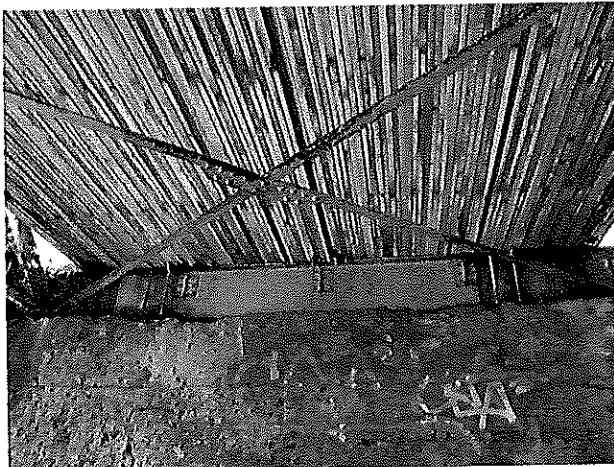
South End.

Element Group:	Deck				Length:	2.5	
Element Name:	End Soffit				Width:	4.7	
Location:	Single Element				Height:	N/A	
Material:	Timber				Count:	2	
Element Type:	Any				Total Quantity:	23.5	
Environment:	Severe				Limited Inspection	<input type="checkbox"/>	
Protection System:	None				Performance Deficiencies	Maintenance Needs	
Condition Data:	Units	Exc.	Good	Fair			
	m2	0	23.5	0	0	00	00
Comments:	None						
Urgency:	None <input checked="" type="checkbox"/>	6-10 years <input type="checkbox"/>	1-5 years <input type="checkbox"/>	<1 year <input type="checkbox"/>	Urgent <input type="checkbox"/>		
Recommended Work:	See Primary Element

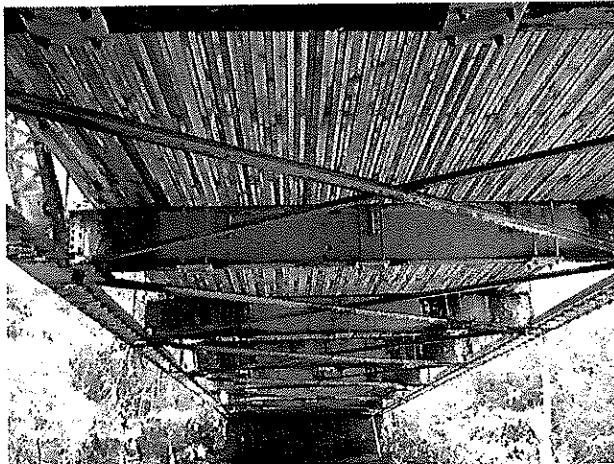
Underside View.

Element Group:	Deck				Length:	26.9	
Element Name:	Interior Soffit				Width:	4.7	
Location:	Single Element				Height:	N/A	
Material:	Timber				Count:	1	
Element Type:	Any				Total Quantity:	126.4	
Environment:	Severe				Limited Inspection	<input type="checkbox"/>	
Protection System:	None					Performance Deficiencies	Maintenance Needs
Condition Data:	Units	Exc.	Good	Fair	Poor		
	m2	0	126.4	0	0	00	00
Comments:	None						
Urgency :	None <input checked="" type="checkbox"/>	6-10 years <input type="checkbox"/>	1-5 years <input type="checkbox"/>	< 1 year <input type="checkbox"/>	Urgent <input type="checkbox"/>		
Recommended Work :	See Primary Element

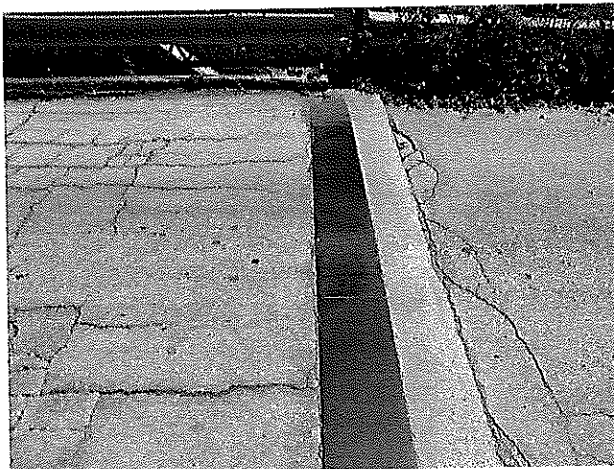
South Side.

Element Group:	South Transverse Joint				Length:	N/A	
Element Name:	Transverse Joint				Width:	N/A	
Location:	Single Element				Height:	N/A	
Material:	Any				Count:	N/A	
Element Type:	Finger Plate				Total Quantity:	4.4	
Environment:	Severe				Limited Inspection	<input type="checkbox"/>	
Protection System:	None				Performance Deficiencies	Maintenance Needs	
Condition Data:	Units	Exc.	Good	Fair			
	m	0	4.4	0	0	00	00
Comments: The steel plate shows light rusting and some light deterioration.							
Urgency:	None <input type="checkbox"/>	6-10 years <input checked="" type="checkbox"/>	1-5 years <input type="checkbox"/>	< 1 year <input type="checkbox"/>	Urgent <input type="checkbox"/>		
Recommended Work:		Ancillary Joint Elimination			Estimated Cost: \$6,084

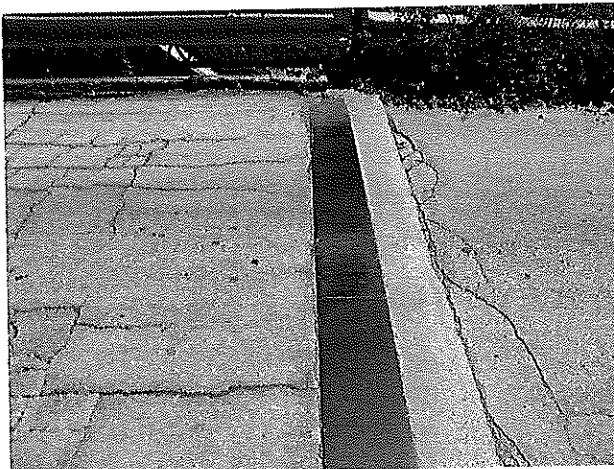
South Side.

Element Group:	South Transverse Joint				Length:	4.4	
Element Name:	Joint Armouring				Width:	N/A	
Location:	Single Element				Height:	N/A	
Material:	Steel				Count:	1	
Element Type:	Any				Total Quantity:	4.4	
Environment:	Severe				Limited Inspection	<input type="checkbox"/>	
Protection System:	None				Performance Deficiencies	Maintenance Needs	
Condition Data:	Units	Exc.	Good	Fair			
	m	0	4.4	0	0	00	00
Comments: The steel plate shows light rusting and some light deterioration.							
Urgency: None <input type="checkbox"/> 6-10 years <input checked="" type="checkbox"/> 1-5 years <input type="checkbox"/> <1 year <input type="checkbox"/> Urgent <input type="checkbox"/>							
Recommended Work: See Primary Element

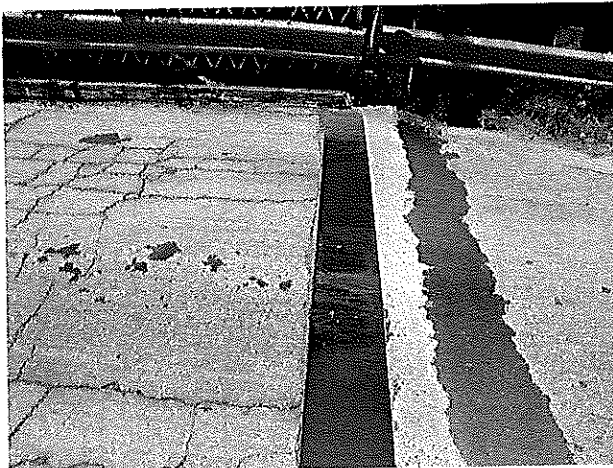
North Side.

Element Group:	North Transverse Joint				Length:	N/A	
Element Name:	Transverse Joint				Width:	N/A	
Location:	Single Element				Height:	N/A	
Material:	Any				Count:	N/A	
Element Type:	Finger Plate				Total Quantity:	4.4	
Environment:	Severe				Limited Inspection	<input type="checkbox"/>	
Protection System:	None				Performance Deficiencies	Maintenance Needs	
Condition Data:	Units	Exc.	Good	Fair			
	m	0	4.4	0	0	00	00
Comments:	The steel plate shows light rusting and some light deterioration.						
Urgency:	None <input type="checkbox"/>	6-10 years <input checked="" type="checkbox"/>	1-5 years <input type="checkbox"/>	< 1 year <input type="checkbox"/>	Urgent <input type="checkbox"/>		
Recommended Work:	Ancillary Joint Elimination				Estimated Cost: \$6,084

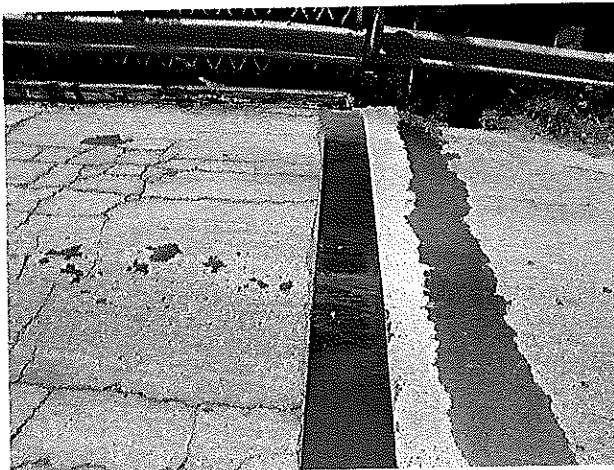
North Side.

Element Group:	North Transverse Joint				Length:	4.4	
Element Name:	Joint Armouring				Width:	N/A	
Location:	Single Element				Height:	N/A	
Material:	Steel				Count:	1	
Element Type:	Any				Total Quantity:	4.4	
Environment:	Severe				Limited Inspection	<input type="checkbox"/>	
Protection System:	None				Performance Deficiencies	Maintenance Needs	
Condition Data:	Units	Exc.	Good	Fair			
	m	0	4.4	0	0	00	00
Comments: The steel plate shows light rusting and some light deterioration.							
Urgency: None <input type="checkbox"/> 6-10 years <input checked="" type="checkbox"/> 1-5 years <input type="checkbox"/> < 1 year <input type="checkbox"/> Urgent <input type="checkbox"/>							
Recommended Work: See Primary Element

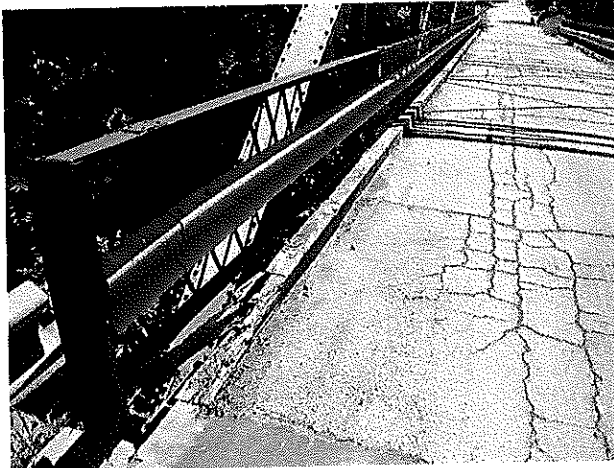
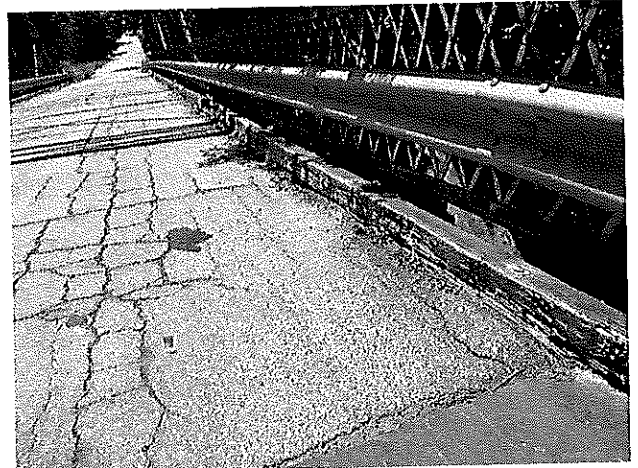
Element Group:	Sidewalk/Curb/Median				Length:	N/A	
Element Name:	Sidewalk/Curb/Median				Width:	N/A	
Location:	Single Element				Height:	N/A	
Material:	Timber				Count:	N/A	
Element Type:	Primary Element				Total Quantity:	1	
Environment:	Severe				Limited Inspection	<input type="checkbox"/>	
Protection System:	None				Performance Deficiencies	Maintenance Needs	
Condition Data:	Units	Exc.	Good	Fair			
	tonnes	0	0	0.5	0.5	16	17
Comments: Timber curbs show severe deterioration.							
Urgency: None <input type="checkbox"/> 6-10 years <input type="checkbox"/> 1-5 years <input type="checkbox"/> <1 year <input type="checkbox"/> Urgent <input checked="" type="checkbox"/>							
Recommended Work: Replacement Estimated Cost: \$2,514

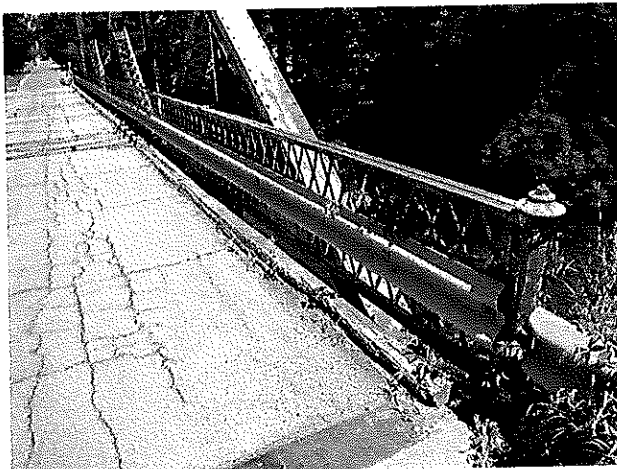
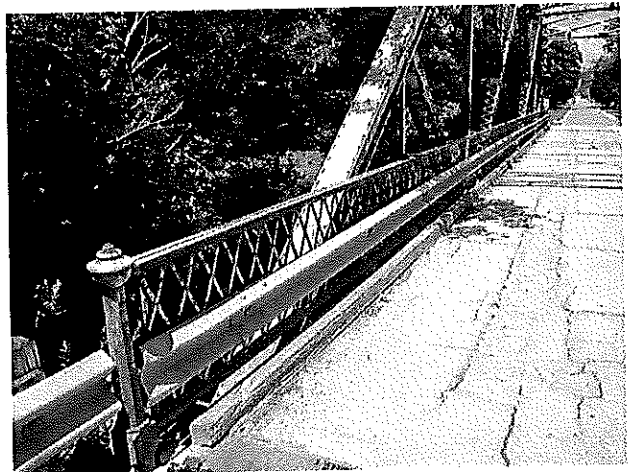
Element Group:	Barrier				Length:	N/A	
Element Name:	CentreBarrier				Width:	N/A	
Location:	Centre				Height:	N/A	
Material:	Steel				Count:	N/A	
Element Type:	Primary Element				Total Quantity:	3	
Environment:	Severe				Limited Inspection	<input type="checkbox"/>	
Protection System:	None					Performance Deficiencies	Maintenance Needs
Condition Data:	Units	Exc.	Good	Fair	Poor		
	tonnes	0	0	1.5	1.5	16	17
Comments:	The barrier is not CHBDC compliant.						
Urgency:	None <input type="checkbox"/>	6-10 years <input type="checkbox"/>	1-5 years <input type="checkbox"/>	< 1 year <input checked="" type="checkbox"/>	Urgent <input type="checkbox"/>		
Recommended Work:	Replacement		Estimated Cost: \$18,478

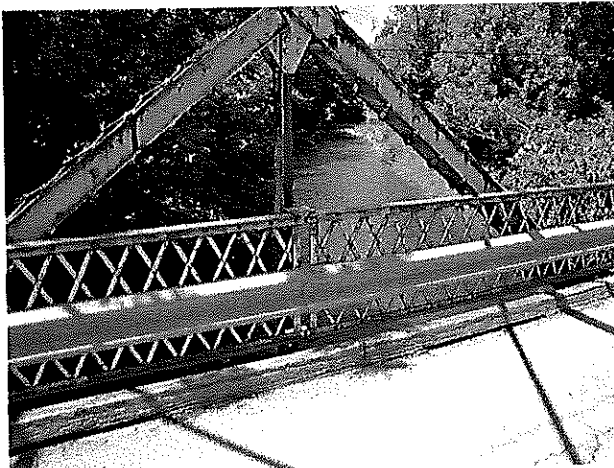
West Side.

Element Group:	Barrier				Length:	31.9	
Element Name:	Railing System				Width:	N/A	
Location:	Single Element				Height:	1	
Material:	Steel				Count:	2	
Element Type:	Any				Total Quantity:	63.8	
Environment:	Severe				Limited Inspection	<input type="checkbox"/>	
Protection System:	None				Performance Deficiencies	Maintenance Needs	
Condition Data:	Units	Exc.	Good	Fair			
	m	0	31.9	31.9	0	16	17
Comments:	The exterior barrier shows light to medium corrosion and is loose.						
Urgency:	None <input type="checkbox"/>	6-10 years <input type="checkbox"/>	1-5 years <input checked="" type="checkbox"/>	< 1 year <input type="checkbox"/>	Urgent <input type="checkbox"/>		
Recommended Work:	See Primary Element

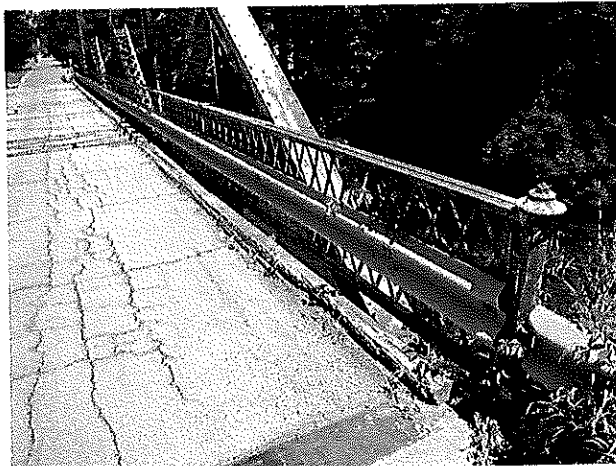
East Side.

Element Group:	Barrier				Length:	0.1	
Element Name:	Centre Posts				Width:	0.1	
Location:	Centre				Height:	1.1	
Material:	Steel				Count:	4	
Element Type:	Any				Total Quantity:	1.6	
Environment:	Severe				Limited Inspection	<input type="checkbox"/>	
Protection System:	None				Performance Deficiencies	Maintenance Needs	
Condition Data:	Units	Exc.	Good	Fair	Poor	01	17
	m2	0	0.82	0.62	0.16		
Comments:	There are 4 posts at the end of the truss and they are inclined, loose and showing light to medium corrosion.						
Urgency:	None <input type="checkbox"/>	6-10 years <input type="checkbox"/>	1-5 years <input checked="" type="checkbox"/>	< 1 year <input type="checkbox"/>	Urgent <input type="checkbox"/>		
Recommended Work:	See Primary Element

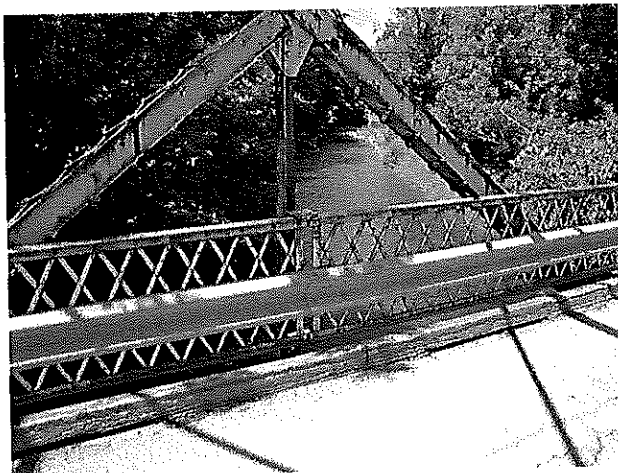
West Side.

Element Group:	Barrier				Length:	31.9	
Element Name:	Interior Railing System				Width:	N/A	
Location:	Interior				Height:	0.75	
Material:	Steel				Count:	2	
Element Type:	Any				Total Quantity:	63.8	
Environment:	Severe				Limited Inspection	<input type="checkbox"/>	
Protection System:	None				Performance Deficiencies	Maintenance Needs	
Condition Data:	Units	Exc.	Good	Fair			
	m	0	63.8	0	0	00	00
Comments:	None						
Urgency:	None <input type="checkbox"/>	6-10 years <input checked="" type="checkbox"/>	1-5 years <input type="checkbox"/>	< 1 year <input type="checkbox"/>	Urgent <input type="checkbox"/>		
Recommended Work:	See Primary Element

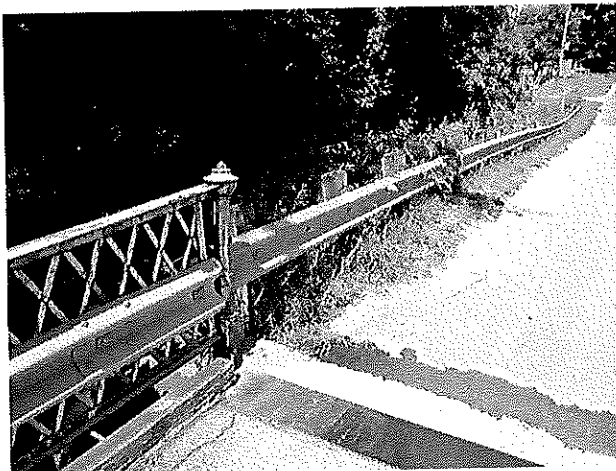
Northwest Side.

Element Group:	Barrier				Length:	N/A	
Element Name:	ExteriorBarrier				Width:	N/A	
Location:	Exterior				Height:	N/A	
Material:	Composite				Count:	N/A	
Element Type:	Primary Element				Total Quantity:	1.5	
Environment:	Severe				Limited Inspection	<input type="checkbox"/>	
Protection System:	None					Performance Deficiencies	Maintenance Needs
Condition Data:	Units	Exc.	Good	Fair	Poor		
	tonnes	0	1.5	0	0	00	00
Comments:	None						
Urgency:	None <input type="checkbox"/>	6-10 years <input checked="" type="checkbox"/>	1-5 years <input type="checkbox"/>	< 1 year <input type="checkbox"/>	Urgent <input type="checkbox"/>		
Recommended Work:	Ancillary Replacement				Estimated Cost: \$2,514

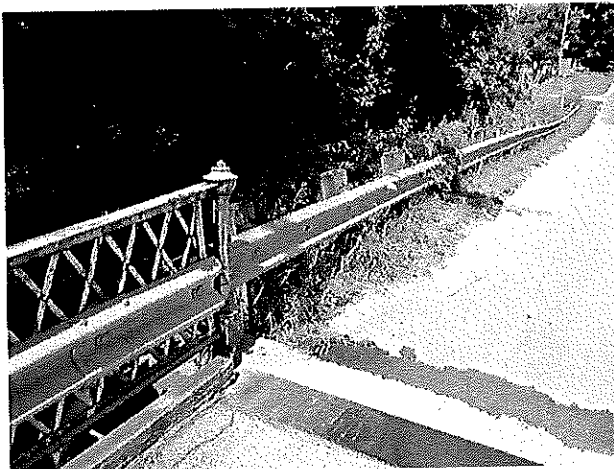
Northwest Side.

Element Group:	Barrier				Length:	0.21	
Element Name:	Posts				Width:	0.21	
Location:	Single Element				Height:	1.5	
Material:	Timber				Count:	24	
Element Type:	Any				Total Quantity:	30.2	
Environment:	Severe				Limited Inspection	<input type="checkbox"/>	
Protection System:	None				Performance Deficiencies	Maintenance Needs	
Condition Data:	Units	Exc.	Good	Fair			
	m2	0	30.2	0	0	00	00
Comments: None							
Urgency : None <input type="checkbox"/> 6-10 years <input checked="" type="checkbox"/> 1-5 years <input type="checkbox"/> < 1 year <input type="checkbox"/> Urgent <input type="checkbox"/>							
Recommended Work : See Primary Element

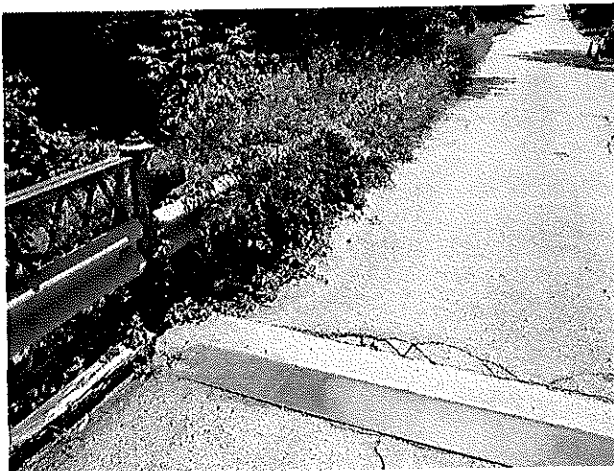
Southeast Side.

Element Group:	Barrier				Length:	6	
Element Name:	Railing System				Width:	N/A	
Location:	Single Element				Height:	0.75	
Material:	Steel				Count:	4	
Element Type:	Any				Total Quantity:	24	
Environment:	Severe				Limited Inspection	<input type="checkbox"/>	
Protection System:	None				Performance Deficiencies	Maintenance Needs	
Condition Data:	Units	Exc.	Good	Fair			
	m	0	24	0	0	00	00
Comments:	None						
Urgency :	None <input type="checkbox"/>	6-10 years <input checked="" type="checkbox"/>	1-5 years <input type="checkbox"/>	<1 year <input type="checkbox"/>	Urgent <input type="checkbox"/>		
Recommended Work :	See Primary Element

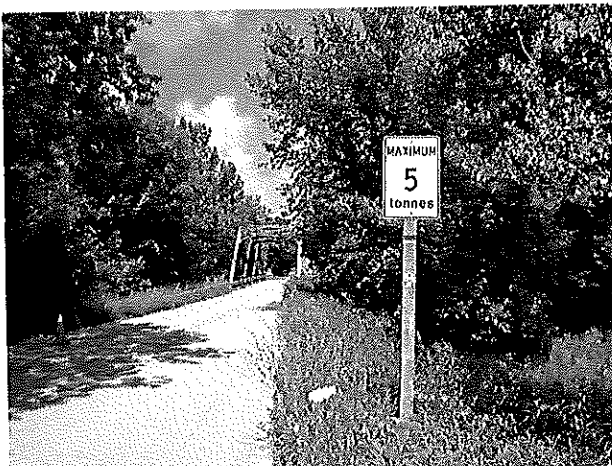
South Side.

Element Group:	Signage					Length:	N/A	
Element Name:	Signage					Width:	N/A	
Location:	Single Element					Height:	N/A	
Material:	Steel					Count:	3	
Element Type:	Primary Element					Total Quantity:	3	
Environment:	Severe					Limited Inspection	<input type="checkbox"/>	
Protection System:	None					Performance Deficiencies	Maintenance Needs	
Condition Data:	Units	Exc.	Good	Fair	Poor			
	all	0	3	0	0	16	17	
Comments:	There are 2 signs indicating the load limit and just one sign indicating the existence of one lane. Single lane bridge sign should be installed at the north end.							
Urgency:	None <input type="checkbox"/>	6-10 years <input type="checkbox"/>	1-5 years <input type="checkbox"/>	< 1 year <input type="checkbox"/>	Urgent <input checked="" type="checkbox"/>			
Recommended Work:	Ancillary Replacement					Estimated Cost: \$2,350

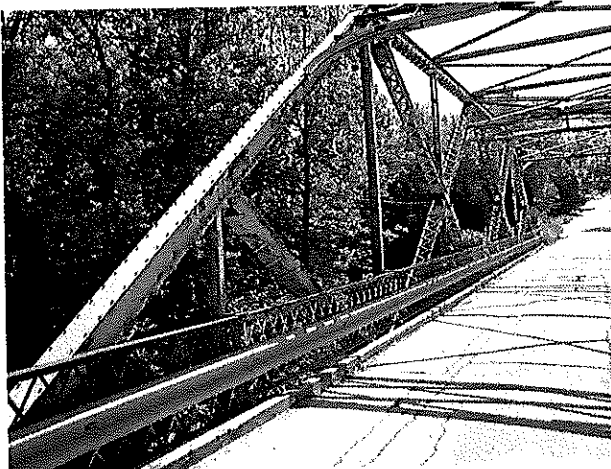
East Side.

Element Group:	Truss				Length:	N/A	
Element Name:	Truss				Width:	N/A	
Location:	Single Element				Height:	N/A	
Material:	Steel				Count:	N/A	
Element Type:	Primary Element				Total Quantity:	18.6	
Environment:	Severe				Limited Inspection	<input type="checkbox"/>	
Protection System:	None				Performance Deficiencies	Maintenance Needs	
Condition Data:	Units	Exc.	Good	Fair			
	tonnes	0	13.02	4.65	0.93	01	17
Comments:	Steel elements show light to medium corrosion and isolated severe to very severe corrosion especially affecting the underside.						
Urgency:	None <input type="checkbox"/>	6-10 years <input type="checkbox"/>	1-5 years <input checked="" type="checkbox"/>	<1 year <input type="checkbox"/>	Urgent <input type="checkbox"/>		
Recommended Work:	Ancillary Replacement				Estimated Cost: \$202,531

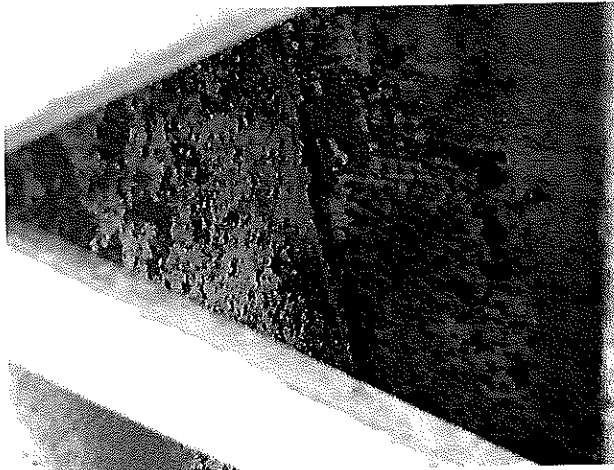
Interior View.

Element Group:	Truss				Length:	36.9	
Element Name:	Top Chords				Width:	0.3	
Location:	Single Element				Height:	0.22	
Material:	Steel				Count:	2	
Element Type:	Any				Total Quantity:	173.4	
Environment:	Severe				Limited Inspection	<input type="checkbox"/>	
Protection System:	None				Performance Deficiencies	Maintenance Needs	
Condition Data:	Units	Exc.	Good	Fair	Poor	00	17
	m2	0	140.45	26.01	6.94		
Comments:	Top chords show light to medium corrosion and isolated severe corrosion and especially around connections and on the underside.						
Urgency:	None <input type="checkbox"/>		6-10 years <input checked="" type="checkbox"/>		1-5 years <input type="checkbox"/>		< 1 year <input type="checkbox"/> Urgent <input type="checkbox"/>
Recommended Work:	See Primary Element

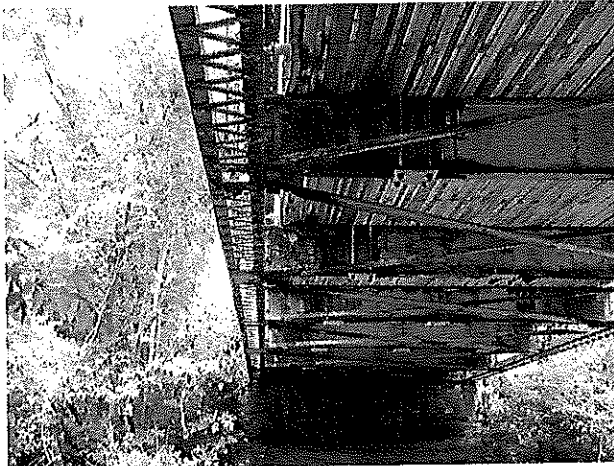
Overall View.

Element Group:	Truss				Length:	31.9	
Element Name:	Bottom Chords				Width:	0.22	
Location:	Single Element				Height:	0.17	
Material:	Steel				Count:	2	
Element Type:	Any				Total Quantity:	89.5	
Environment:	Severe				Limited Inspection	<input checked="" type="checkbox"/>	
Protection System:	None				Performance Deficiencies	Maintenance Needs	
Condition Data:	Units	Exc.	Good	Fair	Poor	00	00
	N/A	0	72.5	13.42	3.58		
Comments:	Bottom chords show light to medium corrosion on approximate half of the total surface and isolated severe corrosion and especially around connections and at the ends.						
Urgency:	None <input type="checkbox"/>	6-10 years <input checked="" type="checkbox"/>	1-5 years <input type="checkbox"/>	< 1 year <input type="checkbox"/>	Urgent <input type="checkbox"/>		
Recommended Work:	See Primary Element

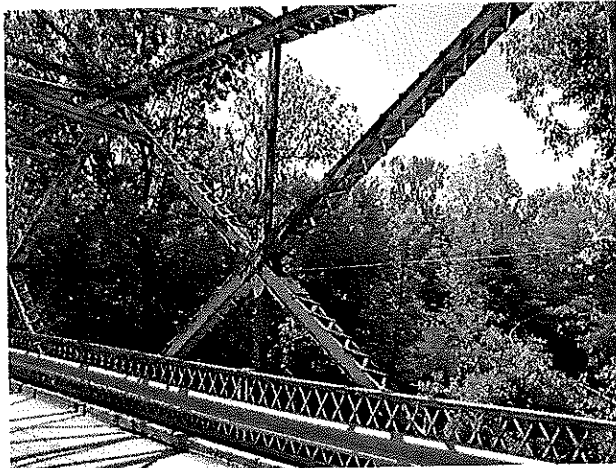
East Side.

Element Group:	Truss				Length:	0.06	
Element Name:	Verticals				Width:	0.13	
Location:	Single Element				Height:	5.29	
Material:	Steel				Count:	12	
Element Type:	Any				Total Quantity:	80	
Environment:	Severe				Limited Inspection	<input type="checkbox"/>	
Protection System:	None				Performance Deficiencies	Maintenance Needs	
Condition Data:	Units	Exc.	Good	Fair	Poor	00	17
	m2	0	65.6	12	2.4		
Comments:	Verticals show light to medium corrosion on approximate half of the total surface and isolated severe corrosion. One vertical on the east side shows light collision damage.						
Urgency:	None <input type="checkbox"/>		6-10 years <input checked="" type="checkbox"/>		1-5 years <input type="checkbox"/>		< 1 year <input type="checkbox"/>
Recommended Work:	See Primary Element

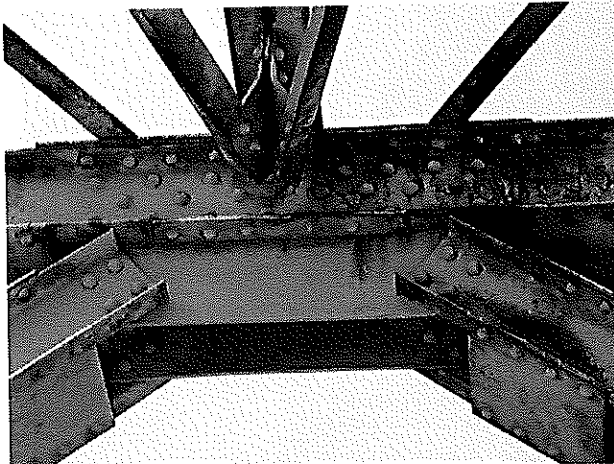
Top Side.

Element Group:	Truss				Length:	N/A	
Element Name:	Connections				Width:	N/A	
Location:	Single Element				Height:	N/A	
Material:	High Strength Steel				Count:	36	
Element Type:	Riveted				Total Quantity:	36	
Environment:	Severe				Limited Inspection	<input checked="" type="checkbox"/>	
Protection System:	None				Performance Deficiencies	Maintenance Needs	
Condition Data:	Units	Exc.	Good	Fair			
	each	0	26.64	7.2	2.16	01	17
Comments:	Steel elements show light to medium corrosion and isolated severe corrosion of the rivets on the underside of the truss and this may affect the load carrying capacity.						
Urgency:	None <input type="checkbox"/>	6-10 years <input type="checkbox"/>	1-5 years <input type="checkbox"/>	< 1 year <input checked="" type="checkbox"/>	Urgent <input type="checkbox"/>		
Recommended Work:	See Primary Element

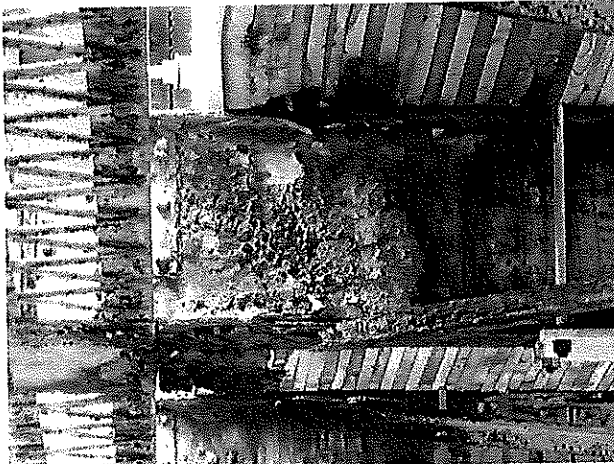
Element Group:	Floor Beams				Length:	4.7	
Element Name:	Intermediate Floor Beams				Width:	0.17	
Location:	Single Element				Height:	0.51	
Material:	Steel				Count:	9	
Element Type:	Any				Total Quantity:	65	
Environment:	Severe				Limited Inspection	<input checked="" type="checkbox"/>	
Protection System:	None				Performance Deficiencies	Maintenance Needs	
Condition Data:	Units	Exc.	Good	Fair			
	m2	0	32.5	16.25	16.25	01	17
Comments:	The floor beams show severe to very severe corrosion concentrated at the end of the floor beams and load carrying capacity is affected. Structure evaluation is immediately required.						
Urgency :	None <input type="checkbox"/>	6-10 years <input type="checkbox"/>	1-5 years <input type="checkbox"/>	< 1 year <input type="checkbox"/>	Urgent <input checked="" type="checkbox"/>		
Recommended Work :	See Primary Element

. Showing very severe corrosion.

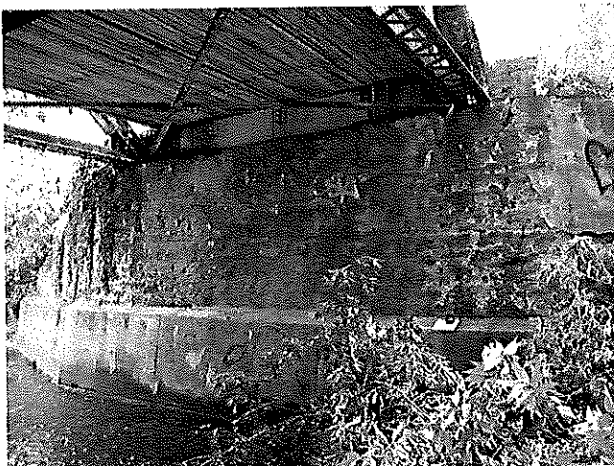
Element Group:	South Abutment				Length:	N/A	
Element Name:	Abutment				Width:	N/A	
Location:	Single Element				Height:	N/A	
Material:	Cast-In-Place Concrete				Count:	N/A	
Element Type:	Primary Element				Total Quantity:	194	
Environment:	Severe				Limited Inspection	<input type="checkbox"/>	
Protection System:	None				Performance Deficiencies	Maintenance Needs	
Condition Data:	Units	Exc.	Good	Fair			
	tonnes	0	19.4	77.6	97	16	17
Comments:	The abutment wall is in partial poor condition and will undergo replacement as a result of bridge widening.						
Urgency :	None <input type="checkbox"/>	6-10 years <input type="checkbox"/>	1-5 years <input type="checkbox"/>	< 1 year <input type="checkbox"/>	Urgent <input checked="" type="checkbox"/>		
Recommended Work :	Replacement				Estimated Cost: \$576,114

South Side. Showing deterioration.

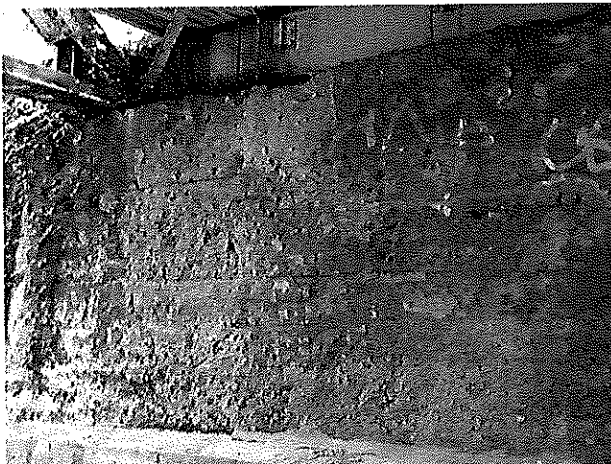
Element Group:	South Abutment				Length:	N/A	
Element Name:	Abutment Wall				Width:	6.7	
Location:	Single Element				Height:	2.2	
Material:	Cast-In-Place Concrete				Count:	1	
Element Type:	Any				Total Quantity:	14.7	
Environment:	Severe				Limited Inspection	<input type="checkbox"/>	
Protection System:	None					Performance Deficiencies	Maintenance Needs
Condition Data:	Units	Exc.	Good	Fair	Poor		
	m2	0	0	0	14.7	16	17
Comments: The abutment wall is in poor condition.							
Urgency :	None <input type="checkbox"/>	6-10 years <input type="checkbox"/>	1-5 years <input checked="" type="checkbox"/>	< 1 year <input type="checkbox"/>	Urgent <input type="checkbox"/>		
Recommended Work : See Primary Element

South Side. Showing extensive very severe scaling.

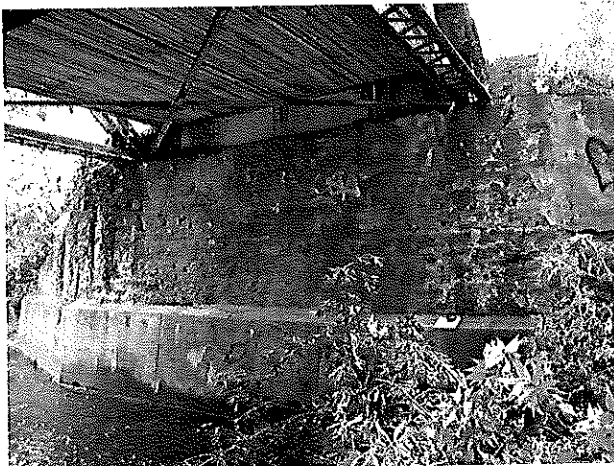
Element Group:	South Abutment				Length:	N/A	
Element Name:	Ballast Wall				Width:	6.7	
Location:	Single Element				Height:	0.8	
Material:	Cast-in-Place Concrete				Count:	1	
Element Type:	Any				Total Quantity:	5.4	
Environment:	Severe				Limited Inspection	<input checked="" type="checkbox"/>	
Protection System:	None				Performance Deficiencies	Maintenance Needs	
Condition Data:	Units	Exc.	Good	Fair			
	m2	0	2.7	1.35	1.35	16	17
Comments:	The ballast wall shows very severe scaling.						
Urgency :	None <input type="checkbox"/>	6-10 years <input type="checkbox"/>	1-5 years <input checked="" type="checkbox"/>	< 1 year <input type="checkbox"/>	Urgent <input type="checkbox"/>		
Recommended Work :	See Primary Element

. Showing very severe scaling.

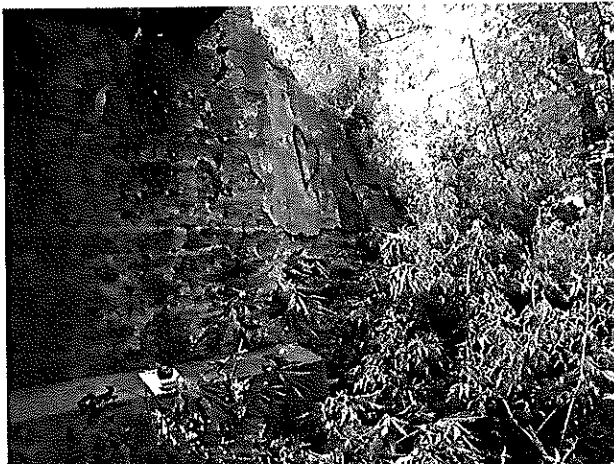
Element Group:	South Abutment				Length:	4	
Element Name:	West Wing Wall				Width:	N/A	
Location:	West				Height:	2	
Material:	Cast-In-Place Concrete				Count:	1	
Element Type:	Any				Total Quantity:	8	
Environment:	Severe				Limited Inspection	<input type="checkbox"/>	
Protection System:	None				Performance Deficiencies	Maintenance Needs	
Condition Data:	Units	Exc.	Good	Fair			
	m2	0	0	4	4	16	17
Comments:	The wing walls show very severe scaling which will further become very severe deterioration and will lead to loss of section.						
Urgency:	None <input type="checkbox"/>	6-10 years <input type="checkbox"/>	1-5 years <input checked="" type="checkbox"/>	< 1 year <input type="checkbox"/>	Urgent <input type="checkbox"/>		
Recommended Work:	See Primary Element

Southwest Side. Showing extensive very severe scaling.

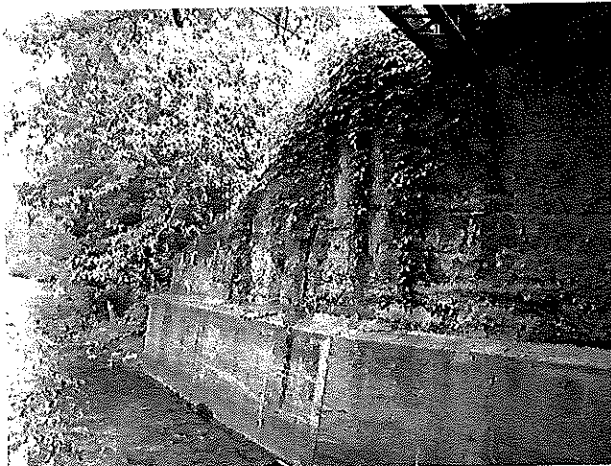
Element Group:	South Abutment				Length:	4	
Element Name:	East Wing Wall				Width:	N/A	
Location:	East				Height:	2	
Material:	Cast-In-Place Concrete				Count:	1	
Element Type:	Any				Total Quantity:	8	
Environment:	Severe				Limited Inspection	<input type="checkbox"/>	
Protection System:	None					Performance Deficiencies	Maintenance Needs
Condition Data:	Units	Exc.	Good	Fair	Poor		
	m2	0	4	2	2	16	17
Comments:	The wing walls show very severe scaling which will further become very severe deterioration and will lead to loss of section.						
Urgency :	None <input type="checkbox"/>	6-10 years <input type="checkbox"/>	1-5 years <input checked="" type="checkbox"/>	< 1 year <input type="checkbox"/>	Urgent <input type="checkbox"/>		
Recommended Work :	See Primary Element

Southeast Side. Showing very severe scaling.

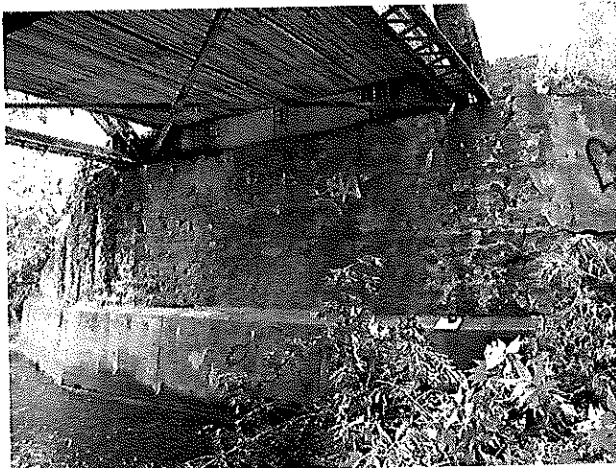
South End.

Element Group:	South Abutment				Length:	N/A	
Element Name:	Footing				Width:	N/A	
Location:	Single Element				Height:	N/A	
Material:	Cast-In-Place Concrete				Count:	N/A	
Element Type:	Any				Total Quantity:	30.5	
Environment:	Severe				Limited Inspection	<input type="checkbox"/>	
Protection System:	None					Performance Deficiencies	Maintenance Needs
Condition Data:	Units	Exc.	Good	Fair	Poor	00	17
	m2	0	26.23	3.05	1.22		
Comments: There are some isolated vertical cracks.							
Urgency :	None <input type="checkbox"/>	6-10 years <input checked="" type="checkbox"/>	1-5 years <input type="checkbox"/>	< 1 year <input type="checkbox"/>	Urgent <input type="checkbox"/>		
Recommended Work : See Primary Element

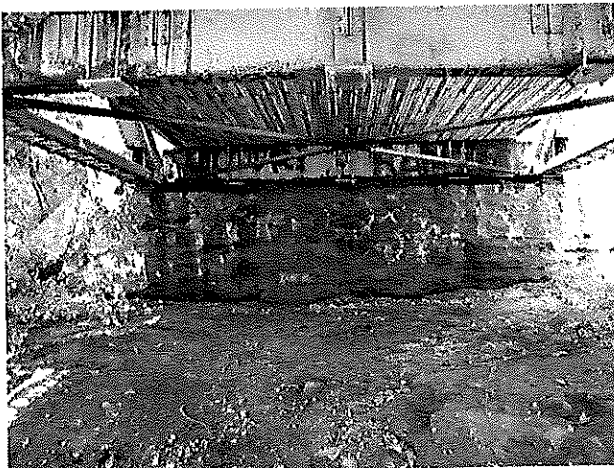
North Side.

Element Group:	North Abutment				Length:	N/A	
Element Name:	Abutment				Width:	N/A	
Location:	Single Element				Height:	N/A	
Material:	Cast-In-Place Concrete				Count:	N/A	
Element Type:	Primary Element				Total Quantity:	70	
Environment:	Severe				Limited Inspection	<input type="checkbox"/>	
Protection System:	None				Performance Deficiencies	Maintenance Needs	
Condition Data:	Units	Exc.	Good	Fair			
	tonnes	0	2.8	18.9	48.3	16	17
Comments:	The abutment wall is in partial poor condition and will undergo replacement as a result of bridge widening.						
Urgency :	None <input type="checkbox"/>	6-10 years <input type="checkbox"/>	1-5 years <input type="checkbox"/>	< 1 year <input type="checkbox"/>	Urgent <input checked="" type="checkbox"/>		
Recommended Work :	Replacement				Estimated Cost: \$144,359

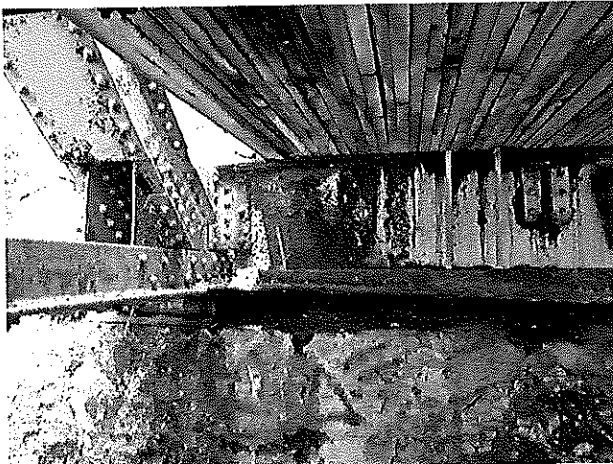
Element Group:	North Abutment				Length:	N/A	
Element Name:	Bearings				Width:	N/A	
Location:	Single Element				Height:	N/A	
Material:	Any				Count:	2	
Element Type:	Plate				Total Quantity:	2	
Environment:	Severe				Limited Inspection	<input checked="" type="checkbox"/>	
Protection System:	None				Performance Deficiencies	Maintenance Needs	
Condition Data:	Units	Exc.	Good	Fair			
	each	0	0	0	2	05	17
Comments: Bearings show severe to very severe corrosion.							
Urgency:	None <input type="checkbox"/>	6-10 years <input type="checkbox"/>	1-5 years <input type="checkbox"/>	< 1 year <input type="checkbox"/>	Urgent <input checked="" type="checkbox"/>		
Recommended Work: See Primary Element

Overall View. Showing severe corrosion.

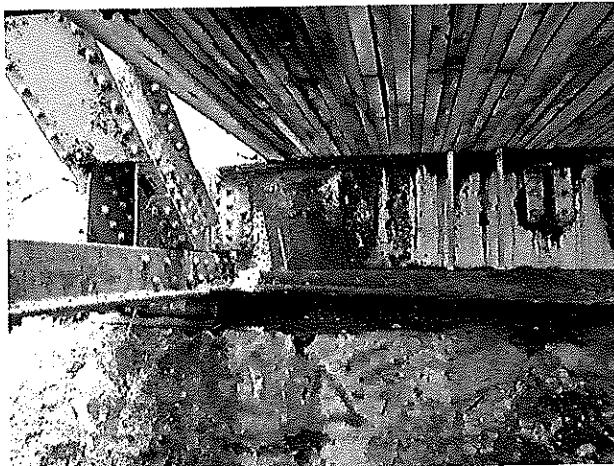
Overall View.

Element Group:	North Abutment				Length:	N/A	
Element Name:	Ballast Wall				Width:	6.7	
Location:	Single Element				Height:	0.8	
Material:	Cast-In-Place Concrete				Count:	1	
Element Type:	Any				Total Quantity:	5.4	
Environment:	Severe				Limited Inspection	<input checked="" type="checkbox"/>	
Protection System:	None					Performance Deficiencies	Maintenance Needs
Condition Data:	Units	Exc.	Good	Fair	Poor		
	m2	0	2.7	1.35	1.35	16	17
Comments: The ballast wall shows very severe scaling.							
Urgency :	None <input type="checkbox"/>	6-10 years <input type="checkbox"/>	1-5 years <input checked="" type="checkbox"/>	< 1 year <input type="checkbox"/>	Urgent <input type="checkbox"/>		
Recommended Work : See Primary Element

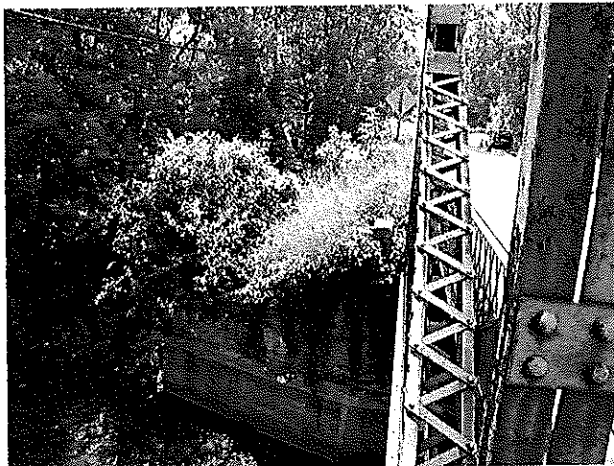
Southeast Side.

Element Group:	South Embankment				Length:	N/A	
Element Name:	Embankment				Width:	N/A	
Location:	Single Element				Height:	N/A	
Material:	Soil				Count:	1	
Element Type:	Primary Element				Total Quantity:	1	
Environment:	Severe				Limited Inspection	<input type="checkbox"/>	
Protection System:	None				Performance Deficiencies	Maintenance Needs	
Condition Data:	Units	Exc.	Good	Fair			
	all	0	0.9	0.1	0	00	17
Comments:	None						
Urgency :	None <input type="checkbox"/>	6-10 years <input checked="" type="checkbox"/>	1-5 years <input type="checkbox"/>	< 1 year <input type="checkbox"/>	Urgent <input type="checkbox"/>		
Recommended Work :	Ancillary Replacement			Estimated Cost: \$2,423

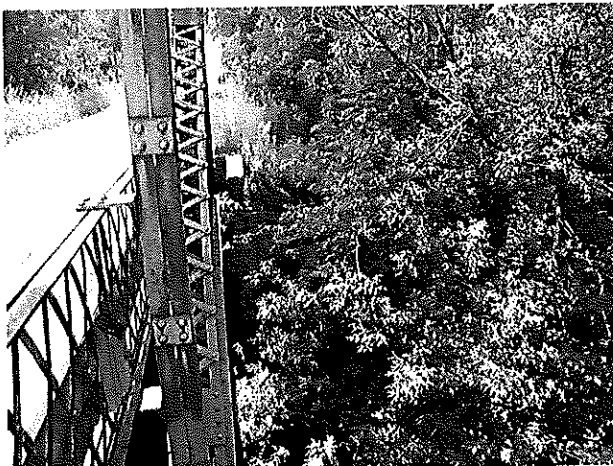
Southwest Side.

Element Group:	South Embankment				Length:	N/A	
Element Name:	Slope Protection				Width:	N/A	
Location:	Single Element				Height:	N/A	
Material:	Foliation				Count:	2	
Element Type:	Any				Total Quantity:	2	
Environment:	Severe				Limited Inspection	<input type="checkbox"/>	
Protection System:	None				Performance Deficiencies	Maintenance Needs	
Condition Data:	Units	Exc.	Good	Fair			
	all	0	1.6	0.4	0	00	17
Comments:	None						
Urgency :	None <input type="checkbox"/>	6-10 years <input checked="" type="checkbox"/>	1-5 years <input type="checkbox"/>	< 1 year <input type="checkbox"/>	Urgent <input type="checkbox"/>		
Recommended Work :	See Primary Element

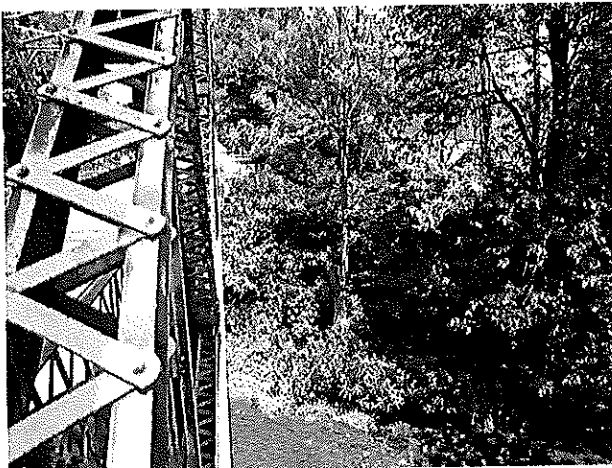
Northeast Side.

Element Group:	North Embankment				Length:	N/A	
Element Name:	Embankment				Width:	N/A	
Location:	Single Element				Height:	N/A	
Material:	Soil				Count:	1	
Element Type:	Primary Element				Total Quantity:	1	
Environment:	Severe				Limited Inspection	<input type="checkbox"/>	
Protection System:	None					Performance Deficiencies	Maintenance Needs
Condition Data:	Units	Exc.	Good	Fair	Poor		
	all	0	0.9	0.1	0	00	17
Comments:	None						
Urgency :	None <input type="checkbox"/>	6-10 years <input checked="" type="checkbox"/>	1-5 years <input type="checkbox"/>	< 1 year <input type="checkbox"/>	Urgent <input type="checkbox"/>		
Recommended Work :	Ancillary Replacement				Estimated Cost: \$2,423

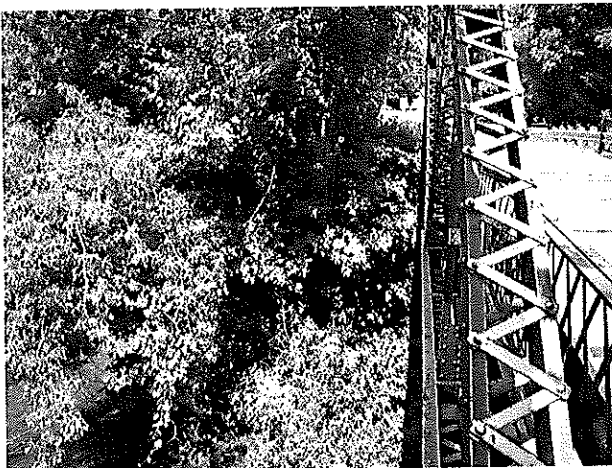
Northwest Side.

Element Group:	North Embankment				Length:	N/A	
Element Name:	Slope Protection				Width:	N/A	
Location:	Single Element				Height:	N/A	
Material:	Foliation				Count:	2	
Element Type:	Any				Total Quantity:	2	
Environment:	Severe				Limited Inspection	<input type="checkbox"/>	
Protection System:	None					Performance Deficiencies	Maintenance Needs
Condition Data:	Units	Exc.	Good	Fair	Poor		
	all	0	1.6	0.4	0	00	17
Comments:	None						
Urgency :	None <input type="checkbox"/>	6-10 years <input checked="" type="checkbox"/>	1-5 years <input type="checkbox"/>	< 1 year <input type="checkbox"/>	Urgent <input type="checkbox"/>		
Recommended Work :	See Primary Element
