County of Simcoe

**Replacement of Collingwood Street Bridge
(Structure No. 000141)
on Collingwood Street over the Mad River
Municipal Class Environmental Assessment
Study Completion Report**

AECOM

January 2012

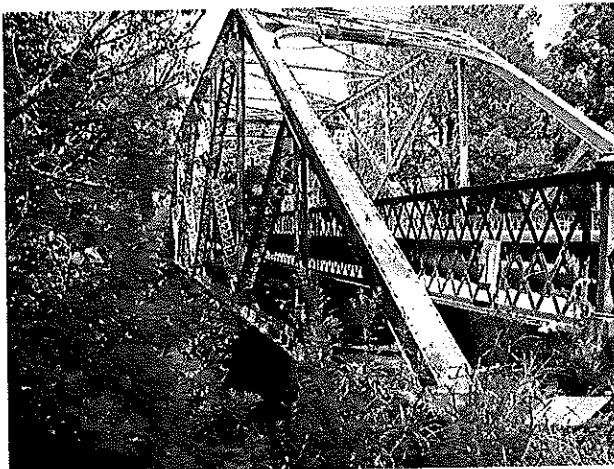
West Side.

Element Group:	Foundation				Length:	N/A	
Element Name:	Foundation				Width:	N/A	
Location:	Single Element				Height:	N/A	
Material:	Steel Piles				Count:	2	
Element Type:	Primary Element				Total Quantity:	2	
Environment:	Severe				Limited Inspection	<input checked="" type="checkbox"/>	
Protection System:	None				Performance Deficiencies	Maintenance Needs	
Condition Data:	Units	Exc.	Good	Fair			
	each	0	2	0	0	00	00
Comments:	None						
Urgency:	None <input type="checkbox"/>	6-10 years <input checked="" type="checkbox"/>	1-5 years <input type="checkbox"/>	< 1 year <input type="checkbox"/>	Urgent <input type="checkbox"/>		
Recommended Work :	Reinstallation		Estimated Cost: \$223,007

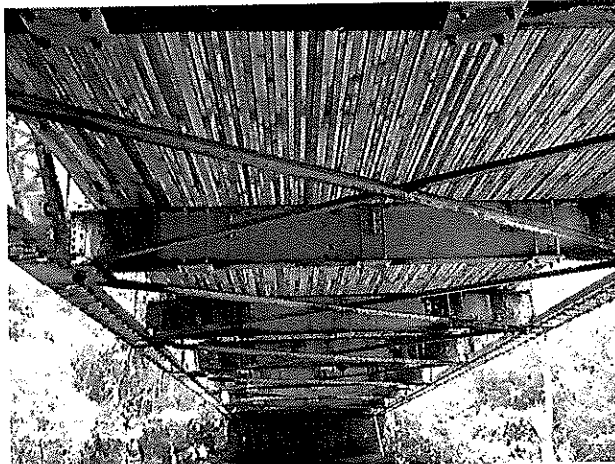
Element Group:	Coating				Length:	N/A	
Element Name:	Coating				Width:	N/A	
Location:	Single Element				Height:	N/A	
Material:	C Other				Count:	N/A	
Element Type:	Primary Element				Total Quantity:	575	
Environment:	Severe				Limited Inspection	<input type="checkbox"/>	
Protection System:	None				Performance Deficiencies	Maintenance Needs	
Condition Data:	Units	Exc.	Good	Fair			
	m2	0	46	69	460	16	17
Comments:	Coating is in poor condition.						
Urgency:	None <input type="checkbox"/>	6-10 years <input type="checkbox"/>	1-5 years <input type="checkbox"/>	< 1 year <input type="checkbox"/>	Urgent <input checked="" type="checkbox"/>		
Recommended Work:	Replacement		Estimated Cost: \$1,477,929

Underside View. Showing poor condition.

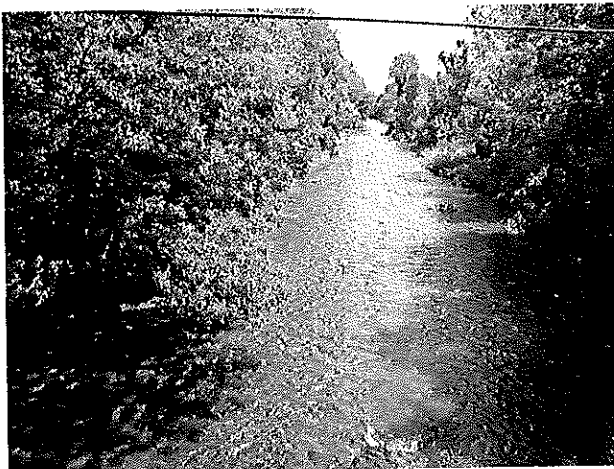
East Side.

Element Group:	Watercourse				Length:	N/A	
Element Name:	Watercourse				Width:	N/A	
Location:	Single Element				Height:	N/A	
Material:	Any				Count:	1	
Element Type:	Straight				Total Quantity:	1	
Environment:	Severe				Limited Inspection	<input type="checkbox"/>	
Protection System:	None					Performance Deficiencies	Maintenance Needs
Condition Data:	Units	Exc.	Good	Fair	Poor		
	all	0	1	0	0	00	00
Comments: None							
Urgency:	None <input checked="" type="checkbox"/>	6-10 years <input type="checkbox"/>	1-5 years <input type="checkbox"/>	< 1 year <input type="checkbox"/>	Urgent <input type="checkbox"/>		
Recommended Work: Defer to Element Level

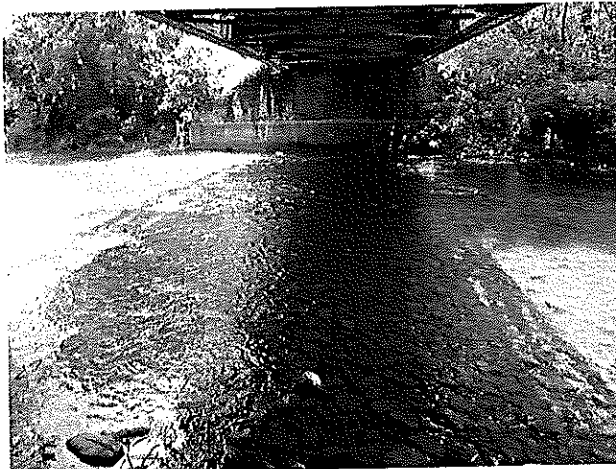
Overall View.

Element Group:	Watercourse				Length:	N/A	
Element Name:	Bottom				Width:	N/A	
Location:	Single Element				Height:	N/A	
Material:	Gravel				Count:	N/A	
Element Type:	Natural				Total Quantity:	150	
Environment:	Severe				Limited Inspection	<input type="checkbox"/>	
Protection System:	None				Performance Deficiencies	Maintenance Needs	
Condition Data:	Units	Exc.	Good	Fair			
	m2	0	150	0	0	00	00
Comments:	None						
Urgency:	None <input checked="" type="checkbox"/>	6-10 years <input type="checkbox"/>	1-5 years <input type="checkbox"/>	< 1 year <input type="checkbox"/>	Urgent <input type="checkbox"/>		
Recommended Work:	None

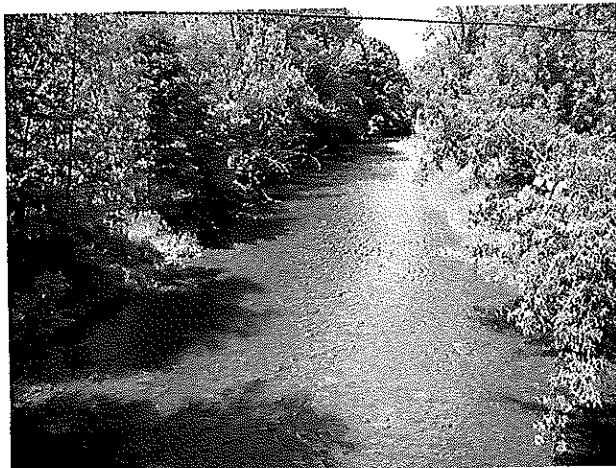
West Side.

Element Group:	Watercourse				Length:	N/A	
Element Name:	Upstream Section				Width:	N/A	
Location:	Single Element				Height:	N/A	
Material:	Gravel				Count:	N/A	
Element Type:	Uncontrolled				Total Quantity:	75	
Environment:	Severe				Limited Inspection	<input type="checkbox"/>	
Protection System:	None				Performance Deficiencies	Maintenance Needs	
Condition Data:	Units	Exc.	Good	Fair			
	m2	0	75	0	0	00	00
Comments:	None						
Urgency:	None <input checked="" type="checkbox"/>	6-10 years <input type="checkbox"/>	1-5 years <input type="checkbox"/>	< 1 year <input type="checkbox"/>	Urgent <input type="checkbox"/>		
Recommended Work:	None

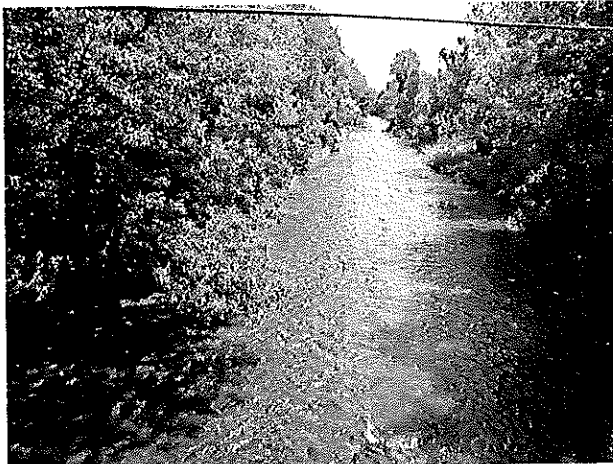
4.7.61 Watercourse - Downstream Section

Element Group:	Watercourse				Length:	N/A	
Element Name:	Downstream Section				Width:	N/A	
Location:	Single Element				Height:	N/A	
Material:	Gravel				Count:	N/A	
Element Type:	Uncontrolled				Total Quantity:	75	
Environment:	Severe				Limited Inspection	<input type="checkbox"/>	
Protection System:	None				Performance Deficiencies	Maintenance Needs	
Condition Data:	Units	Exc.	Good	Fair	Poor	00	00
	m2	0	75	0	0		
Comments:	None						
Urgency :	None <input checked="" type="checkbox"/>	6-10 years <input type="checkbox"/>	1-5 years <input type="checkbox"/>	< 1 year <input type="checkbox"/>	Urgent <input type="checkbox"/>		
Recommended Work :	None

Overall View.

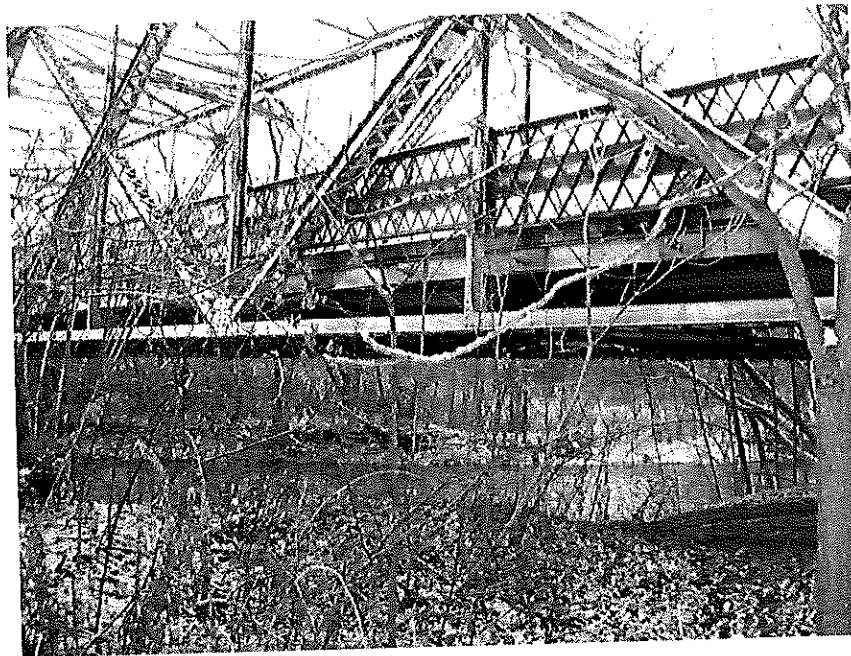
Plate 4 View from the West Side of the South Bank Abutment

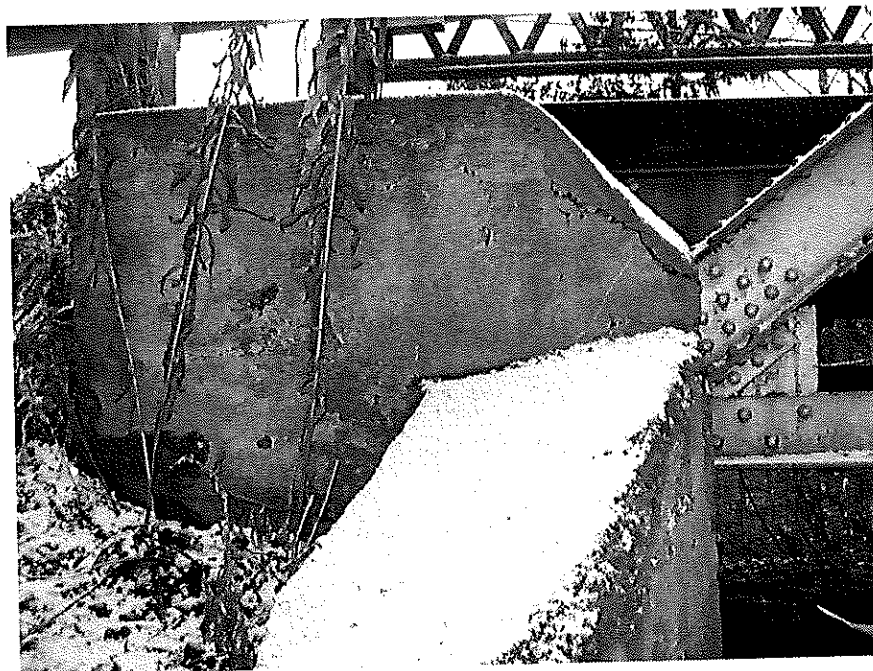
**Plate 6 Abutment and Wing Wall on the East Side of Collingwood Street Bridge
on the South Bank**

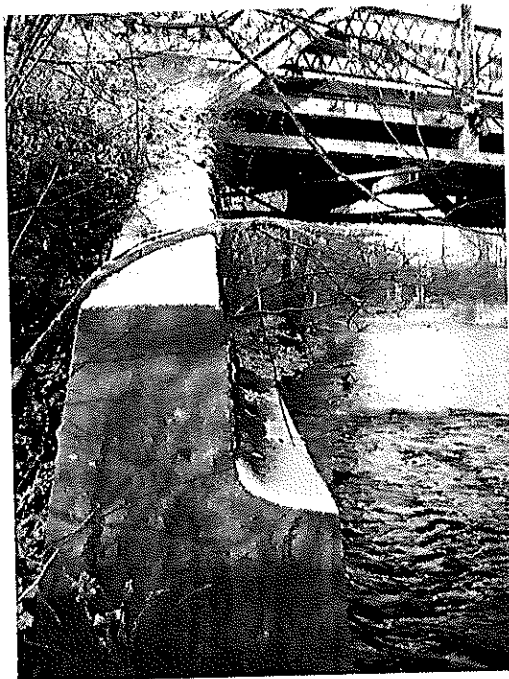
Plate 8 Abutment and Wing Wall on the West Side of Collingwood Street Bridge on the North Bank

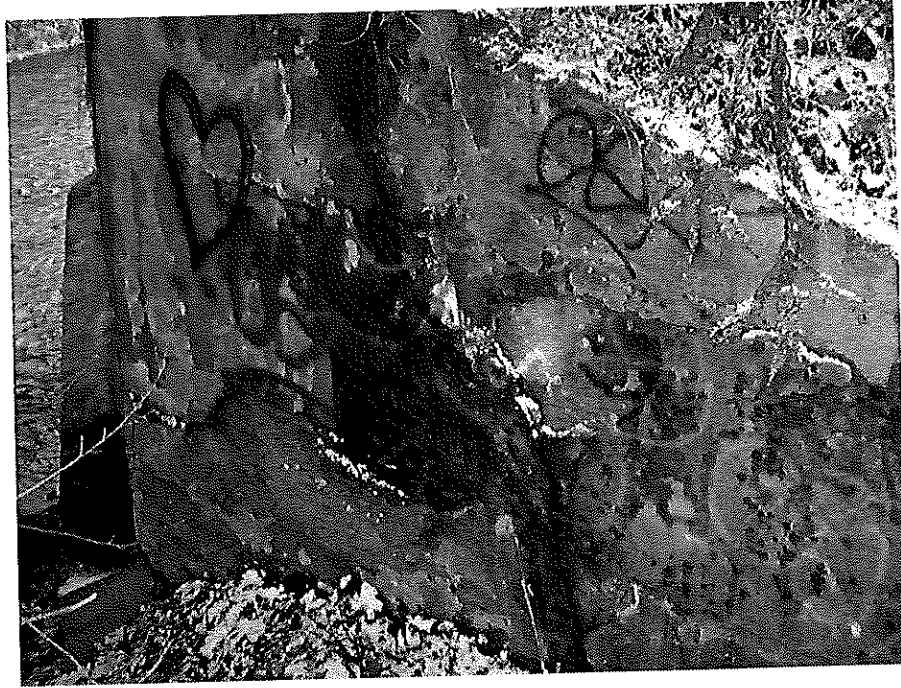
Plate 9 Wing Wall on the East Side of Collingwood Street Bridge on the North Bank

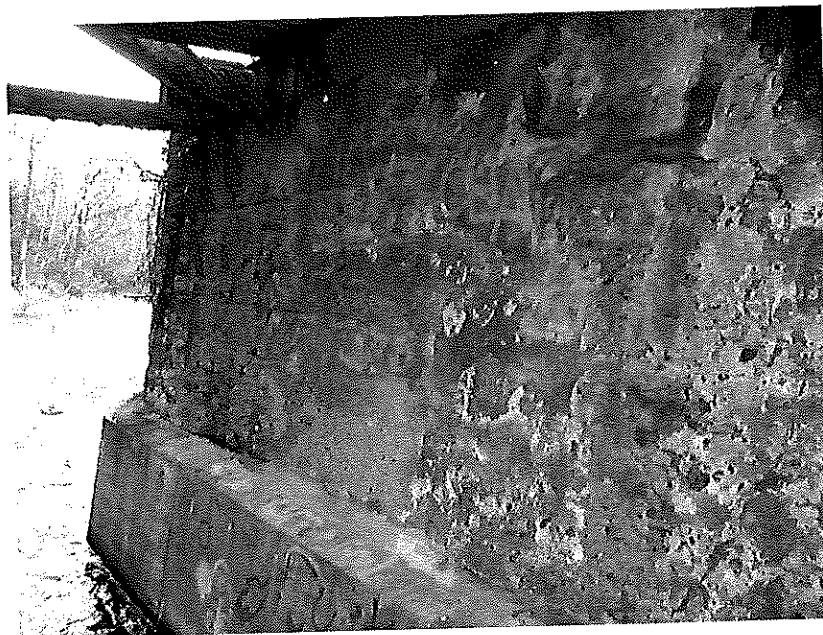
Plate 10 North Bank Abutment of Collingwood Street Bridge

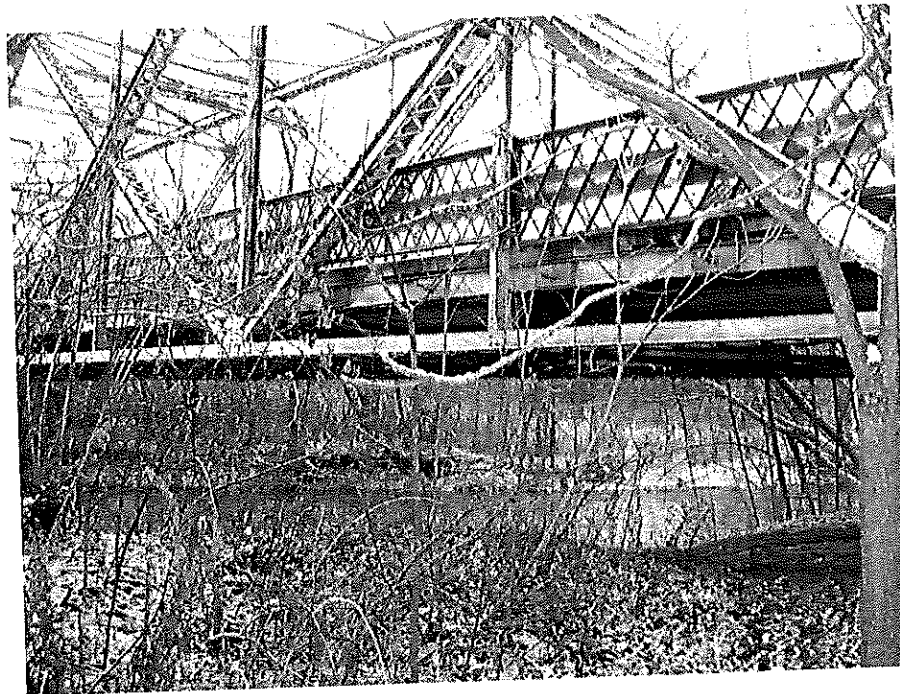
Plate 4 View from the West Side of the South Bank Abutment

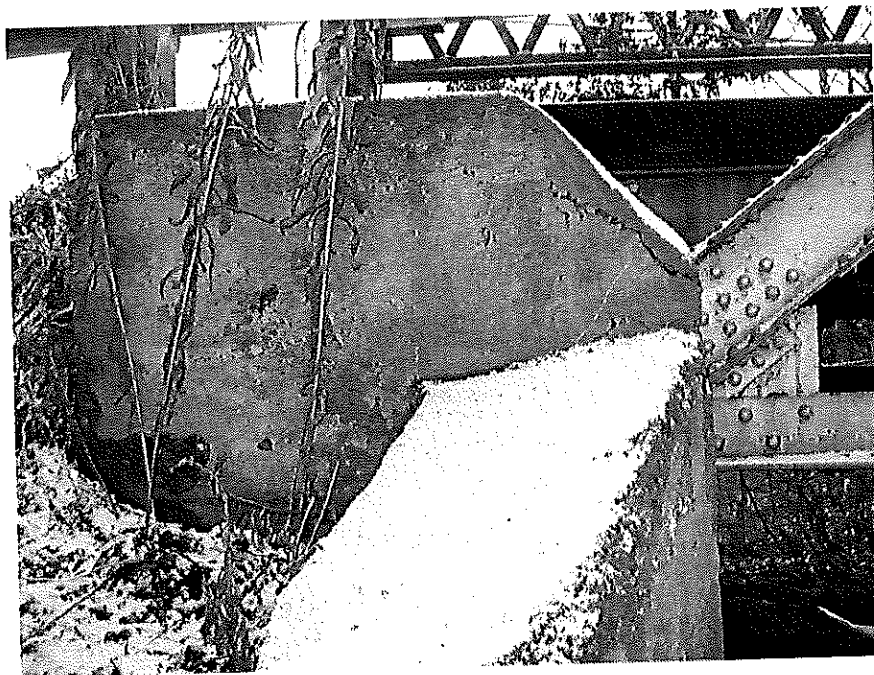
**Plate 6 Abutment and Wing Wall on the East Side of Collingwood Street Bridge on
the South Bank**

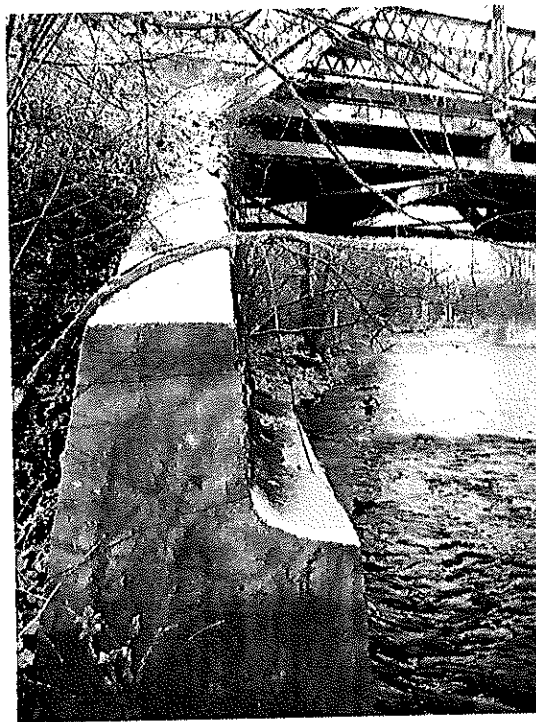
Plate 8 Abutment and Wing Wall on the West Side of Collingwood Street Bridge on the North Bank

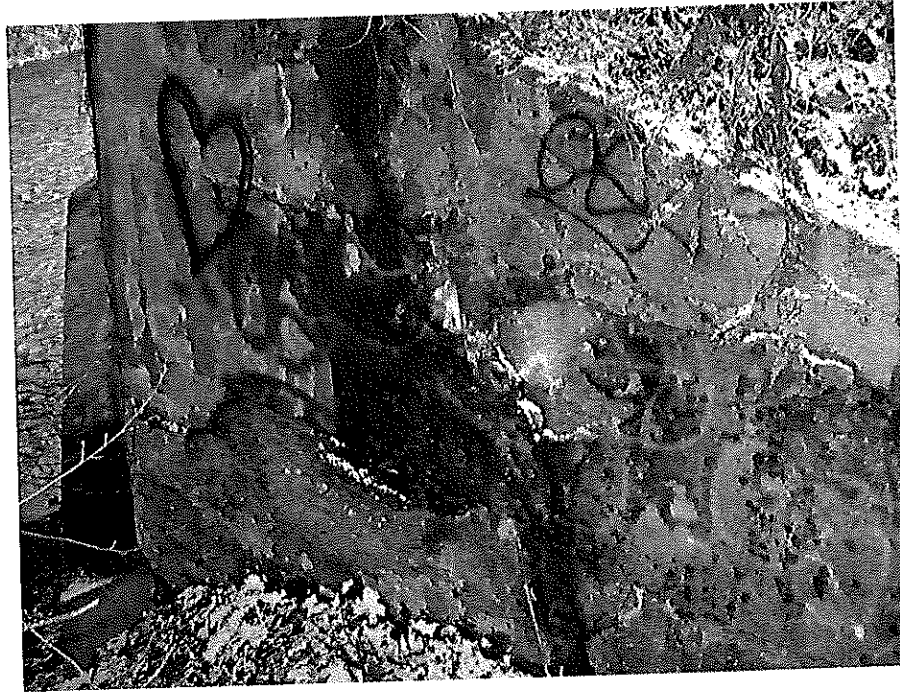
Plate 9 Wing Wall on the East Side of Collingwood Street Bridge on the North Bank

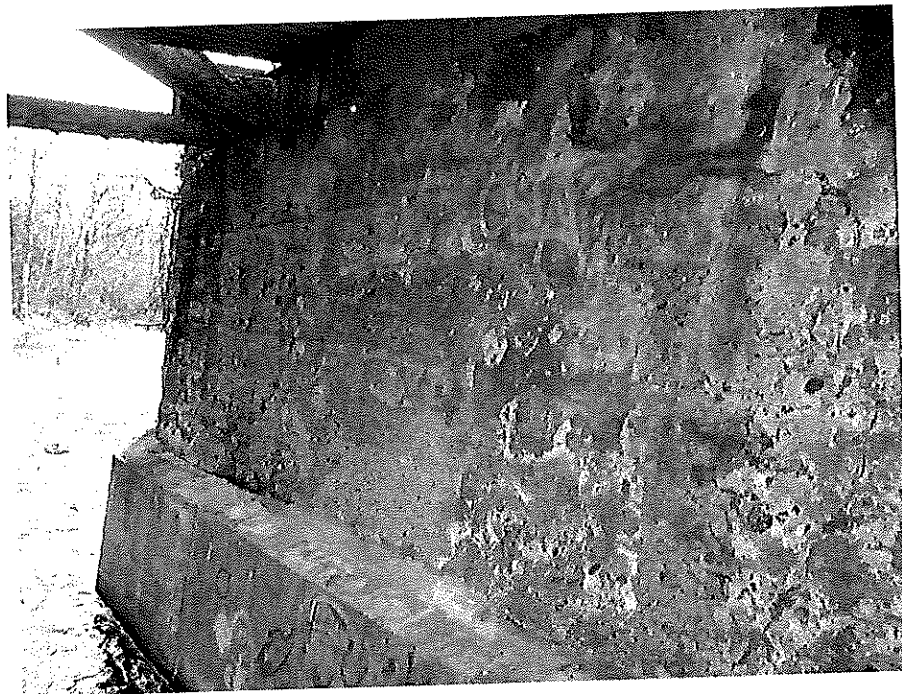
Plate 10 North Bank Abutment of Collingwood Street Bridge
