Approaches to Historic Bridge Rehabilitation

Rehabilitation of the Phalen Park Arch Bridge

Saint Paul, Minnesota

Historic Bridge Rehabilitation Strategies – 3 Project Examples

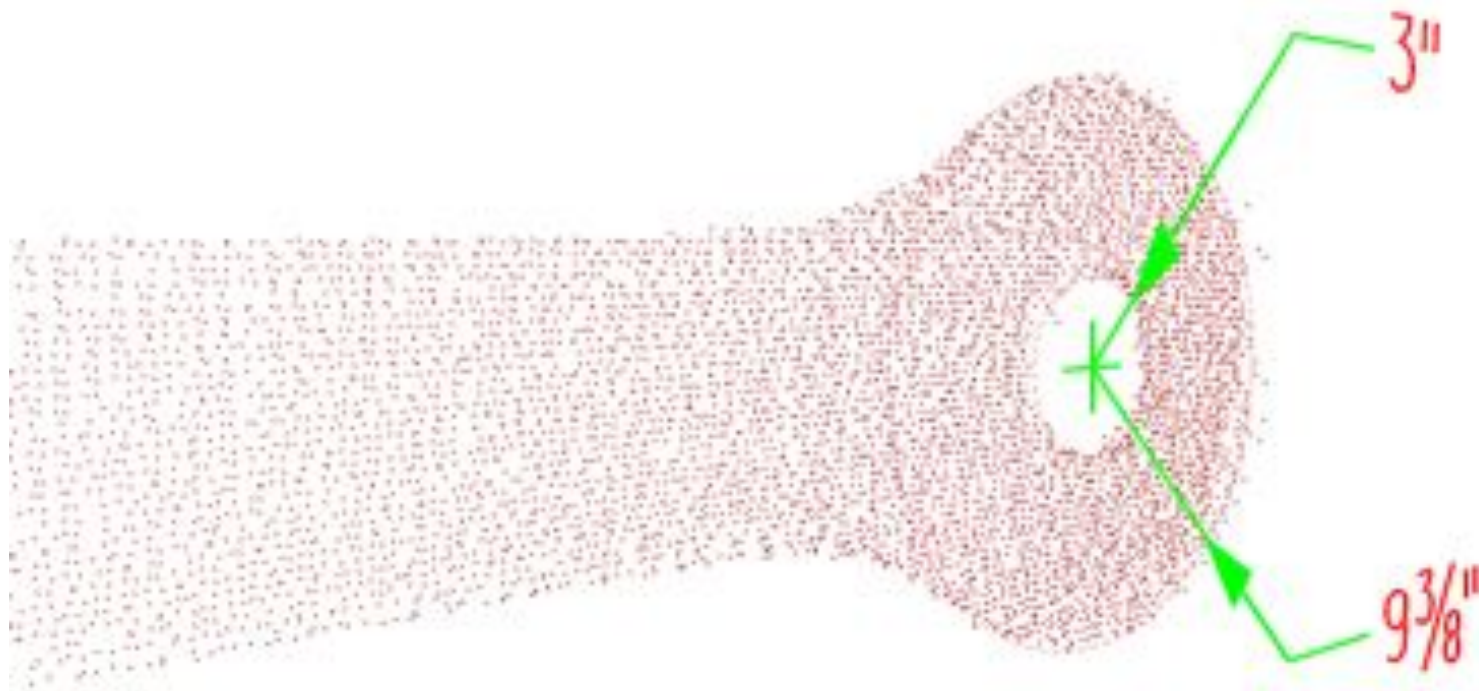
Scan of an eyebar head

- Started out assuming a stress approach would be used
- Conversation with Dr. Galambos
- Computed some stresses with Timoshenko equations. But what is an acceptable stress?
- Reversed course and ended up using a geometric criteria based on AASHTO/AISC specs
 - Area at the sides needs to be at least 135% of body area
 - Area behind pin needs to be at least 75% of body area

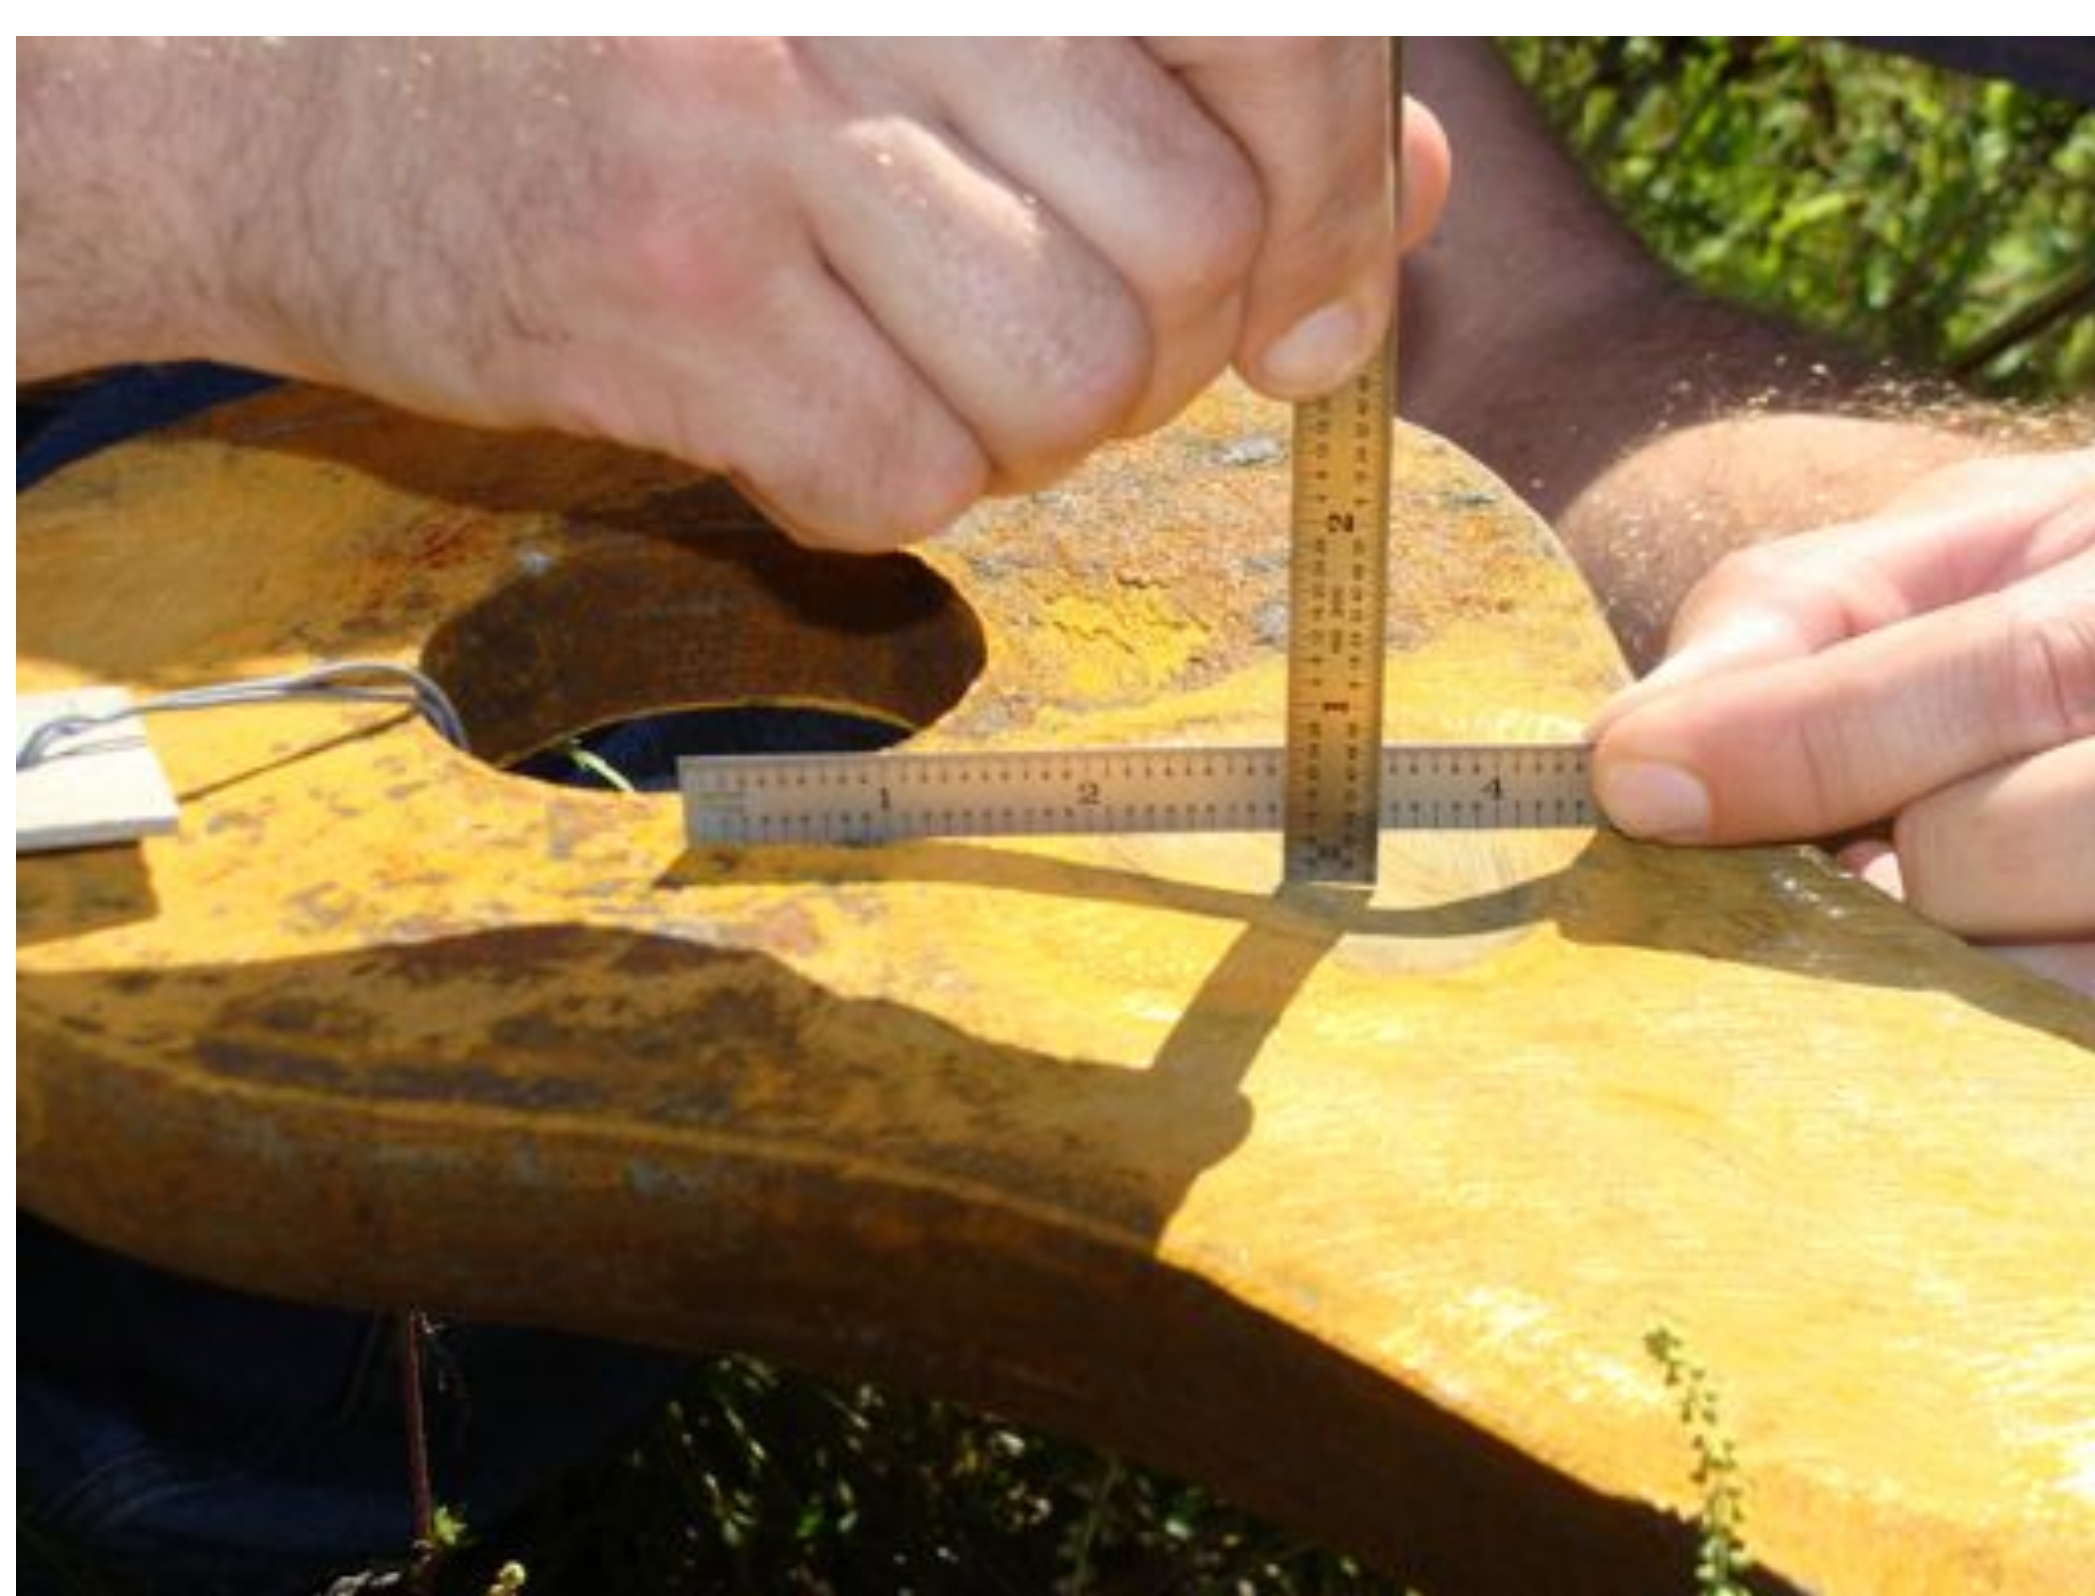
90-90 - 1" wide x 1/2" wide gitting x 1/8" deep; 0-0 2" transverse to body x 2" along body x 1/8" deep; diameter at 0-0 is 3-5/16"

REQUIRED AREAS AT DIFFERENT HEAD SECTIONS

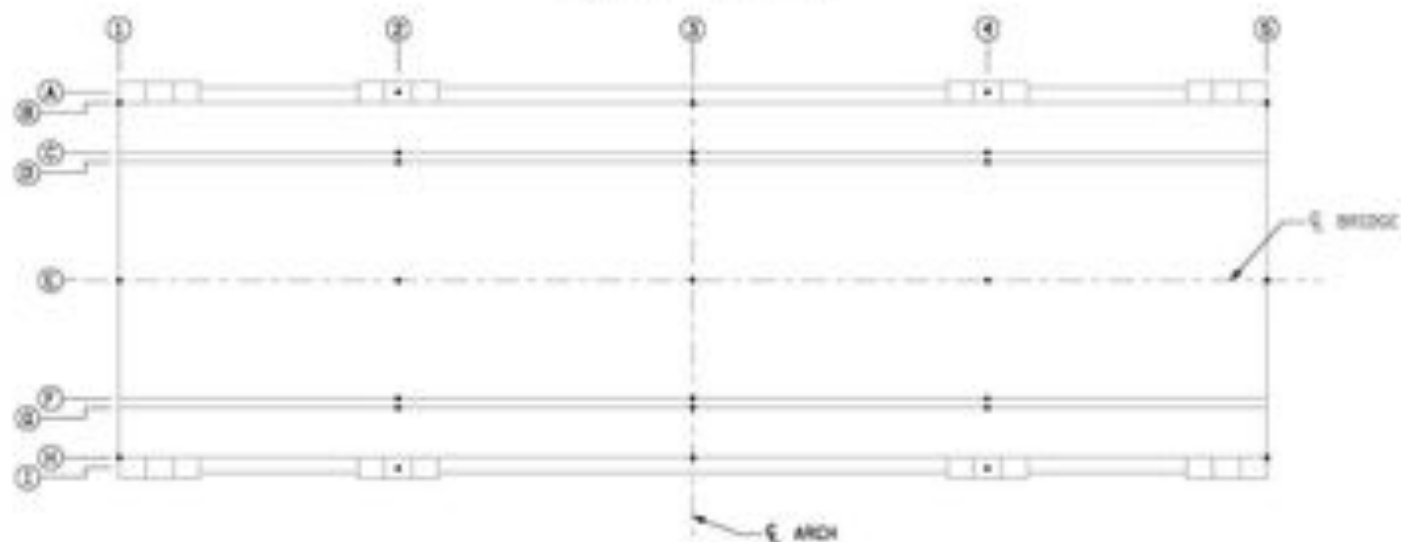
PHALEN PARK
ARCH BRIDGE
SURVEY
FIGURE 1
1-19-07

ELEVATIONS				
		COLUMN				
ROW	COLUMN	1	2	3	4	5
A		---	502.03	---	502.03	---
B		501.47	---	501.77	---	501.77
C		---	498.48	498.64	498.57	---
D		---	498.00	498.26	498.19	---
E		497.72	498.06	498.21	498.19	497.98
F		---	497.95	498.19	498.13	---
G		---	498.40	498.64	498.49	---
H		501.65	---	501.65	---	501.81
I		---	502.04	---	502.05	---

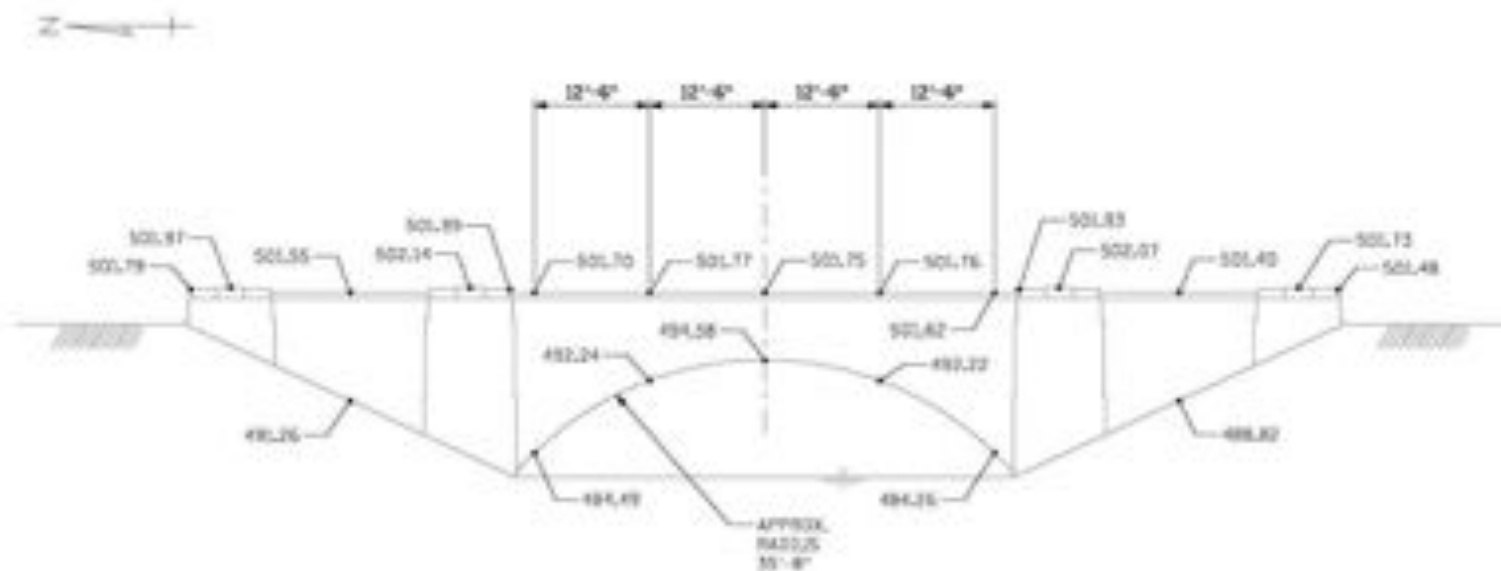
PHALEN PARK
 ARCH BRIDGE
 SURVEY
 FIGURE 2
 1-19-07

WEST ELEVATION
