**LOWER TODDSVILLE BRIDGE**

**BIN #2227960**

Existing Conditions Survey

Recommended Rehabilitation Steps  
To Convert Bridge from a Vehicular Bridge to  
A Pedestrian and Bicycle Bridge

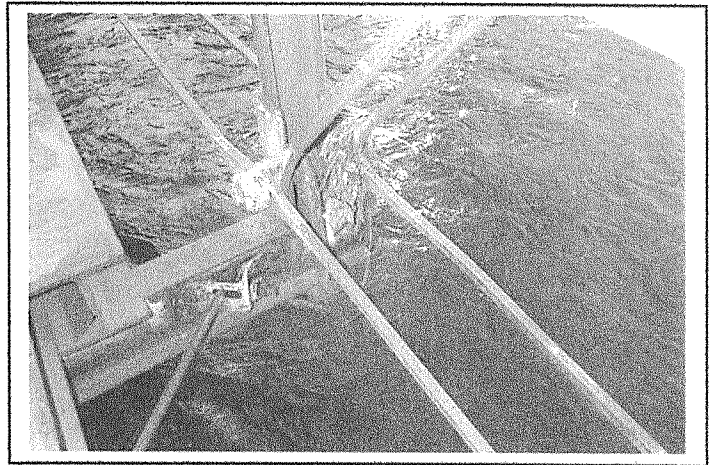
L4 South Truss

Oaks Creek runs southerly past the bridge in a meandering path. Just north of the bridge the creek makes a sharp loop and straightens out below the site with maximum flow and depth on the easterly side of the creek. During a 2006 summer flood the creek rose in elevation, with the bridge deck near the level of flow. Lands west of the bridge were completely inundated by the flood, and debris is still evident on the bridge at panel point L4 on the southerly truss.

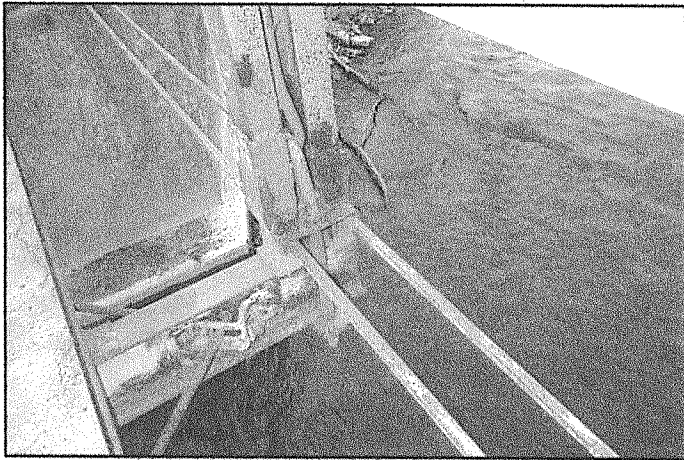
L5 North Truss

2. Vertical members L5-U5 have had welded reinforcement members around the original vertical round bars on both the north and south truss.
3. The original wooden stringers were replaced with 8" steel beams.
4. Guide rails were added.
5. The masonry abutments were encased in concrete and new steel bearing plates added.
6. The wooden deck was replaced on several occasions before being torn up in November 2006.
