**County of Simcoe
County Road 44 Reconstruction
Environmental Study Report
Addendum – Hart Bridge**

October, 2011

**County Road 44 Reconstruction
Environmental Study Report
Addendum – Hart Bridge
October, 2011**

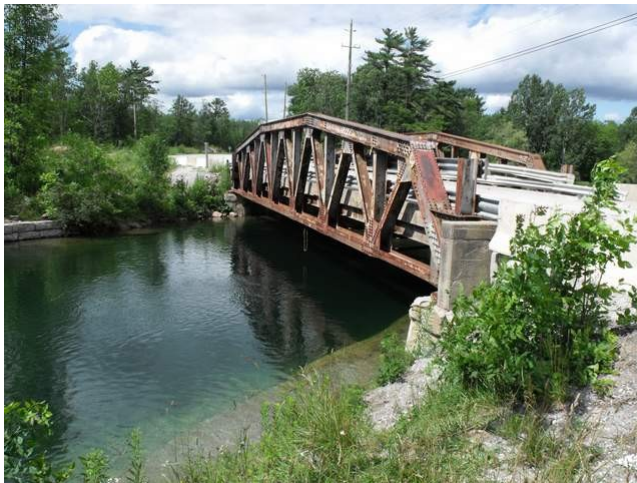
West Elevation.

Overall the structure is in very poor condition with an aggregate condition index of 0. The major concerns at this site are the severe deterioration of the east bottom chord at both ends including connections and affecting the load carrying capacity, partial poor condition of floor beams, stringers, bracing, abutments, south embankment and coating.

Recommended Work :	Defer to Element Level

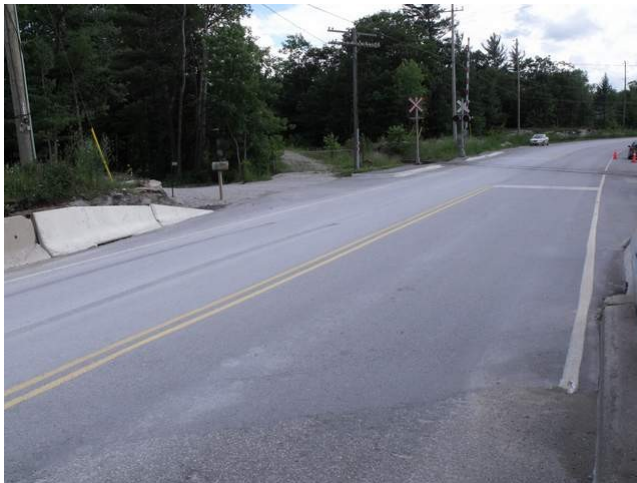
South Side.

The following defects were noted in the elements comprising this component: The approach consists of 43.5 tonnes of asphalt. In total, an estimated 10% exhibits light general deterioration. The estimated remaining service life is 15 years. The entire component will undergo ancillary replacement.

Element Group:	South Approach				Length:	N/A	
Element Name:	Approach				Width:	N/A	
Location:	Single Element				Height:	N/A	
Material:	Asphalt				Count:	N/A	
Element Type:	Primary Element				Total Quantity:	43.5	
Environment:	Severe				Limited Inspection	<input type="checkbox"/>	
Protection System:	None				Performance Deficiencies	Maintenance Needs	
Condition Data:	Units	Exc.	Good	Fair	Poor		
	tonnes	0	43.5	0	0	00	00
Comments: None							
Urgency : None <input checked="" type="checkbox"/> 6-10 years <input type="checkbox"/> 1-5 years <input type="checkbox"/> < 1 year <input type="checkbox"/> Urgent <input type="checkbox"/>							
Recommended Work : Ancillary Replacement Estimated Cost: \$7,919

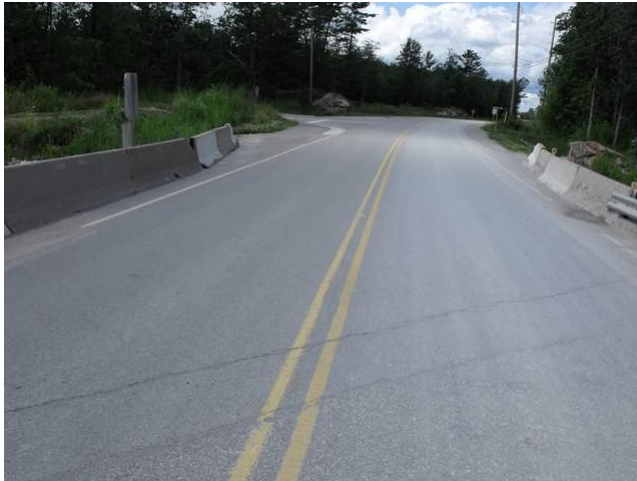
Overall View.

The following defects were noted in the elements comprising this component: The approach consists of 43.5 tonnes of asphalt. In total, an estimated 10% exhibits light general deterioration. The estimated remaining service life is 15 years. The entire component will undergo ancillary replacement.

Element Group:	North Approach				Length:	N/A	
Element Name:	Approach				Width:	N/A	
Location:	Single Element				Height:	N/A	
Material:	Asphalt				Count:	N/A	
Element Type:	Primary Element				Total Quantity:	43.5	
Environment:	Severe				Limited Inspection	<input type="checkbox"/>	
Protection System:	None				Performance Deficiencies	Maintenance Needs	
Condition Data:	Units	Exc.	Good	Fair	Poor		
	tonnes	0	43.5	0	0	00	00
Comments: None							
Urgency :	None <input checked="" type="checkbox"/>	6-10 years <input type="checkbox"/>	1-5 years <input type="checkbox"/>	< 1 year <input type="checkbox"/>	Urgent <input type="checkbox"/>		
Recommended Work : Ancillary Replacement Estimated Cost: \$7,919

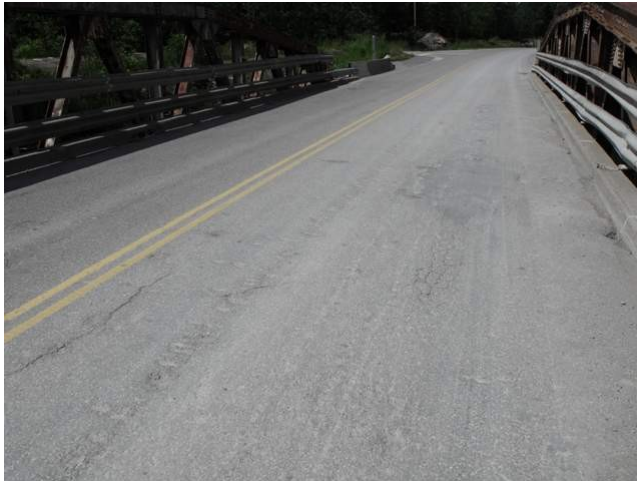
Overall View.

The following defects were noted in the elements comprising this component: The wearing surface consists of 48.5 tonnes of asphalt. In total, an estimated 10% exhibits severe general deterioration. The estimated remaining service life is 5 years. The entire component will undergo ancillary replacement.

Element Group:	Wearing Surface				Length:	N/A	
Element Name:	Wearing Surface				Width:	N/A	
Location:	Single Element				Height:	N/A	
Material:	Asphalt				Count:	N/A	
Element Type:	Primary Element				Total Quantity:	48.5	
Environment:	Severe				Limited Inspection	<input type="checkbox"/>	
Protection System:	None				Performance Deficiencies	Maintenance Needs	
Condition Data:	Units	Exc.	Good	Fair	Poor		
	tonnes	0	29.1	14.55	4.85	09	12
Comments:	The wearing surface is in partial poor condition showing potholing areas which are partially patched and alligator cracking.						
Urgency :	None <input type="checkbox"/>	6-10 years <input type="checkbox"/>	1-5 years <input checked="" type="checkbox"/>	< 1 year <input type="checkbox"/>	Urgent <input type="checkbox"/>		
Recommended Work :	Ancillary Replacement				Estimated Cost: \$24,721

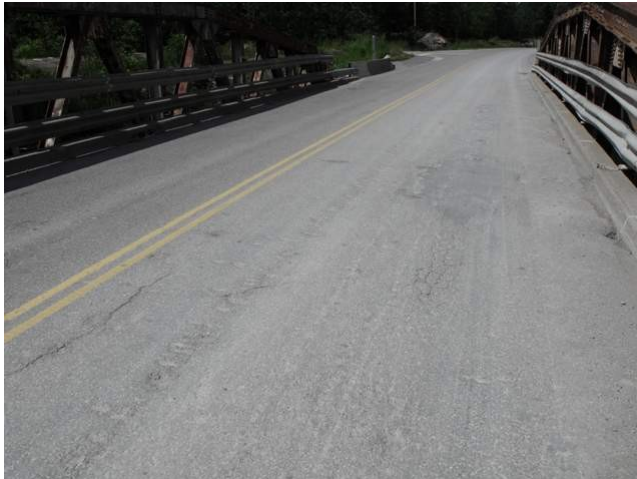
Element Group:	Wearing Surface				Length:	33.7	
Element Name:	Top Surface				Width:	8	
Location:	Single Element				Height:	0.08	
Material:	Asphalt				Count:	1	
Element Type:	Any				Total Quantity:	269.6	
Environment:	Severe				Limited Inspection	<input type="checkbox"/>	
Protection System:	None				Performance Deficiencies	Maintenance Needs	
Condition Data:	Units	Exc.	Good	Fair	Poor		
	m2	0	161.76	80.88	26.96	09	12
Comments:	The wearing surface is in partial poor condition showing potholing areas which are partially patched and alligator cracking.						
Urgency :	None <input type="checkbox"/>	6-10 years <input type="checkbox"/>	1-5 years <input checked="" type="checkbox"/>	< 1 year <input type="checkbox"/>	Urgent <input type="checkbox"/>		
Recommended Work :	See Primary Element

Top Surface. Showing deterioration.

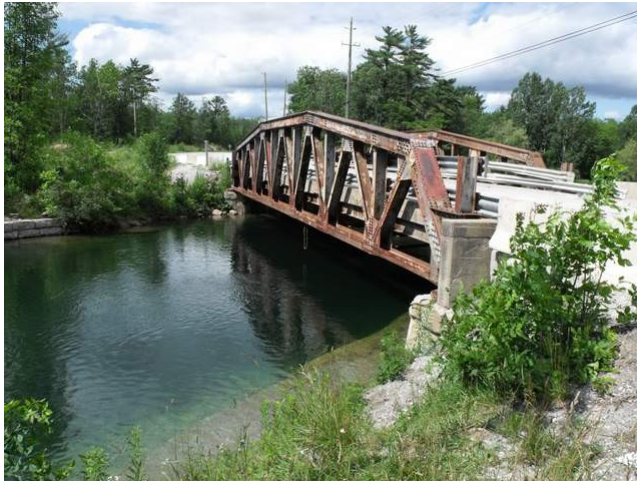
West Side.

The following defects were noted in the elements comprising this component: The deck consists of 2.1 tonnes of cast-in-place concrete. In total, an estimated 4% exhibits severe general deterioration. The estimated remaining service life is 5 years. The entire component will undergo ancillary replacement.

Element Group:	Deck	Length:	N/A				
Element Name:	Deck	Width:	N/A				
Location:	Single Element	Height:	N/A				
Material:	Cast-In-Place Concrete	Count:	N/A				
Element Type:	Primary Element	Total Quantity:	2.1				
Environment:	Severe	Limited Inspection	<input checked="" type="checkbox"/>				
Protection System:	None	Performance Deficiencies	Maintenance Needs				
Condition Data:	Units	Exc.	Good	Fair	Poor		
	tonnes	0	1.26	0.74	0.1	16	17
Comments:	The inspection of the deck was limited due to water level however the deck progressively deteriorates as a result of moisture penetration.						
Urgency :	None <input type="checkbox"/>	6-10 years <input type="checkbox"/>	1-5 years <input checked="" type="checkbox"/>	< 1 year <input type="checkbox"/>	Urgent <input type="checkbox"/>		
Recommended Work :	Ancillary Replacement		Estimated Cost: \$3,584

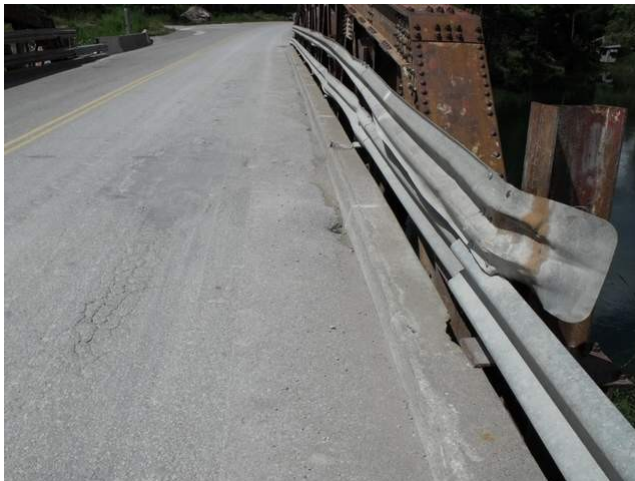
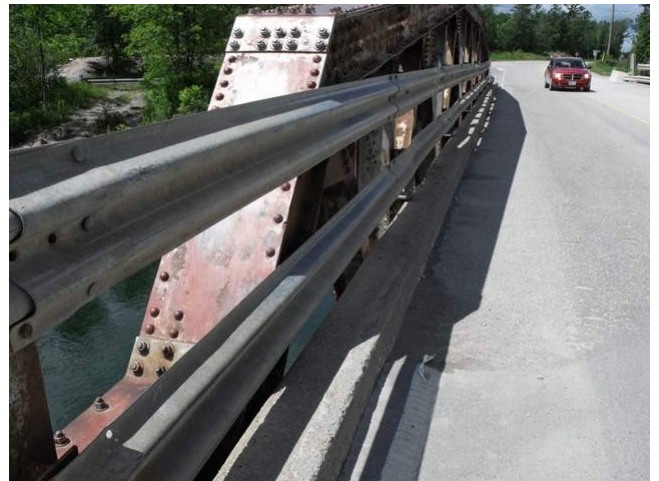
The following defects were noted in the elements comprising this component: The sidewalk/curb/median consists of 10.5 tonnes of cast-in-place concrete. In total, an estimated 18% exhibits severe general deterioration. The estimated remaining service life is 5 years. The entire component will undergo ancillary replacement.

Element Group:	Sidewalk/Curb/Median			Length:	N/A		
Element Name:	Sidewalk/Curb/Median			Width:	N/A		
Location:	Single Element			Height:	N/A		
Material:	Cast-In-Place Concrete			Count:	N/A		
Element Type:	Primary Element			Total Quantity:	10.5		
Environment:	Severe			Limited Inspection	<input type="checkbox"/>		
Protection System:	None					Performance Deficiencies	Maintenance Needs
Condition Data:	Units	Exc.	Good	Fair	Poor		
	tonnes	0	6.82	1.78	1.89	16	17
Comments: Curbs are in partial poor condition.							
Urgency : None <input type="checkbox"/> 6-10 years <input type="checkbox"/> 1-5 years <input checked="" type="checkbox"/> < 1 year <input type="checkbox"/> Urgent <input type="checkbox"/>							
Recommended Work : Ancillary Replacement Estimated Cost: \$11,468

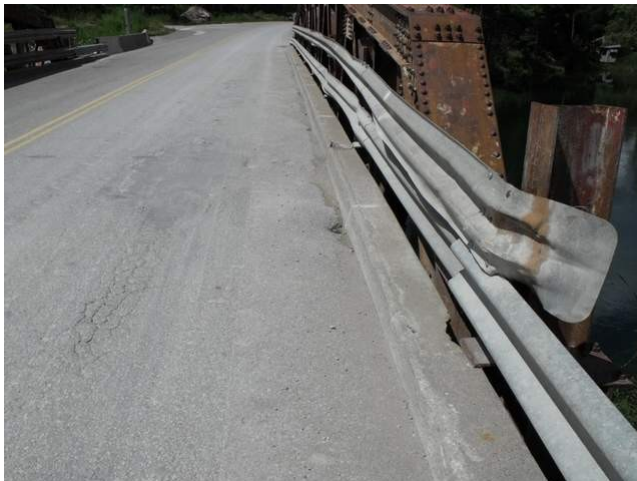
East Side.

The following defects were noted in the elements comprising this component: The barrier consists of 1.7 tonnes of steel. The element is functionally obsolete and replacement is warranted. The estimated remaining service life is 0 years. The east barrier consists of 24 tonnes of precast concrete. The element is structurally inadequate. The estimated remaining service life is 10 years. The entire component will undergo ancillary replacement.

Element Group:	Barrier				Length:	N/A	
Element Name:	Barrier				Width:	N/A	
Location:	Single Element				Height:	N/A	
Material:	Steel				Count:	N/A	
Element Type:	Primary Element				Total Quantity:	1.7	
Environment:	Severe				Limited Inspection	<input type="checkbox"/>	
Protection System:	None					Performance Deficiencies	Maintenance Needs
Condition Data:	Units	Exc.	Good	Fair	Poor		
	tonnes	0	0	0.85	0.85	16	17
Comments: The barrier is not CHBDC compliant and is also loose and showing collision damage.							
Urgency : None <input type="checkbox"/> 6-10 years <input type="checkbox"/> 1-5 years <input type="checkbox"/> < 1 year <input type="checkbox"/> Urgent <input checked="" type="checkbox"/>							
Recommended Work : Replacement Estimated Cost: \$11,028

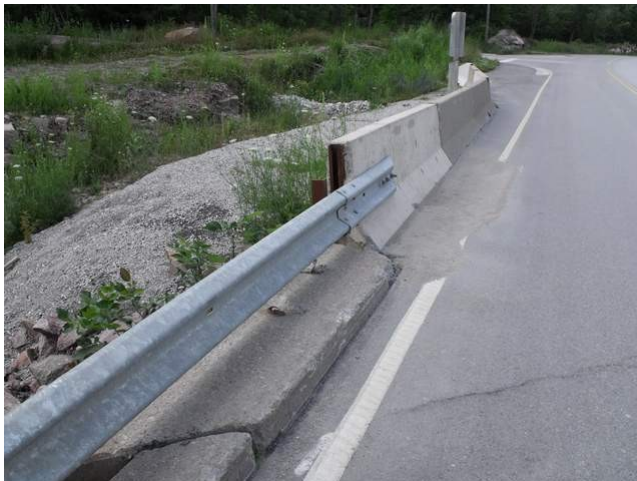
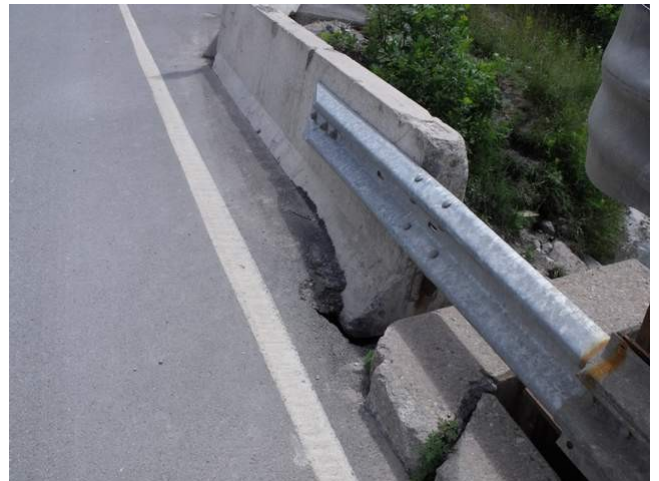
Element Group:	Barrier				Length:	N/A	
Element Name:	EastBarrier				Width:	N/A	
Location:	East				Height:	N/A	
Material:	Precast Concrete				Count:	N/A	
Element Type:	Primary Element				Total Quantity:	24	
Environment:	Severe				Limited Inspection	<input type="checkbox"/>	
Protection System:	None				Performance Deficiencies	Maintenance Needs	
Condition Data:	Units	Exc.	Good	Fair	Poor		
	tonnes	0	24	0	0	16	17
Comments: The jersey walls at the end of the bridge are temporary solutions and they will eventually need to be replaced.							
Urgency : None <input type="checkbox"/> 6-10 years <input checked="" type="checkbox"/> 1-5 years <input type="checkbox"/> < 1 year <input type="checkbox"/> Urgent <input type="checkbox"/>							
Recommended Work : Ancillary Replacement Estimated Cost: \$34,951

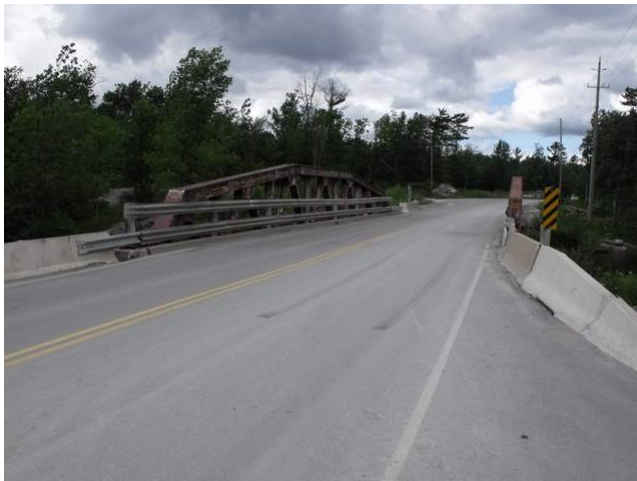
Overall View.

The following defects were noted in the elements comprising this component: The signage number 4 all together constructed of steel. In total, an estimated 20% exhibits medium general deterioration. The estimated remaining service life is 10 years. The entire component will undergo ancillary replacement.

Element Group:	Signage				Length:	N/A	
Element Name:	Signage				Width:	N/A	
Location:	Single Element				Height:	N/A	
Material:	Steel				Count:	4	
Element Type:	Primary Element				Total Quantity:	4	
Environment:	Severe				Limited Inspection	<input type="checkbox"/>	
Protection System:	None				Performance Deficiencies	Maintenance Needs	
Condition Data:	Units	Exc.	Good	Fair	Poor		
	all	0	3.2	0.8	0	16	17
Comments: None							
Urgency :	None <input type="checkbox"/>	6-10 years <input checked="" type="checkbox"/>	1-5 years <input type="checkbox"/>	< 1 year <input type="checkbox"/>	Urgent <input type="checkbox"/>		
Recommended Work : Ancillary Replacement Estimated Cost: \$2,350

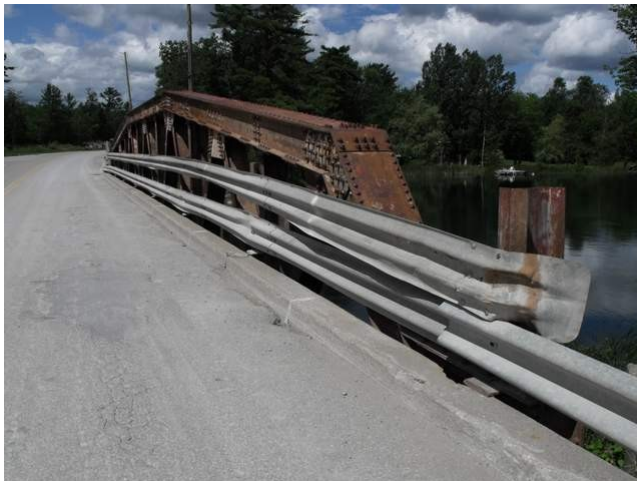
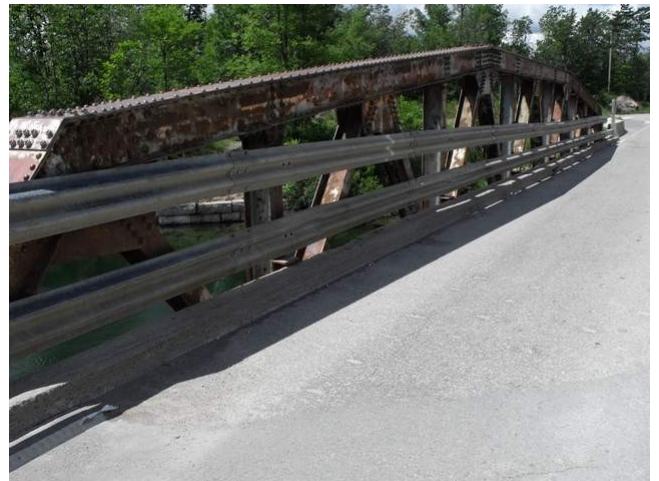
The following defects were noted in the elements comprising this component: The truss consist of 45 tonnes of steel. In total, an estimated 6% exhibits severe general deterioration and replacement is warranted. The estimated remaining service life is 0 years.

Element Group:	Truss				Length:	N/A	
Element Name:	Truss				Width:	N/A	
Location:	Single Element				Height:	N/A	
Material:	Steel				Count:	N/A	
Element Type:	Primary Element				Total Quantity:	45	
Environment:	Severe				Limited Inspection	<input checked="" type="checkbox"/>	
Protection System:	None				Performance Deficiencies	Maintenance Needs	
Condition Data:	Units	Exc.	Good	Fair	Poor		
	tonnes	0	28.8	13.5	2.7	01	17
Comments:	The inspection of the bottom side was limited due to water level and watercraft inspection is recommended in order to properly evaluate the condition of the truss. The east bottom chord shows severe to very severe corrosion affecting the ends and end connections and sudden collapsing may occur as a result						
Urgency :	None <input type="checkbox"/>	6-10 years <input type="checkbox"/>	1-5 years <input type="checkbox"/>	< 1 year <input type="checkbox"/>	Urgent <input checked="" type="checkbox"/>

Recommended Work :	Replacement				Estimated Cost: \$656,829

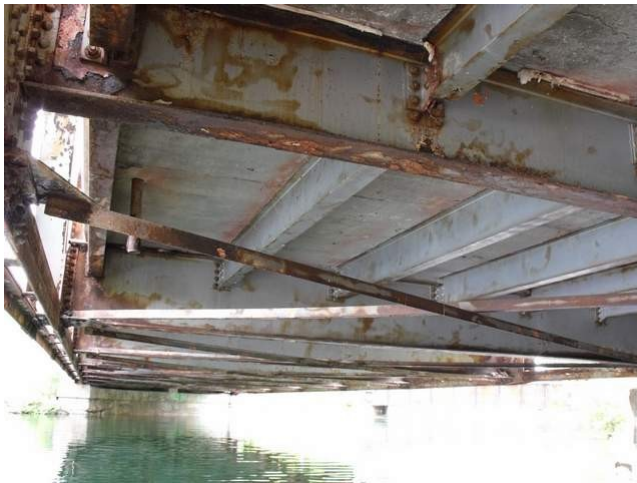
The following defects were noted in the elements comprising this component: The stringers consist of 20 tonnes of steel. In total, an estimated 8% exhibits severe general deterioration. The estimated remaining service life is 5 years. The entire component will undergo ancillary replacement.

Element Group:	Stringers				Length:	33.7	
Element Name:	Stringers				Width:	0.14	
Location:	Single Element				Height:	0.38	
Material:	Steel				Count:	7	
Element Type:	Primary Element				Total Quantity:	7	
Environment:	Severe				Limited Inspection	<input checked="" type="checkbox"/>	
Protection System:	None				Performance Deficiencies	Maintenance Needs	
Condition Data:	Units	Exc.	Good	Fair	Poor		
	each	0	5.74	0.7	0.56	16	17
Comments:	The inspection was limited due to water level however stringers show some severe corrosion on the top flange and around connections. The 2 exterior ones show severe corrosion. Watercraft inspection is recommended in order to have a proper evaluation.						
Urgency :	None <input type="checkbox"/>	6-10 years <input type="checkbox"/>	1-5 years <input checked="" type="checkbox"/>	< 1 year <input type="checkbox"/>	Urgent <input type="checkbox"/>		
Recommended Work :	Ancillary Replacement				Estimated Cost: \$203,569

Underside Surface. Showing condition.

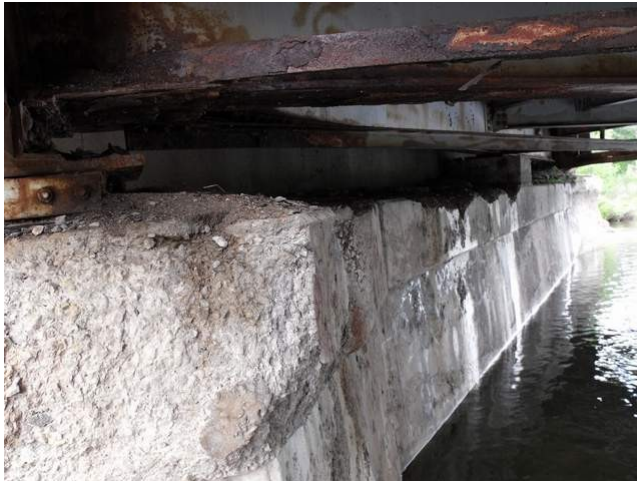
North Side.

The following defects were noted in the elements comprising this component: The abutment consists of 115 tonnes of cast-in-place concrete. In total, an estimated 12% exhibits severe general deterioration. The estimated remaining service life is 1 years. The entire component will undergo ancillary replacement.

Element Group:	North Abutment				Length:	N/A	
Element Name:	Abutment				Width:	N/A	
Location:	Single Element				Height:	N/A	
Material:	Cast-In-Place Concrete				Count:	N/A	
Element Type:	Primary Element				Total Quantity:	115	
Environment:	Severe				Limited Inspection	<input type="checkbox"/>	
Protection System:	None				Performance Deficiencies	Maintenance Needs	
Condition Data:	Units	Exc.	Good	Fair	Poor		
	tonnes	0	51.75	40.25	23	16	17
Comments:	The abutment is in partial poor condition. The width of the watercourse is wider than the length of the span and water flow encroaches against the abutments as a result. When replacing the structure a longer span should be considered.						
Urgency :	None <input type="checkbox"/>	6-10 years <input type="checkbox"/>	1-5 years <input checked="" type="checkbox"/>	< 1 year <input type="checkbox"/>	Urgent <input type="checkbox"/>		
Recommended Work :	Ancillary Replacement				Estimated Cost: \$282,616

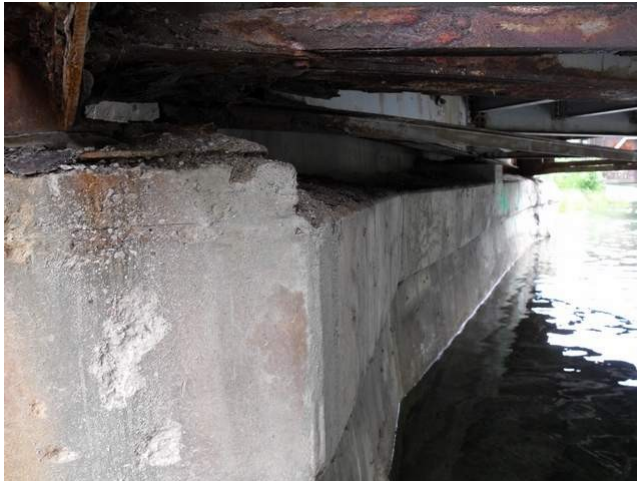
Overall View.

The following defects were noted in the elements comprising this component: The abutment consists of 115 tonnes of cast-in-place concrete. In total, an estimated 20% exhibits severe general deterioration. The estimated remaining service life is 2 years. The entire component will undergo ancillary replacement.

Element Group:	South Abutment			Length:	N/A		
Element Name:	Abutment			Width:	N/A		
Location:	Single Element			Height:	N/A		
Material:	Cast-In-Place Concrete			Count:	N/A		
Element Type:	Primary Element			Total Quantity:	115		
Environment:	Severe			Limited Inspection	<input type="checkbox"/>		
Protection System:	None					Performance Deficiencies	Maintenance Needs
Condition Data:	Units	Exc.	Good	Fair	Poor		
	tonnes	0	77.05	24.15	13.8	16	17
Comments:	The abutment is in partial poor condition. The width of the watercourse is wider than the length of the span and water flow encroaches against the abutments as a result. When replacing the structure a longer span should be considered.						
Urgency :	None <input type="checkbox"/>	6-10 years <input type="checkbox"/>	1-5 years <input type="checkbox"/>	< 1 year <input checked="" type="checkbox"/>	Urgent <input type="checkbox"/>		
Recommended Work :	Ancillary Replacement			Estimated Cost: \$282,616

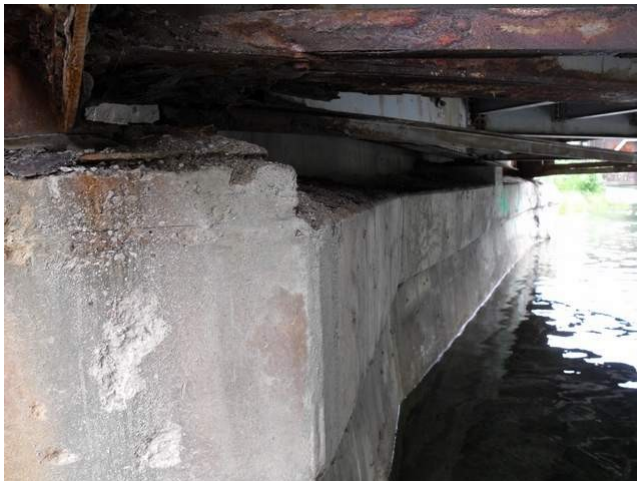
South Side. Showing condition.

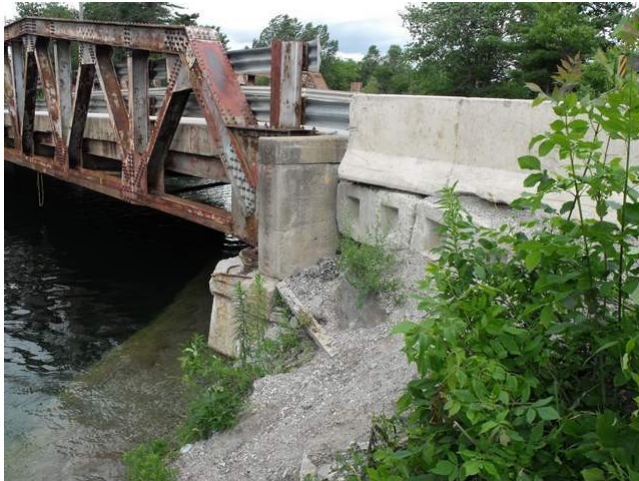
Southwest Side.

4.7.48 South Abutment - Ballast Wall

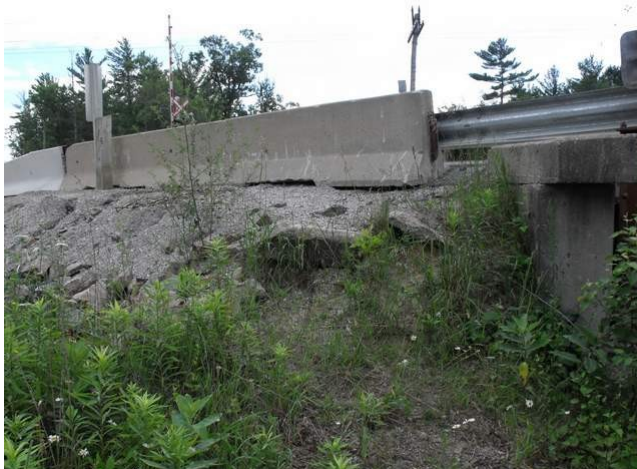
Southeast Side.

4.7.50 South Abutment - East Wing Wall

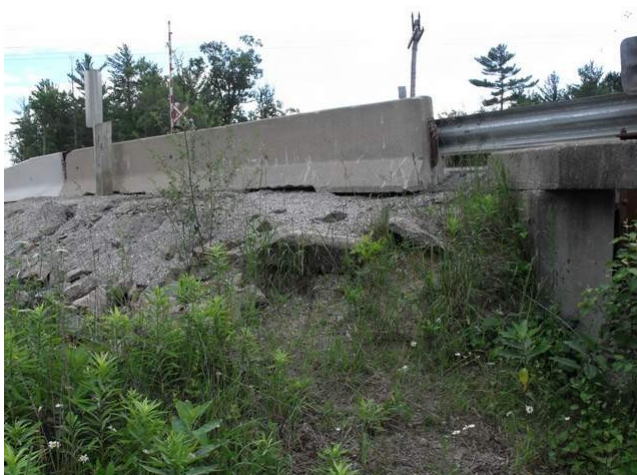
4.7.51 South Embankment - Embankment

Southeast Side. Showing poor condition.

Element Group:	South Embankment				Length:	N/A	
Element Name:	Embankment				Width:	N/A	
Location:	Single Element				Height:	N/A	
Material:	Gravel				Count:	1	
Element Type:	Primary Element				Total Quantity:	1	
Environment:	Severe				Limited Inspection	<input type="checkbox"/>	
Protection System:	None				Performance Deficiencies	Maintenance Needs	
Condition Data:	Units	Exc.	Good	Fair	Poor		
	all	0	0	0.5	0.5	16	17
Comments: Embankment is in poor condition and may further affect the road system.							
Urgency : None <input type="checkbox"/> 6-10 years <input type="checkbox"/> 1-5 years <input type="checkbox"/> < 1 year <input checked="" type="checkbox"/> Urgent <input type="checkbox"/>							
Recommended Work : Ancillary Replacement Estimated Cost: \$4,847

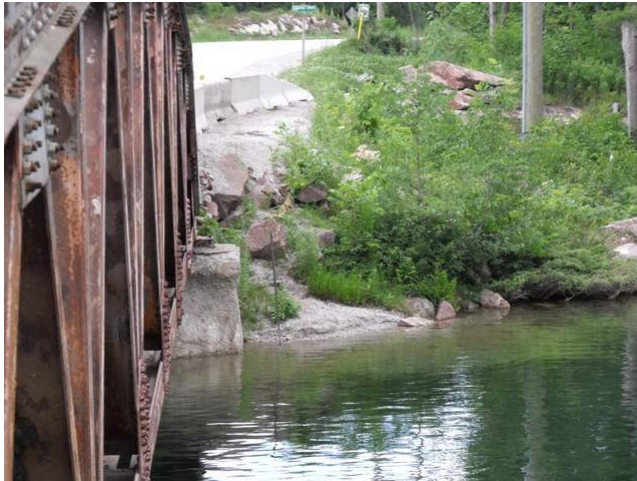
Northwest Side.

4.7.52 North Embankment - Embankment

Element Group:	North Embankment				Length:	N/A	
Element Name:	Embankment				Width:	N/A	
Location:	Single Element				Height:	N/A	
Material:	Gravel				Count:	1	
Element Type:	Primary Element				Total Quantity:	1	
Environment:	Severe				Limited Inspection	<input type="checkbox"/>	
Protection System:	None				Performance Deficiencies	Maintenance Needs	
Condition Data:	Units	Exc.	Good	Fair	Poor		
	all	0	0	0.5	0.5	16	17
Comments: Slope protection is in partial poor condition.							
Urgency : None <input type="checkbox"/> 6-10 years <input type="checkbox"/> 1-5 years <input checked="" type="checkbox"/> < 1 year <input type="checkbox"/> Urgent <input type="checkbox"/>							
Recommended Work : Ancillary Replacement Estimated Cost: \$4,847

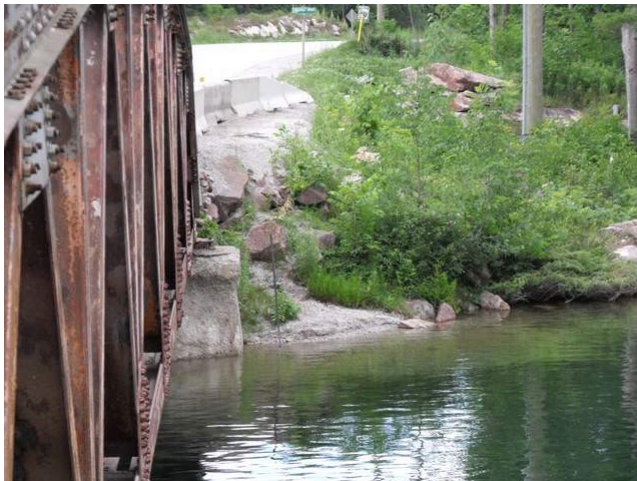
Northeast Side.

4.7.53 North Embankment - Slope Protection

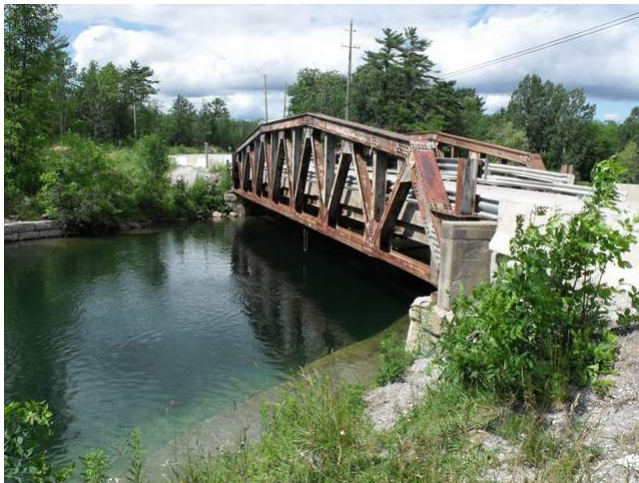
West Side.

4.7.54 Foundation - Foundation

Element Group:	Foundation				Length:	N/A	
Element Name:	Foundation				Width:	N/A	
Location:	Single Element				Height:	N/A	
Material:	Steel Piles				Count:	2	
Element Type:	Primary Element				Total Quantity:	2	
Environment:	Severe				Limited Inspection	<input checked="" type="checkbox"/>	
Protection System:	None				Performance Deficiencies	Maintenance Needs	
Condition Data:	Units	Exc.	Good	Fair	Poor		
	each	0	2	0	0	00	00
Comments: None							
Urgency :	None <input type="checkbox"/>	6-10 years <input checked="" type="checkbox"/>	1-5 years <input type="checkbox"/>	< 1 year <input type="checkbox"/>	Urgent <input type="checkbox"/>		
Recommended Work : Reinstallation Estimated Cost: \$360,654

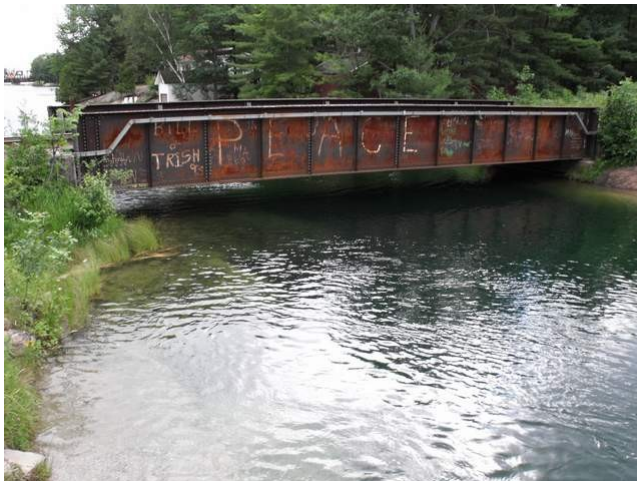
West Side.

4.7.56 Watercourse - Watercourse

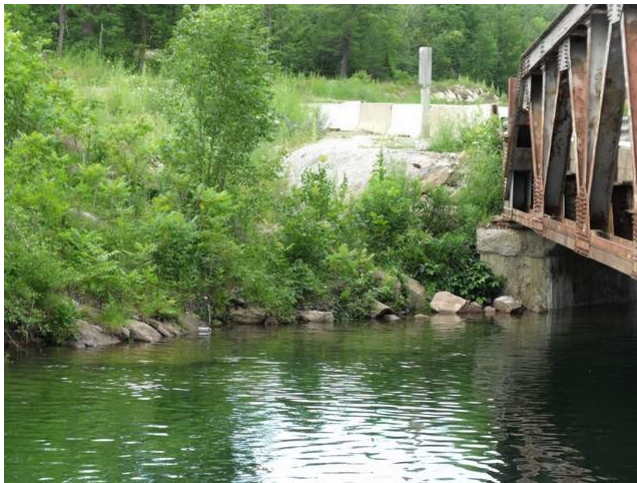
Overall View.

4.7.57 Watercourse - Bottom

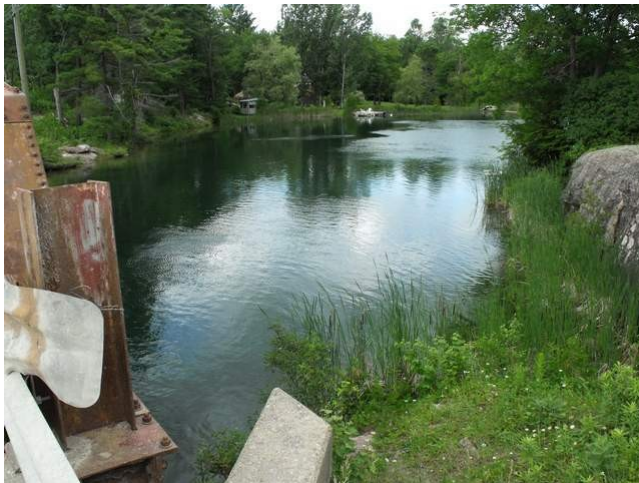
East Side.

4.7.58 Watercourse - Upstream Section
