Technical Aspects of Cable Wire Breakages on the Mount Hope Suspension Bridge

Breaks Localized in Strand Shoes—Progressive Breaking Noted in Spite of Load Reduction—Cable Spinning Methods—Characteristics of Wire and Its Manufacture—Temporary Repair Measures

IN MARCH of this year engineering circles were shocked to learn of serious breakages in the cable wires of two important highway suspension bridges then under construction. News of the breakages was followed by a cessation of work on both structures and later by the decision to dismantle the bridges and replace the suspension systems with satisfactory wire. Interesting operations of unprecedented kind were involved in the dismantling. Both structures utilized the same kind of wire, a heat-treated product of high elastic limit, heretofore untried in suspension bridge service. The Mount Hope bridge, near Providence, R. I., which had a center span of 1,200 ft., was within about twelve months of completion, requiring only the placing of the concrete floor slab. The Ambassador bridge at Detroit, whose sus-

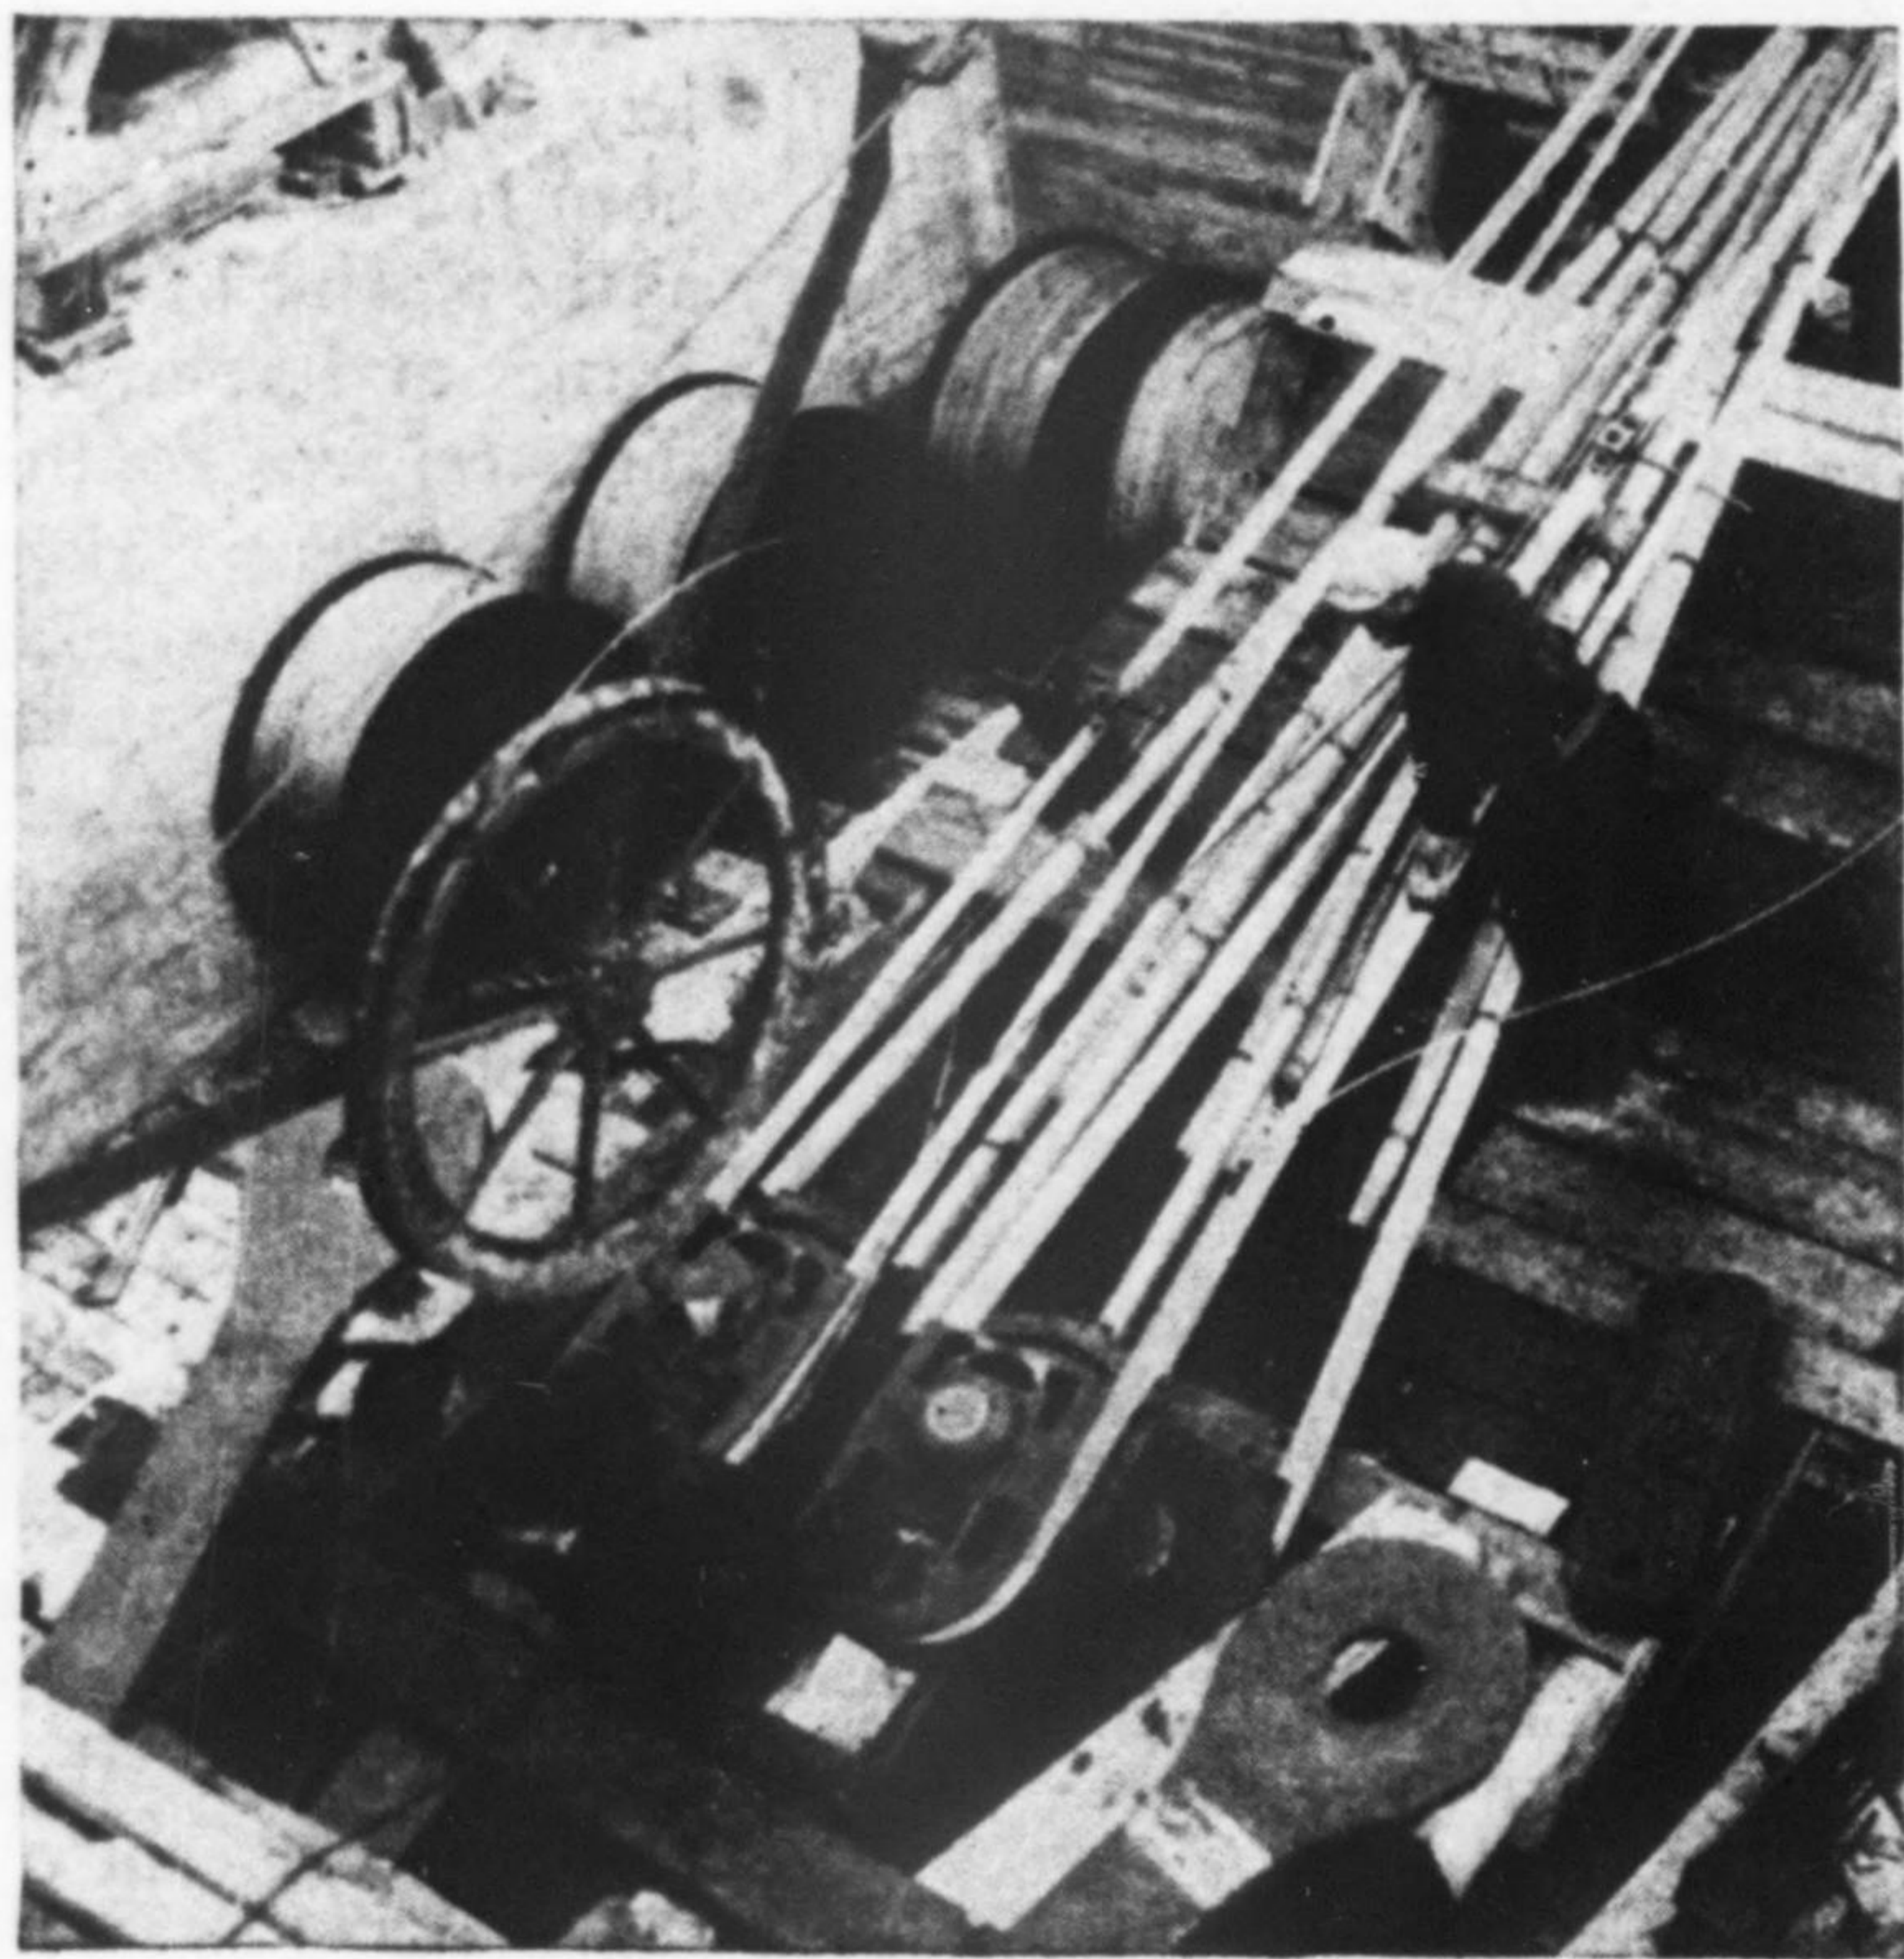
FIG. 4—SPINNING CABLE IN THE BRISTOL WEST ANCHORAGE

Note pulley sheave on lower left of strand shoe around which each wire was performed so that it would lie flat around the shoe. Traveling wheel is ready to leave anchorage with a bight of wire to be carried to the opposite side.

The traveling wheel when coming into a strand shoe released the wire to the shoe as soon as the line end was clamped. A man stationed at the shoe then bent the free end of the wire around a 9½-in. diameter sheave (visible on top of the shoe in Figs. 4 and 5). This bending gave the wires a permanent set, and since the bending was done in a complete circle of half the diameter of the 19-in. shoe, the wire should upon release exactly conform to the lower half of the strand shoe. The lengths

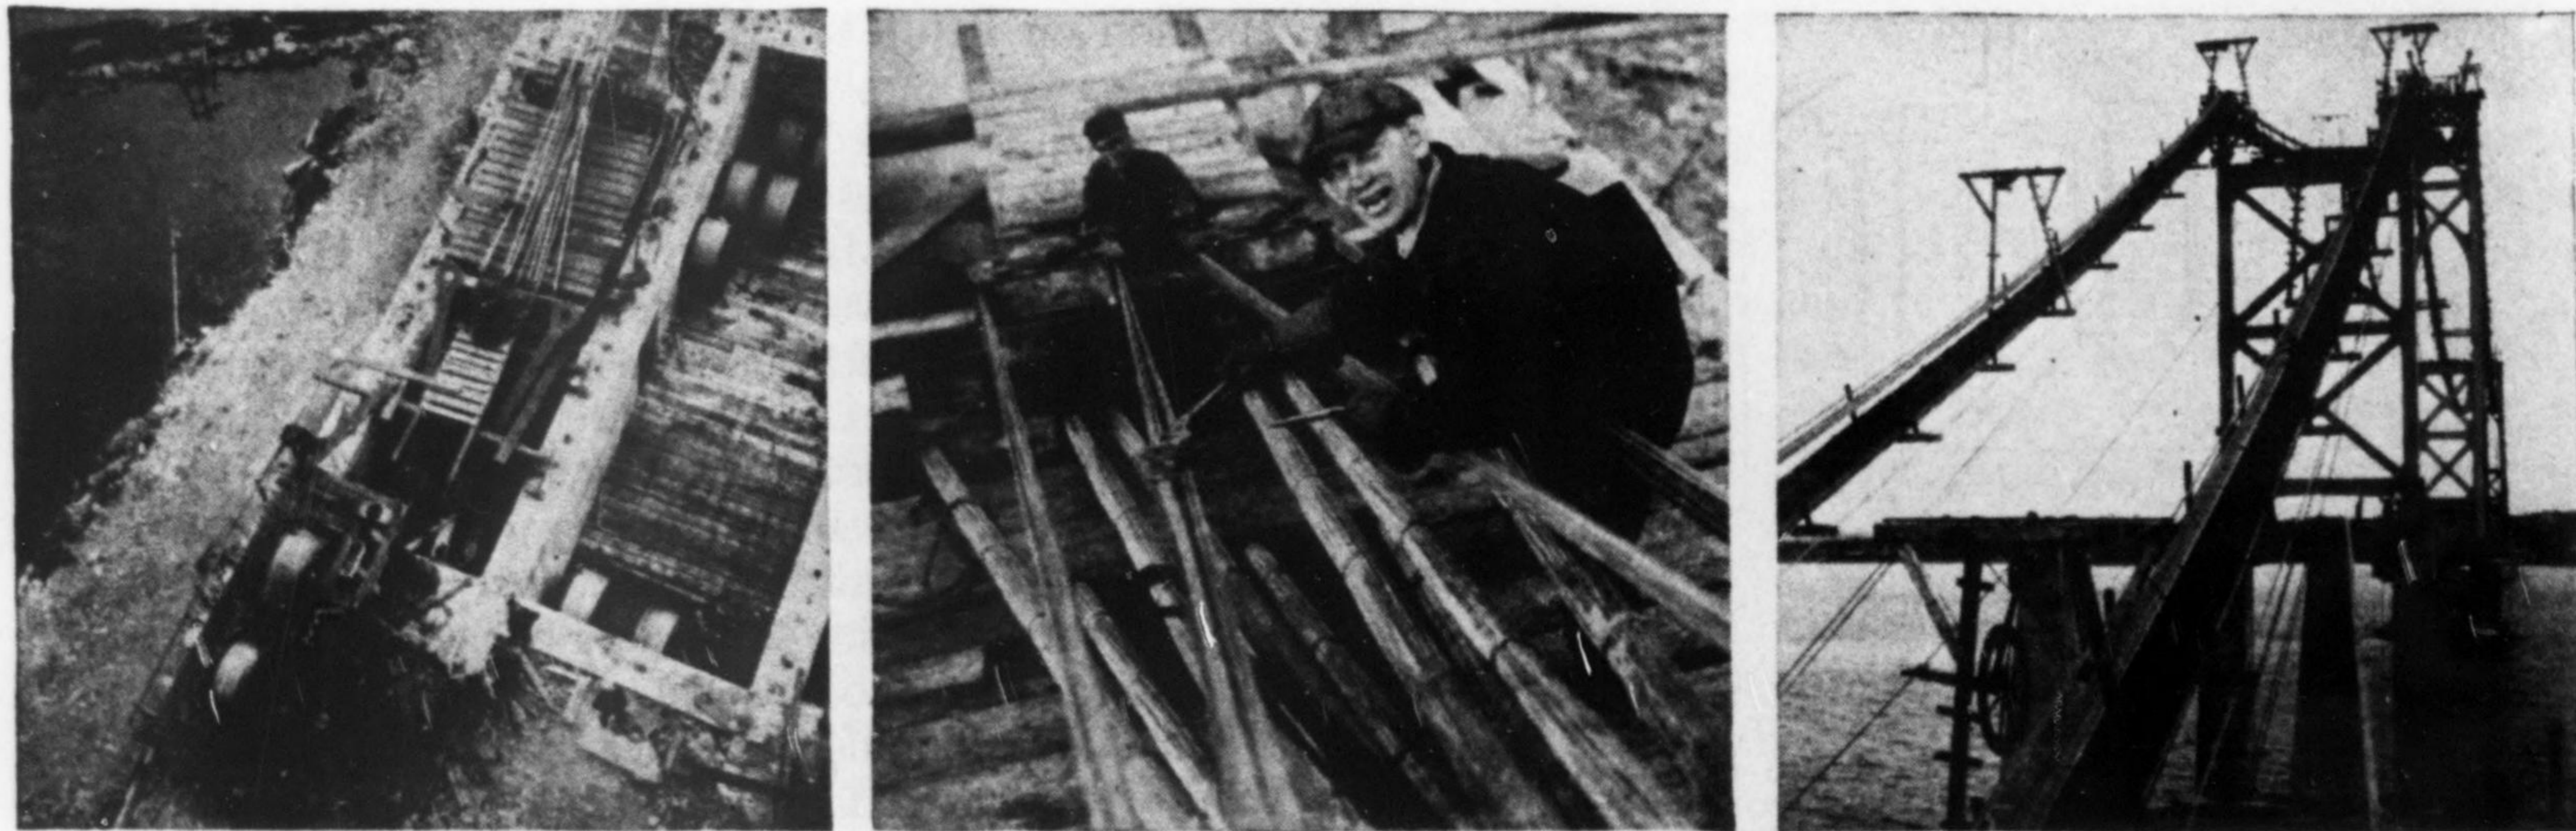
FIG. 5—THREE VIEWS OF THE CABLE-SPINNING OPERATIONS ON THE MOUNT HOPE BRIDGE

There are two 11-in. wire cables 34 ft. apart, each consisting of seven strands of 350 wires (No. 6, heat treated and galvanized) having a theoretical diameter of 0.196 in. and providing a total cross-section per cable of 74 sq.in. Actually the wires ran somewhat under the theoretical cross-section and several more than the 350 wires were included in most of the strands. The seven strands are arranged in three tiers, two strands on the top, three strands in the center and two strands in the bottom tier (Fig. 5, center).

At left—Arrangement of equipment in the Bristol East anchorage showing reels of wire in reel frames; extra reels in pit at right. Center—Adjusting wires for sag. Note arrangement of strand shoes in three tiers. Right—Traveling wheel running on endless hauling cable and bringing a bight of wire from the far shore.

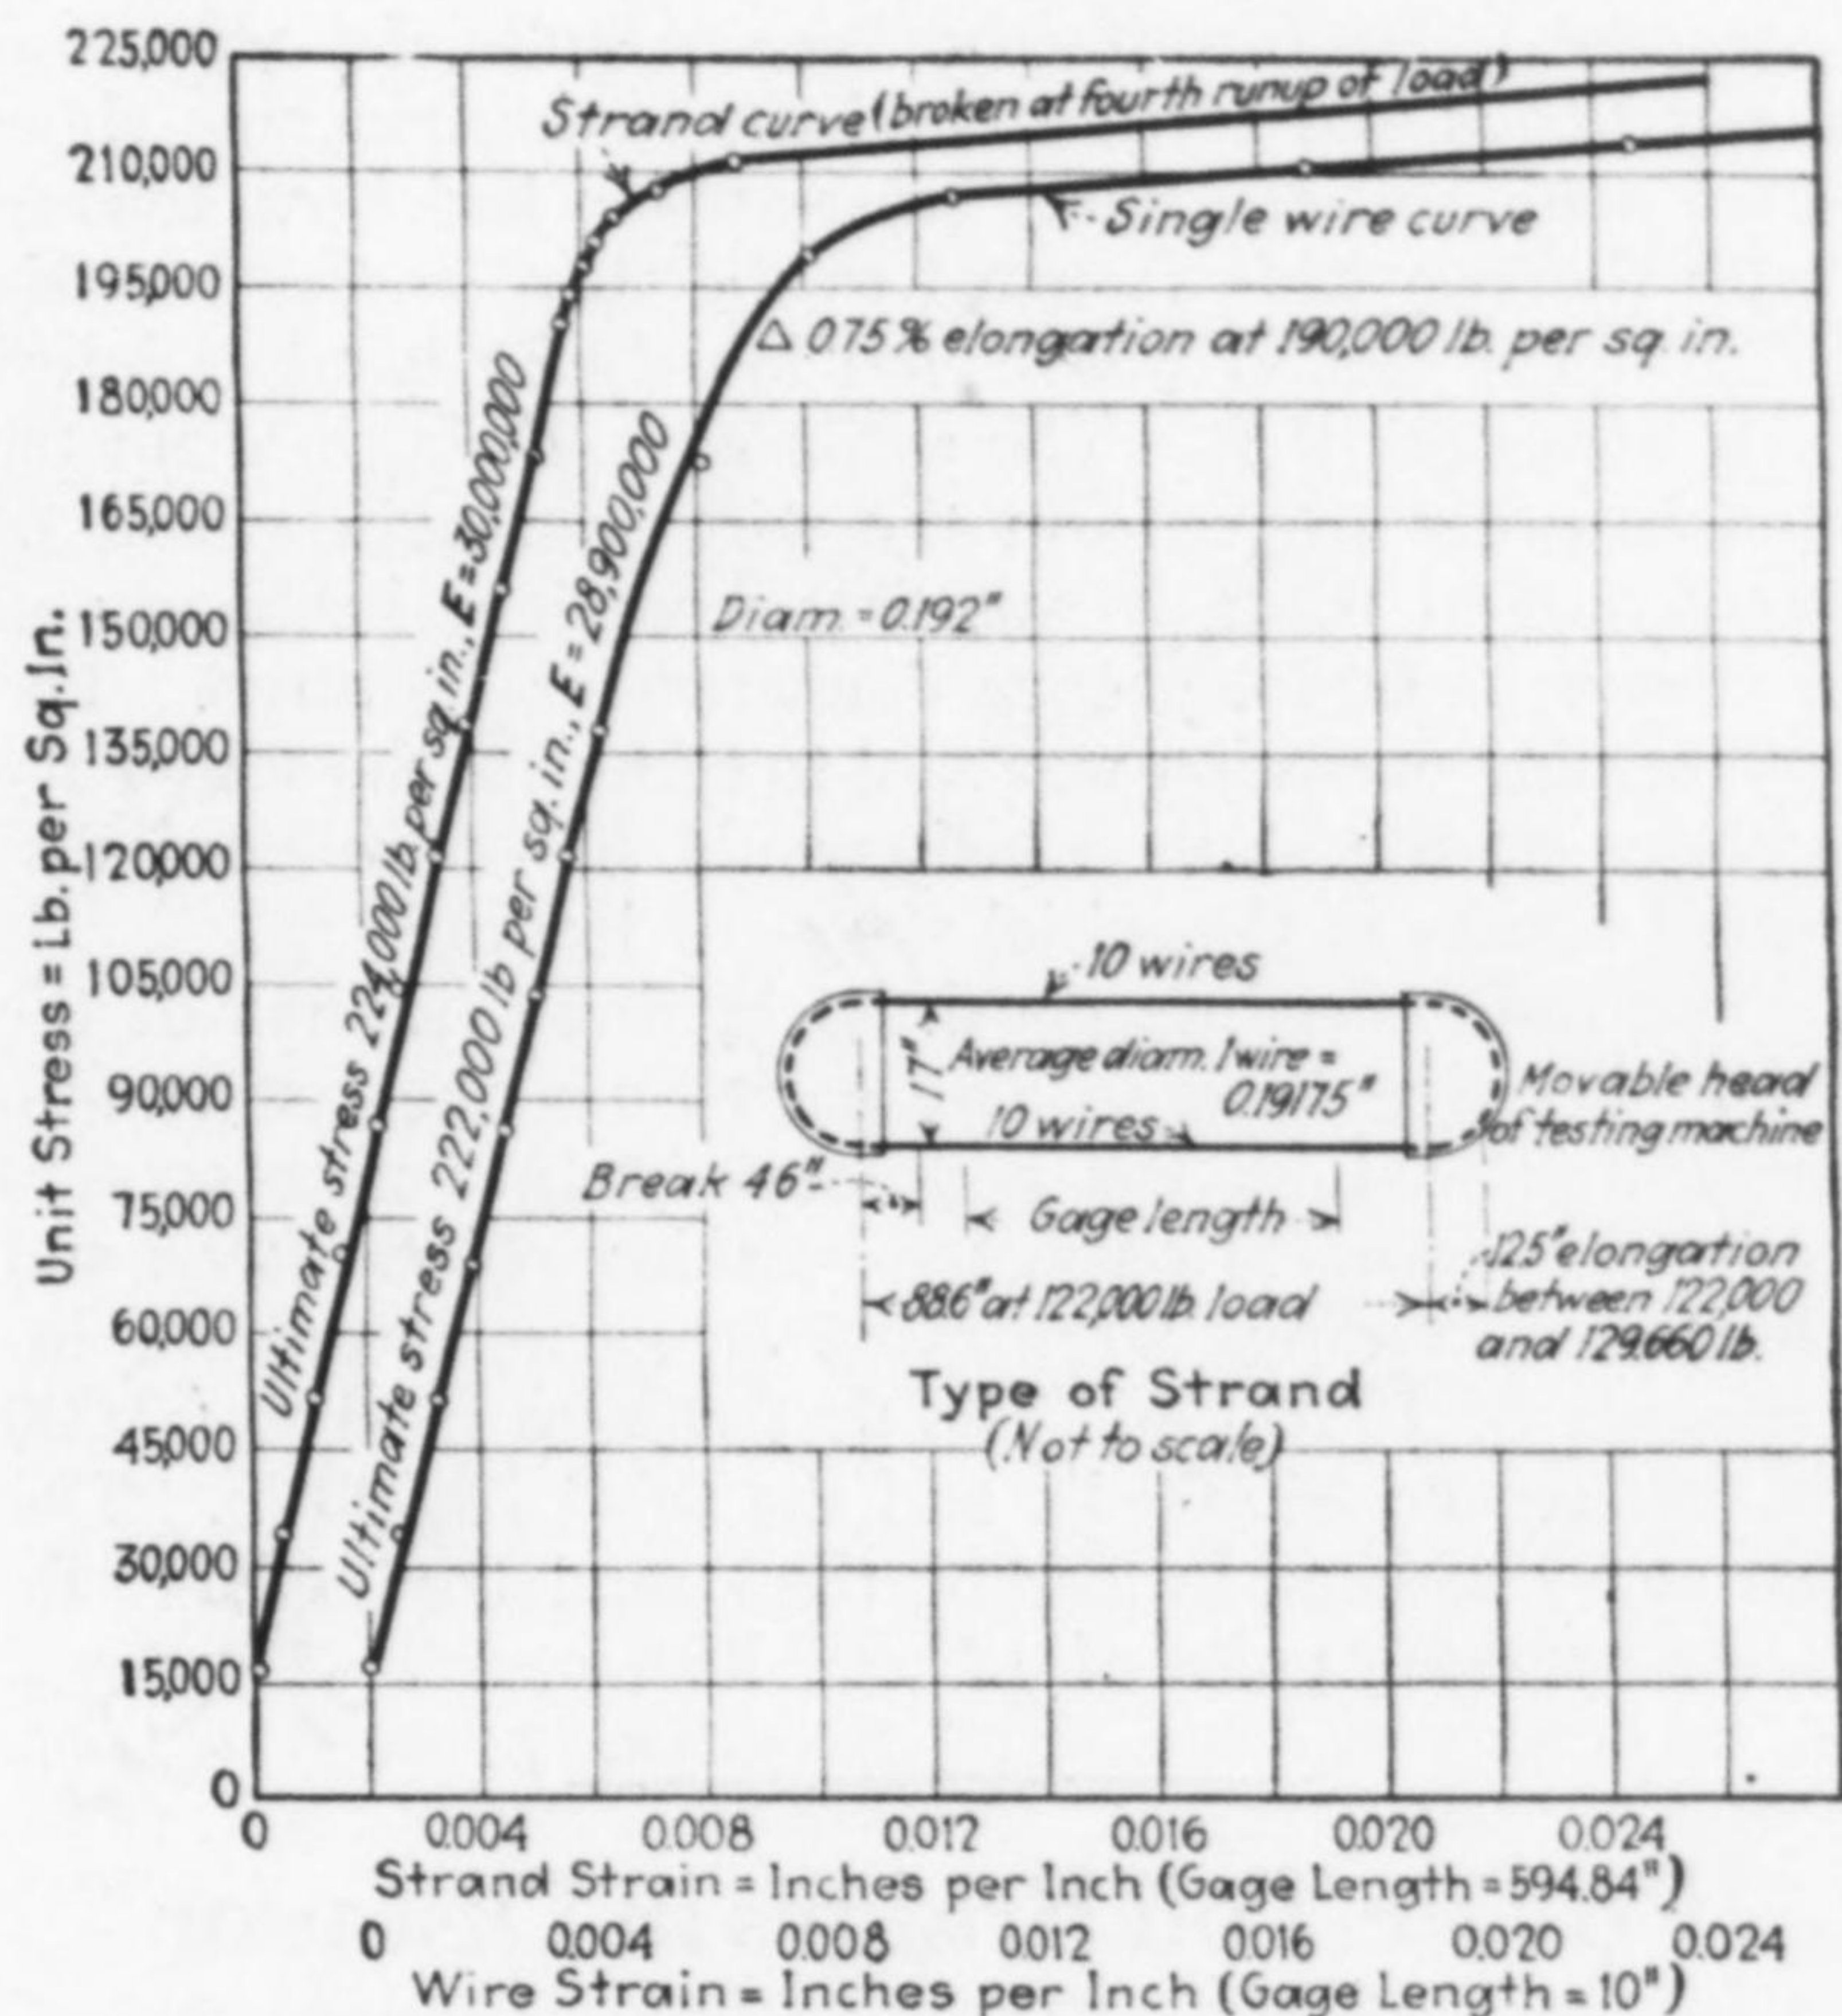
FIG. 6—STRESS-STRAIN DIAGRAMS OF A TWENTY-WIRE STRAND AND OF AN INDIVIDUAL WIRE (FROM PRELIMINARY SHOP TESTS)

In Fig. 6 are shown the stress-strain diagrams of a strand containing twenty parallel wires of No. 6 gage and of a single wire from the same coil, the data originating in a shop test made in May, 1928, to determine the modulus of elasticity. The wire in the strand was approximately 2,000 ft. long and was cut from a coil which had been rejected because of a rough coat of gal-

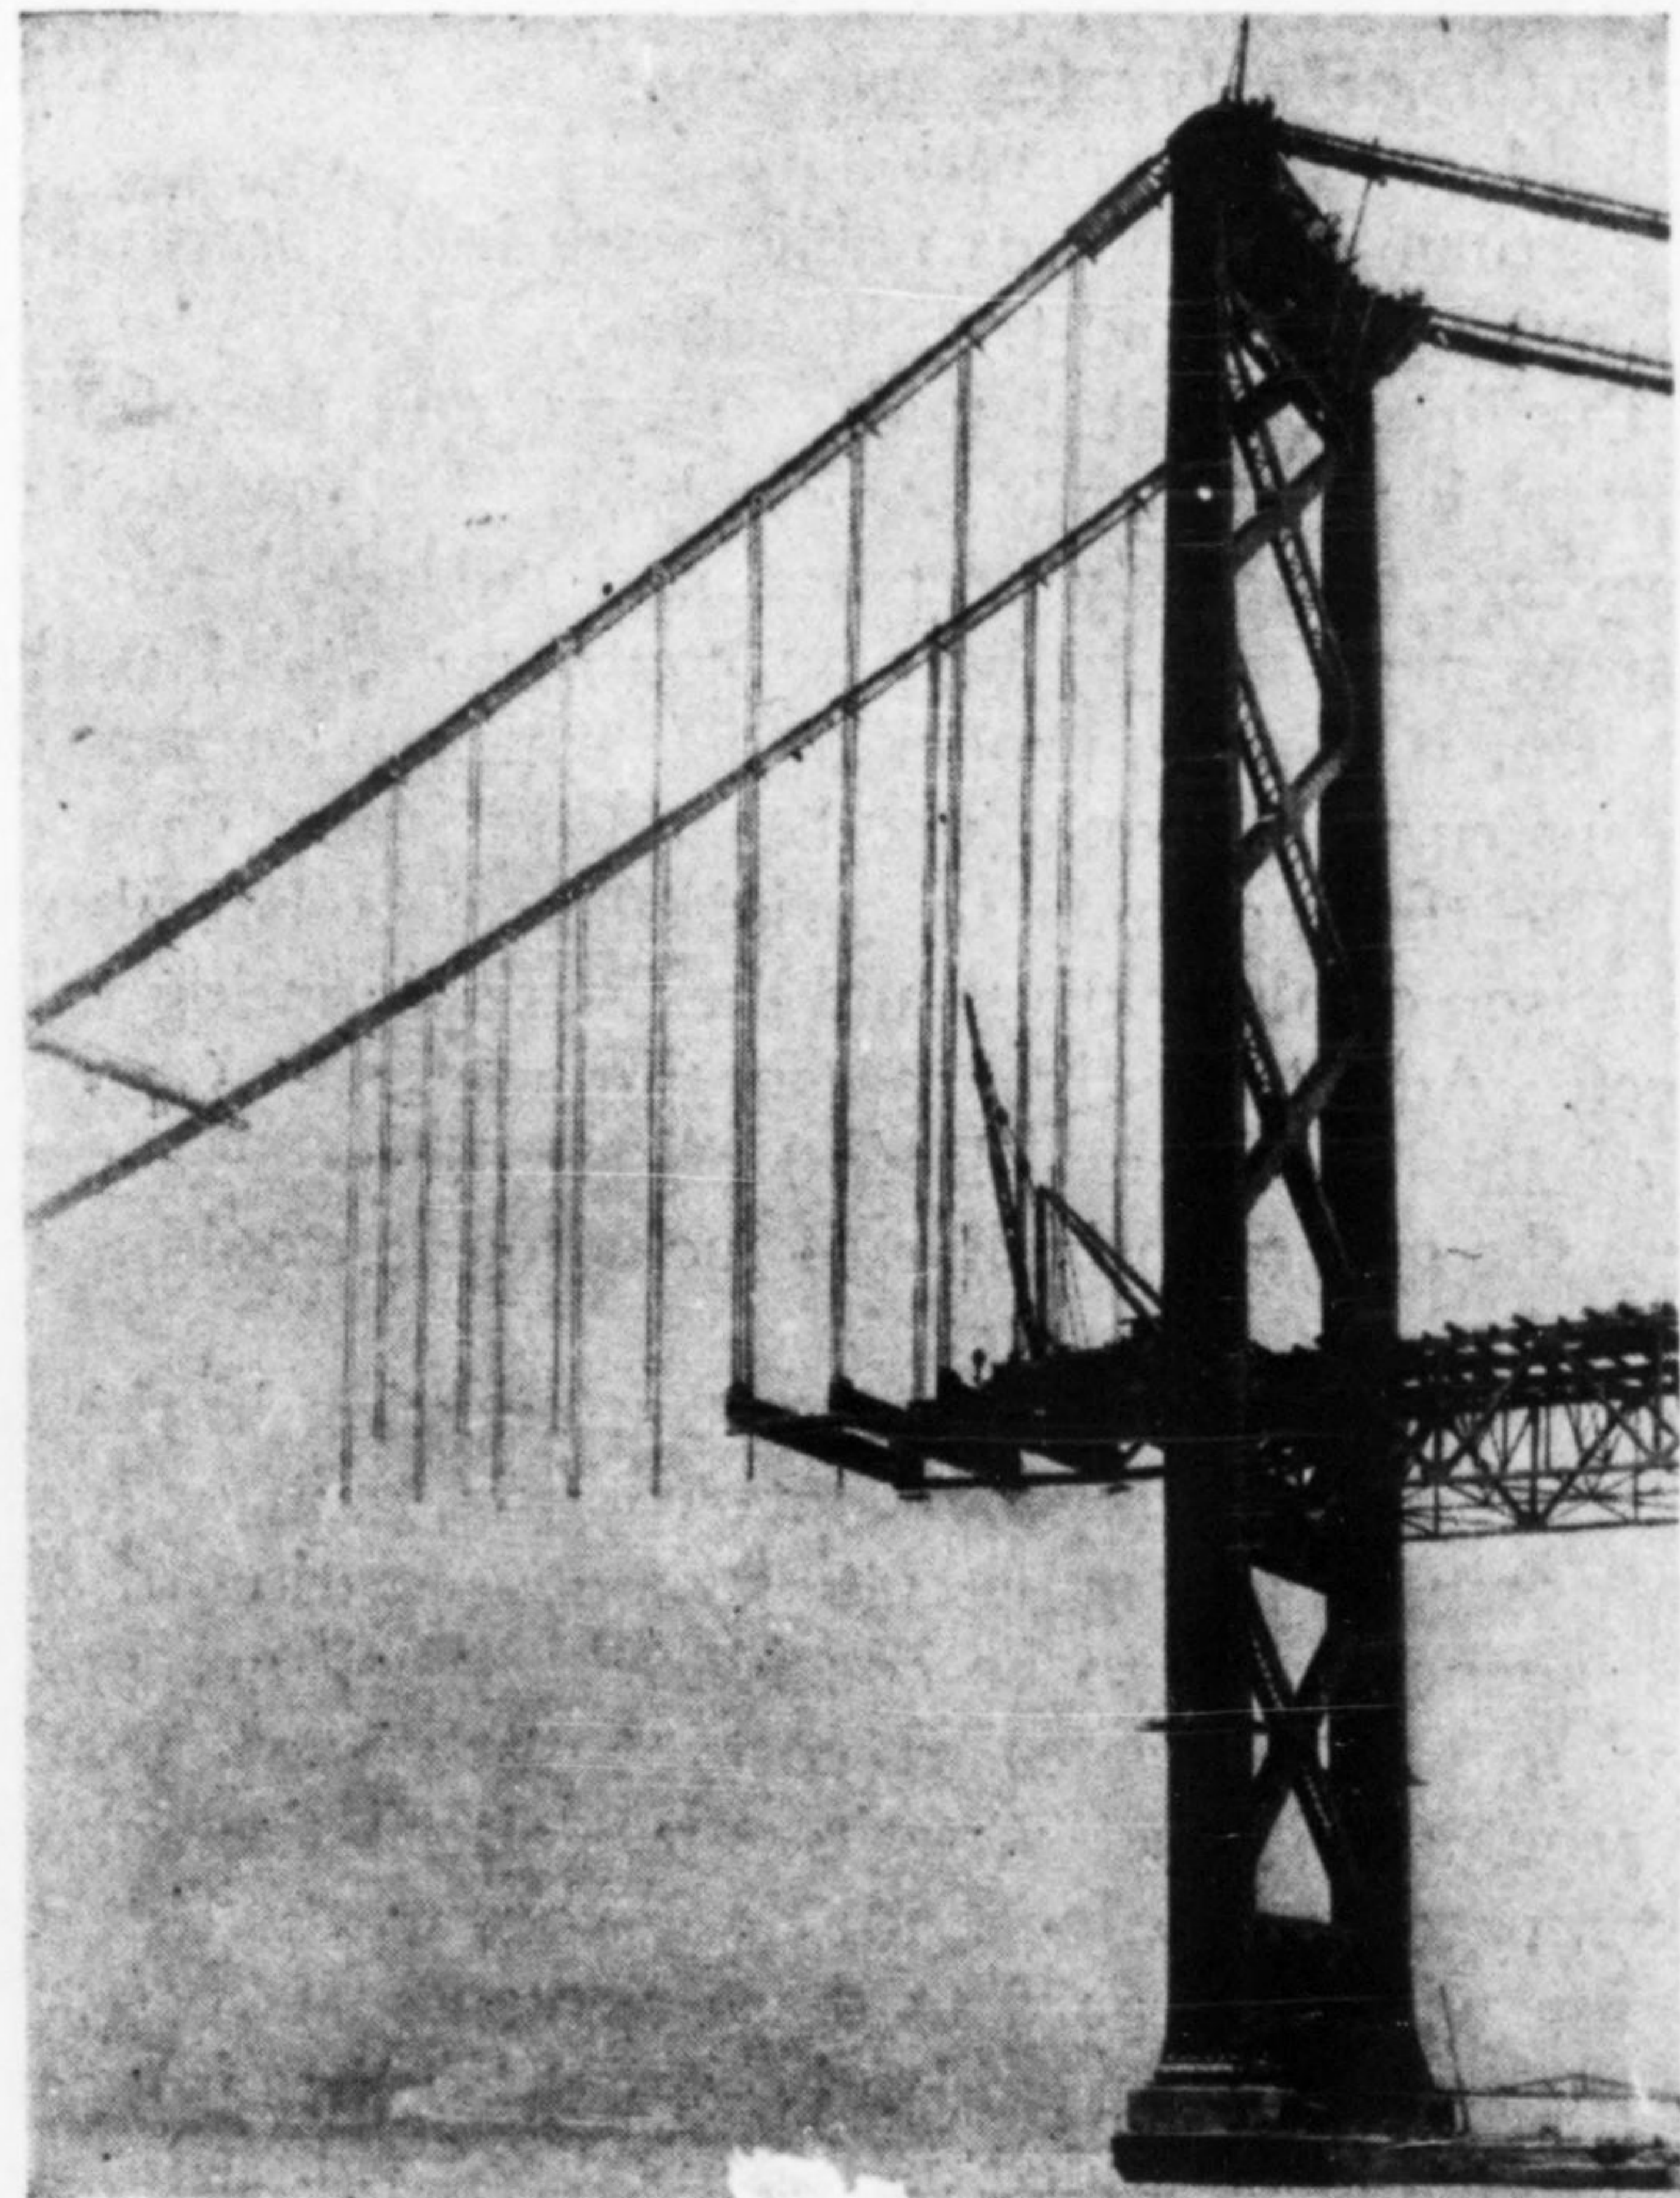
FIG. 2—AMBASSADOR BRIDGE BEFORE DISMANTLING

Four of fourteen panels of floor steel that had been erected before dismantling began are still in place.

Dismantling Structural Steel—Fourteen panels of structural steel similar to those shown in Fig. 2 and extending outward approximately 340 ft. from each main tower were in place when dismantling work began. This steel comprised floorbeams, bottom chords of stiffening trusses and four lines of stringers. No riveting had been done, hence removal of the structural steel was easily accomplished. The procedure was the exact reverse of erection, the deck travelers lowering the stringers, bottom chords and floorbeams in sequence to barges in the river below. Structural steel dismantling began on April 2, and was completed on April 10.

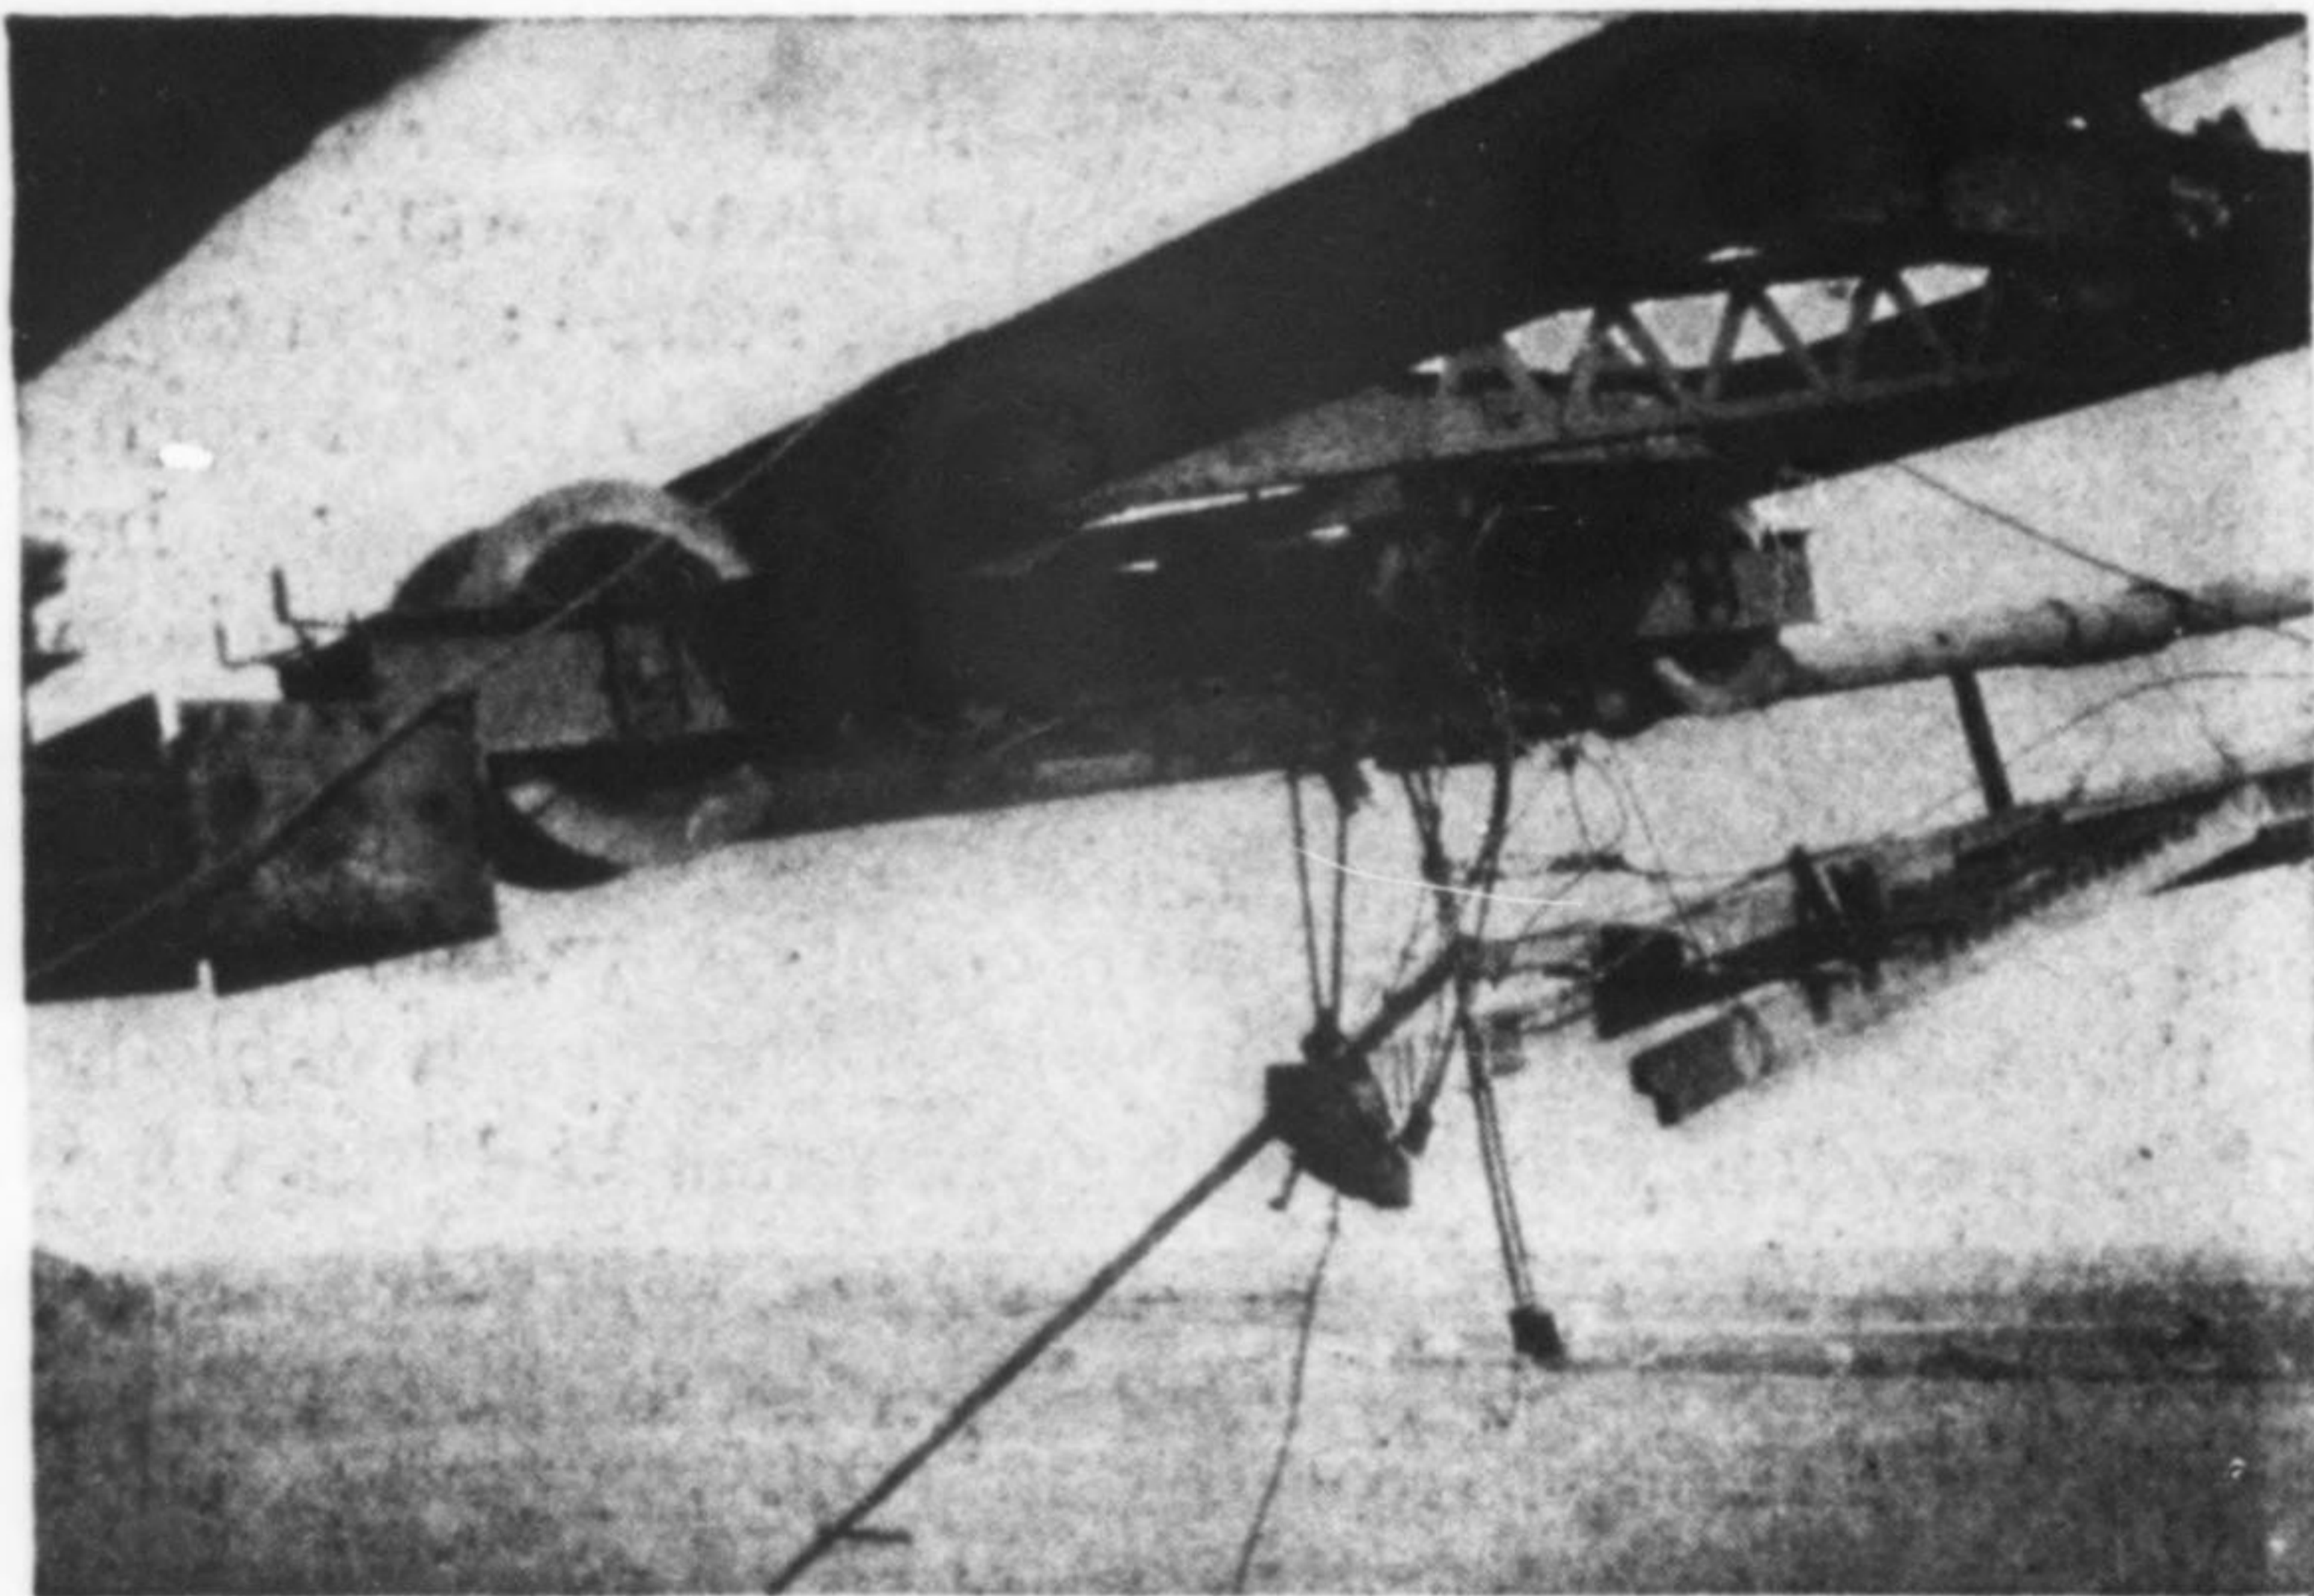
FIG. 5—TRAVELERS AT MOUNT HOPE DESIGNED TO RUN ON CABLES

Sheave shown used for setting truss sections. Another sheave just out of picture at the right carried falls for handling floorbeams and stringers. Cable bent holdback yoke at left.

A view of the traveler is shown in Fig. 5. Grooved cast-steel wheels are mounted between a pair of 15-in. channels, while the framework of the traveler, spanning from cable to cable, consists of two 18-in. I-beams spaced by four pairs of 12-in. channels running parallel to the cables. These 12-in. channel frames carry the hoisting sheaves, those shown in the accompanying illustration being 3 ft. off the center line of the cable and used for setting truss sections. Another set of sheaves 10 ft. 7½ in. off the cable center line carries the falls for handling floor beams and stringers.

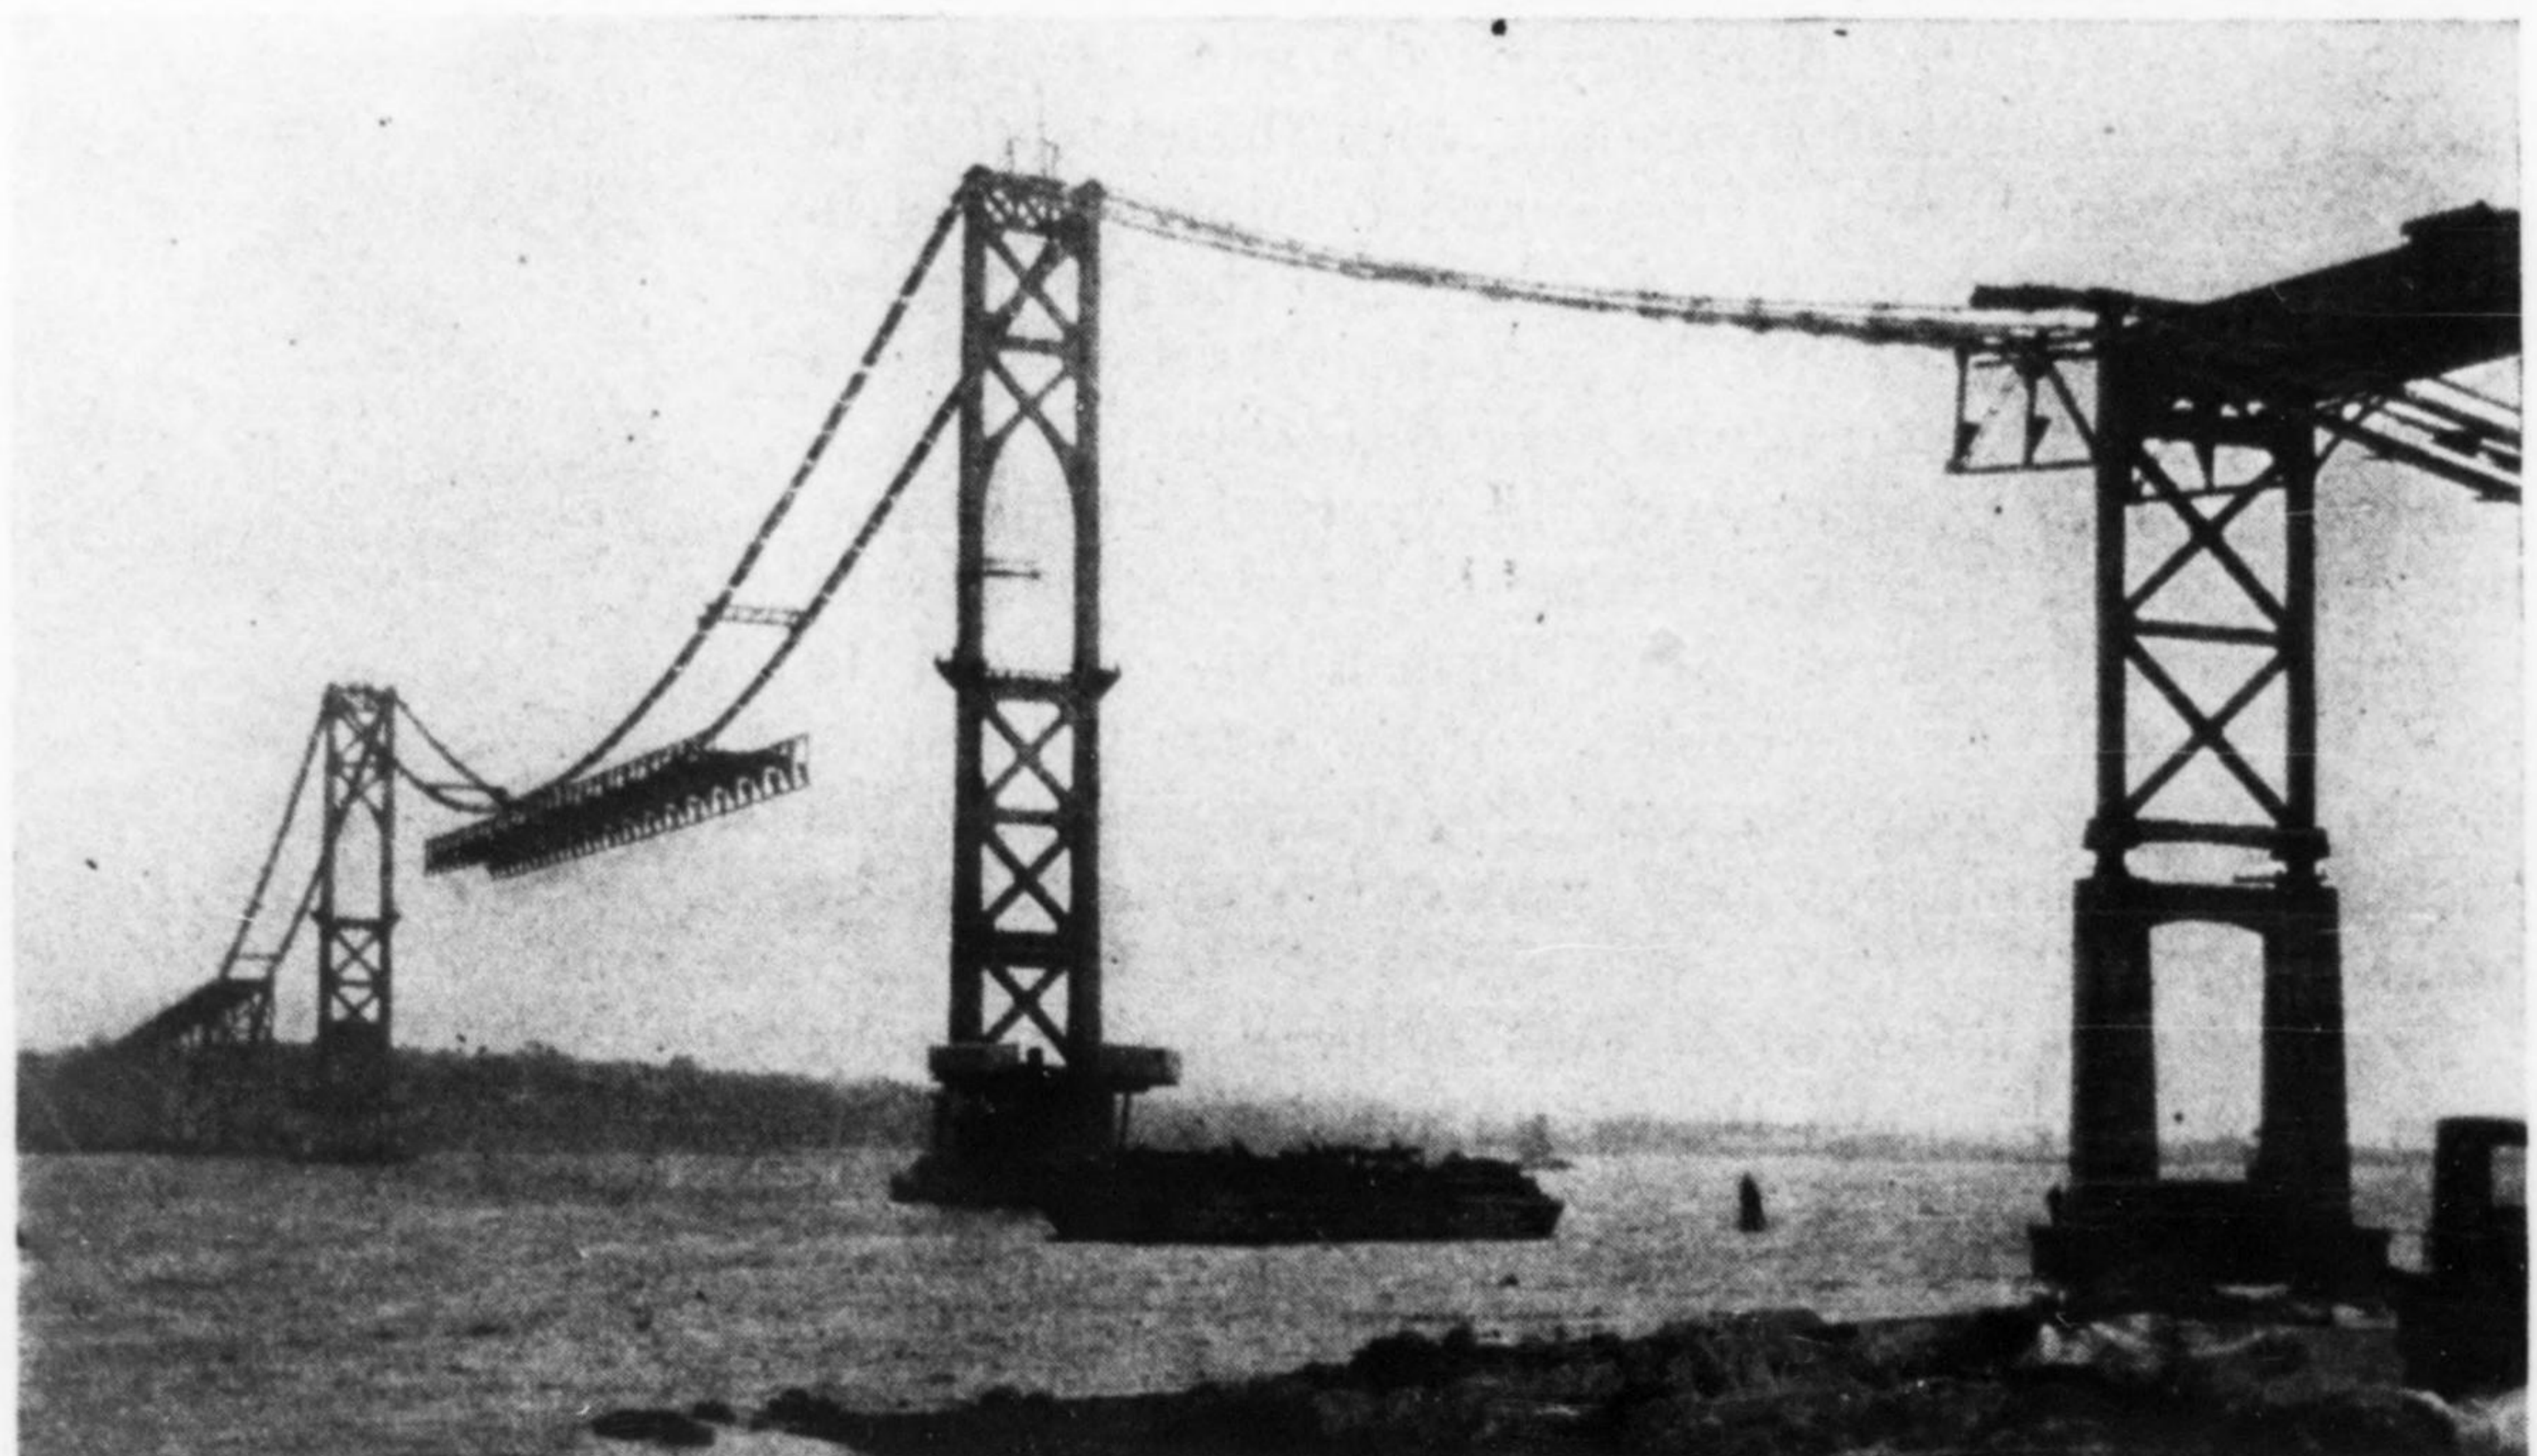
FIG. 6—DISMANTLING TRAVELERS WORKING AWAY FROM MAIN TOWERS, MOUNT HOPE

Note that side spans are down except for one panel. Before the last ten panels in main span could be removed, the main tower saddles had to be jacked shoreward 10 in. to maintain the system in balance.
