Technical Aspects of Cable Wire Breakages on the Mount Hope Suspension Bridge

Breaks Localized in Strand Shoes—Progressive Breaking Noted in Spite of Load Reduction—Cable Spinning Methods—Characteristics of Wire and Its Manufacture—Temporary Repair Measures

IN MARCH of this year engineering circles were shocked to learn of serious breakages in the cable wires of two important highway suspension bridges then under construction. News of the breakages was followed by a cessation of work on both structures and later by the decision to dismantle the bridges and replace the suspension systems with satisfactory wire. Interesting operations of unprecedented kind were involved in the dismantling. Both structures utilized the same kind of wire, a heat-treated product of high elastic limit, heretofore untried in suspension bridge service. The Mount Hope bridge, near Providence, R. I., which had a center span of 1,200 ft., was within about twelve months of completion, requiring only the placing of the concrete floor slab. The Ambassador bridge at Detroit, whose sus-

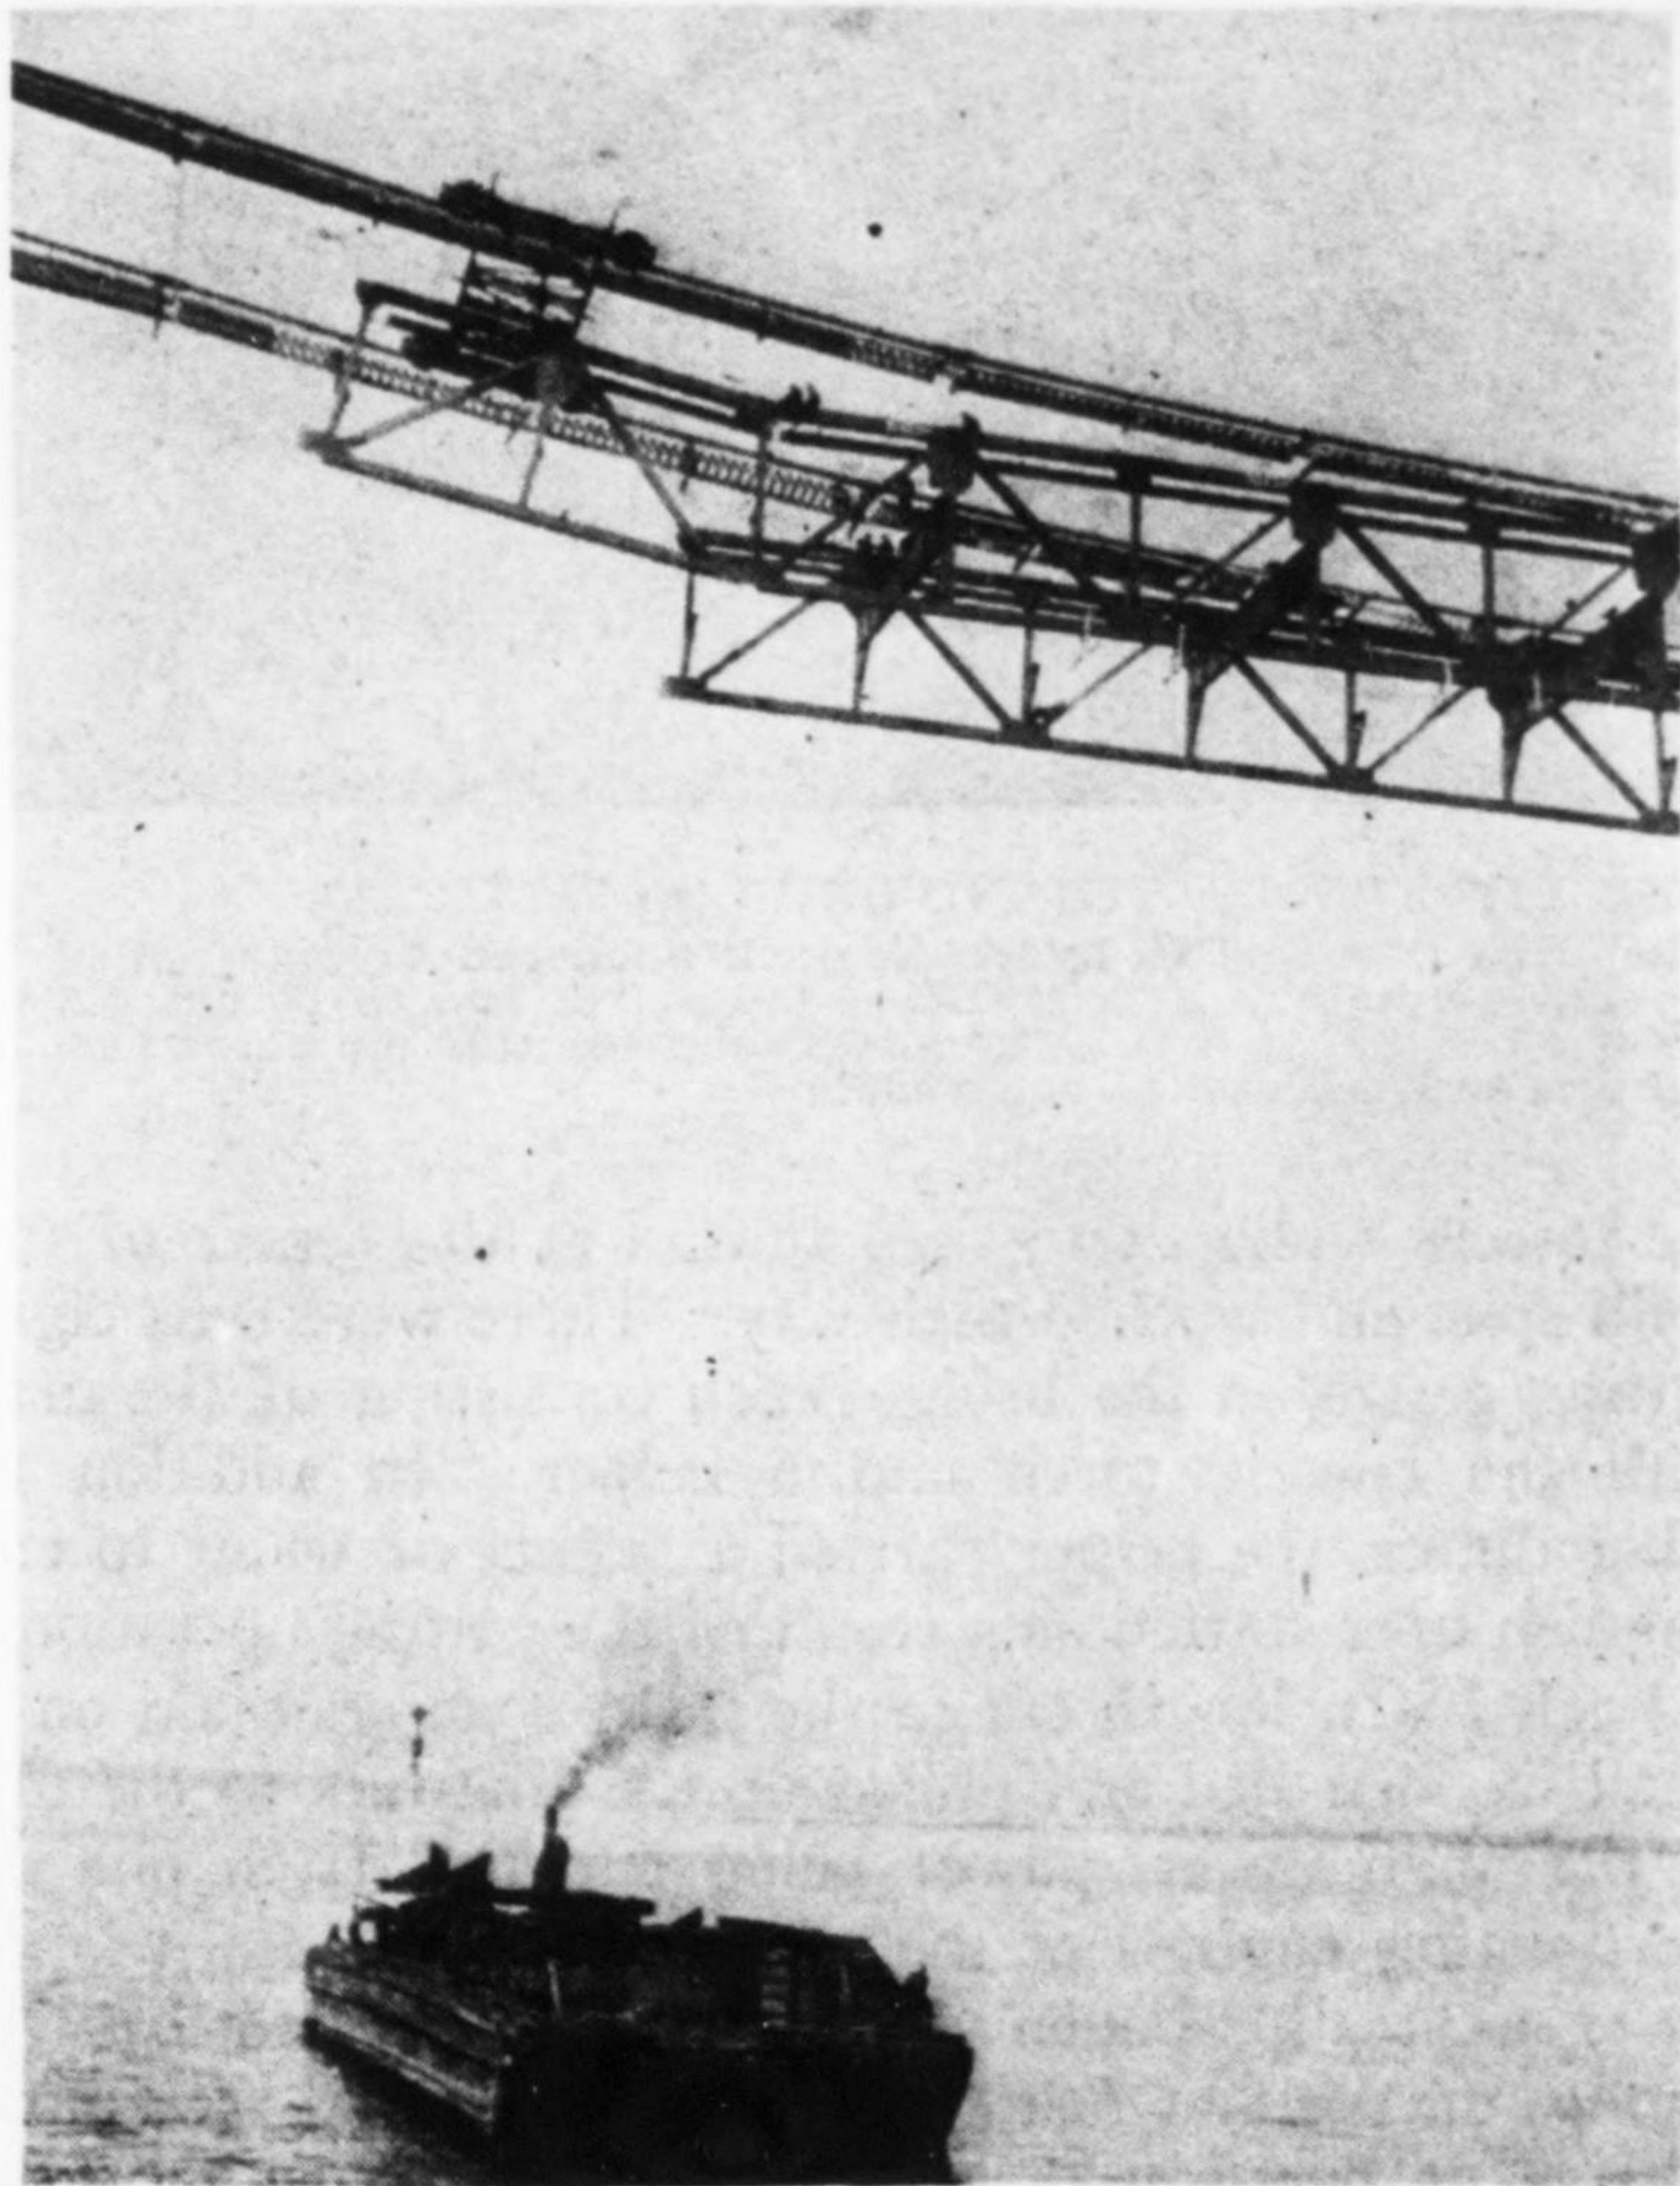
FIG. 7—TRAVELER LIFTING TRUSS SECTION FREE OF SUSPENDERS, MOUNT HOPE

Note alternate floorbeams at suspender points. Floorbeams at splice points were lowered on first pass of traveler. Truss section has just been deposited on barge.

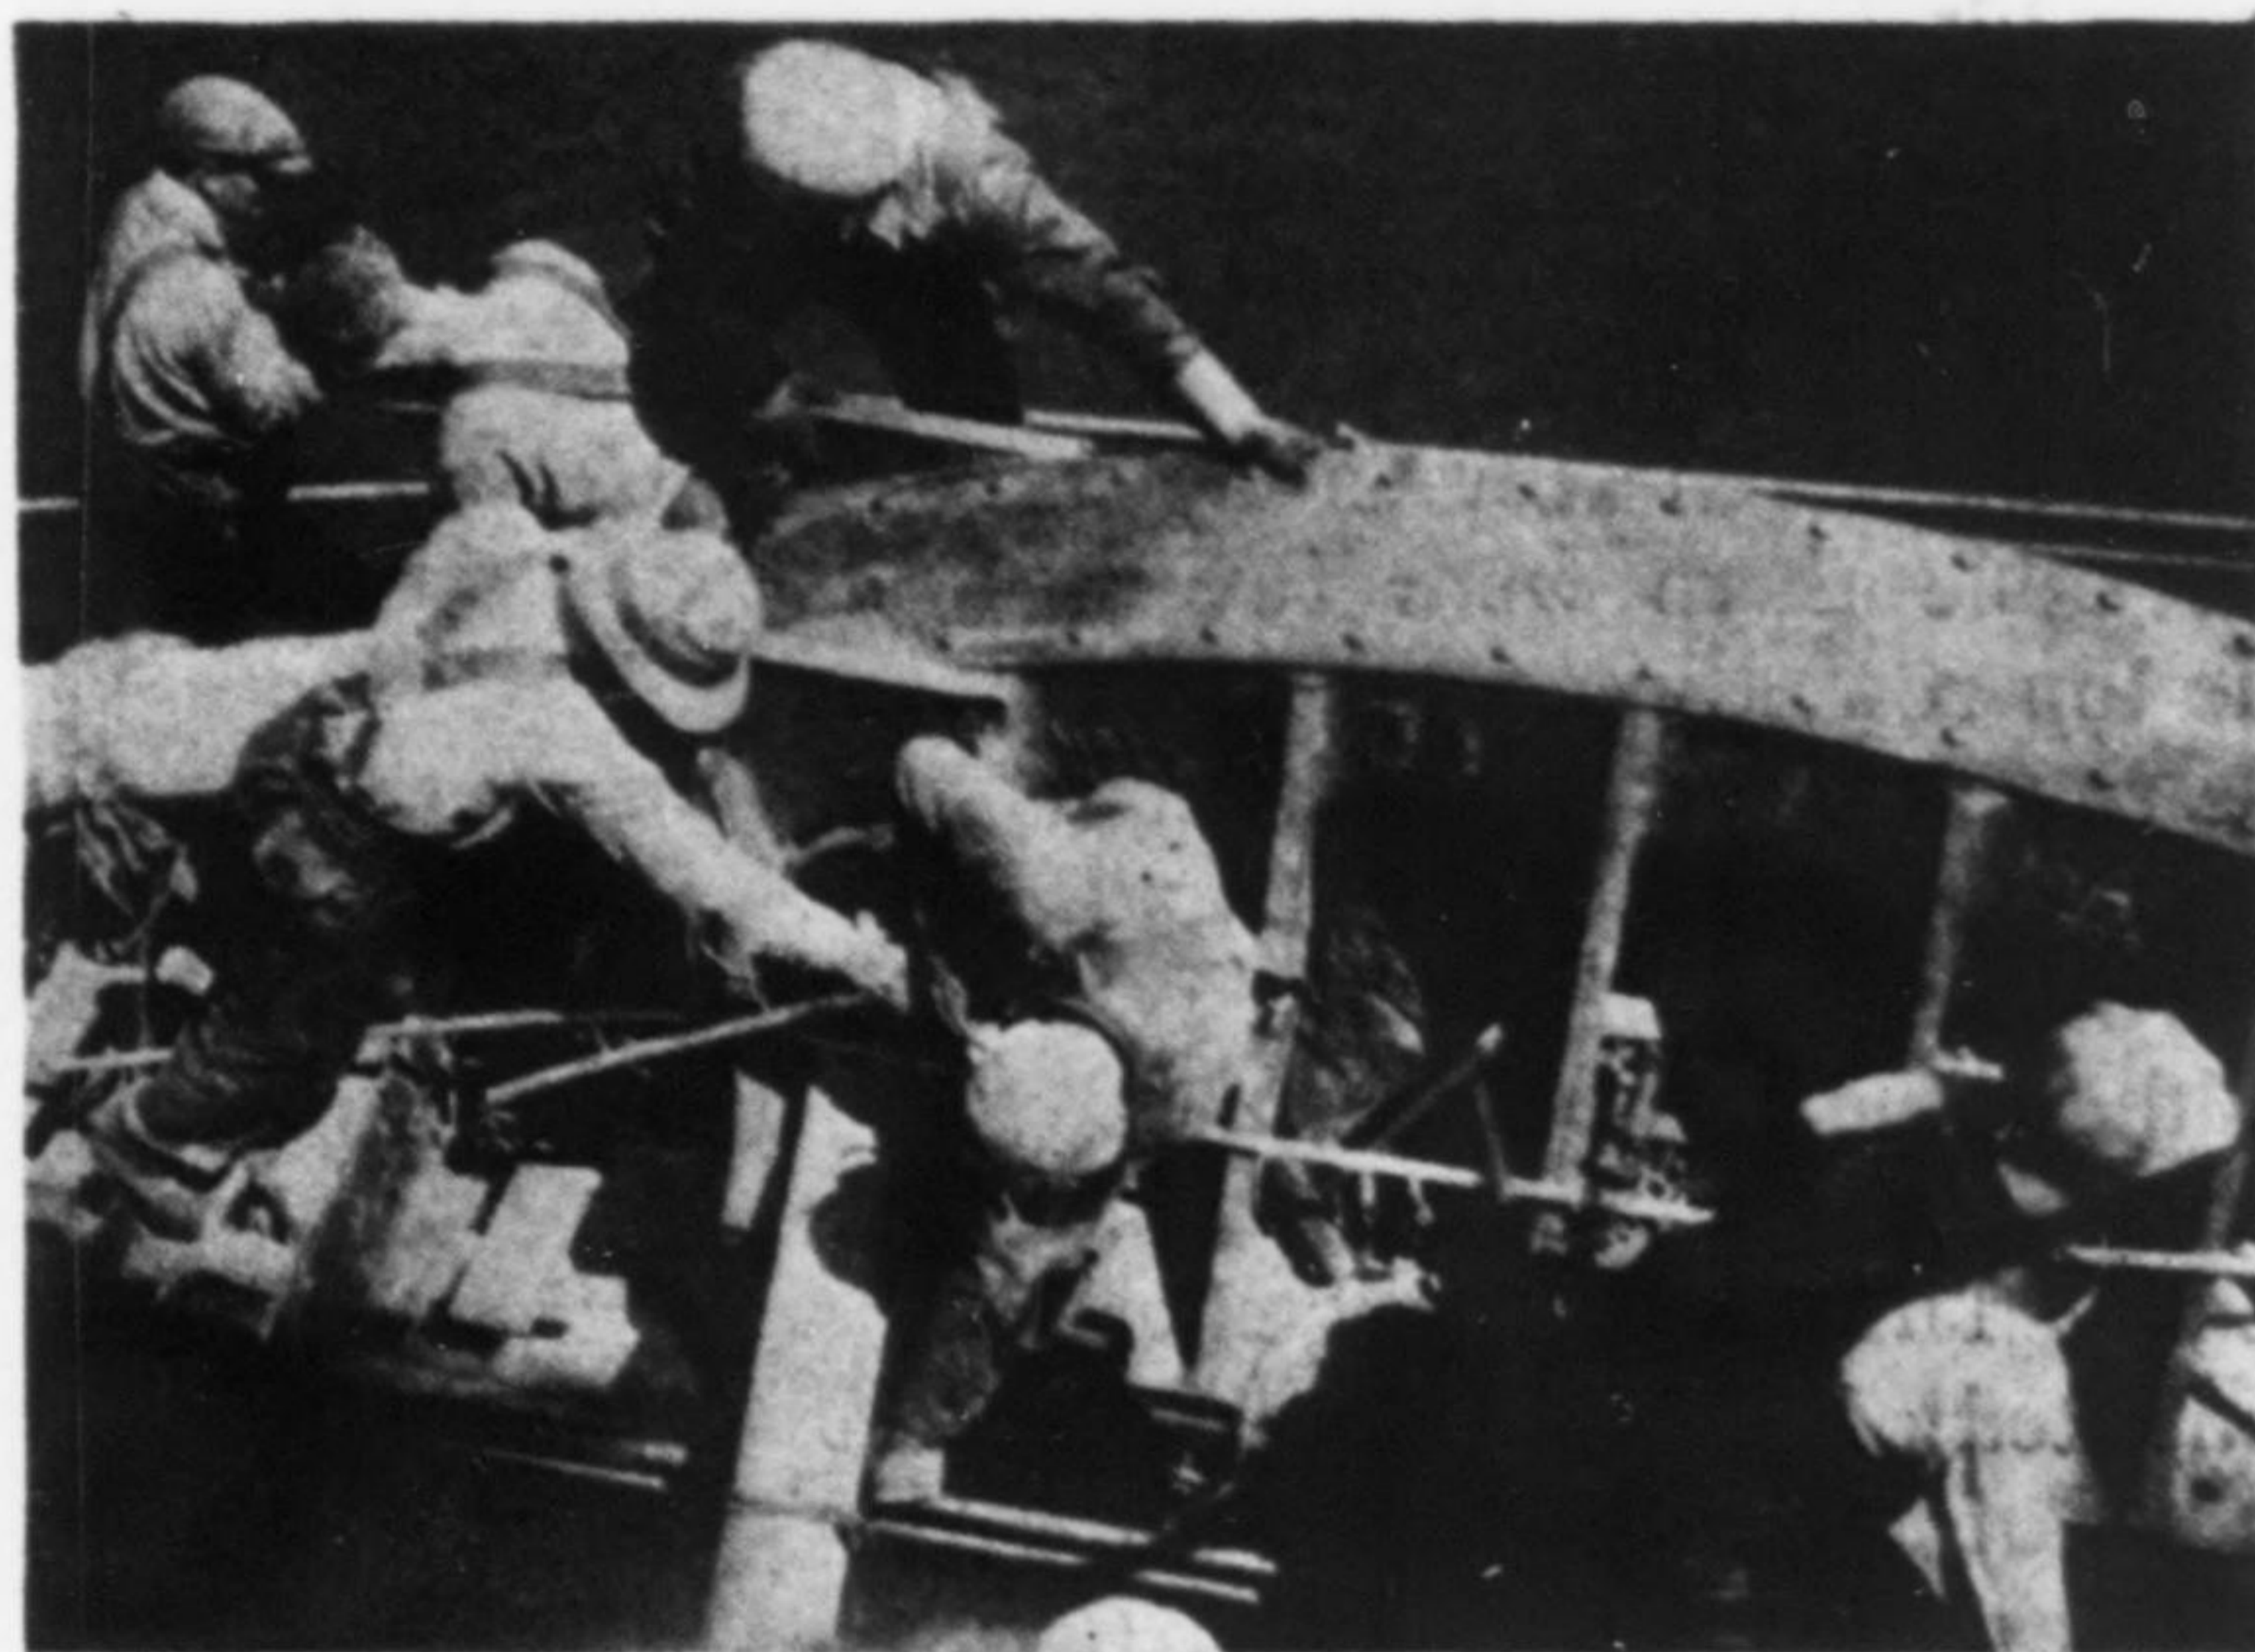
FIG. 8—JACKING THE MAIN TOWER SADDLE AT MOUNT HOPE

trusses having been previously taken down as shown in Fig. 6) the saddles on the towers had to be jacked back 10 in. toward the anchorages—the reverse of the operation performed during erection. Graphite had been spread on the base plate when the saddles were erected, so that two 25-ton screwjacks easily moved them the required distance (Fig. 8). After these ten sections of stiffening trusses had been lowered, jacking was continued for 10½ in. more in order to restore the towers to a plumb position.

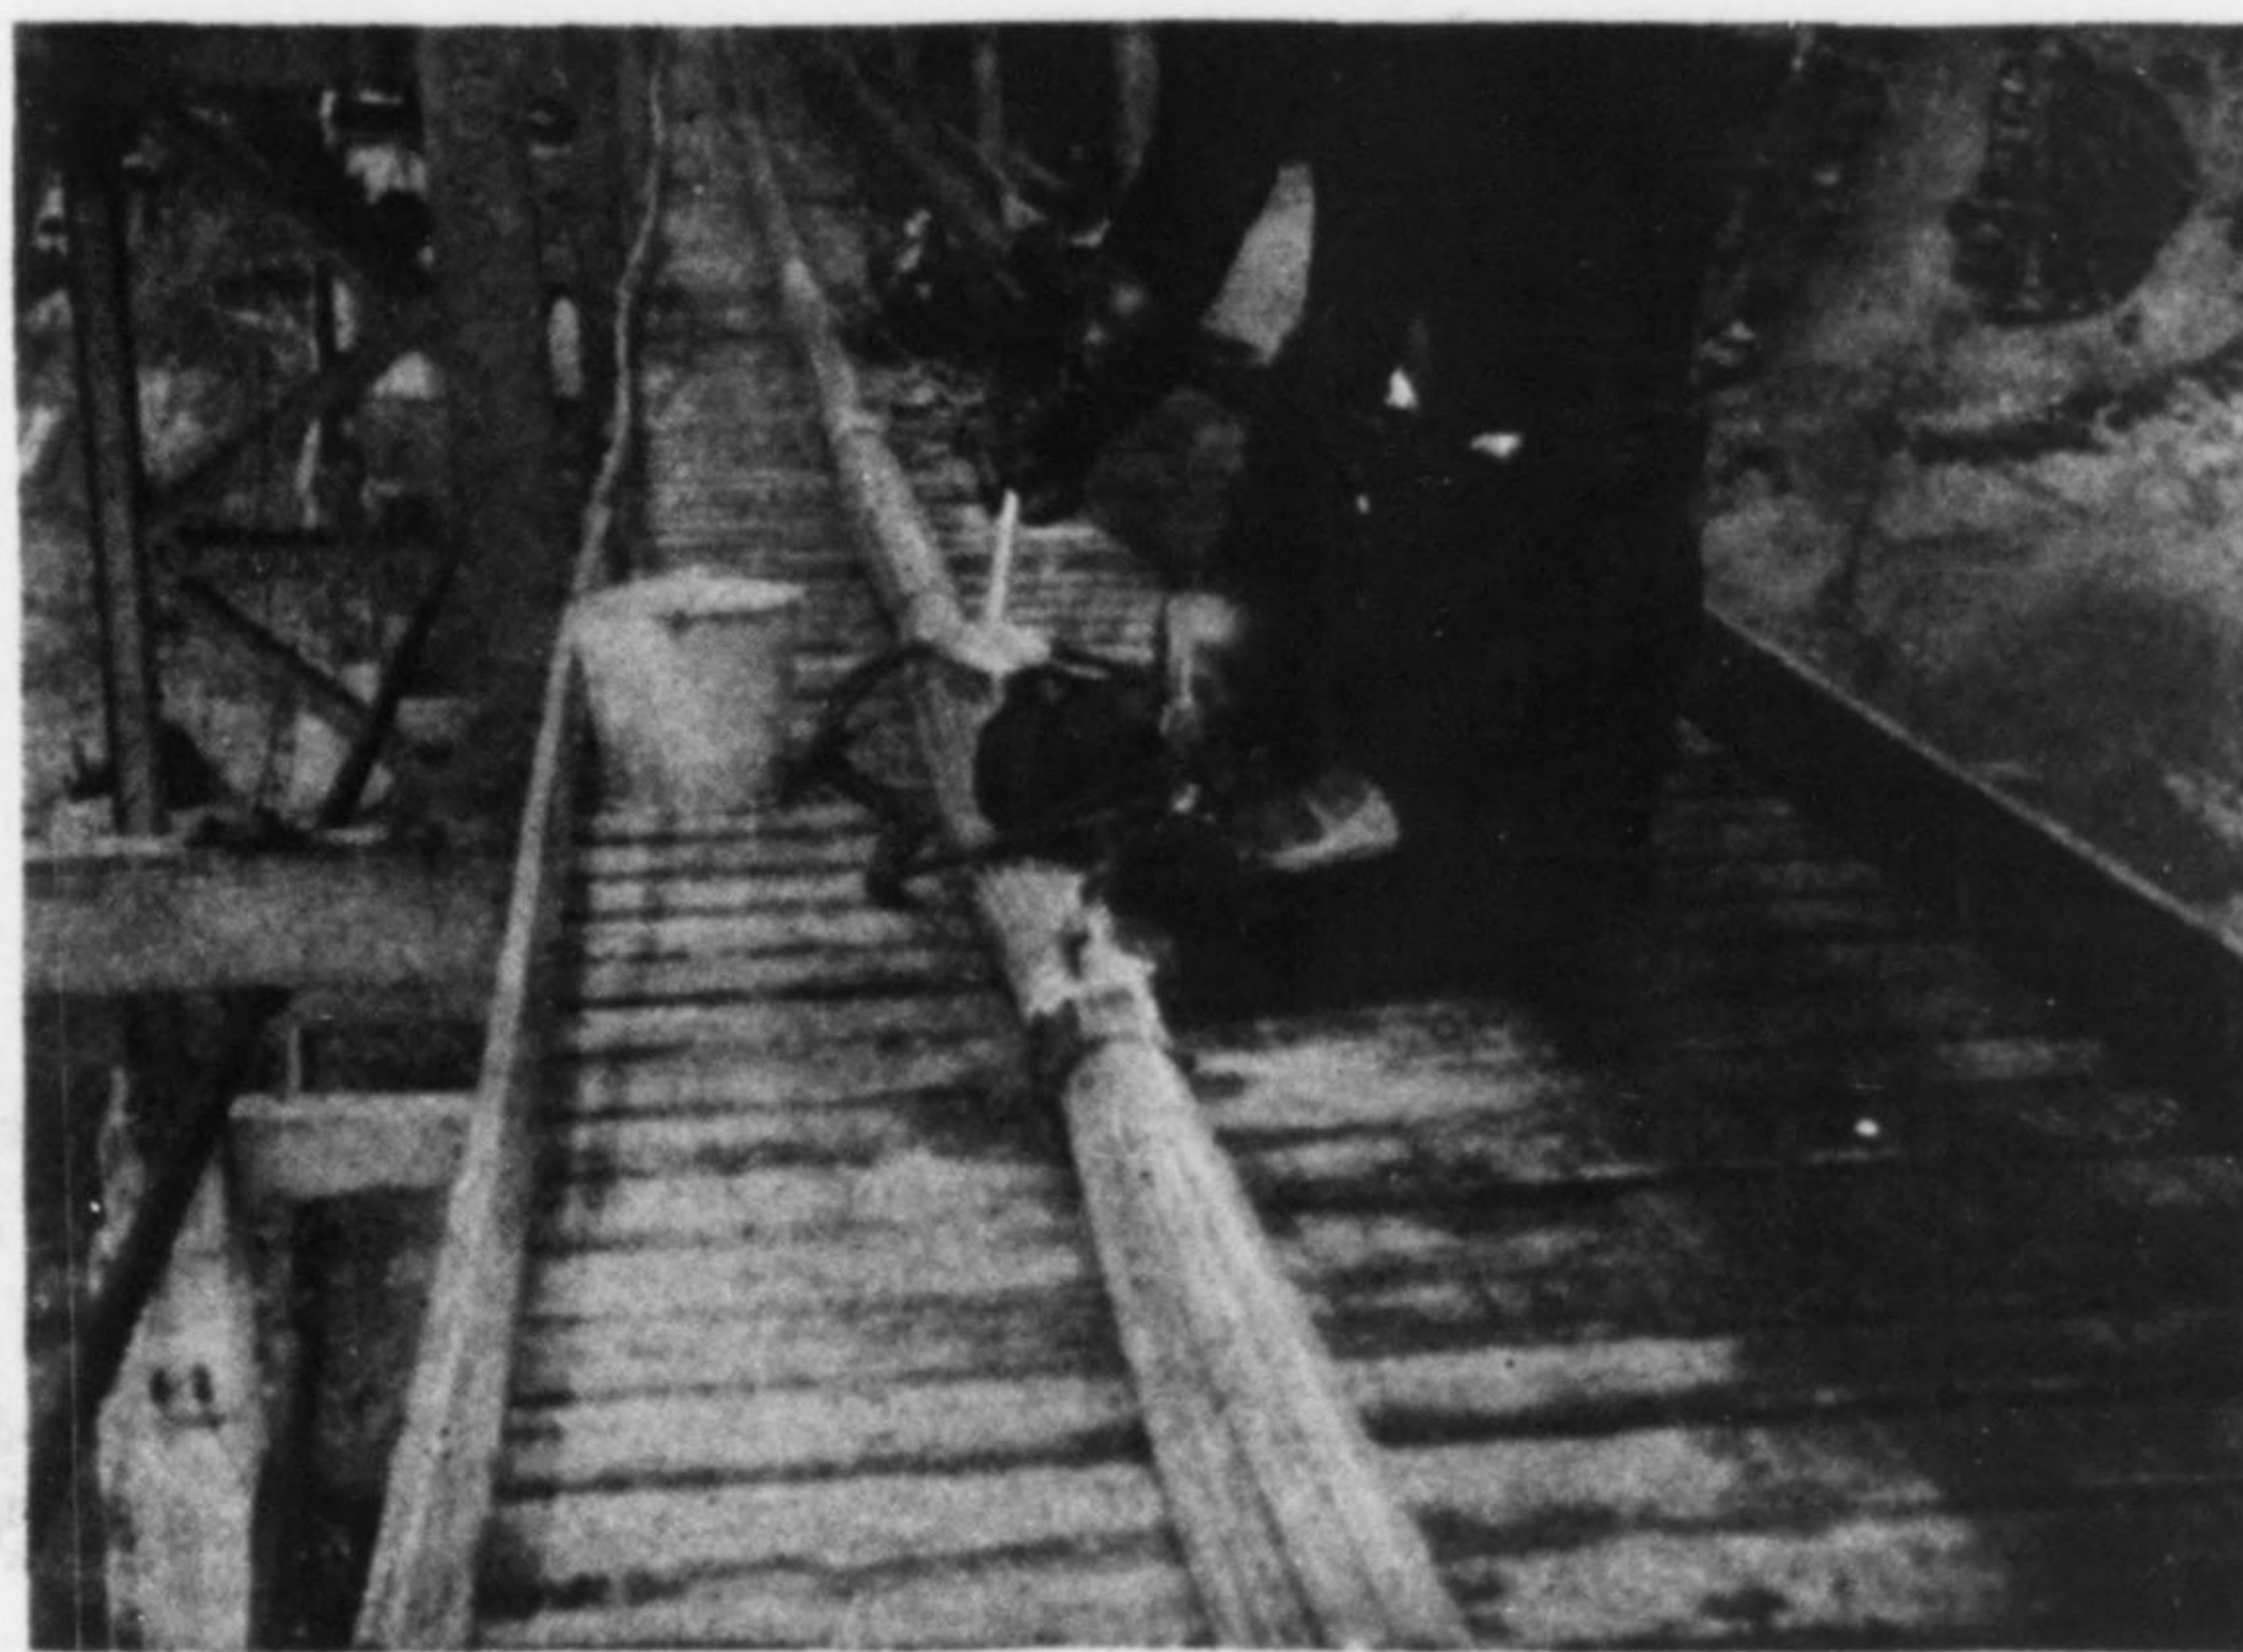
FIG. 9—CUTTING A STRAND INTO 15-FT. LENGTHS AT MOUNT HOPE

Helper moves sleds carrying gas tanks and stands by with pail of water to put out any fires in footwalk.

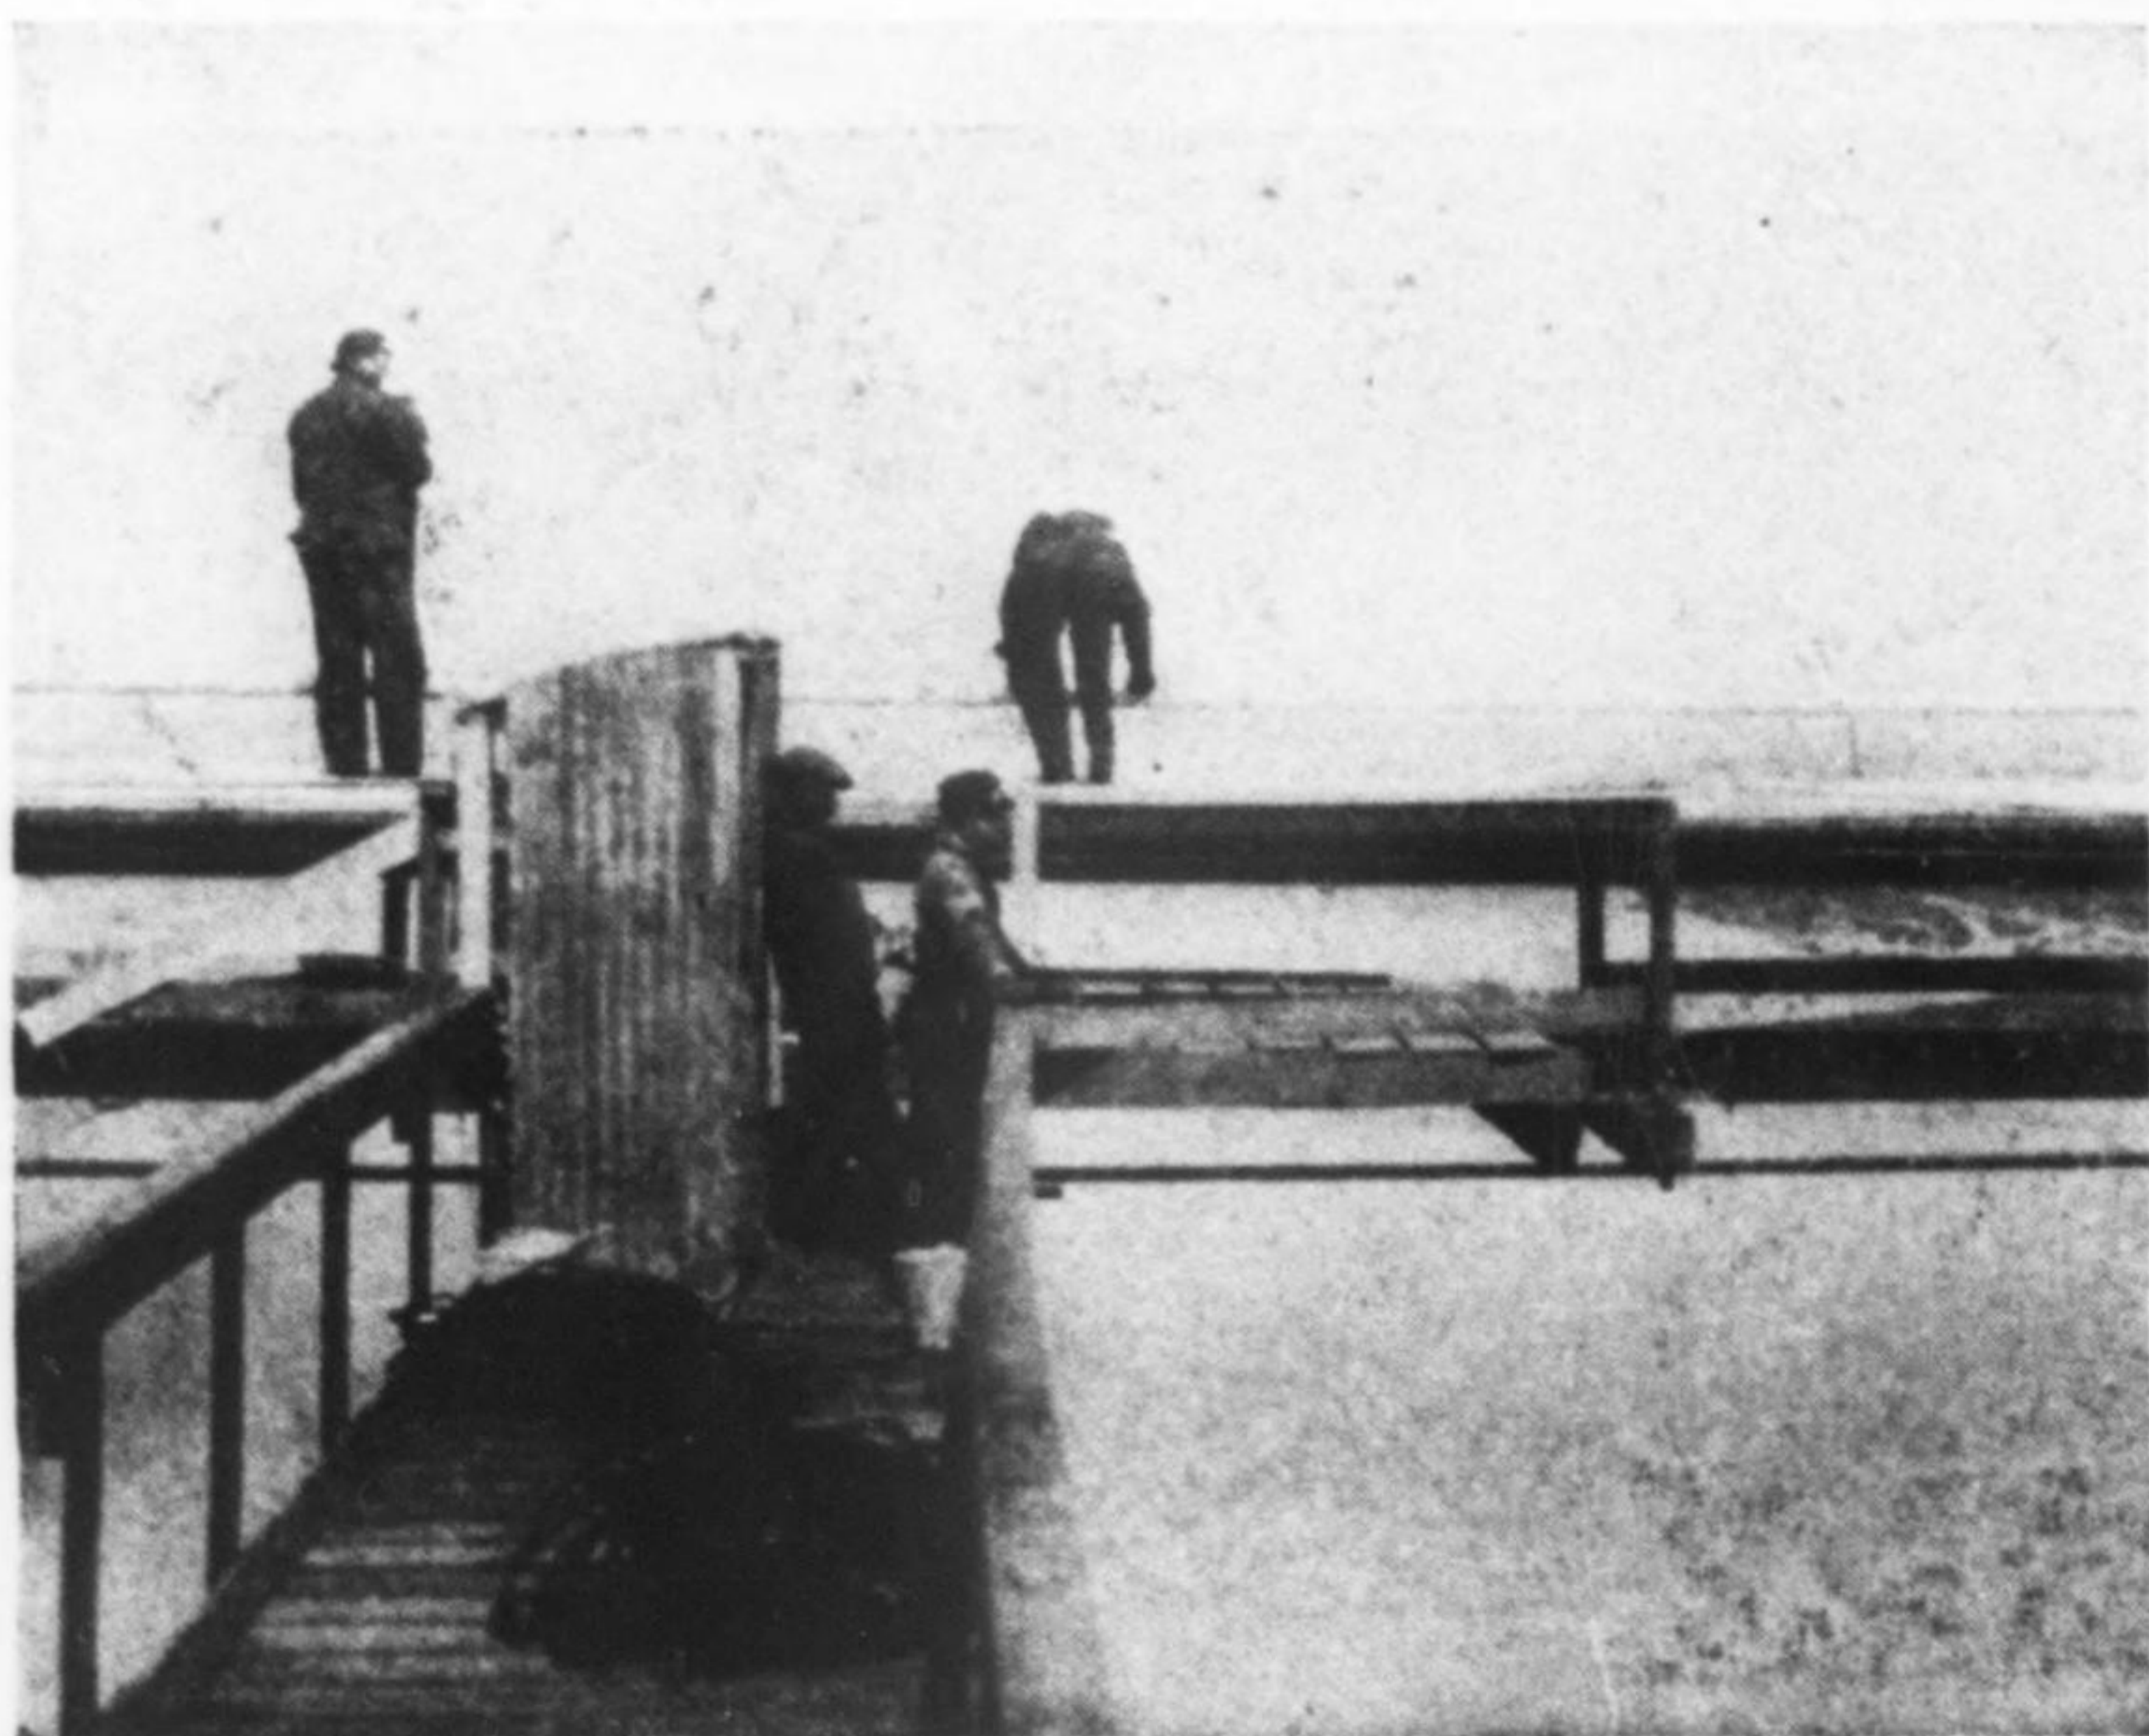
FIG. 10—A STRAND JACKED FREE OF THE CABLE IN THE MAIN SPAN AT DETROIT
Cross footwalk in foreground.

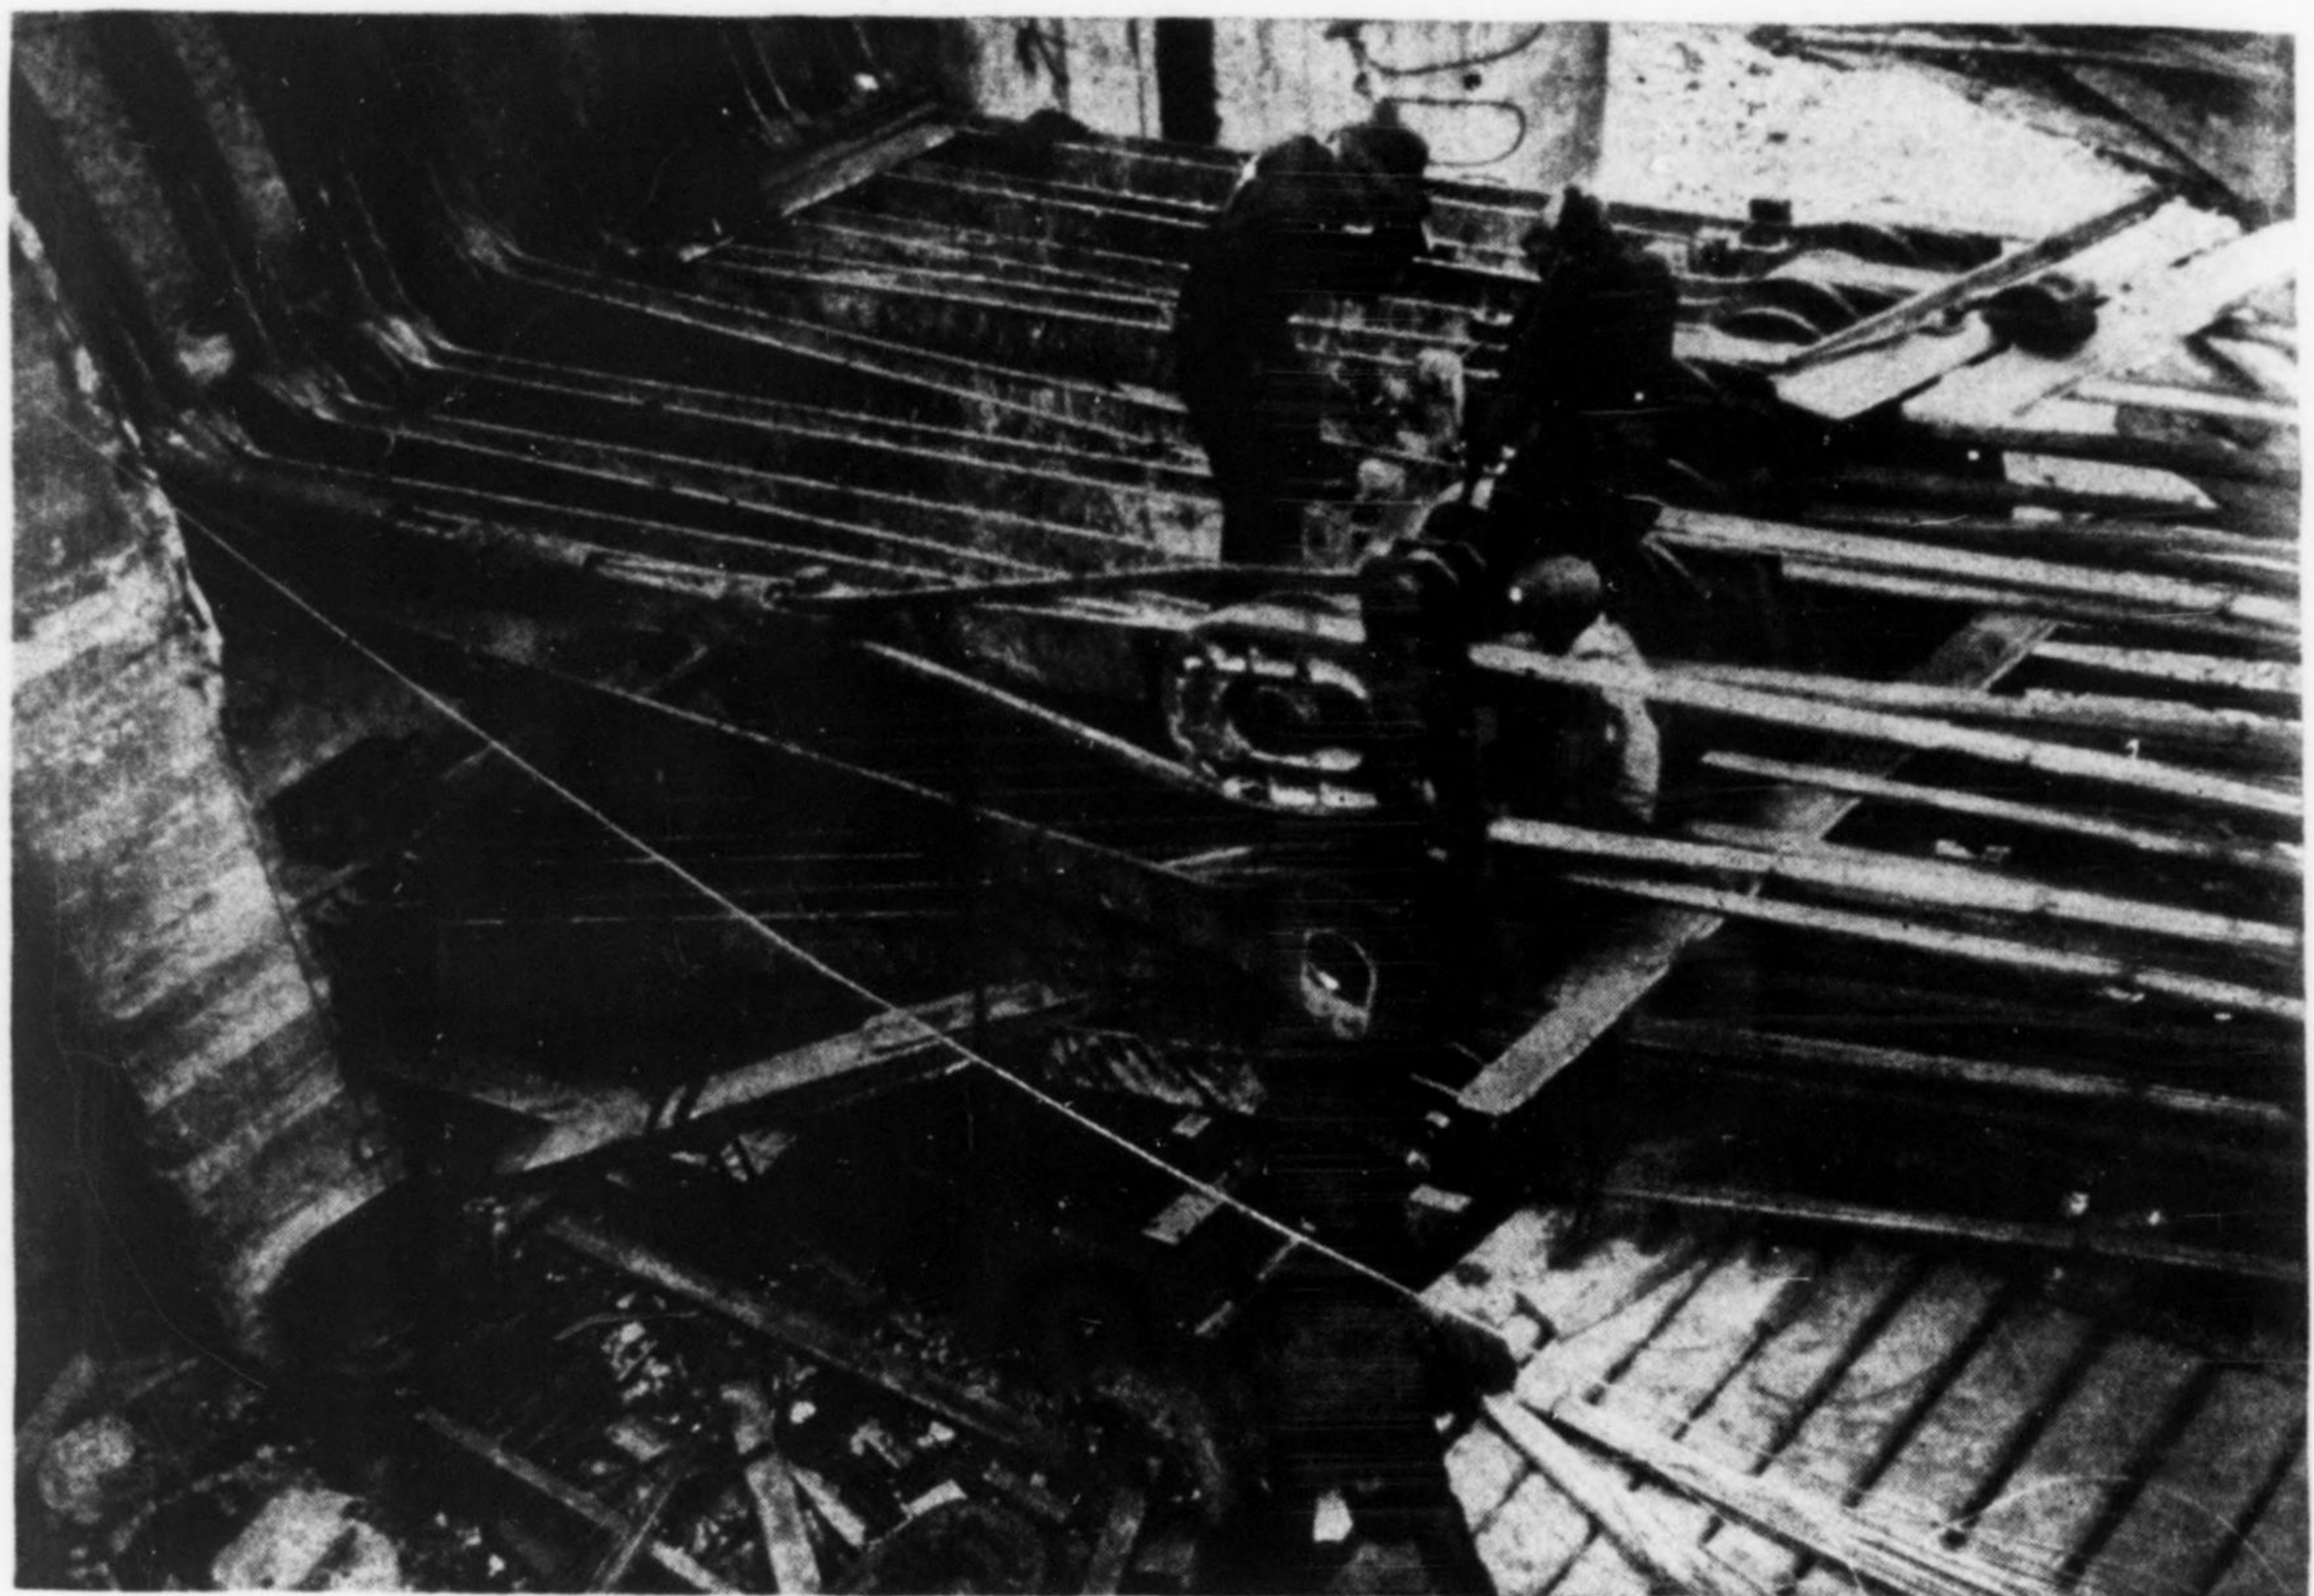
FIG. 11—REMOVING PIN FROM A STRAND SHOE AT DETROIT
Note yoke ahead of strand shoe and attached to hydraulic jack anchored to rear pin of anchorage eyebar. Note also concrete adhering to eyebars; 150 cu.yd. had to be cut out before the dismantling work could begin. At bottom in foreground the take-up screws on the footwalk anchorage are visible.

pneumatic hammer drills. A view of the east Detroit anchorage with the concrete removed is shown in Fig. 11.

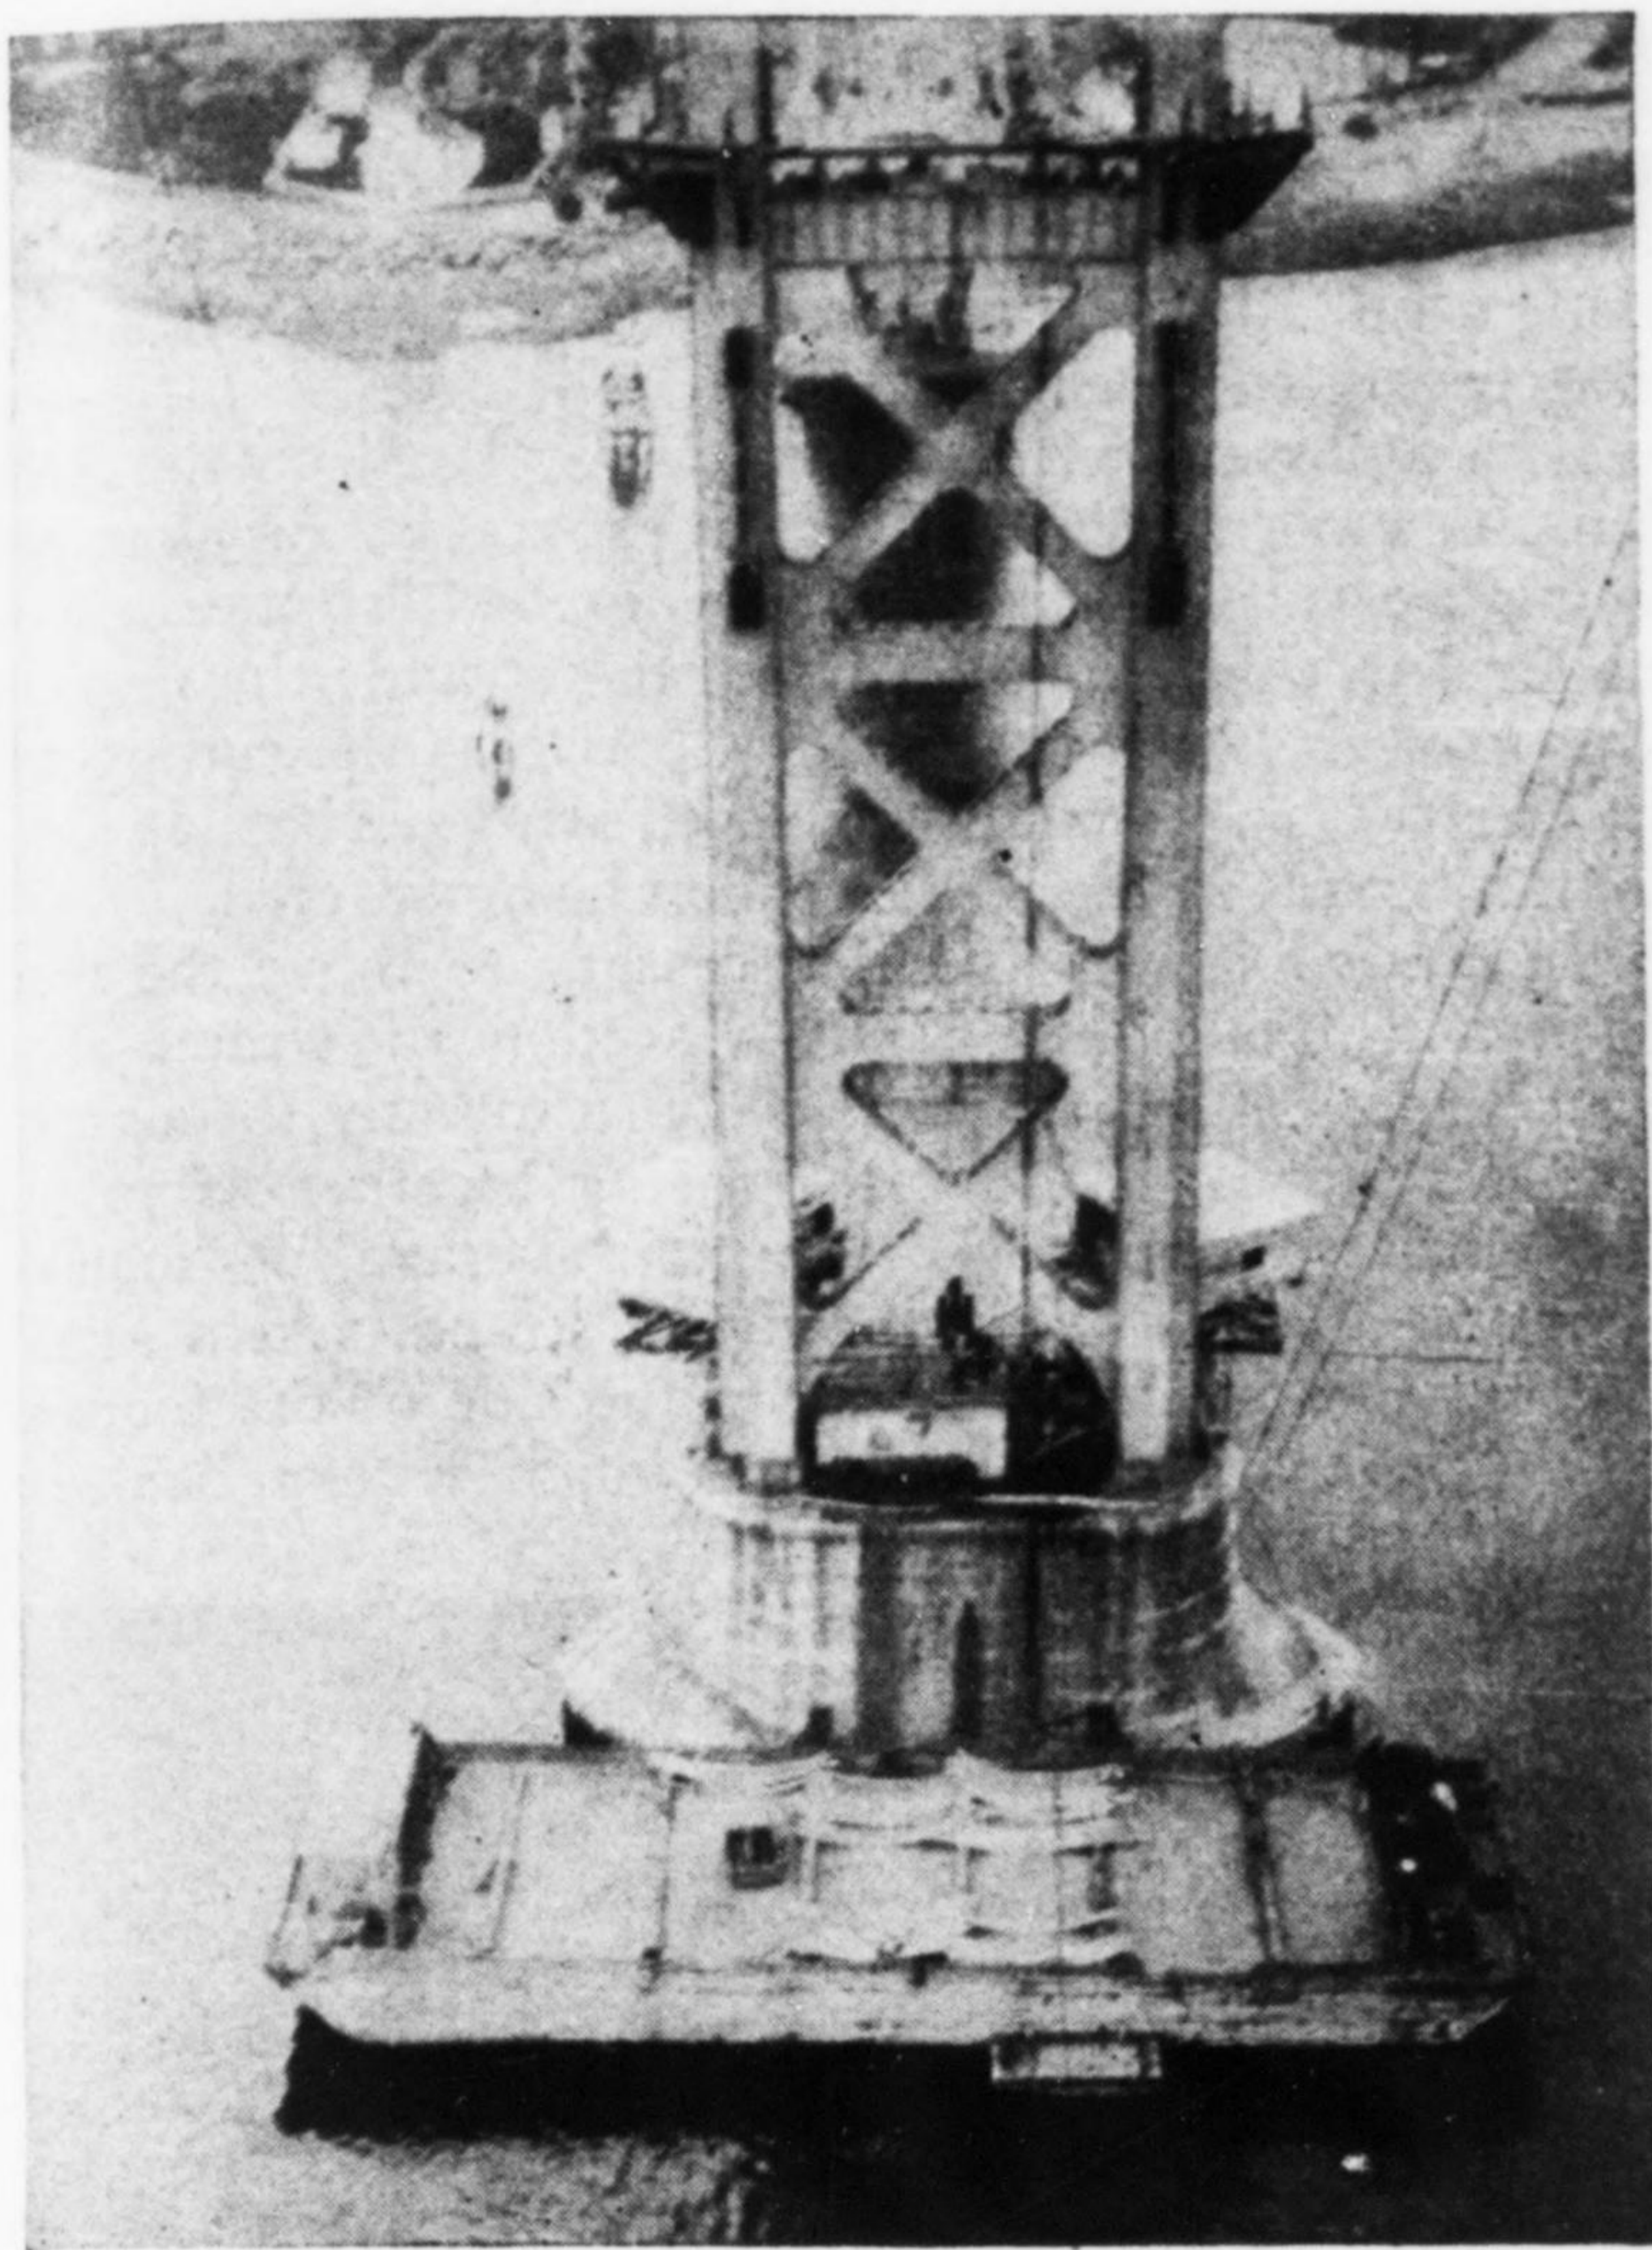
FIG. 12—SEVERED SECTIONS OF CABLE ON BARGE AT BASE OF MAIN PIER, MOUNT HOPE
Note houses on far side of tower inclosing hoists which operate the travelers.
