Technical Aspects of Cable Wire Breakages on the Mount Hope Suspension Bridge

Breaks Localized in Strand Shoes—Progressive Breaking Noted in Spite of Load Reduction—Cable Spinning Methods—Characteristics of Wire and Its Manufacture—Temporary Repair Measures

IN MARCH of this year engineering circles were shocked to learn of serious breakages in the cable wires of two important highway suspension bridges then under construction. News of the breakages was followed by a cessation of work on both structures and later by the decision to dismantle the bridges and replace the suspension systems with satisfactory wire. Interesting operations of unprecedented kind were involved in the dismantling. Both structures utilized the same kind of wire, a heat-treated product of high elastic limit, heretofore untried in suspension bridge service. The Mount Hope bridge, near Providence, R. I., which had a center span of 1,200 ft., was within about twelve months of completion, requiring only the placing of the concrete floor slab. The Ambassador bridge at Detroit, whose sus-

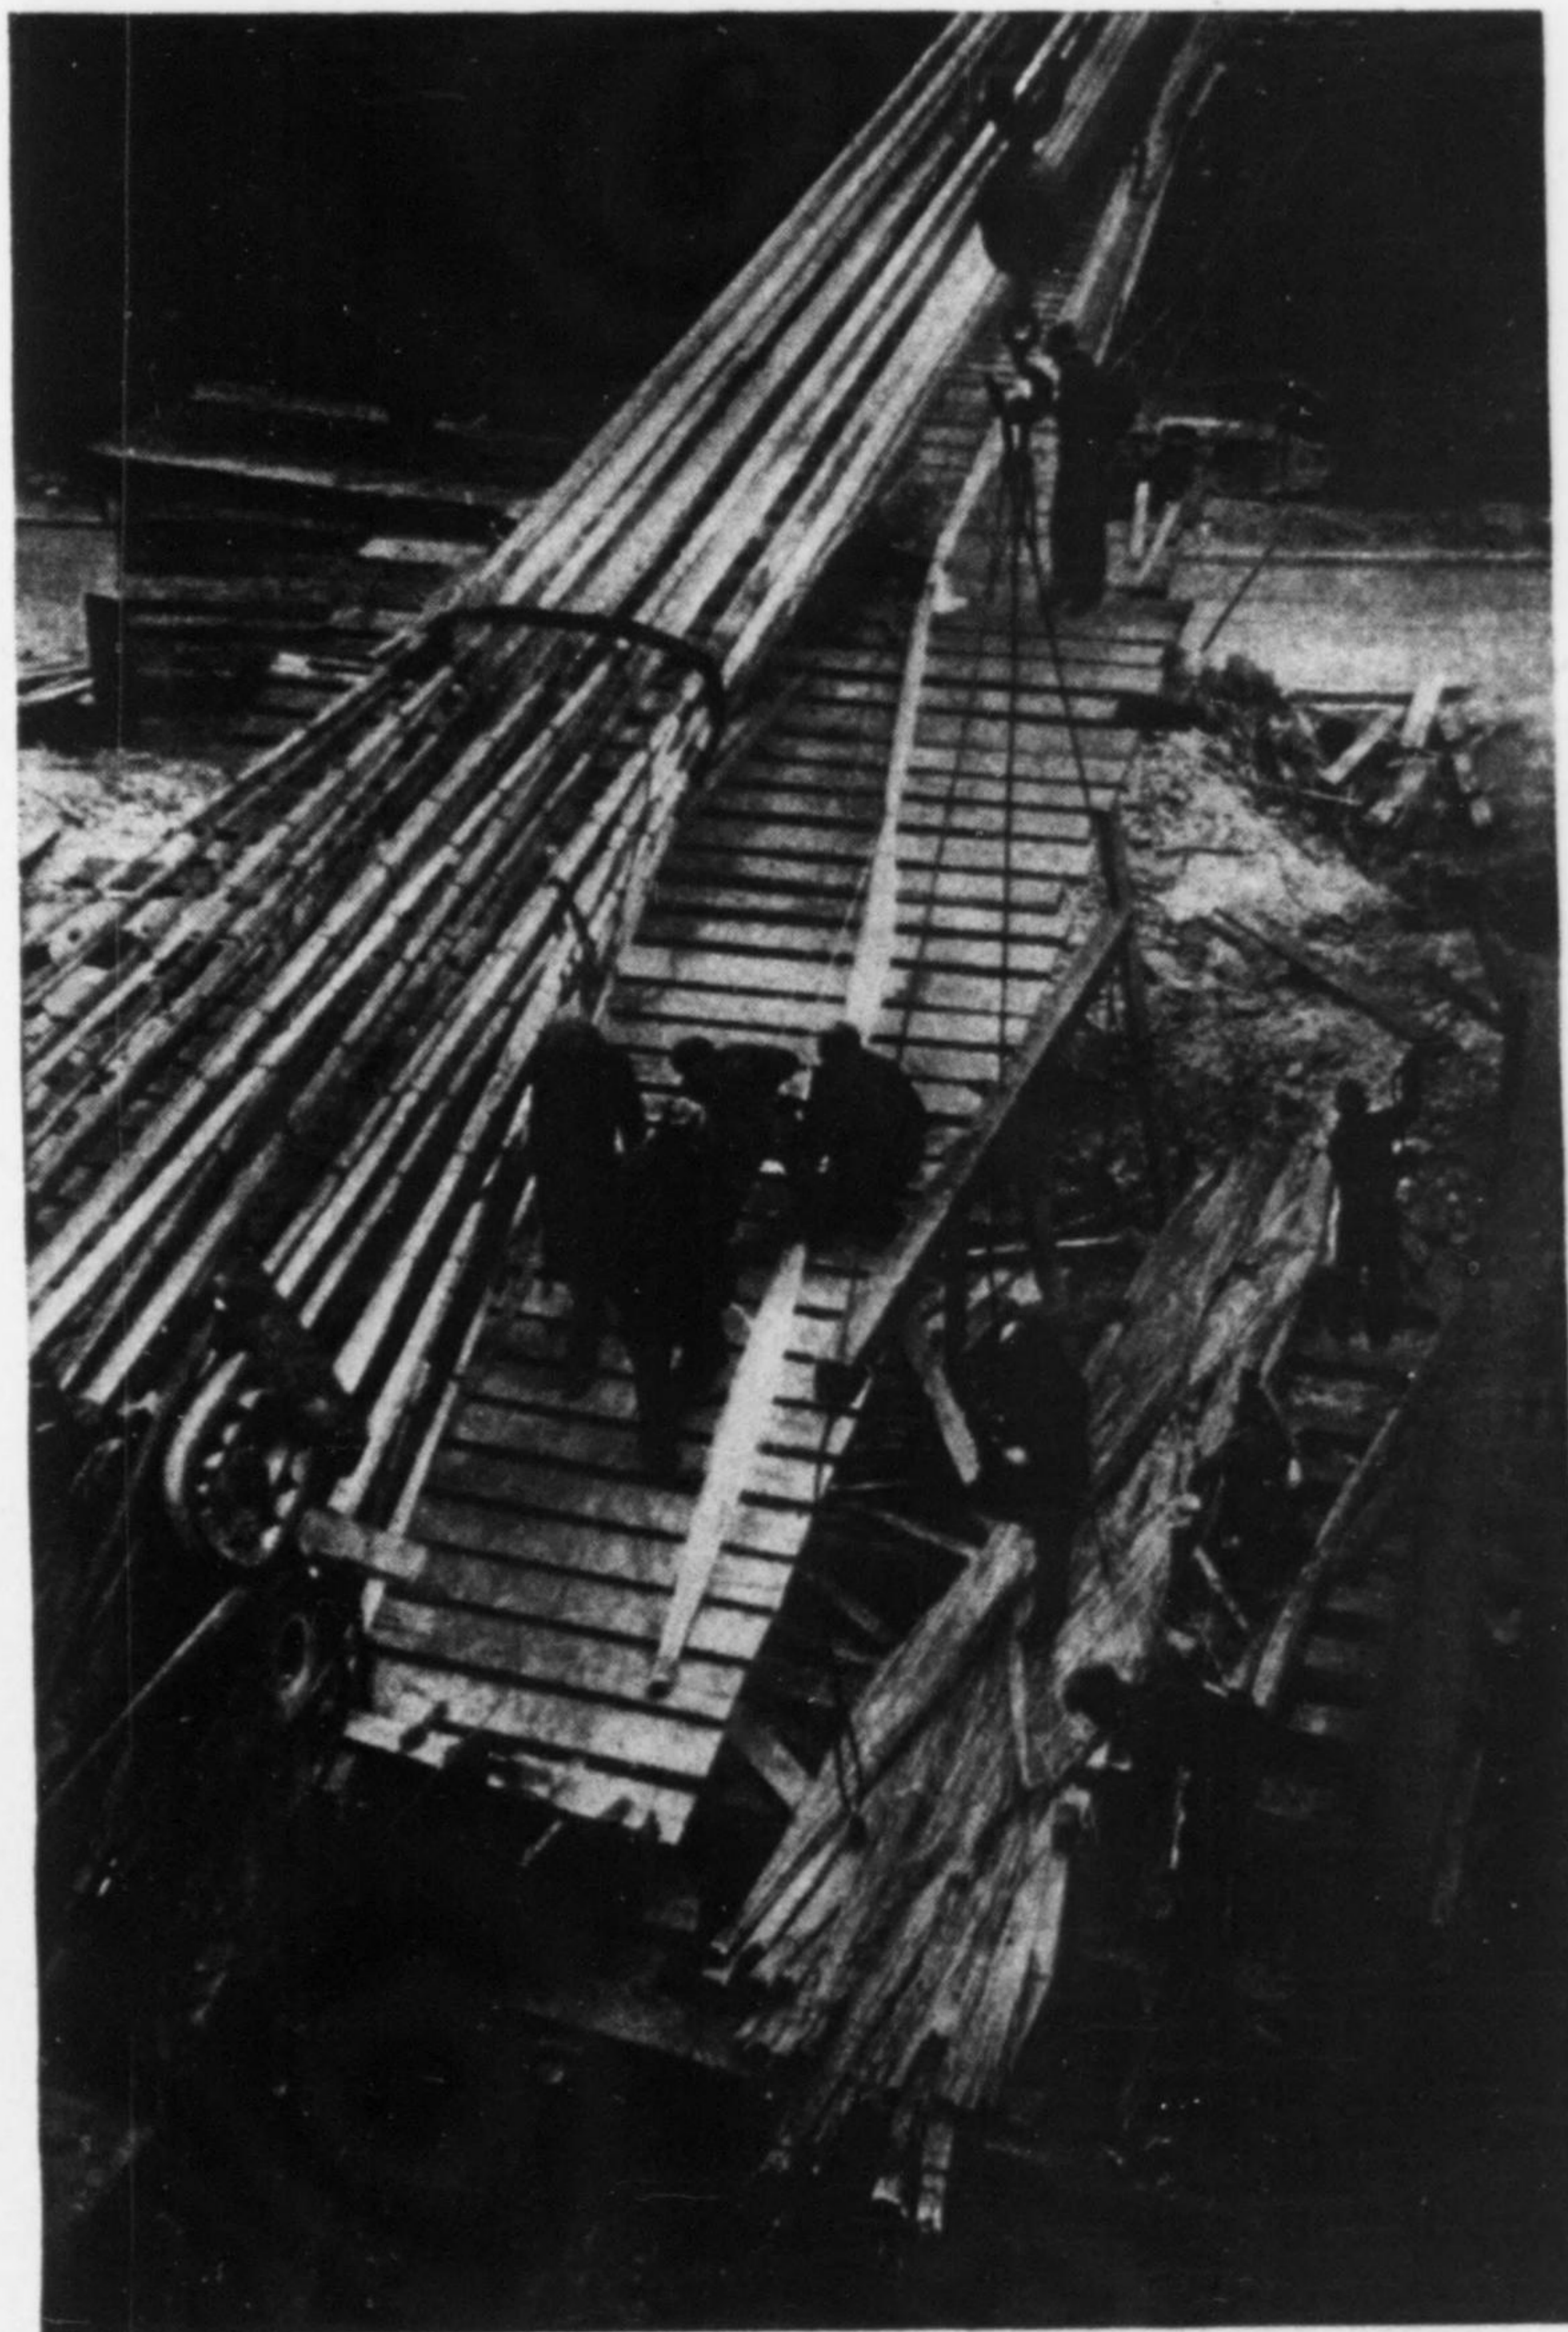
FIG. 13—CUTTING A BACKSTAY STRAND INTO 30-FT. SECTIONS AT DETROIT ANCHORAGE

Note widened footwalk and men placing wire seizings on strand. As a section is cut it is pushed off the footwalk to the "boneyard" below. Men on ground are ready to hook a half-dozen sections to boom falls for transfer to waiting trucks.

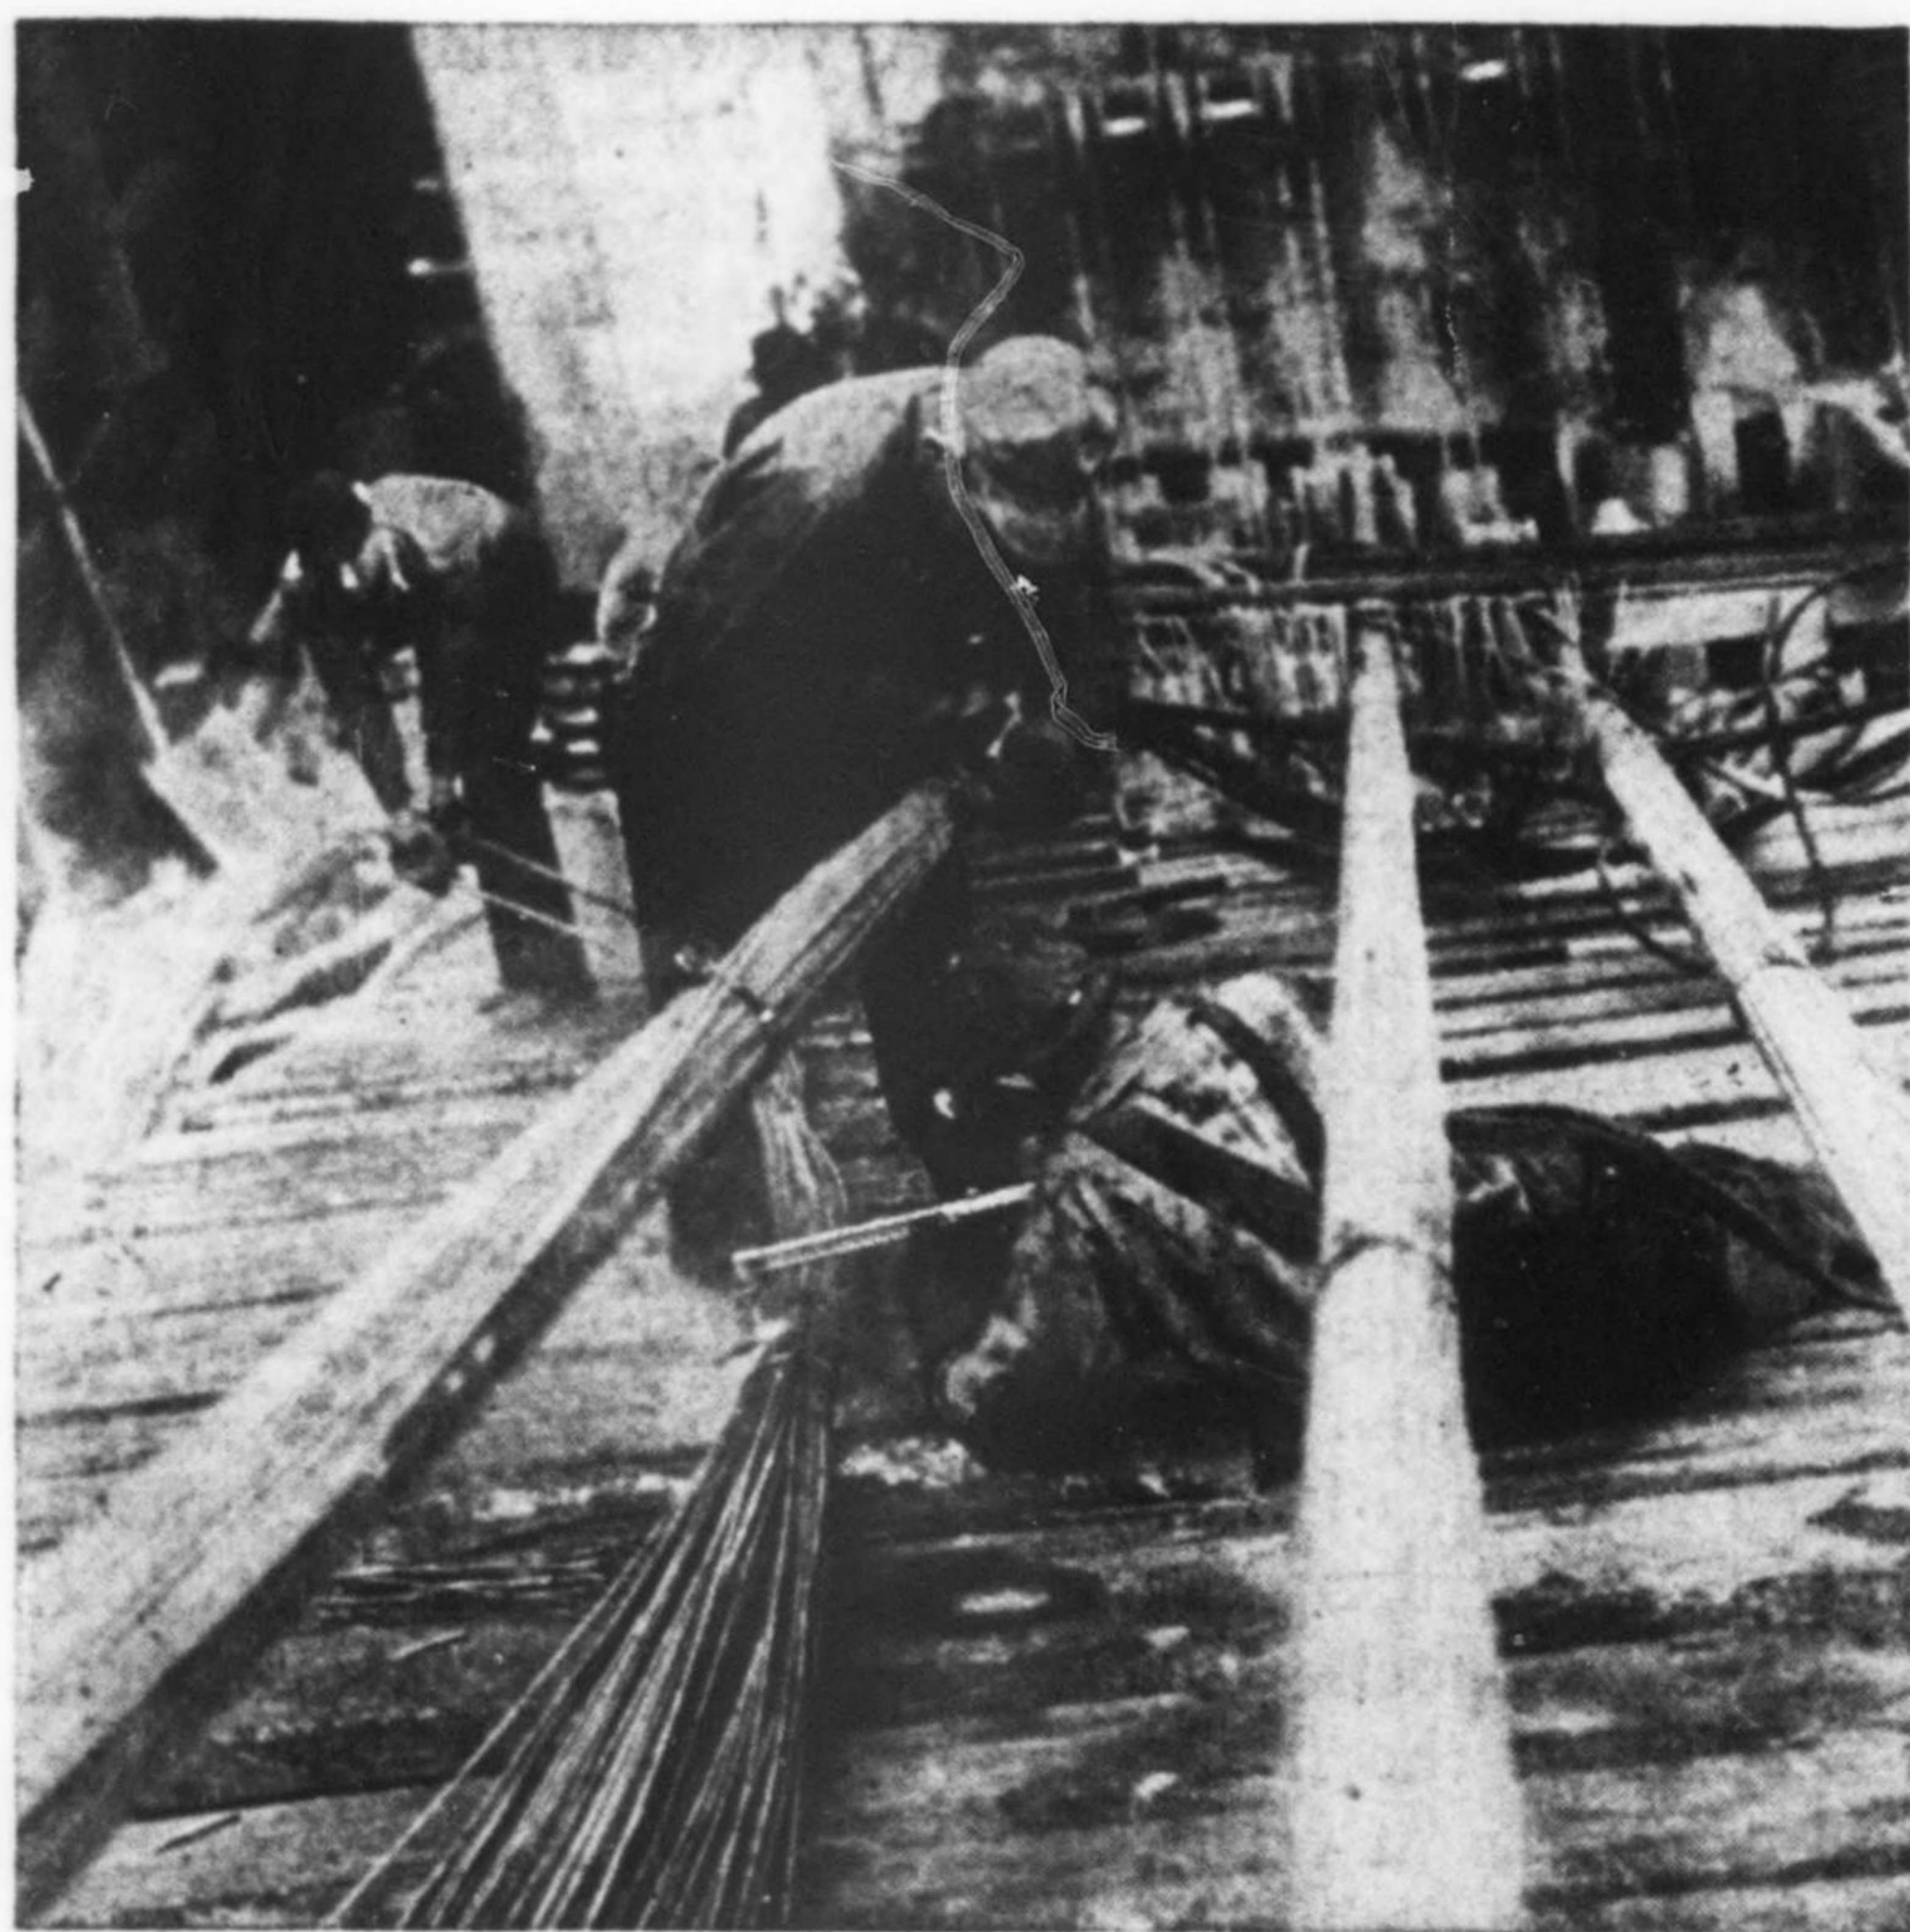
FIG. 14—CUTTING OPERATION AT DETROIT WEST ANCHORAGE
Note that the cut is being made between seizings about 6 in. apart.

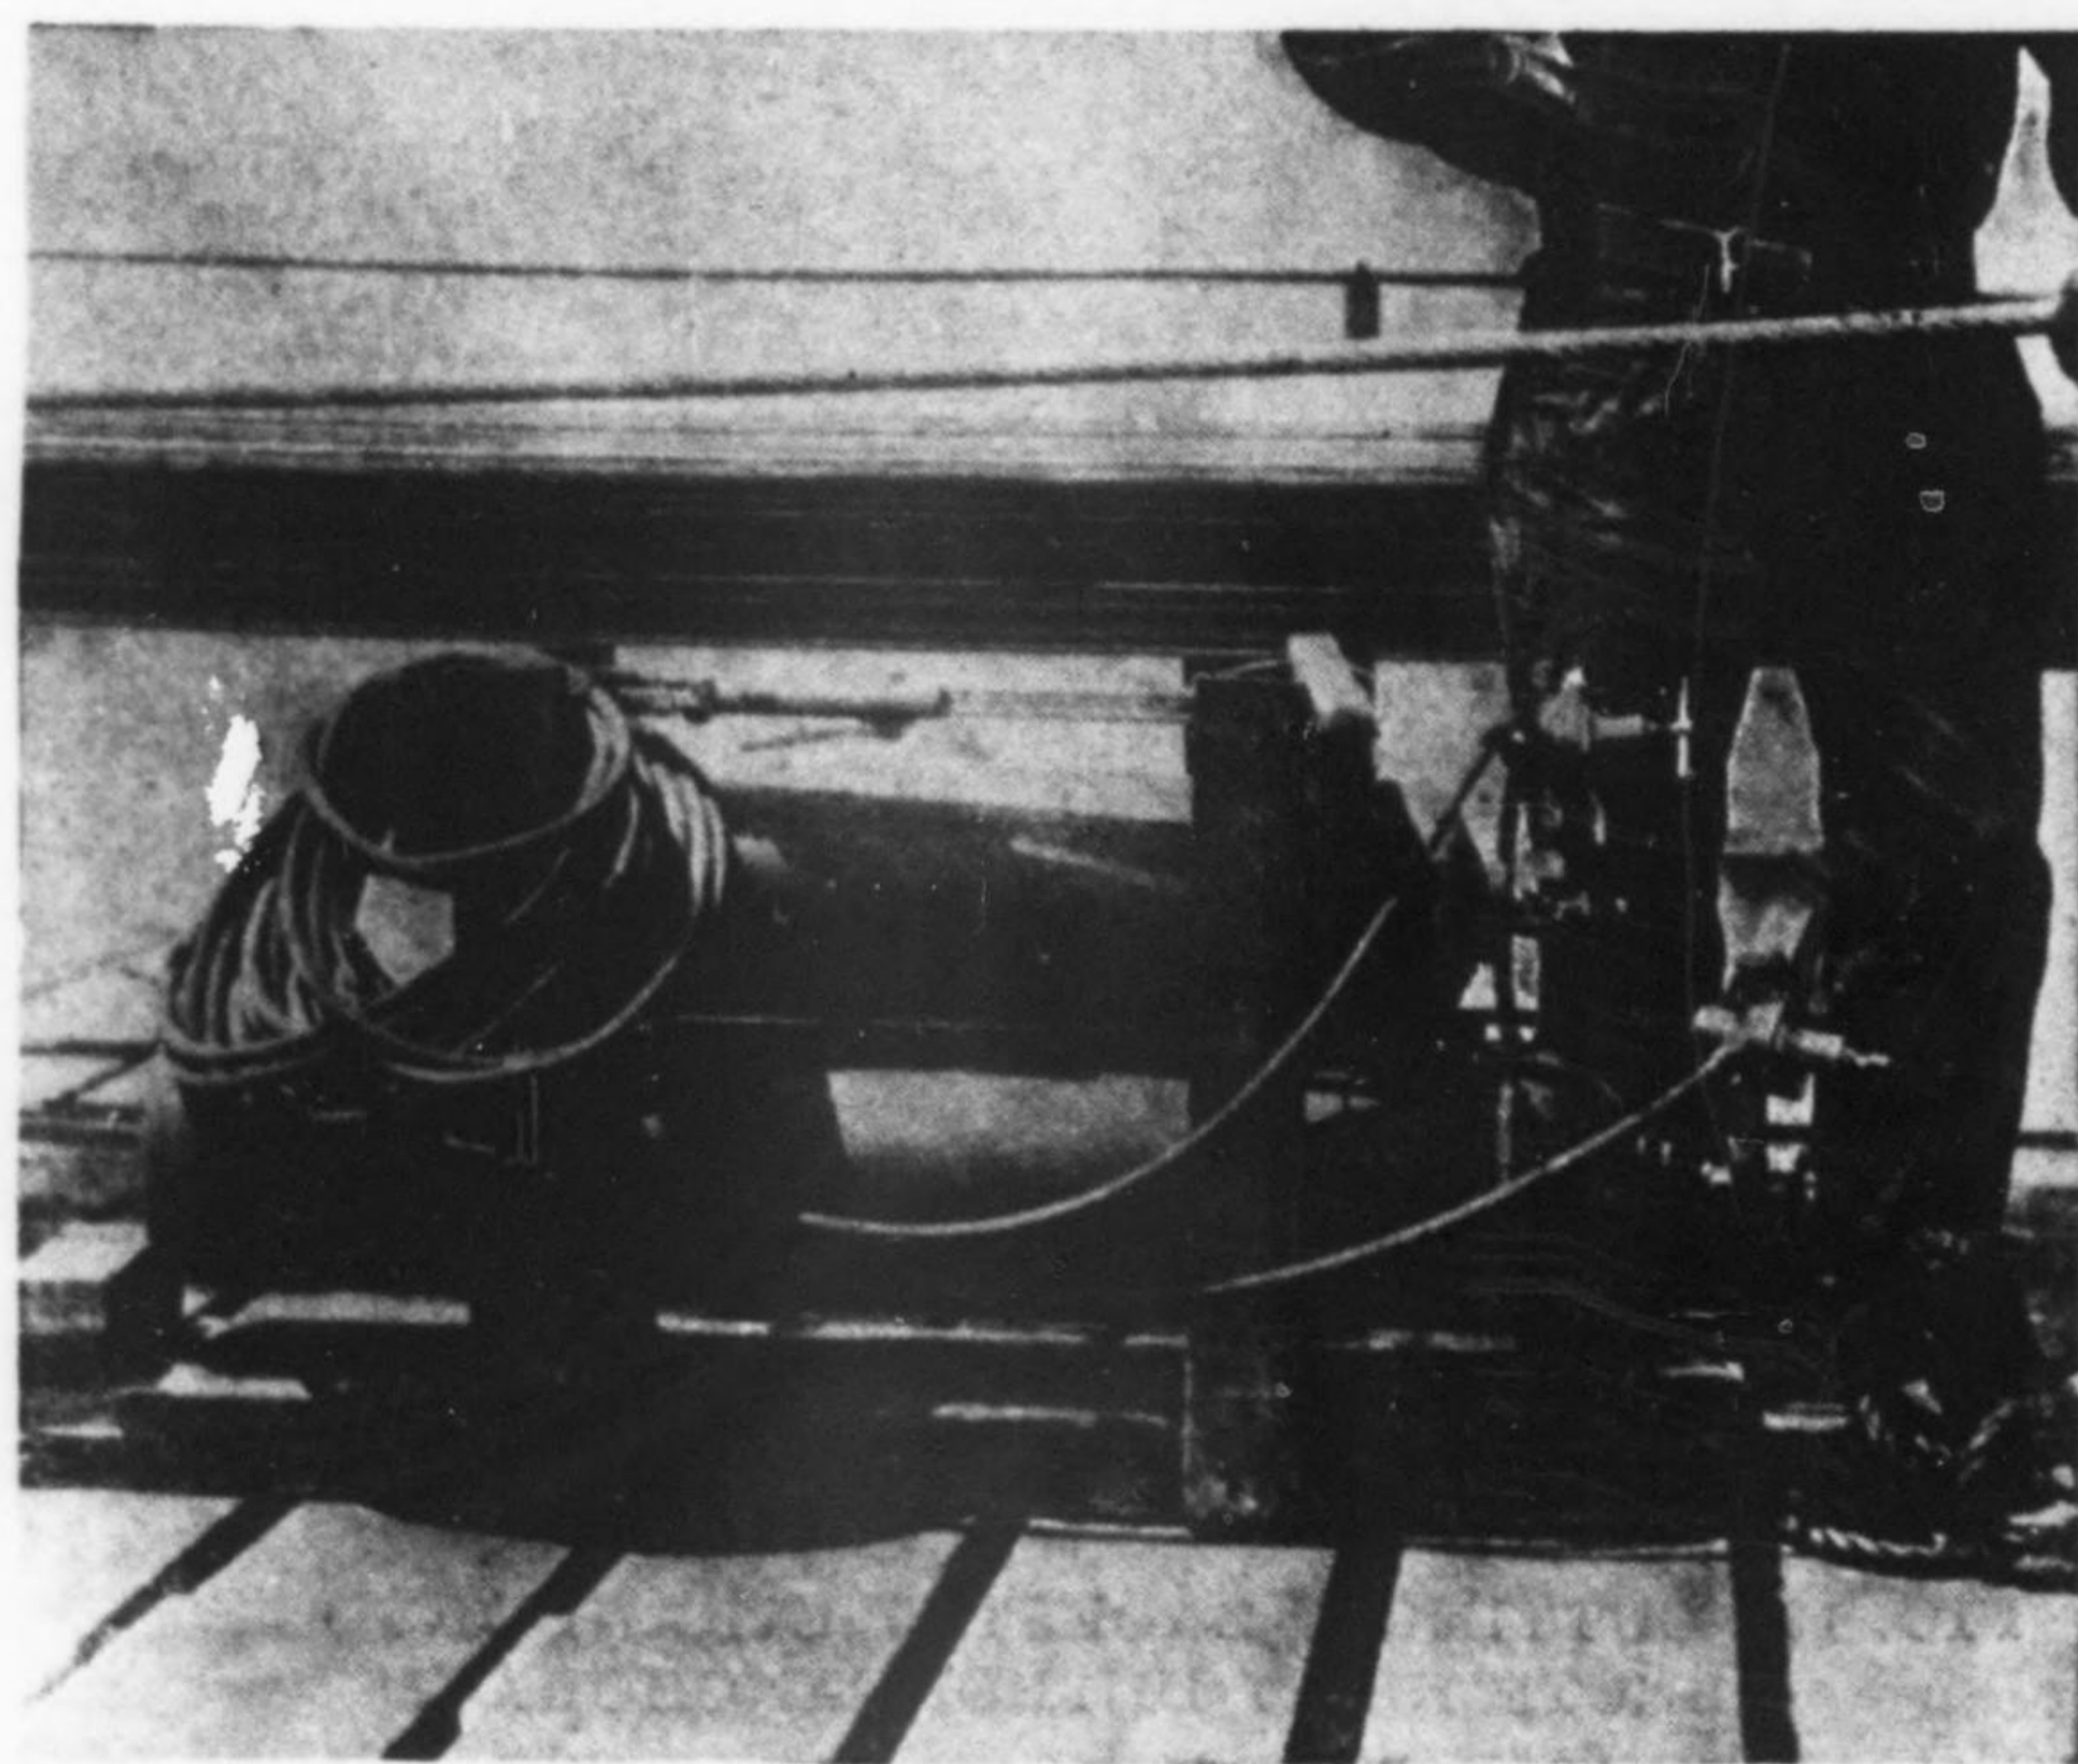
FIG. 15—FLAME-CUTTING OUTFIT USED ON MAIN SPAN AT DETROIT

Eight cutting crews were employed in dismantling the cable. On the main span the oxygen and acetylene tanks of the cutting outfits were placed on sleds (Fig. 15), and each cutting crew consisted of a torch operator, a helper and a man with water to put out any fires.
