### The Schell Memorial Bridge.—I.

This is a highway bridge crossing the Connecticut River at Northfield, Mass. About a half mile below, in this river, was an old covered timber bridge, carrying a track of the Central Vermont R. R. on its upper deck and a town highway below. This bridge had become unsafe from age and increase in the railroad traffic, and the new bridge was originally projected simply to take the place of the highway portion of the old bridge and to shorten the distance between the Northfield Seminary and the Moody Auditorium, where large numbers of people assemble at the summer conferences, and the station of the Boston & Maine R. R. and Central Vermont Ry., at South Vernon Junction.

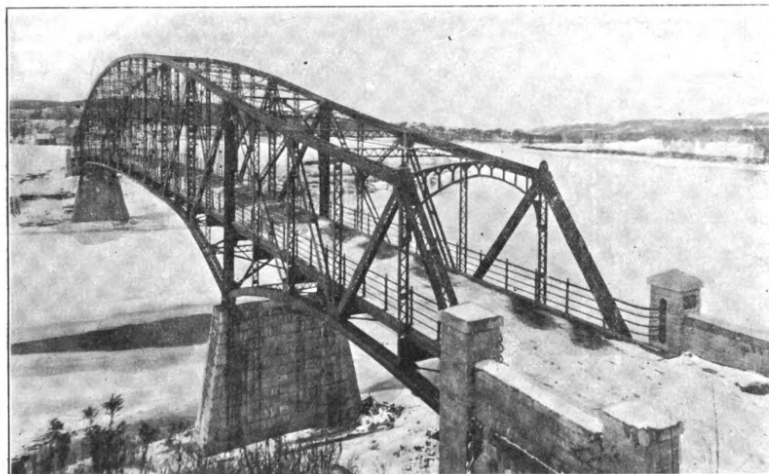
The Schell Memorial Bridge across the Connecticut River.

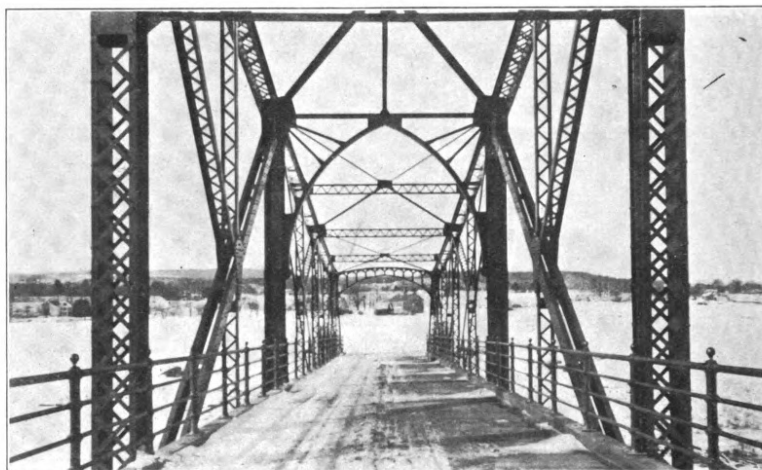
End Span from Near Pier.
