## Long-Span Steel Arch Bridge Over Niagara Gorge for Michigan Central R. R.

Well-Known Cantilever Bridge Will Be Replaced After 40 Years' Service by Two-Hinged Spandrel-Braced Arch of 640-Ft. Span, Carrying a Solid-Floor Independent Deck—Advanced Methods of Design

# New Niagara Gorge Arch Nearing Completion

The Two Cantilever Arms of the Michigan Central's 640-Ft. Span Were Joined in October

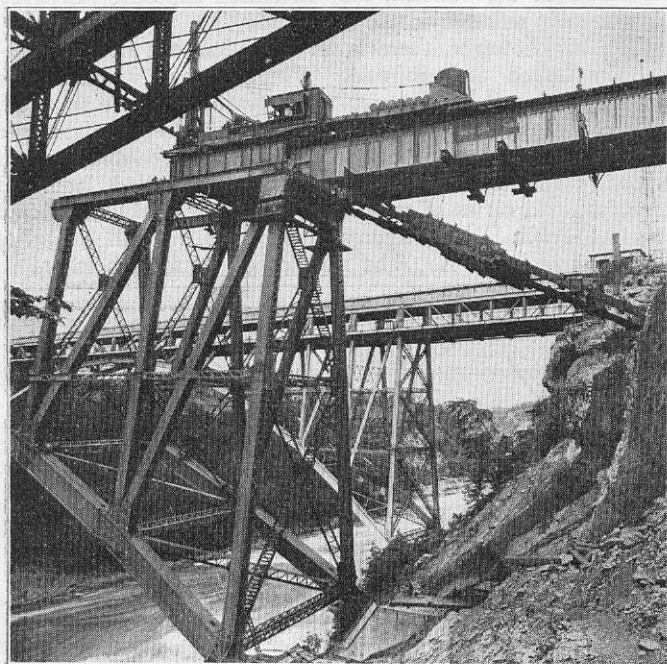
An Early Stage in the Erection of the Arch on the United States Side

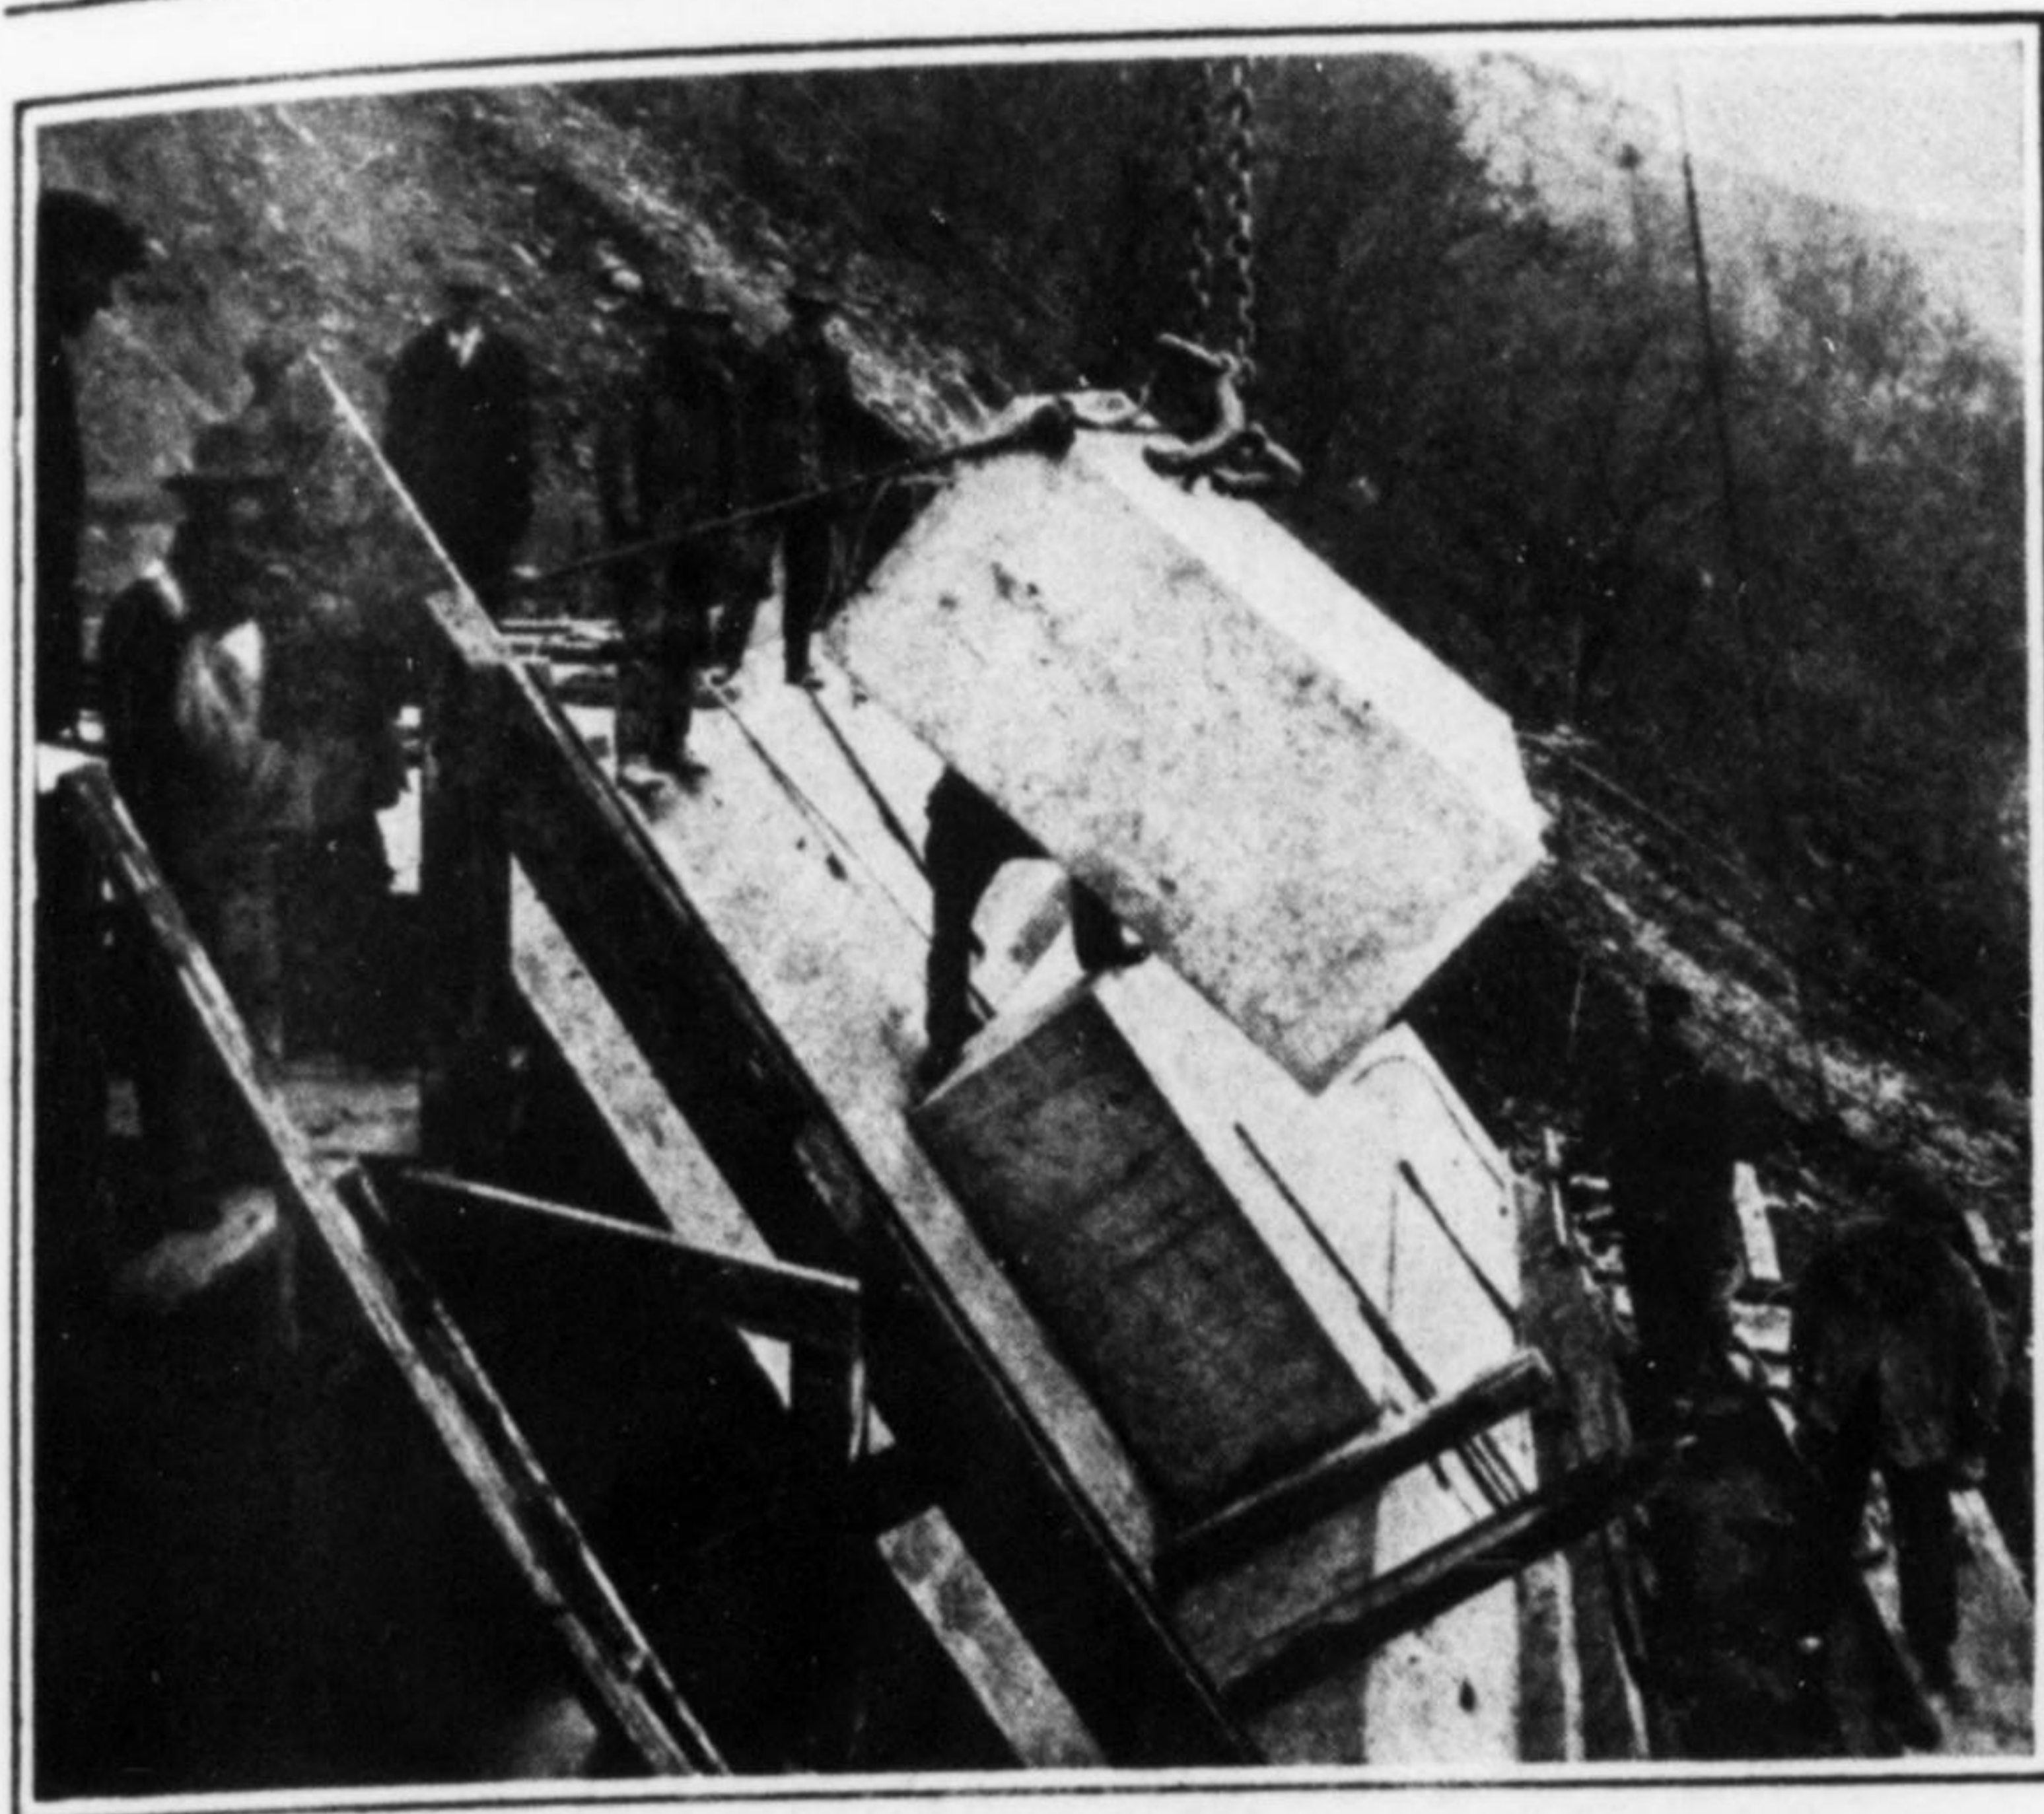
FIG. 3—SETTING GRANITE COPING, SOUTH PIER

spandrel-braced arch of 640-ft. span, as described in *Engineering News-Record* of March 1, 1923, p. 380. Four heavy concrete blocks constructed at the edge of the principal hard rock stratum at the sides of the gorge form its foundation. The beginning of work on the American side and the appearance of the completed abutments are shown in Figs. 1 and 2, herewith. The last operation, setting the granite coping, is represented in Fig. 3.
