Tower Elevations

Axonometrics Scale: 1/8" = 1'-0", 1:96

<u>Damping Mechanism</u> 1950 Bridge

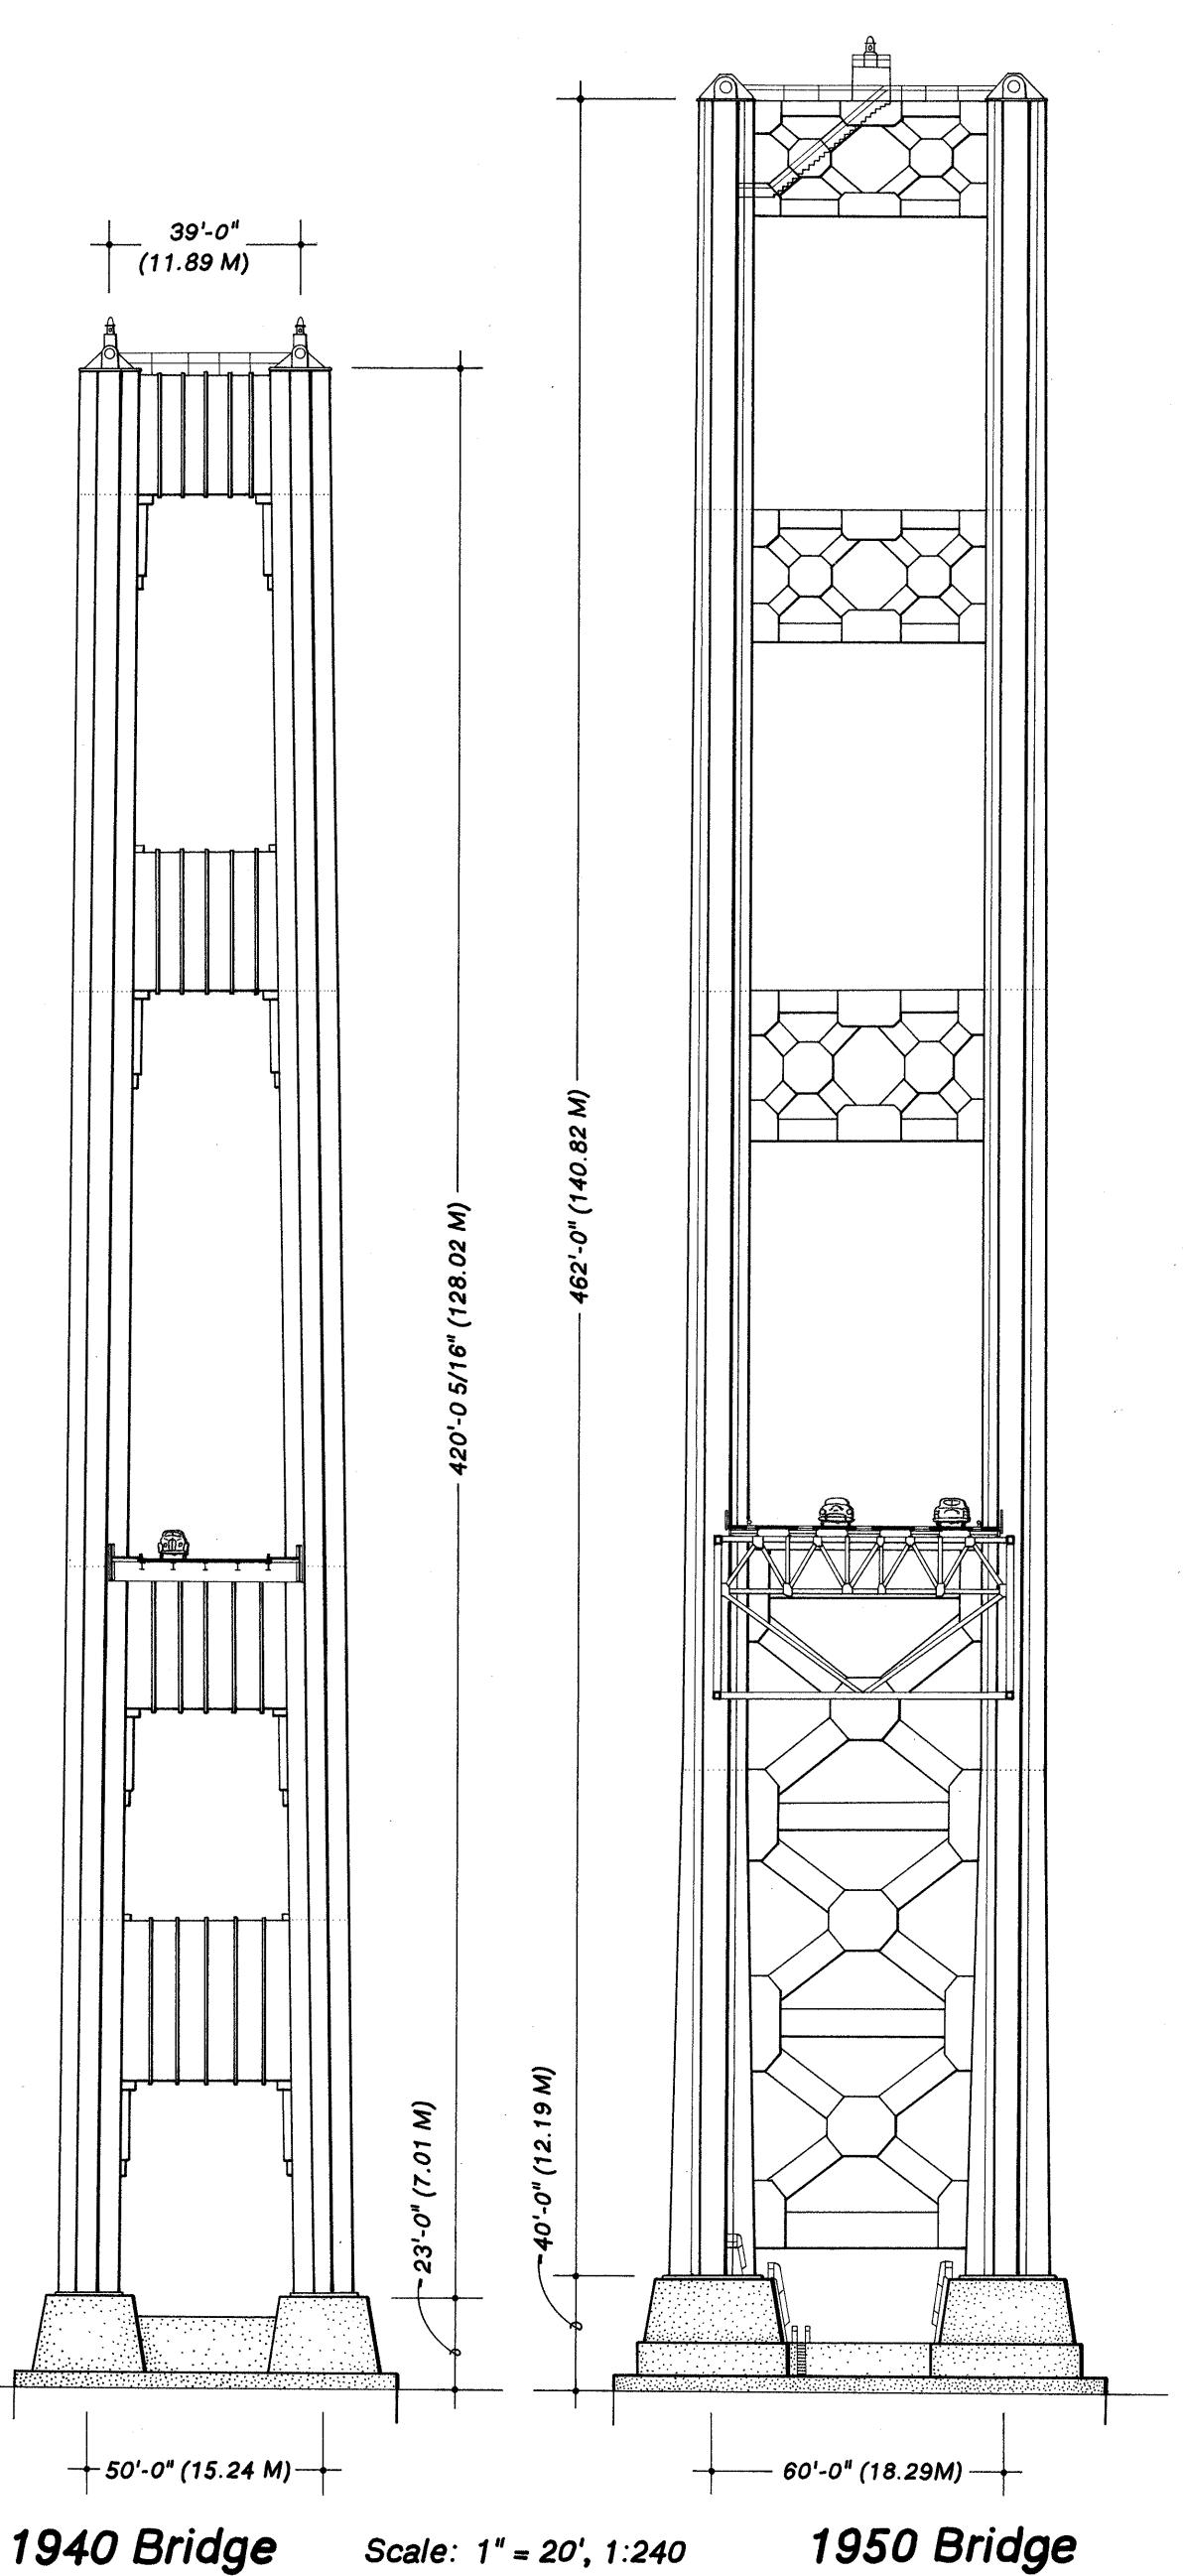
pedestals were erected for the new tower legs. They were also lengthened 18 feet to raise the tower steel above the Narrows' corrosive salt water.

The towers of the 1940 bridge

accomodated a two-lane road

deck. Tower legs for the 1950

bridge were designed for a four-lane road deck. Wider pier

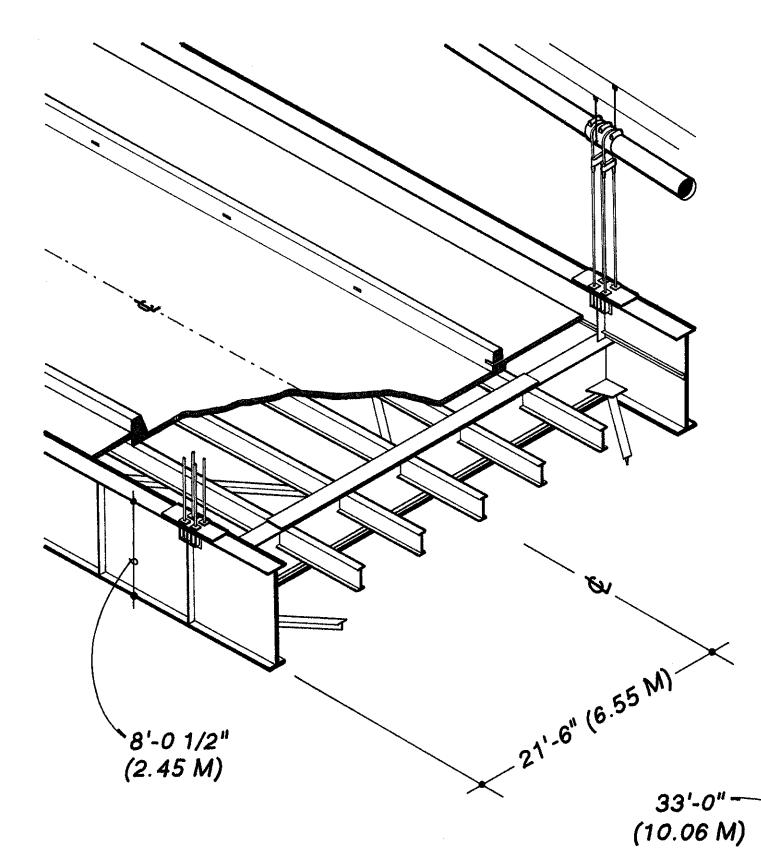
1940 Bridge Roadway

I he Tacoma Narrows Bridge collapsed on 7 November 1940 during a gale between 35 to 42 miles per hour, with a wind pressure of only five pounds per square foot. The steady wind's effects on the structure produced a fluctuating resultant force that synchronized in timing and direction with the bridge's natural harmonic motions (figs. 1&2), progressively amplifying them to destructive levels. Both vertical and torsional oscillations contributed to the failure of the bridge. The bridge's inherent weakness and susceptibility to these winds lay in its shallow stiffening girders and its narrow roadway.

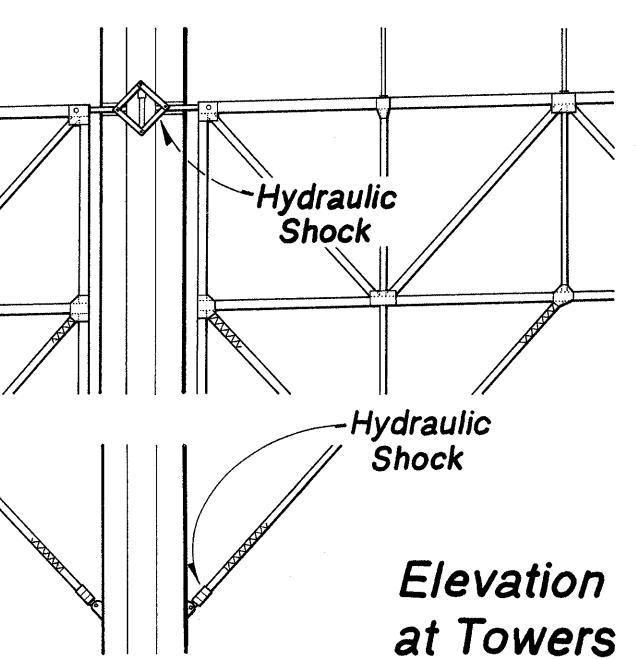
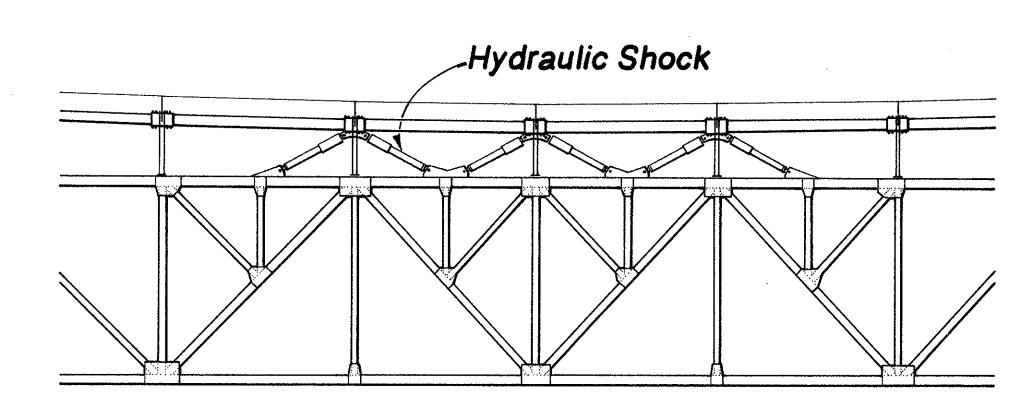
Elevation at Mid-Span

Lo eliminate torsional and vertical movement cylindrical hydraulic shock absorbers were used at three points on the bridge: coupling the top of the stiffening truss at mid-span with the suspension cables, connecting between the top chords of the main span and side span stiffening trusses, and extending as outriggers from the trusses' bottom chords to the towers.

Designers for the 1950 bridge were not satisfied with their ability to eliminate torsional and vertical movements in their proposed structure. They hoped to enhance their design's natural damping ability with mechanical devices. One of these was a double-lateral bracing system in the stiffening truss. It increased torsional frequency motion and tortional stiffness.

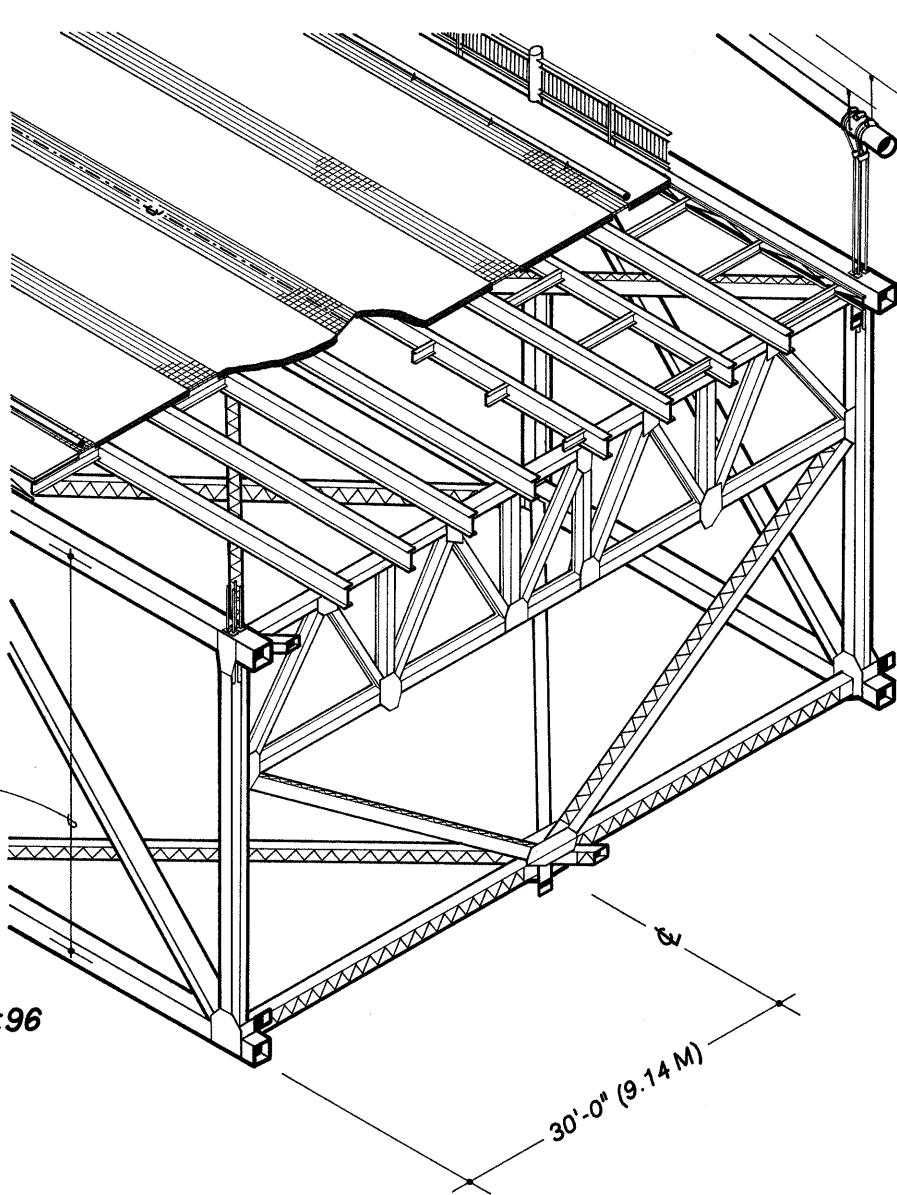
1950 Bridge Roadway

Designing the replacement bridge's deck stiffening system involved subjecting dynamic scale models to wind tunnel testing to better understand wind effects on them.
