NTSB National Transportation Safety Board

Design Error

Joe Epperson

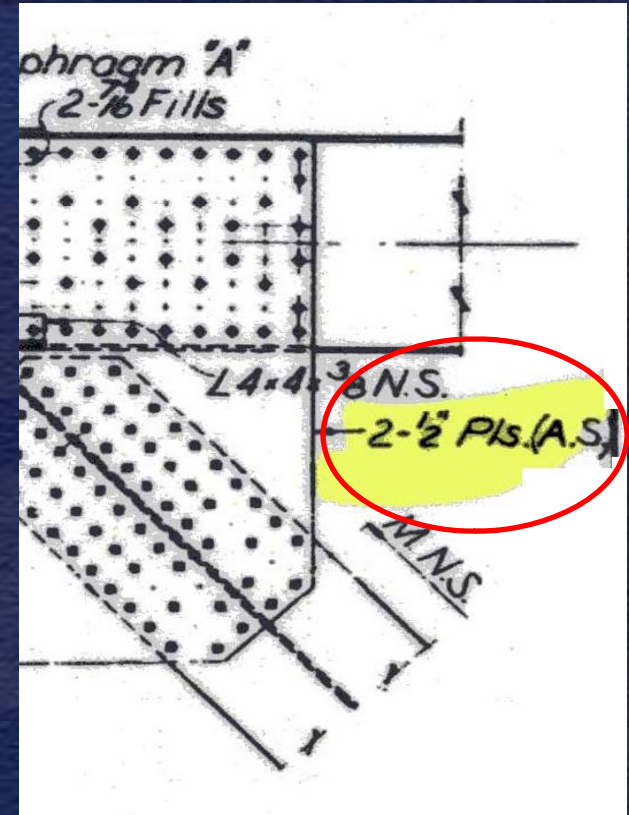
Potential Sources of Error

- Fabrication
 - ~~– Material mix-up~~
 - ~~– Transcription error~~
 - No shop drawing changes
 - Tests and measurements found correct components installed
- Design firm was source of error
