# Reconstruction of Mississippi River Bridge at Keokuk

**SYNOPSIS**—The old single-deck spans are being replaced with double-deck spans having a railway track below and highway and sidewalk above. The reconstruction is of special interest in that the bridge has to be kept open for railway and roadway traffic during the progress of the work.

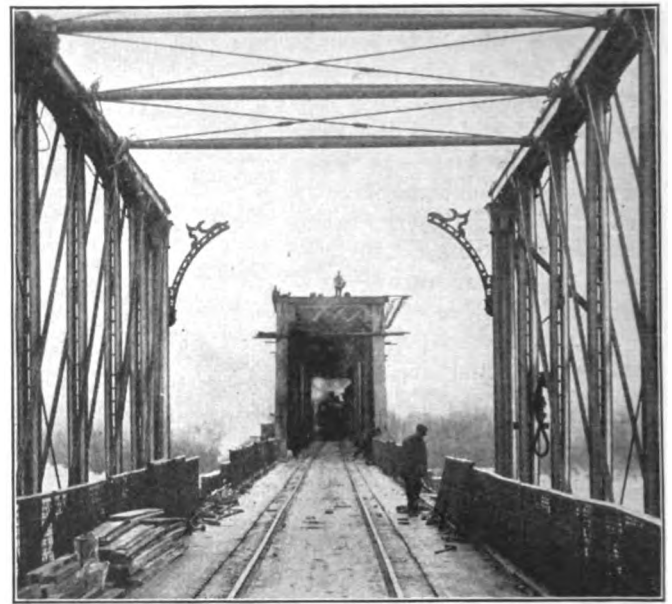
FIG. 5. DISMANTLING ONE OF THE SPANS

Fig. 5 is a view of the work in progress. In the background is a train on one of the new spans. An old span is in the foreground, and between this and the new one is a dismantled span with track carried on falsework. The brackets extending out to the right on top of the new span are for the sidewalk on the upper deck. These are also shown in Fig. 6.

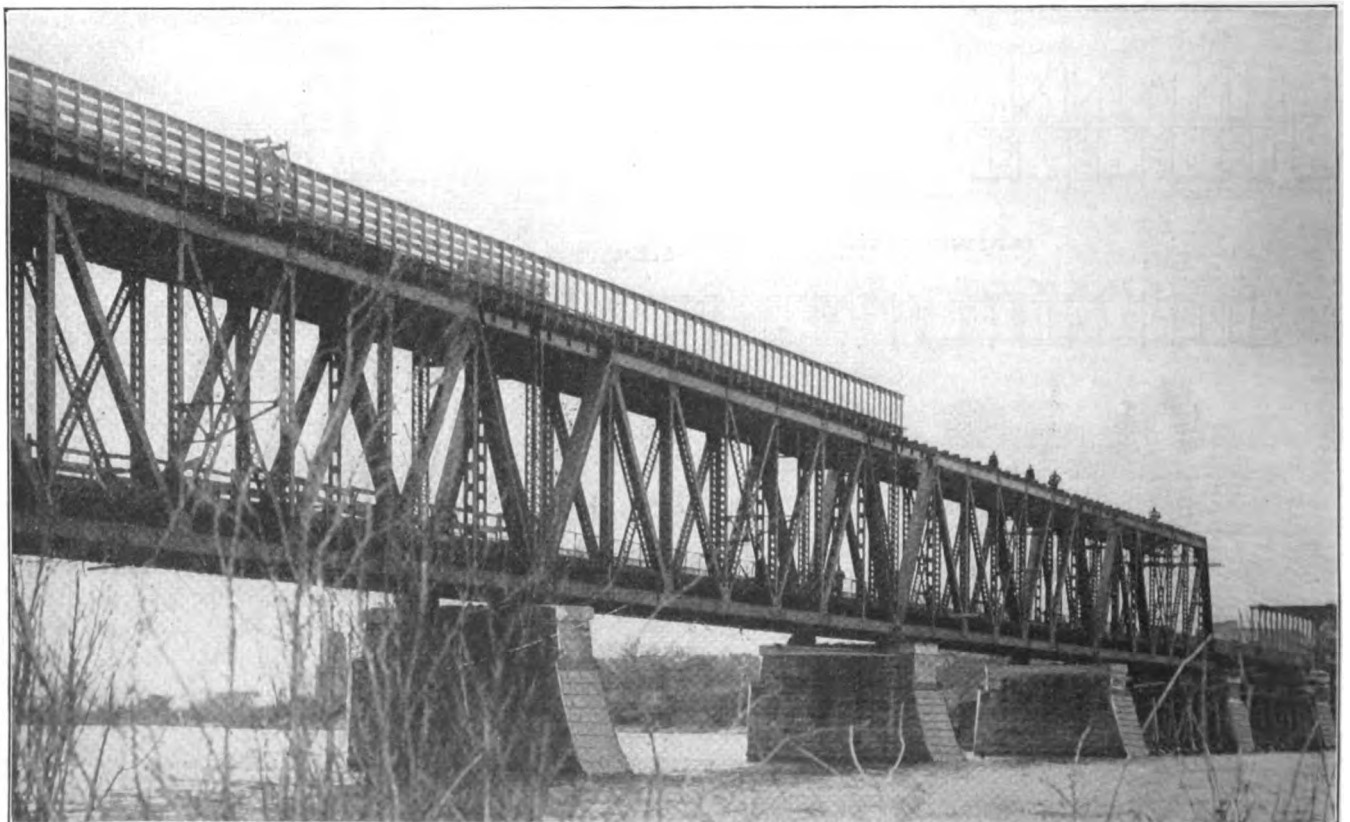
FIG. 6. NEW DOUBLE-DECK SPANS OF THE KEOKUK BRIDGE

The work of renewing the first span was commenced in September, 1915. On Dec. 6 five spans had been completed, the new sixth span was partly erected and the old seventh span partly dismantled, while falsework was being placed under the eighth span. Falsework was also being placed under the drawspan. Fig. 1 shows the condition on Dec. 1, and Fig. 6 shows some of the completed double-deck spans.
