## Simple Truss Bridge Lengthened Into Long Cantilever

HARRY J. ENGEL

Assistant Engineer, Modjeski and Masters, Harrisburg, Pa.

**Contents in Brief**—Widening the Atchafalaya River for flood control required lengthening the Missouri Pacific R.R. bridge at Krotz Springs, La. Scheme was to separate two of the existing 300-ft. simple truss spans by 720 ft. of new steel in the form of twin cantilevers having a common anchor arm, the 300-ft. spans being hung from the ends of the new cantilevers. The 300-ft. span to be removed to the far end of the new bridge was rolled out of position simultaneously with the roll in of 300 ft. of new steel, so as not to interfere with train operation. While remainder of new steel was being erected trains operated over a detour trestle. Work involved removal of two old piers and the construction of two new deep caisson piers of special design, incorporating a jet system and sounding wells in the walls and three dredging wells.

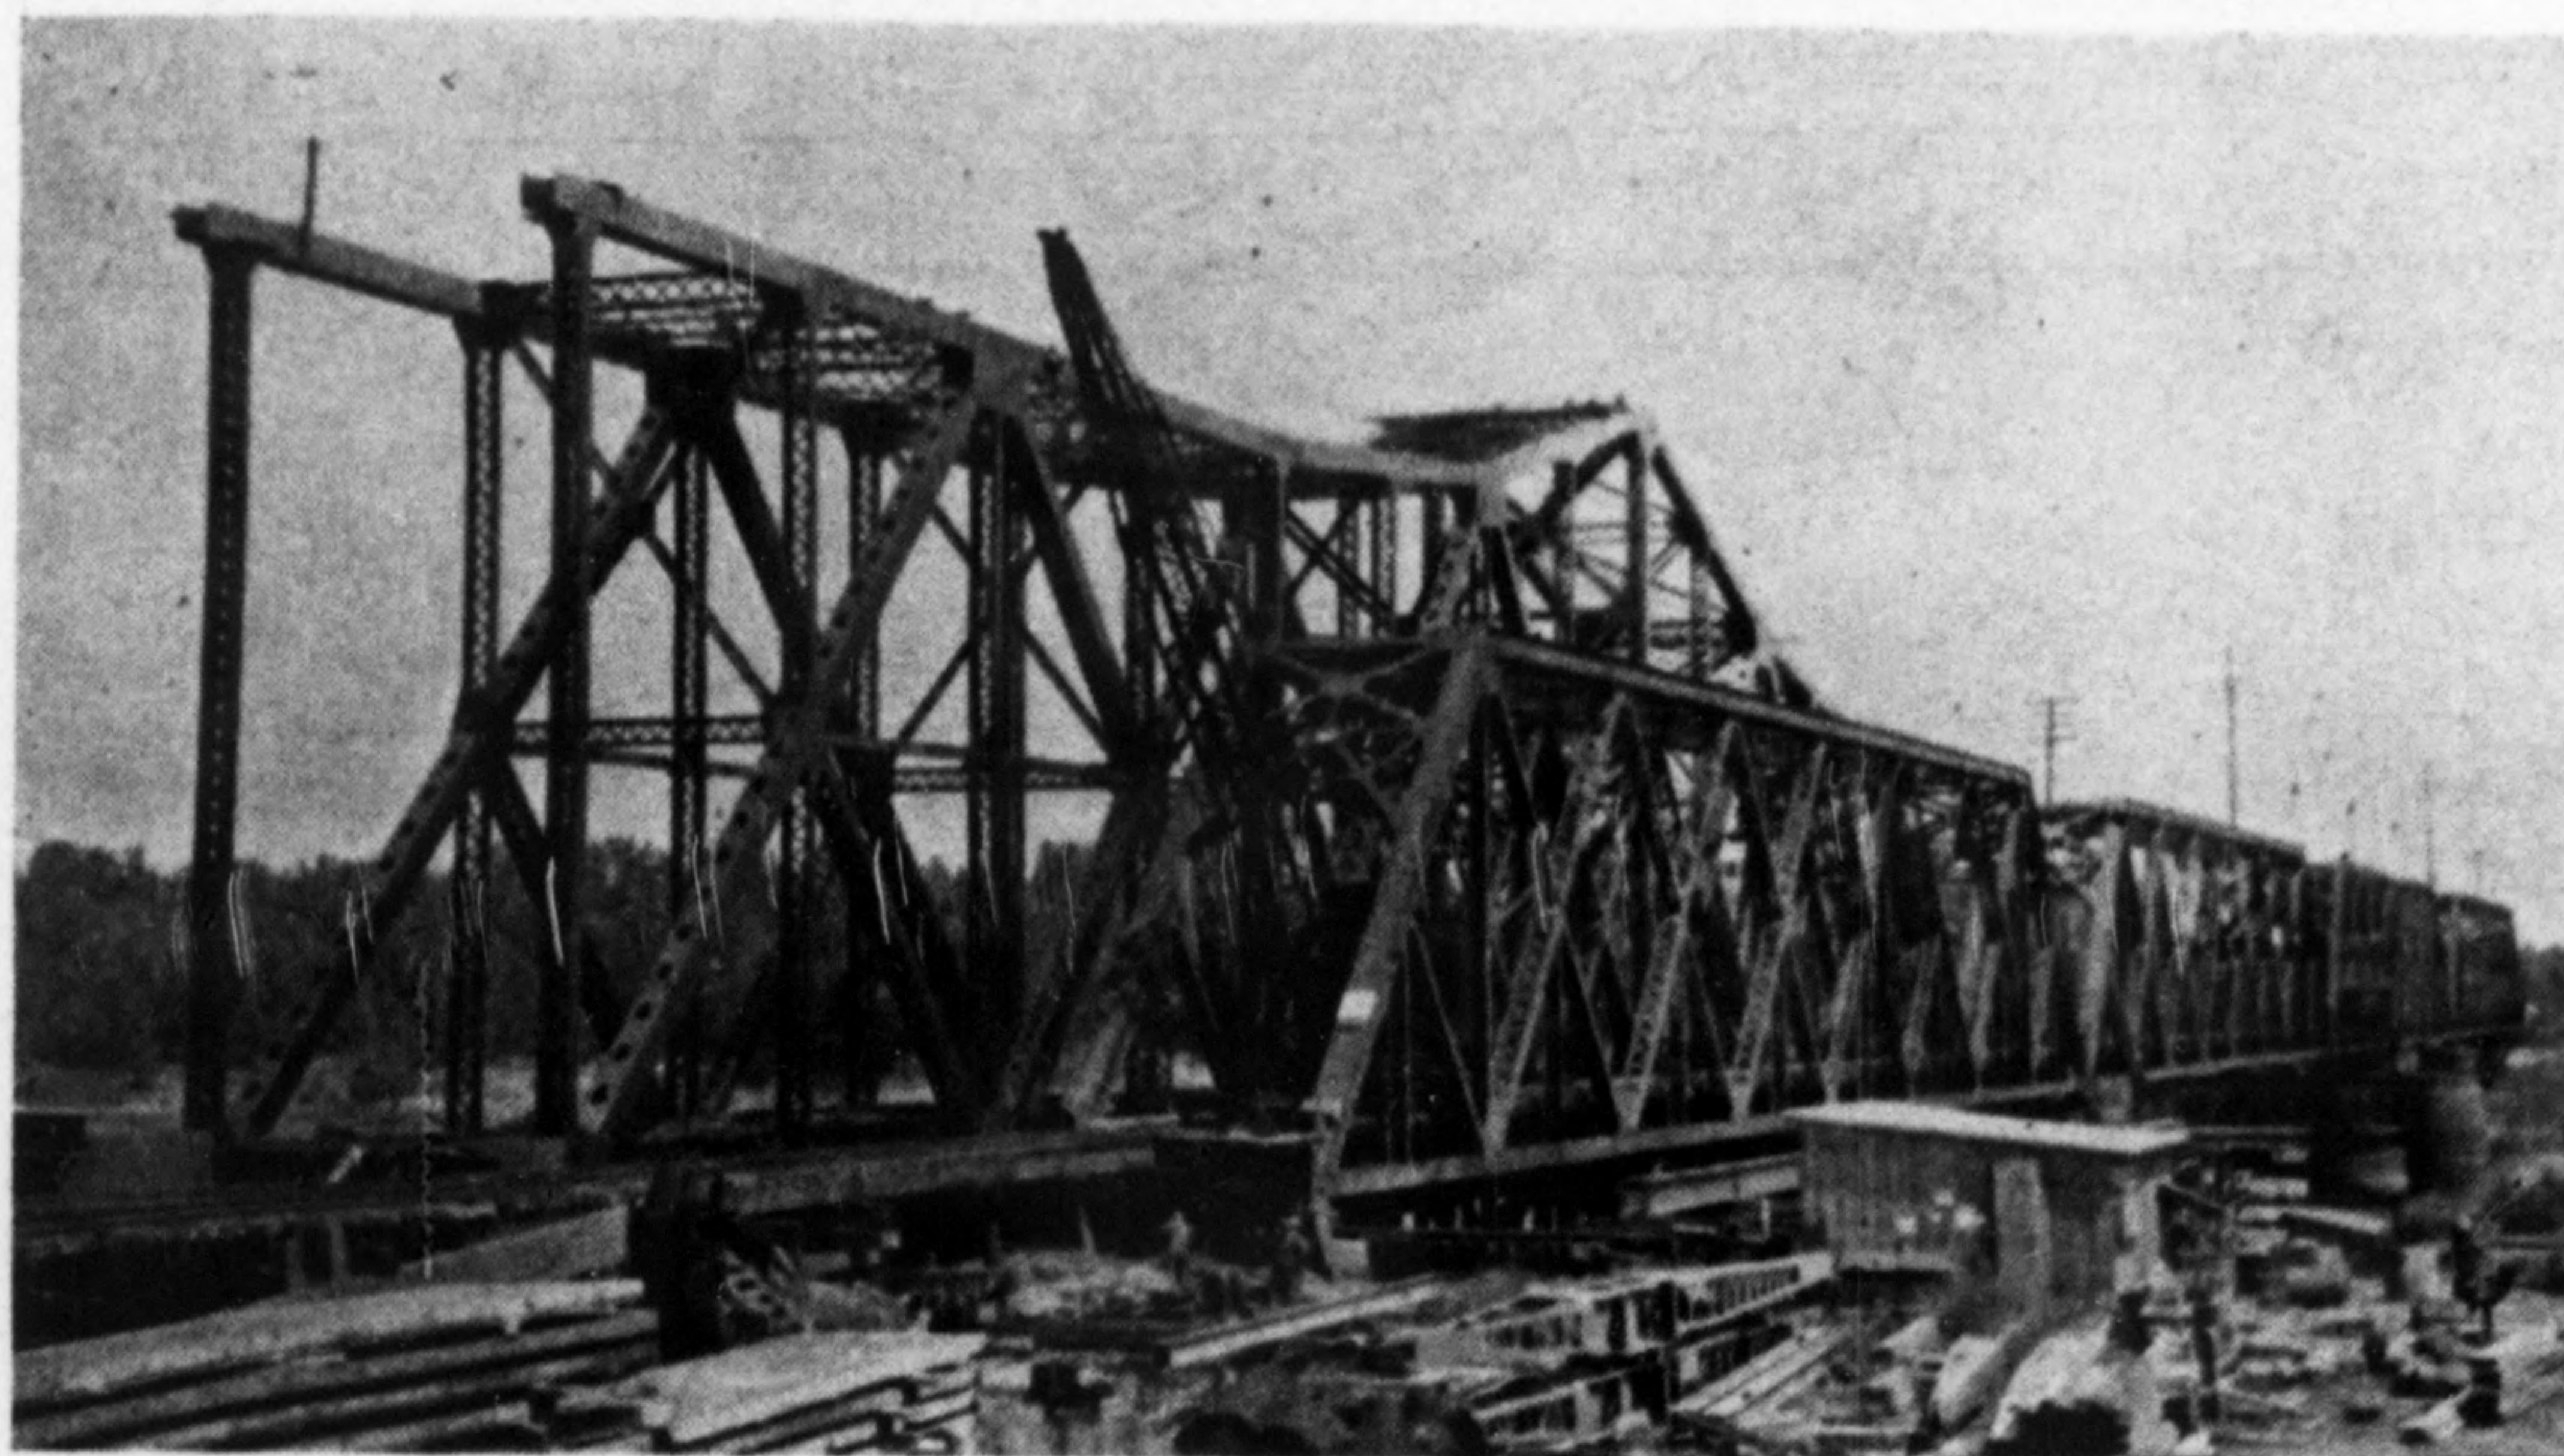
Fig. 4. Ready to roll out the 300 ft. truss span and roll in the new steelwork, which is part of a long span cantilever.
