Half-Circle Corrugated Culverts for Street Drainage

By JOHN C. HITESHEW*

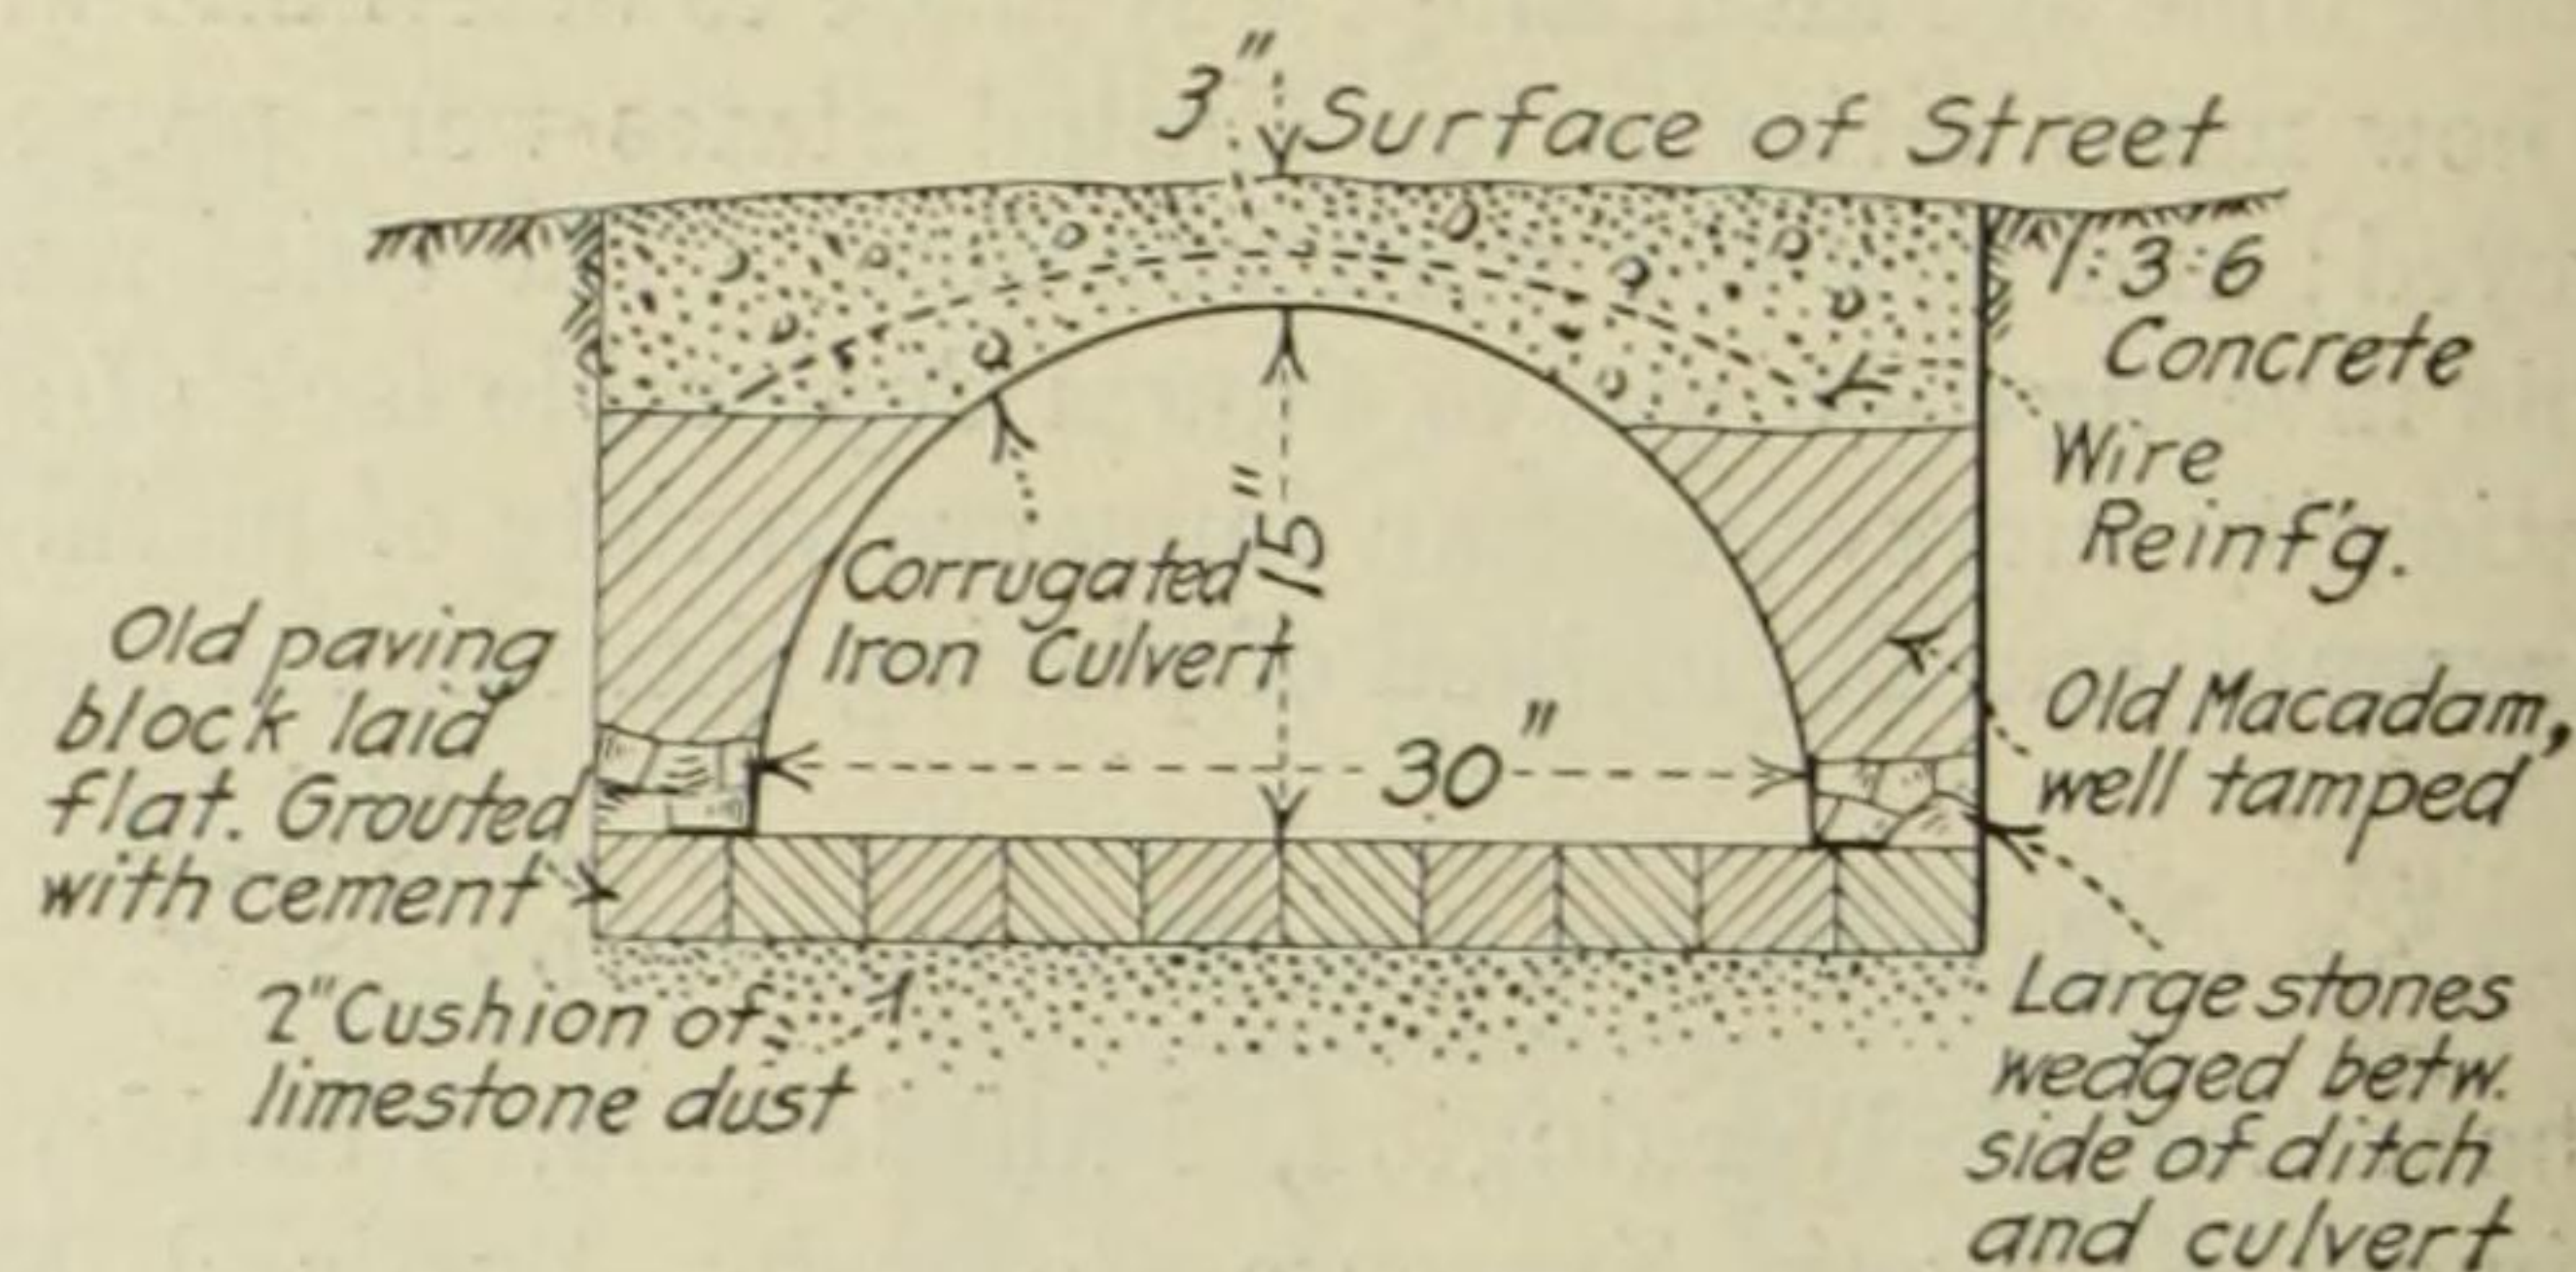
Cross-Section

FIG. 3. DETAILS OF HALF-CIRCLE CORRUGATED CULVERTS, CARLISLE, PENN.

The new corrugated culvert shown in detail in Fig. 3, is made of half-circle sections of corrugated culvert pipe with a bottom of bricks laid flat. The bricks were second-

Had there been sufficient covering over the culvert, concrete would not have been used, but as we only had about 3 in. of top covering, the crushed stone would have been

kicked loose by horses' hoofs, and would continually require patching. Light reinforcing wire was also placed in the concrete over the culvert to bond the thin concrete on top to the heavier mass on either side.

The ditch was excavated roughly to grade, and limestone screenings spread to proper grade, a brick gutter was then laid and rammed by hand hammer (using a 2x10-in. plank on the bricks), and then grouted with cement and sand, mixed 1:1 $\frac{1}{2}$. The half-circle was then placed and overlapped. Large stones were then laid between the culvert and the side of the ditch, so that there could be no spreading of the culvert pipe. These were well rammed, and a layer of macadam was then placed over the large stone for a depth of about 6 in., and well rammed, then concreted to the surface of the street.

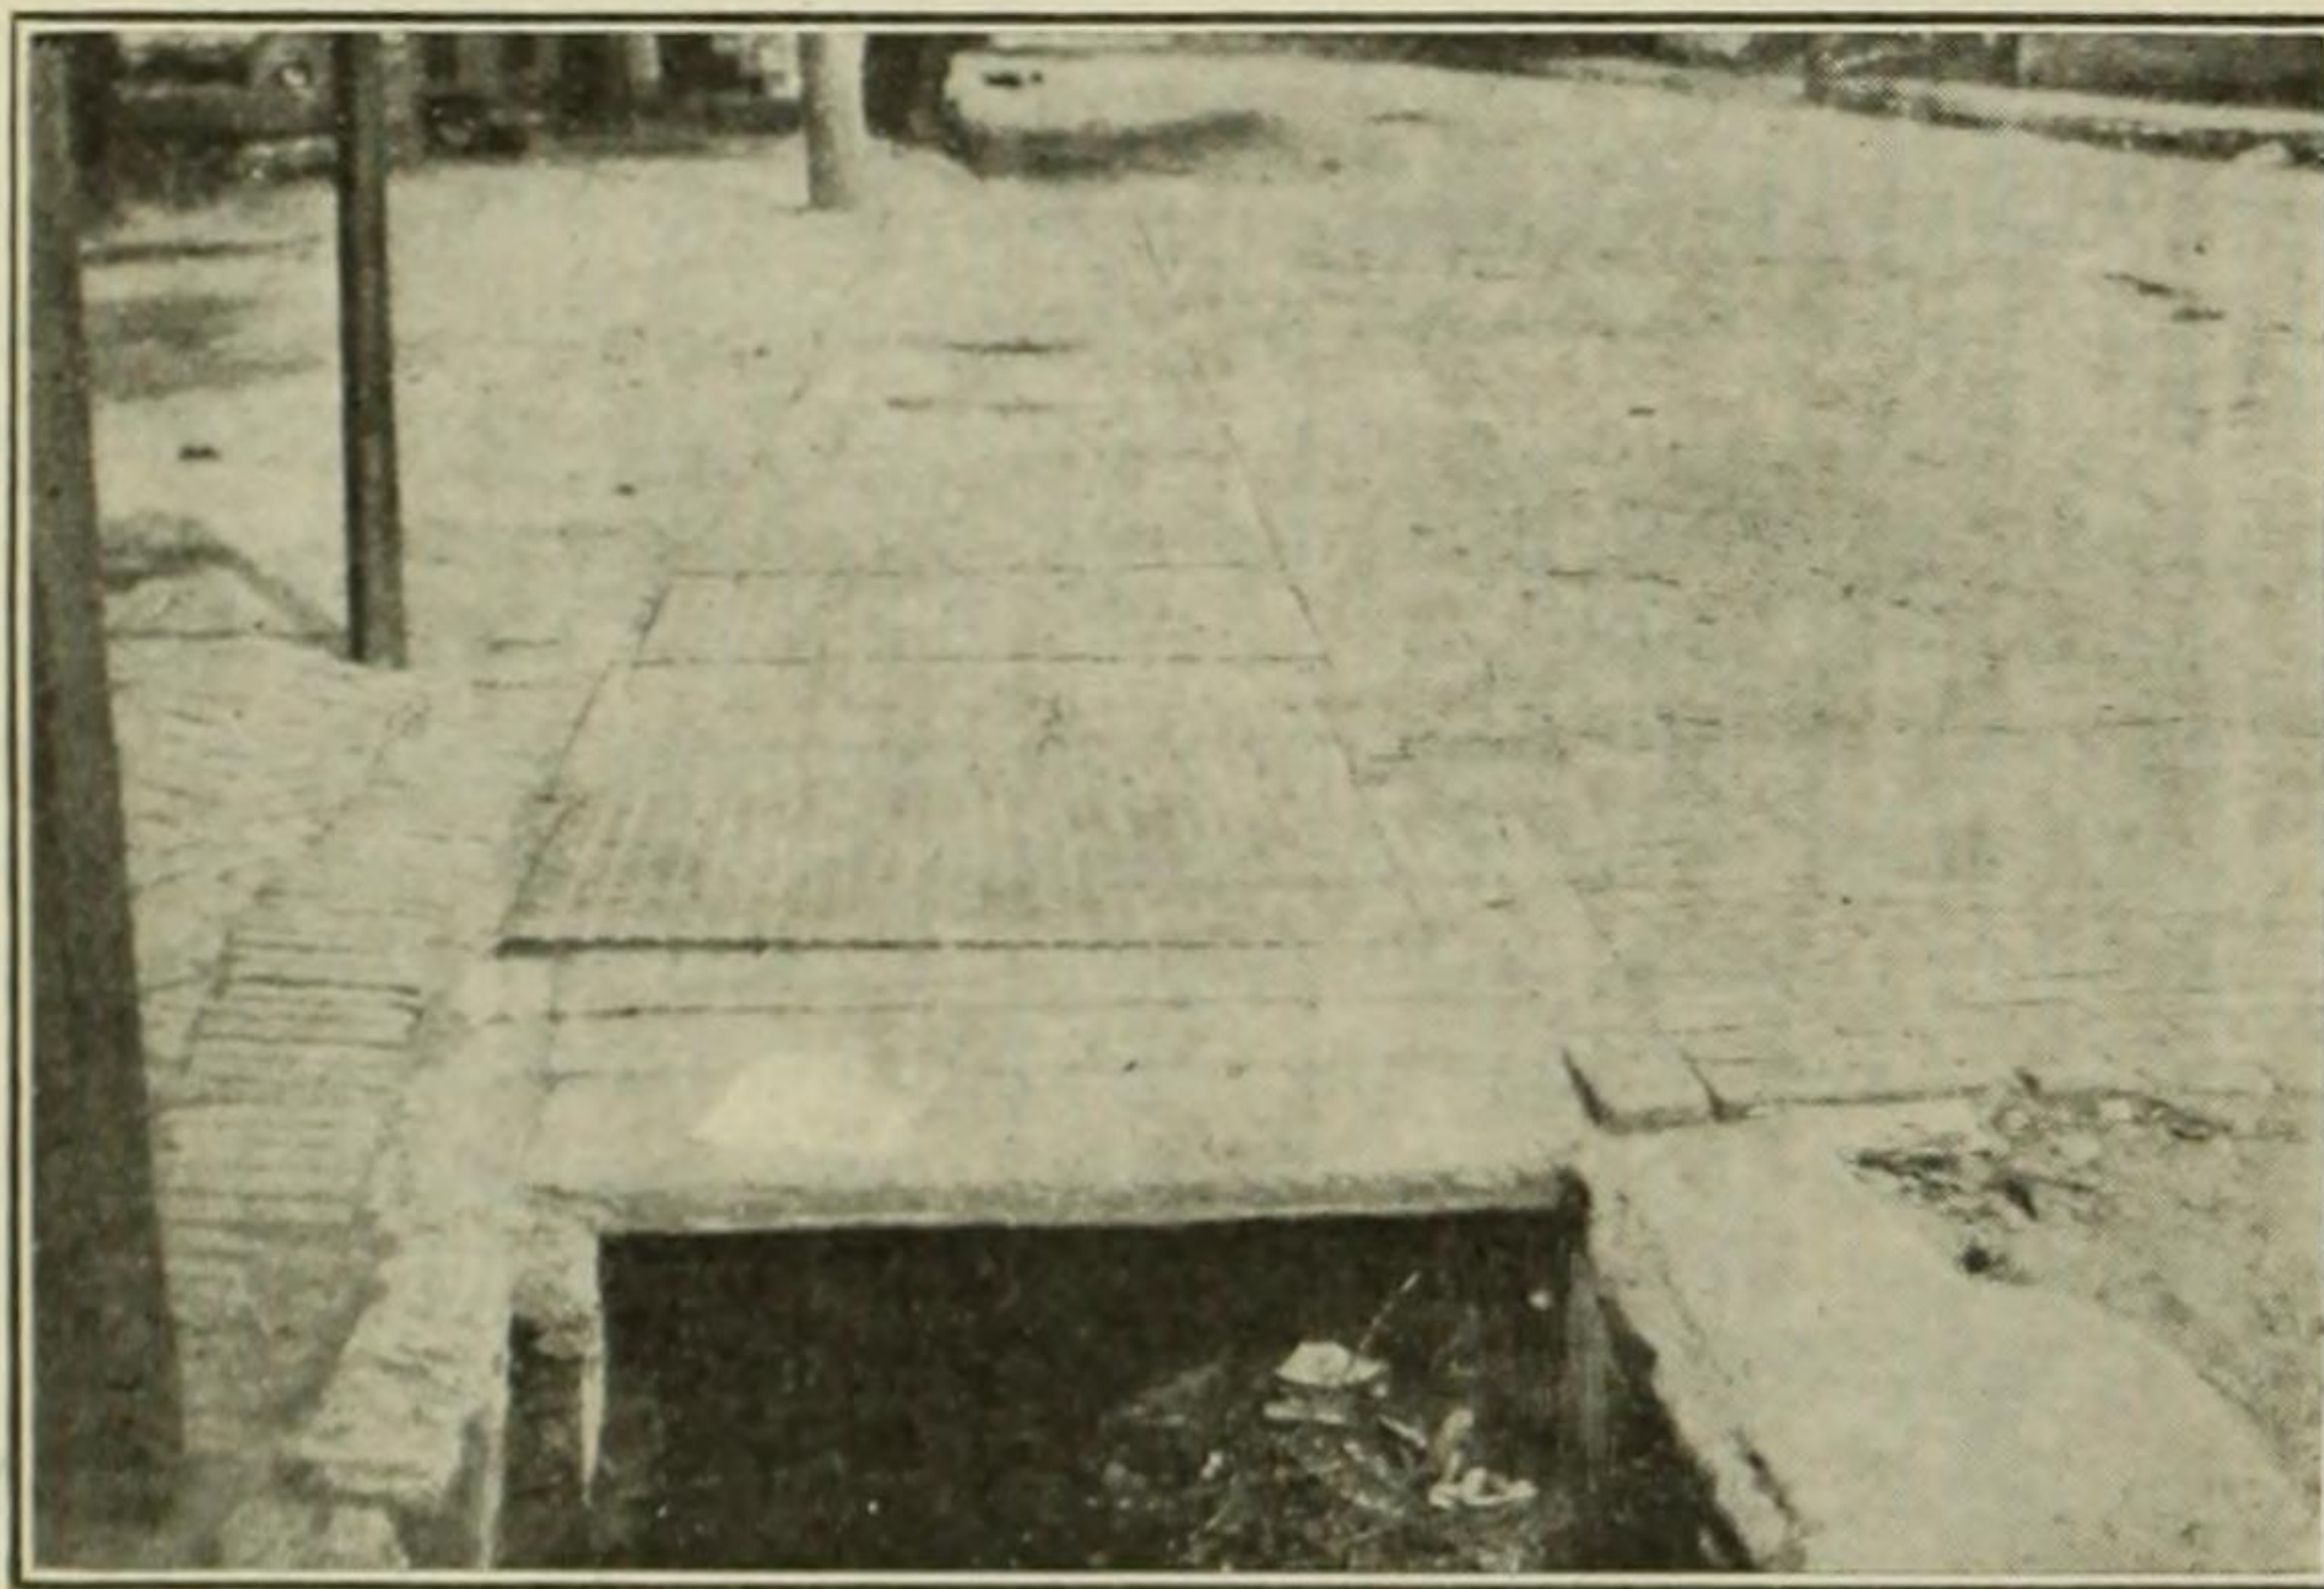
FIG. 1. OLD-STYLE CAST-IRON PLATE CULVERT

In Carlisle, Penn., at present practically all culverts across intersections are constructed of iron plates, $\frac{3}{4}$ in. thick, laid on old flagstone curbs, forming a conduit without a smooth flow line, having nothing more than a dirt floor (see Fig. 1). The plates are continually broken by traffic, entailing a repair cost of \$2.50 per plate. The first cost of the plate culverts on a 60-ft. street is approximately \$200.

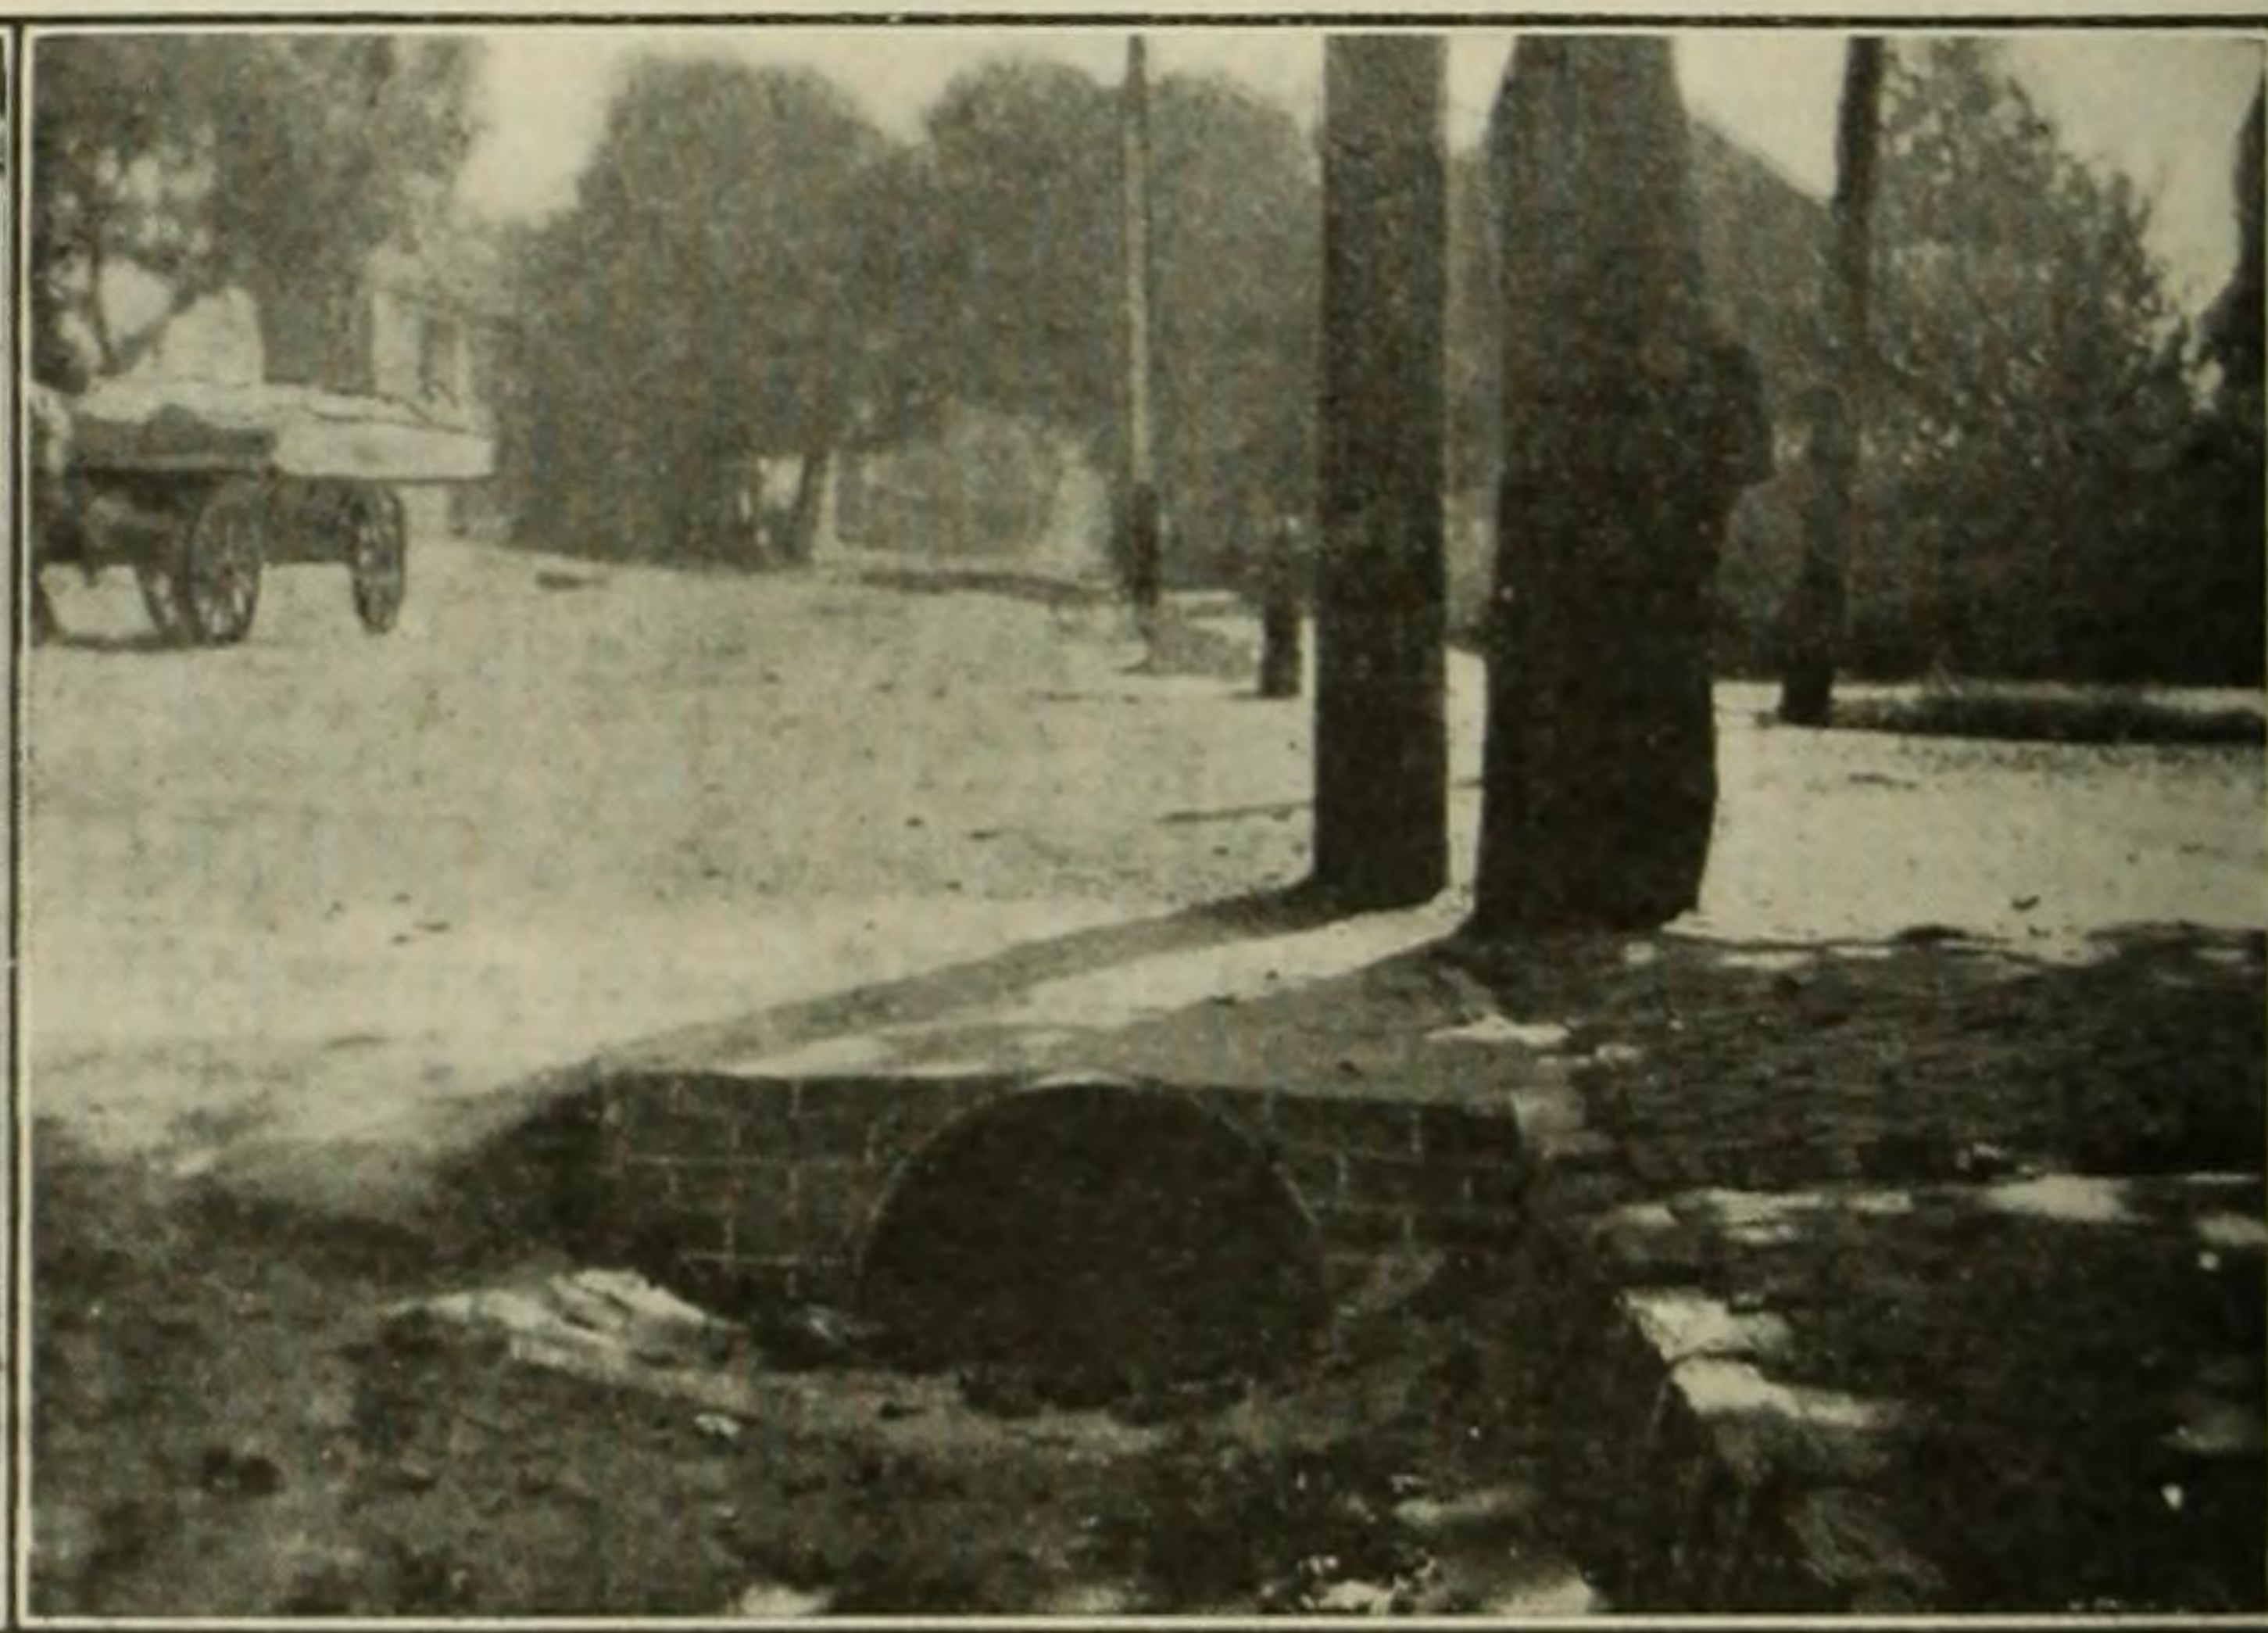
FIG. 2. NEW HALF-CIRCLE CORRUGATED CULVERT

Not only is a much neater and satisfactory job obtained, but the cost is less than half that of the old-style culverts.

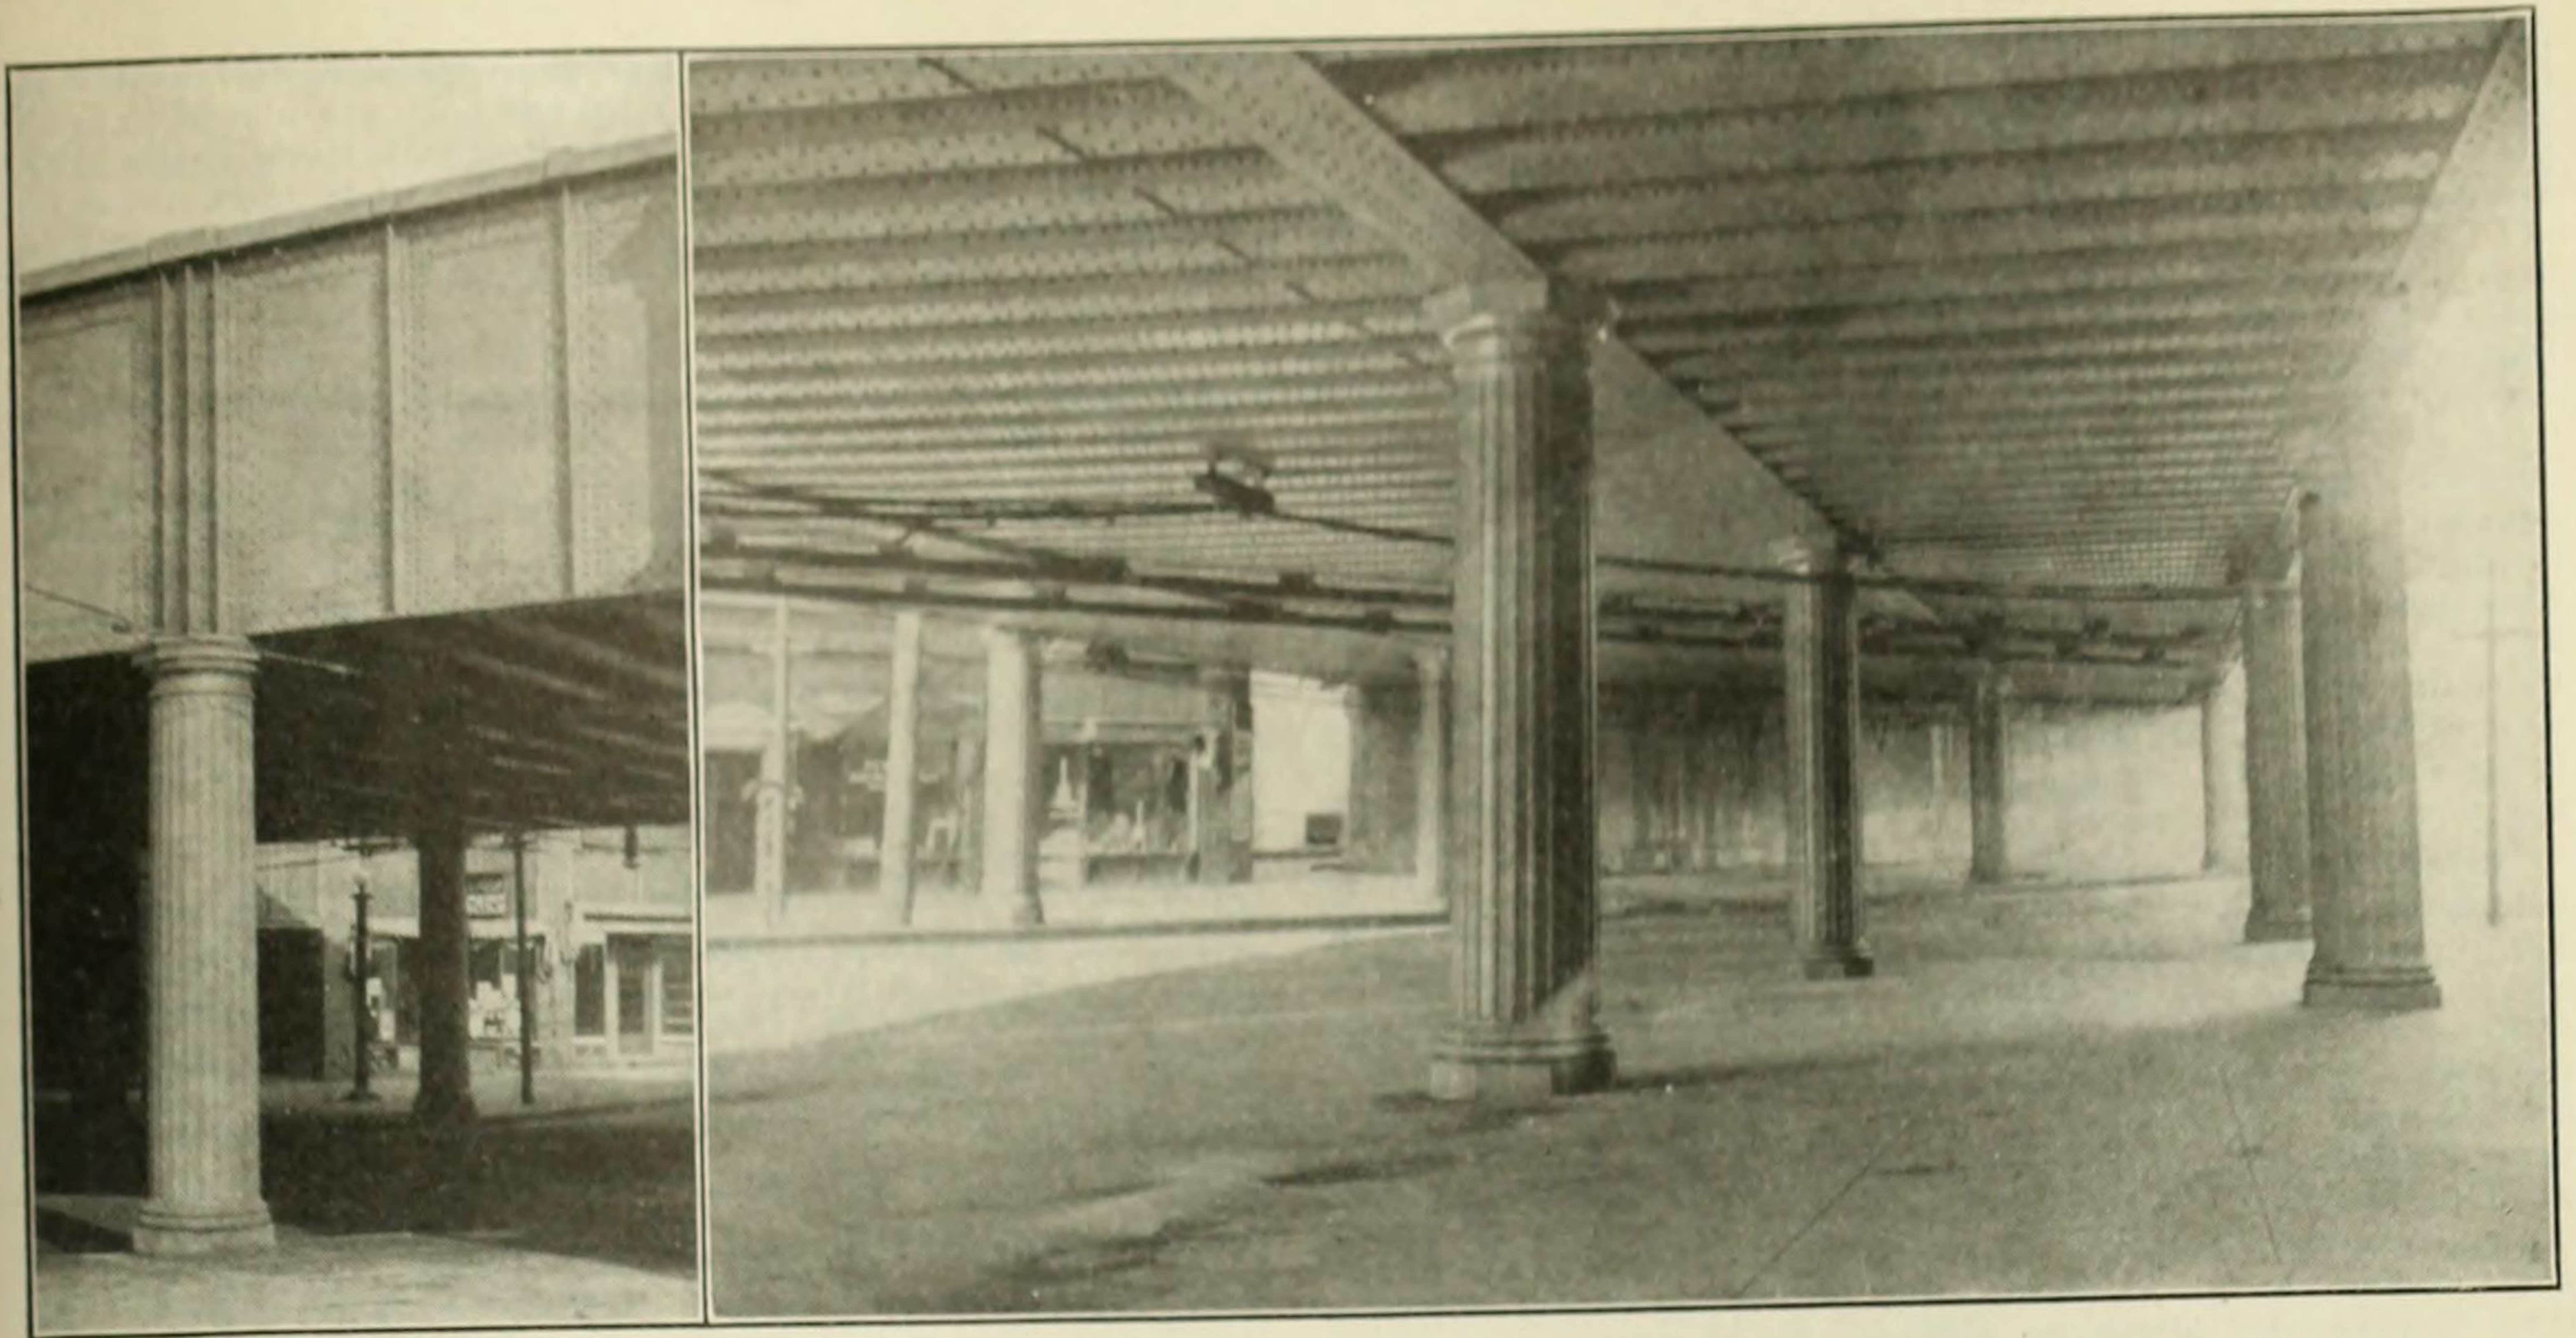
FIG. 1. CAST-IRON ORNAMENTAL CASING OF STEEL BRIDGE COLUMNS, EUCLID AVE. CROSSING, CLEVELAND, PENNSYLVANIA Co.

Two recent interesting examples of decorative treatment of girder bridges in a city can be seen in Cleveland, Ohio. The Pennsylvania Co., at a new bridge crossing at Euclid Ave. and 55th St., Fig. 1, has incased the steel columns supporting the girders in an ornamental cast-iron housing. There are a few other decorative details about this bridge, as for instance a cast-iron coping

on the top flanges of the girders. The bridge is painted a concrete gray.

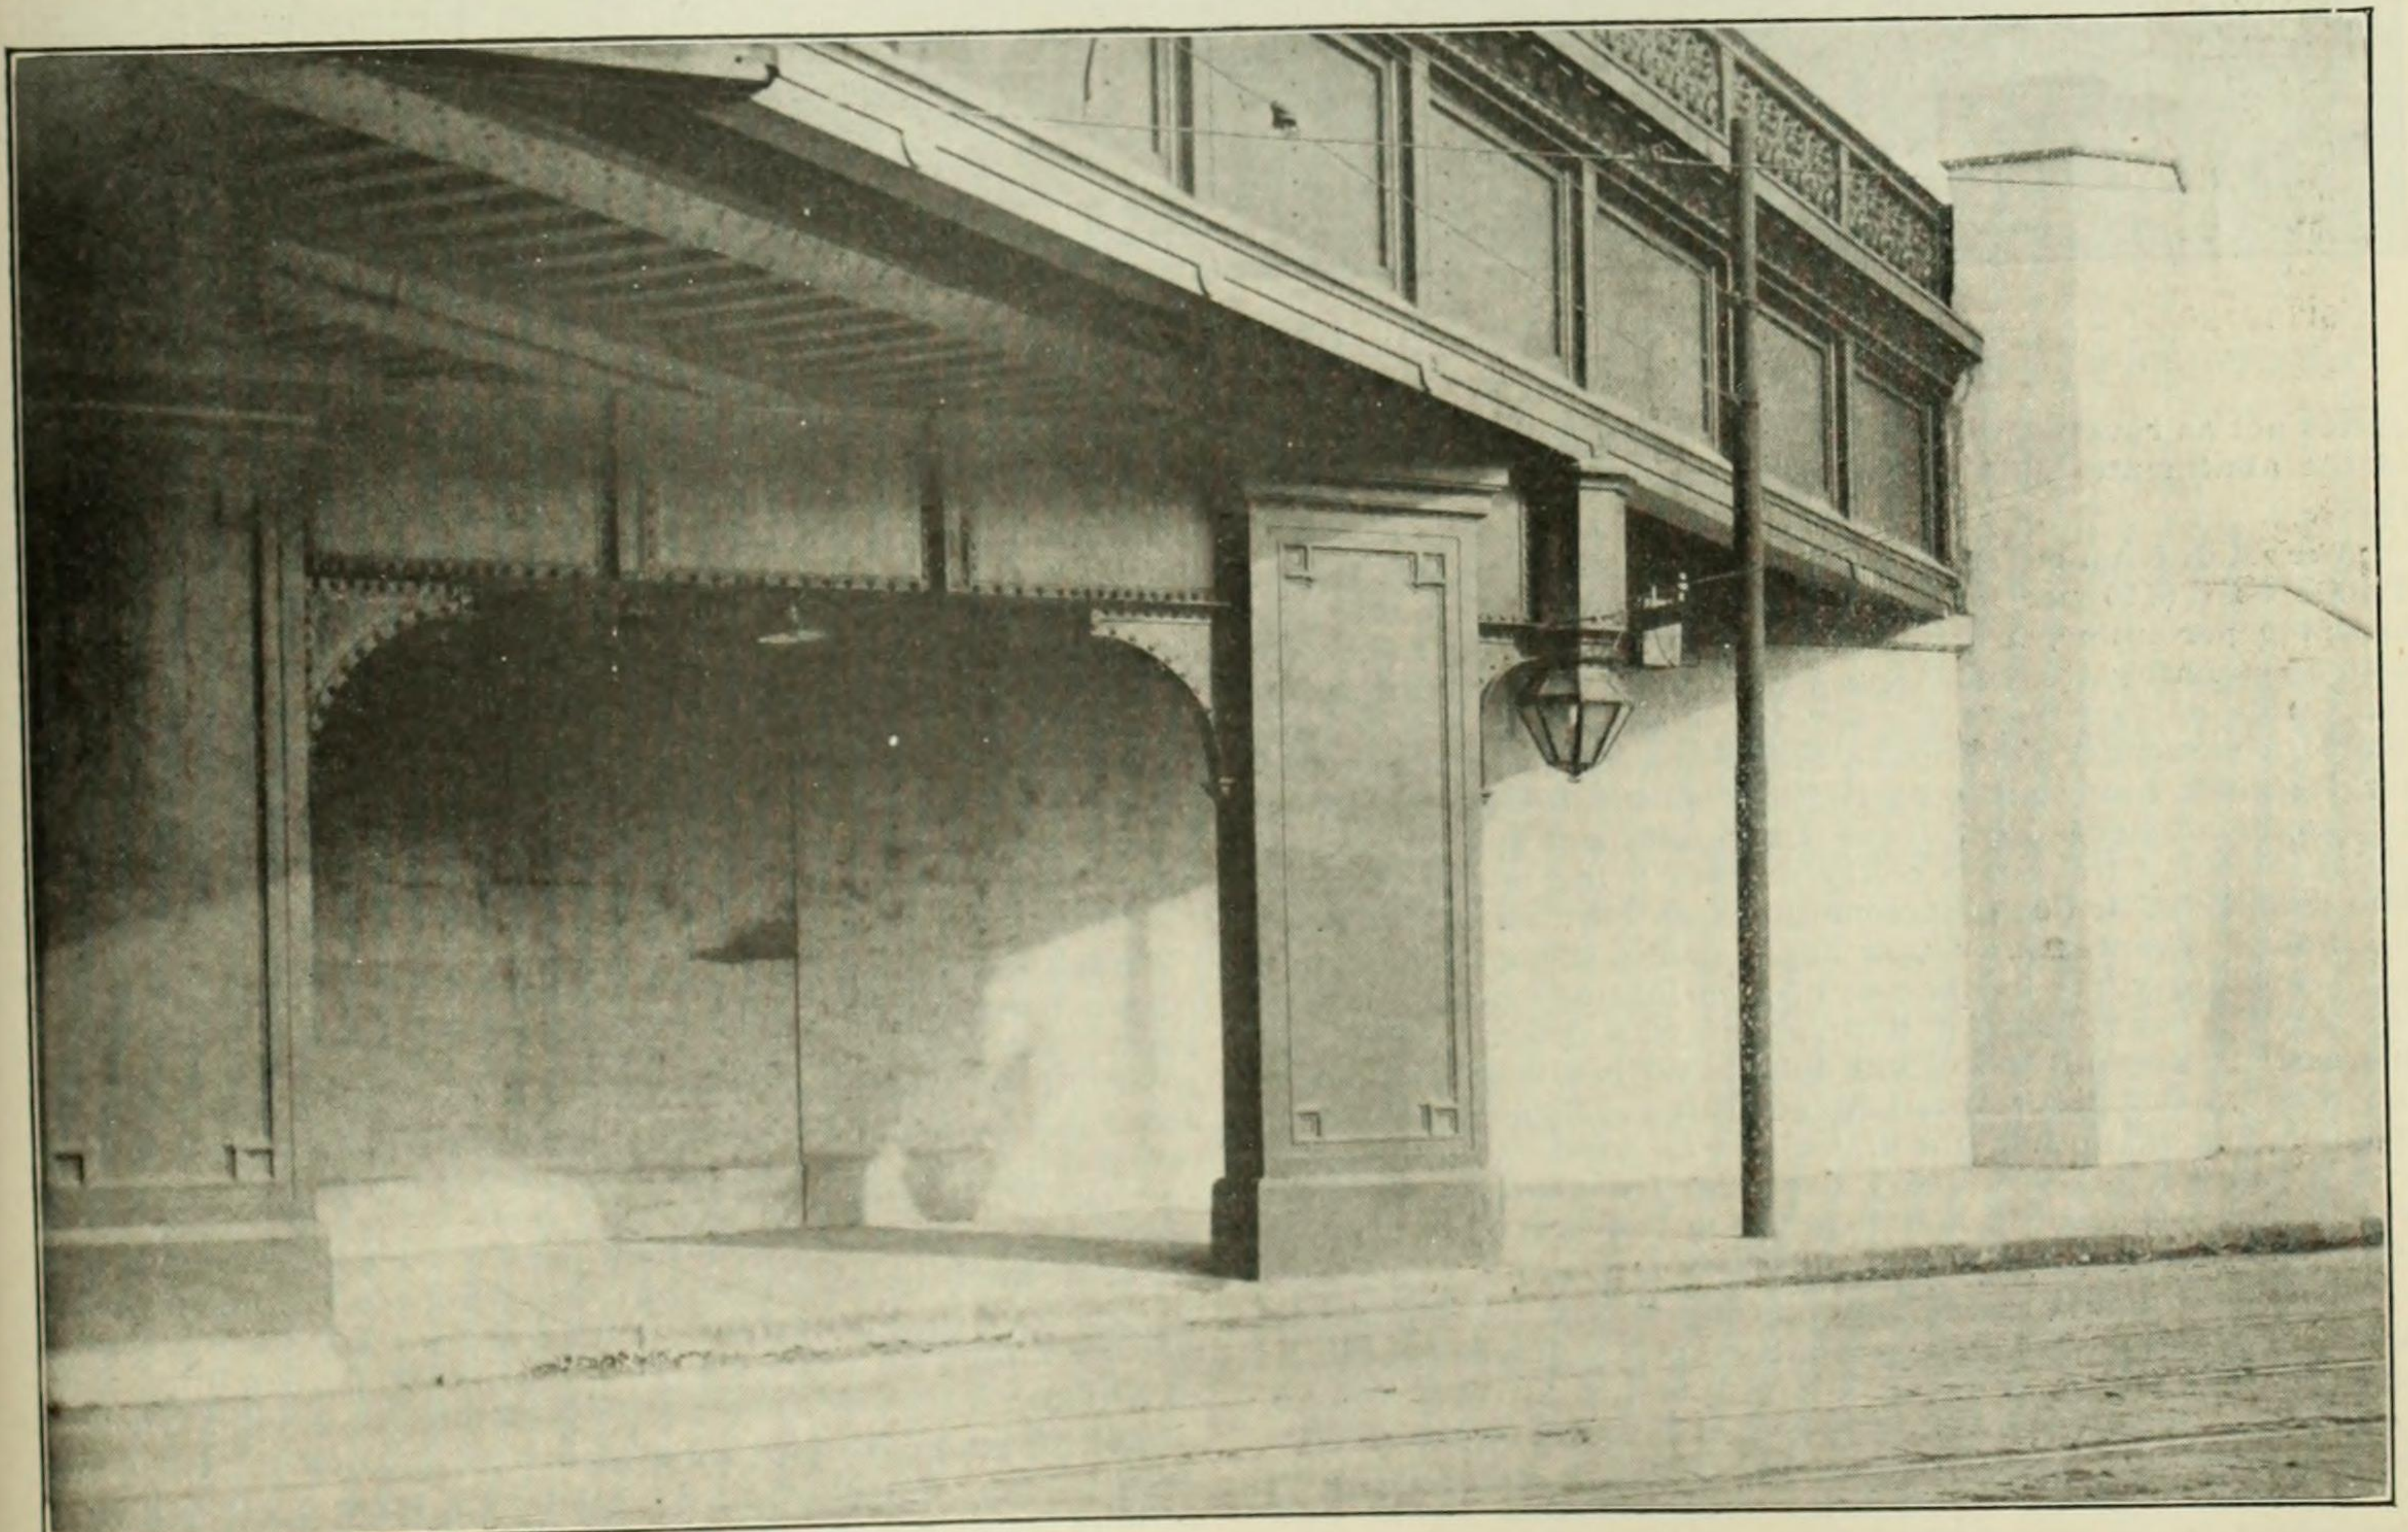
FIG. 2. LAKE AVE. BRIDGE OF L. S. & M. S. RY., CLEVELAND; FULL CAST-IRON INCASEMENT

The Lake Ave. bridge, on the Lake Shore & Michigan Southern Ry. at the entrance of Edgewater Park, is a far more elaborate attempt at cast-iron incasement. Fig. 2 shows this. The original proposal was that the whole soffit of the structure should also be incased, but the objections to this course were substantial enough to bring

about the simplified proposal which was carried into execution. A remarkable feature of this work is its enormous cost, amounting to about \$10,000, which, while made upon the requirement of the city, had to be paid 65% by the railway company and 35% by the city. Undoubtedly the similarity of the result to painted stonework in appearance will prove pleasing to a large number of people who see the bridge.
