WA-III-168 Sandy Hook Bridge (SHA 21041)

Architectural Survey File

MARYLAND INVENTORY OF HISTORIC BRIDGES HISTORIC BRIDGE INVENTORY MARYLAND STATE HIGHWAY ADMINISTRATION/ MARYLAND HISTORICAL TRUST

SHA Bridge No. 21041 Bridge name Sandy Hook Bridge
LOCATION: Street/Road name and number [facility carried] U.S. Route 340 over the Potomac River, CSX Railroad, C & O Canal, and Sandy Hook Road
City/town Sandy Hook Vicinity X
County Washington
This bridge projects over: Road X Railway X Water X Land
Ownership: State X County Municipal Other
HISTORIC STATUS: Is the bridge located within a designated historic district? Yes X No National Register-listed district National Register-determined-eligible district Locally-designated district Other
Name of district Sandy Hook
BRIDGE TYPE: Timber Bridge: Beam Bridge Truss -Covered Trestle Timber-And-Concrete
Stone Arch Bridge
Metal Truss Bridge X
Movable Bridge: Swing Bascule Single Leaf Bascule Multiple Leaf Swing Retractile Pontoon
Metal Girder X X Rolled Girder X Rolled Girder Concrete Encased Plate Girder Plate Girder Concrete Encased
Metal Suspension
Metal Arch

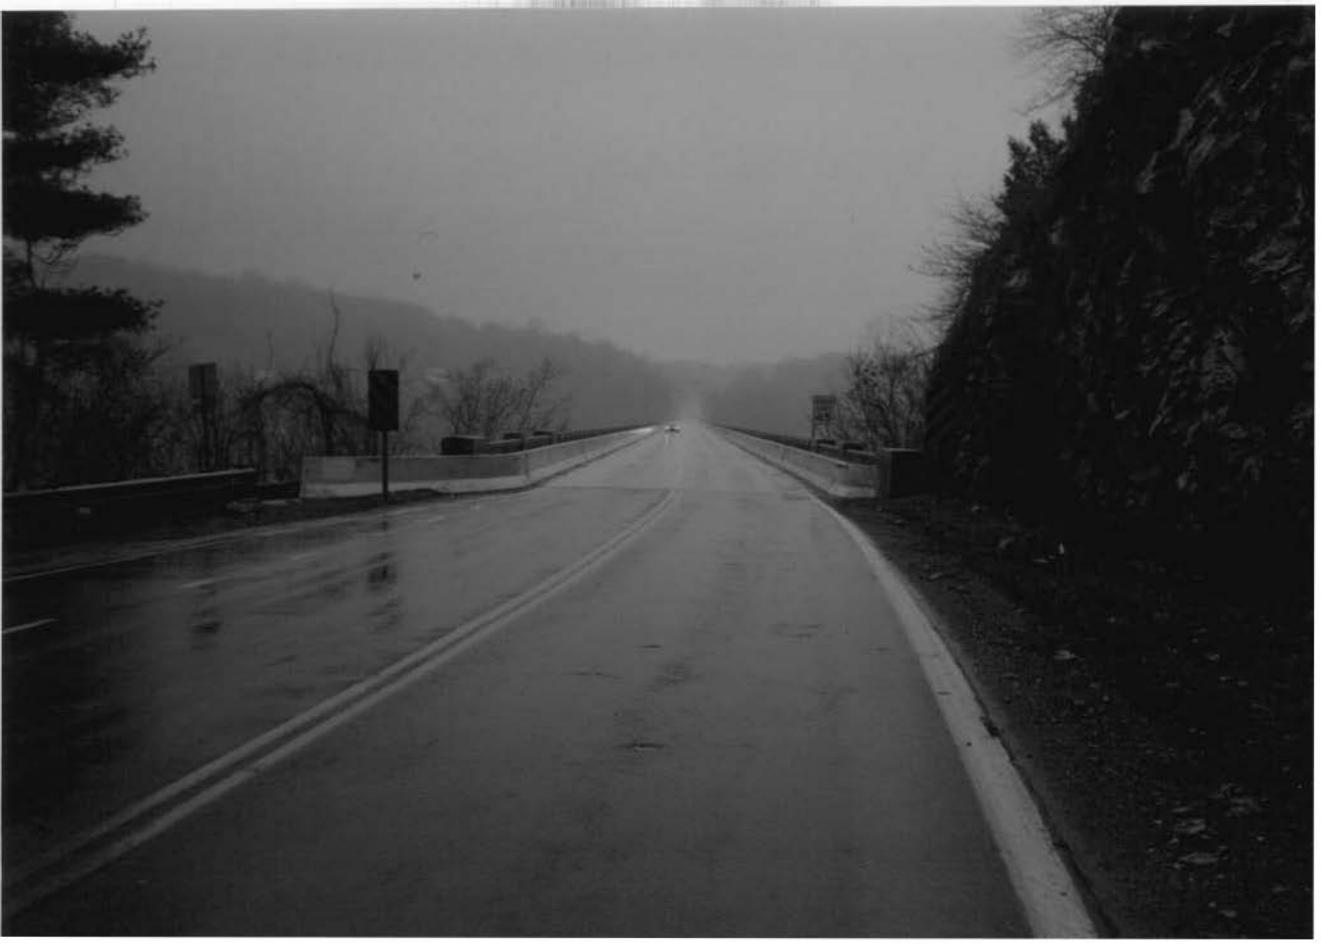
1. WA-III-163 2. 21041, Sandy Hook Budge 3. Washington County, MD 4. Dave Dik, WMa abooc. 5. March 1998 6. MD SHPO 7 South approach, view northennin 1200002 8. 196

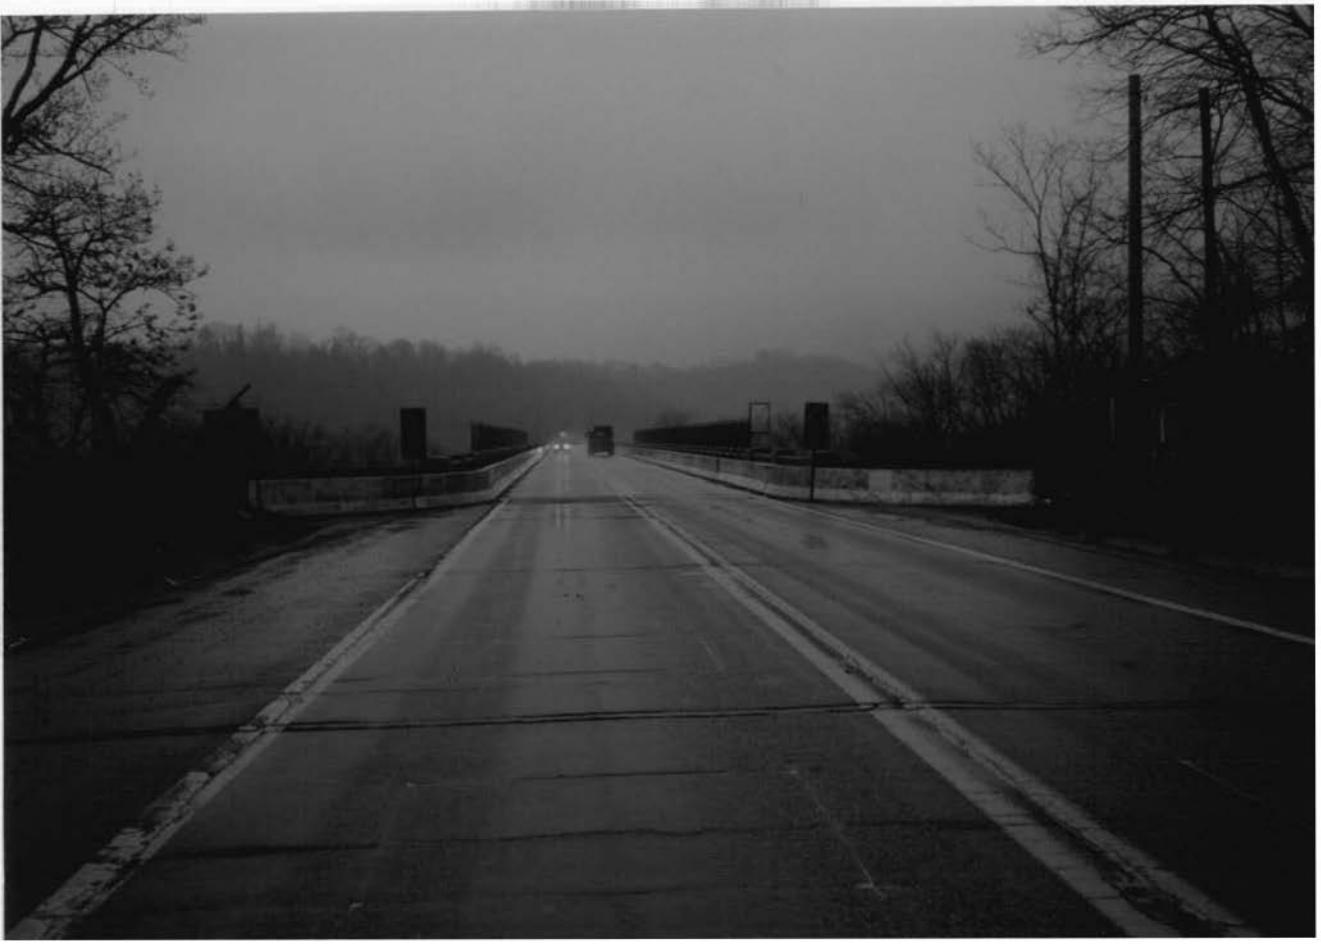
1. WA-III-168 2. 21041, Sandy Hook Bridge 3. Washington County Maryland 4. Dave Dick, WM& Cooc. 5. March 1993 6. MD SHPB 7. North approach, view south CHANNELSONG 8. 20h6

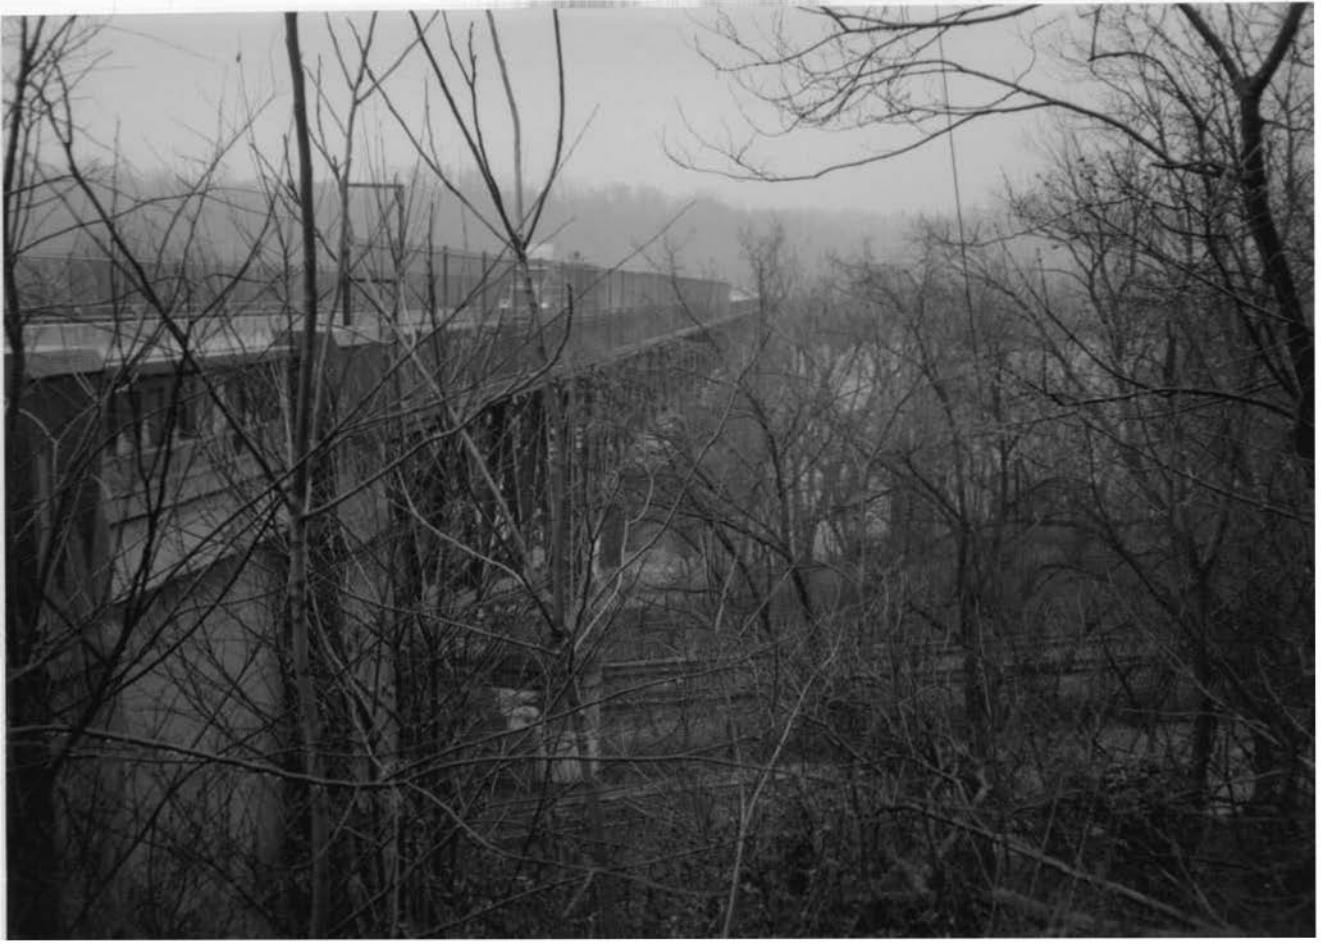
1. WA-III-168 2. 21041, Sandy Hook Budge 3. Washington County, MD 4. Dave Dick, WM. assoc. 5. March 1998 6. MD SHPO 7. West elevation, view cost 8. 3 g 6 THE PLAN IS STORE

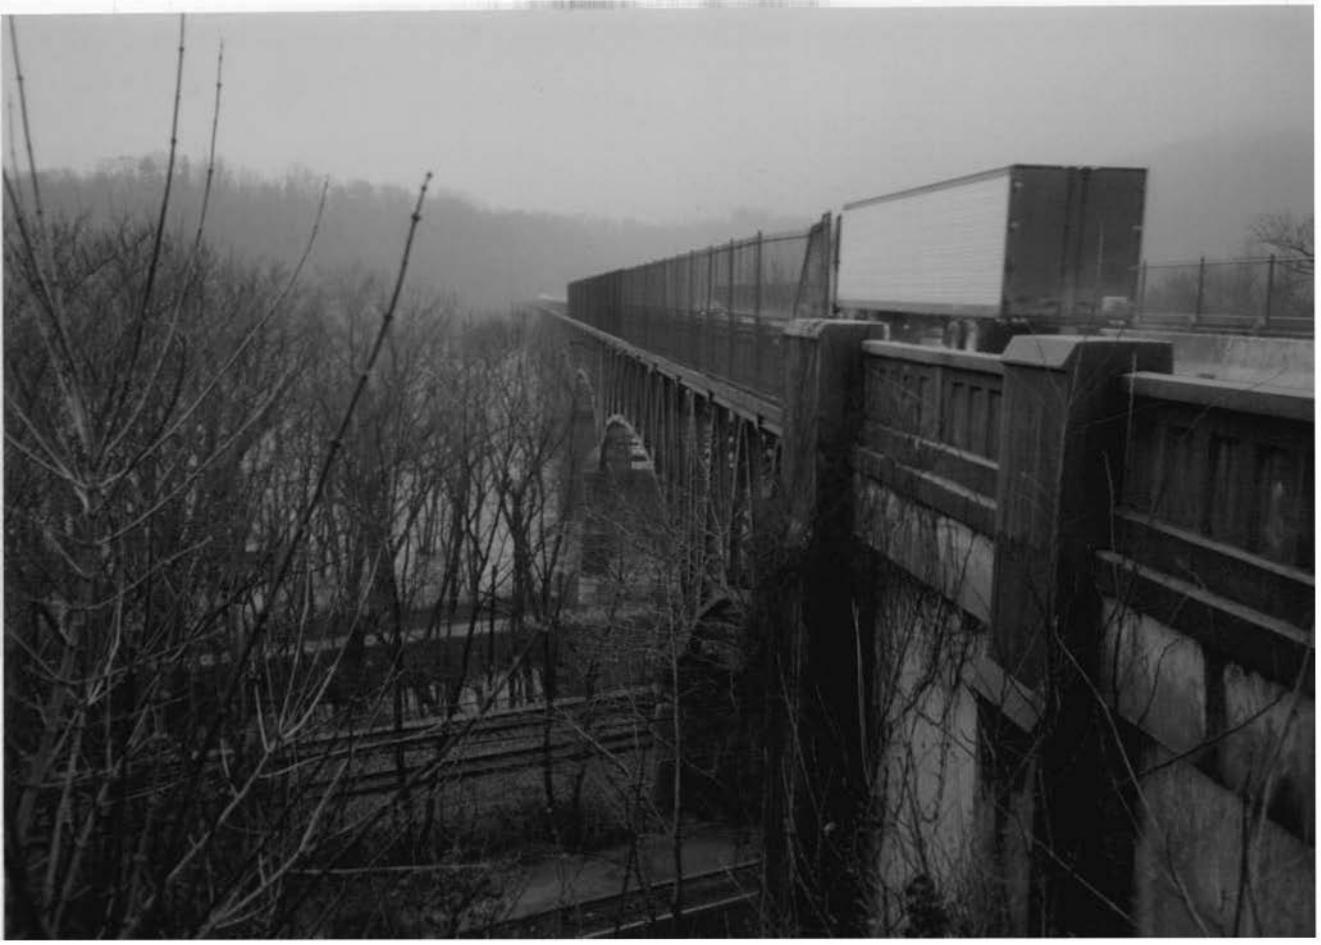
1. WA-ITE-168 2. 21041, Sandy Hook Bridge 3. Washington County, MD 4. Dave Dick, WM & assoc 5. March 1998 6. MD SHPO 7. East elevation, view west + N.N. \$2216 -8. 40/6

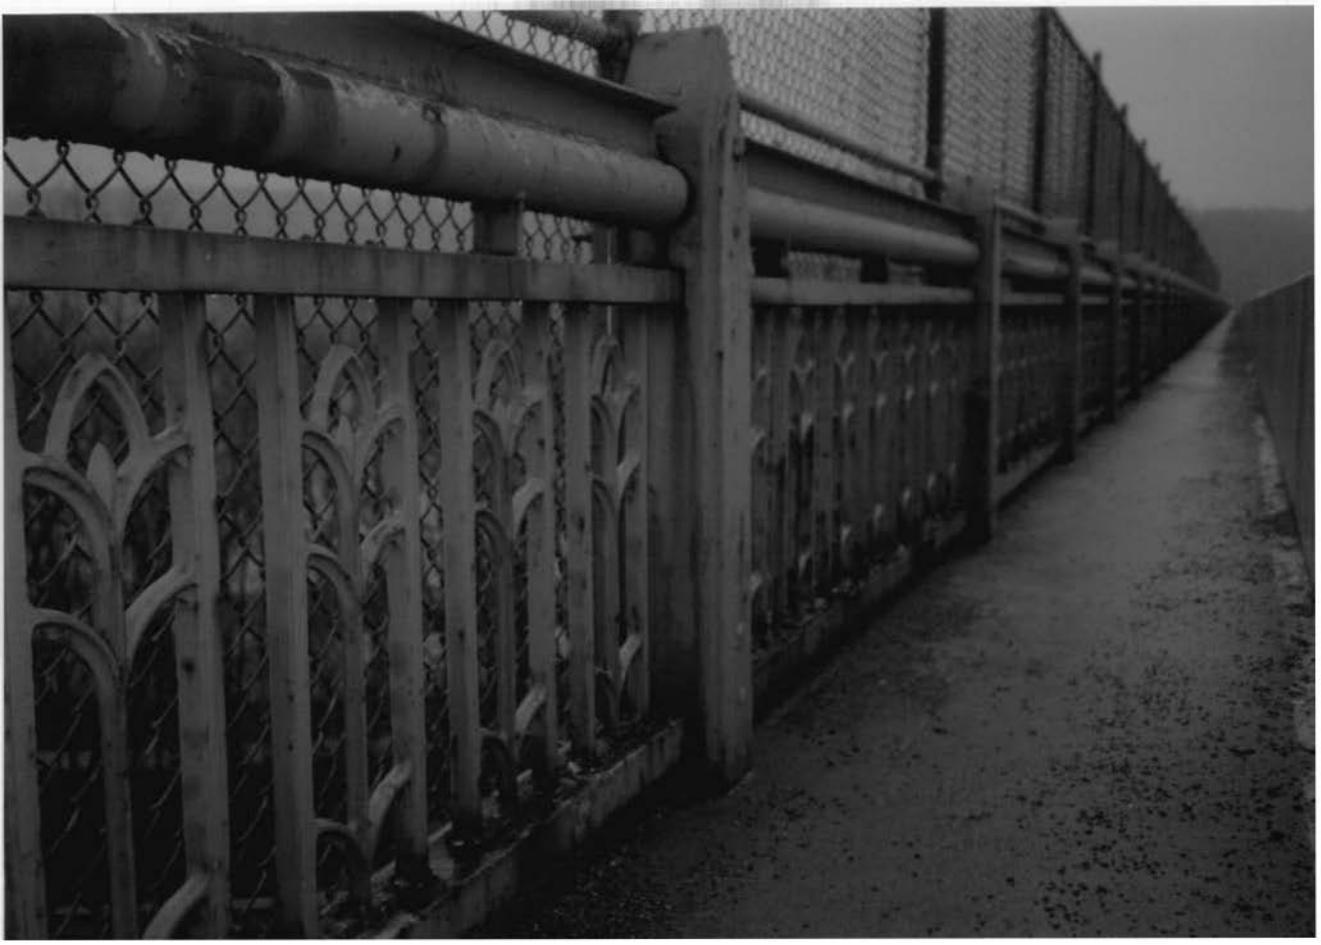
The original construction consisted of reinforced concrete bridge deck which supported two (2) interior mountable curbs and an exterior elaborate ornamental metal railing. The sidewalk areas were built at grade with the roadway.

The original railing was modified with the addition of a structural Tee section welded to the top rail for purposes of upgrading the railing to conformity to AASHTO safety criteria. The roadway joint and backwall were replaced at each abutment. A chain link safety fence was added to the bridge at span no. 2, which spans the CSX Railroad.

1. WA-IT- 168 2. 21041, Sandy Acok Bridge 3. Washington County, MD 4. Dove Dick, WM & assoc. 5. March 1998 6. MD SAPO 7. Detail of railing 8.5 g 6

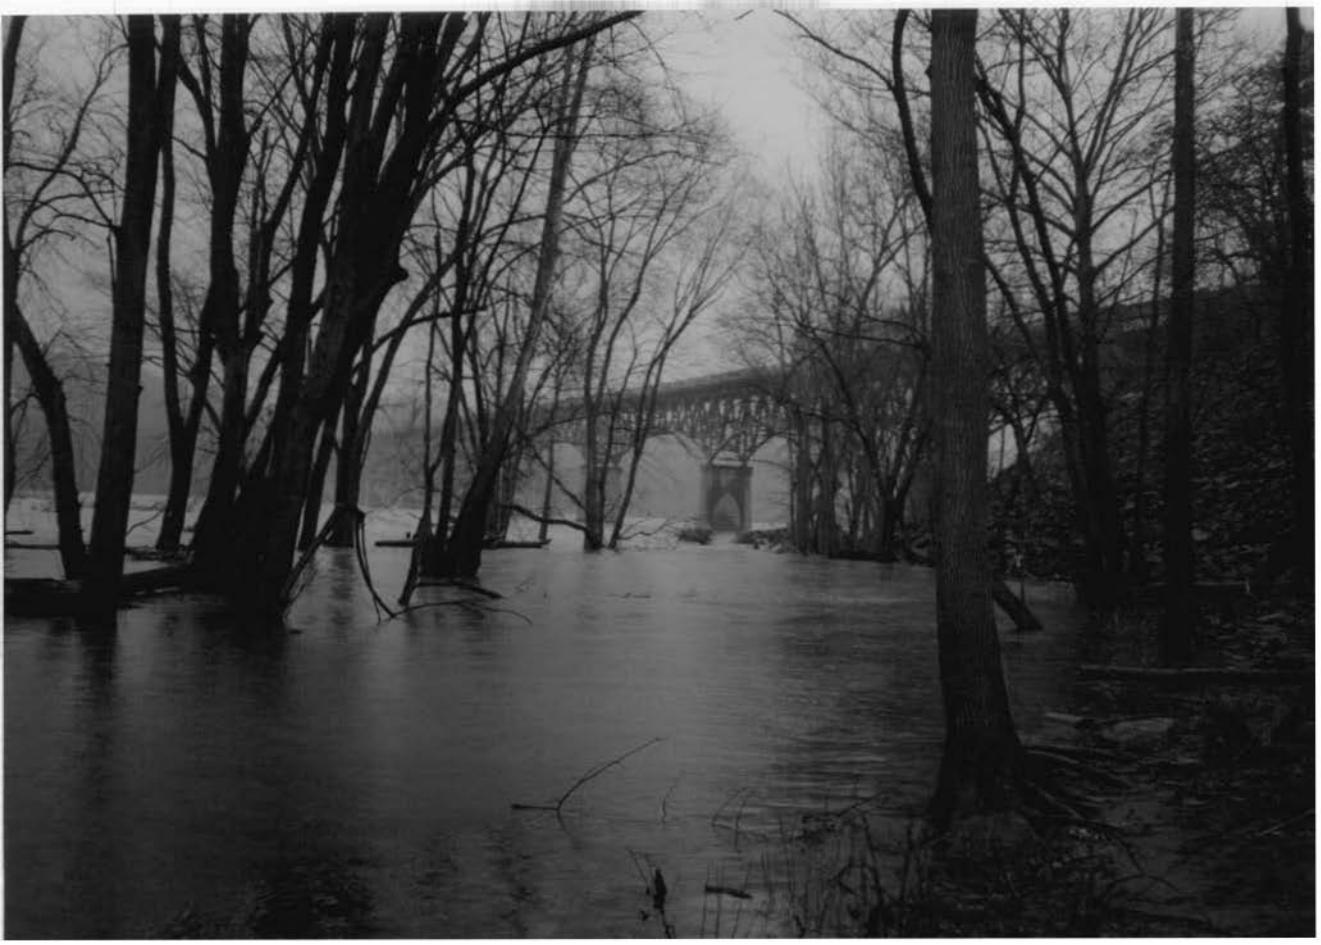
1. WA-III-168 2. 21041, Sandy Hook Bridge 3. Washington County, MD 4. Dave Dick, WM+ assoc. 5. March 1998 6. MD SHPO 7. West elevation, view east 7 & B. L. M. Barner Bran 8. 696
