## **Centre Wellington Bridge 1-P**

General Information	Physical Details
Bridge No. CW12	<b>Type</b> : Pony Truss (Pin Jointed)
Ownership: Township of Centre Wellington	Span: Single
Construction Date: 1890	Dimensions: 11.8m x 4.5m (LxW)
Water Crossing: Carroll Creek	Materials: Steel, Timber

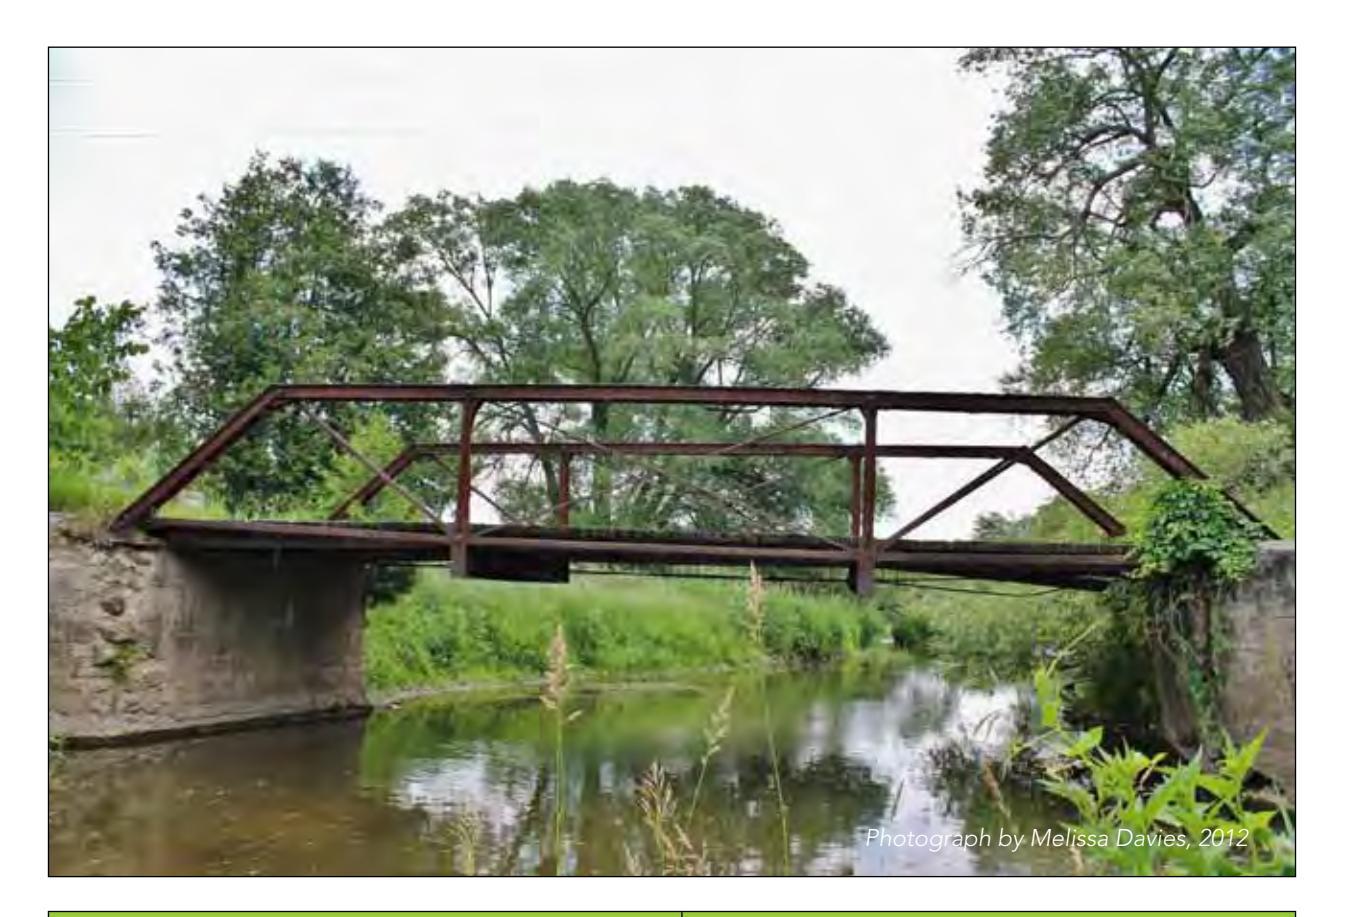
Centre Wellington Bridge 1-P is located on Sideroad 5, 0.9 km east of Eighth Line West. It was constructed in 1890; making it the oldest steel truss bridge remaining in the Township of Centre Wellington. There are five remaining steel truss bridges in Centre Wellington, and together with the Salem Bridge, Centre Wellington Bridge 1-P is one of only two remaining pony truss bridges.

Aside from its early date of construction and pin jointing, now a rare feature, this bridge is unique due to its uncharacteristically short span. The bridge is constructed of steel with a timber deck. It is in poor condition and has been closed to the public.
