PENNSYLVANIA LINES
WEST OF PITTSBURGH

A HISTORY
OF THE
FLOOD
OF
MARCH, 1913

COMPILED
BY
C. W. GARRETT

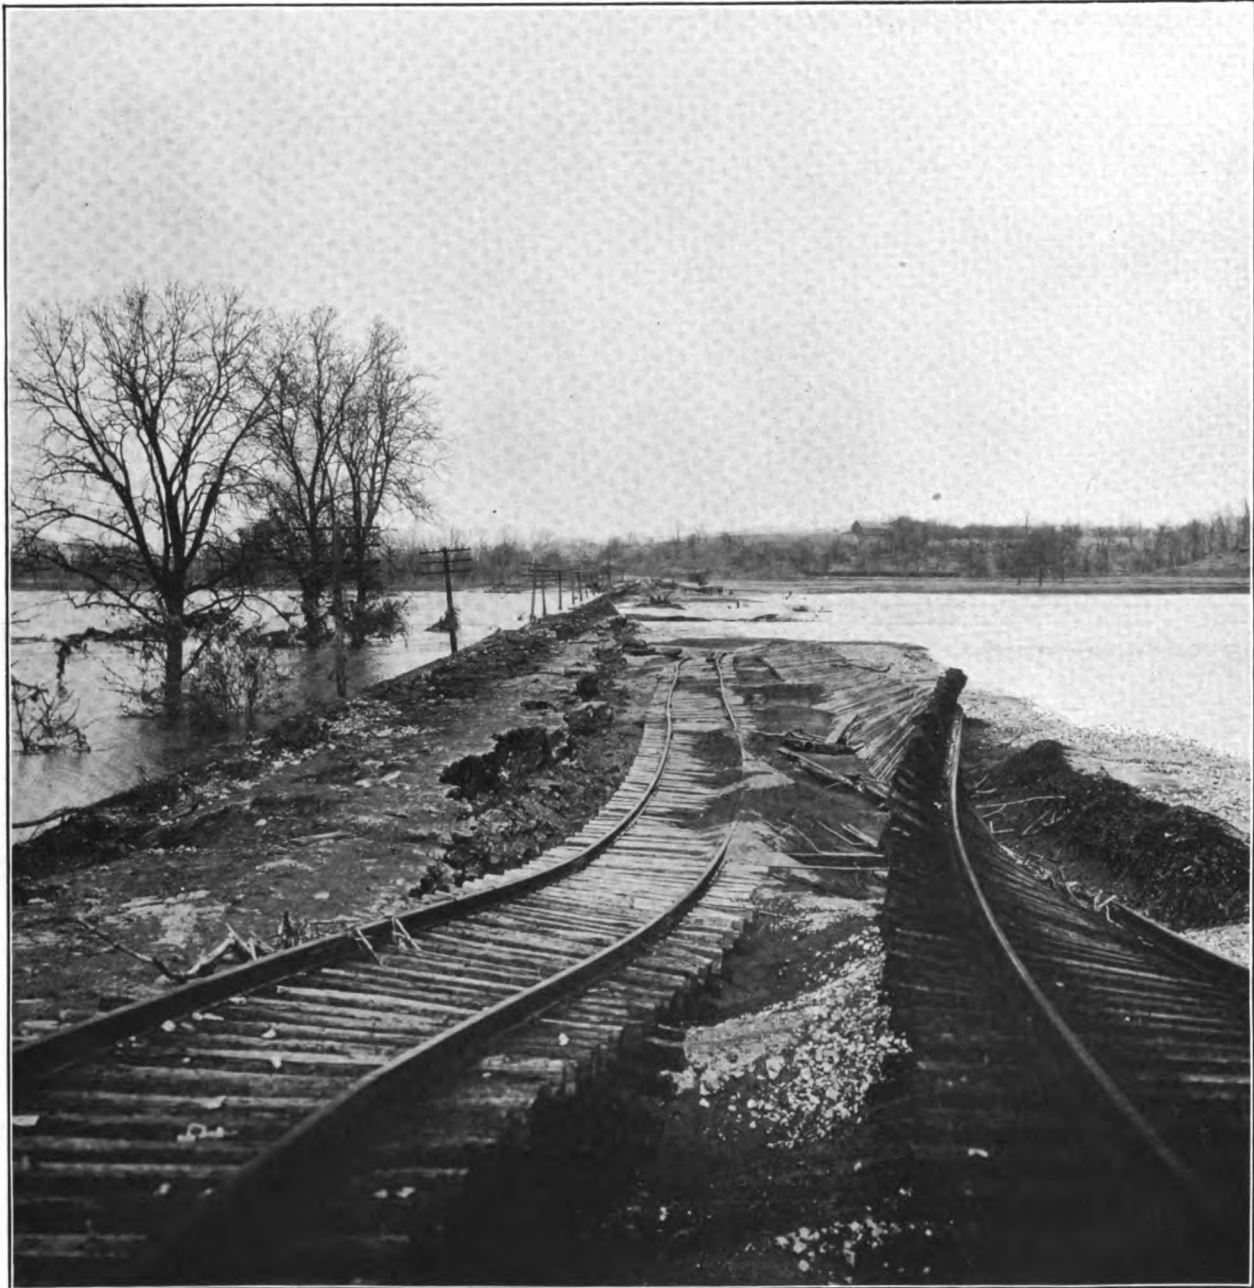
Coshocton, Ohio, west of.

Looking toward Pittsburgh from the east approach to Bridge No. 100, over the Muskingum River. The normal channel of the river lies a quarter of a mile or more to the left of the railway, which was carried on a high embankment, 2,700 lineal feet of which was washed away, from 10 to 25 feet deep ; two of the four spans of the bridge were swept away and a third damaged.

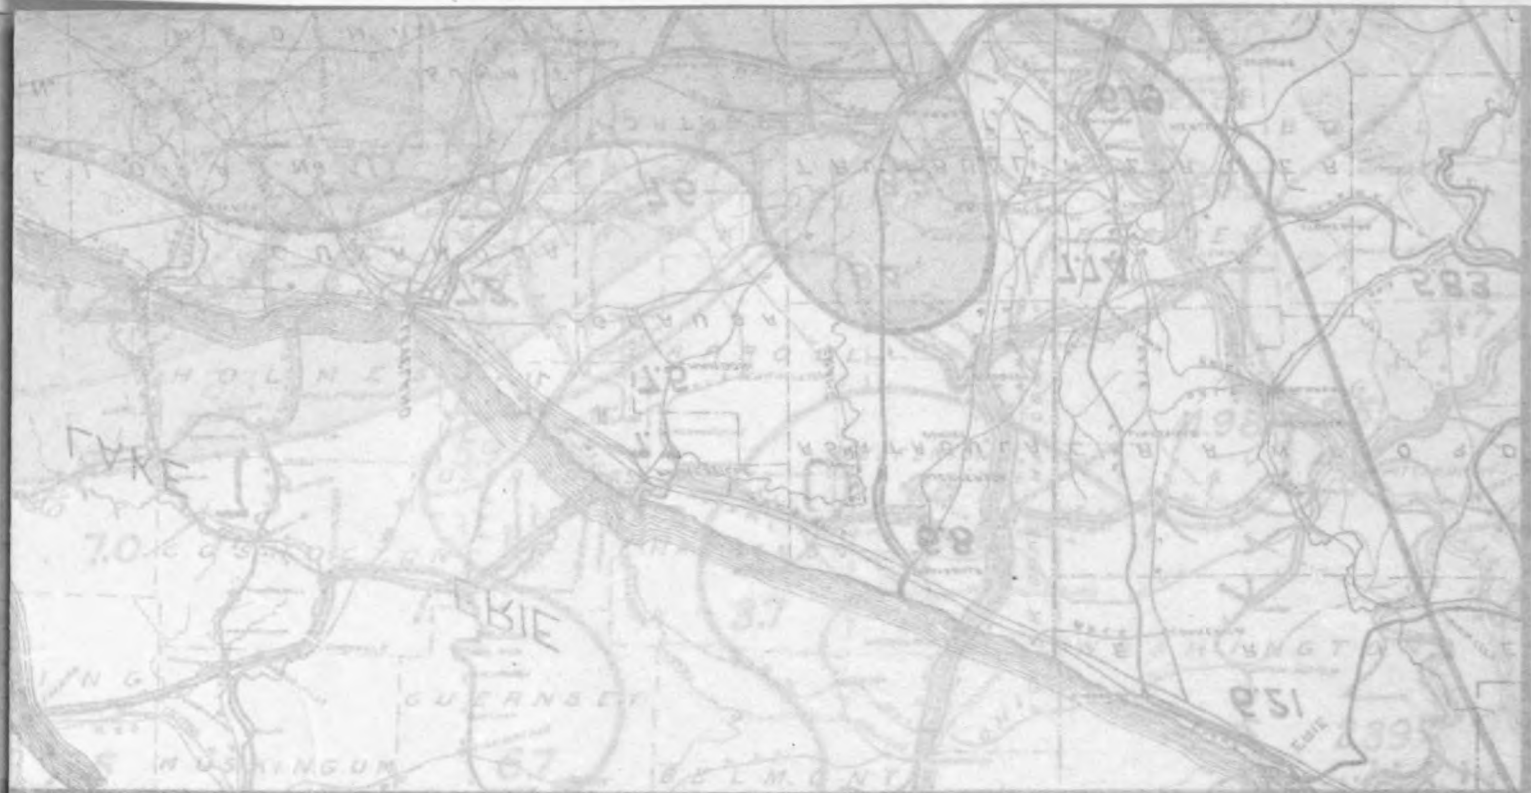
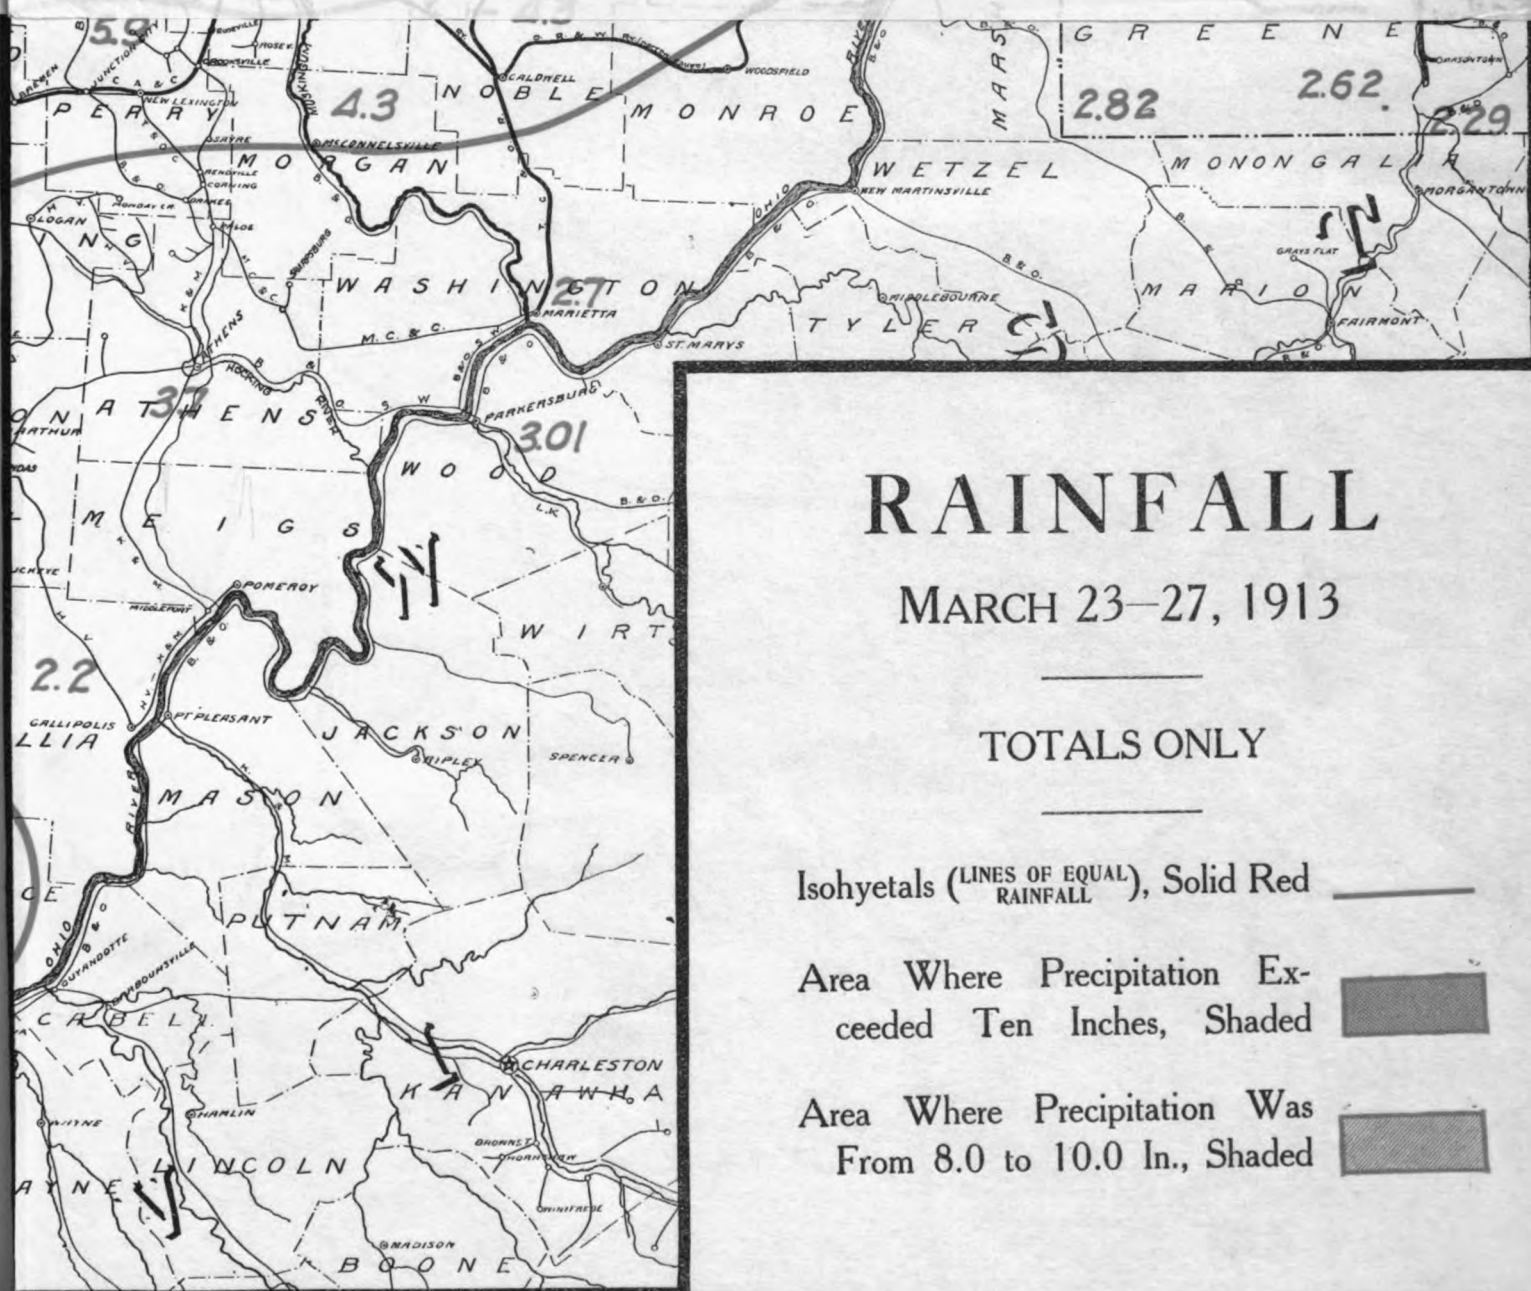
RAINFALL

On a map of the Pennsylvania Lines West of Pittsburgh, the figures for total rainfall for the period have been shown for all points at which reliable observations were made, and an appendix gives a complete detailed tabulation of the rainfall, by days, over this territory.

MARCH 23-27, 1913

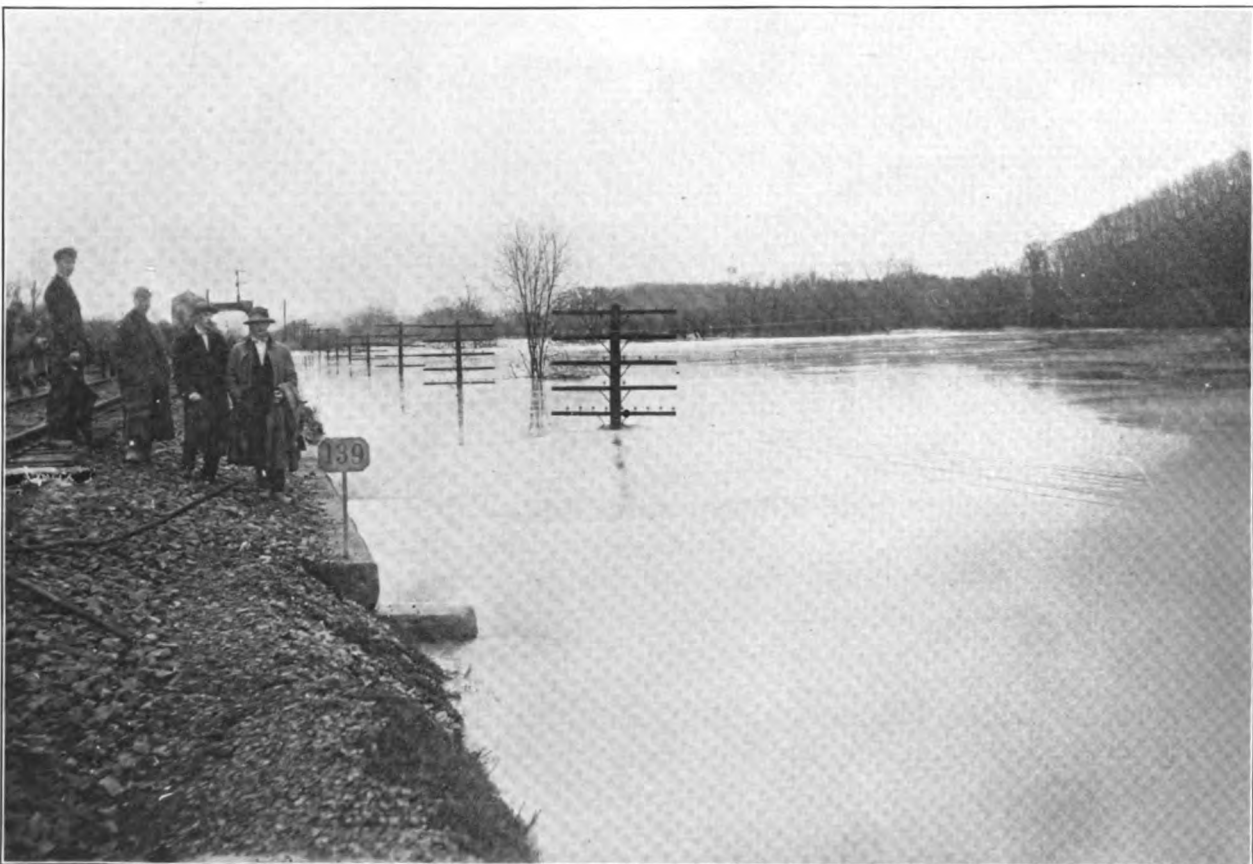
Loudonville, Ohio, west of

Bridge 139, Eastern Division, "Double Barrel" stone arch over roadway and mill race, later washed out. The stream which parallels the railway is the Black Fork of the Mohican River.

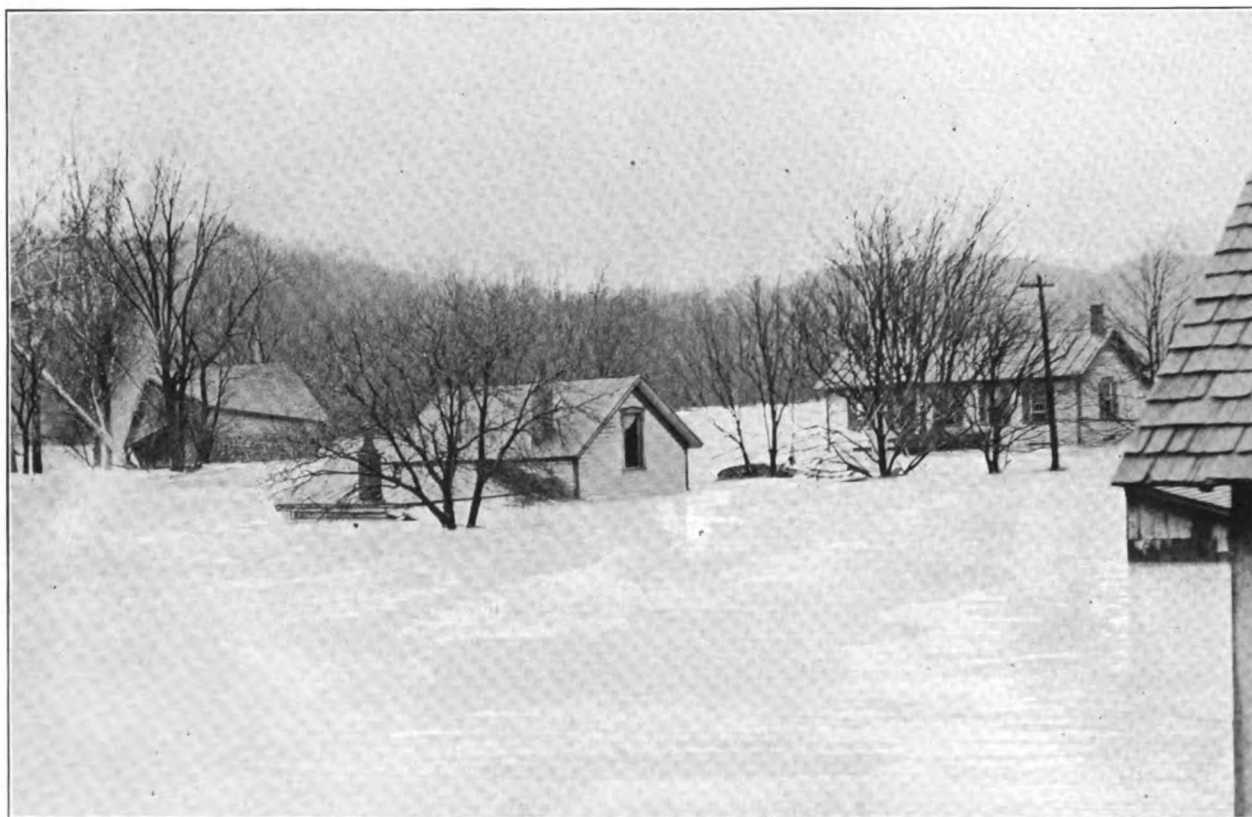
Brink Haven, Ohio.

Looking across Mohican River valley, just above Akron Div. Bridge 68,
both approaches to which were washed away.

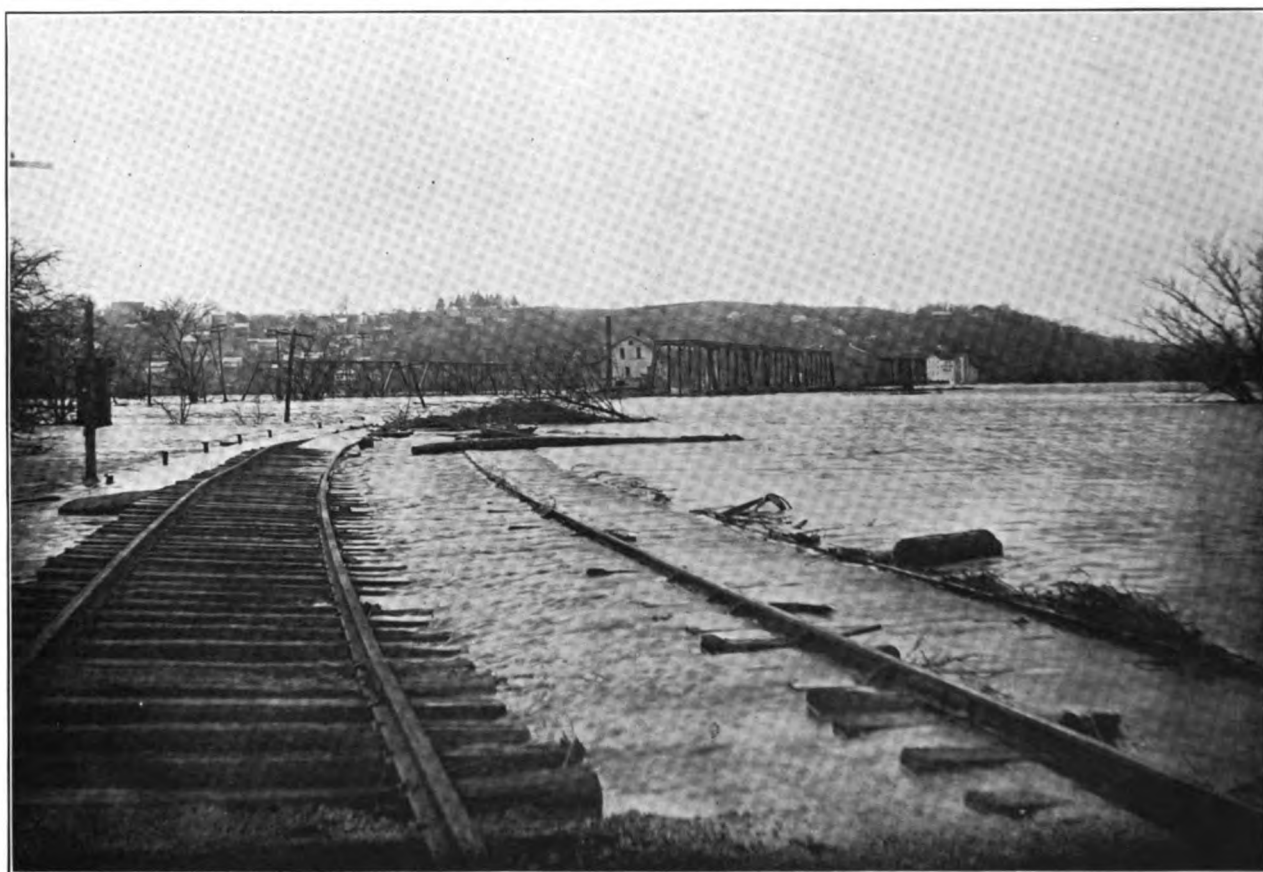
Coshocton, Ohio,

Junction of Walhonding and Tuscarawas Rivers, forming the Muskingum. Trestle over lowland between Bridges 1 and 2, Walhonding Branch (about 1,200 feet), and approach to Bridge 1, where brush is over track in foreground, later washed away.

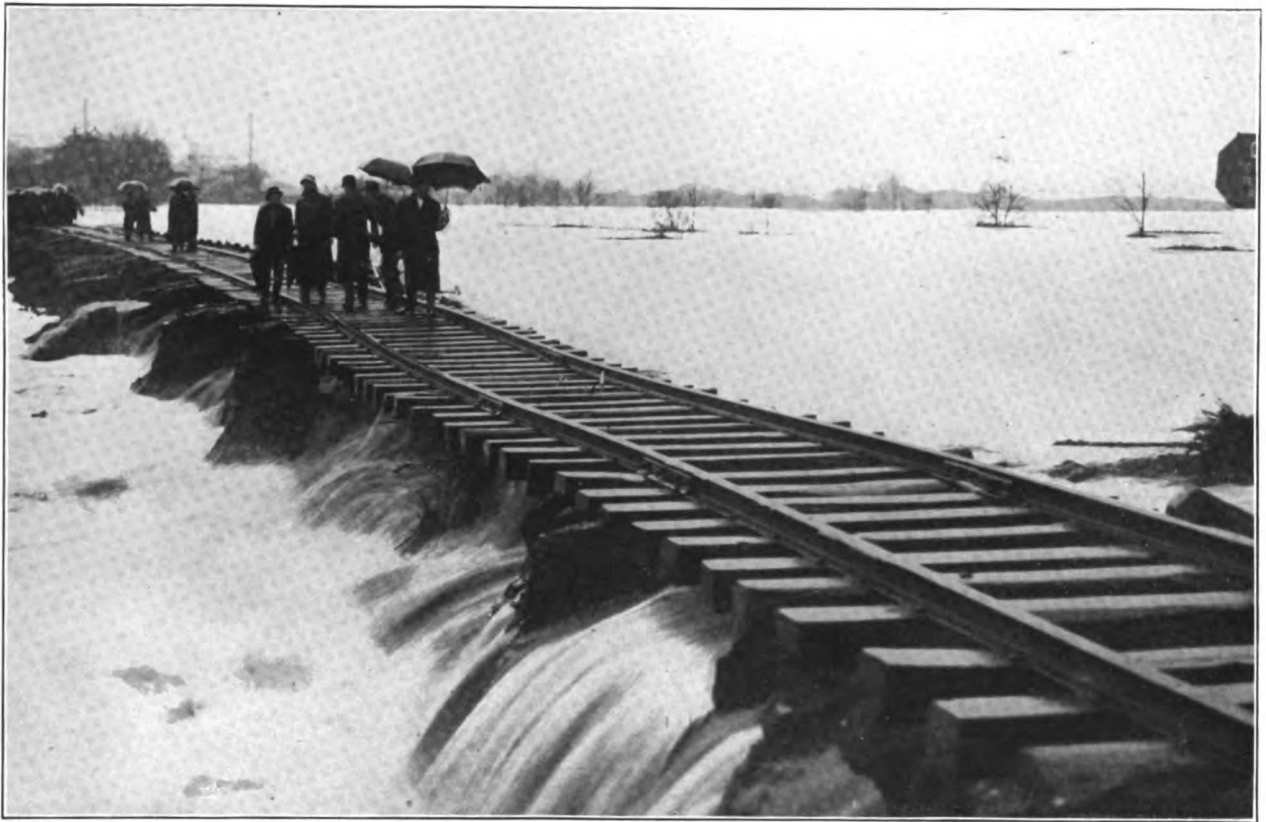
Mount Vernon, Ohio.

South of station; waters of Kokosing River pouring through fill of Akron Division main track.

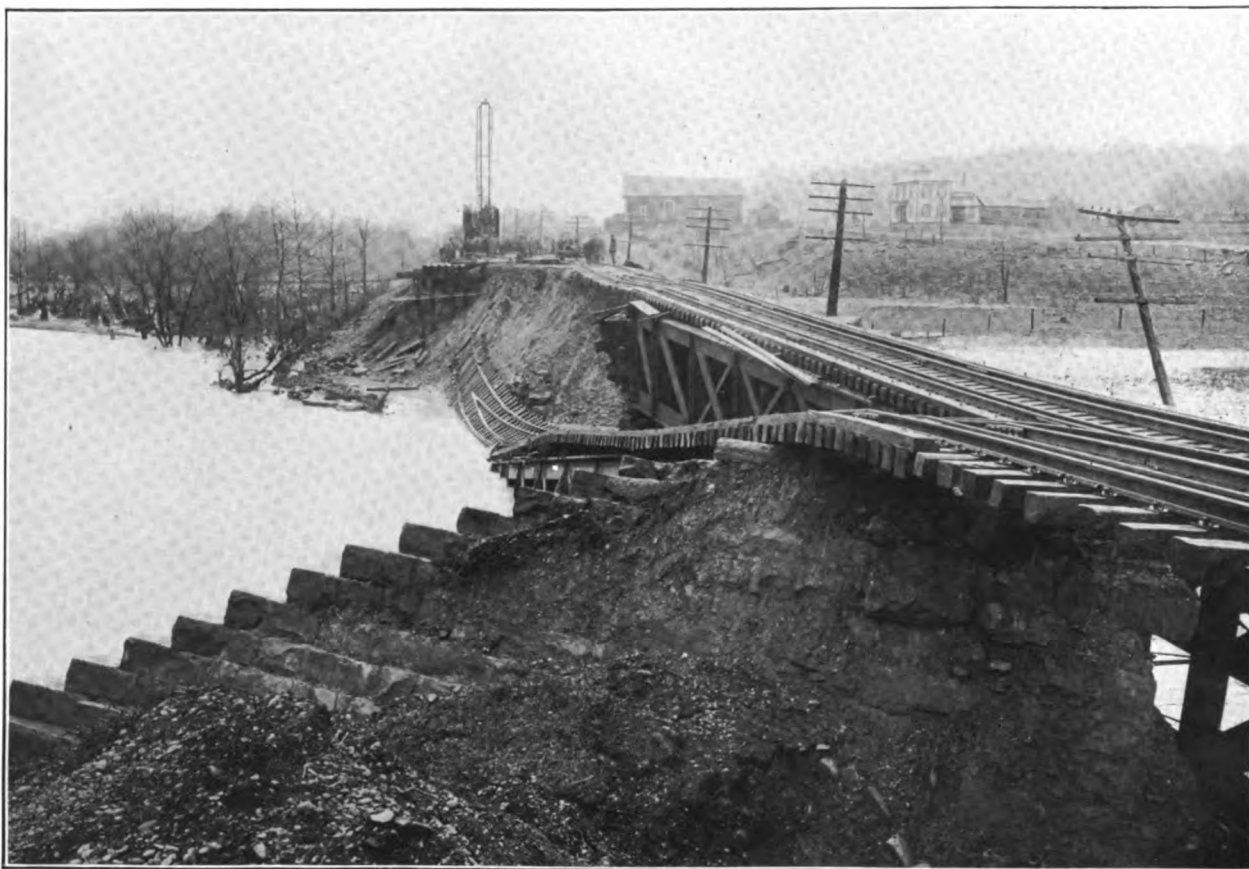
Lucas, Ohio, east of.

Bridge No. 146, looking west, over Rocky Fork. Both abutments
and 125 feet of approach embankment destroyed.

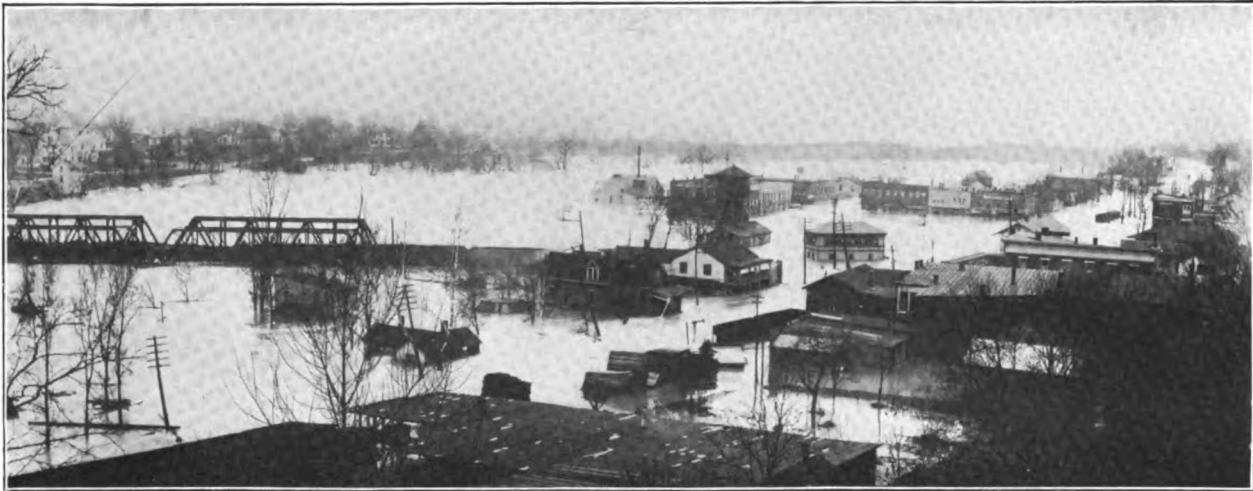
Loveland, Ohio.

Pennsylvania Lines tracks under water, B. & O. S. W. bridge weighted down.
Interlocking tower at crossing about one-half story under water.

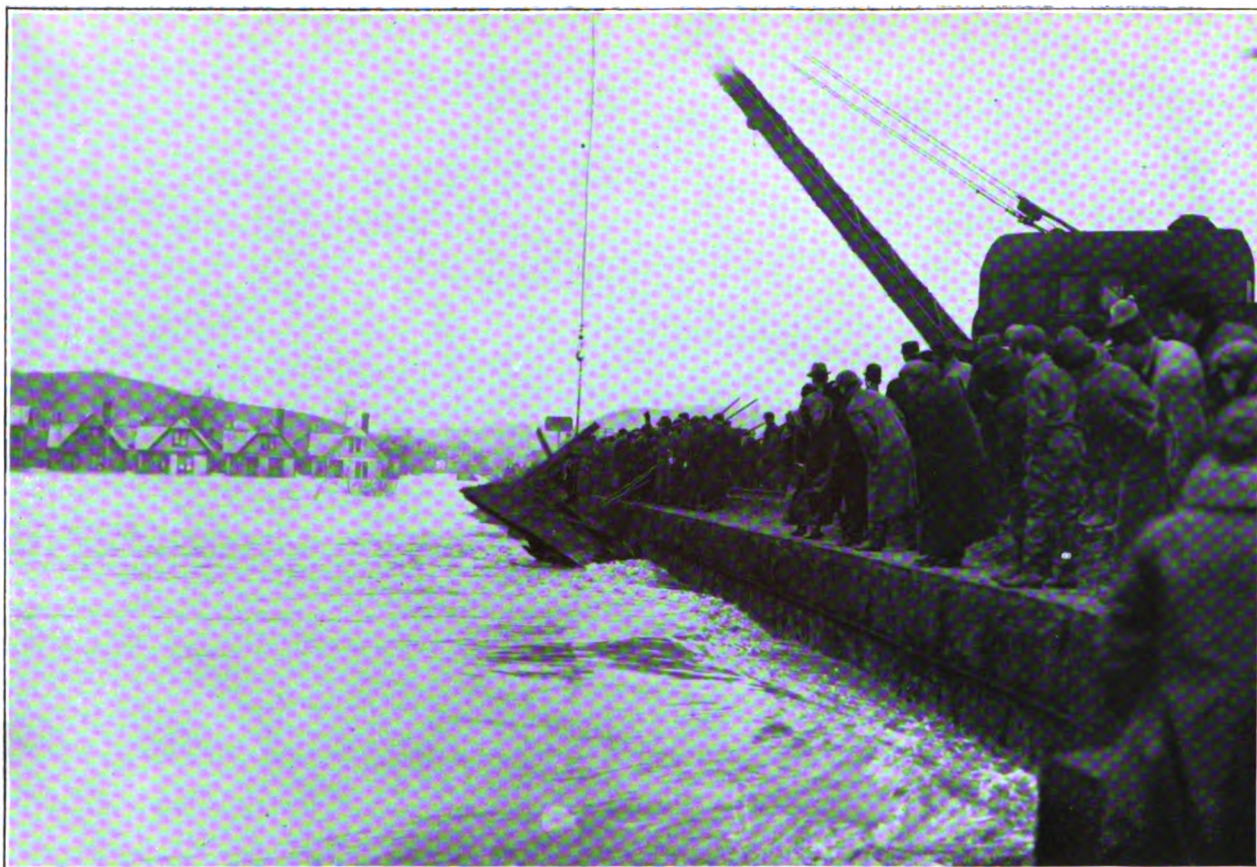
Uhrichsville, Ohio.

Removing part of a dwelling which lodged against stone arch.

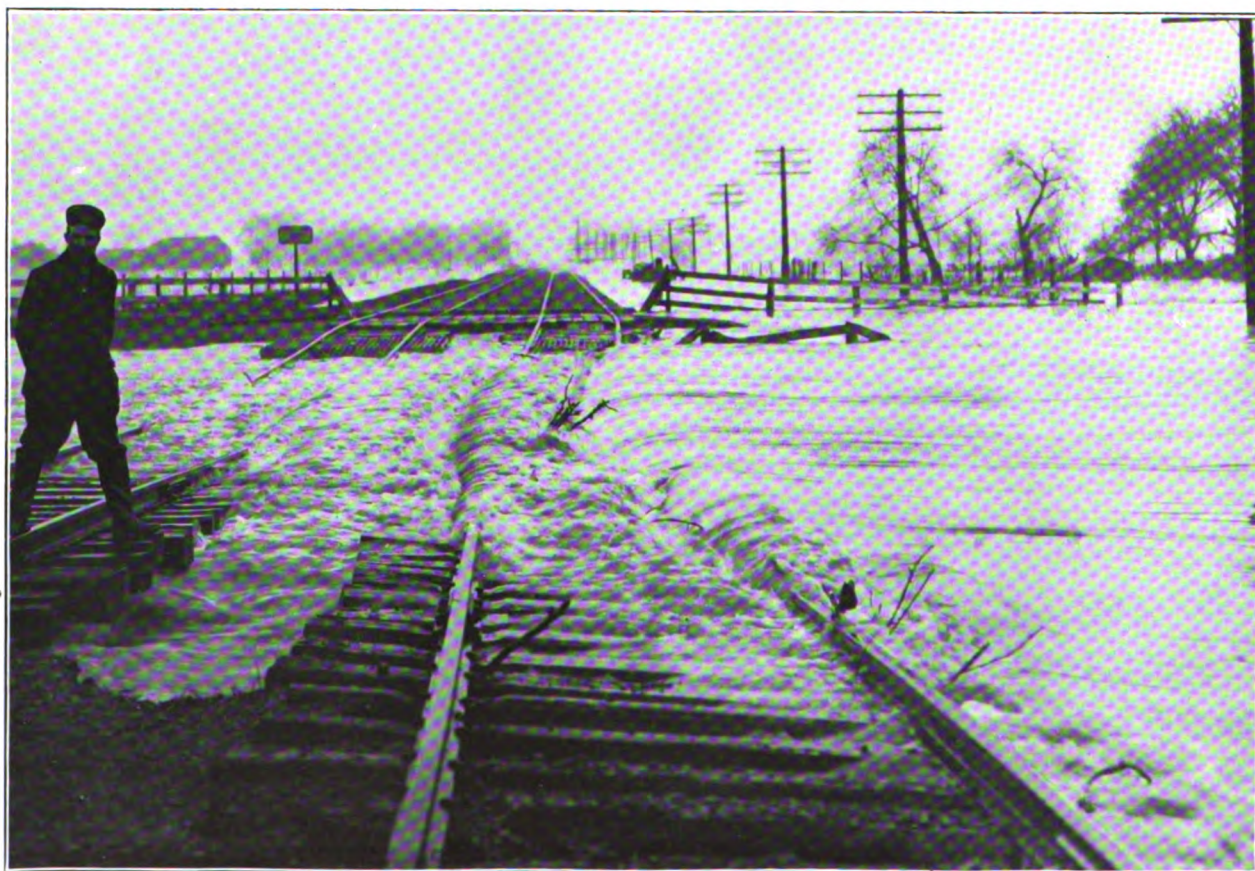
Tuscarawas, Ohio, west of.

Water had fallen 10 inches, but roadbed was later washed out from four to eight feet deep for a distance of 125 feet.

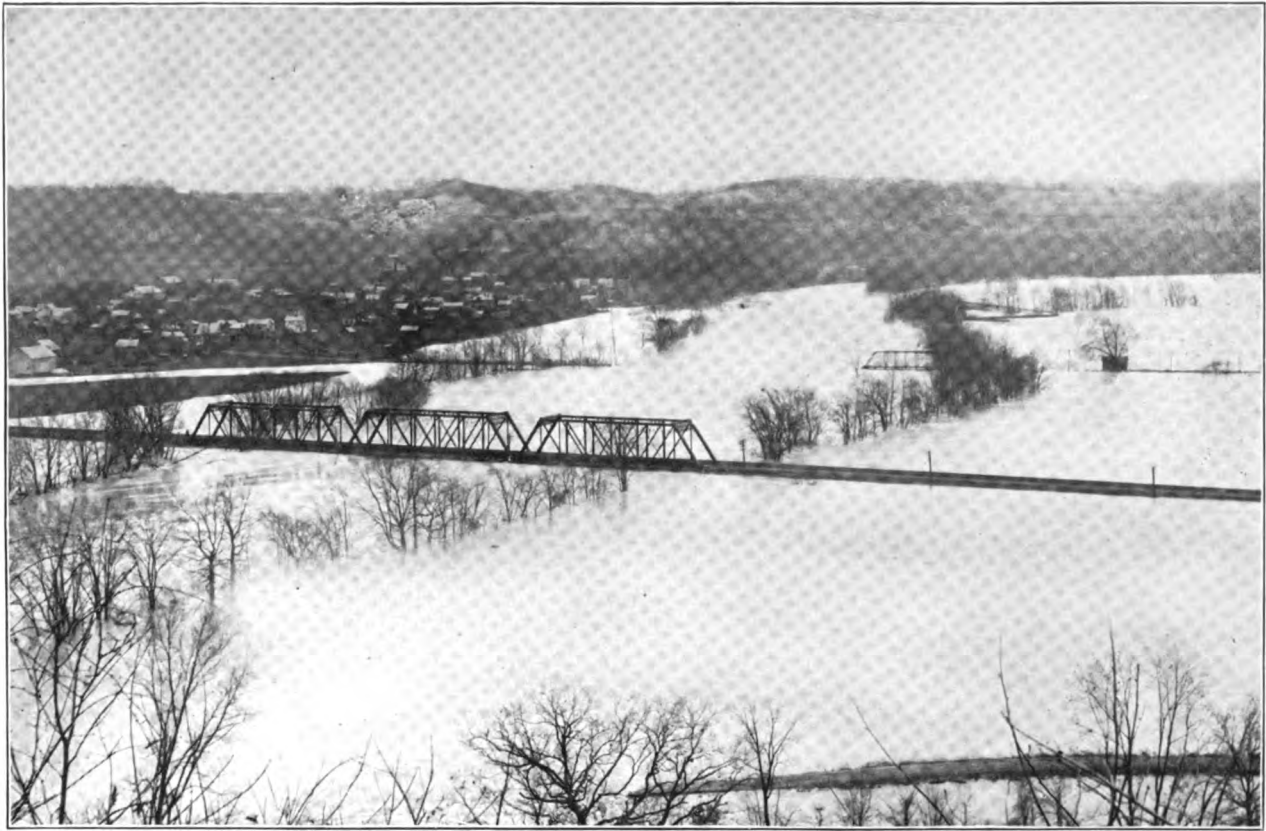
Gnadenhutten, Ohio.

Bridge 92, Pittsburgh Division, over Tuscarawas River. County bridge below washed away.

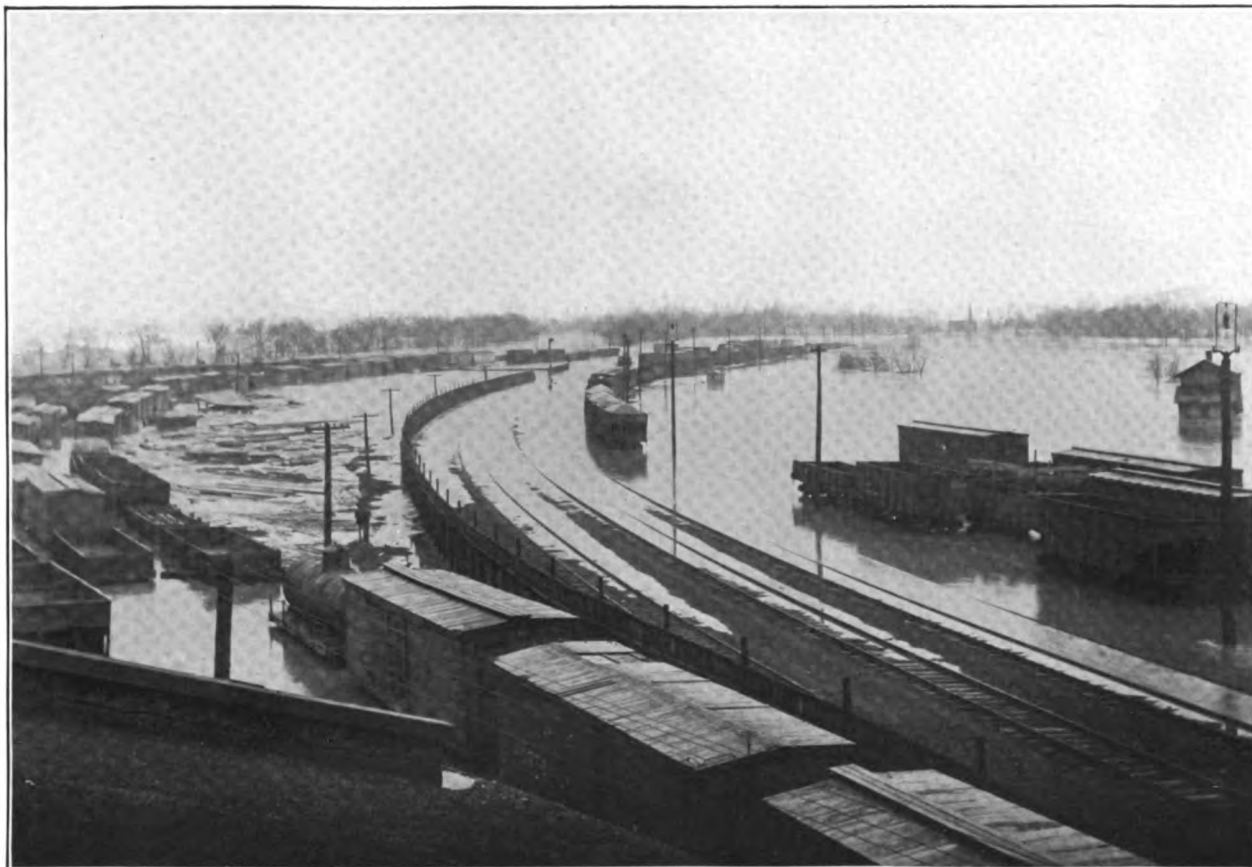
Lawrence Junction, Pa.

East from roof of enginehouse, showing P. Y. & A. main tracks in center,
and part of car repair yard at left.

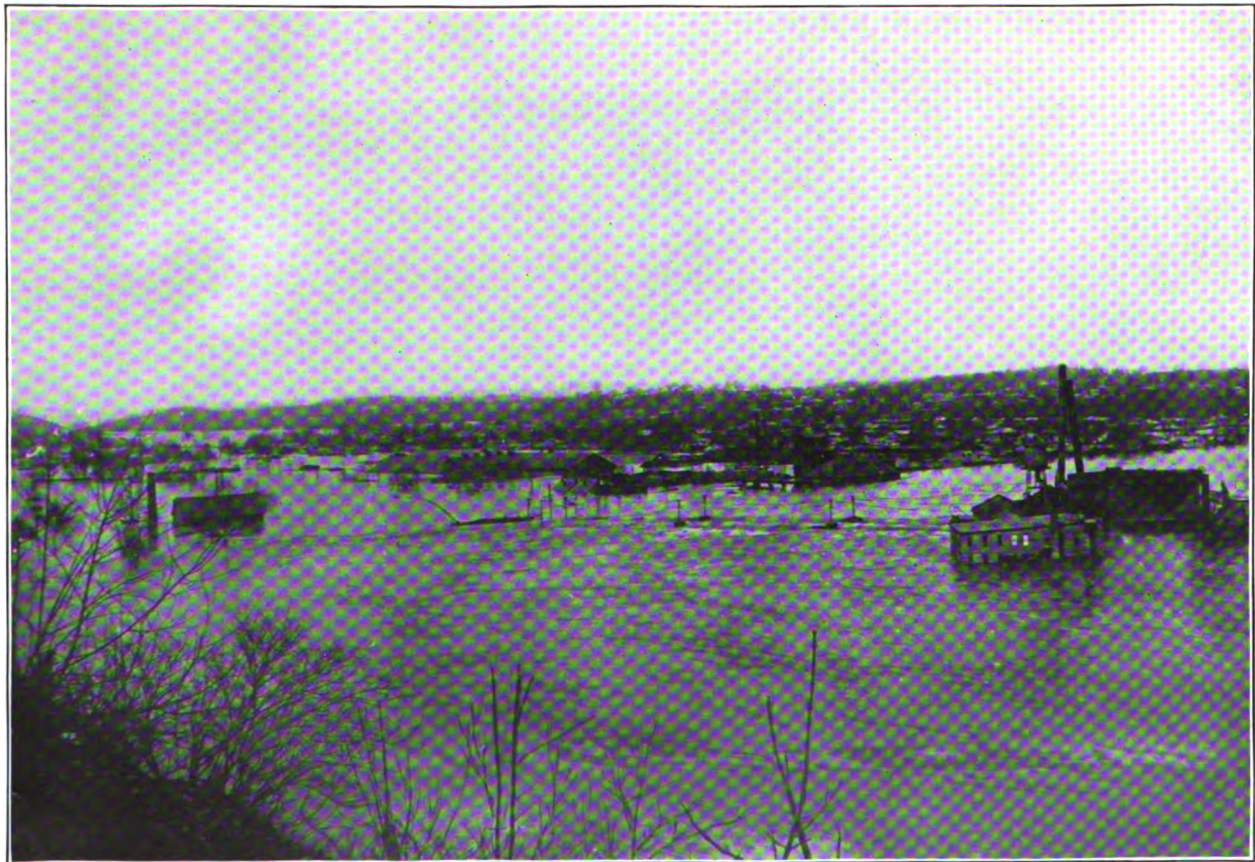
Zanesville, Ohio.

Water at highest—"Y" bridge at junction of Muskingum and Licking rivers completely submerged.

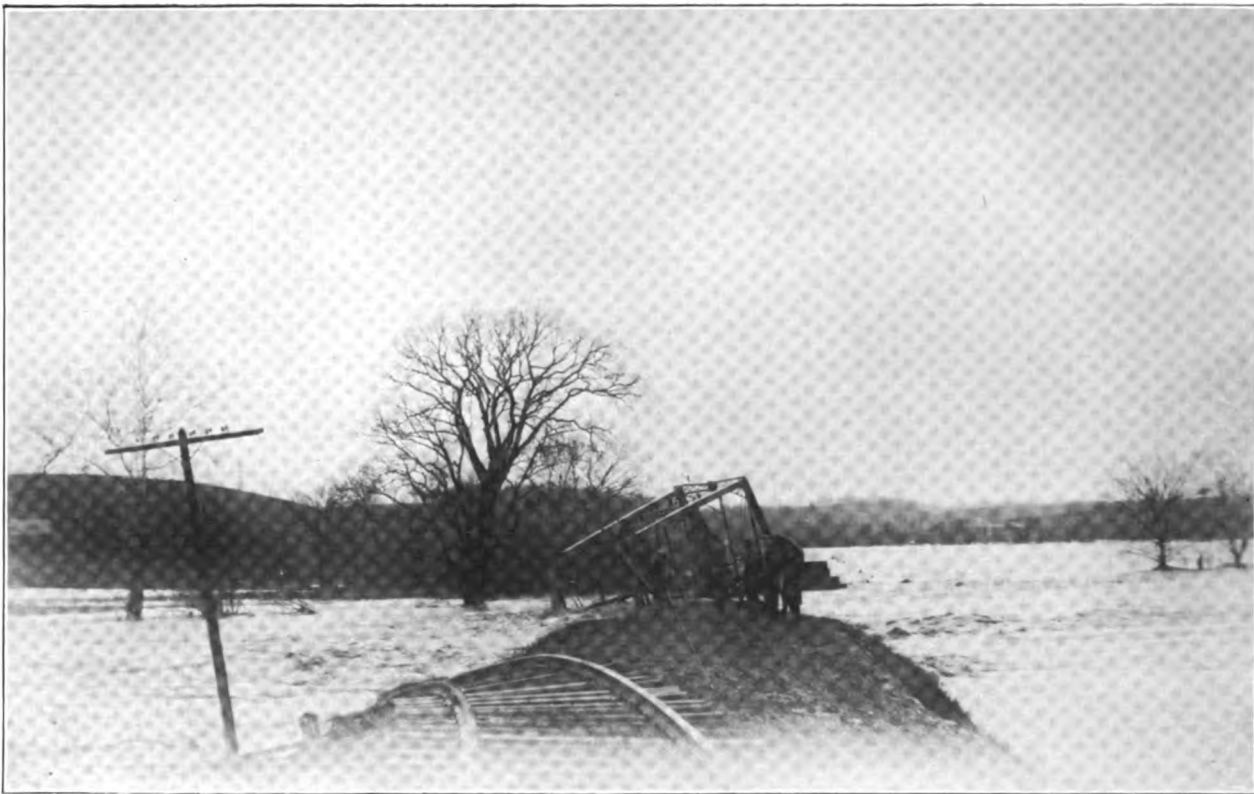
Gambier, Ohio.

Bridge 83, over Kokosing River, Akron Division.

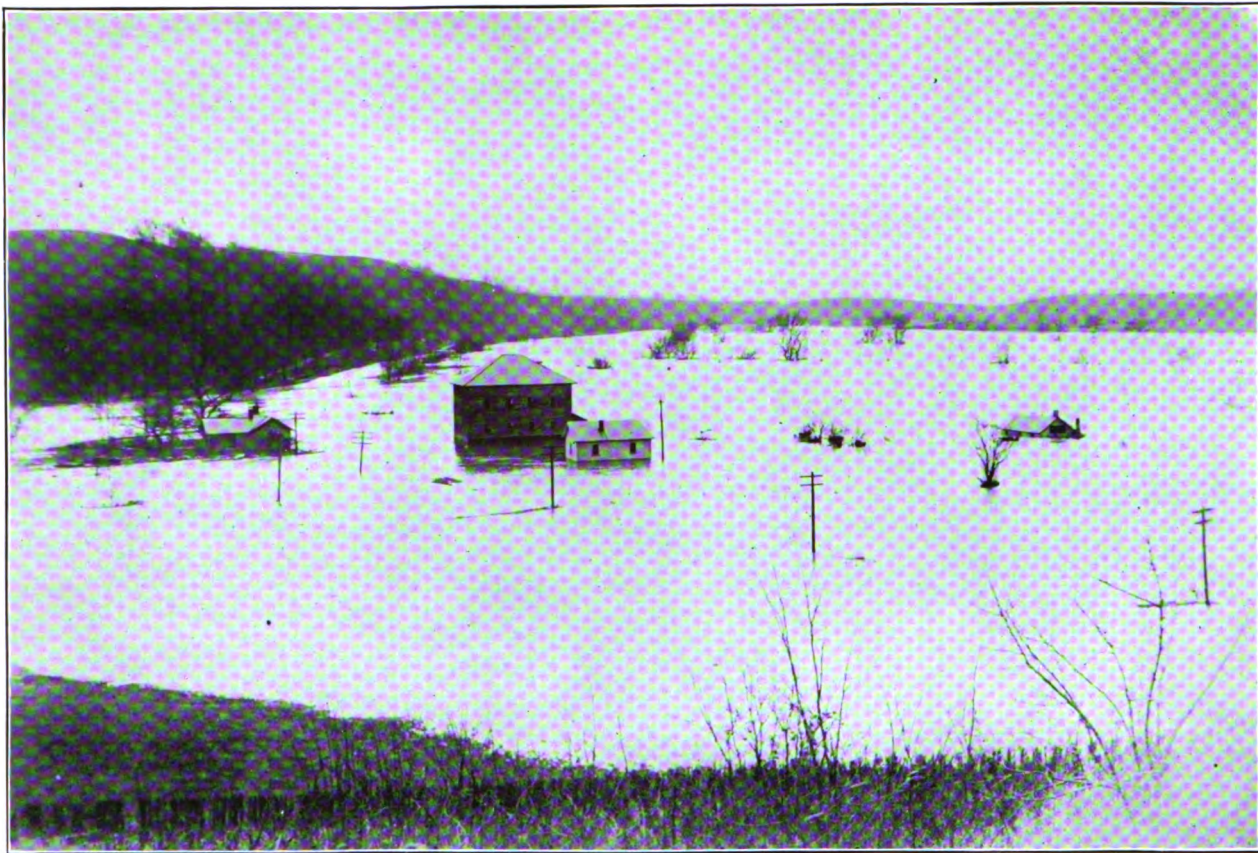
Ellis, Ohio.

Bridge 12, over Muskingum River, water receding; both approaches and all channel spans but one washed away.

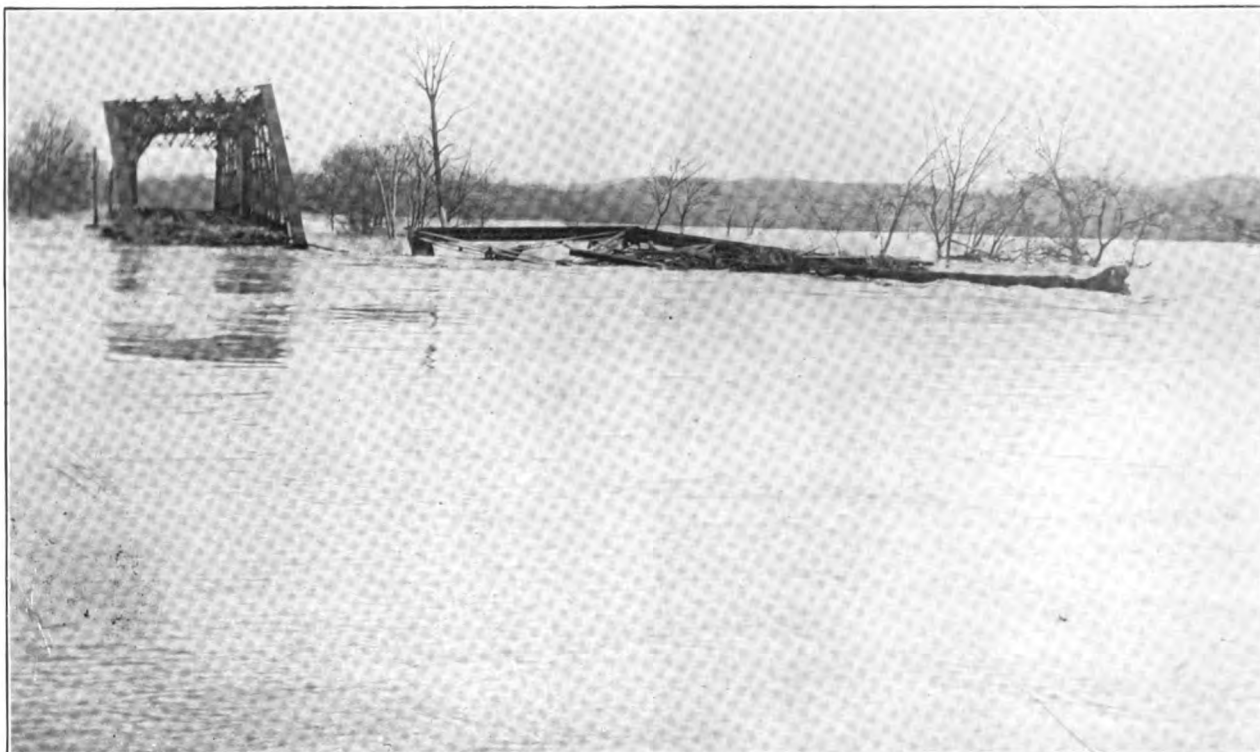
Coshocton, Ohio, west of

Bridge 100, Pittsburgh Division, over Muskingum River.
View east from west bank of river, 11:00 a. m.

Water had receded several feet.
Two spans standing,
two entirely destroyed.

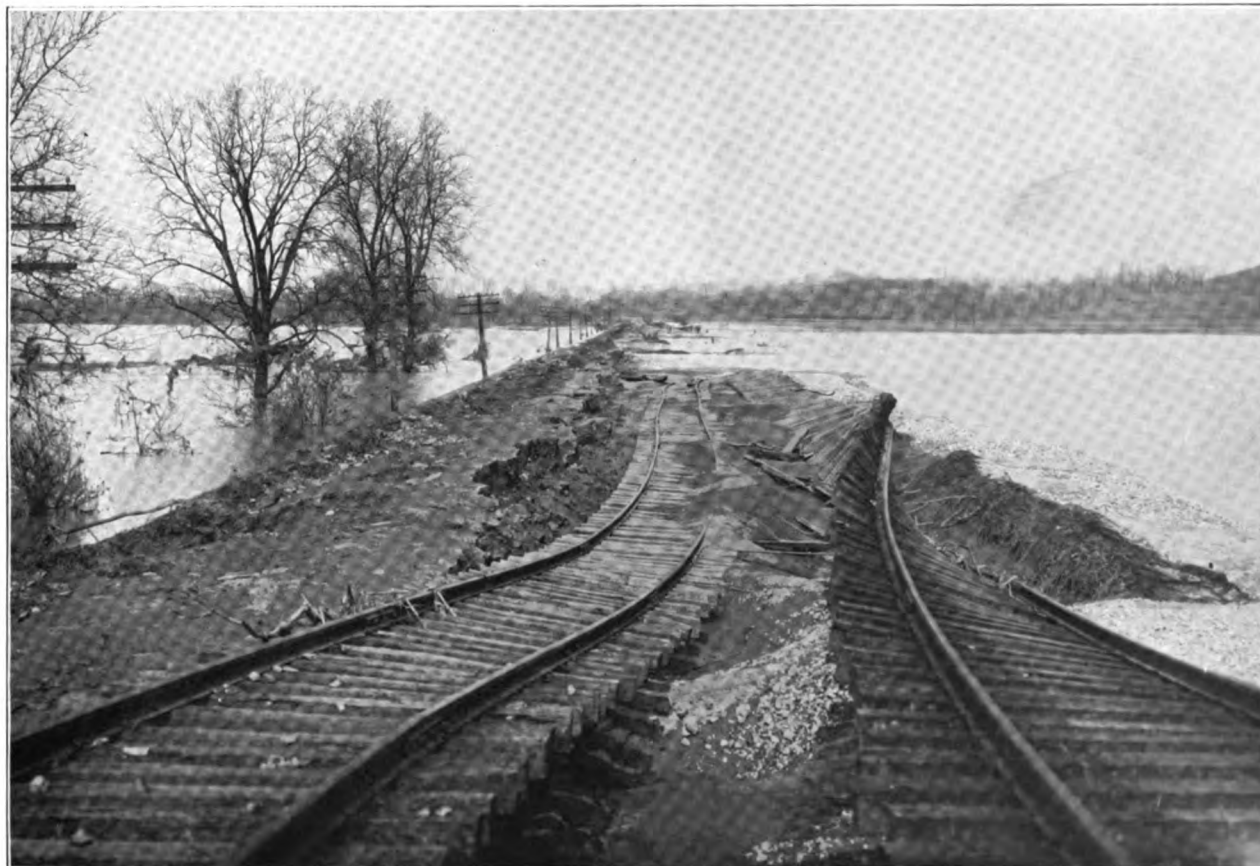
Coshocton, Ohio, west of.

View east, east of Bridge 100, showing roadbed destroyed for two thousand feet.

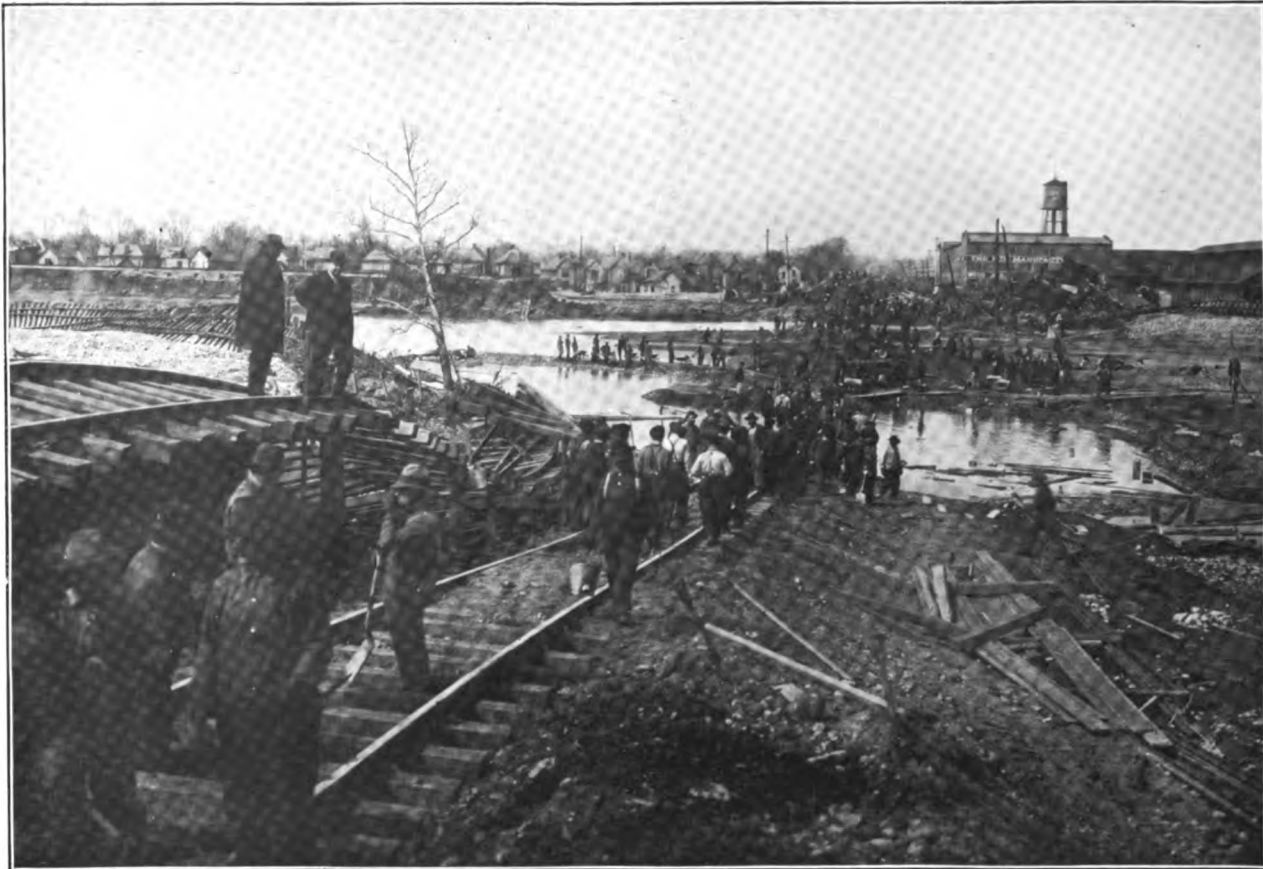
West Columbus, Ohio.

B. & O. R. R. Crossing, looking west. Material of former fill being reclaimed as much as possible.

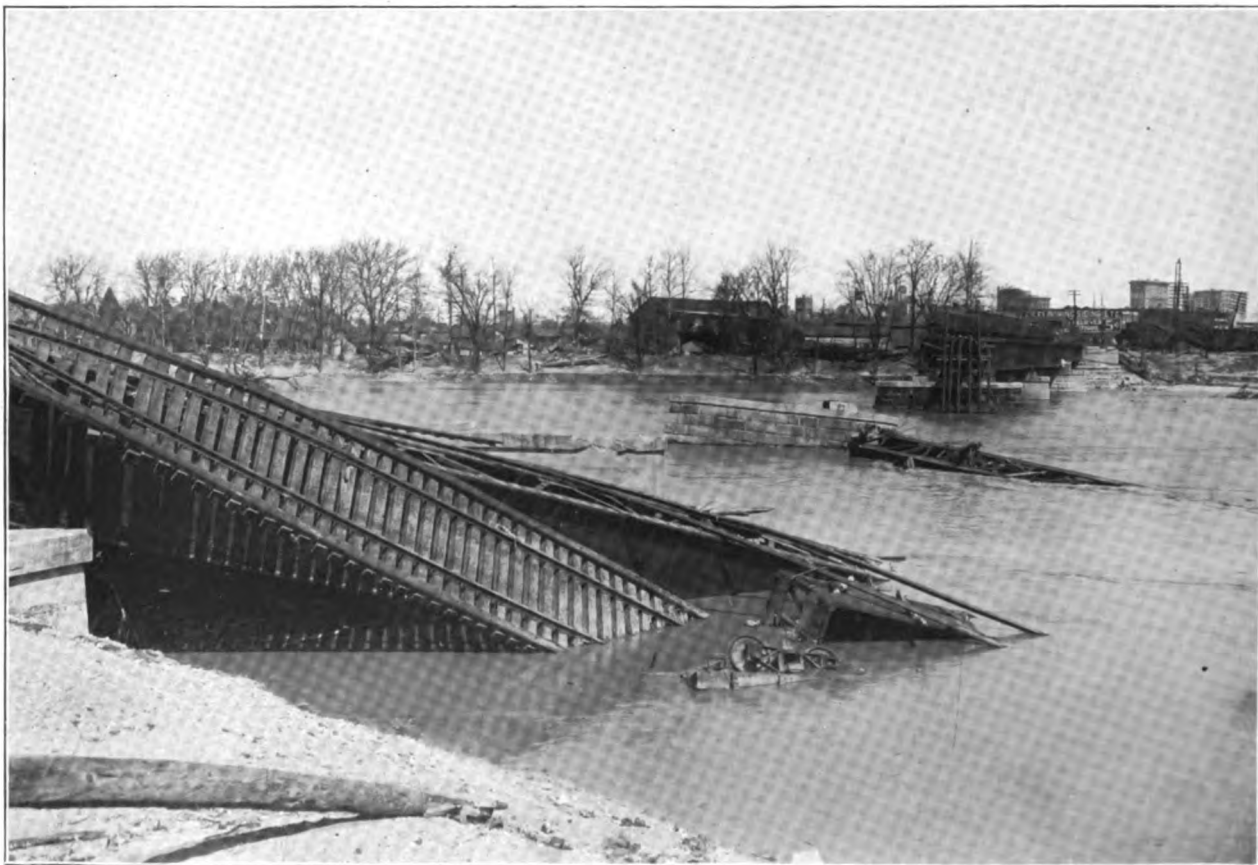
Dayton, Ohio.

Dayton Union Bridge over Miami River, from west side, just after Big Four had begun construction of temporary trestle.
