PENNSYLVANIA LINES
WEST OF PITTSBURGH

A HISTORY
OF THE
FLOOD
OF
MARCH, 1913

COMPILED
BY
C. W. GARRETT

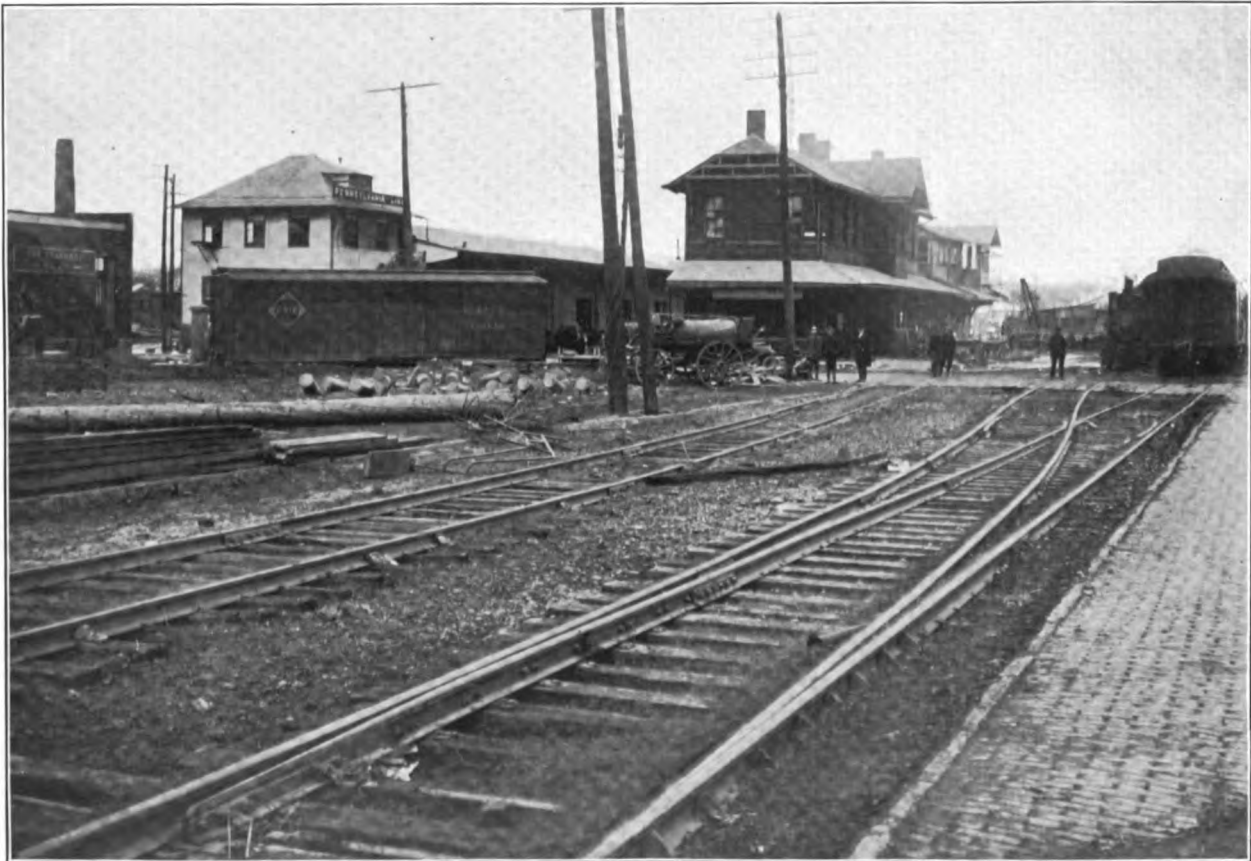
Zanesville, Ohio.

Pennsylvania Lines Passenger and Freight Stations after water had receded. High water line was at the window sills of the second story of the freight station and eaves of the freight shed.

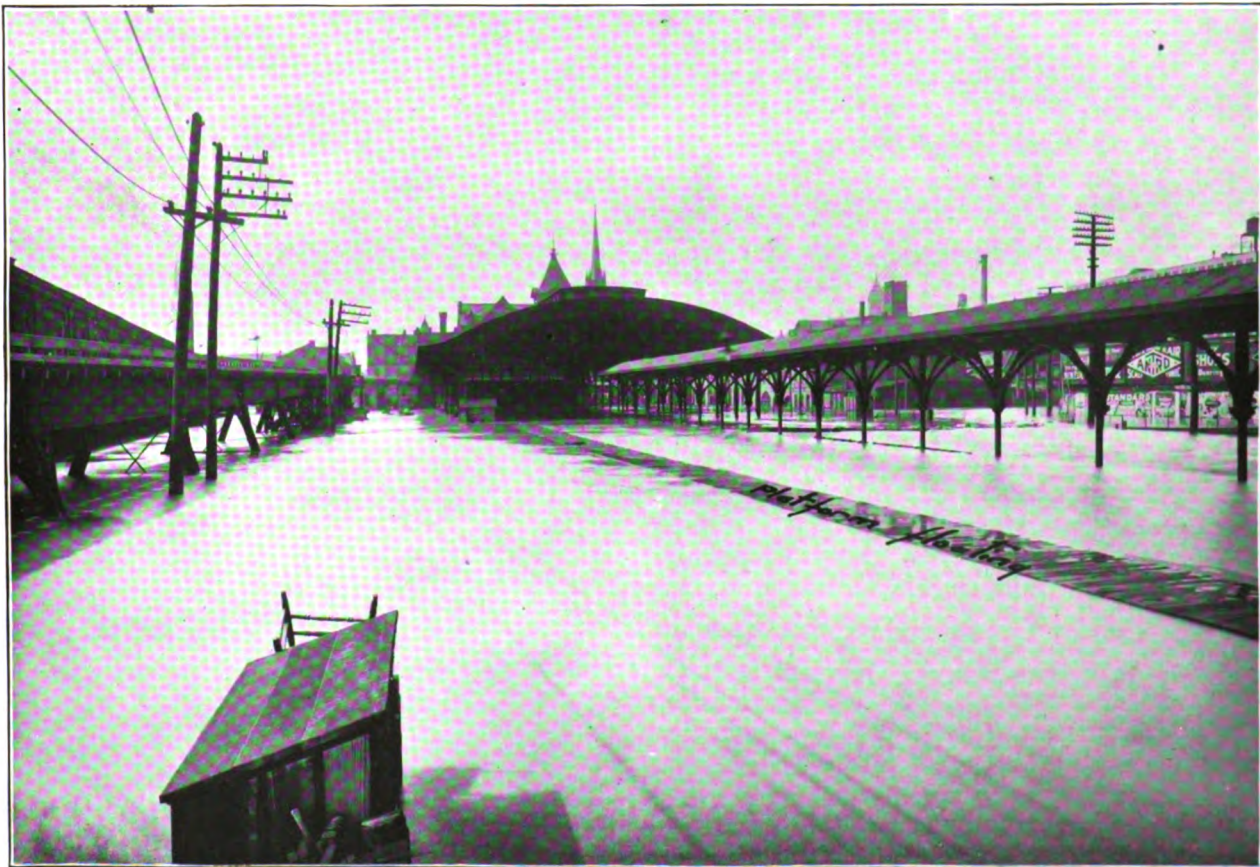
Cincinnati, Ohio.

Rear of Union Station when water was about at the highest in the Ohio.
Platform in foreground is floating.

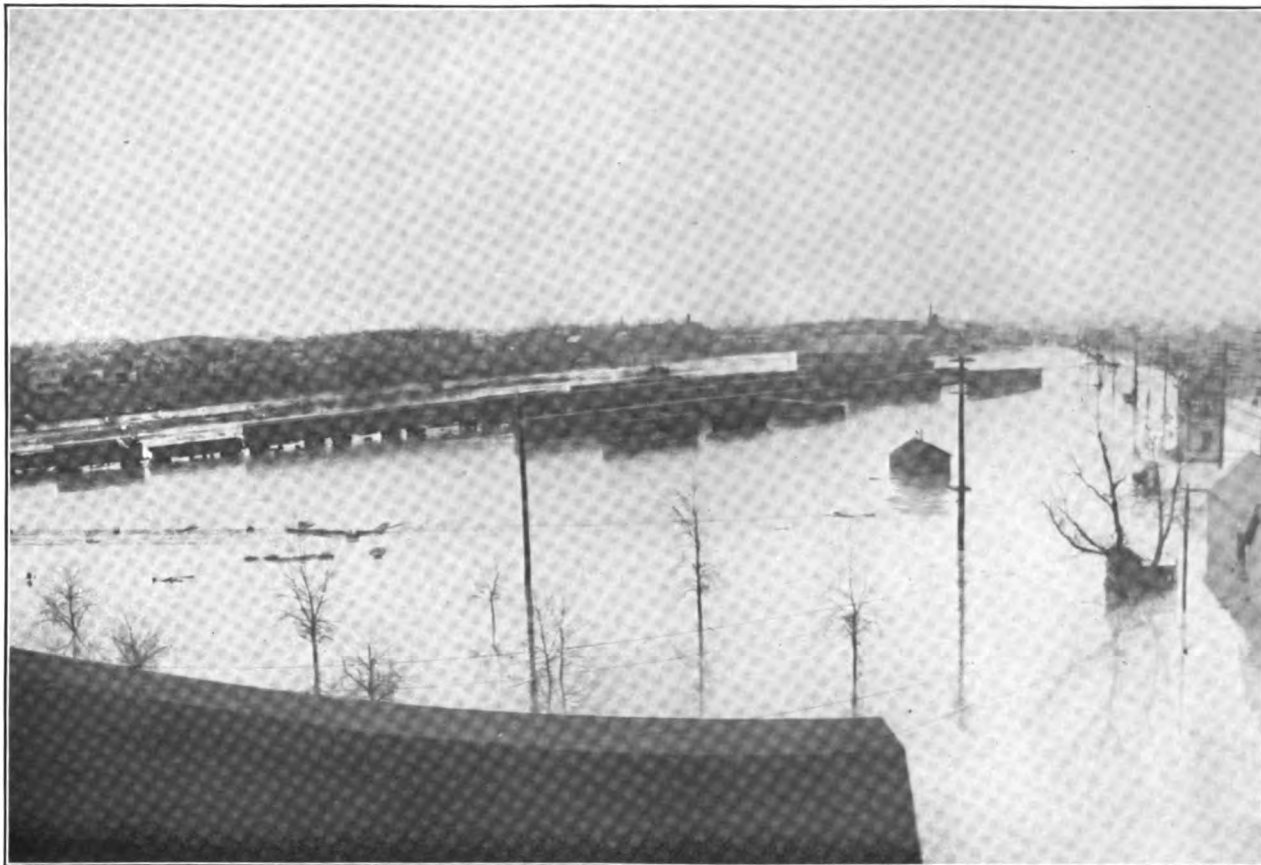
Mansfield, Ohio.

Yard tracks opposite Union Station building, which stands just at right of interlocking tower appearing at right of picture. These tracks are used for interchange with Erie R. R.

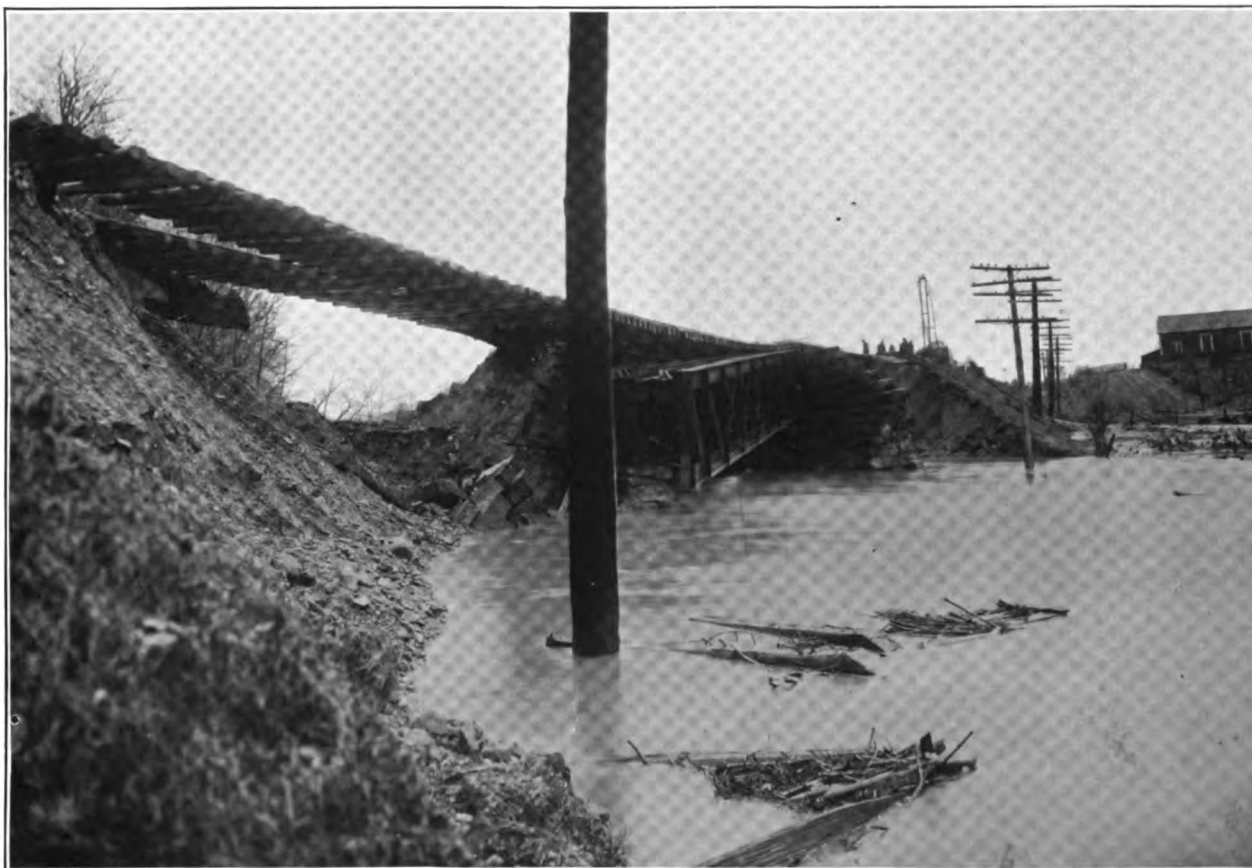
Lucas, Ohio, east of.

Bridge No. 146, over Rocky Fork, both abutments and about 125 feet of embankment approach destroyed.

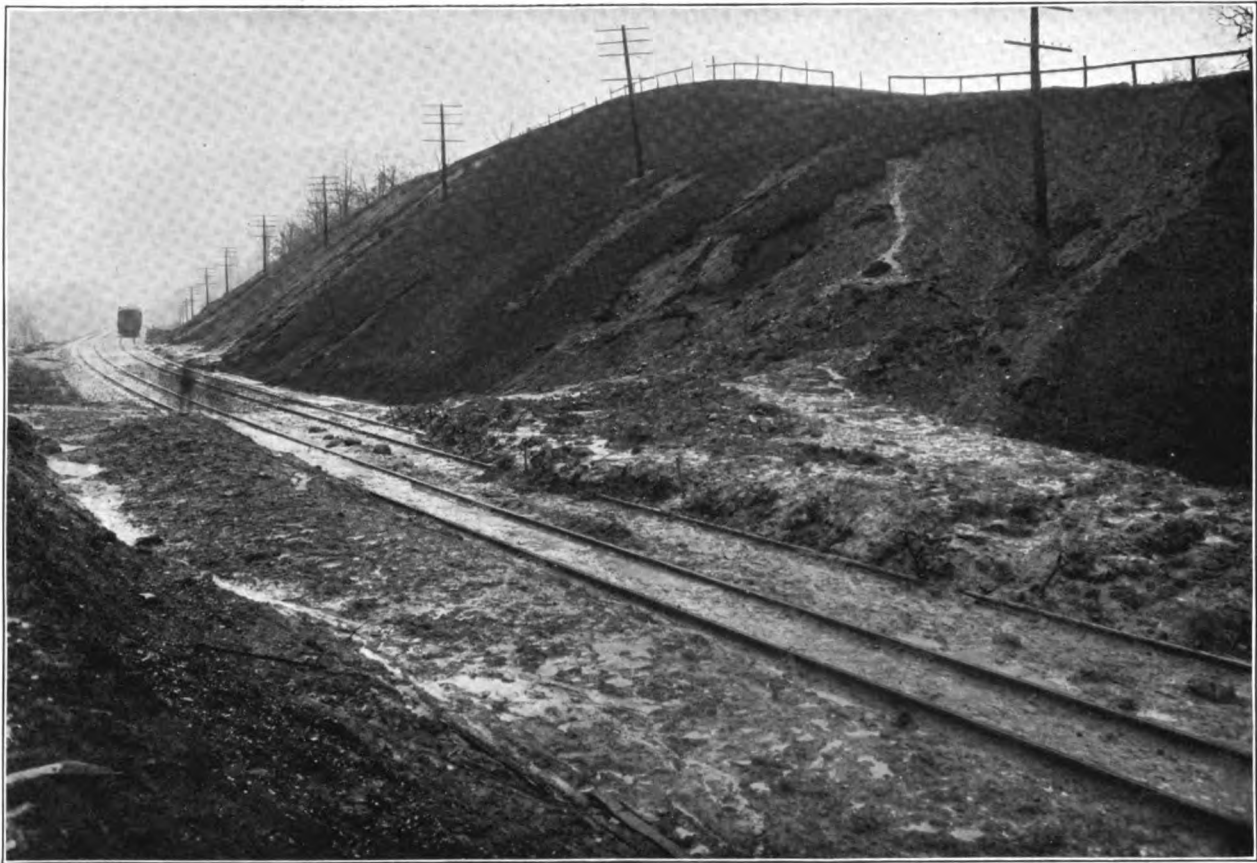
Lucas, Ohio, east of.

Landslide at M. P. 167, after No. 1 track had been cleared.

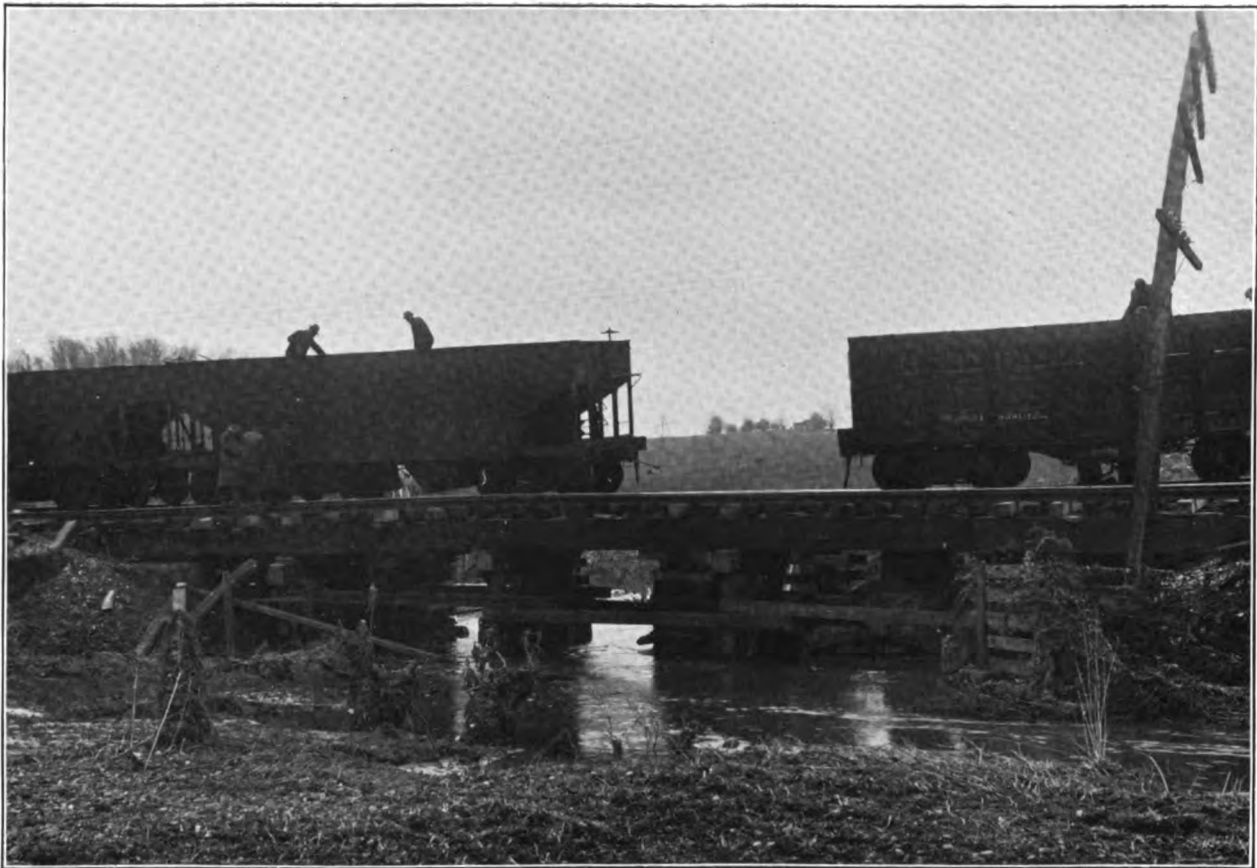
Loudonville, Ohio, east of.

Bridge No. 136, over Plum Run, arch washed out, with about 50 feet of embankment. Tracks supported on cribbing.

A Pennsylvania Railroad pile driver arrived at Lakeville on the evening of the 27th, and it was desired to use this instead of the driver then at work at Bridge No. 136, as it was equipped with a steam hammer for more rapid work. In bringing it up to position, however, it was overturned through the straightening of a guy-rope hook due to the strain caused by the unusual superelevation of the track on a curve. The foreman of the outfit was killed and an engineer severely injured and the pile driver was so damaged that it had to be returned to the shop for repairs. The work proceeded with the old driver after the wreckage was cleared up.

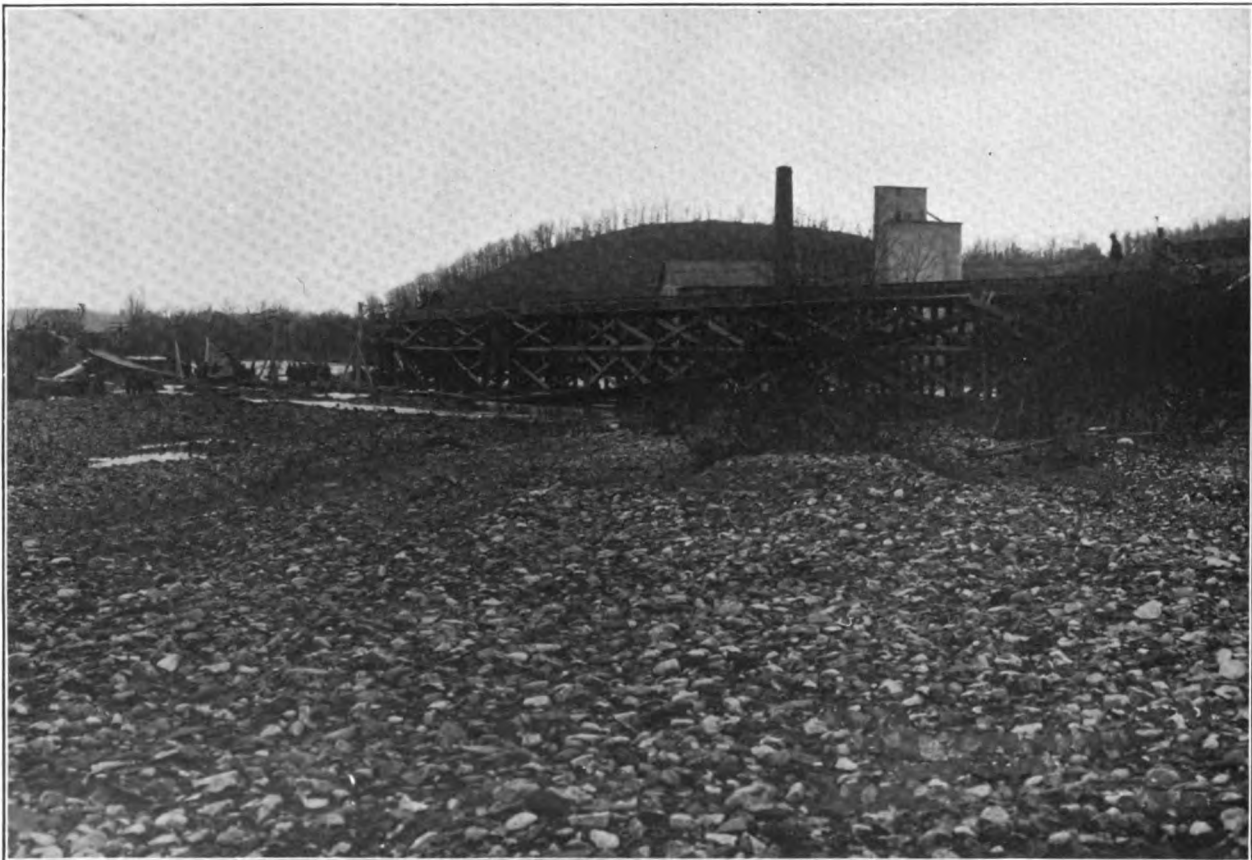
Loudonville, Ohio, west of.

Bridge 139, over road and mill race, and 750 feet of embankment, washed away.
Temporary trestle about half completed for one track.

abutment failed. Bridge No. 139, a double stone arch of 16 and 24 foot spans, was destroyed completely, and the twenty-five foot fill on each side washed out, leaving a gap seven hundred and fifty feet long.

On Saturday, the 29th, the work of repairing the washed tracks at Wooster and Lakeville continued; the old pile driver at work at Bridge No. 139 was replaced with a new and better one, and work proceeded rapidly there; one track was completed across the gap at Bridge No. 146 at midnight, and the pile driver immediately moved eastwardly to Bridge No. 145.

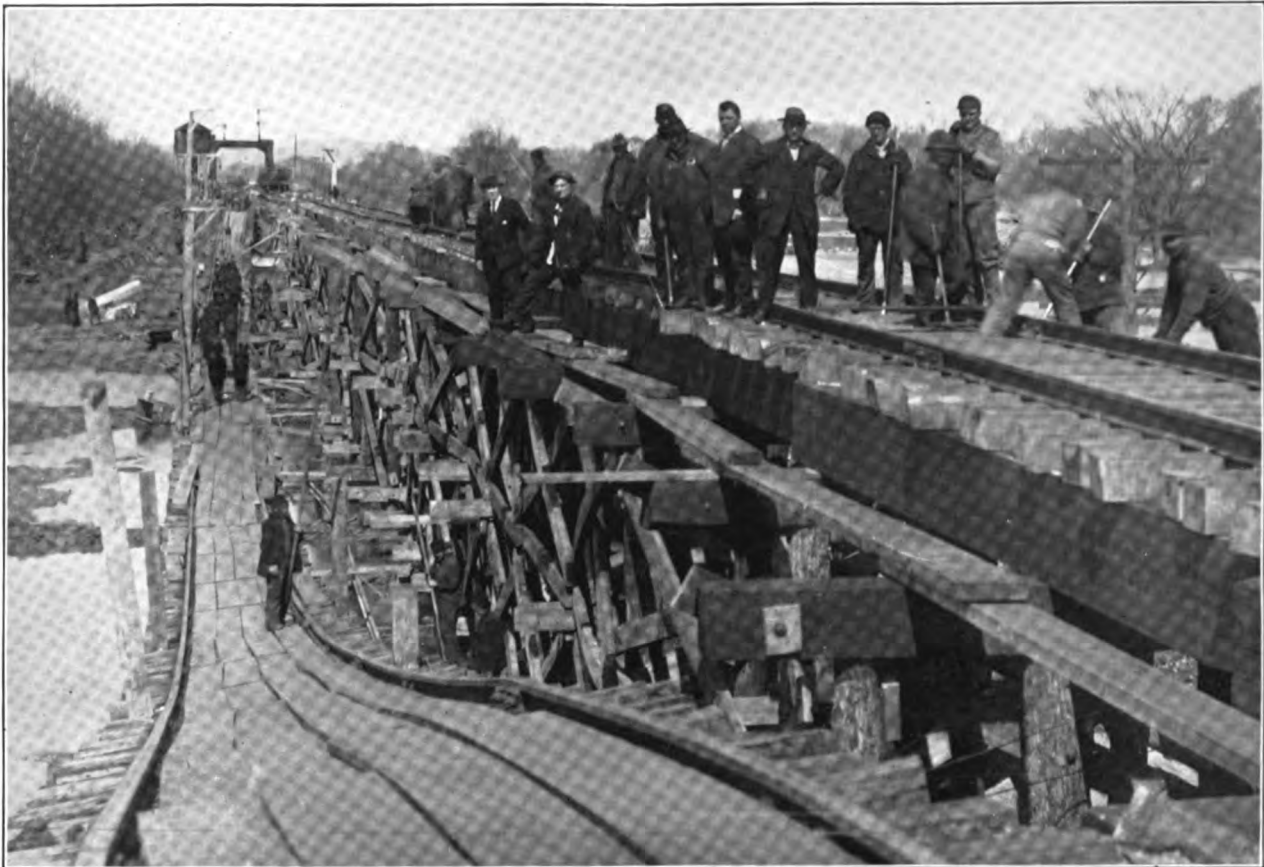
Loudonville, Ohio, west of.

Bridge No. 139, over road and mill race; temporary trestle for one track completed, and about ready for service—looking west.

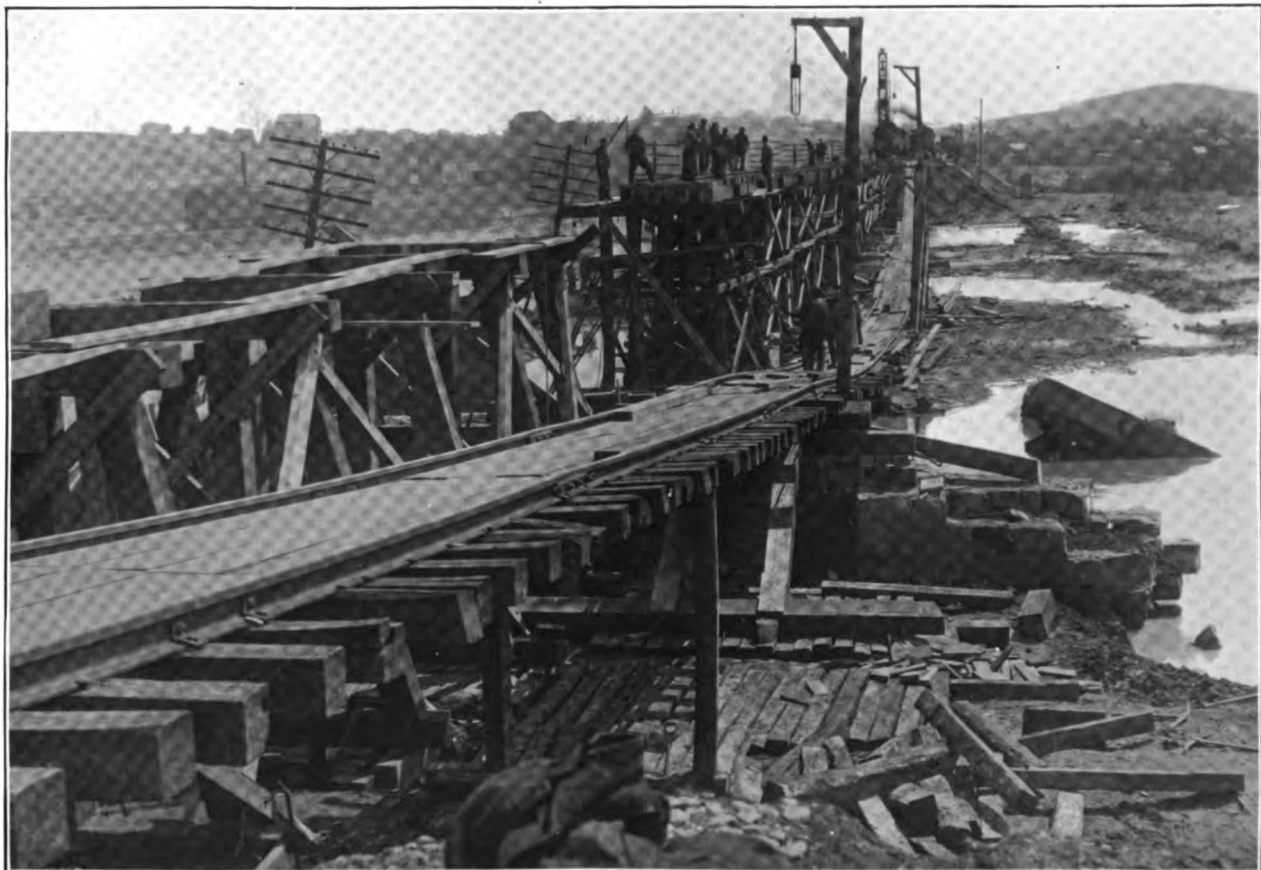
Loudonville, Ohio, west of.

Bridge No. 139, over road and mill race; temporary trestle for one track about completed. Looking east.

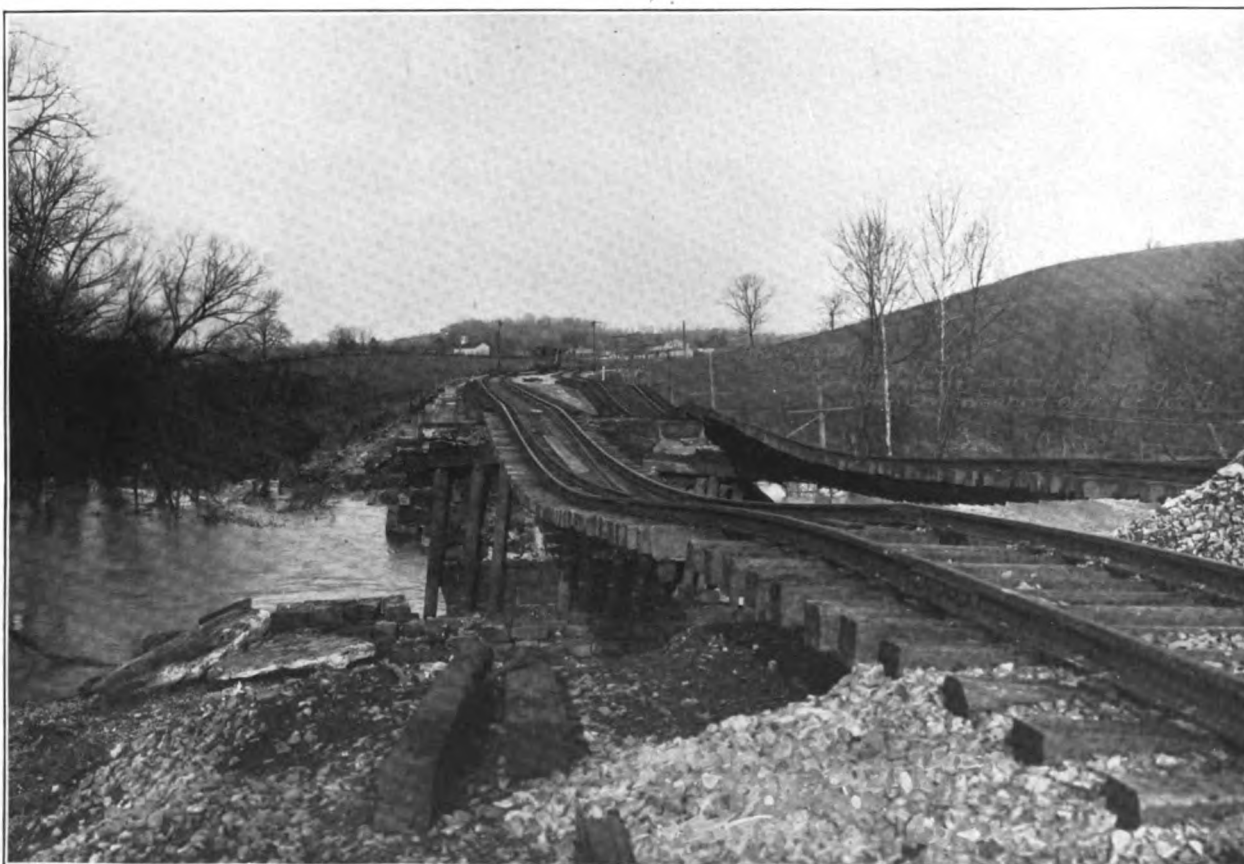
Perrysville, Ohio.

Bridge No. 141, over Black Fork. East abutment and about 100 feet
of approach embankment destroyed.

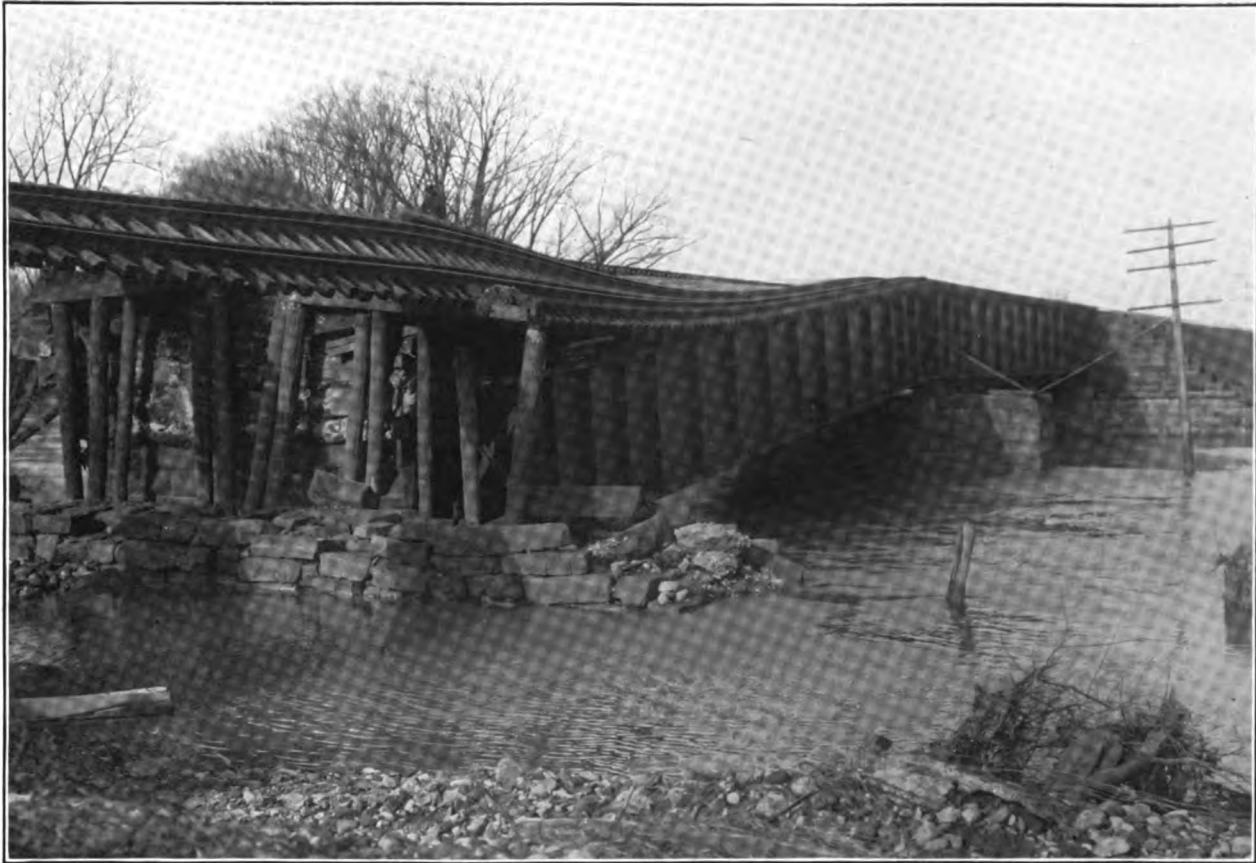
Perrysville, Ohio.

Bridge 141, over Black Fork, showing east approach and abutment destroyed.

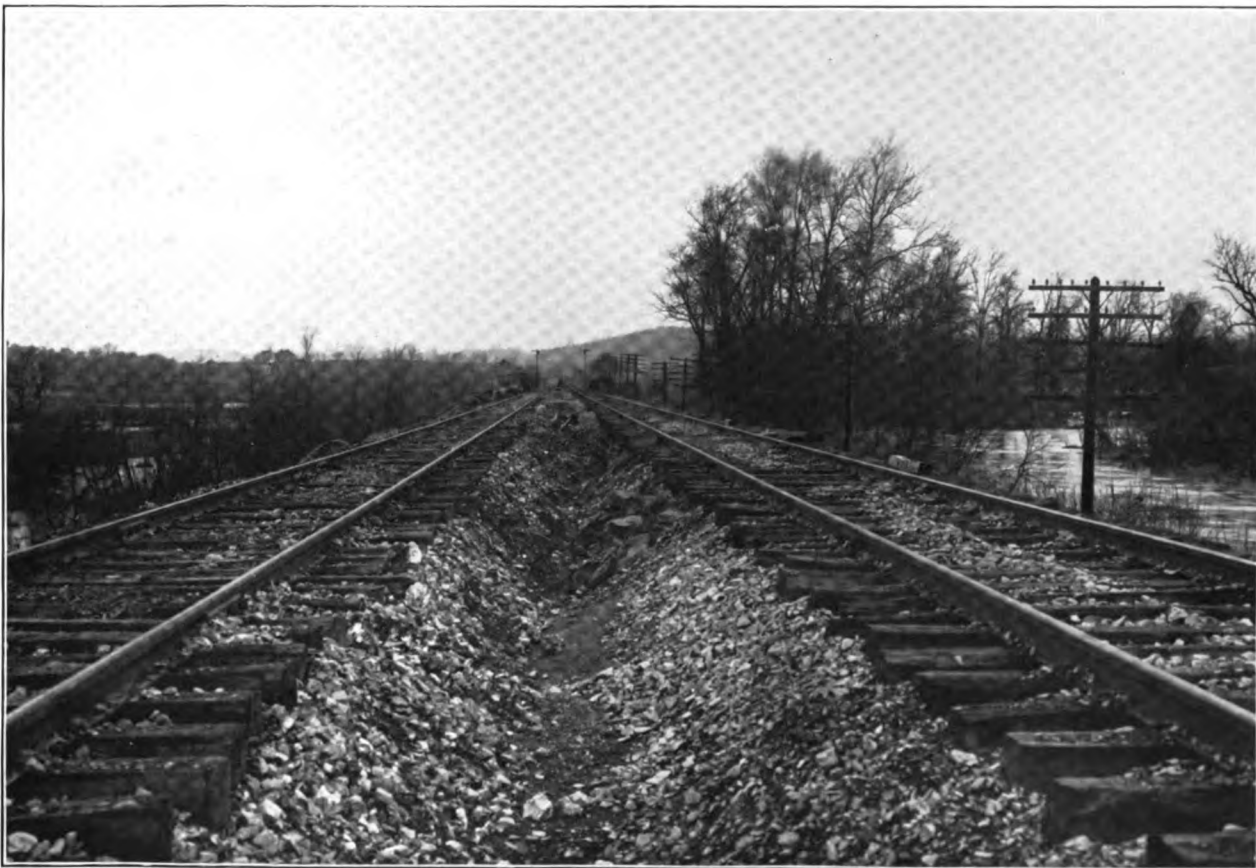
Perrysville, Ohio, west of.

Looking west over Bridge 143, over Black Fork, showing fill washed away and replaced for service.

On Sunday, the 30th, the approaches to Bridge No. 144 were filled with coal and screenings which were on the passing track near by. Bridge No. 143 was in course of reconstruction before the flood, and was supported on temporary timbers which the water took away. These supports were replaced and the approaches at both sides, which had been damaged for several hundred feet, repaired with screenings. At Bridge No. 145, it was also necessary to drive run-around trestles to avoid the old structure, each about three hundred feet long. A driver was started at work on a second track at Bridge No. 146, and made good progress.

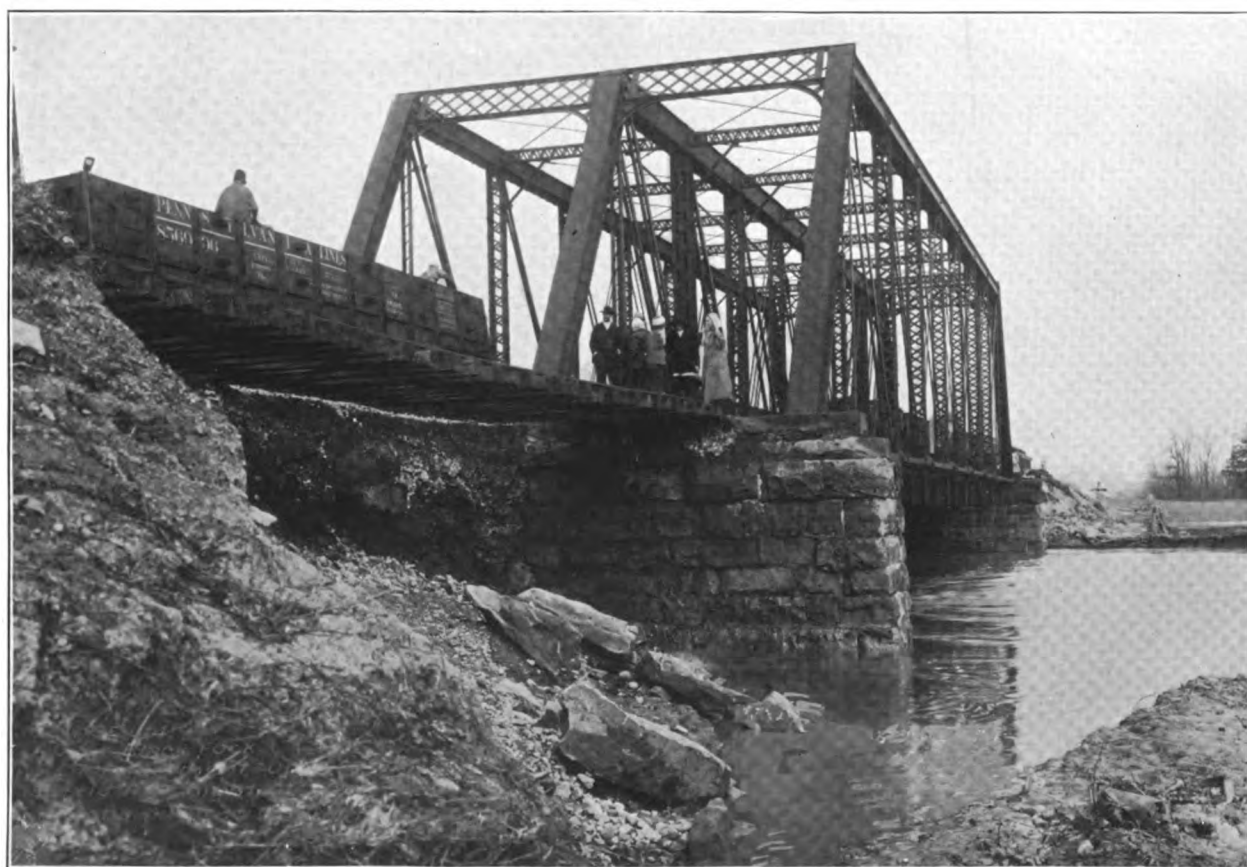
Coulter, Ohio, west of.

Bridge No. 145, over Black Fork; pier and both abutments and 100 feet of approach destroyed. Pile driver starting repair work at west side.

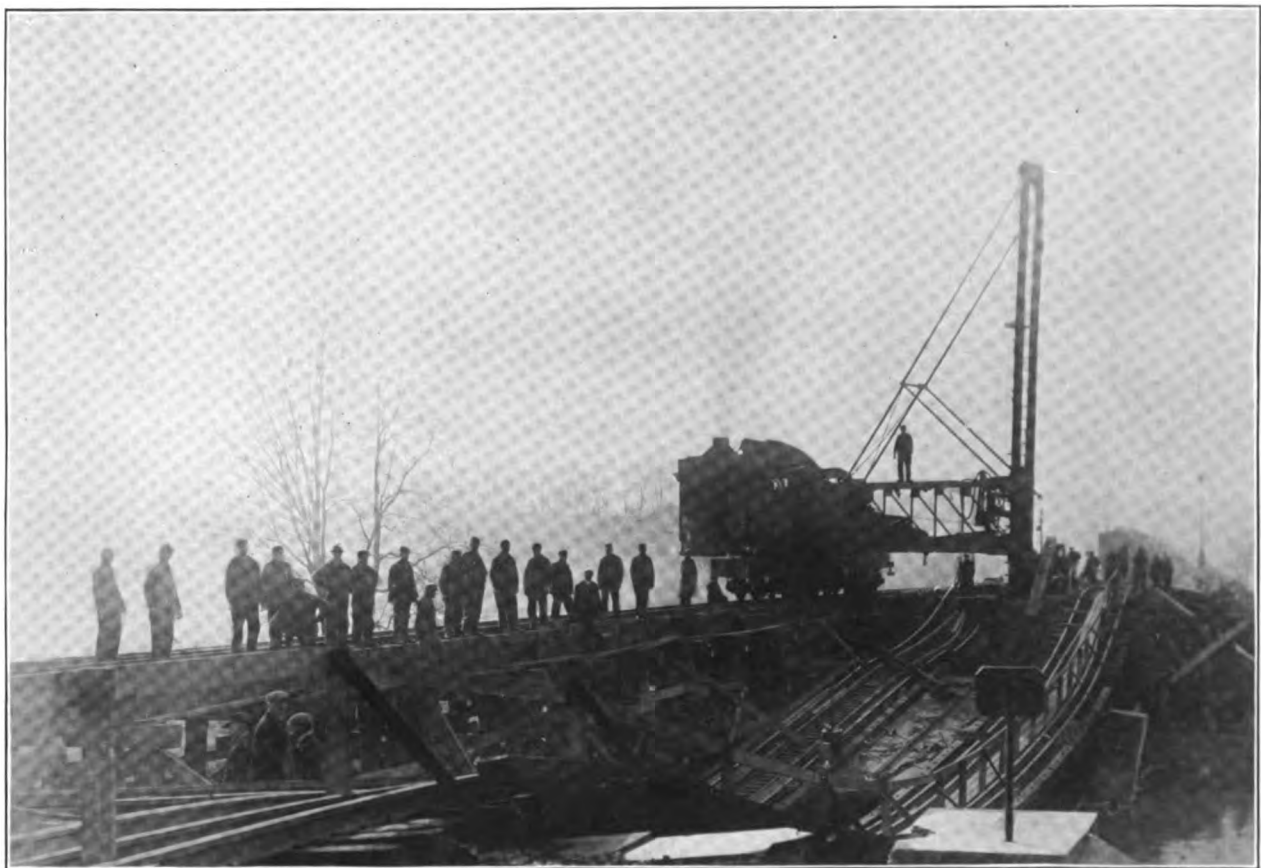
Lucas, Ohio, east of.

Bridge No. 145, over Black Fork, from east end, showing break in abutment as well as general condition of bridge. One "run-around" track about completed.

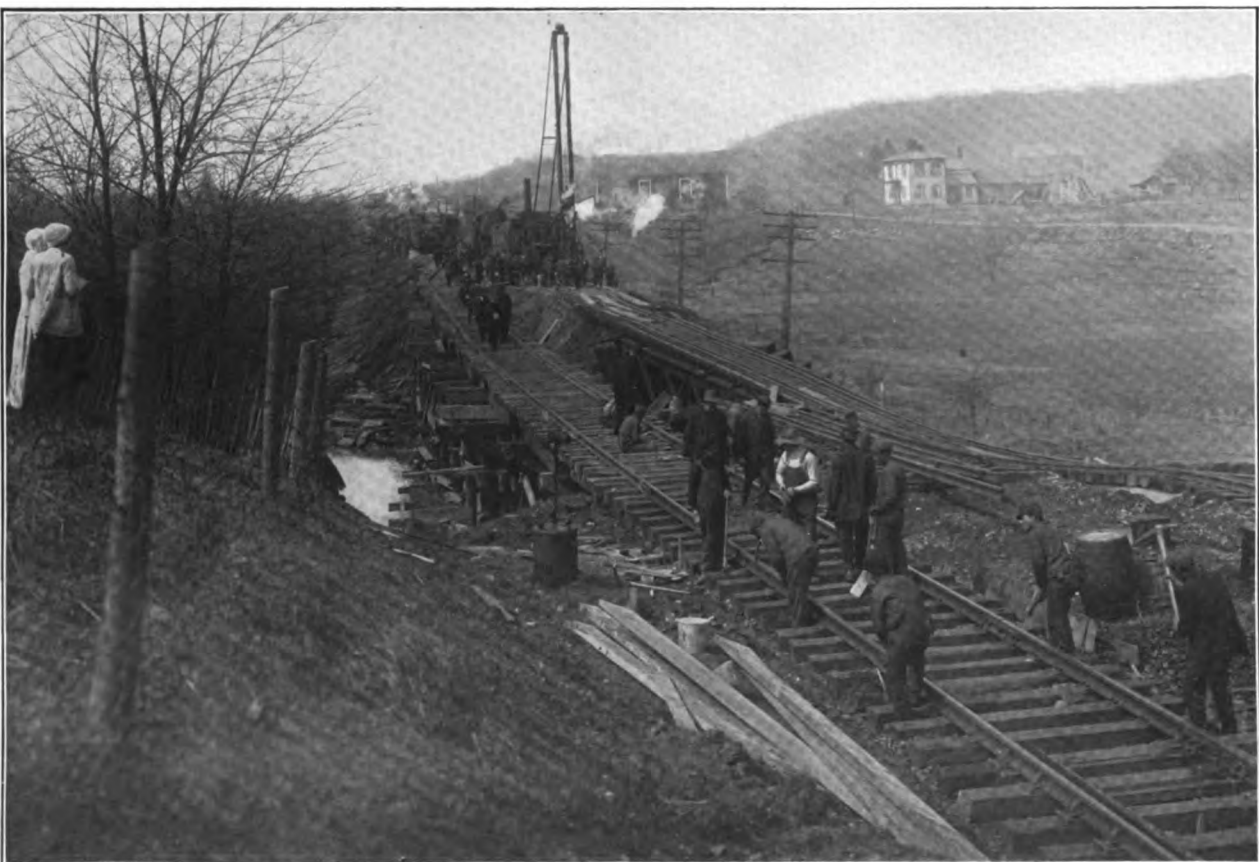
Lucas, Ohio, east of.

Bridge No. 146, over Rocky Fork; both abutments and 125 feet of roadbed destroyed.

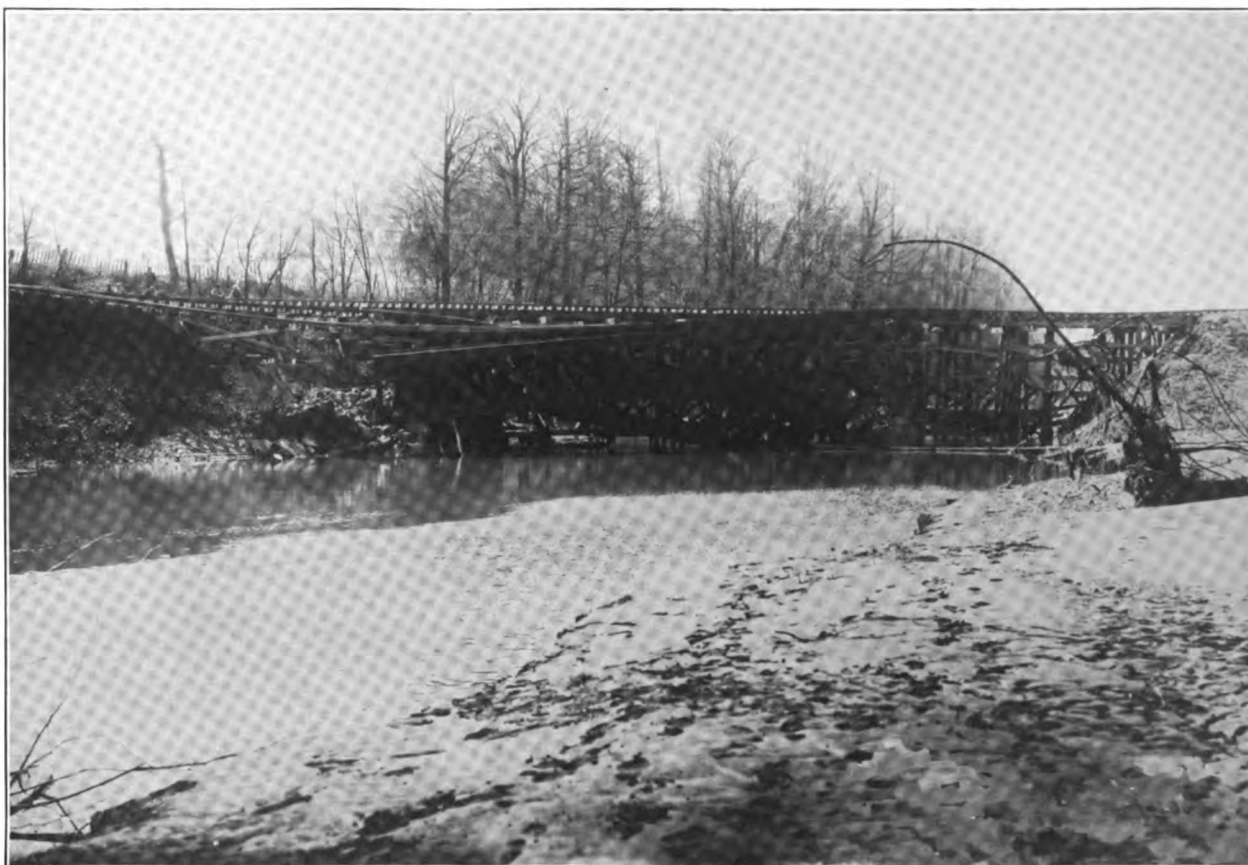
Lucas, Ohio, east of.

Looking south at Bridge 146, over Rocky Fork, showing temporary trestle back of bridge destroyed.

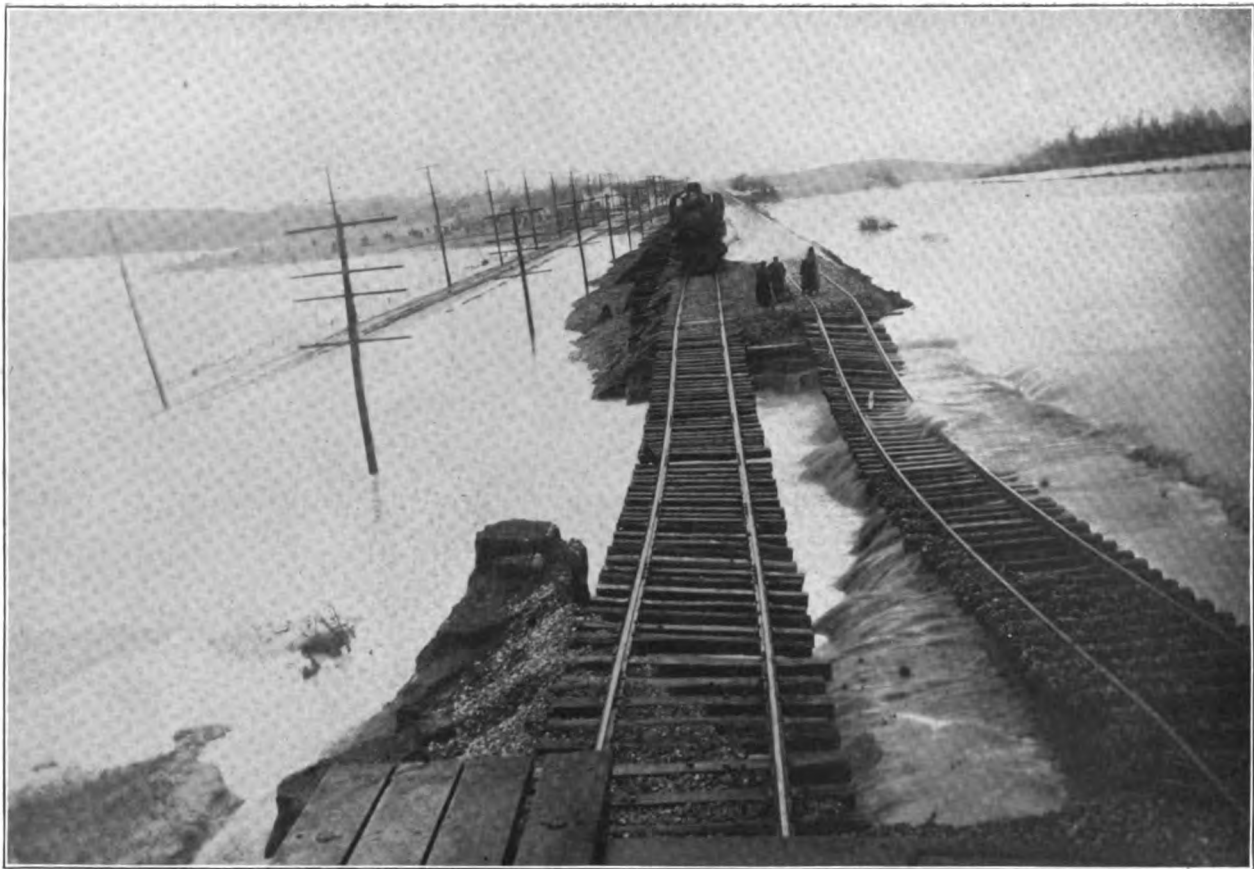
Auglaize, Ohio, west of.

Western Division Bridge 182, view looking east, 8:00 A. M. Abutment of former bridge at left of track. This bridge was filled in in 1895, after a 24" C. I. pipe had been placed.

Culvert 182, about one third of a mile west of Auglaize, was originally a 16 foot bridge, but in 1895 it was filled in, except for a twenty-four inch cast iron pipe which was placed in the bottom of the opening. This waterway was too small for the March flood, and when the water broke through the fill, it washed away about 120 feet of the embankment. For part of the distance it was necessary to trestle over the opening and this trestle will be replaced with a bridge of the original span.

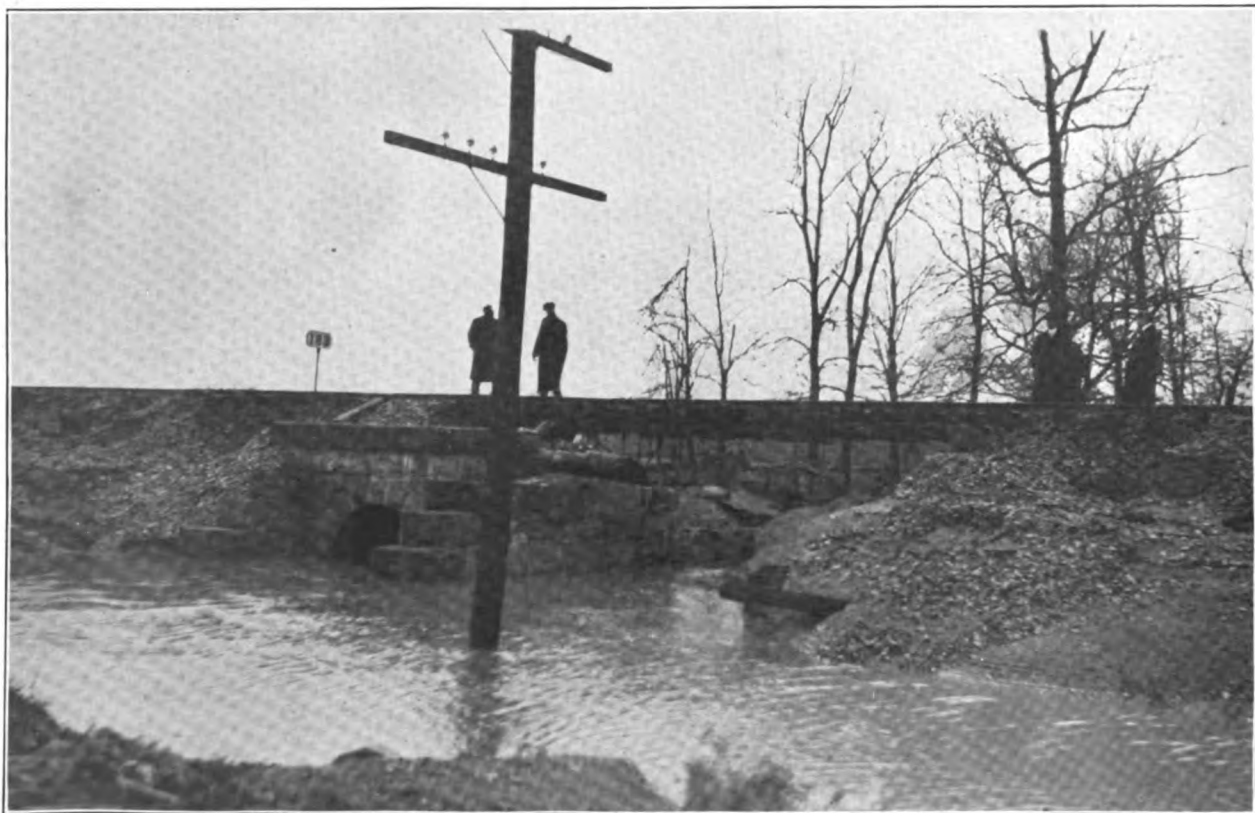
Auglaize, Ohio, west of.

Bridge 183, six foot arch damaged, and approach washed away.

Culvert 183, about one mile west of Auglaize, was a six foot stone arch, of which the east side under the older track was destroyed, and with it about forty lineal feet of embankment. The damaged arch was rebuilt in concrete.

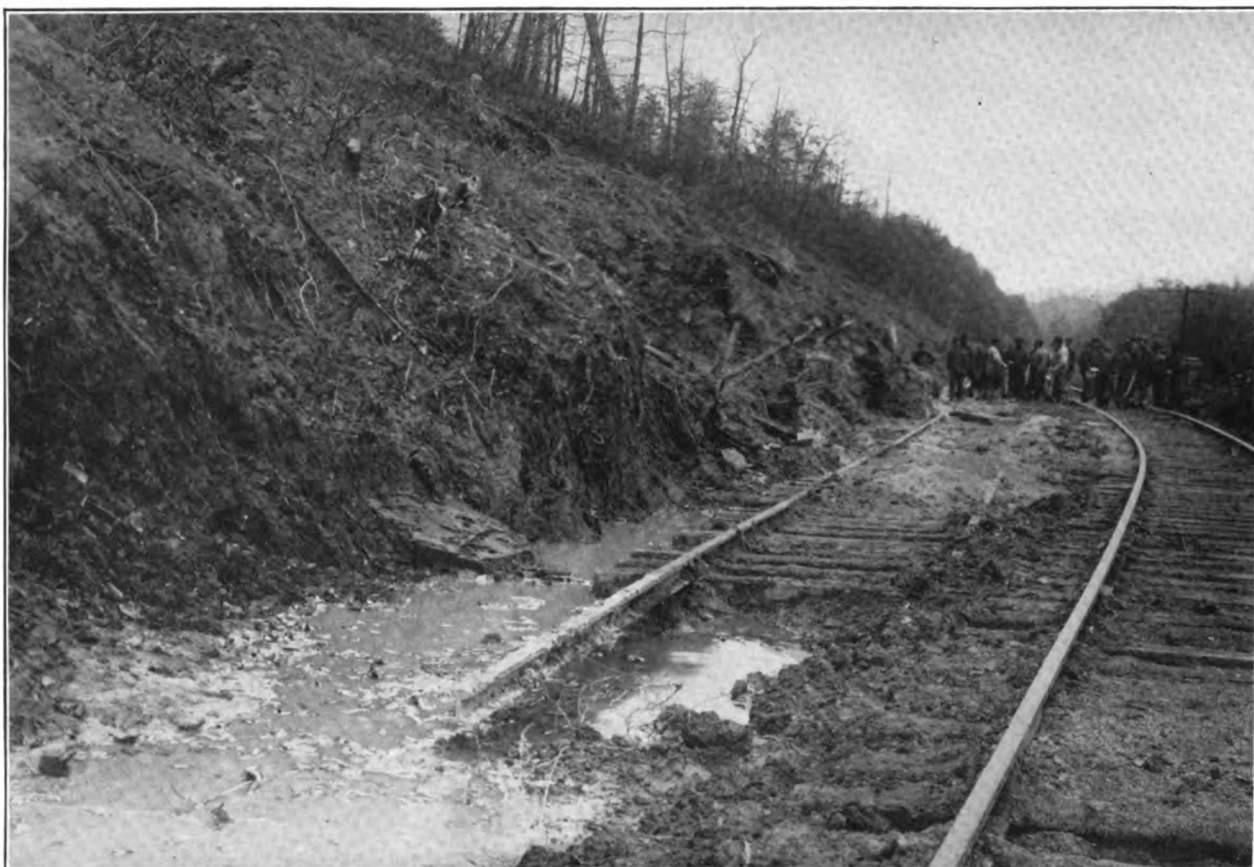
Zoar, Ohio, west of.

Land slide at Eagle Hill, Tuscarawas Branch.

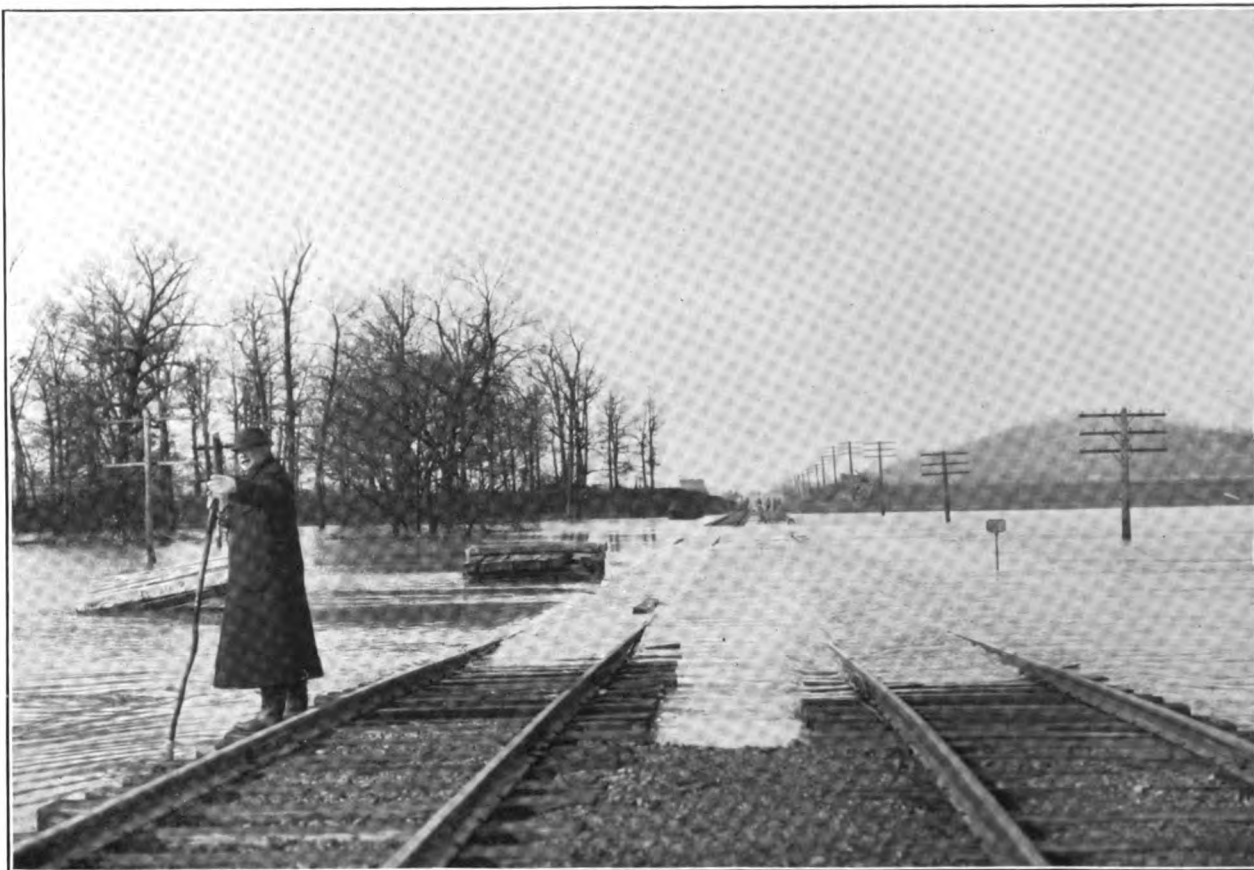
Gnadenhutten, Ohio.

Culvert 91½, one-half mile east of Station. Water had fallen 10 inches.
