PENNSYLVANIA LINES
WEST OF PITTSBURGH

A HISTORY
OF THE
FLOOD
OF
MARCH, 1913

COMPILED
BY
C. W. GARRETT

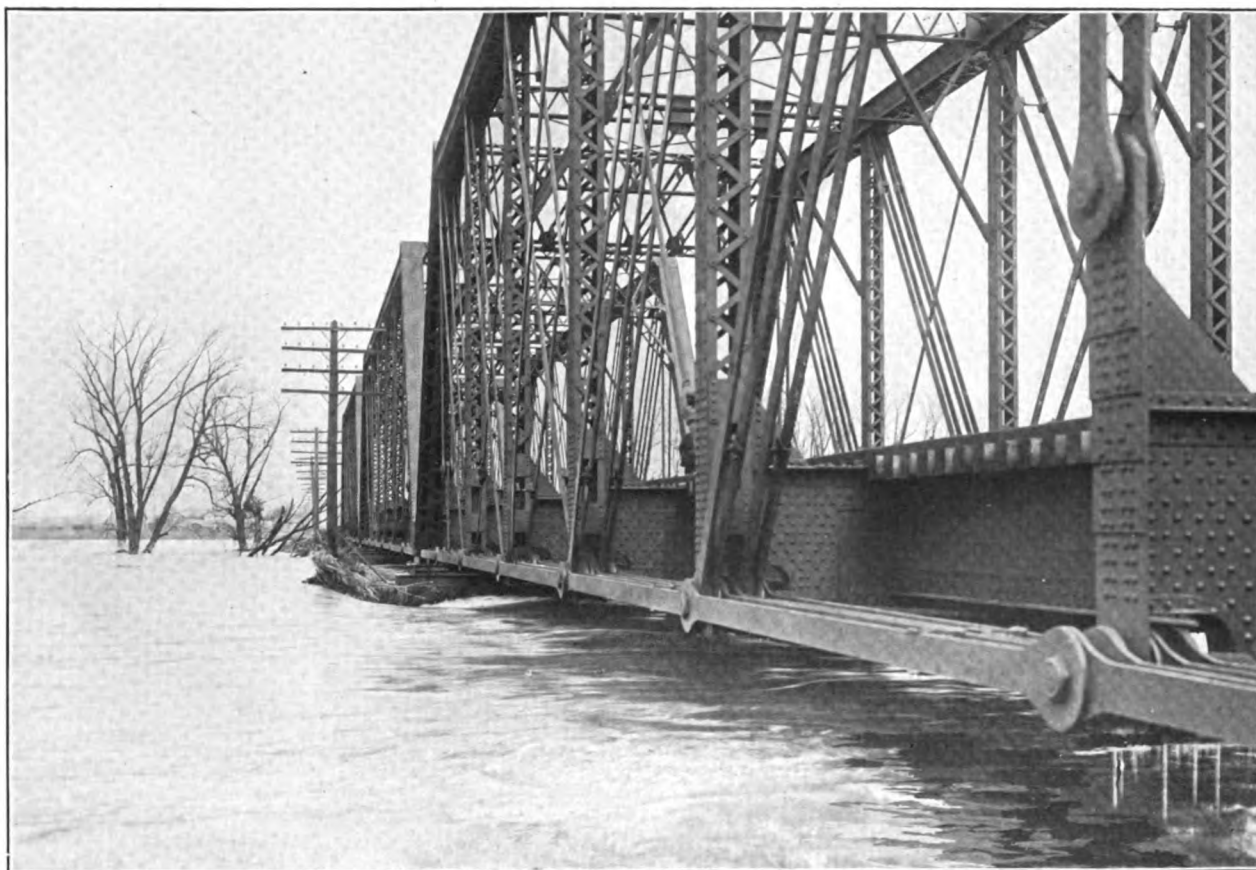
Gnadenhutten, Ohio.

Bridge 92, over Tuscarawas River. Water had fallen 18 inches.

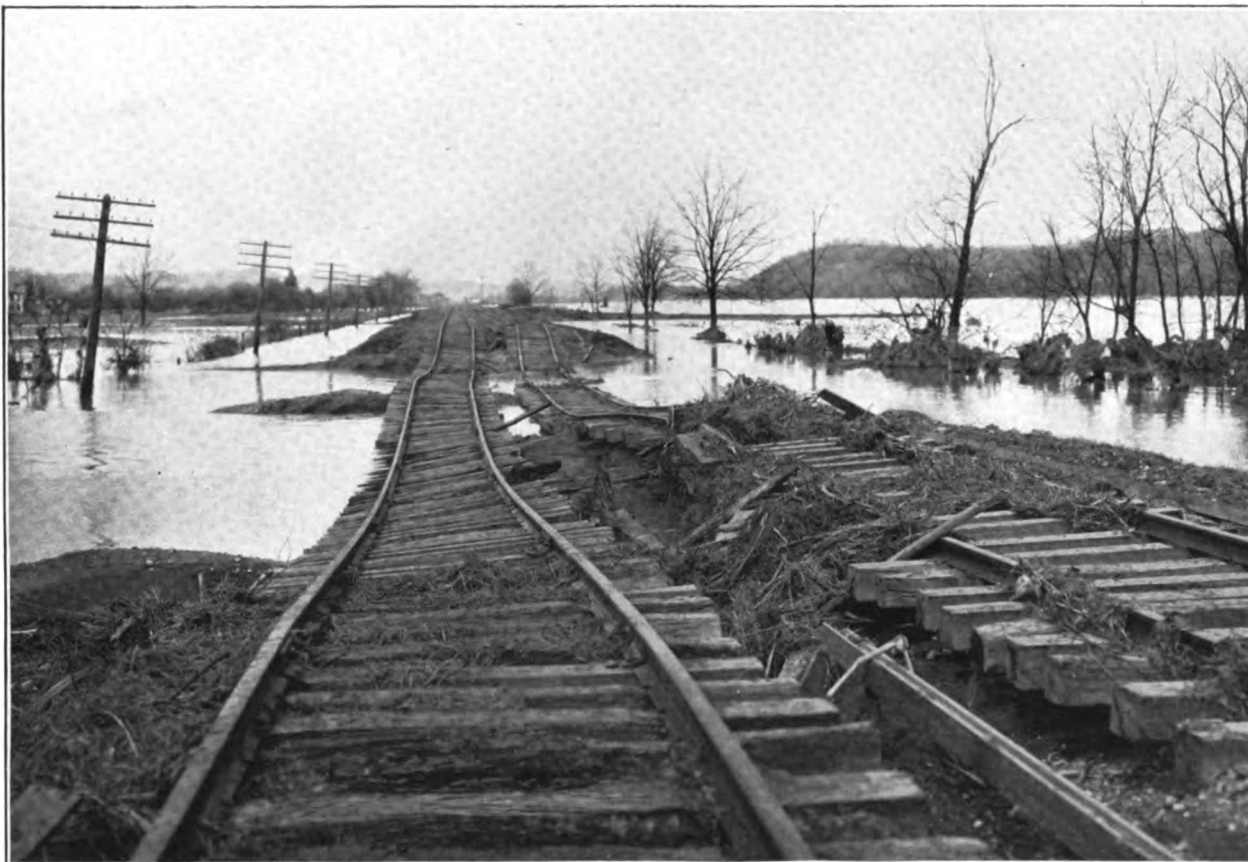
New Comerstown, Ohio, east of.

View east, over washout at Culvert 92-G.

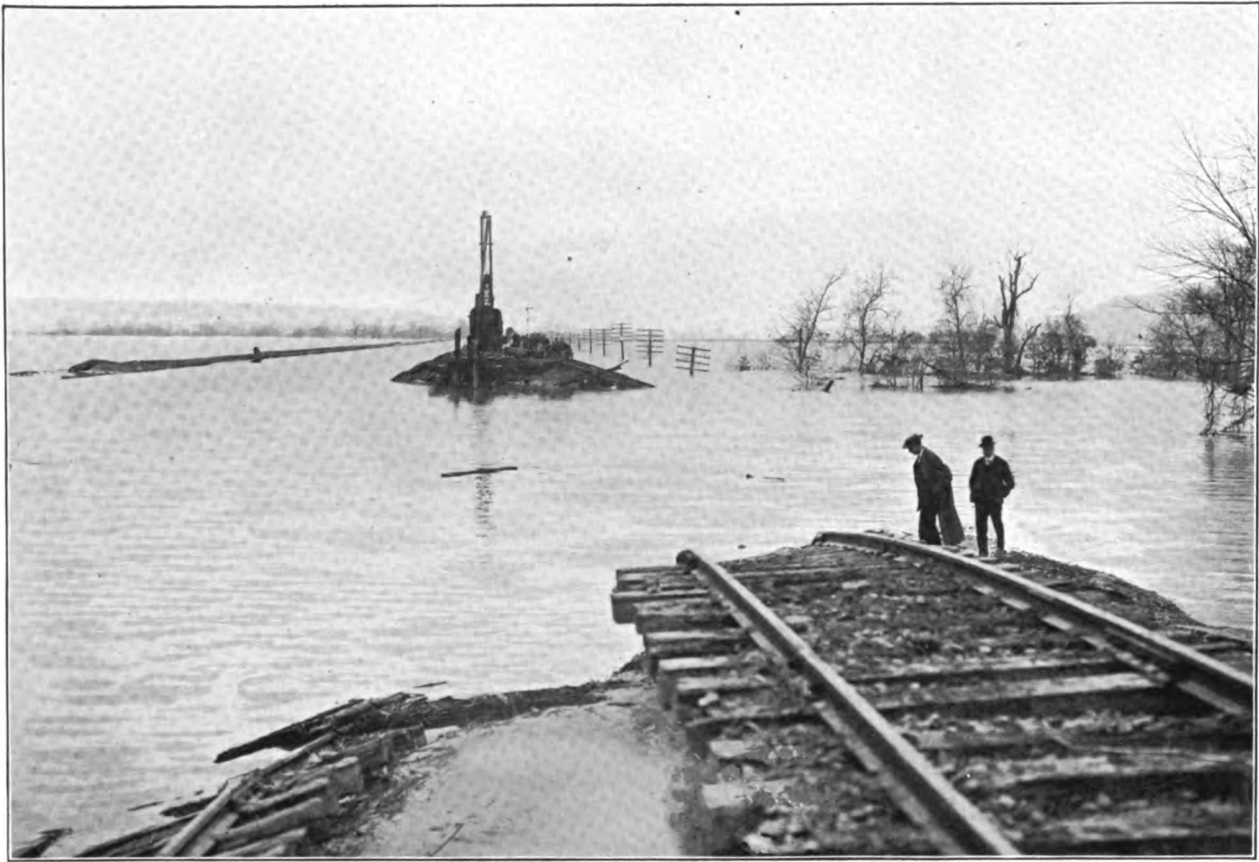
Trinway, Ohio, east of.

View west at site of Bridge 104, carrying an overflow from the Ohio Canal;
10 foot stone arch washed out.

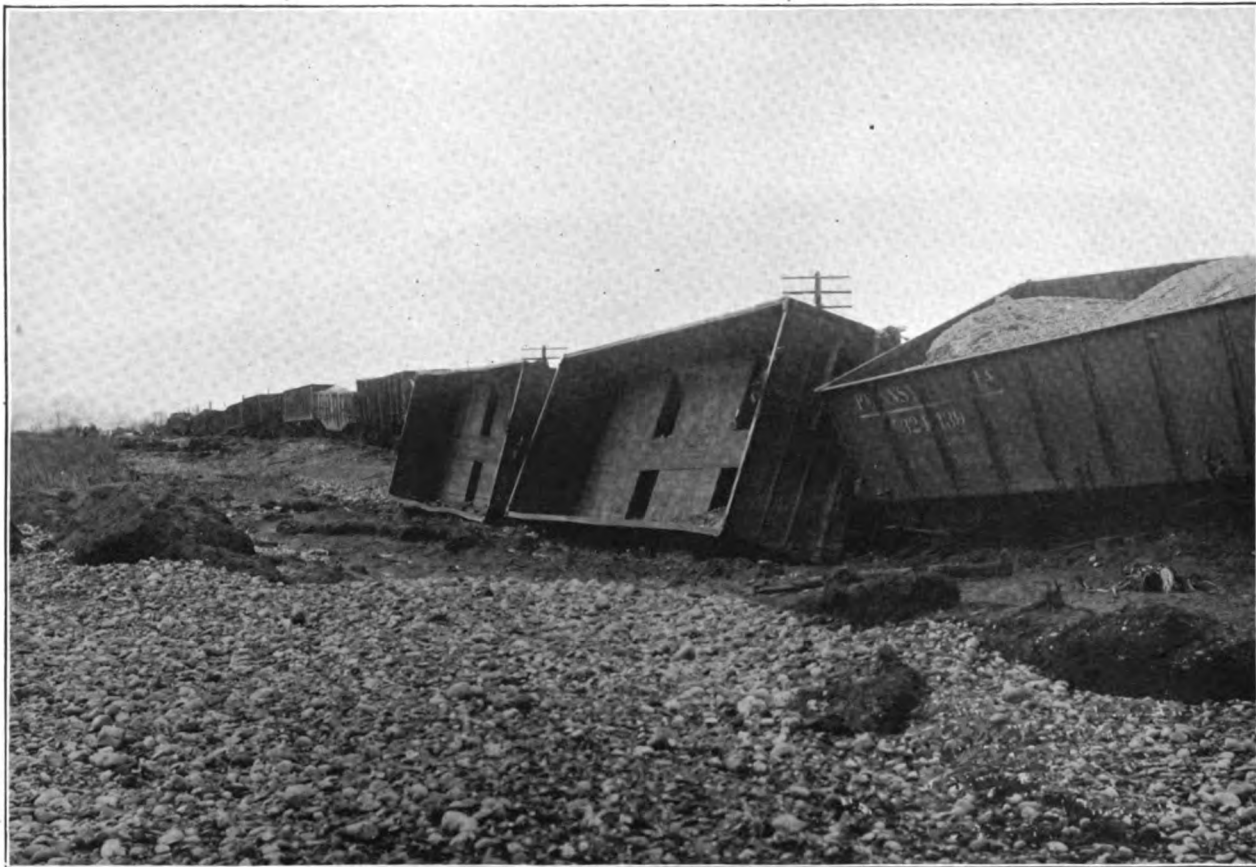
Coshocton, Ohio, west of.

Passing tracks, etc., at "Clow" undermined, and equipment more or less damaged.

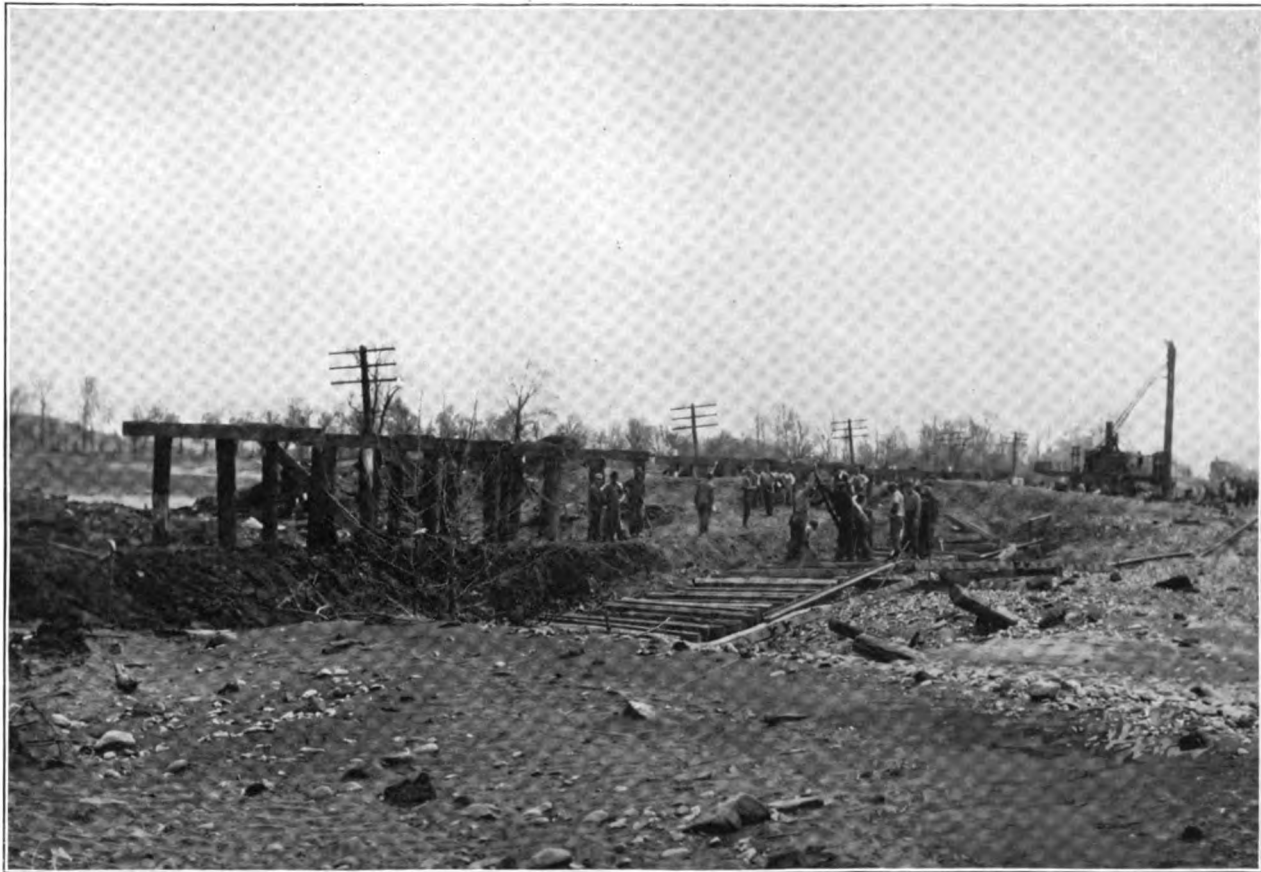
Coshocton, Ohio, west of.

Fill east of Bridge 100 washed away, exposing piling driven in repairing damage done by flood of 1898, but not in condition for use.

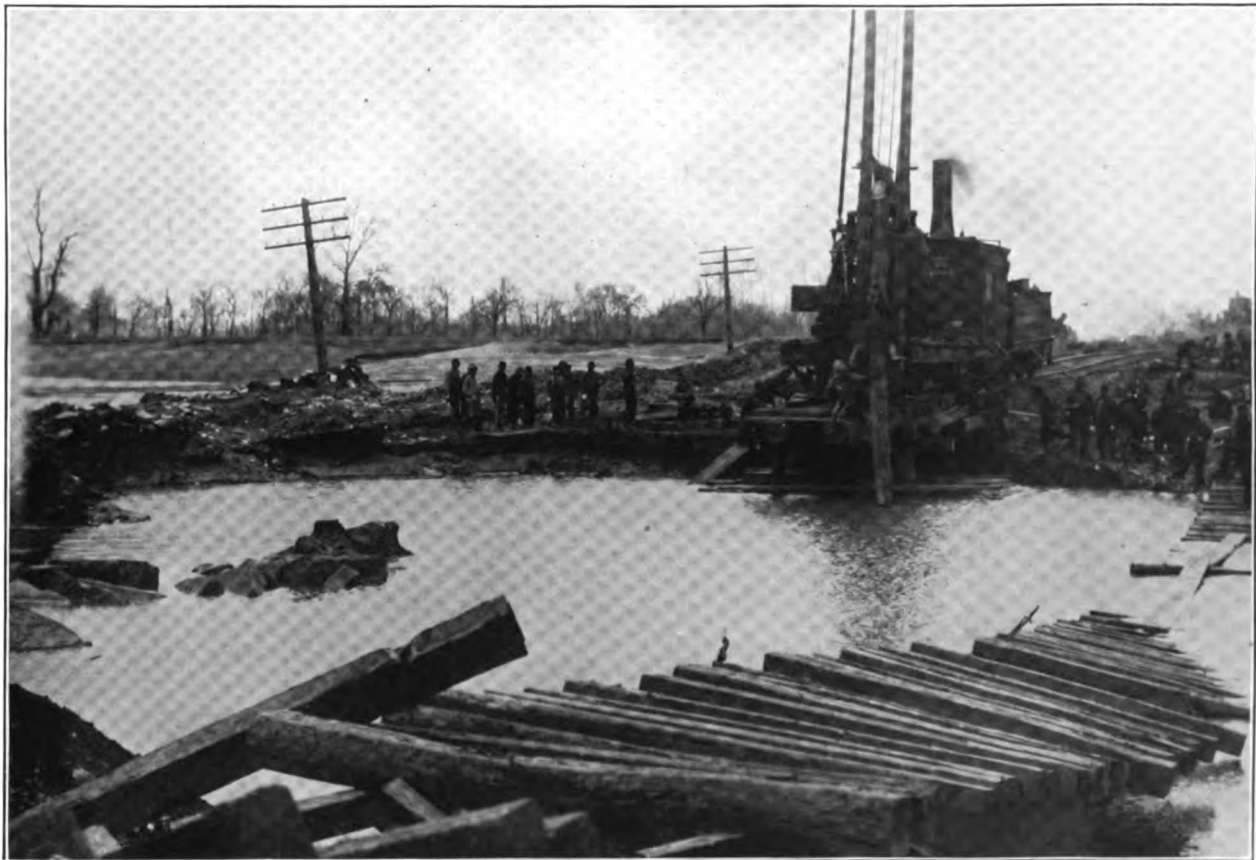
Coshocton, Ohio, west of.

Driving piling at deepest hole washed in approach to Bridge 100, over Muskingum River, driver working on "lower level."

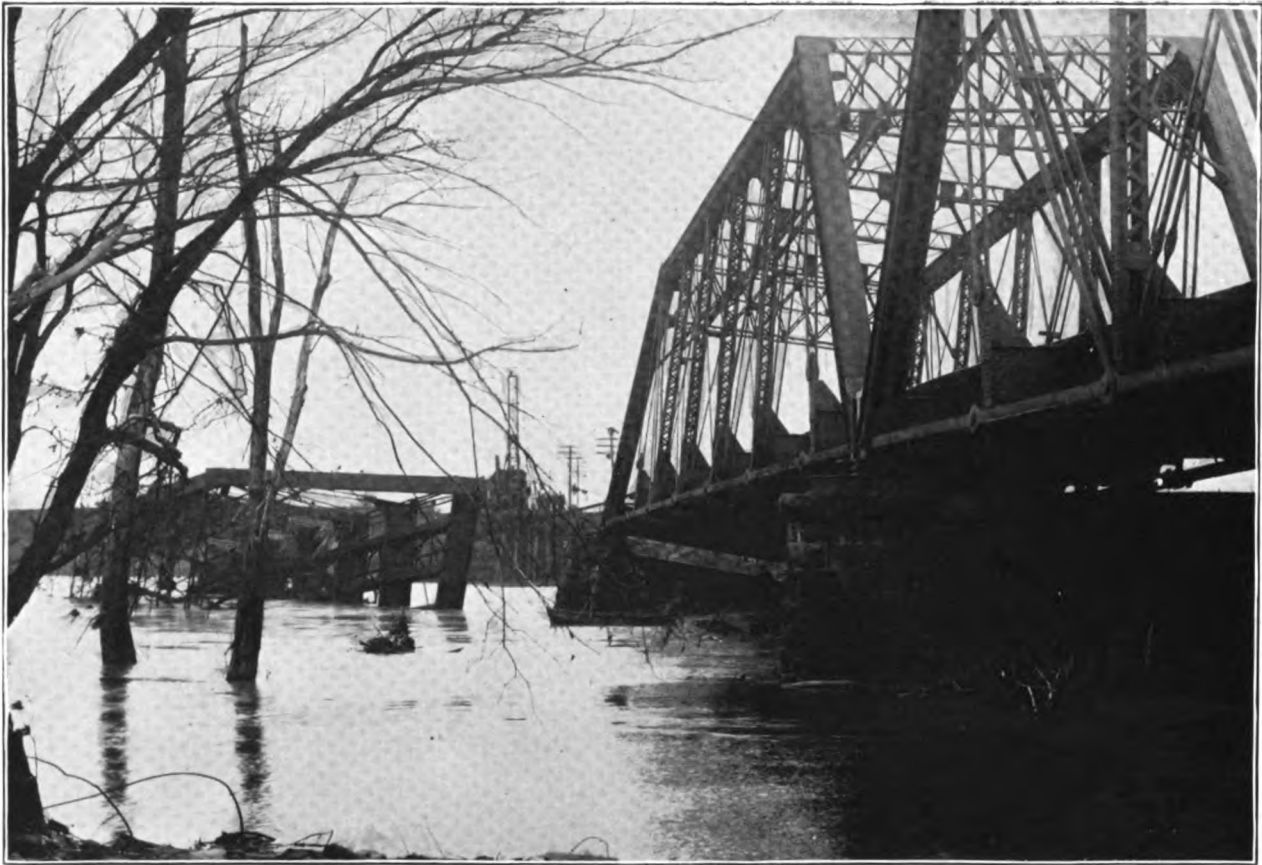
Coshocton, Ohio, west of.

Bridge 100, looking west, where first piling is being driven in channel of river at west side.

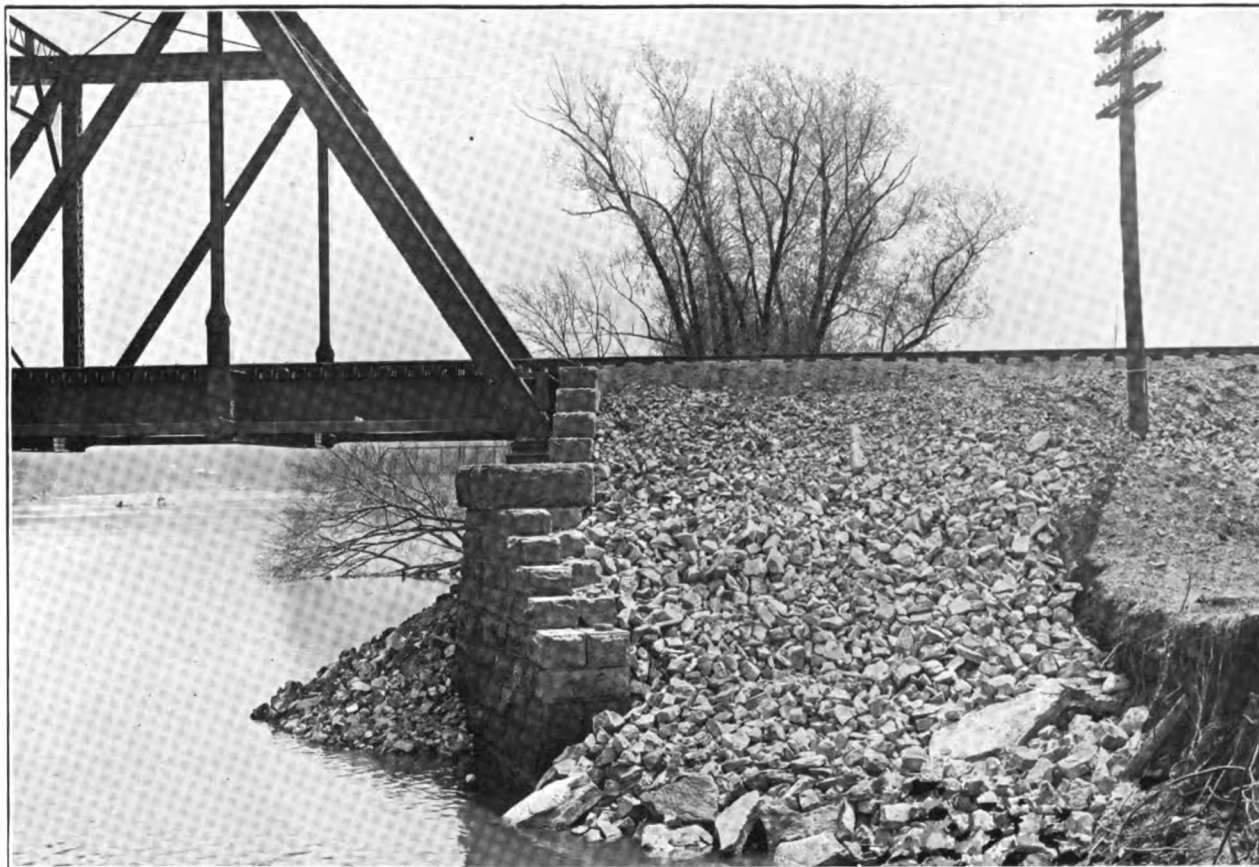
Gnadenhutten, Ohio.

Bridge 92, over Tuscarawas River. West approach fill washed out, and replaced with stone and riprap. Abutment slightly cracked.

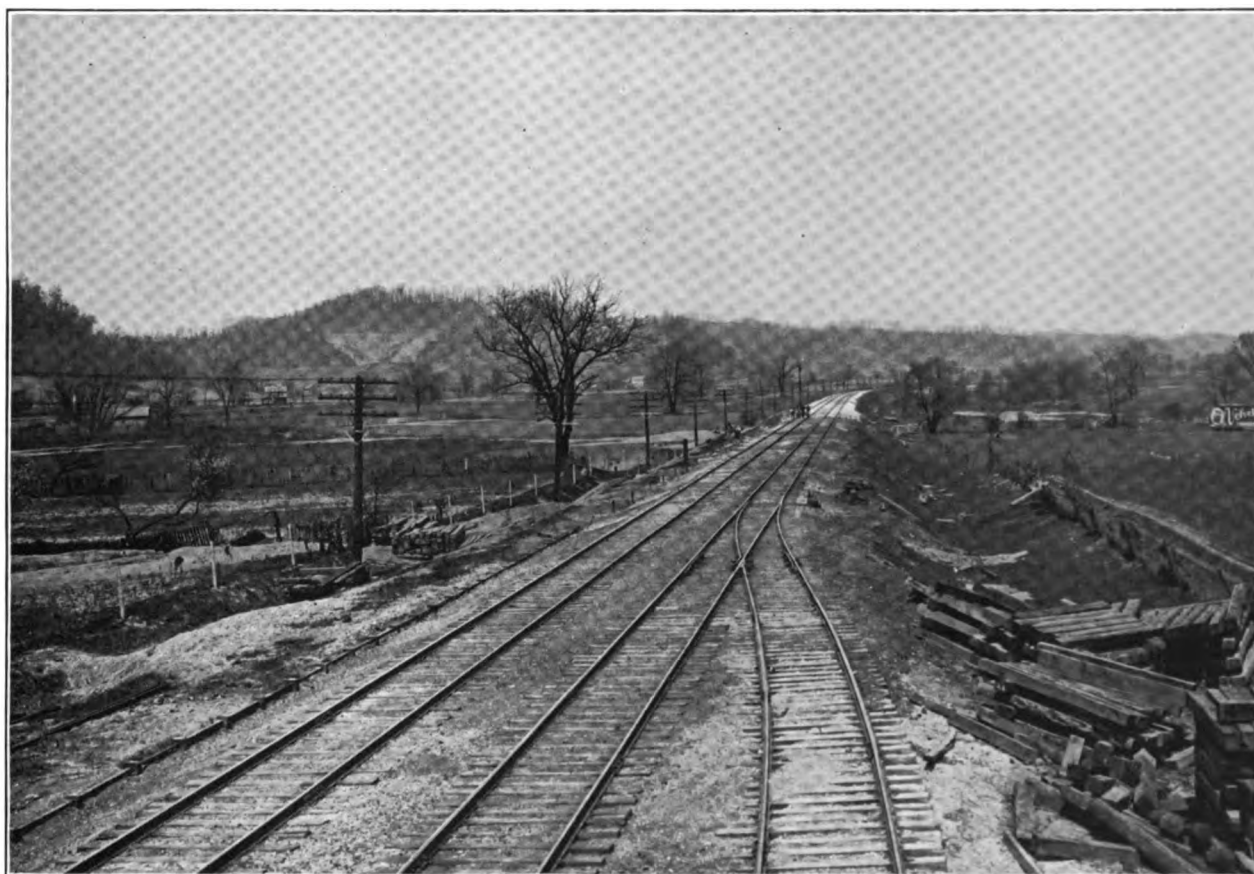
Port Washington, Ohio.

View east, showing track as replaced for regular service.

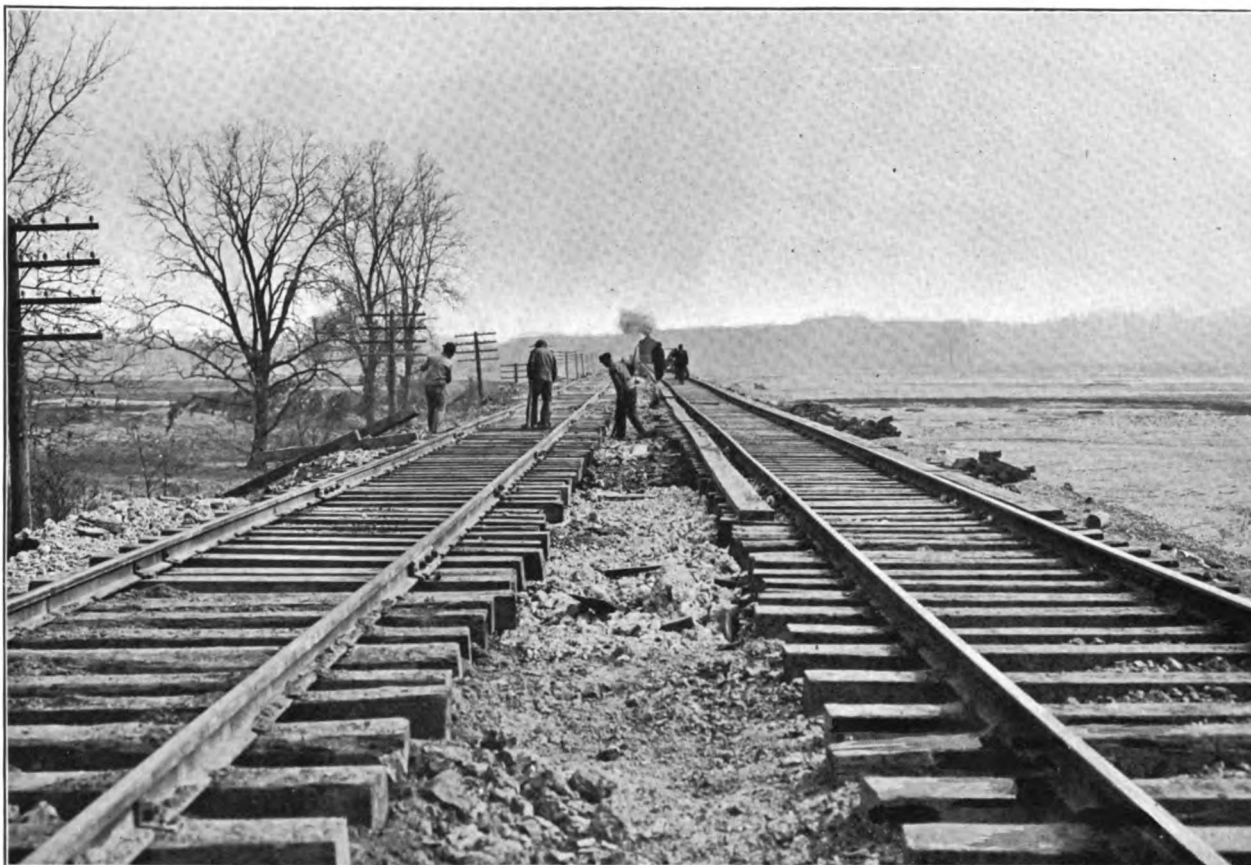
Coshocton, Ohio, west of.

View east, east of Bridge 100, showing new fill replacing conditions shown in the frontispiece.

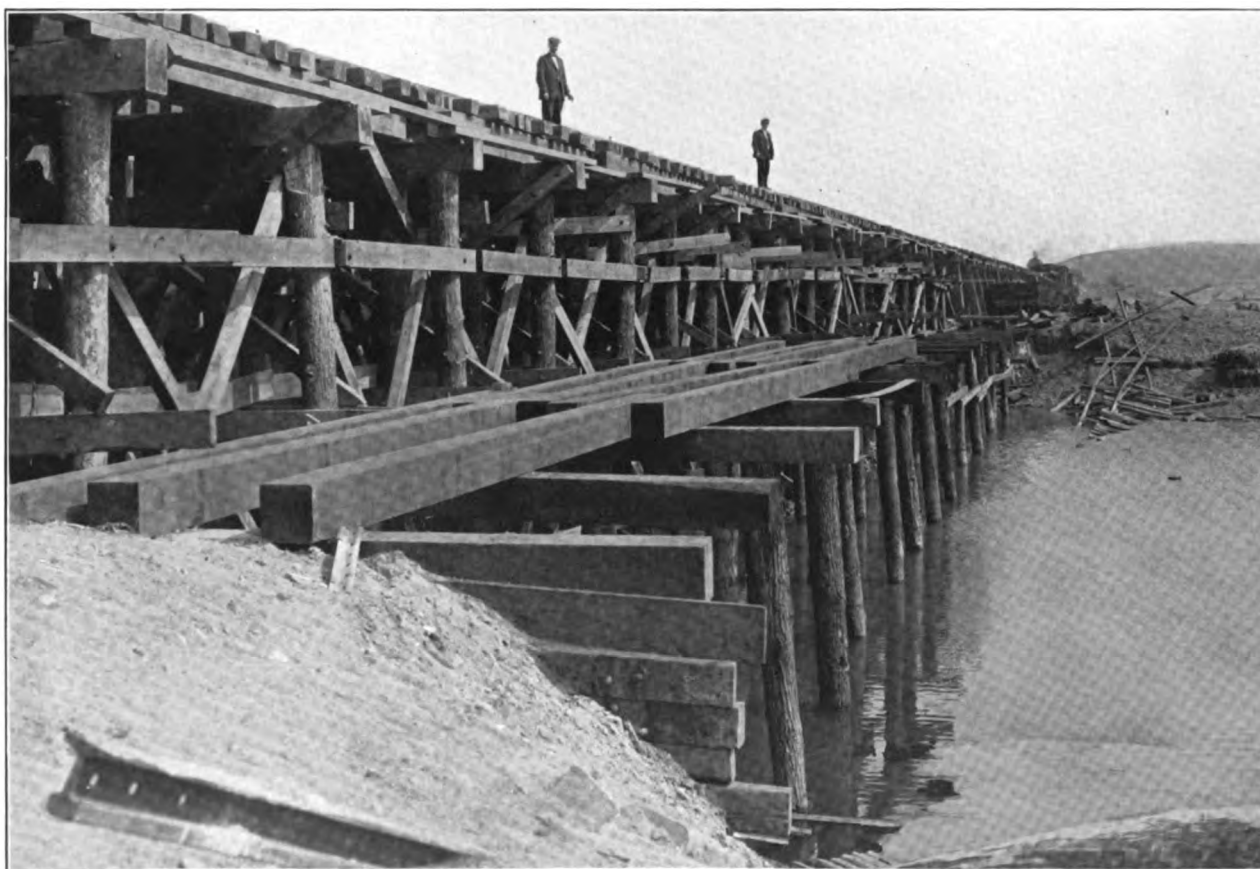
Coshocton, Ohio, west of.

View east, east of Bridge 100, showing pile trestle over deepest washout in fill.

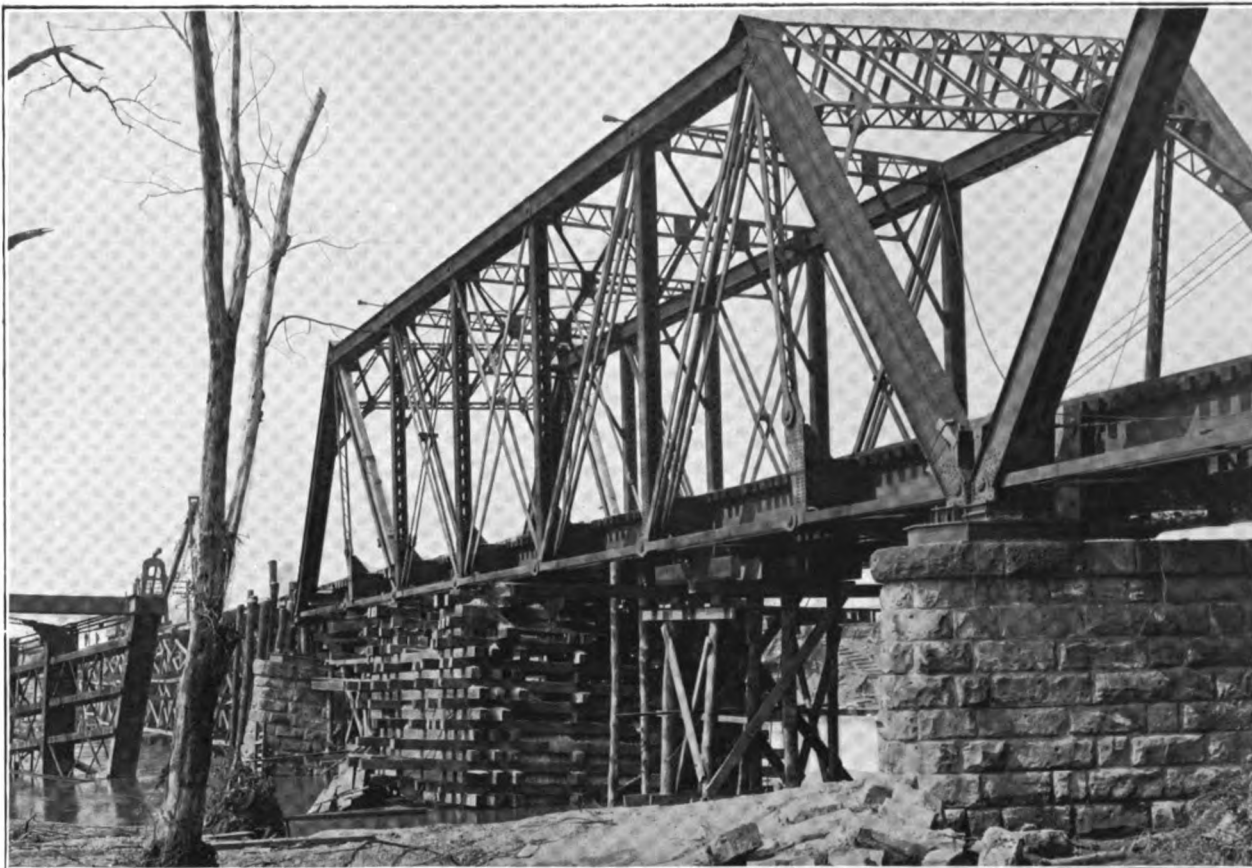
Coshocton, Ohio, west of.

Bridge 100, over Muskingum River; second span raised and supported on timber falsework on account of undermining of pier.

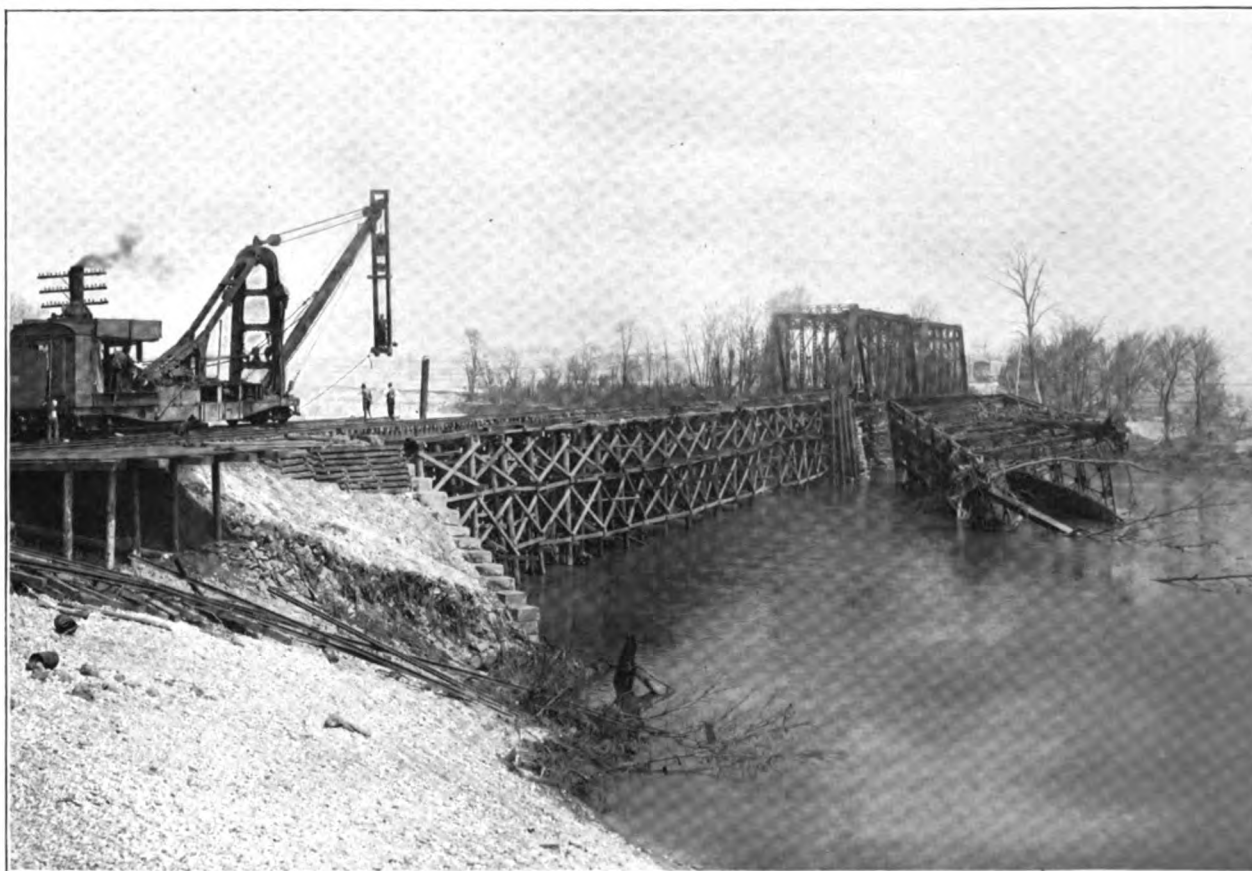
Coshocton, Ohio, west of.

Bridge 100, over Muskingum River; trestle replacing one track across channel of river completed; driver starting work for second track.

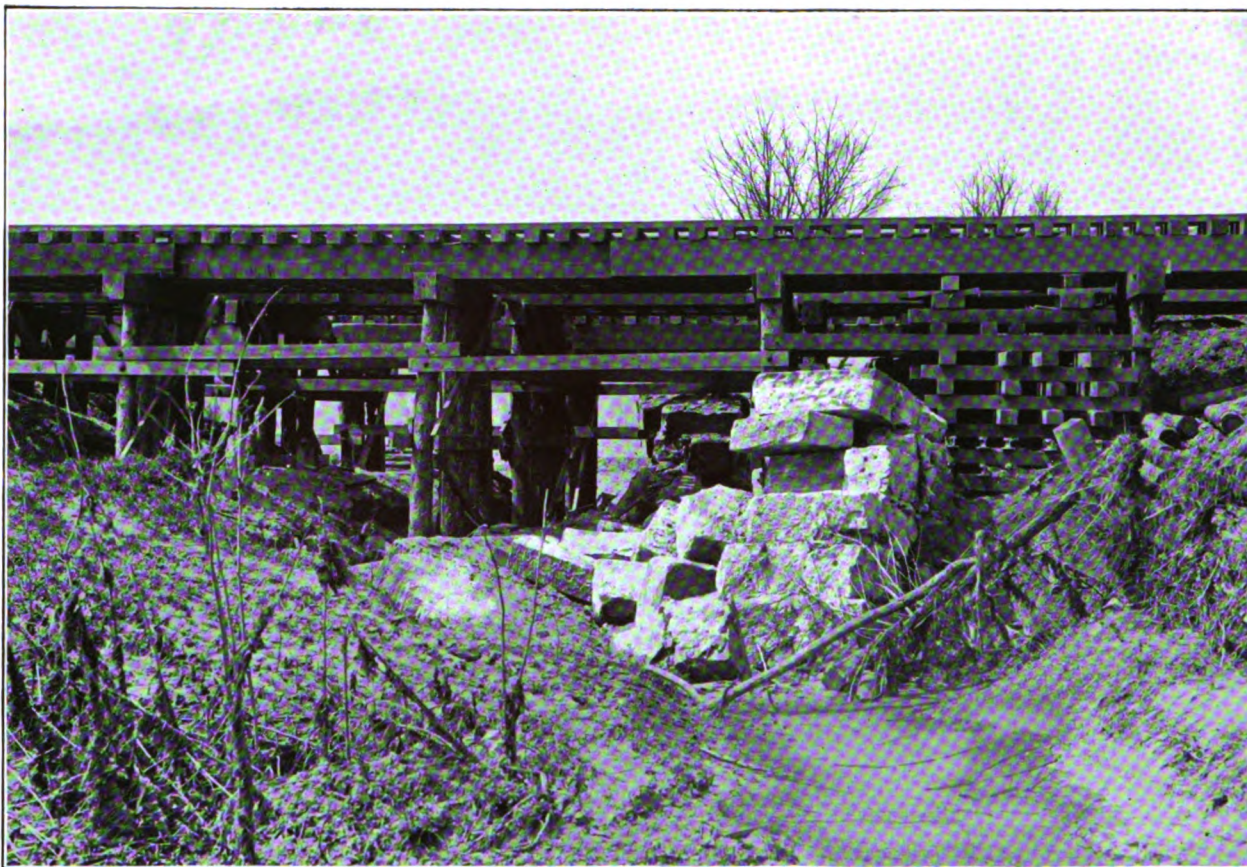
Coshocton, Ohio, west of.

Trestle replacing Bridge 101, a cattle pass. Rail used in cribbing is part of the top of the old bridge, which had a slab top of rail, brick and concrete.

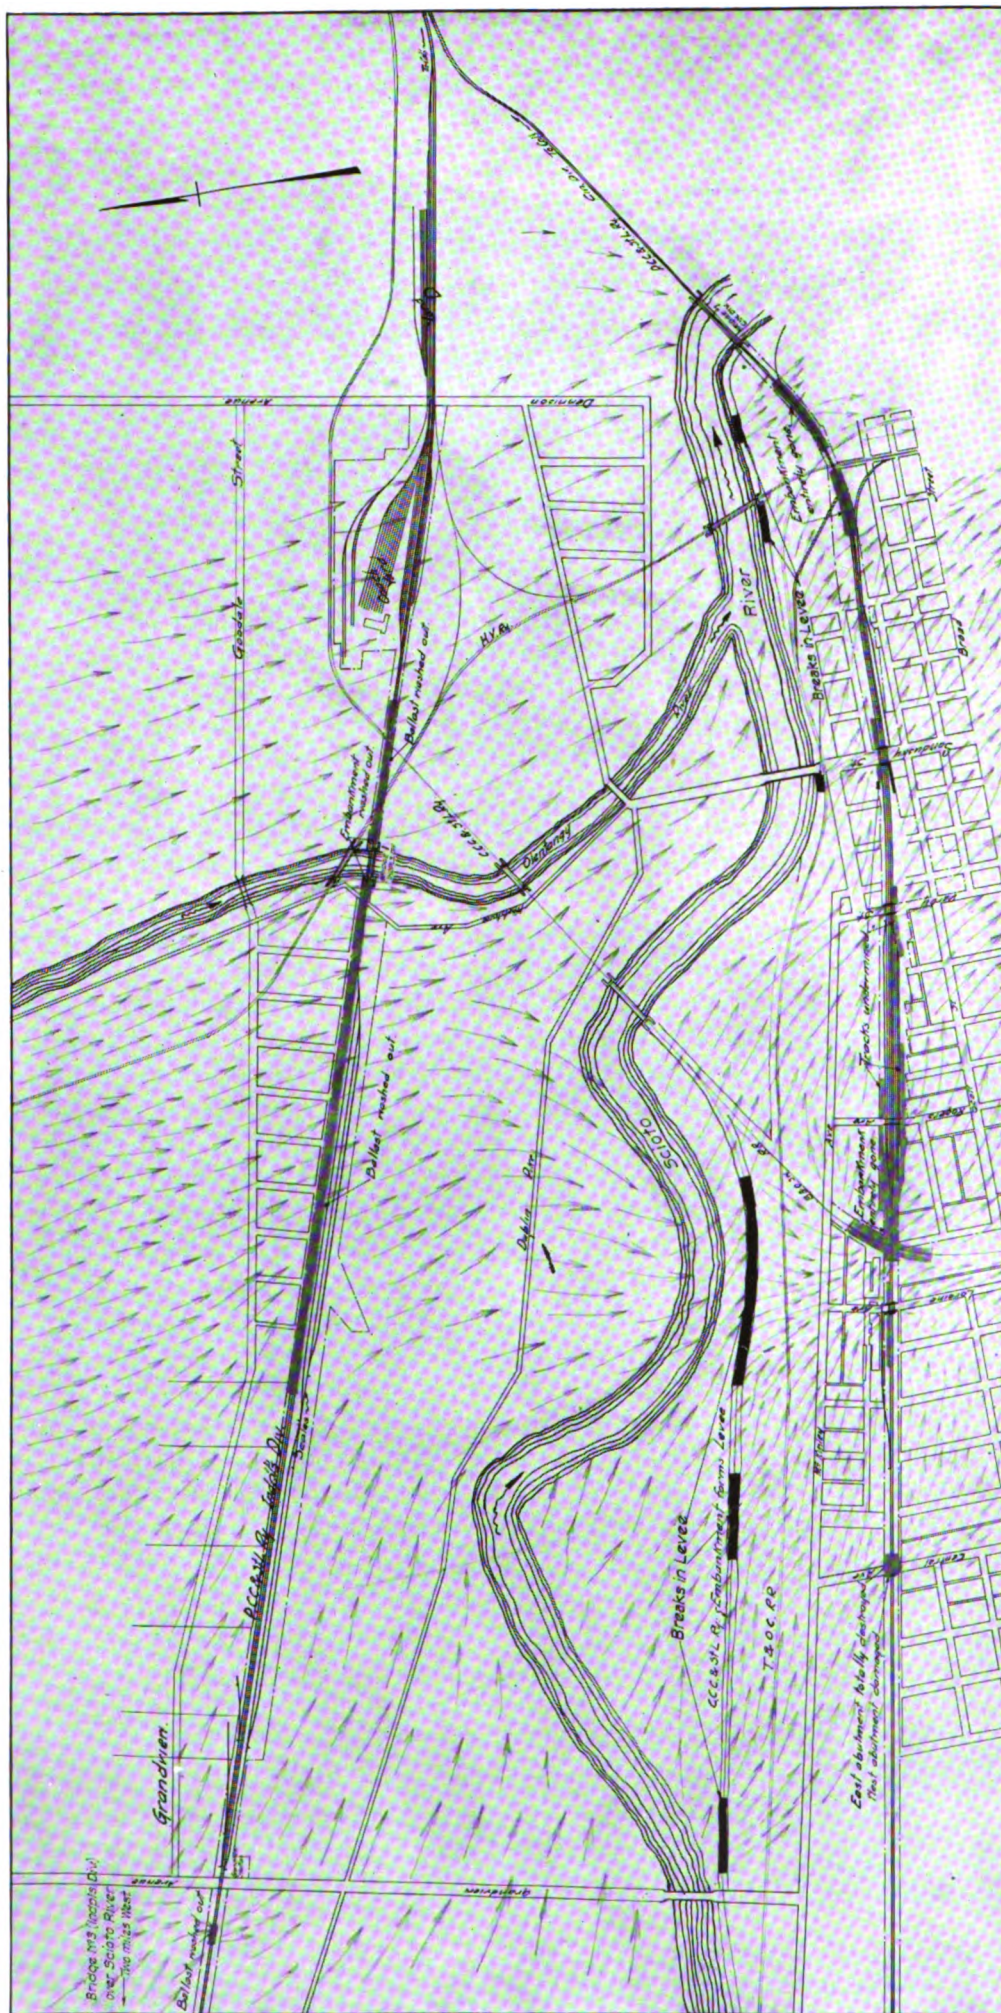
Columbus, Ohio, West Side.

Sketch map showing tracks of Indianapolis and Cincinnati Divisions, direction of currents over lowlands, and points of main damage to roadbed and bridges.

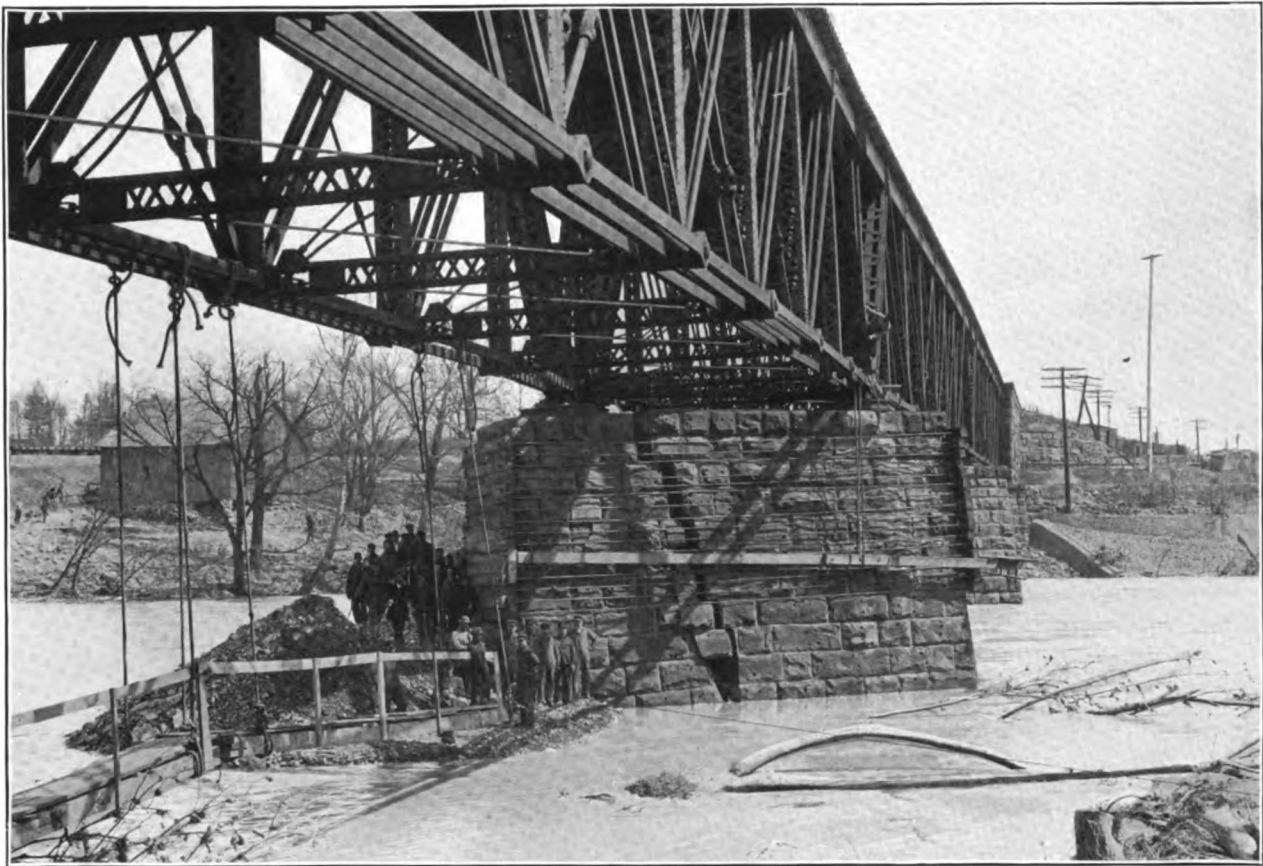
Marble Cliff, Ohio.

Bridge No. 3, over Scioto River, showing west pier undermined on north side; cracked pier held together with iron rod bands; Rip-rap thrown in stream around it, and walkway from shore to pier suspended by ropes from Bridge superstructure.

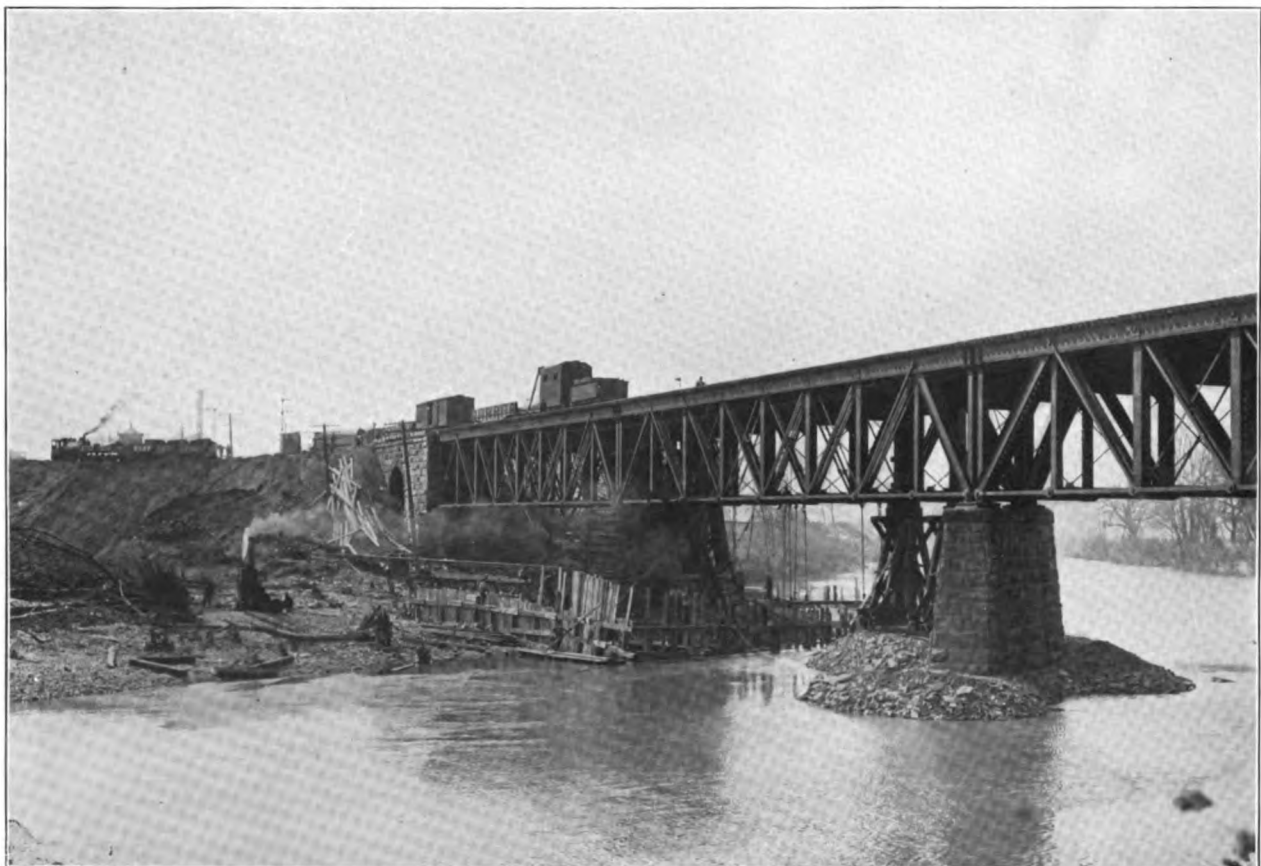
Marble Cliff, Ohio.

View west, at Bridge 3, over Scioto River, showing west pier being replaced.

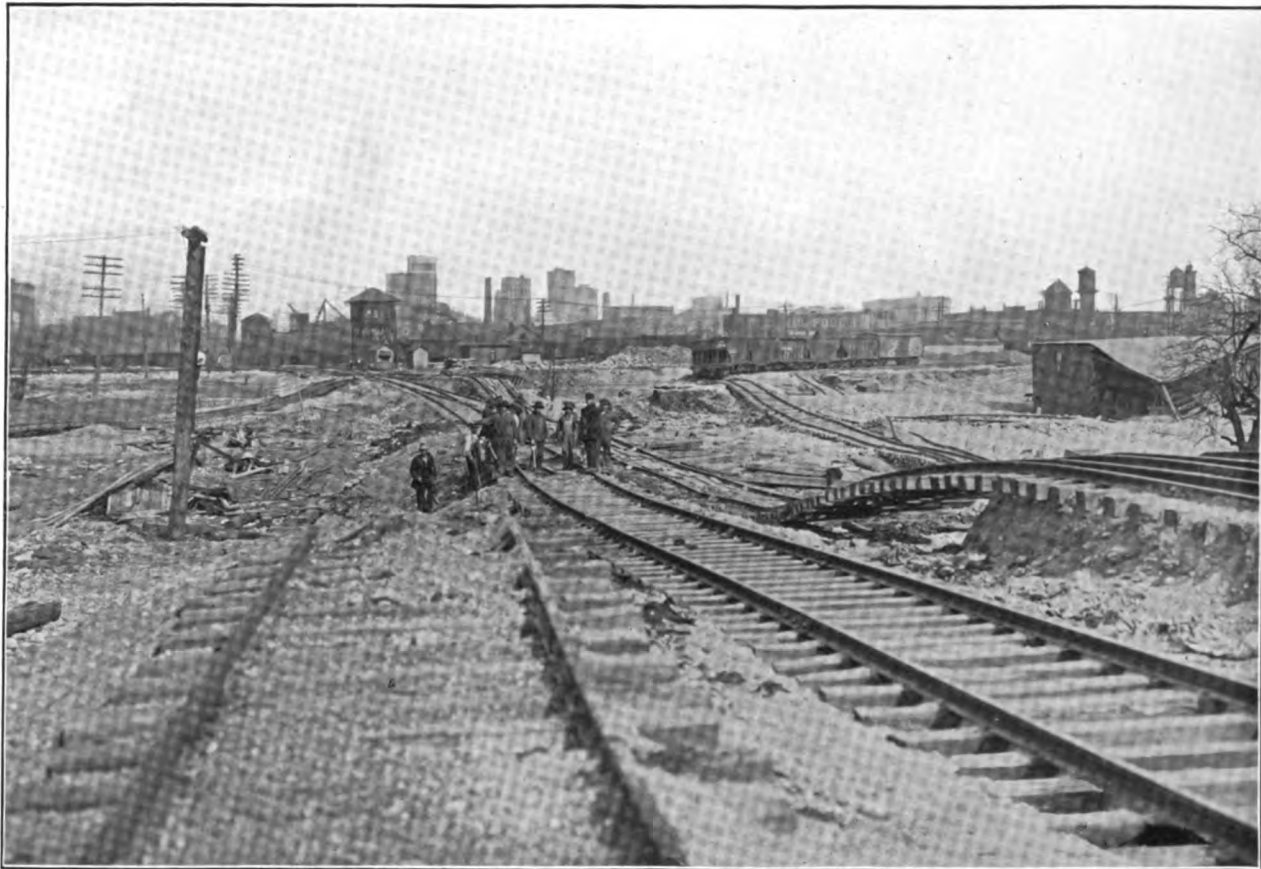
West Columbus, Ohio.

Looking east over washout west of Hocking Valley Crossing.

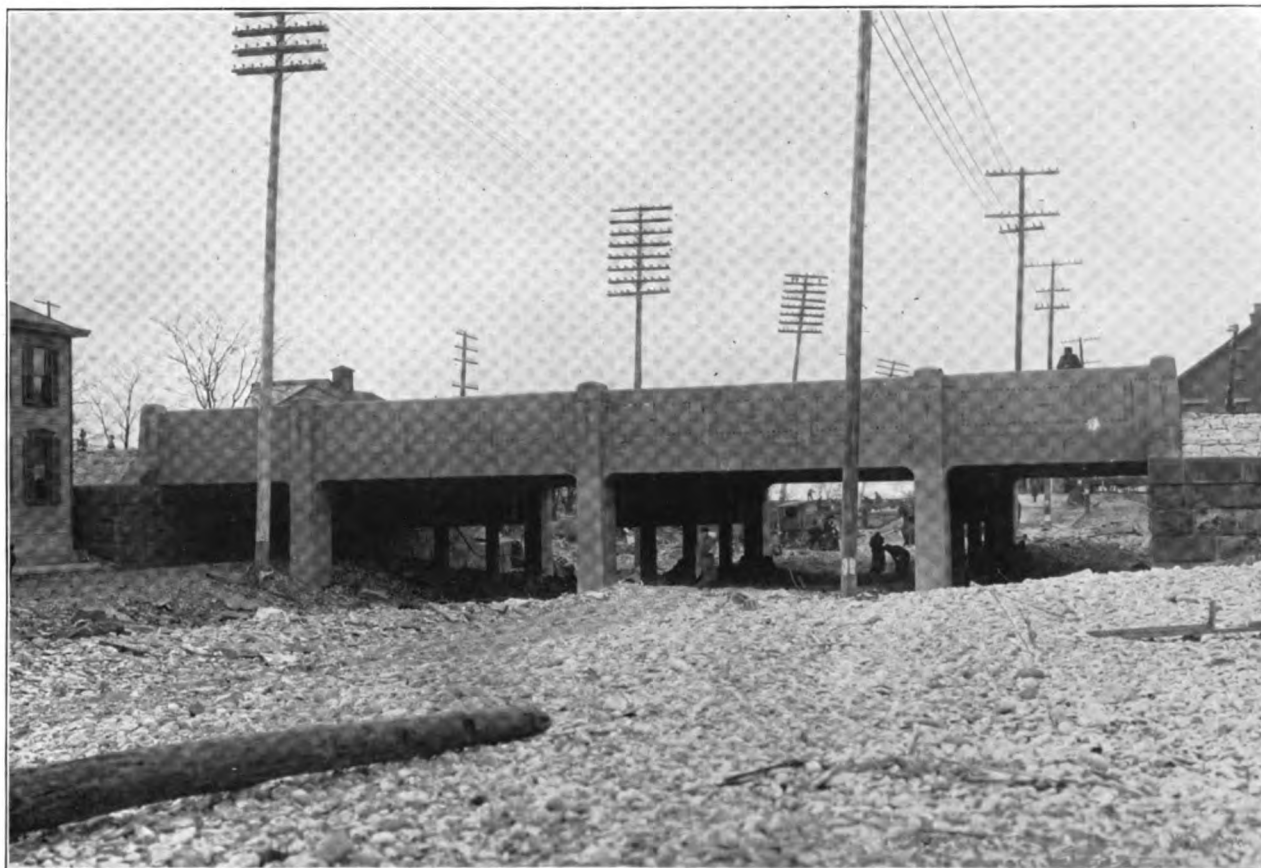
West Columbus, Ohio.

Sandusky Street viaduct, looking toward river channel, at point where levee was washed entirely away, taking large water main with it.

At the Sandusky Street viaduct, the roadway under the bridge was partially filled with debris, but the structure was not damaged. At Rogers Avenue, the south wing walls were undermined by the deep scouring, and were repaired by filling in with concrete, the structure being otherwise undamaged.
