PENNSYLVANIA LINES
WEST OF PITTSBURGH

A HISTORY
OF THE
FLOOD
OF
MARCH, 1913

COMPILED
BY
C. W. GARRETT

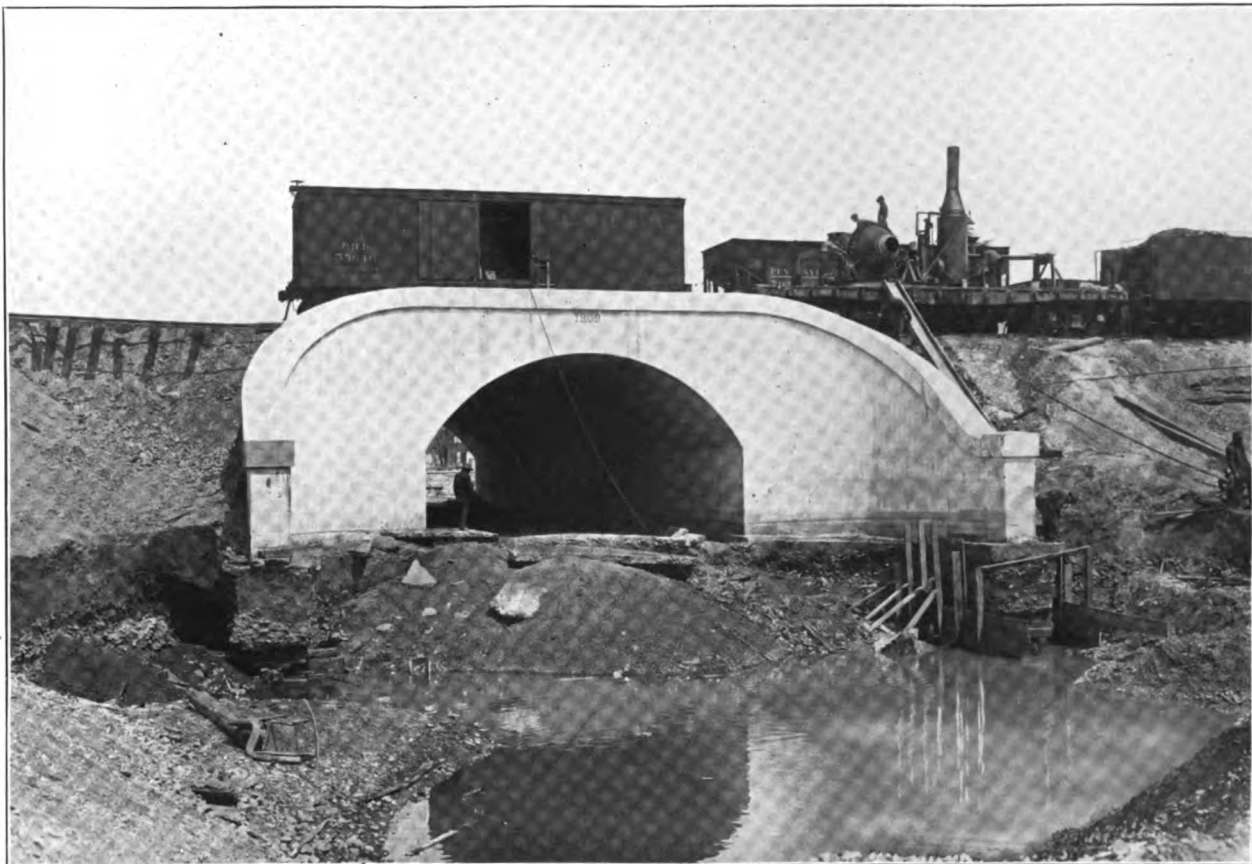
West Columbus, Ohio.

Rodgers Avenue viaduct, showing condition of street pavement and subgrade under viaduct. Foundations of viaduct being deepened.

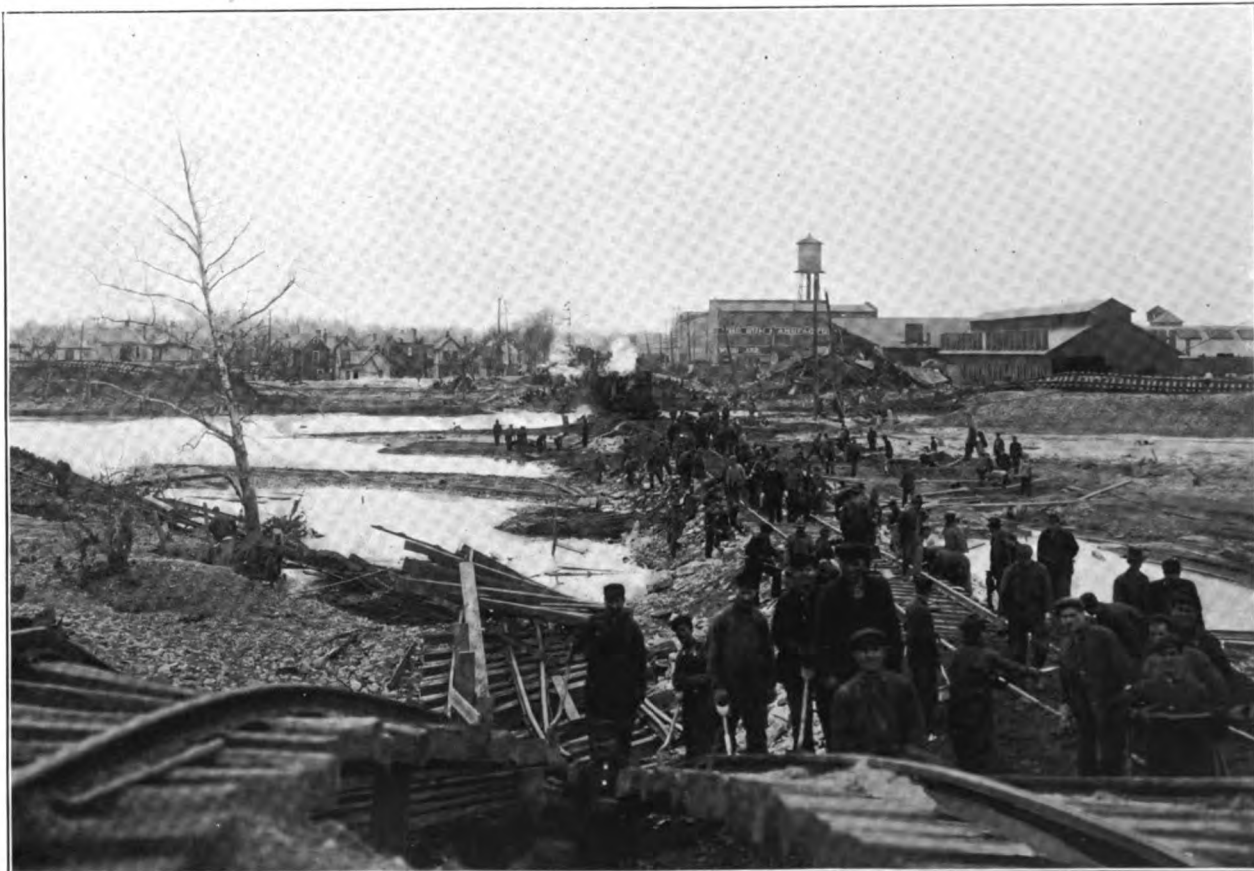
West Columbus, Ohio.

B. & O. Crossing, looking west, showing forces at work replacing roadbed destroyed.

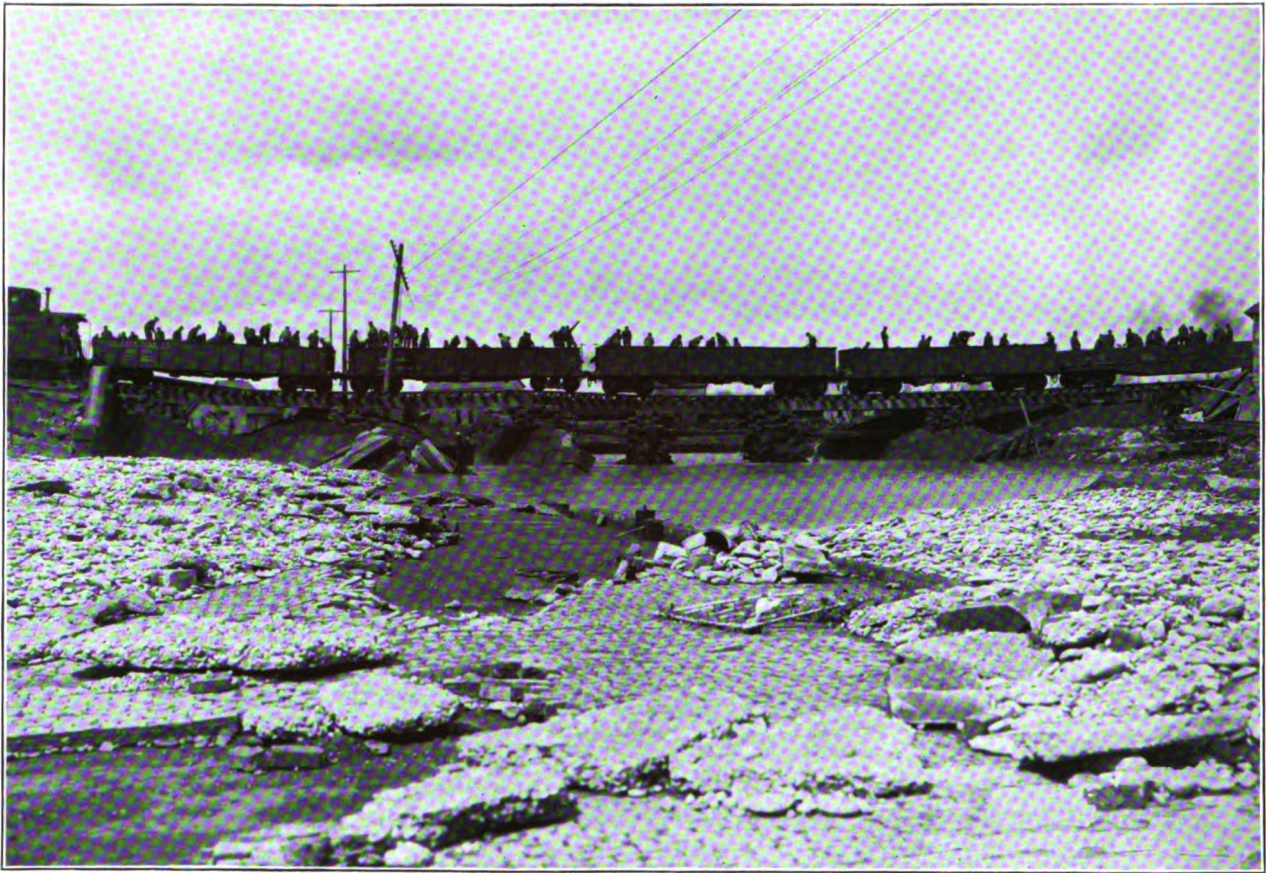
West Columbus, Ohio.

Looking north on Central Avenue; filling in from temporary cribbed trestle where viaduct was washed away.

At the fourth washout, Central Avenue viaduct, stringers were placed between the damaged abutments, supported on cribbing, and a fill made, using material from a contractor's steam shovel cut in near Alton. One track was put in service here on April 1st, and double track service was re-established on the Cincinnati Division on April 2d except for four gauntlets where the breaks had been, where only one track had been replaced. It was not until the 16th that the last of these gauntlets had been removed.

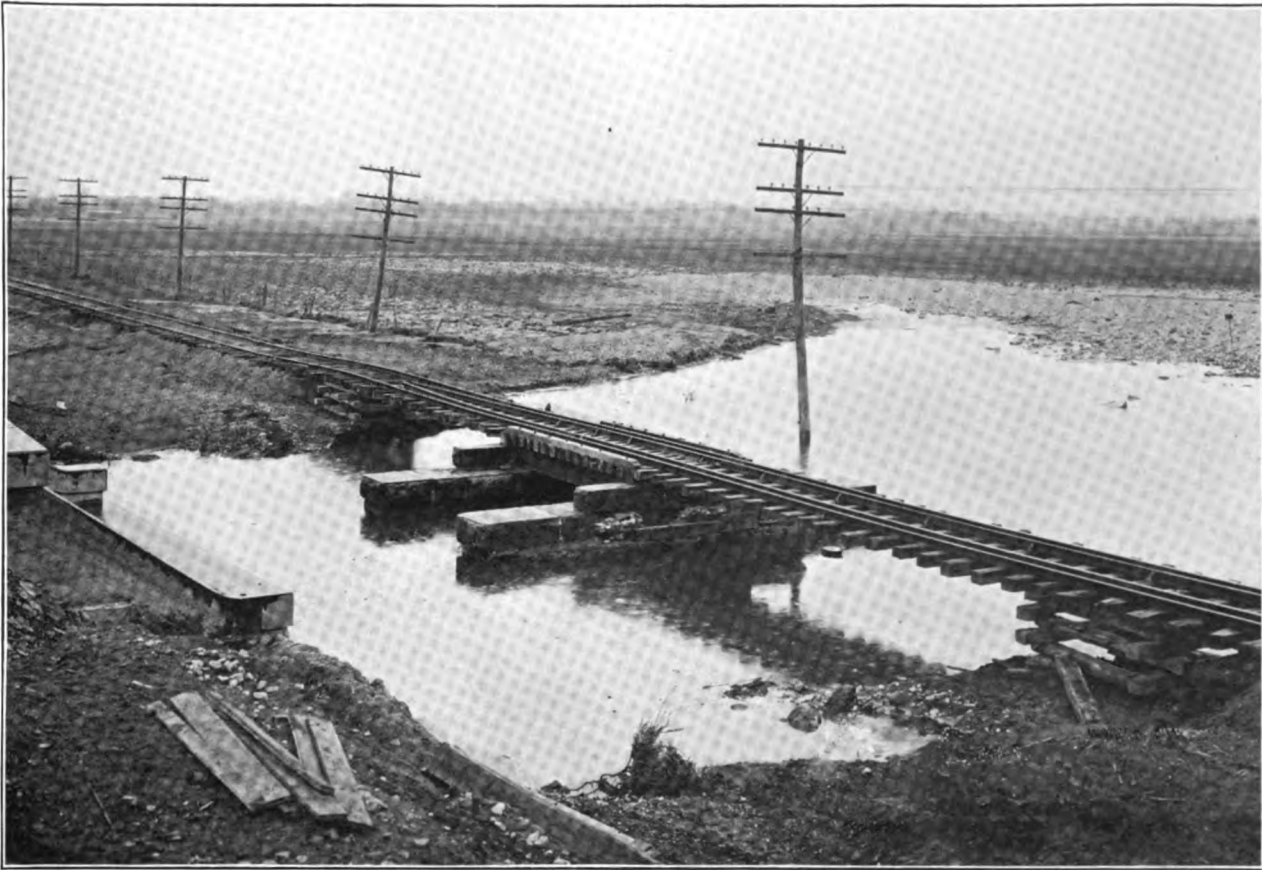
Urbana, Ohio, west of.

Bridge No. 37, on old line, approaches washed away, abutments undermined.

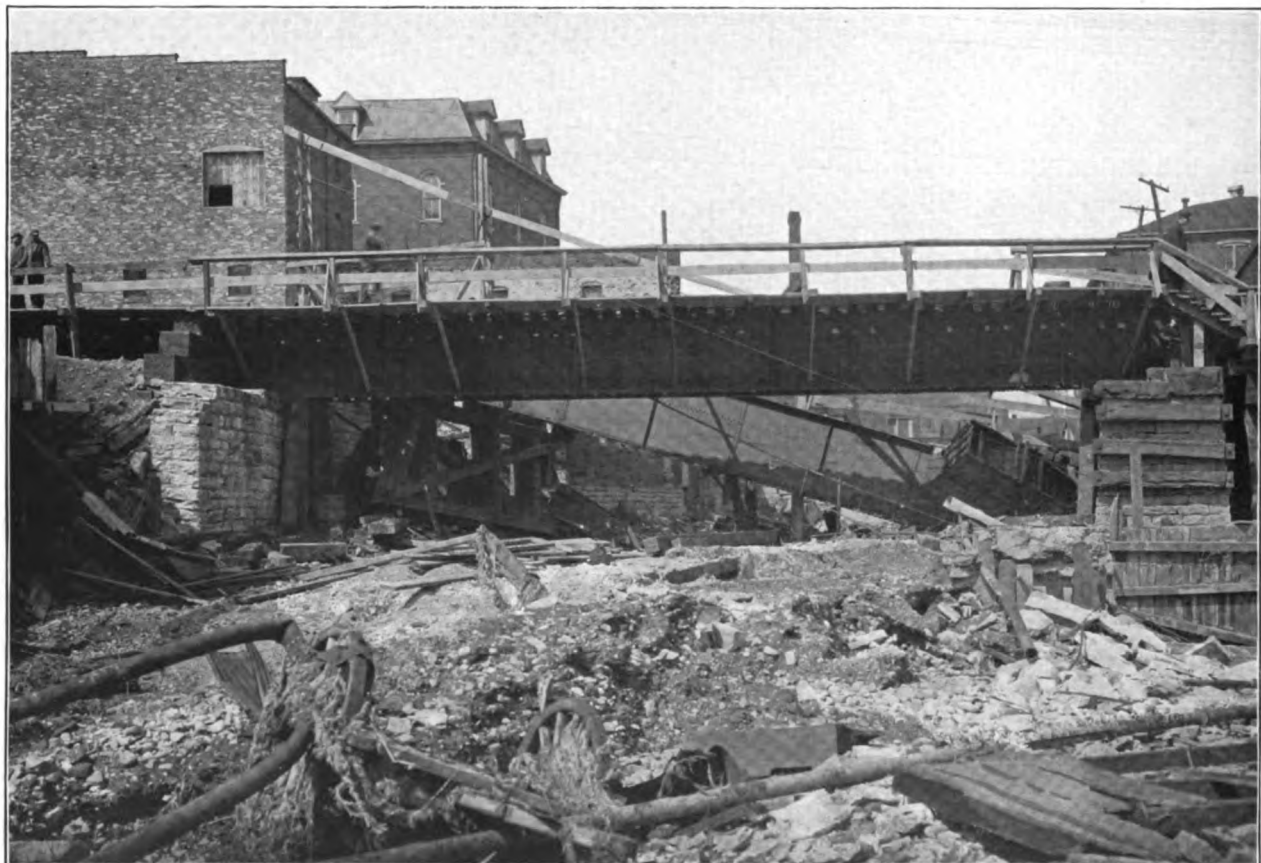
Piqua, Ohio.

West approach to Bridge 50, looking north; span over Canal, showing damage to other structures near Bridge 50.

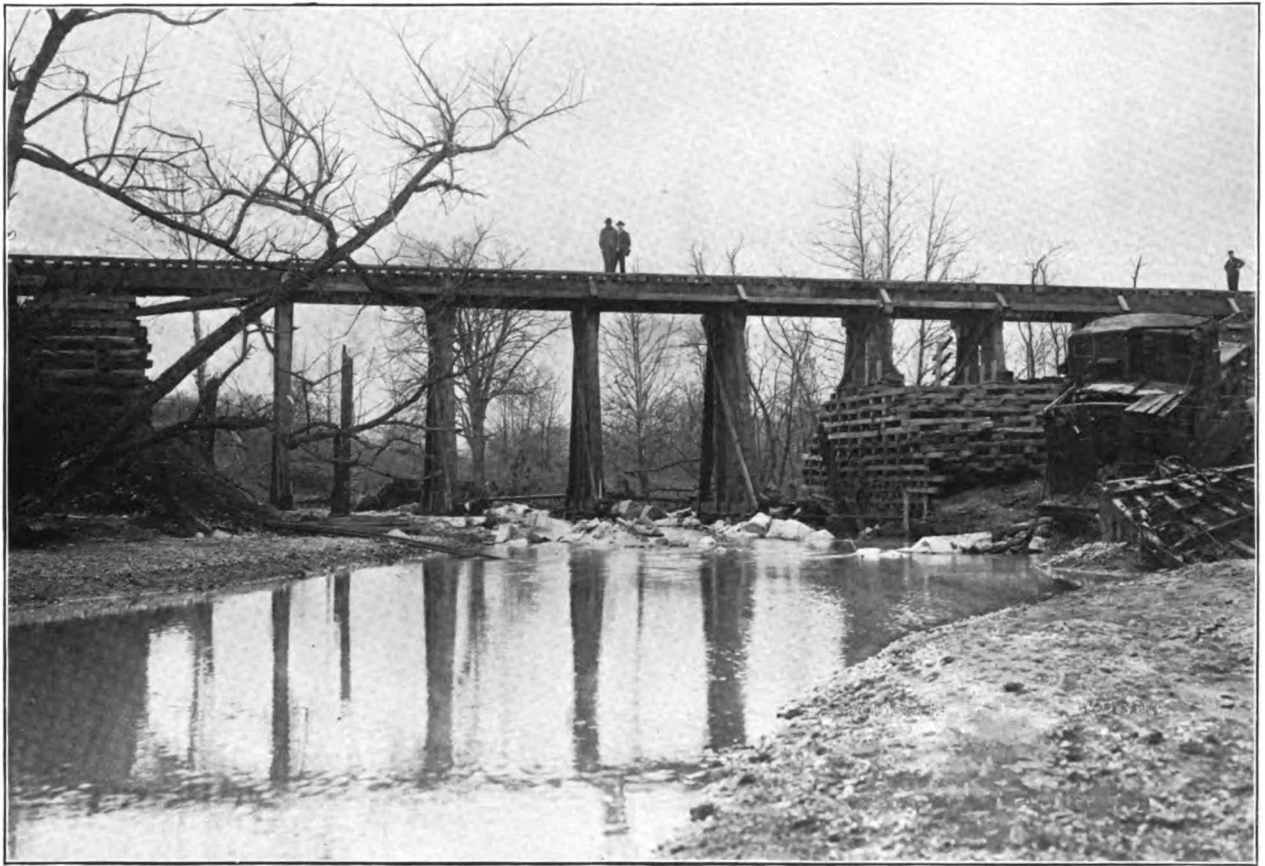
Gettysburg, Ohio, west of.

Bridge No. 64, over Mud Creek, south abutment undermined.

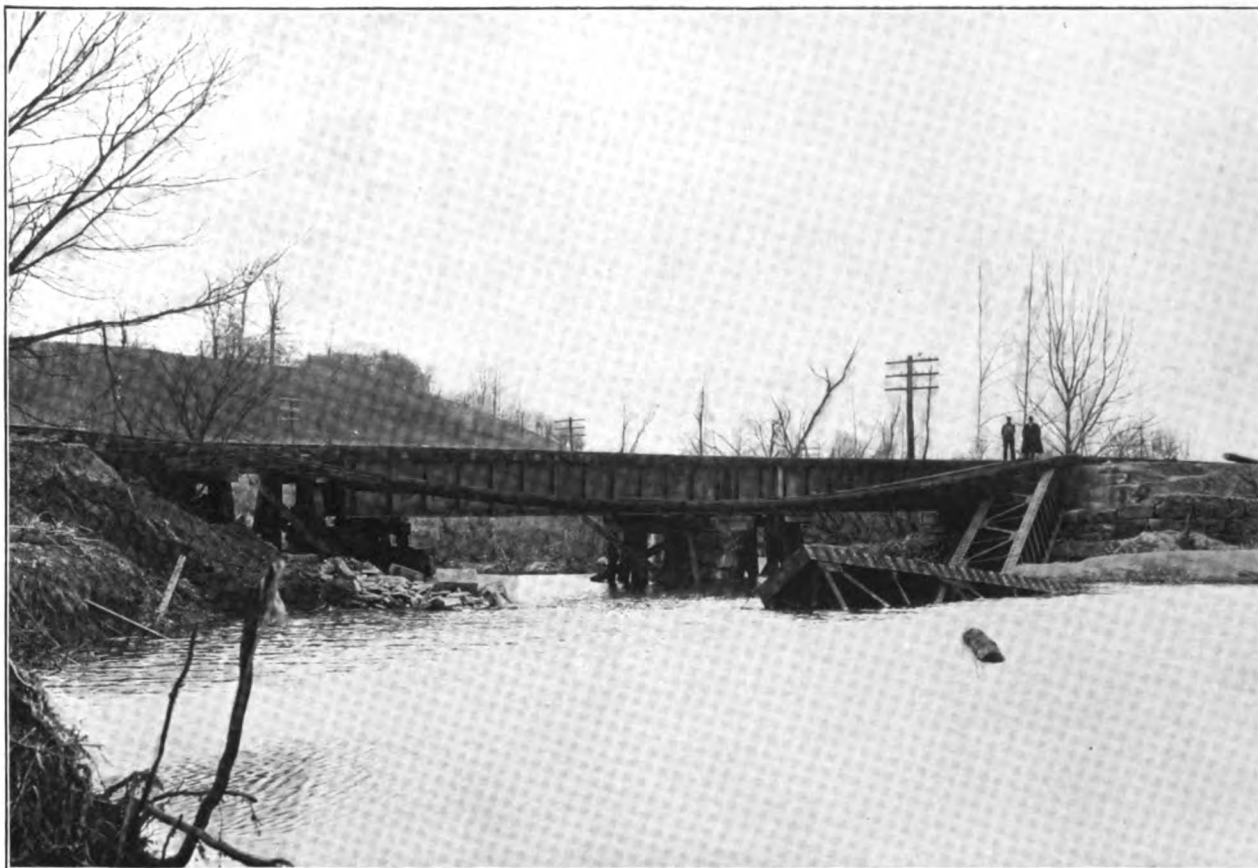
New Paris, Ohio, west of.

Bridge No. 92, over East Fork, White River, looking north. Double track bridge built as two separate structures, one of which was destroyed; other only damaged.

Abutments and pier practically destroyed. Superstructure for one track in river, had to be replaced with pile trestle; superstructure for second track supported on timber bents. Bridge to be replaced with through truss bridge with thirty feet longer span.

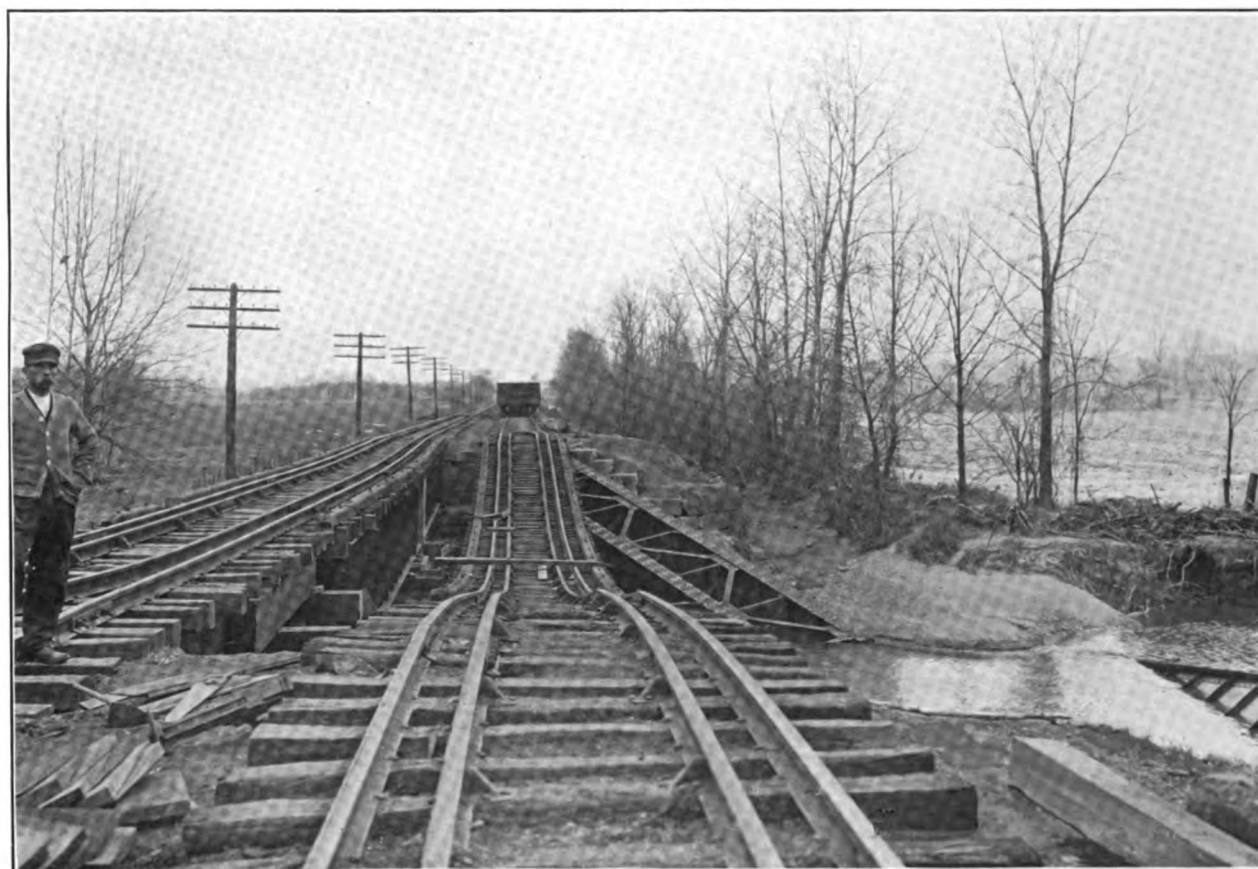
New Paris, Ohio.

Bridge No. 92, over East Fork, White River, showing one track replaced for slow speed service, the other without support.

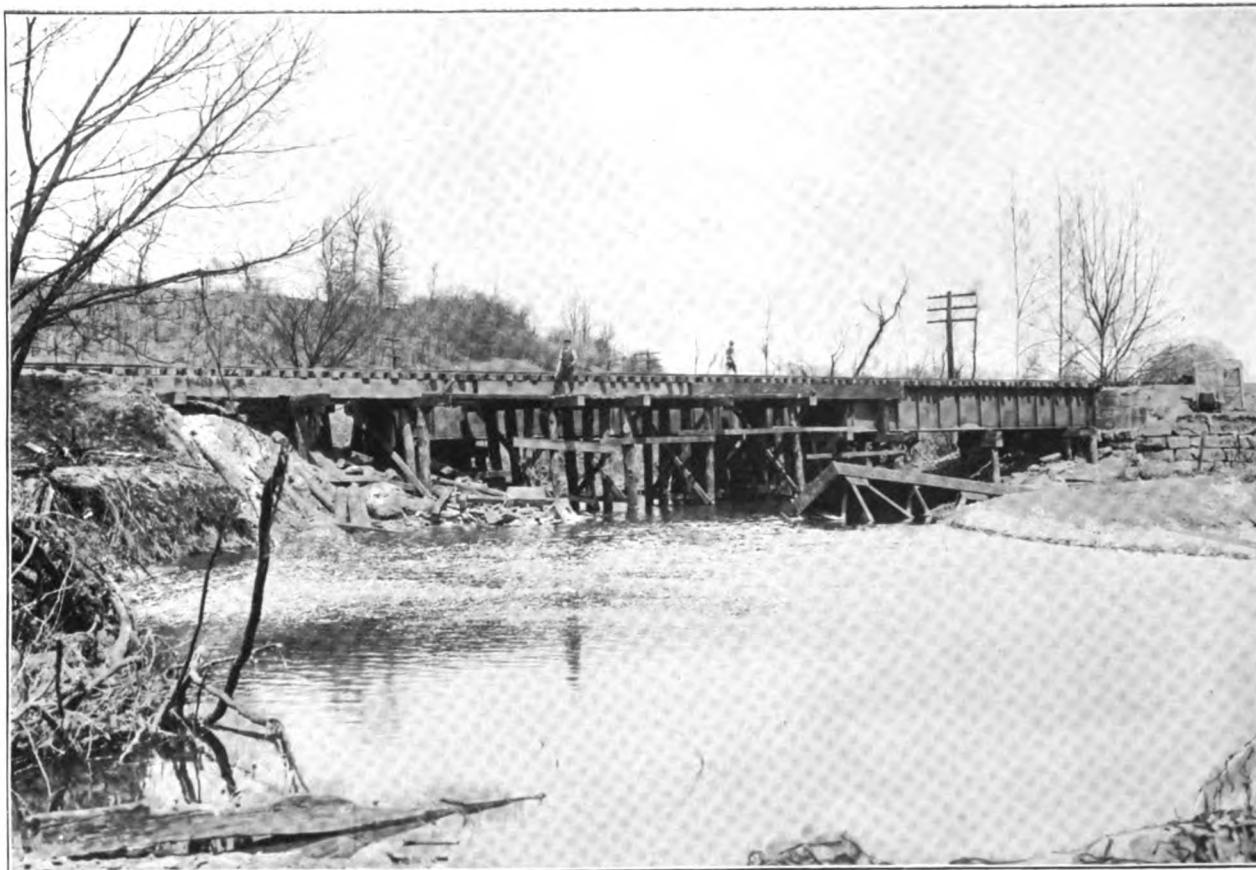
New Paris, Ohio, west of. April 25, 1913.
 Bridge No. 92, over East Fork White River (separate structures for two tracks),
 with girders of north bridge supported on timbers, and part of south
 bridge replaced with temporary trestle.

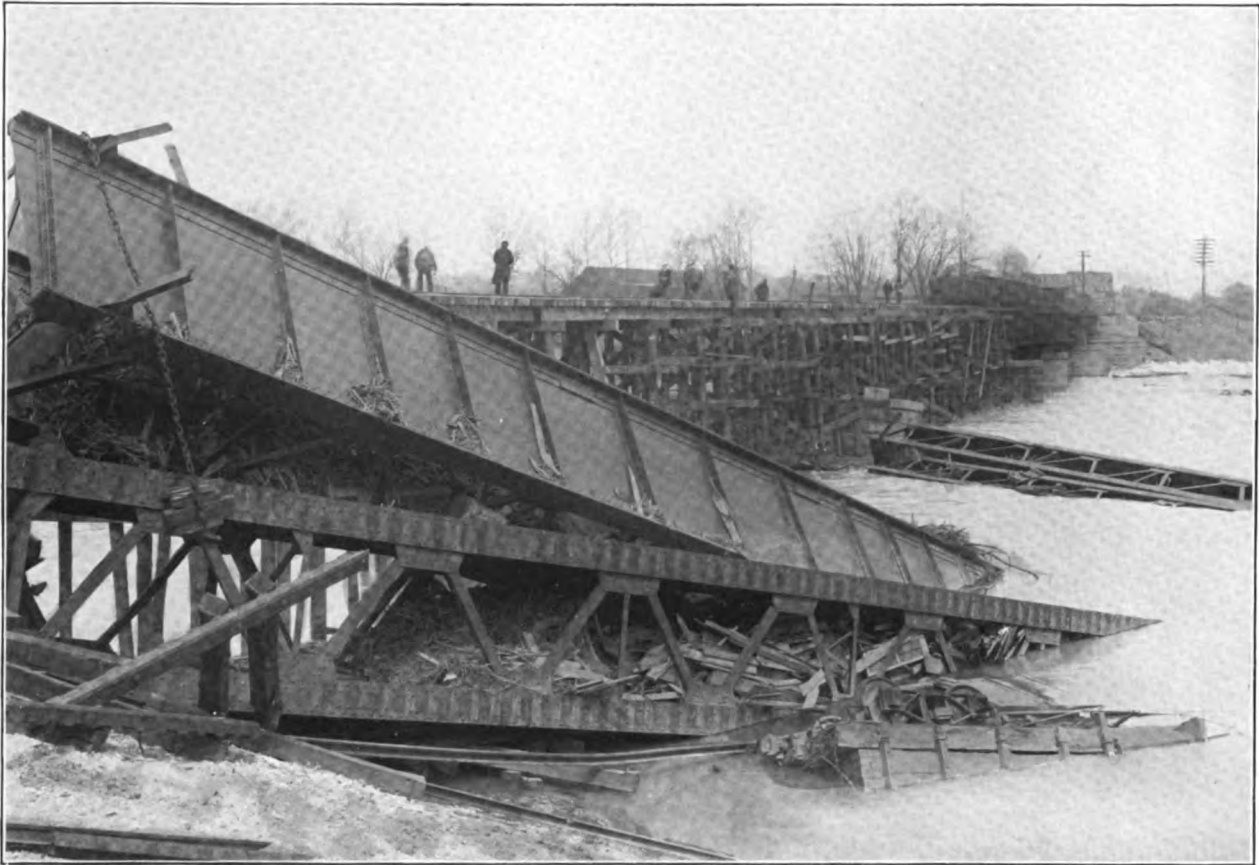
Dayton, Ohio.

Dayton Union Bridge, over Miami River, looking east, showing temporary trestle for one track replacing destroyed spans.

On the night of April 8th trestle for one track was completed over the Miami River at Dayton, by the Big Four forces, and through passenger service was resumed. Work was then started on trestling for a second track across the river, which was completed on April 26th.

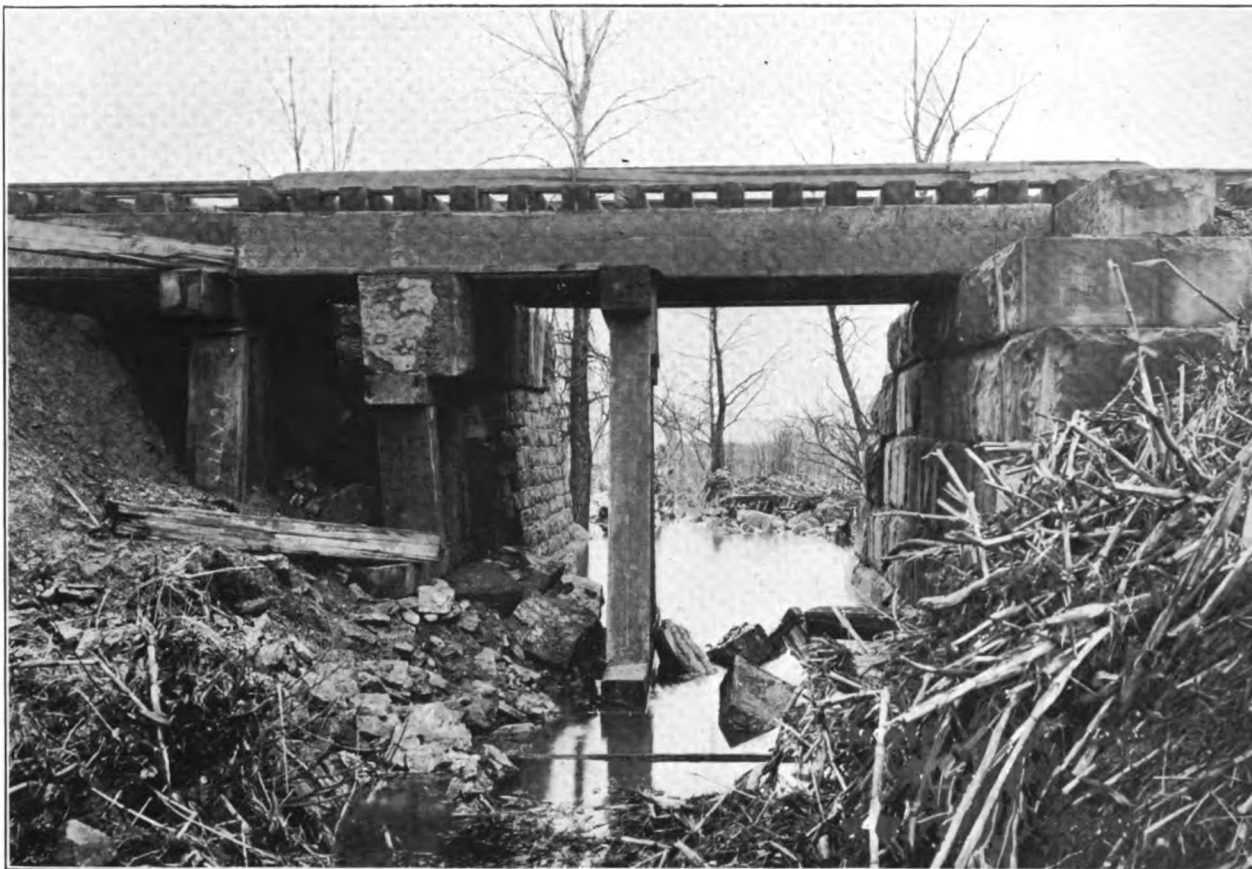
Campbellstown, Ohio, west of.

Bridge No. 81, looking south, showing damaged masonry.

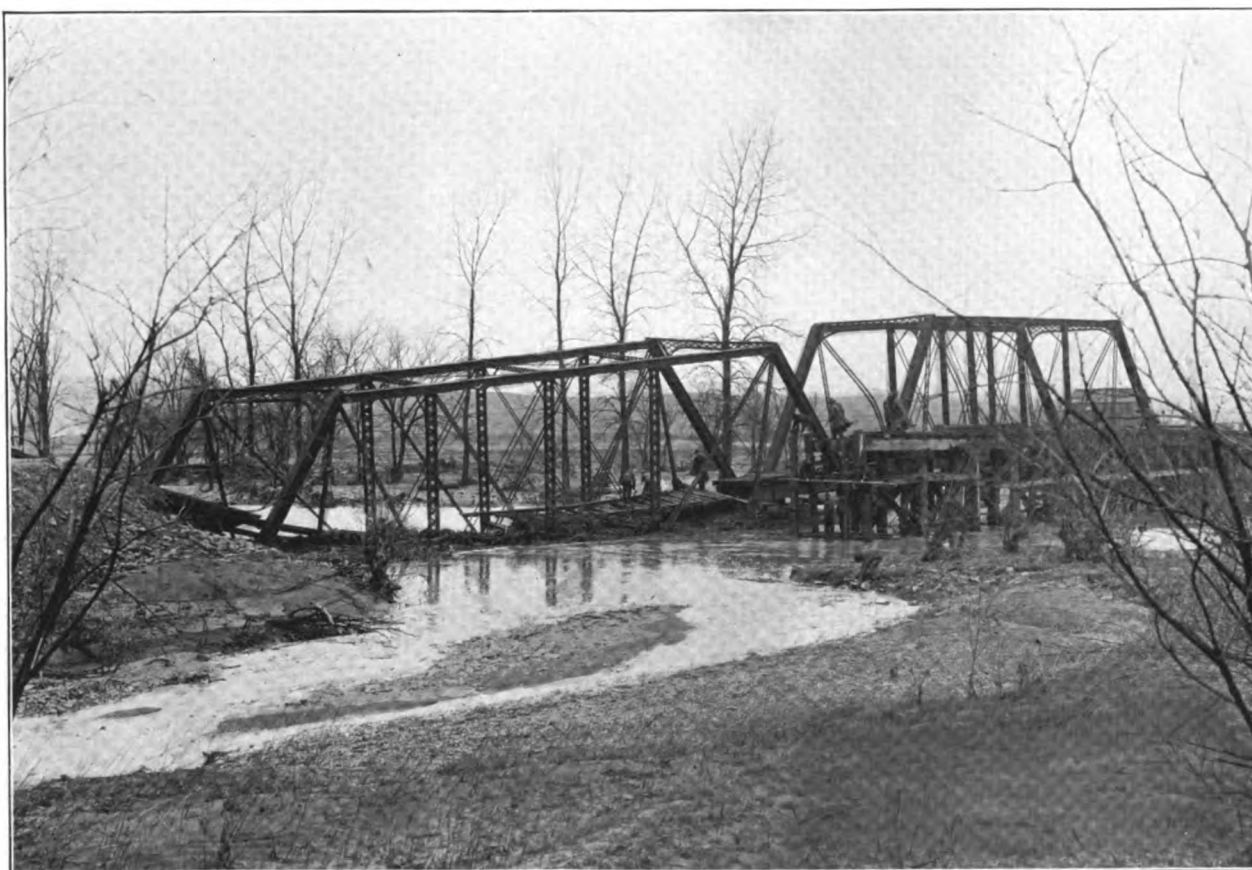
Somerville, Ohio, west of.

Near view of undermined pier and resulting damage to superstructure of Bridge No. 48, over Seven Mile Creek.

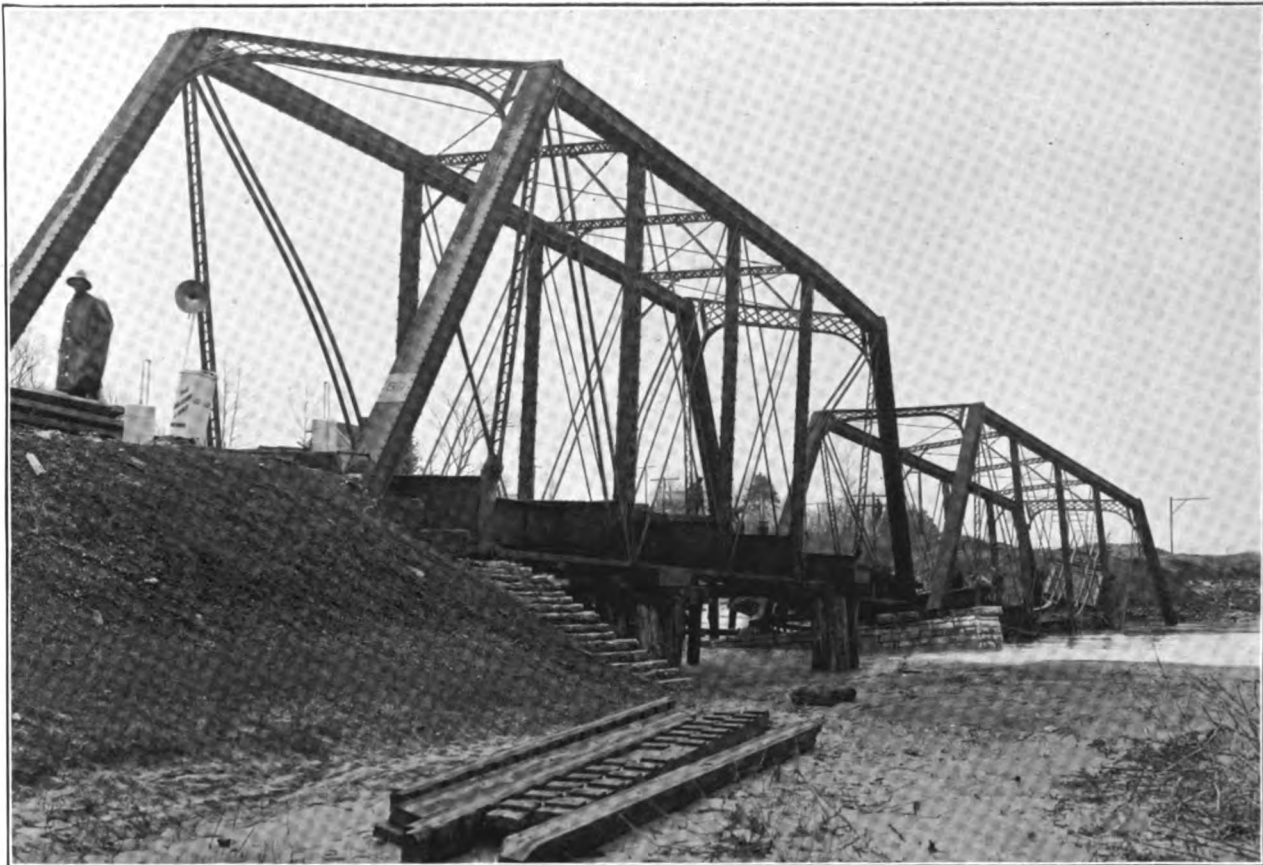
Somerville, Ohio, west of.

Bridge No. 57, over Seven Mile Creek, showing pier undermined
and east abutment destroyed.

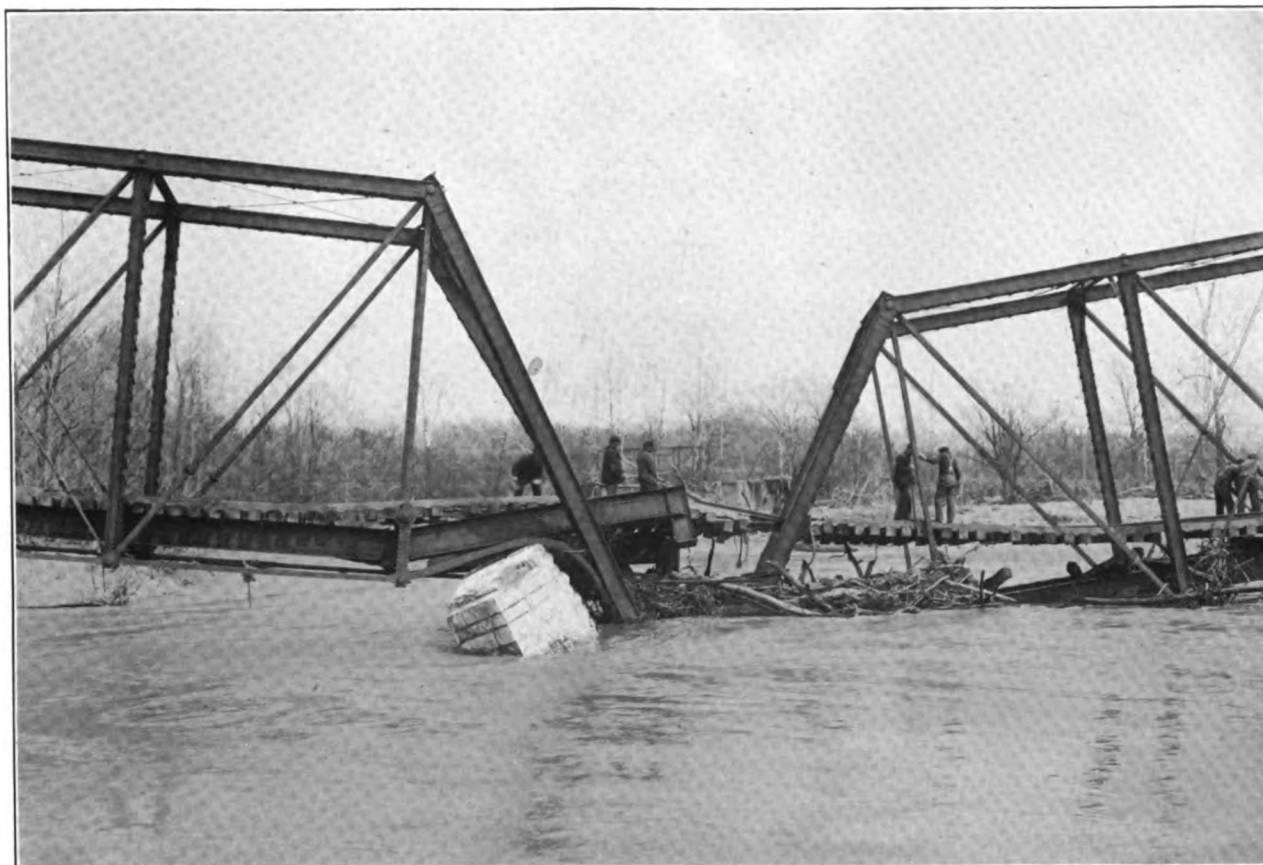
Bridge No. 48, over Seven Mile Creek, looking north, showing pier undermined.

undermined, letting the steel work down. When Bridge 57 had been replaced, the pile driver which had been there was taken to Bridge 48, to work from the opposite end, and this trestle was completed at 5:00 A. M. April 10th.

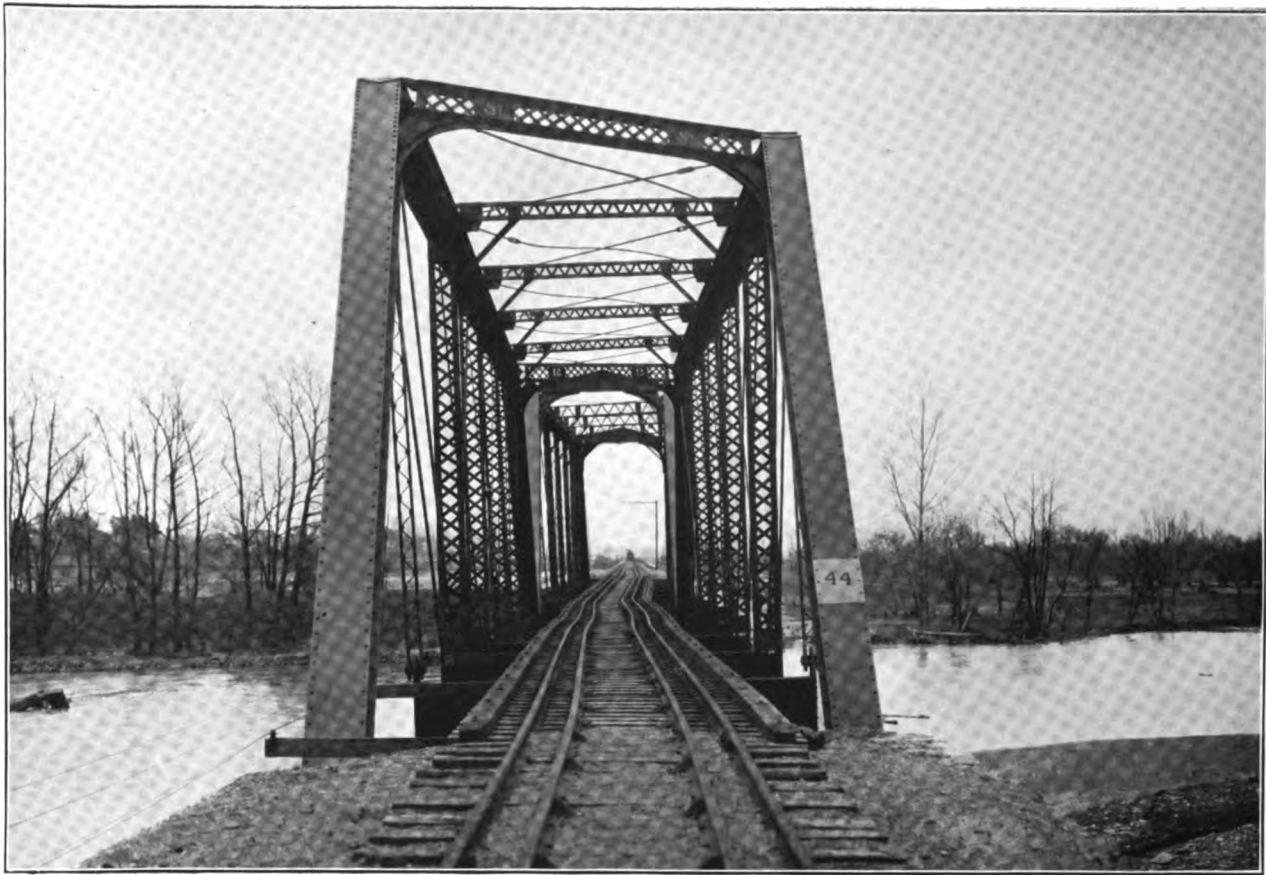
Bridge No. 44, over Seven Mile Creek, looking east, showing pier undermined.

A gang from the Cincinnati Division arriving on the same day completed the work on Bridge 44, and another from the same Division went to the washout just north. Two gangs from the Logansport Division arrived on the 7th also, at Bridge 48, where trestling was completed at 5:00 A. M. April 10th. This pile driver then went to the washout at Collinsville to work from the opposite end, and the gap was closed at 10:00 A. M., Saturday, April 12th, restoring the entire Division to service, the minor washouts and damage having in the meantime been all repaired.

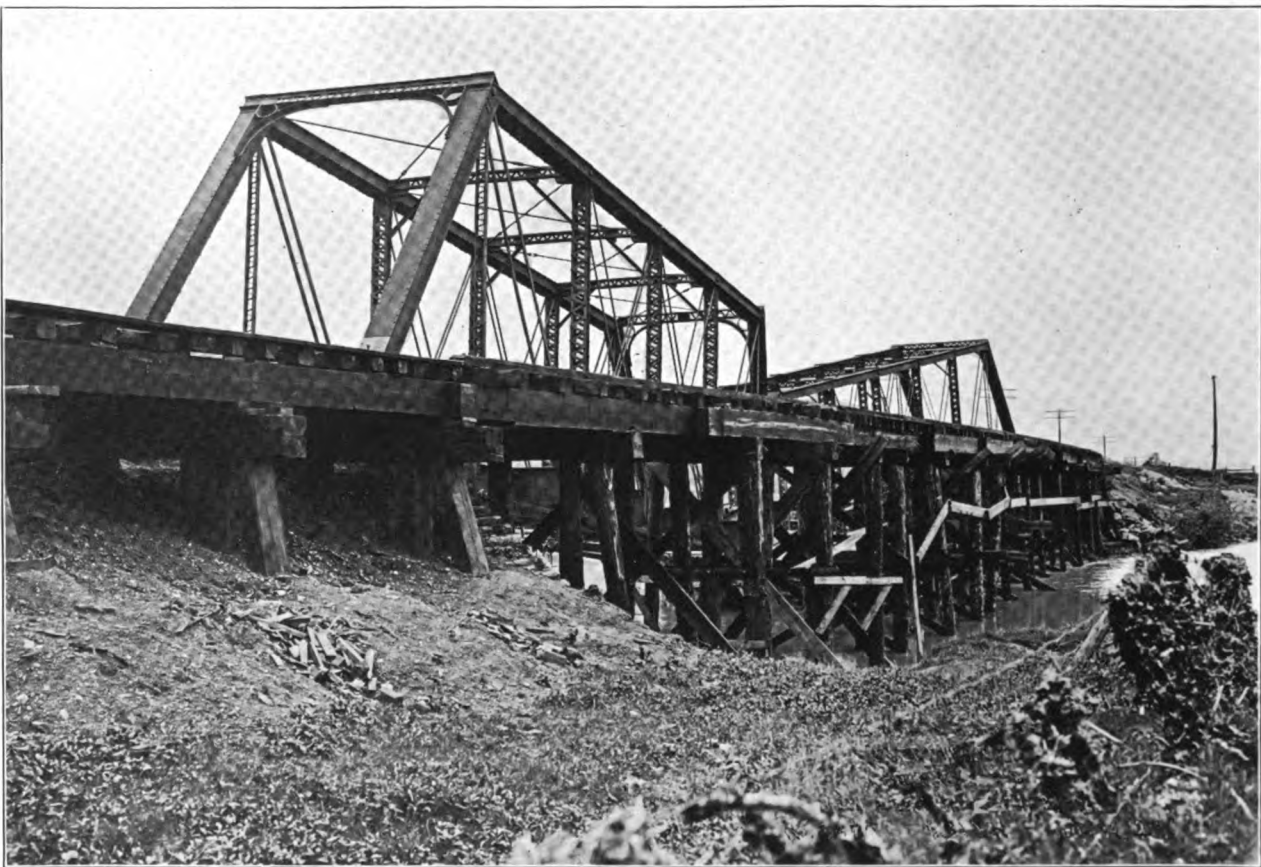
Bridge No. 57 over Seven Mile Creek, looking south, showing temporary trestle replacing bridge.

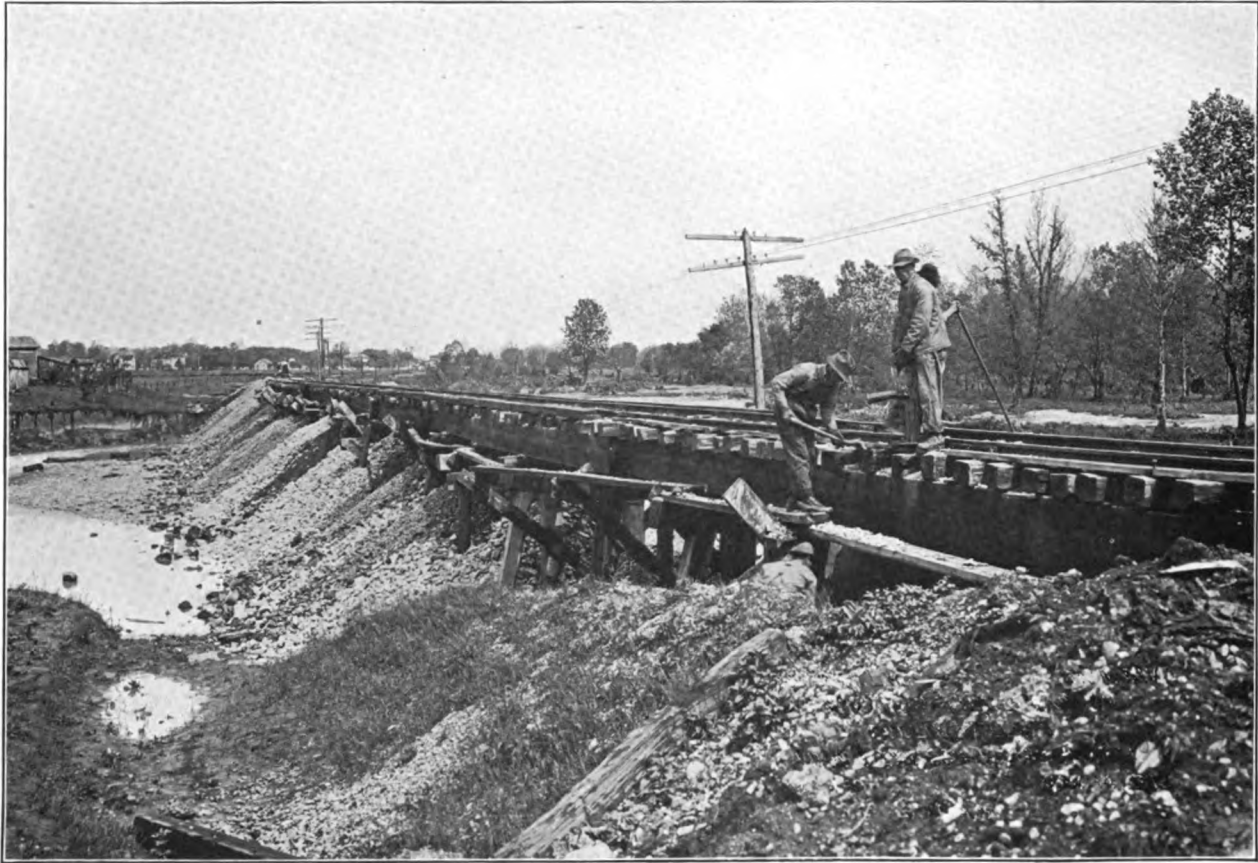
Bridge No. 48, over Seven Mile Creek, looking east, showing temporary trestle replacing Bridge.

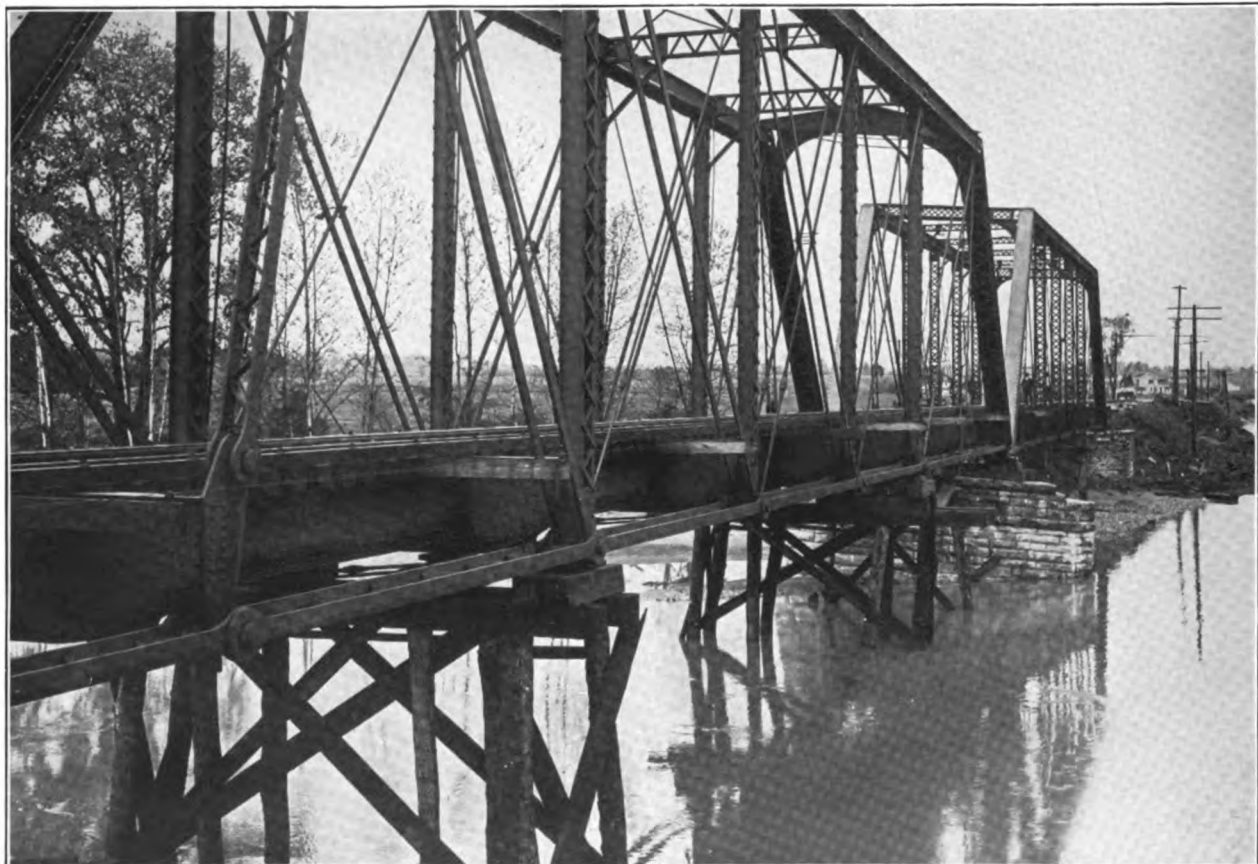
New fill replacing former embankment, about completed.

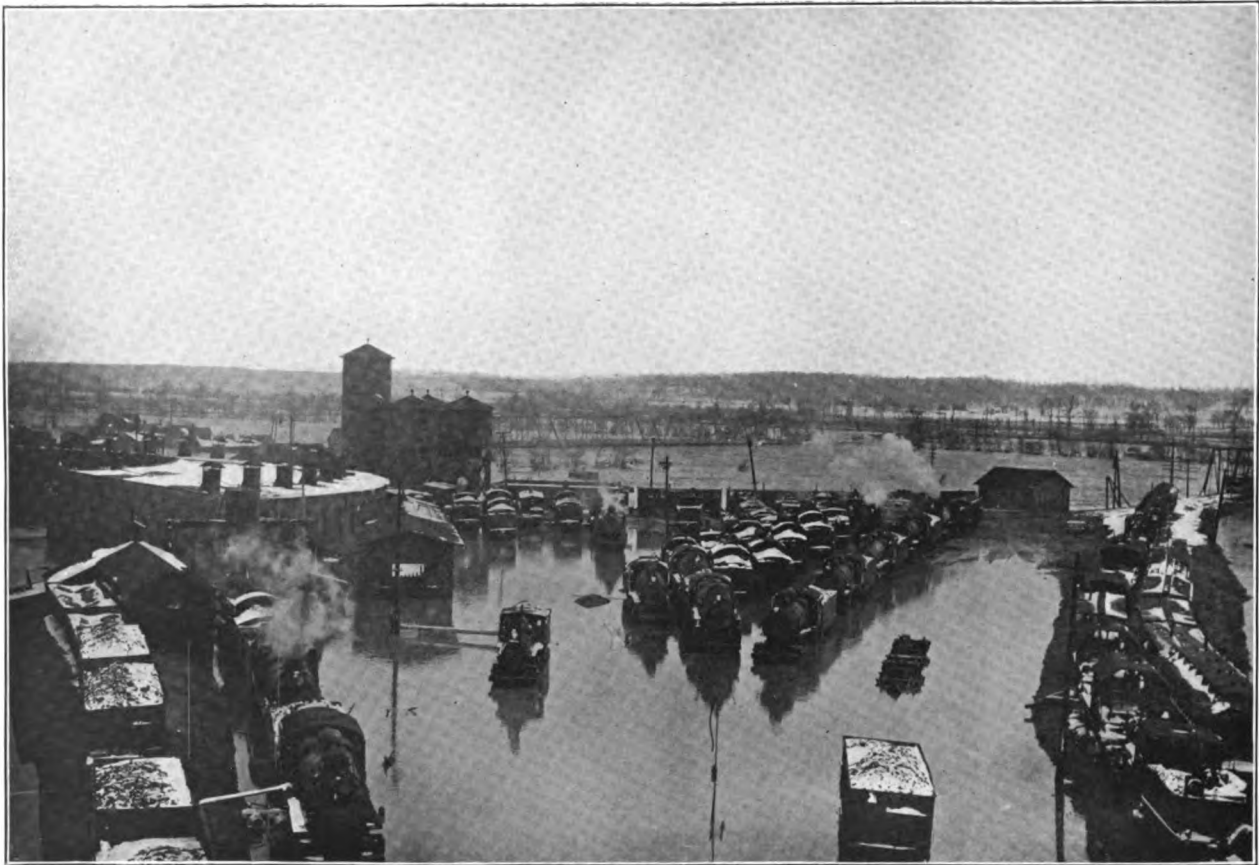
Logansport, Ind. March 27, 1913.
 Enginehouse and tracks in shop yard near old Wabash River Bridge.
 Water had fallen a foot or two.

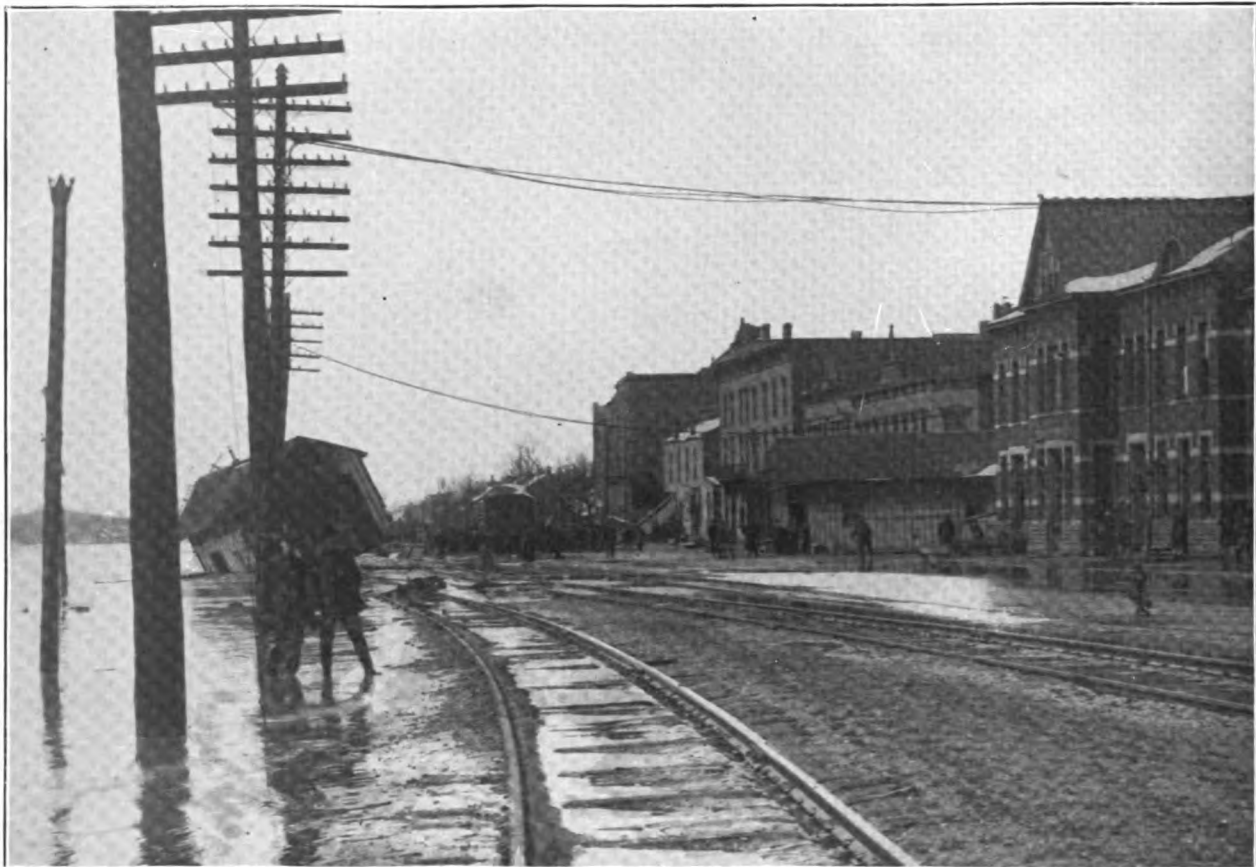
Logansport, Ind. March 28, 1913.
 Passenger Station after water had receded about 10 feet. Water had been three
 inches above the lower belt of light colored brick. The Third Street city
 bridge and a trolley line bridge spanned the river just beyond
 the shed left on the tracks.
