PENNSYLVANIA LINES
WEST OF PITTSBURGH

A HISTORY
OF THE
FLOOD
OF
MARCH, 1913

COMPILED
BY
C. W. GARRETT

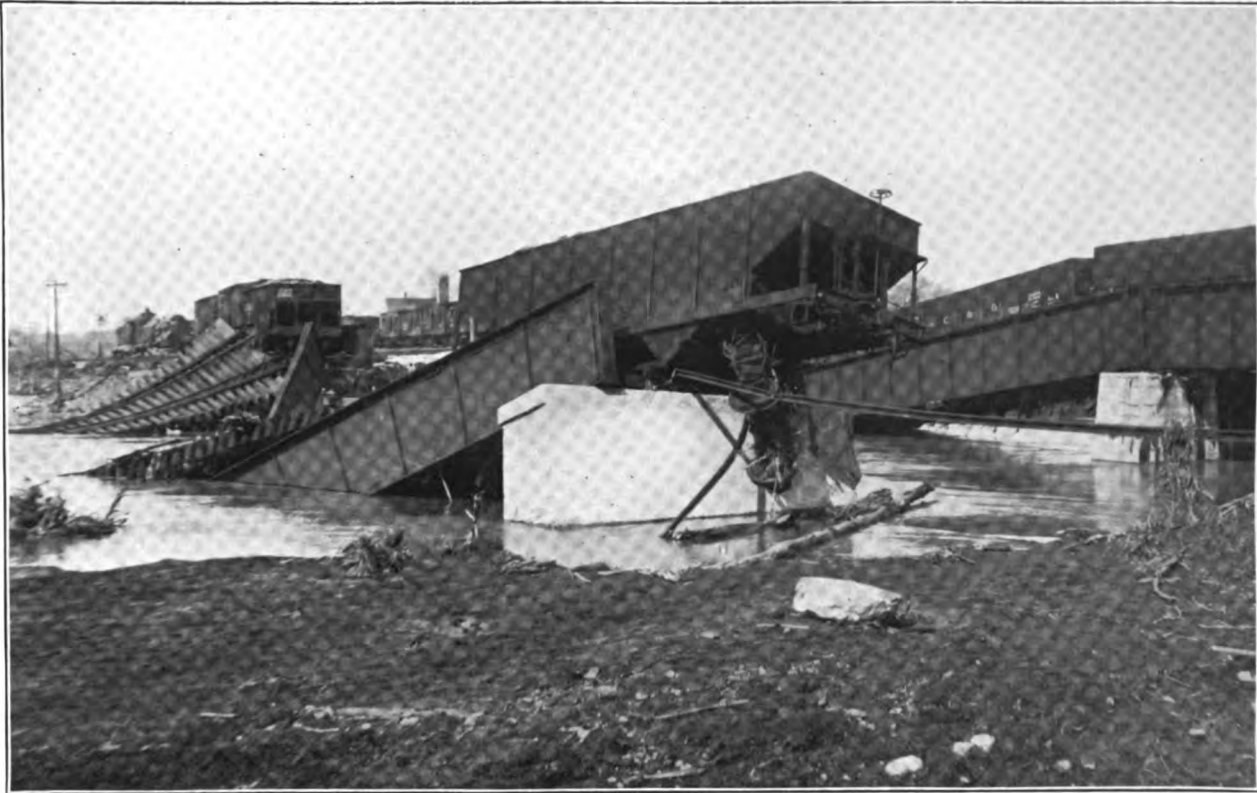
Pennsylvania Lines Bridge over White River, in foreground. Chesapeake & Ohio Bridge to the right.

At Muncie, one pier and one abutment of the bridge over the White River were undermined, and two of the three spans, and the loaded cars which had been placed on them, went into the river. Passengers were taken to and from the station in carriages, and passenger service was not stopped by the loss of the bridge. A frame trestle replaced it, completed on April 10th.

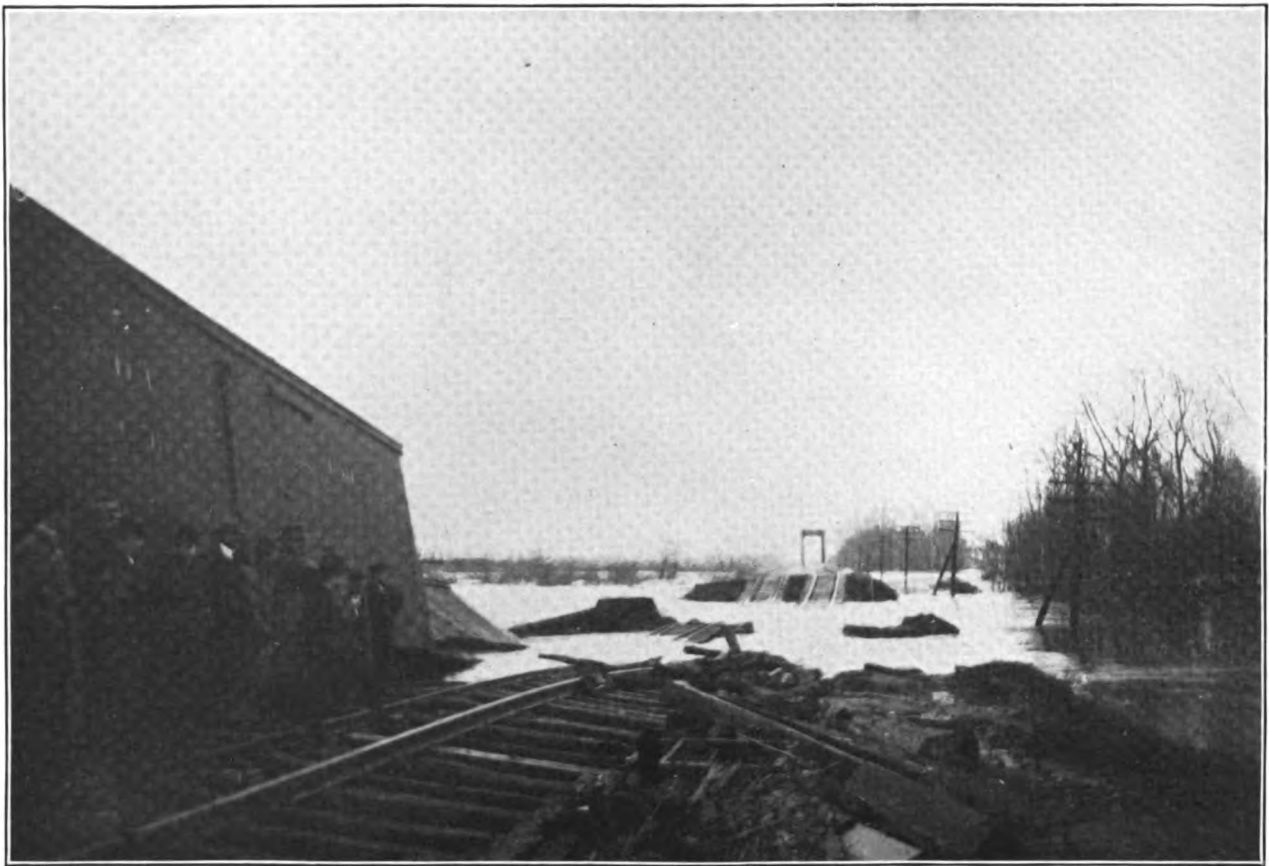
Looking north at starch works. Water down four feet. Bridge 18, over Blue River, in distance. Approach and yard tracks badly washed away.

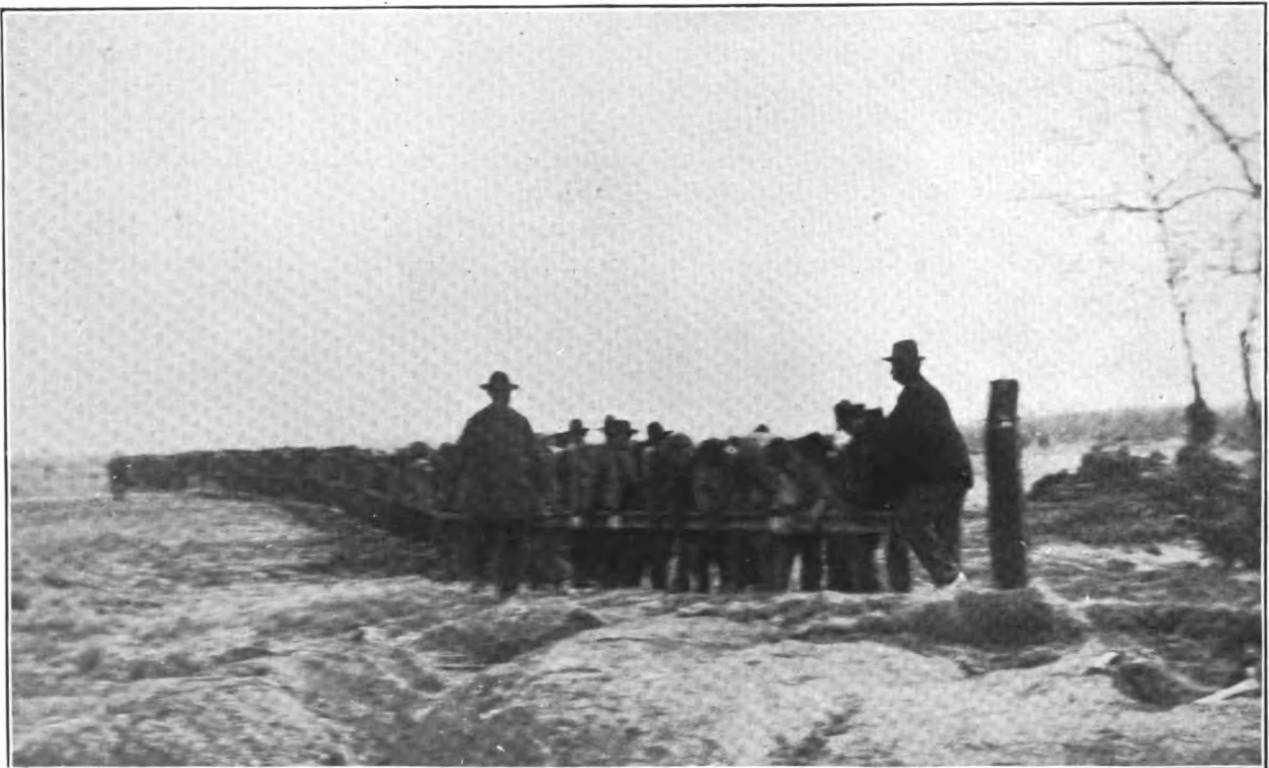
Replacing rail washed from roadbed, without taking time to disconnect the joints.

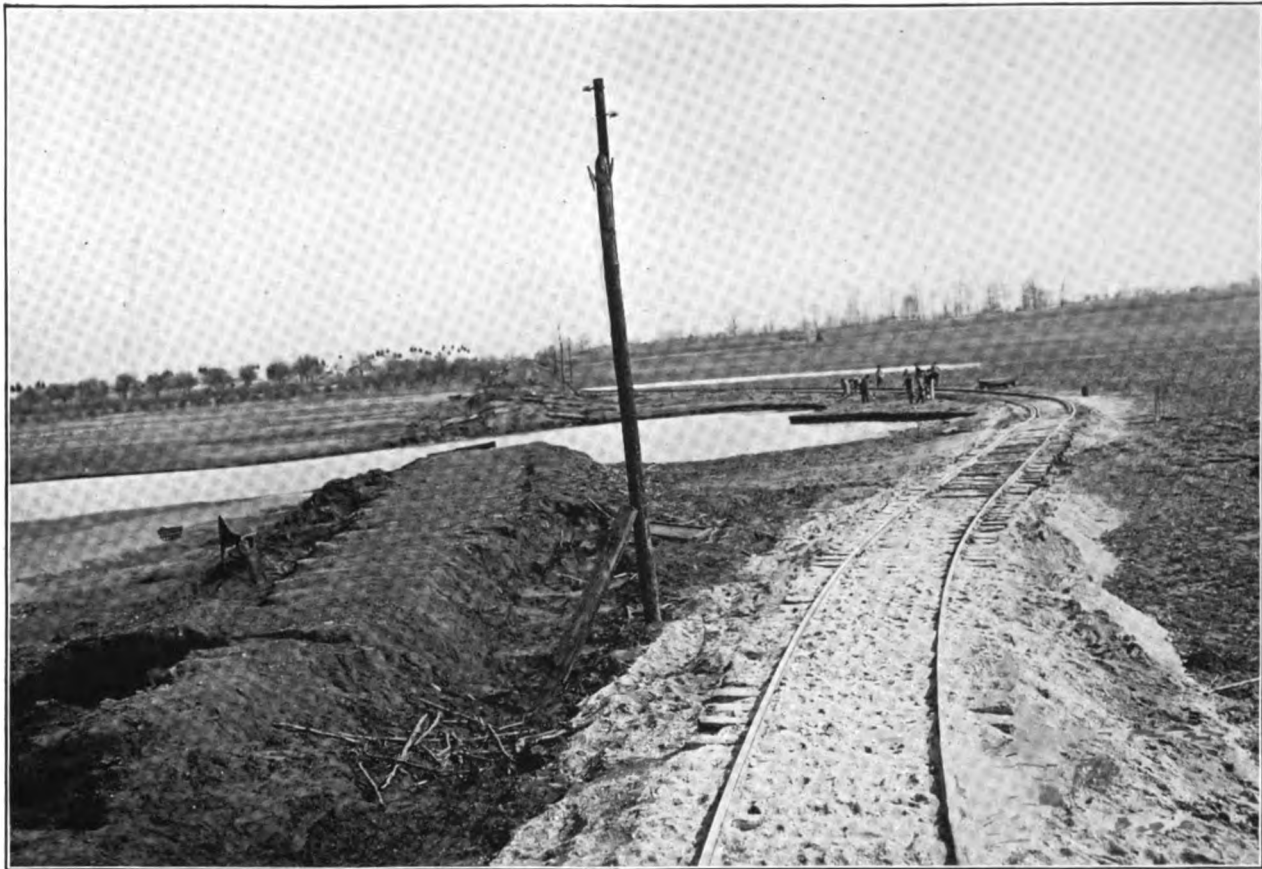
"Run-around" track in field for temporary service. Cambridge City Branch.

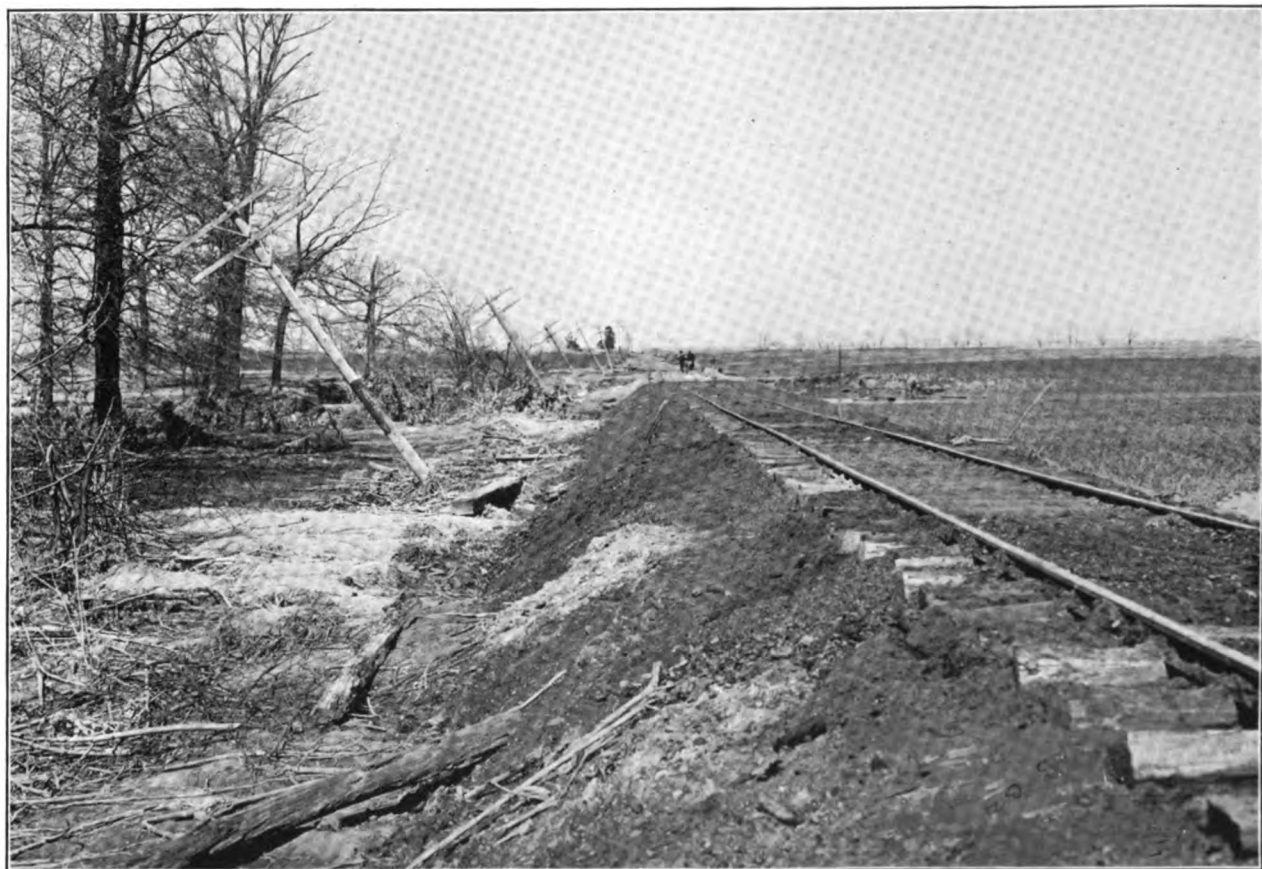
Madison Branch track replaced, and about ready for regular service,
after having been washed out a second time.

Heavy rains on the 3d washed out the new fill at Haw Creek, just south of Columbus on the Madison Branch, during the night, blocking the road again, and it was necessary all day on the 4th to send passenger trains between Louisville and Indianapolis over the B. & O. S. W. from Seymour to North Vernon and from there over the Big Four to Indianapolis. This new gap was repaired and track made ready for service again on the morning of the 5th.

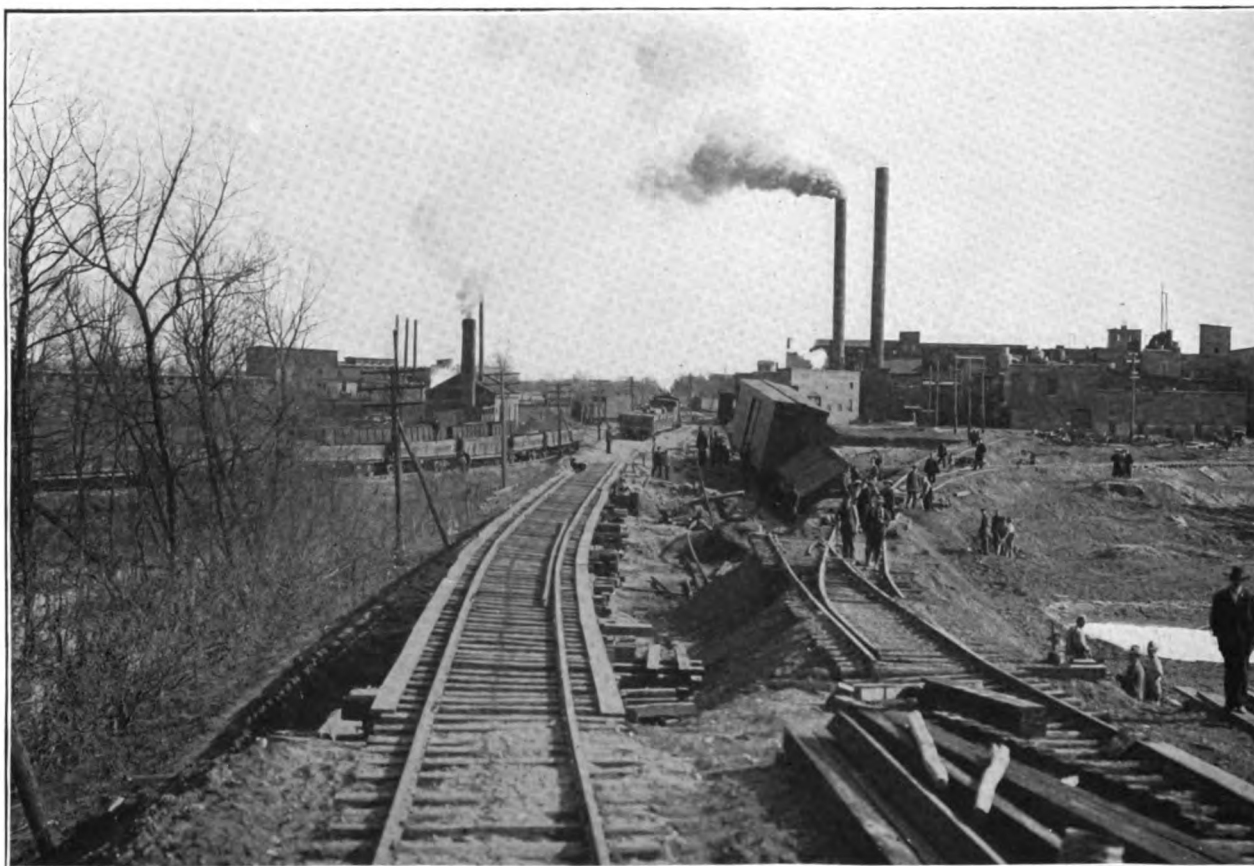
View south at starch works, main track supported on cribbing.

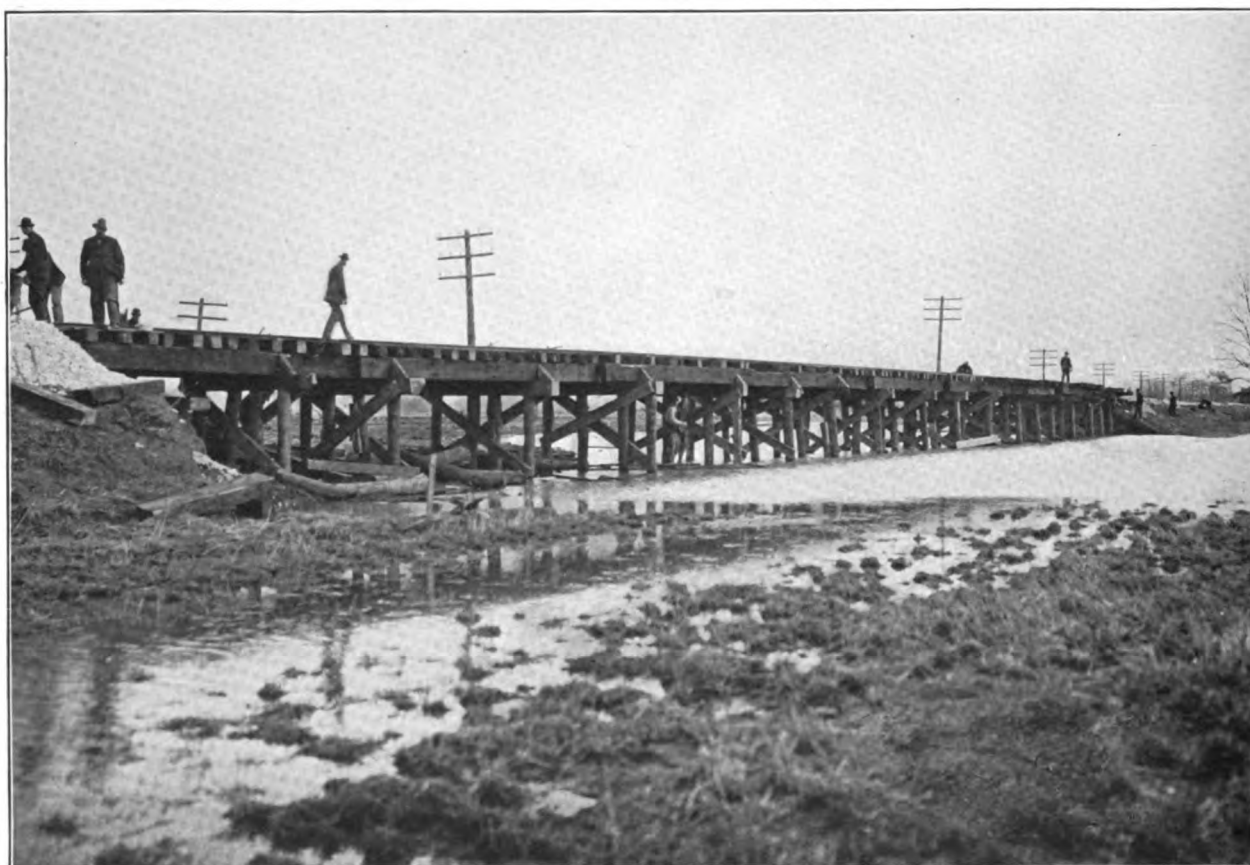
Temporary trestle five hundred feet south of Bridge No. 22, over
East Fork of White River.

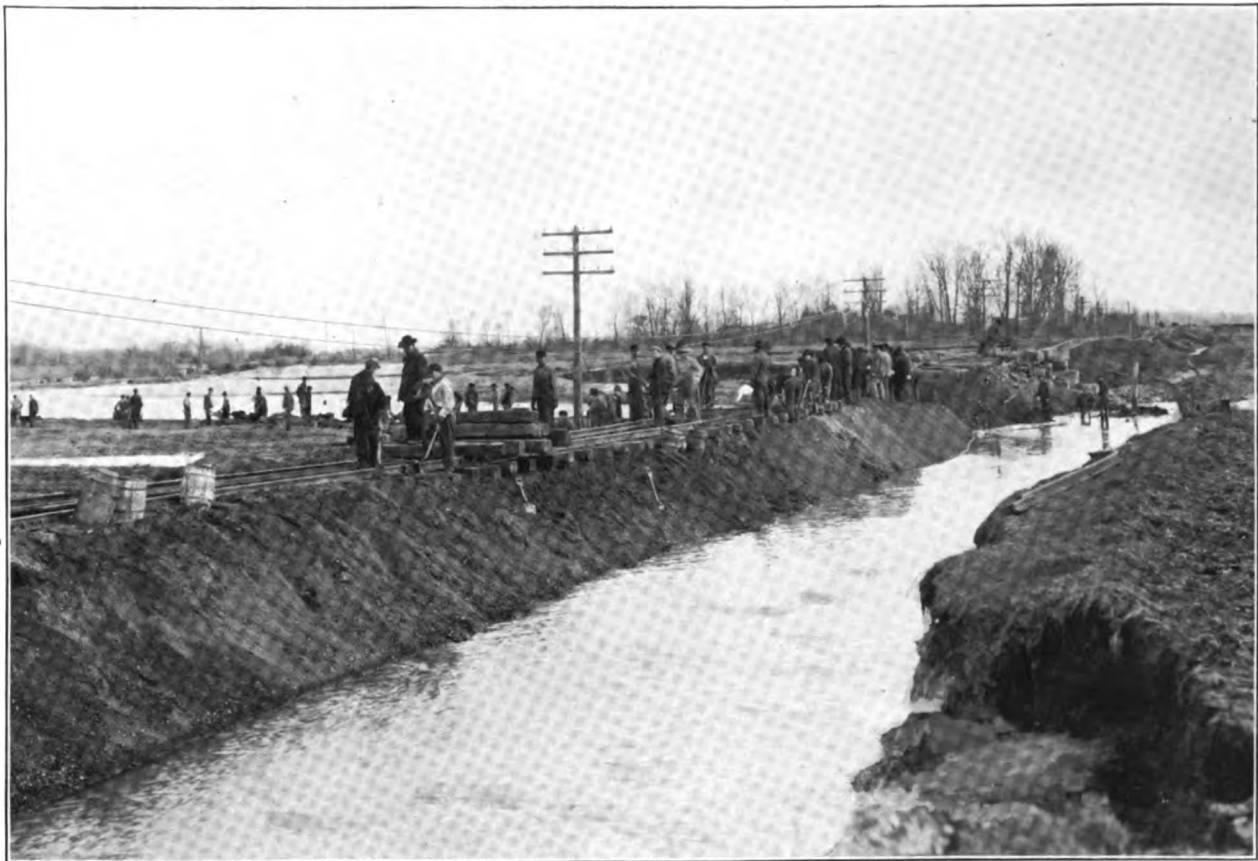
Main line, looking south across Bridge No. 24.

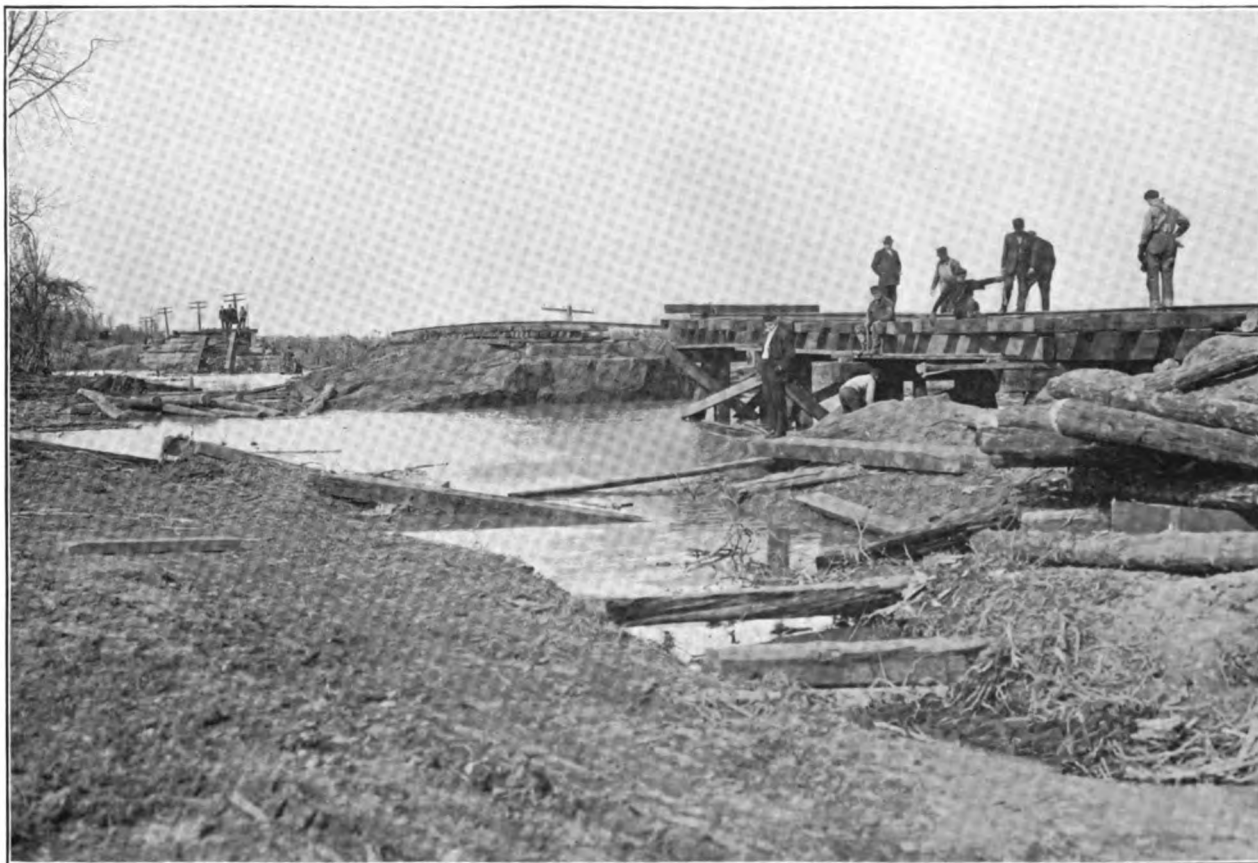
Temporary trestle built south of Bridge No. 37, over Boardley's Hole.

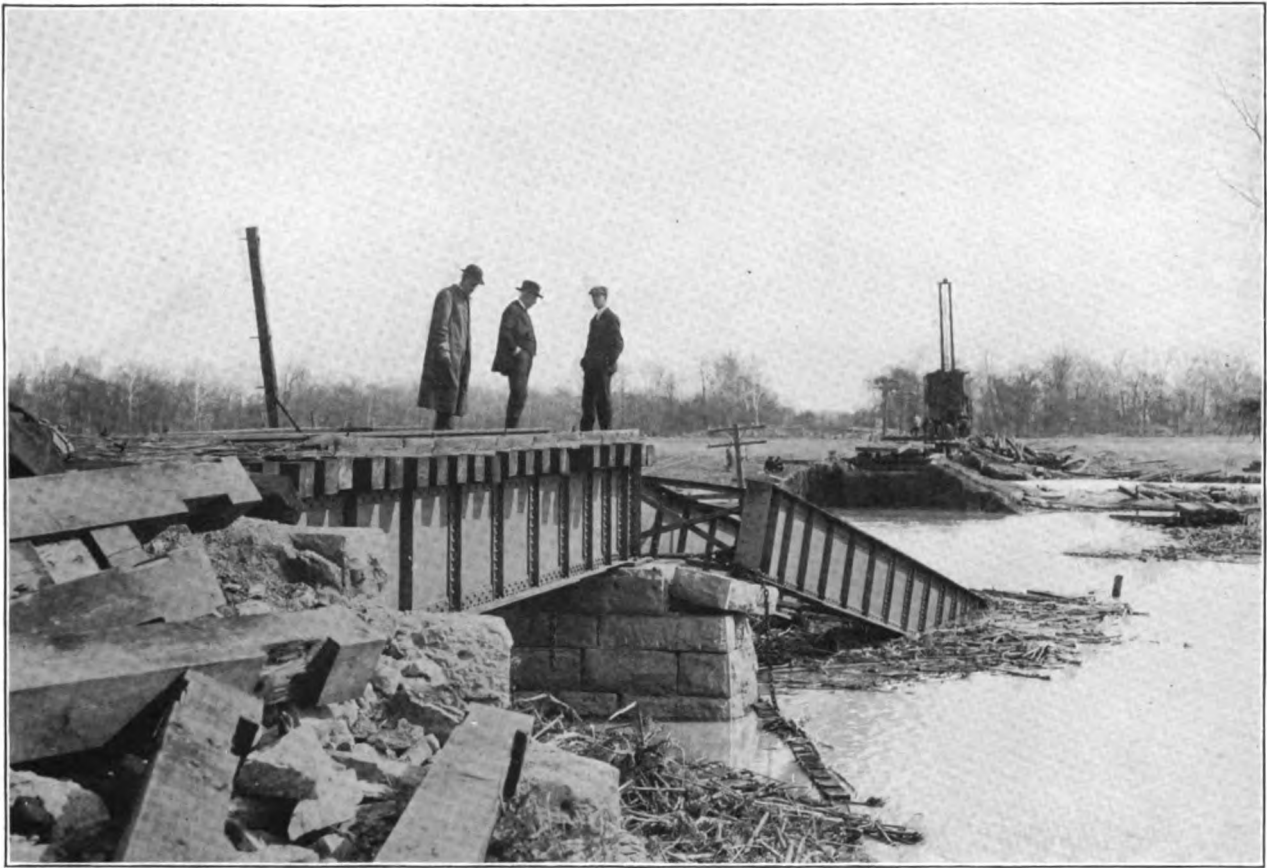
View south on west side of Bridge 37, over Boardley's Hole.

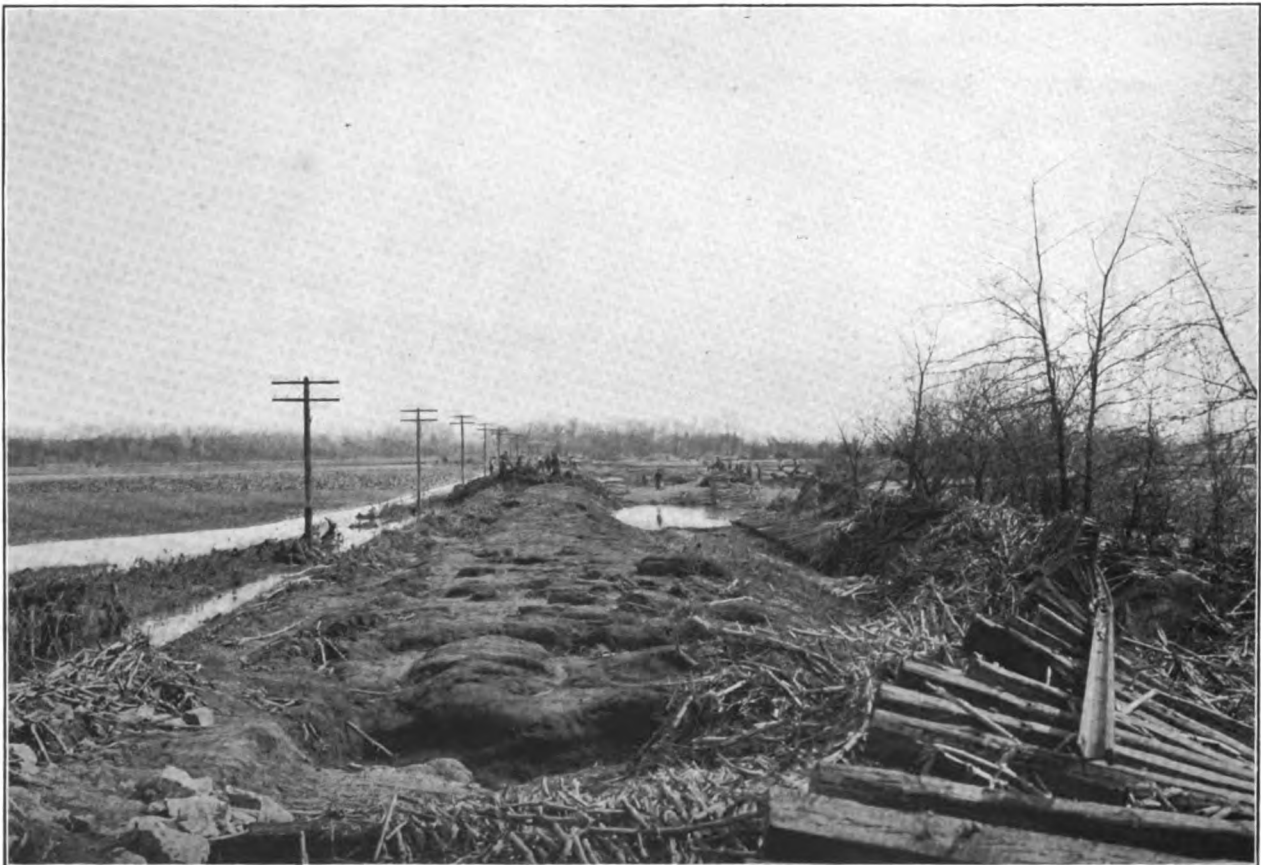
View south from Bridge 35, showing track swept from fill, and fill badly damaged.

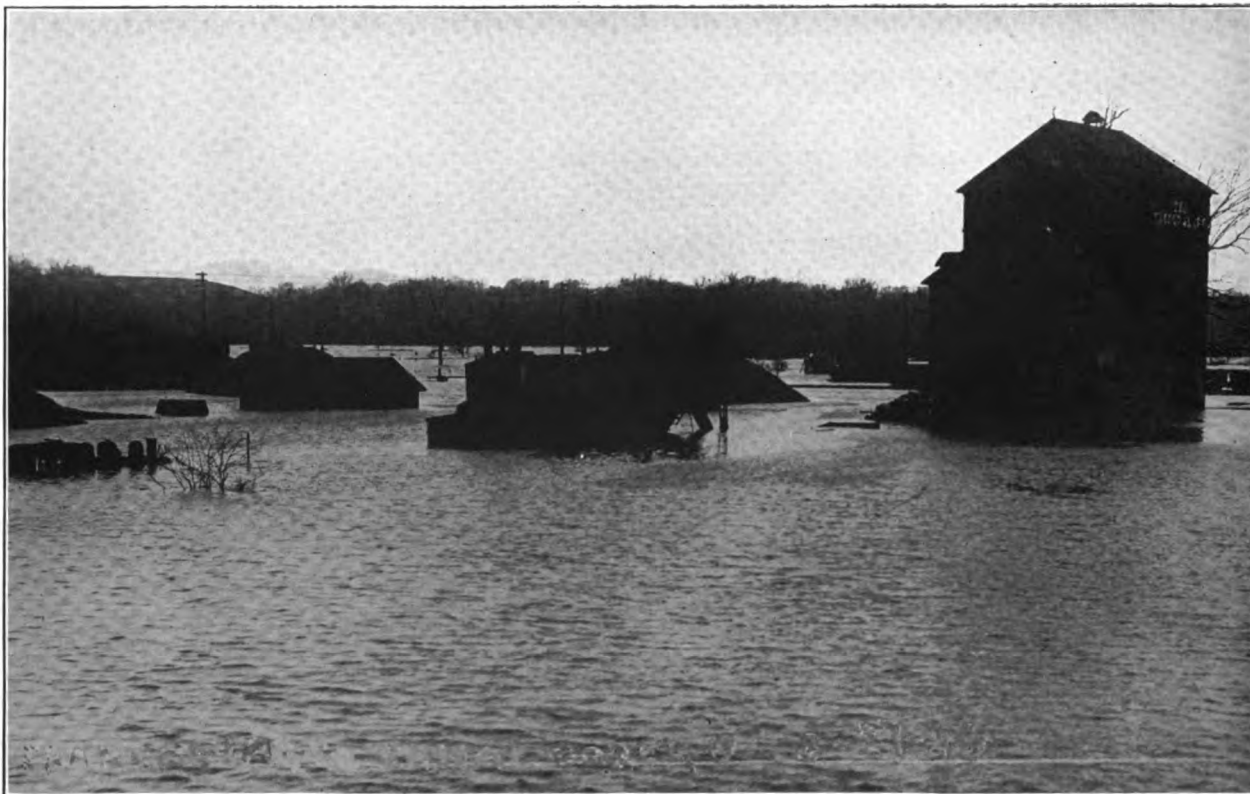
Marietta Division main track in mid-distance, in front of large building at right; valley of Tuscarawas River.

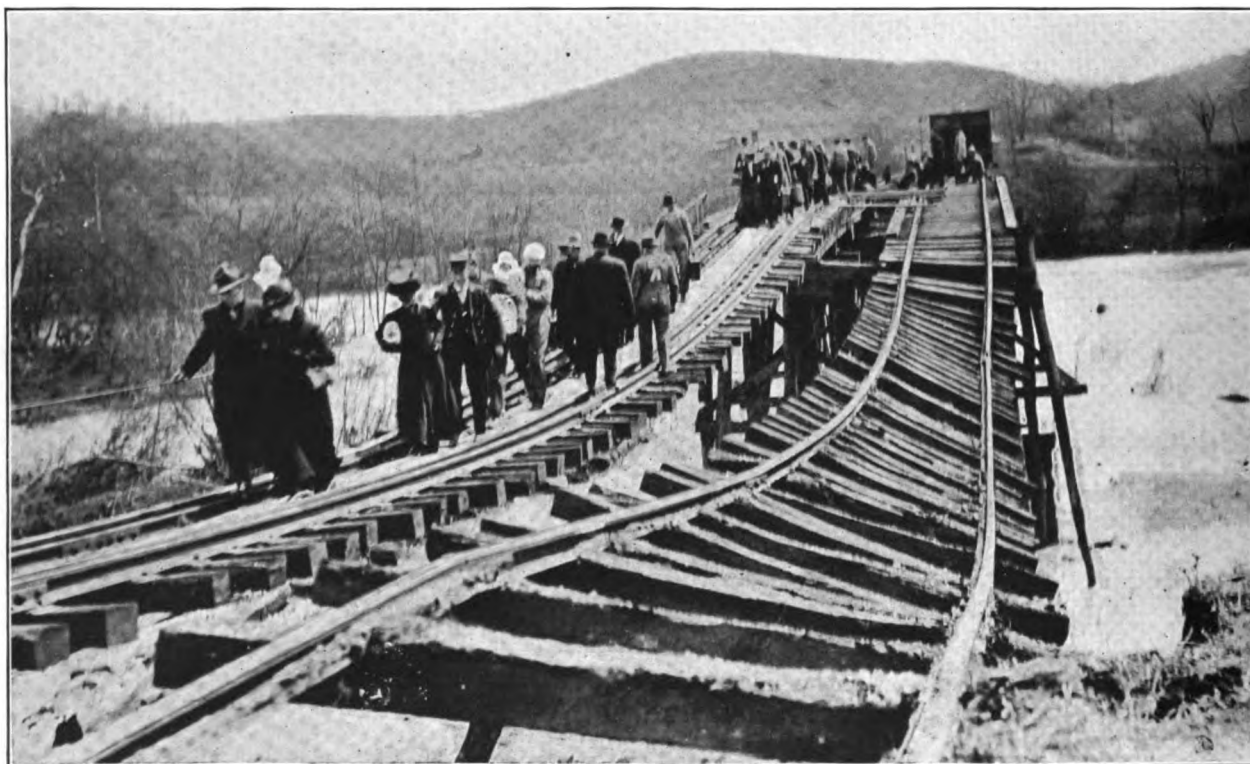
Marietta Division Bridge No. 27, over Tuscarawas River. North approach to bridge washed out. Ties of one track supported on steel cables, another cable placed for a hand rail, plank laid between rails, and the swinging track used for transferring passengers.

As the Tuscarawas River receded at New Comerstown, it was found that the east (north) approach to the bridge had been washed out for 150 feet, thirty feet deep, while a longer hole but only half as deep had been made through the embankment at the west (south) end of New Comerstown yard under main and ladder tracks. On Sunday, March 30th, work was begun on blocking up these tracks and making new fill. To permit transfer of passengers over Bridge 27, two wire cables were strung under the ties of one of the swinging tracks, and a third cable strung for a hand rail. Planks were laid between the rails, and a foot-bridge had been improvised over which passengers, baggage, mail and repair material were transferred until the afternoon of April 3d, when the approach to Bridge 27 had been replaced with a pile and frame trestle.

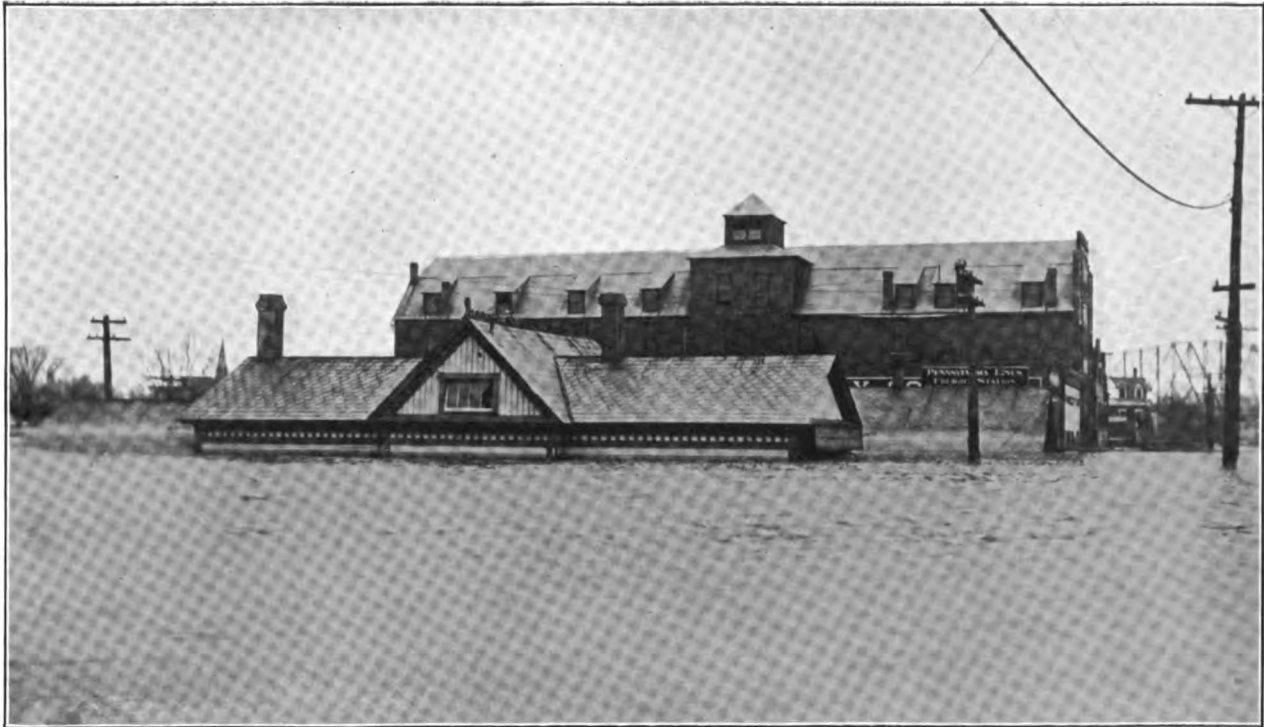
Pennsylvania Lines Passenger Station in foreground, and Freight Station just back of it to the right. Water receding. High water line may be seen on roofs.

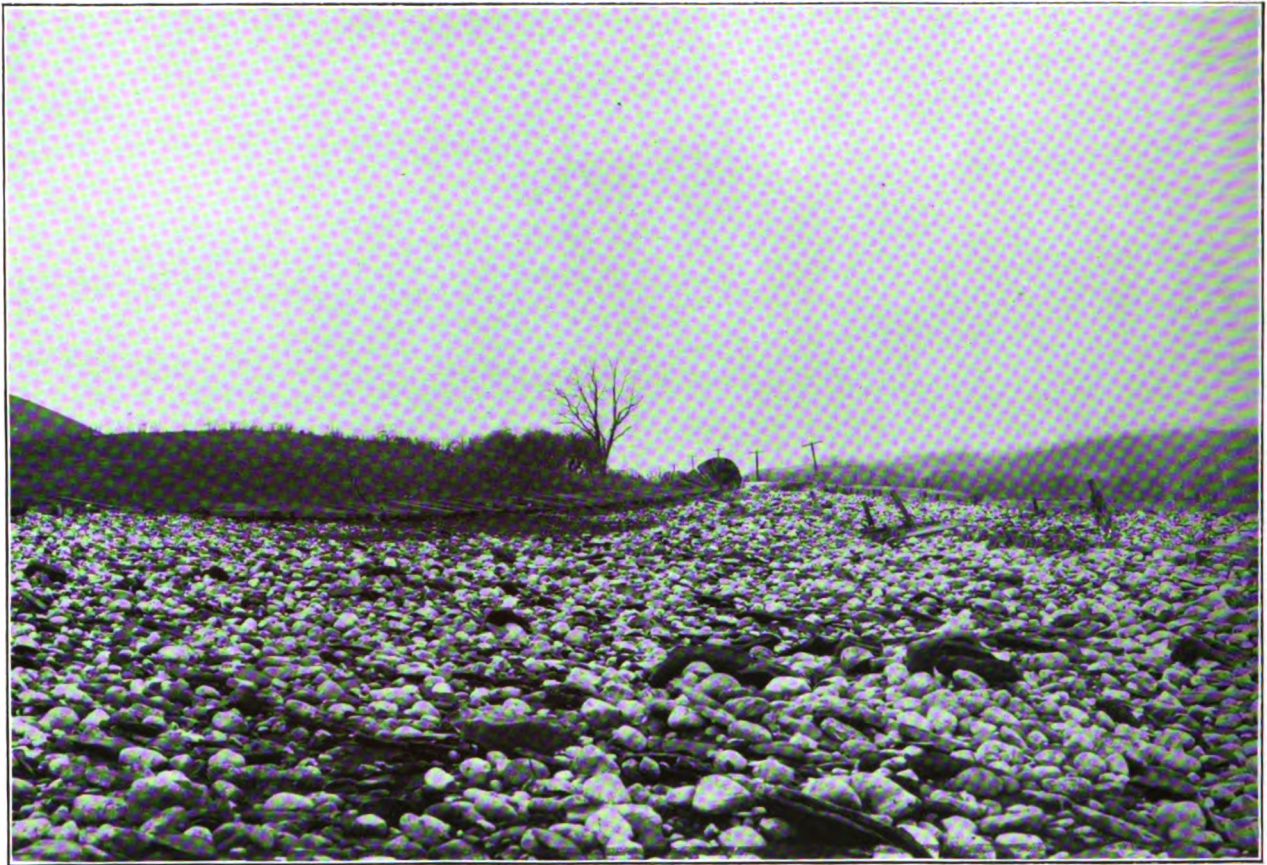
View west, of washout west of Bridge 14, over Walhonding River, showing nothing but the larger stone left of the fill, and the overturned track in the field.

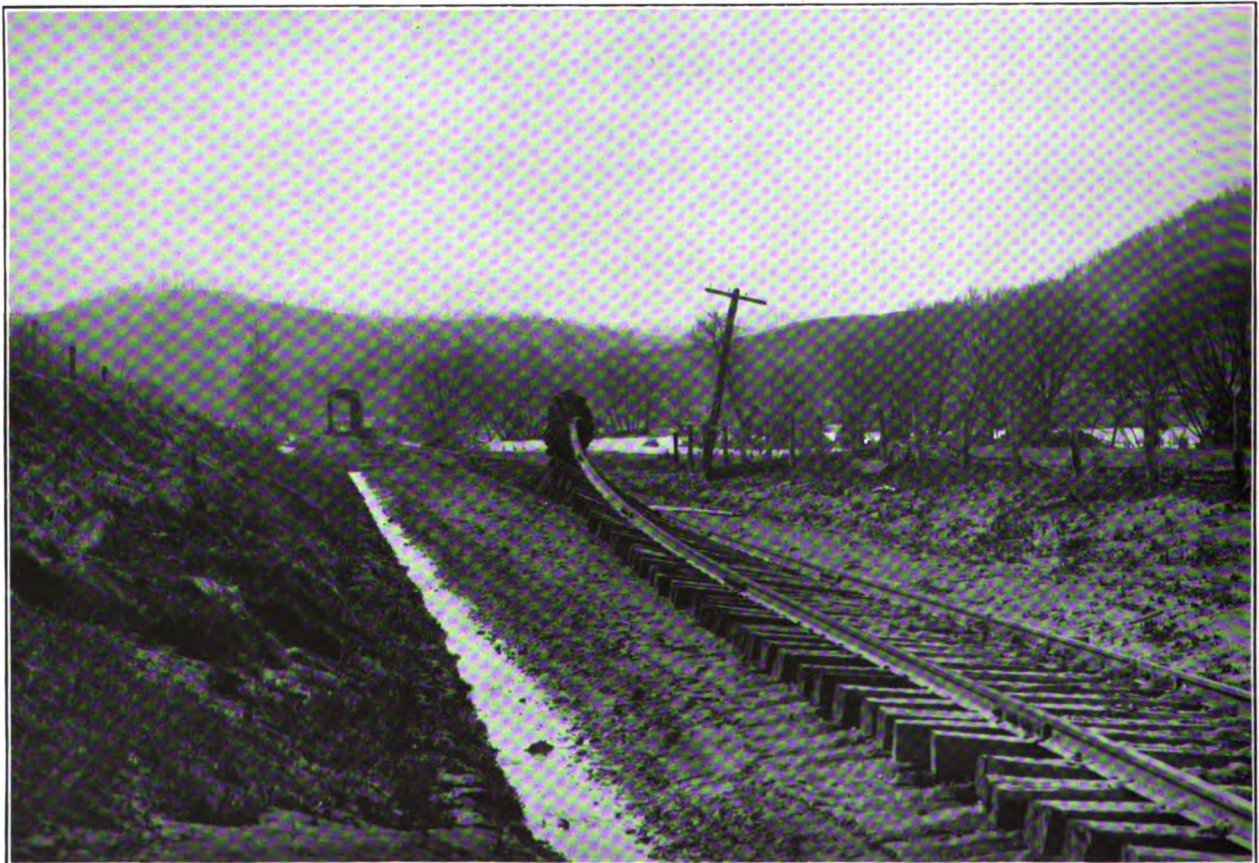
Looking east toward Bridge 14, over Walhonding River.

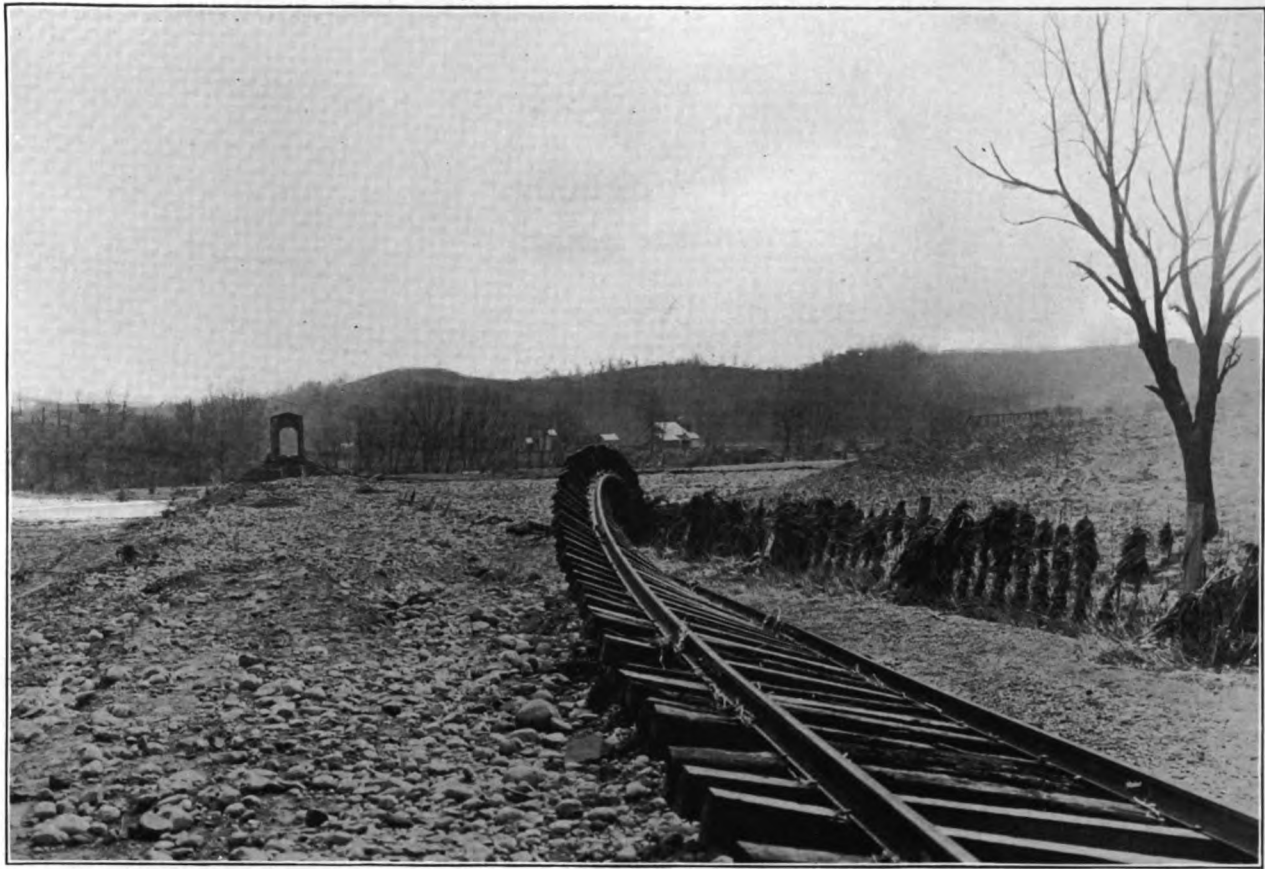
Looking west toward Bridge 18, over Mohican River.

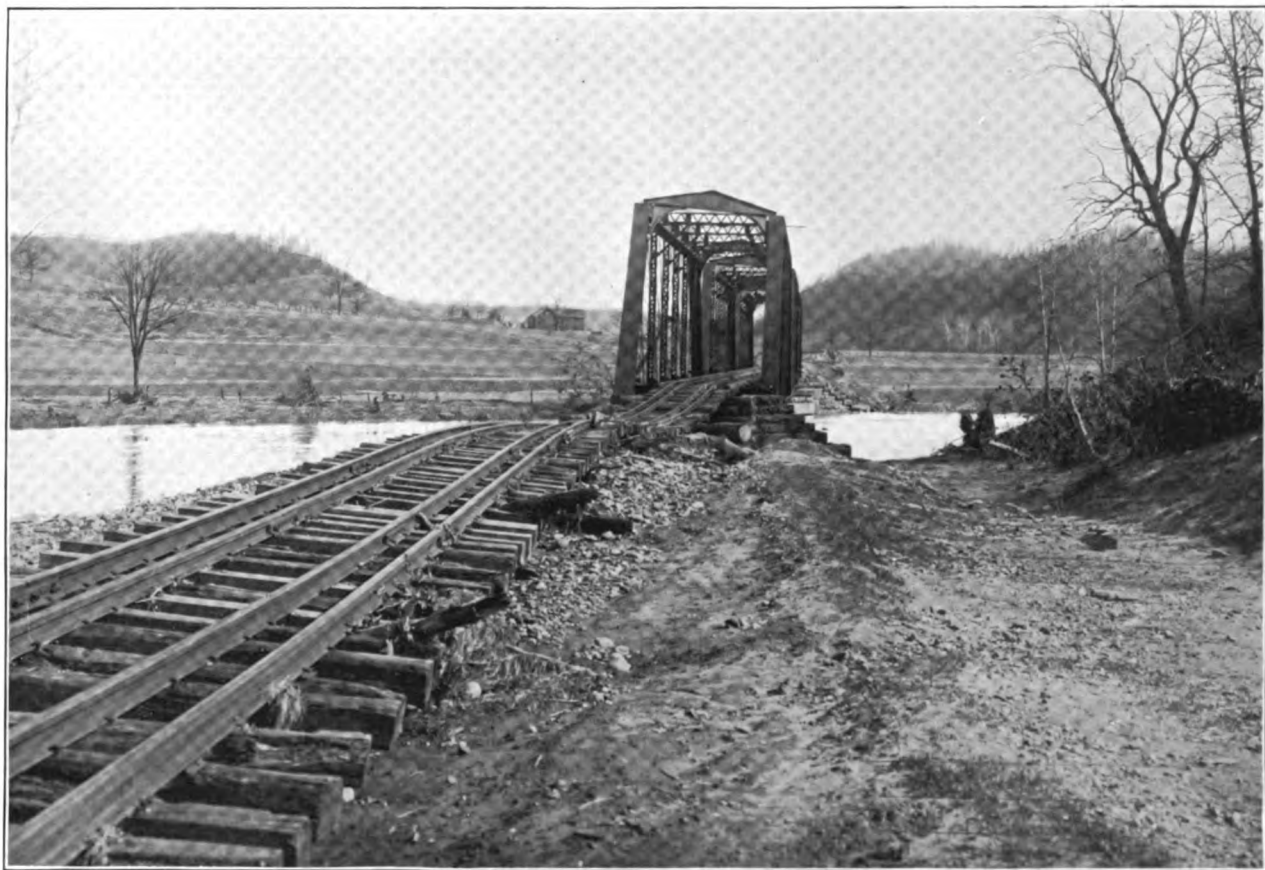
East approach to Bridge No. 26, over Mohican River.

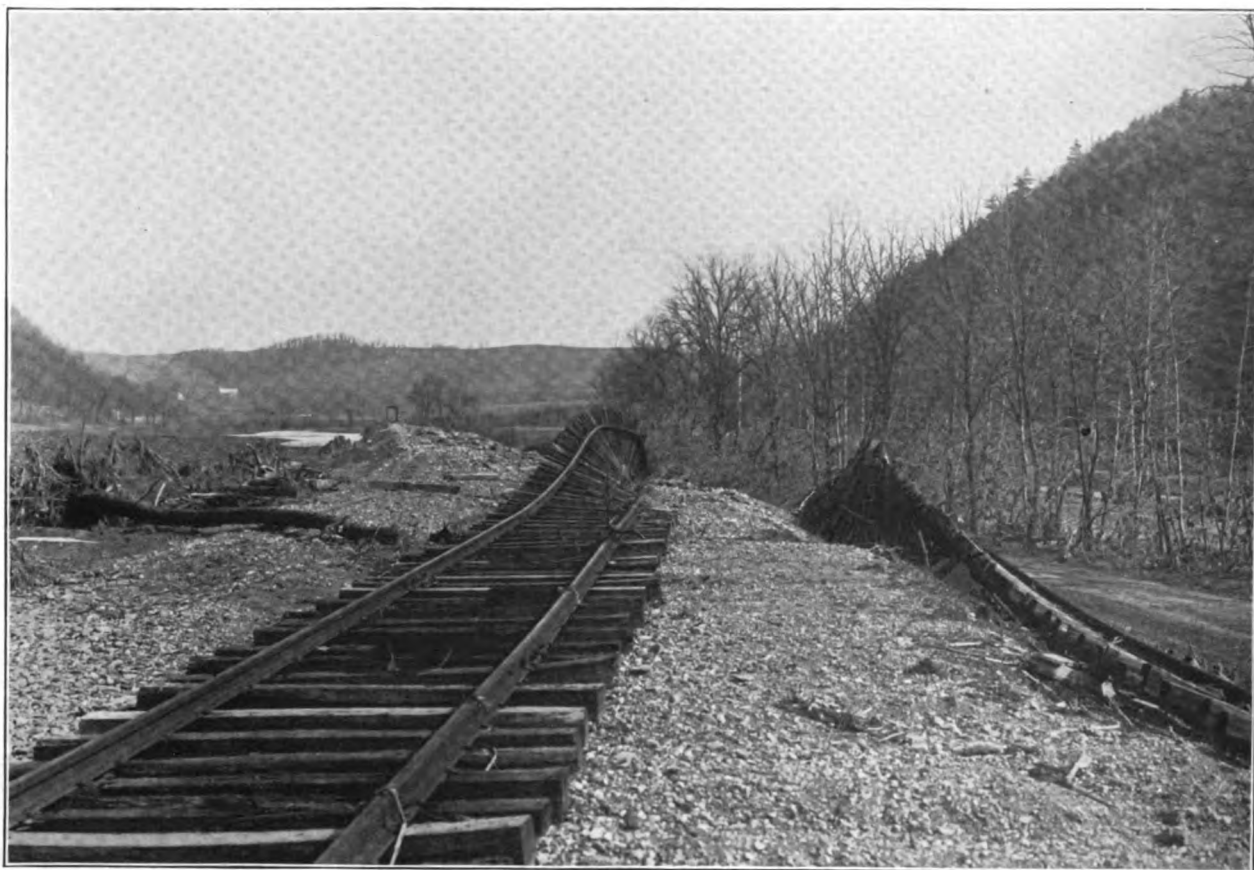
East approach to Bridge 27, over Mohican River.

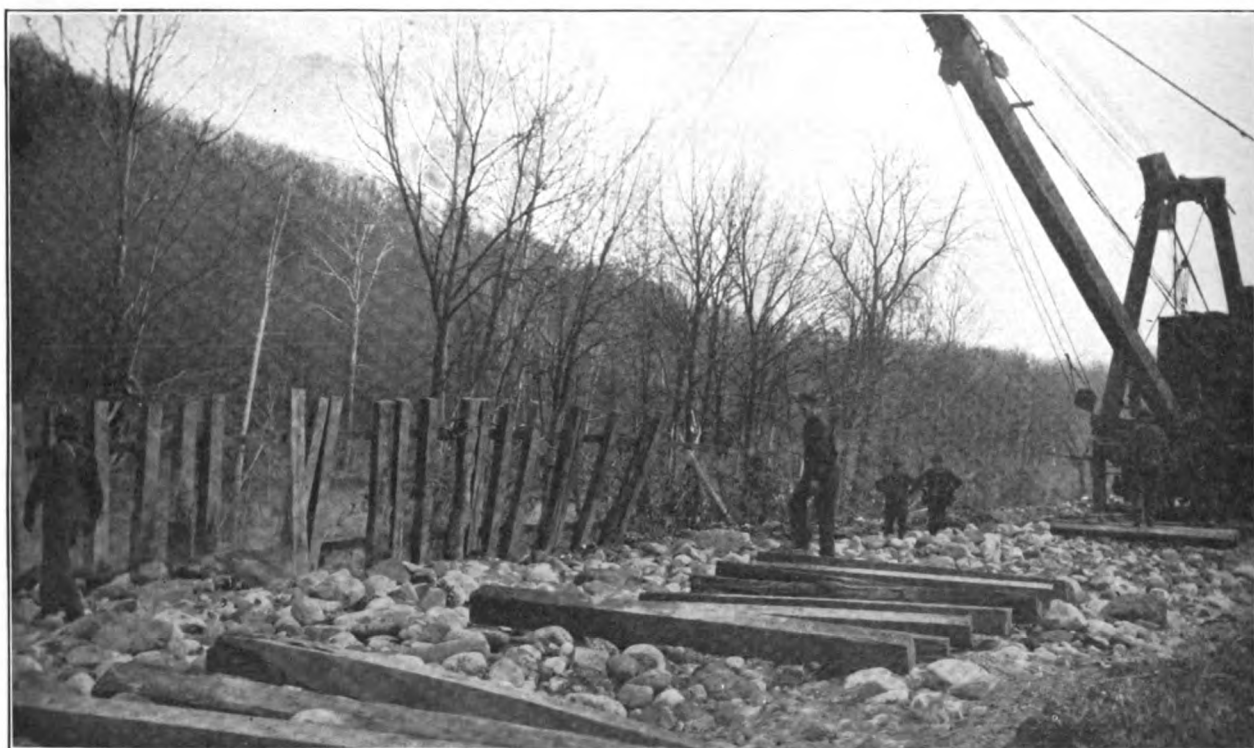
Derrick car turning over track which had been washed—rails downward—into the adjoining field, east of Bridge No. 27.

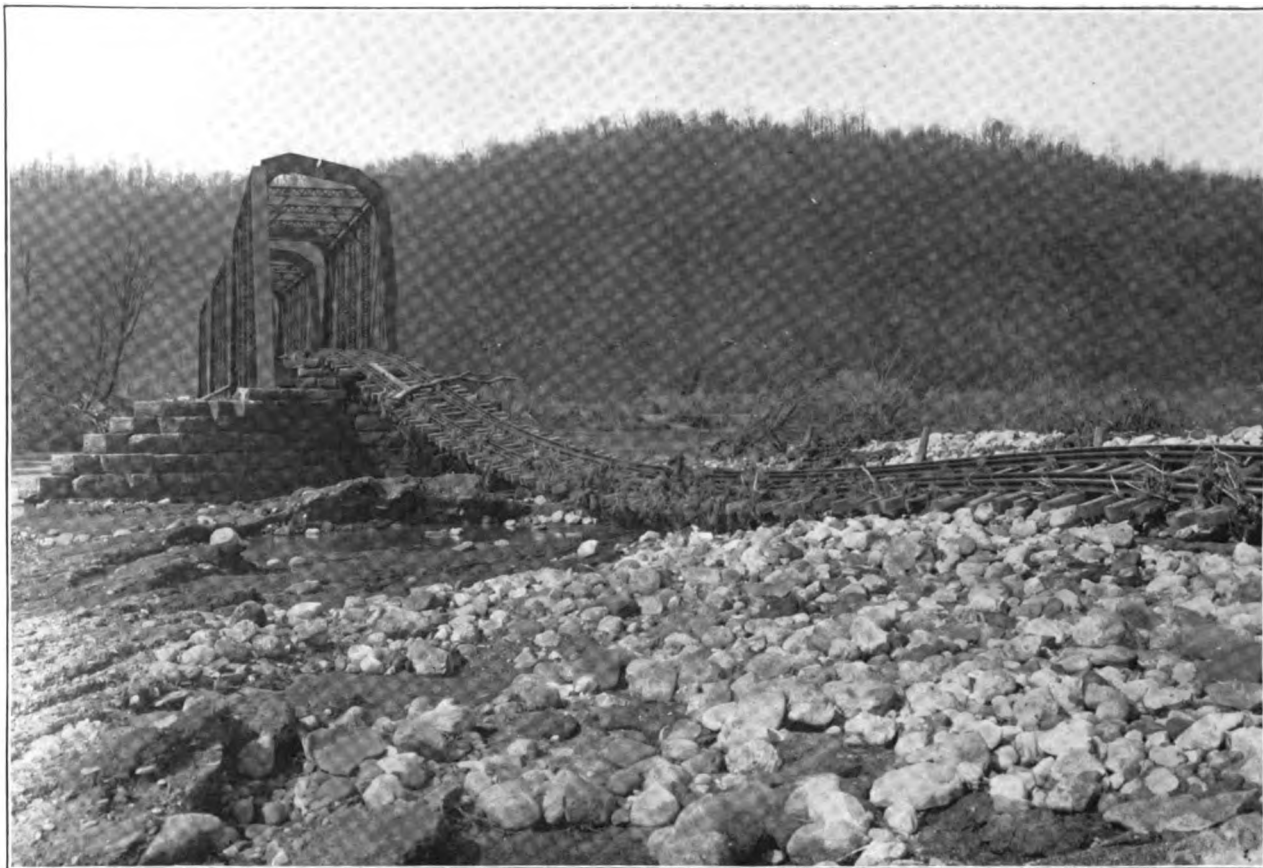
View east, of washout at west end of Bridge No. 28, over Mohican River.
