PENNSYLVANIA LINES
WEST OF PITTSBURGH

A HISTORY
OF THE
FLOOD
OF
MARCH, 1913

COMPILED
BY
C. W. GARRETT

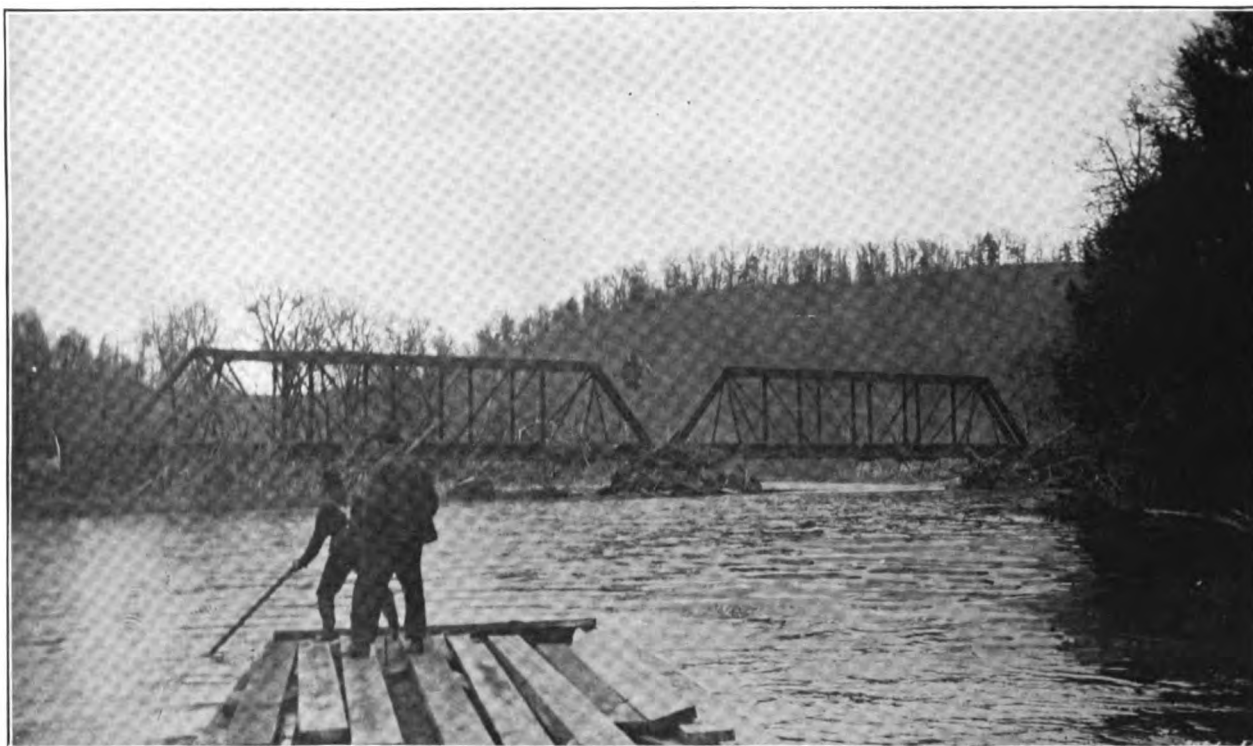
Bridge material for trestle at Bridge 28, being rafted down stream.
Bridge 29 in center of picture.

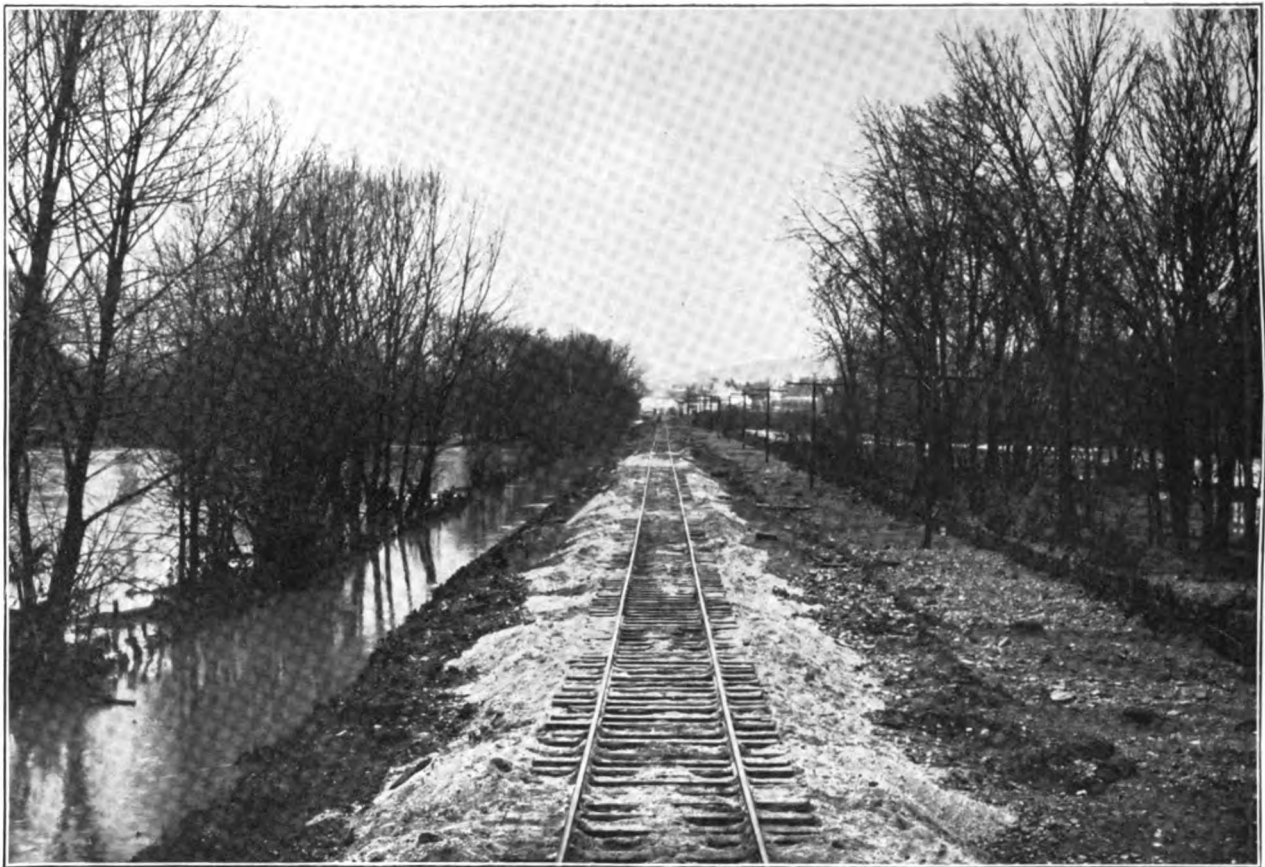
View of track replaced where it had been washed away south of Millersburg, looking north.

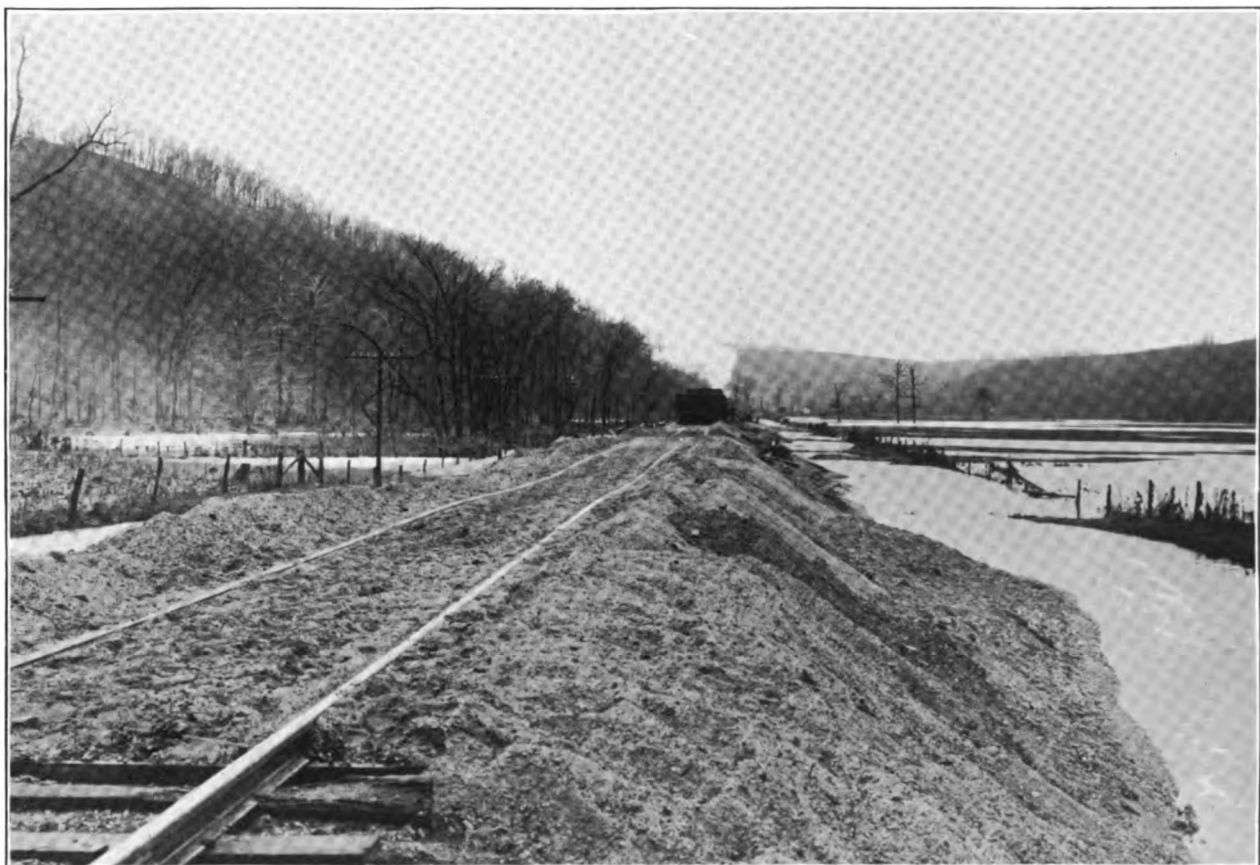
Killbuck, Ohio, north of.

Showing new fill replacing that washed away north of Bridge 49, over Killbuck Creek.

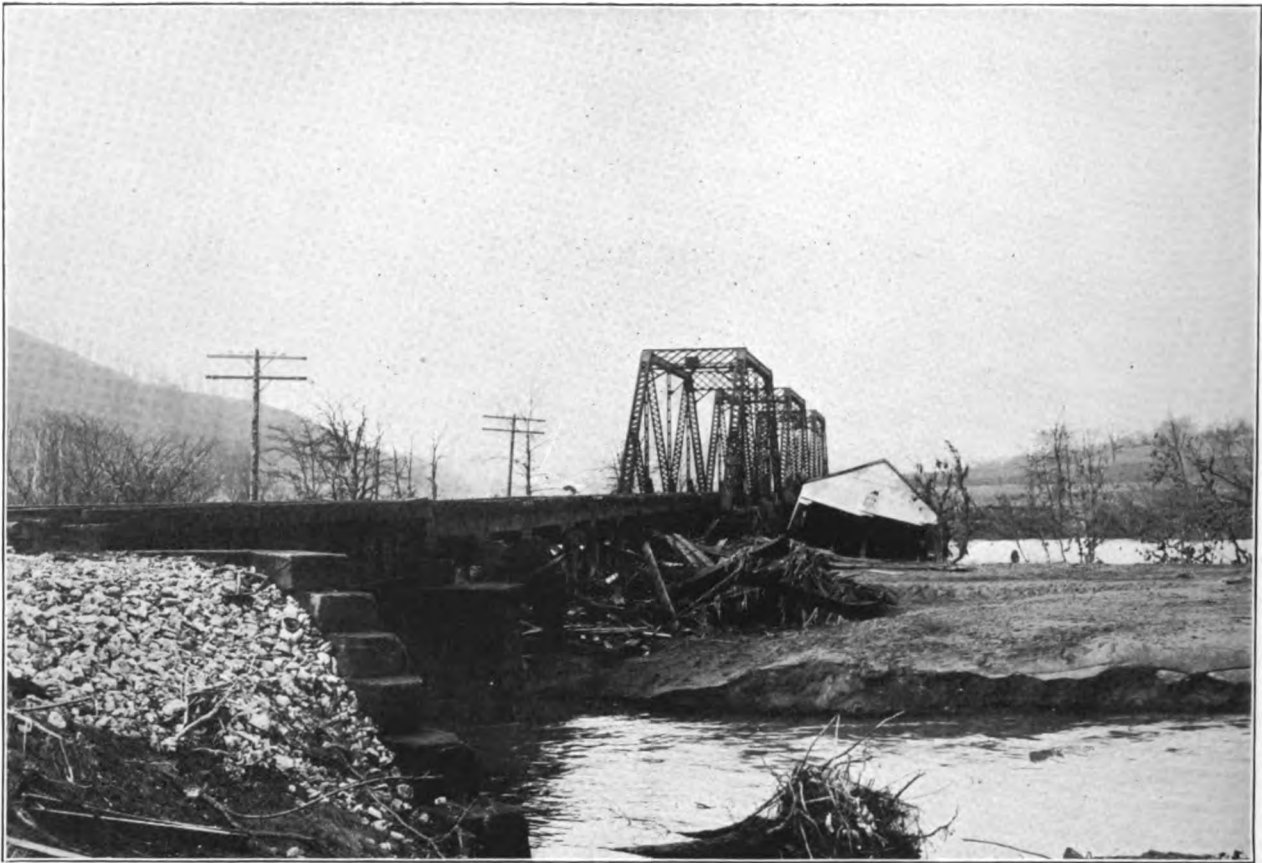
Brink Haven, Ohio.

Building, evidently an old stable, lodged against Bridge No. 68, both approaches to which were washed away.

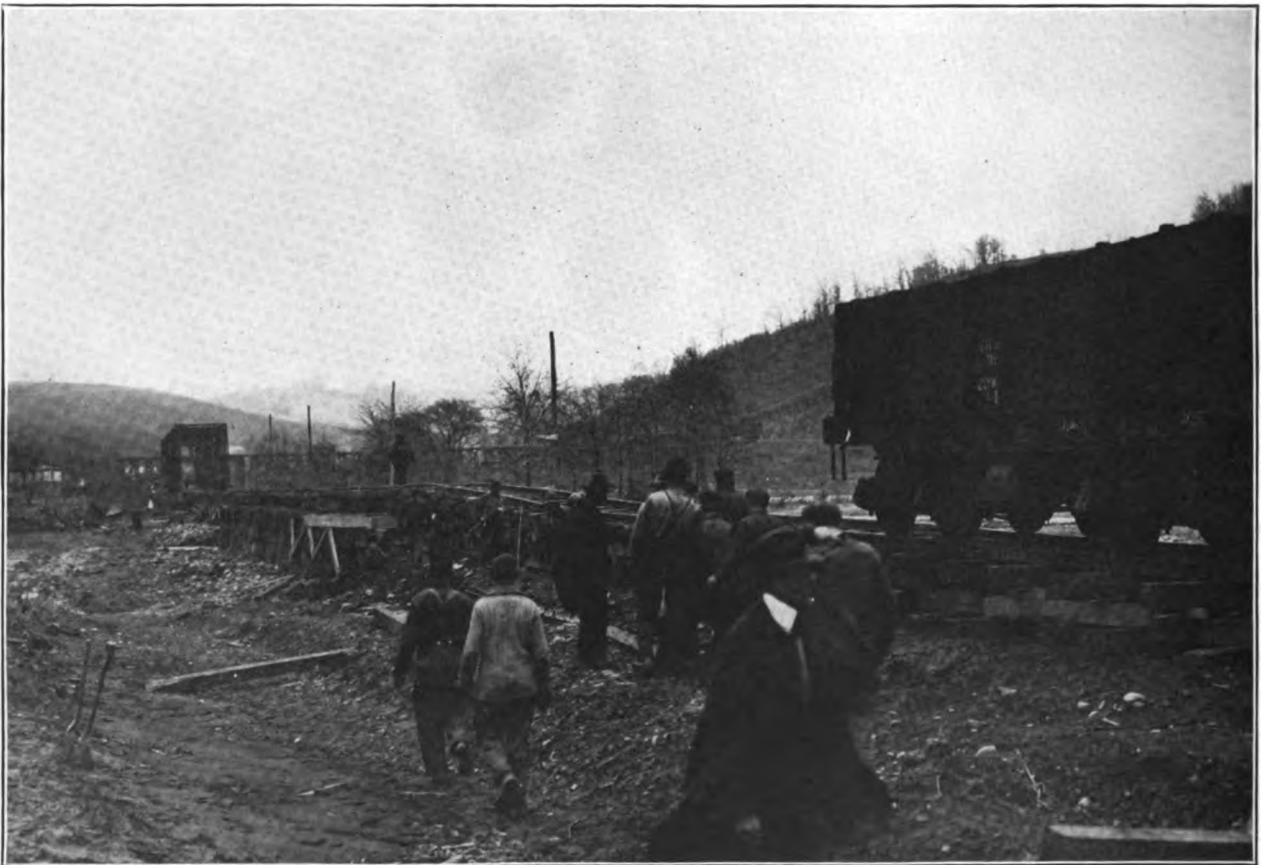
Brink Haven, Ohio.

South approach to Bridge 68, over Mohican River, replaced with temporary trestle and cribbing ready to fill. Walhonding Branch overhead bridge to be seen in distance.

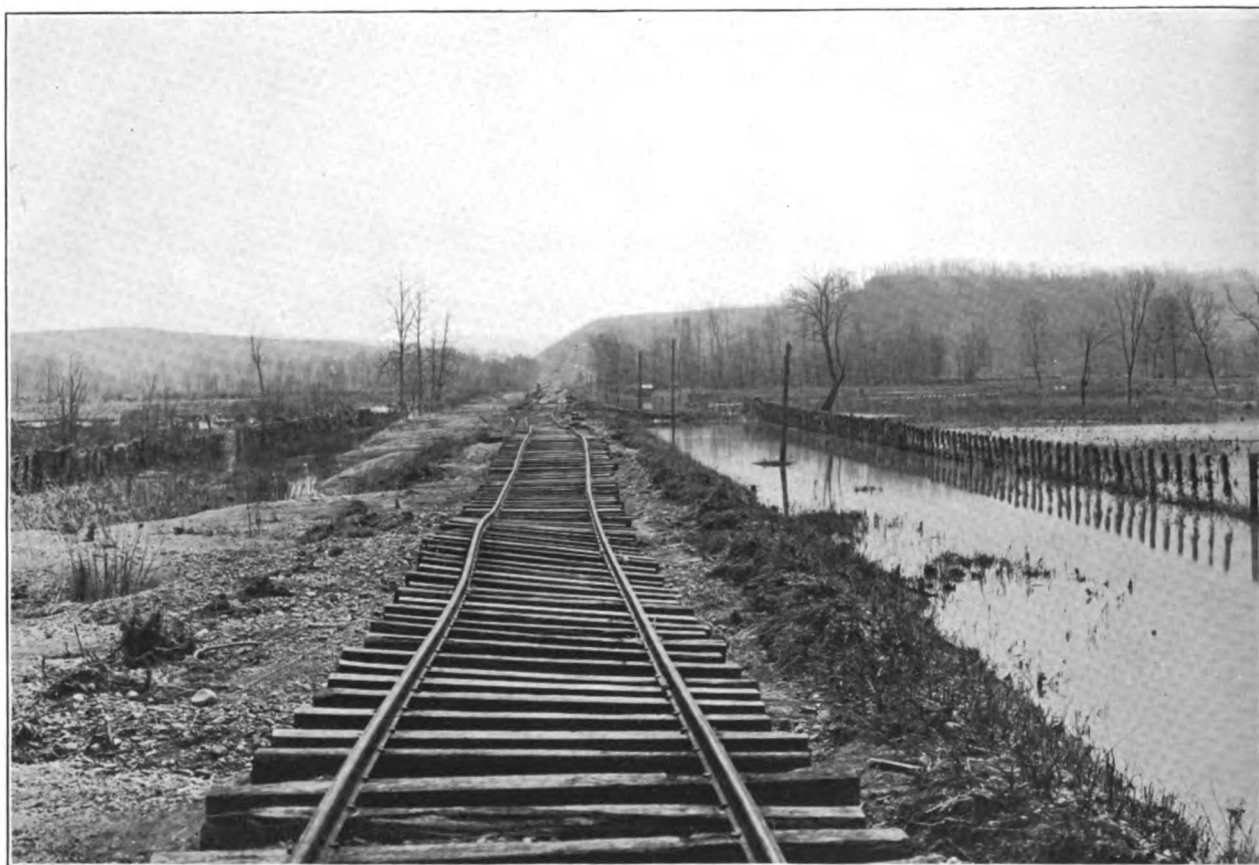
Layland, Ohio, north of.

Approach to Bridge No. 118, over Killbuck Creek. Fences covered with hay, grass and debris typical of all valleys in State of Ohio.

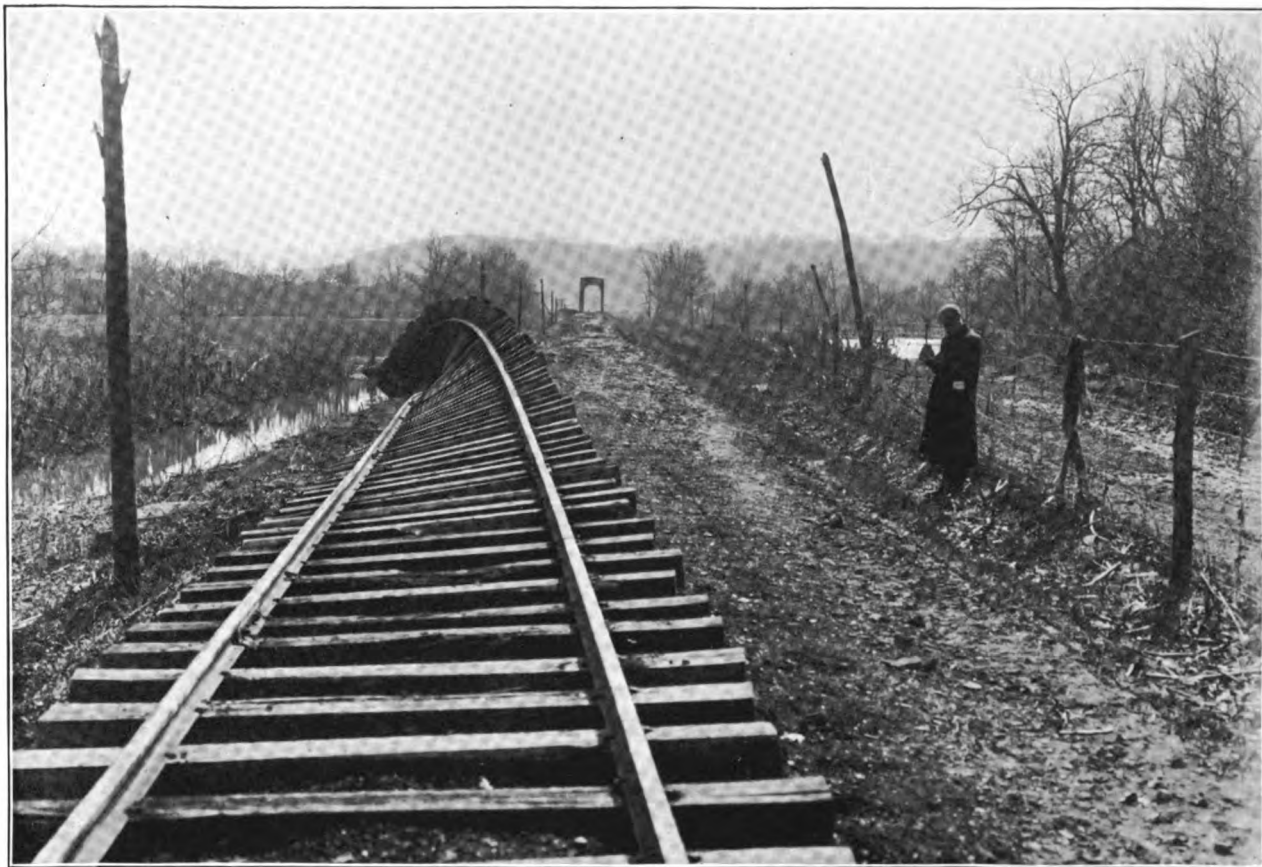
Helmick, Ohio, south of.

South approach to Bridge 120, over Killbuck Creek.

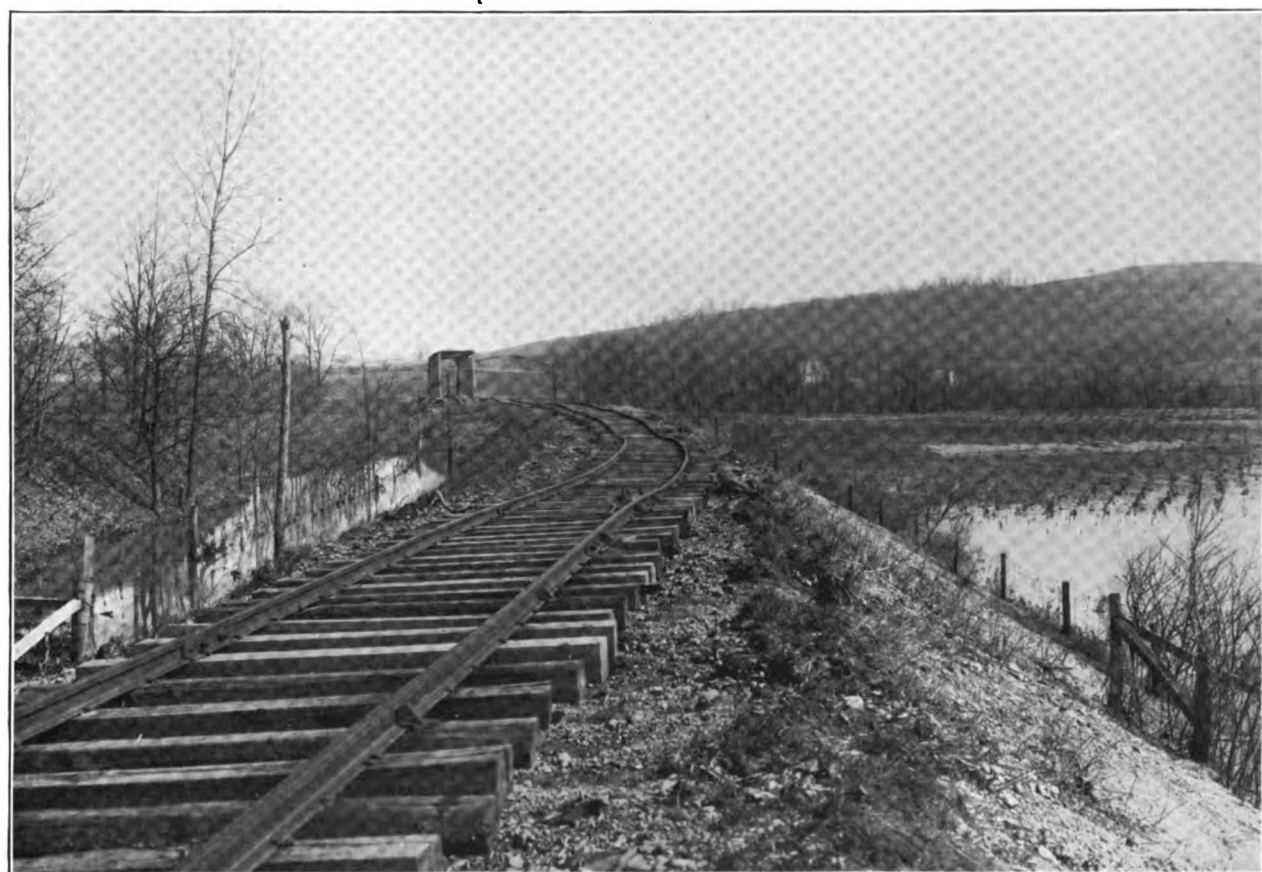
Blissfield, Ohio, south of.

South approach to Bridge 121, over Killbuck Creek.

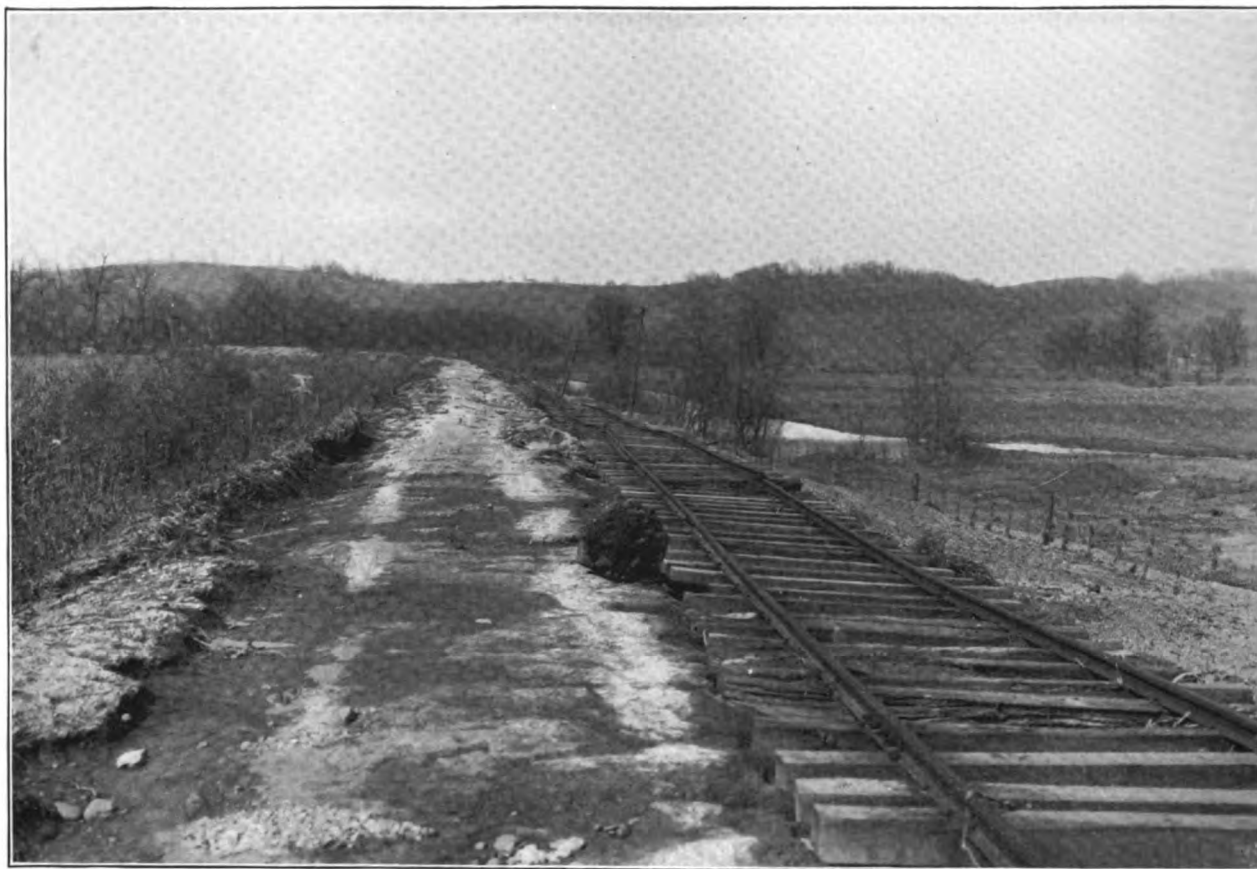
Metham, Ohio, north of.

Looking south, over north approach to Bridge No. 122, over Killbuck Creek;
fill not badly damaged, but track swept to one side.

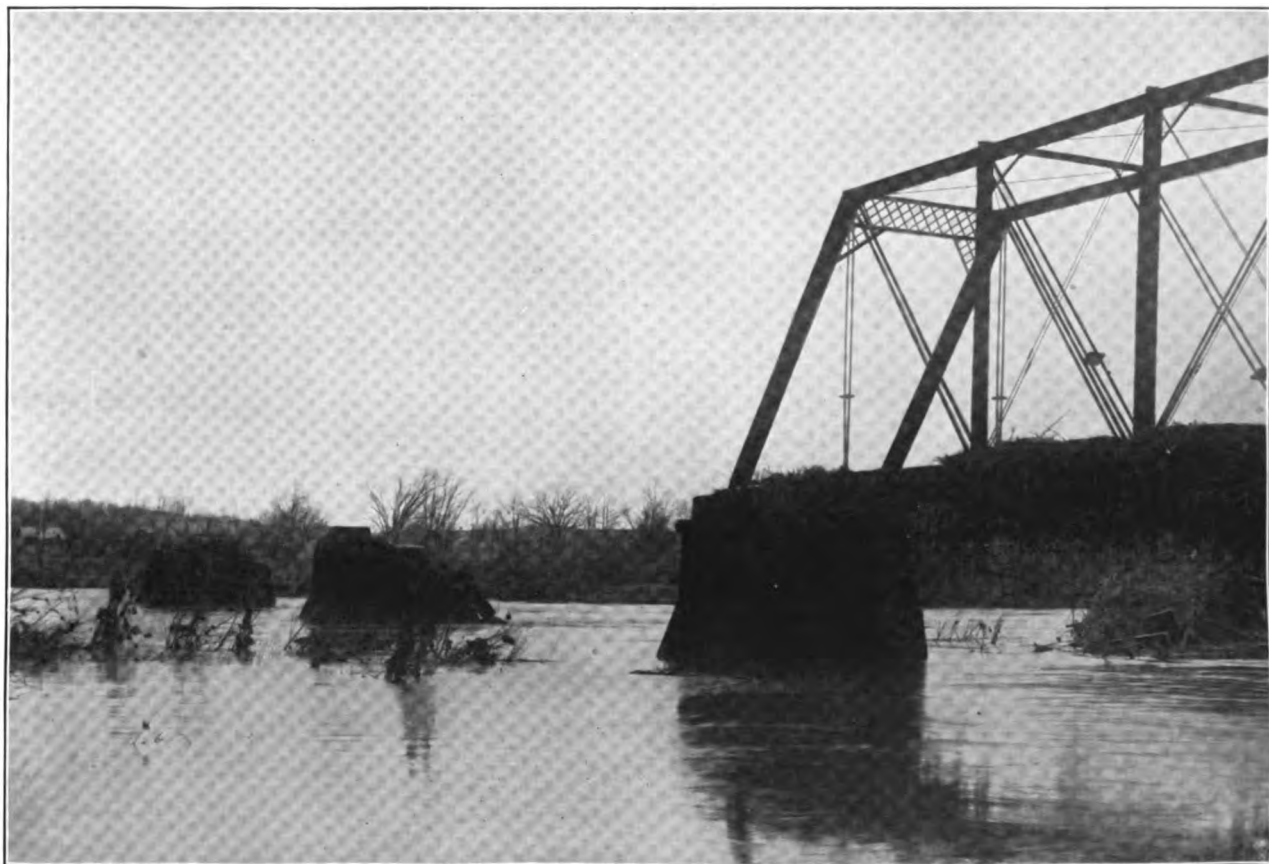
Warsaw Junction, Ohio.

Dresden Branch Bridge No. 126, over Walhonding River.

On the Dresden Branch there was 4.81 miles of track requiring rebuilding or repairs, having been damaged by Killbuck Creek between Killbuck and Warsaw, by the Walhonding River at Warsaw Junction, and by flood water from the Muskingum River at Trinway. The point of greatest damage was at Bridge No. 126, over the Walhonding River, at Warsaw Junction, only one of the four spans of which was left standing, the track on the approach from the Junction being washed off the roadbed and turned upside down in the fields, one abutment destroyed and the three piers damaged. The location of the Branch will be apparent from the sketch map given in connection with the Walhonding Branch in the chapter next preceding, and this, with the photographs which follow, placed in order from Killbuck to Trinway, will give an idea of the conditions on the Dresden Branch.

After the main line had been put in good shape for traffic, the Division forces made the necessary repairs to the Dresden Branch. The pile trestle replacing Bridge 126, over the Walhonding River, was completed at 4:00 P. M. April 26th, and traffic was resumed on usual schedules.

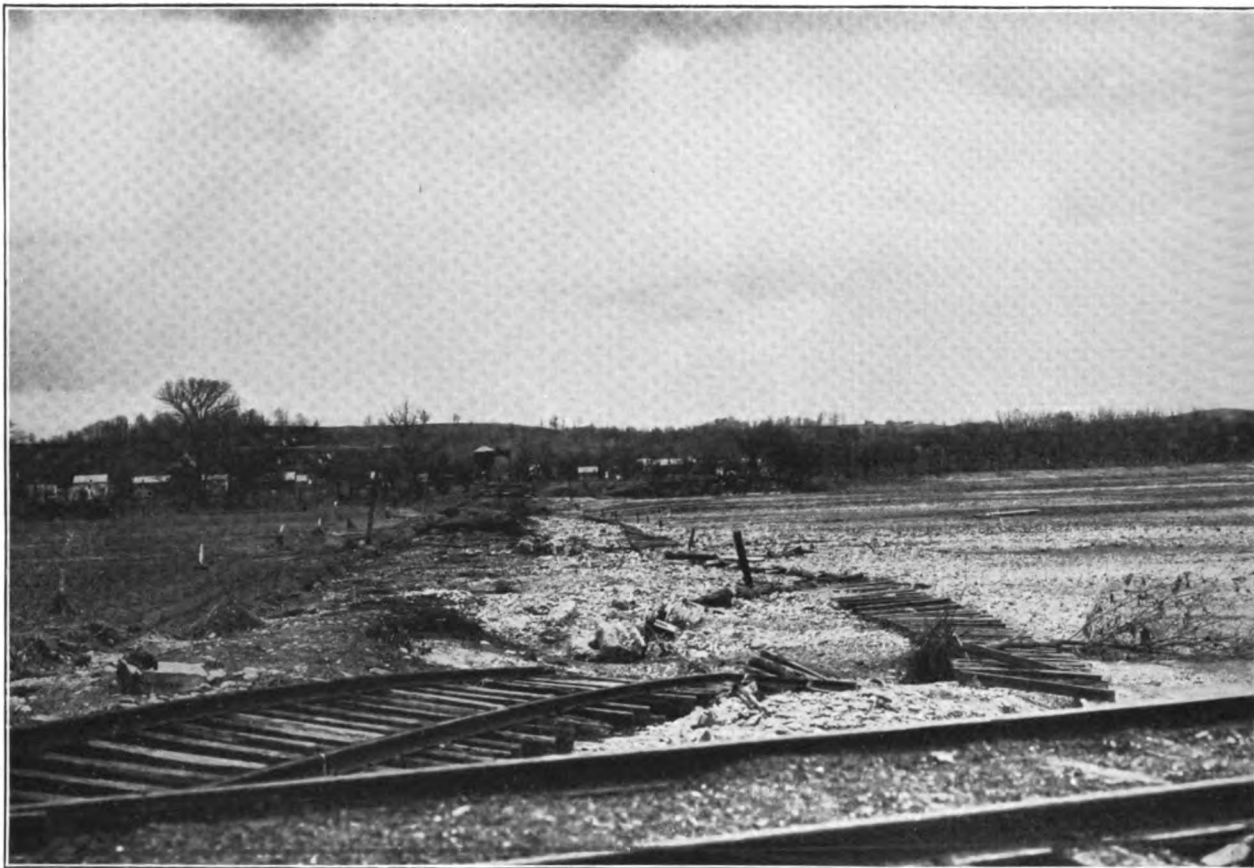
Warsaw Junction, Ohio.

View north, of approach to Bridge 126, over Walhonding River.

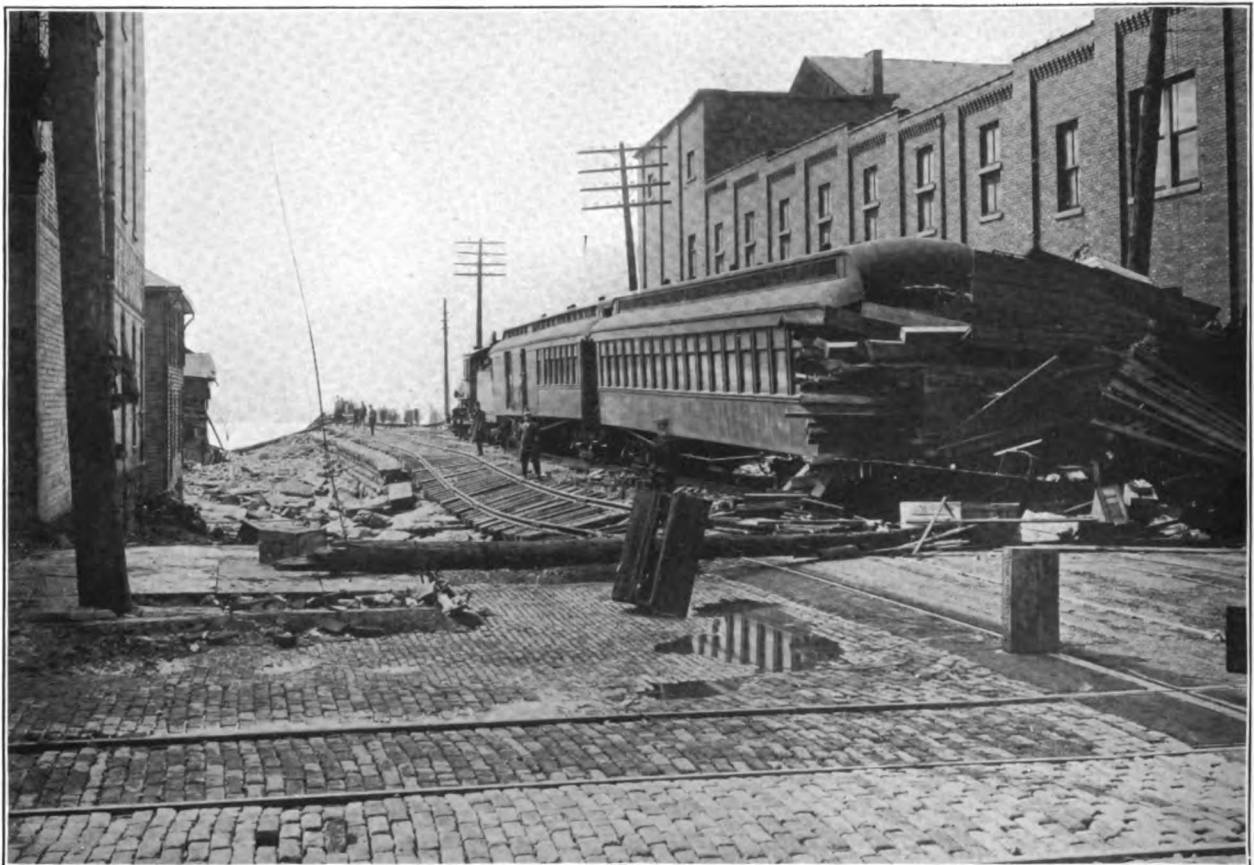
Zanesville, Ohio.

Looking south from Main Street toward former location of Bridge No. 20, over Muskingum River.

The passenger train is a Zanesville & Western (tenant line) train which was marooned here during the flood, the high water line being visible about half way up on the coach windows.

Bridge 20, over the Muskingum, had been swept off its piers, the steelwork destroyed, and the piers damaged. At the north end of it, Bridge 19, a 22 foot girder span over the canal towpath, and Bridge 18, a 110 foot girder draw span over the canal, were swept from their supports.

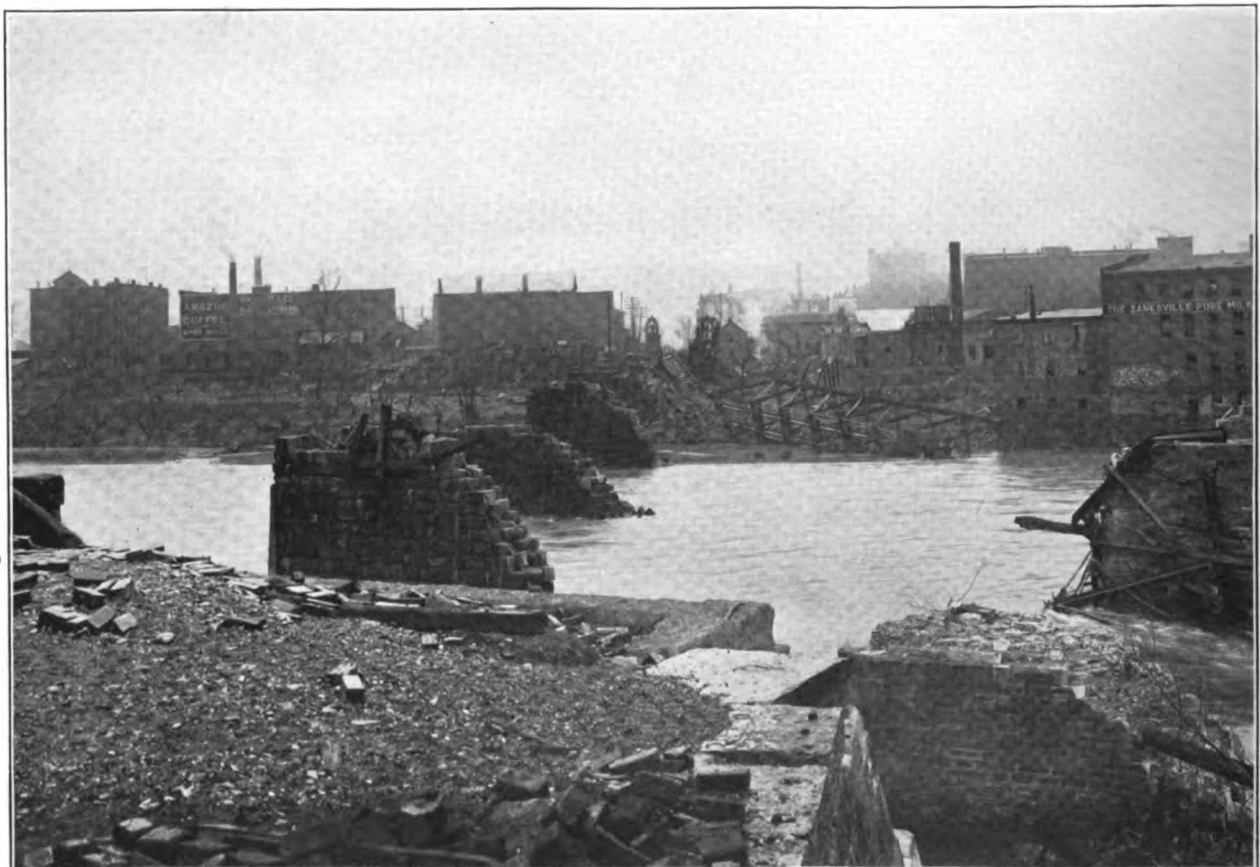
Zanesville, Ohio.

Bridge No. 20, over Muskingum River, destroyed and masonry badly damaged.

The present channel of the Muskingum is therefore narrow, and in many places bed rock is exposed by the stream. This happens at Zanesville, where, on account of the rock, it was impossible, in replacing Bridge 20, to resort to the pile trestle, usually so quick a solution of the problem of replacing the bridges destroyed. Instead, frame towers were constructed, and steel girders placed on them. At Ellis, however, there is a depth of about forty-five feet to the bed rock, and it was therefore possible to replace Bridge 12 at that point with a pile trestle.

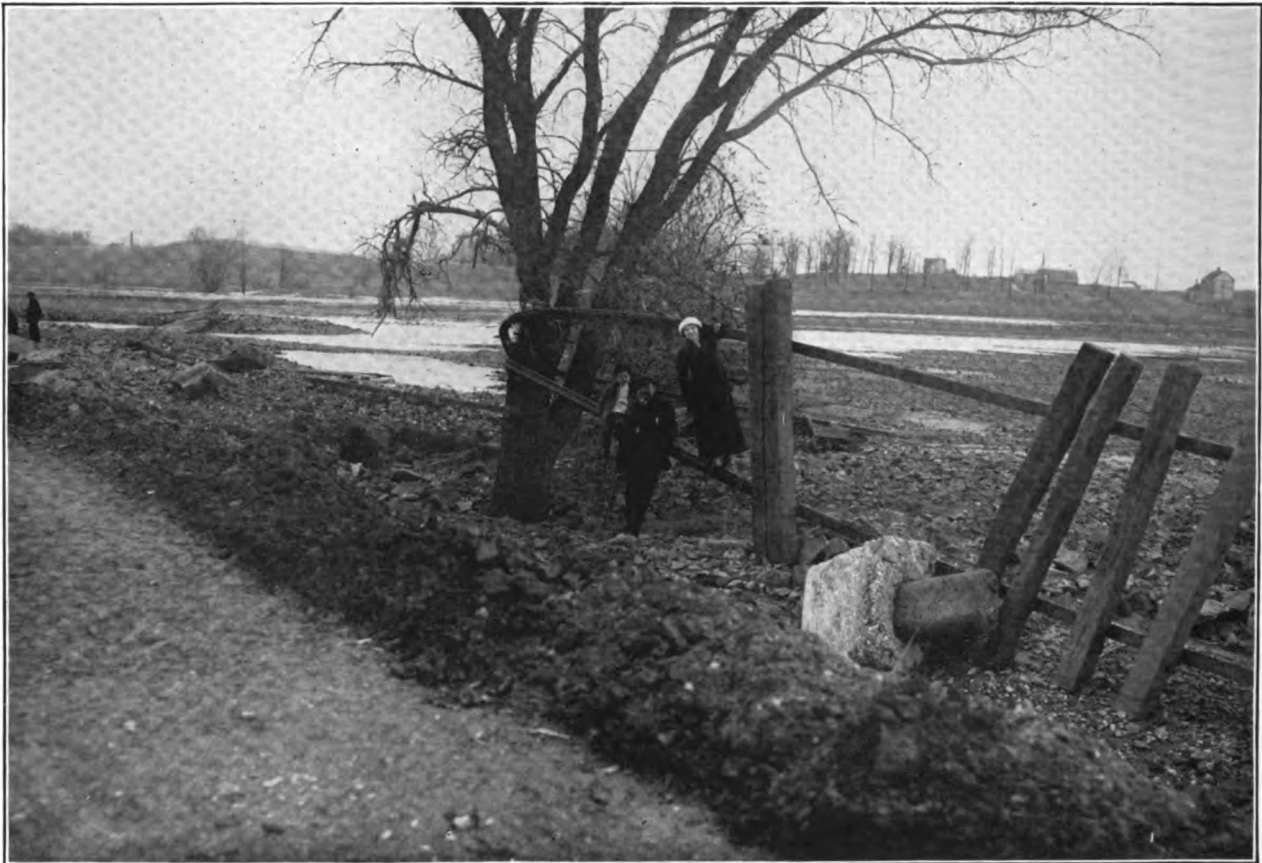
Circleville, Ohio.

About half mile east of Bridge No. 96, over Scioto River, showing track wrapped around tree and washed into fields.

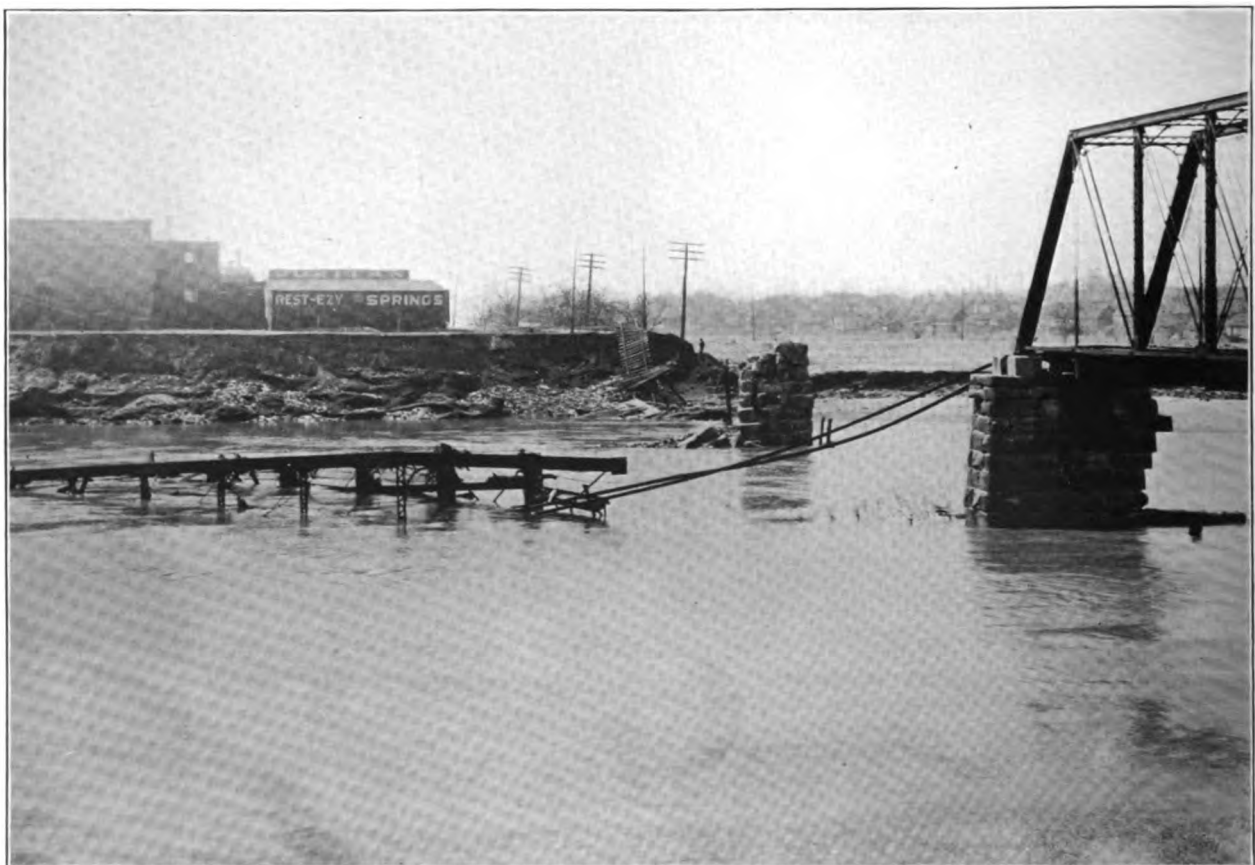
Indianapolis, Ind.

Vincennes Division Bridge No. 1, over White River, on old main line.

In the vicinity of Indianapolis the White River did immense damage, particularly to railroad property. The first railroad bridge to go out was the old line Vincennes Division Bridge (now used for industrial purposes only) the west span of which was carried from its supports in the evening of the 25th. During the night the St. Louis Division old line bridge (now used for yard purposes only) was undermined and went down. North of this latter bridge stood the new bridge used to carry the main traffic of both Divisions, but this was not damaged by the flood.

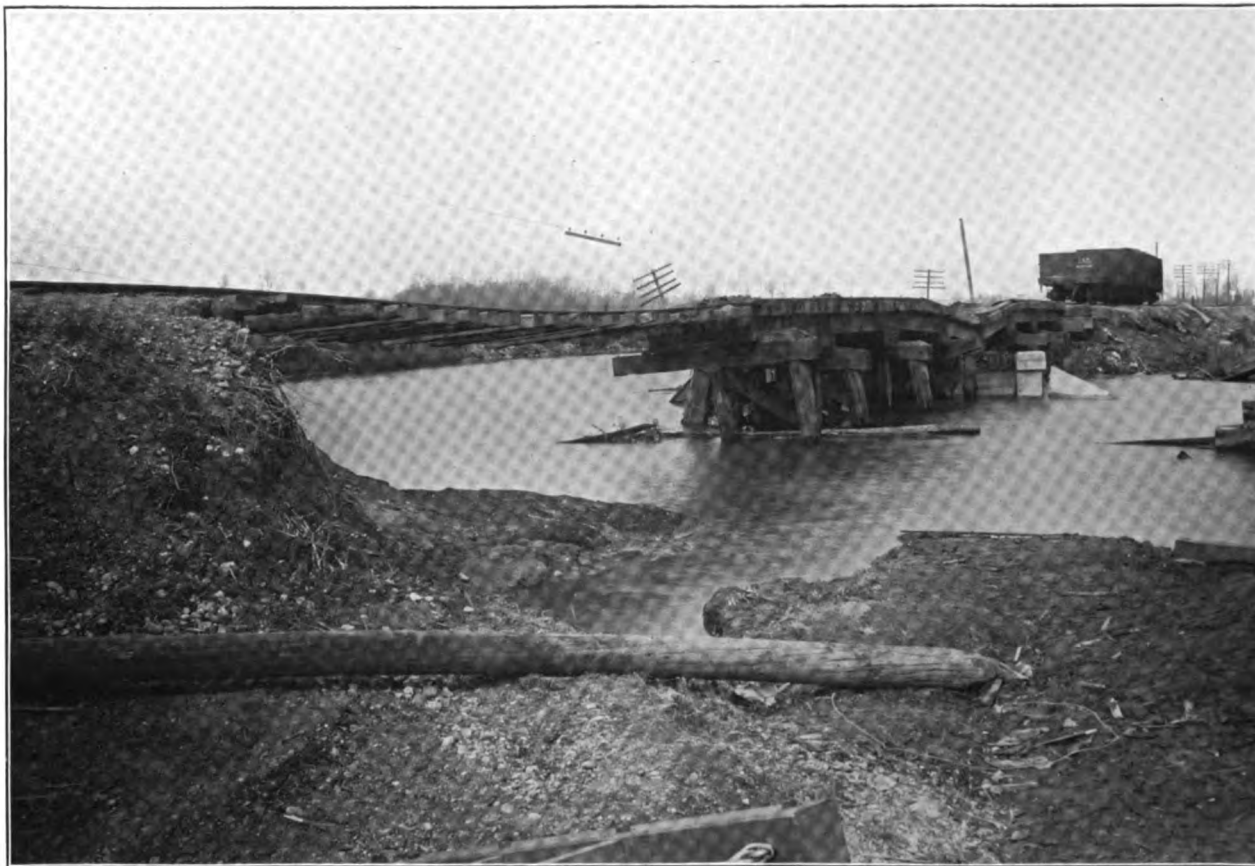
Indianapolis, Ind., south of.

Bridge 3, Vincennes Division just south of Belt Crossing. A concrete box culvert had been built replacing a wooden trestle partly filled in.

Both were destroyed.

At Bridge No. 3, where a wooden trestle had been replaced with a concrete box culvert, just north of Belt Crossing, the fill was so badly washed away as to require an eleven bent trestle.

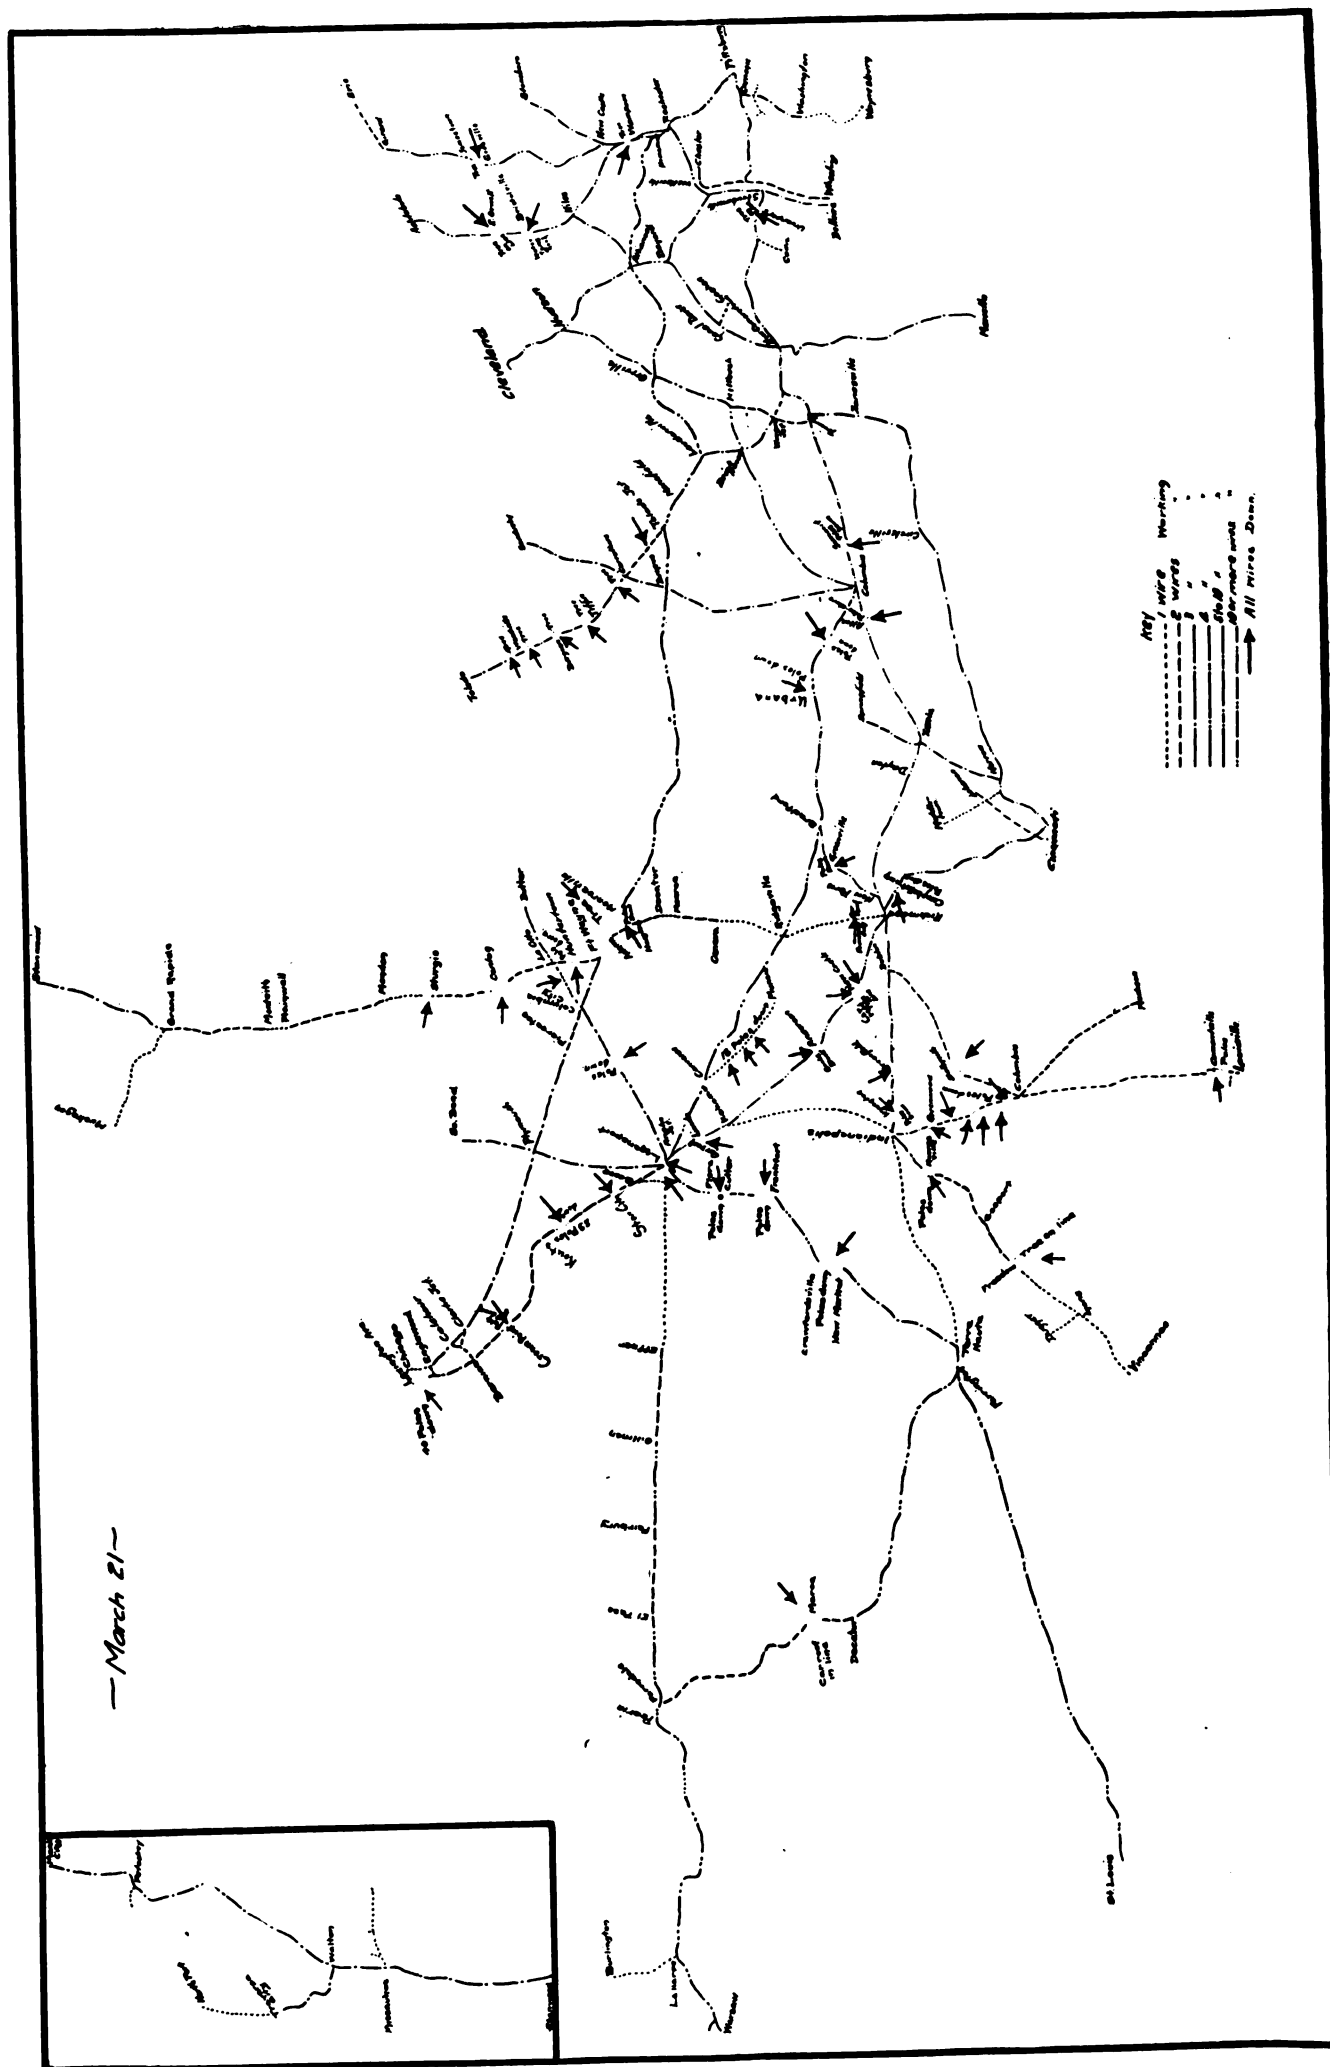
DIAGRAM OF TELEGRAPH FACILITIES, MARCH 21, 1913.

For a clear understanding of the situation from day to day, the following series of diagrams showing the conditions of the telegraph lines, the number in service, and the location of the breaks, will be found superior to any description that could be given. It is impossible to show the hundreds of breaks due to the sleet storms of the 26th and 27th, but the points of damage by high water are all shown.
