PENNSYLVANIA LINES
WEST OF PITTSBURGH

A HISTORY
OF THE
FLOOD
OF
MARCH, 1913

COMPILED
BY
C. W. GARRETT

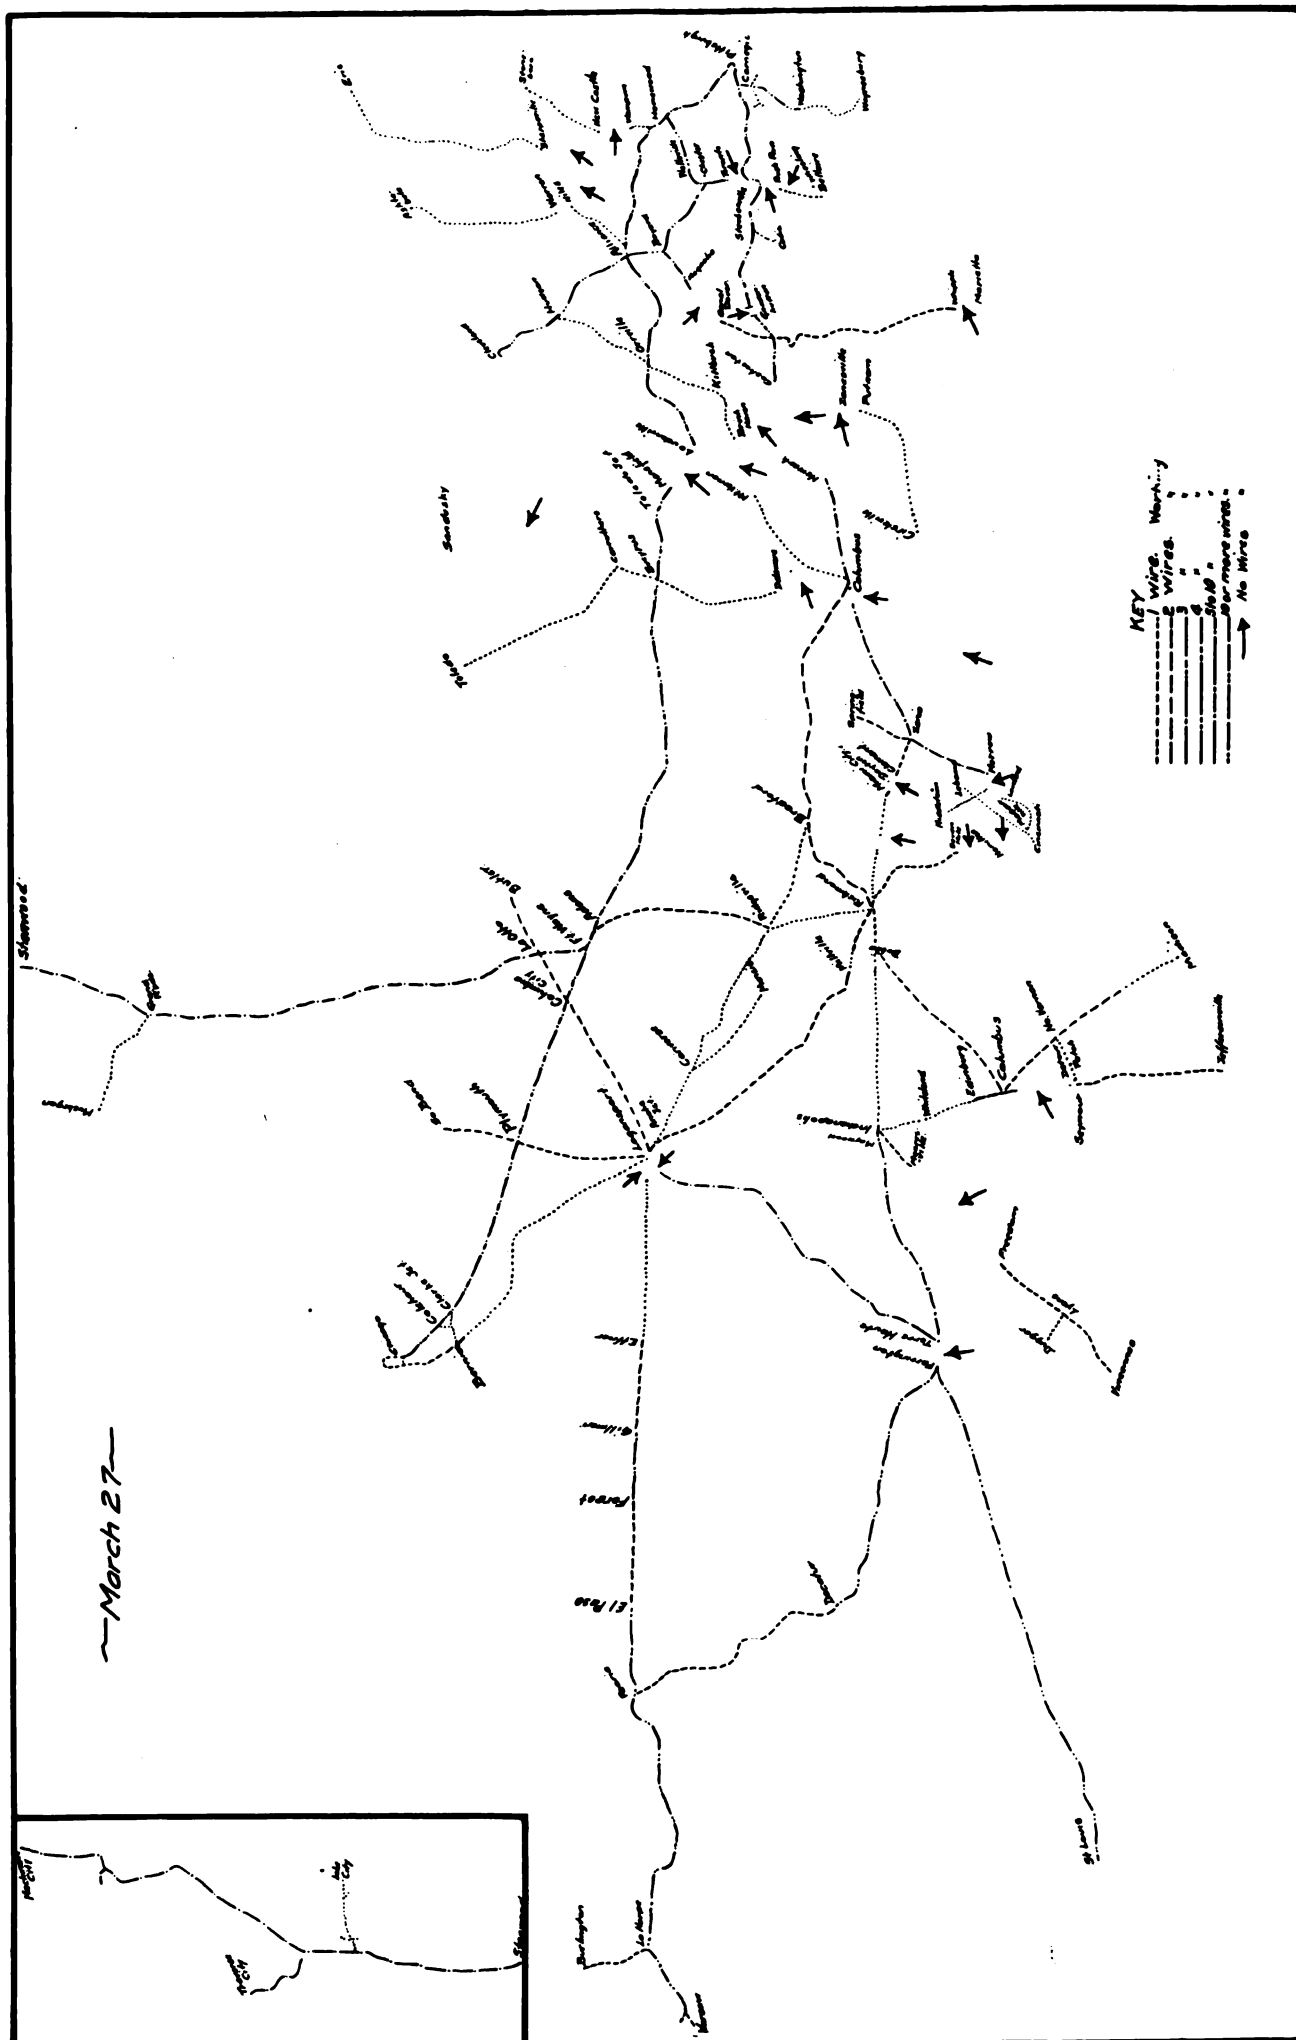
DIAGRAM OF TELEGRAPH FACILITIES, MARCH 27, 1913.

The damage on this and following days was from high water in the streams and was almost universal.
