**Subject: MO-79 over Noix Creek #K0487: (Pike 79 Bridges Programmatic Agreement),
Consulting Party Comments**

**Subject: MO-79 over Noix Creek #K0487: (Pike 79 Bridges Programmatic Agreement),
Consulting Party Concerns**

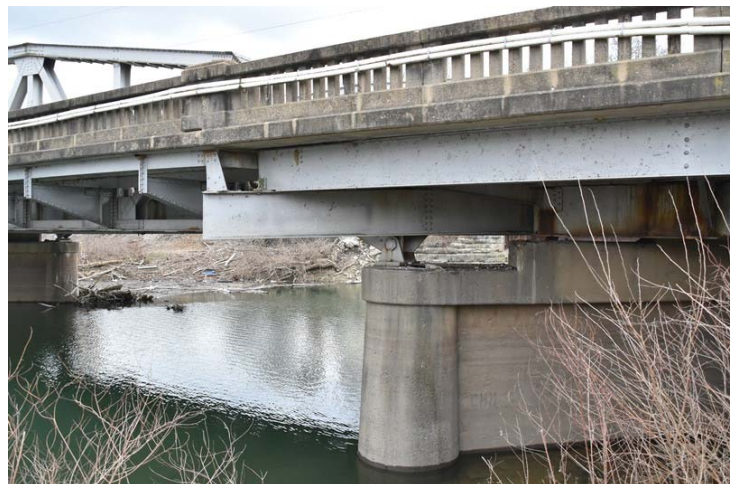
1. This bridge exhibits one of the most unusual skews I have ever seen in a bridge. Note in the photo shown, the bridge actually has a steel beam cantilevered off the concrete pier to support the approach stringer and sidewalk as well. A skew with such unusual design details represents an additional engineering design challenge (and unusual engineering) and adds to the historic significance (Criterion C) of the bridge. Skew has

design and fabrication challenges including but not limited to diaphragm placement, floor beam placement, bracing placement, pier design, etc.

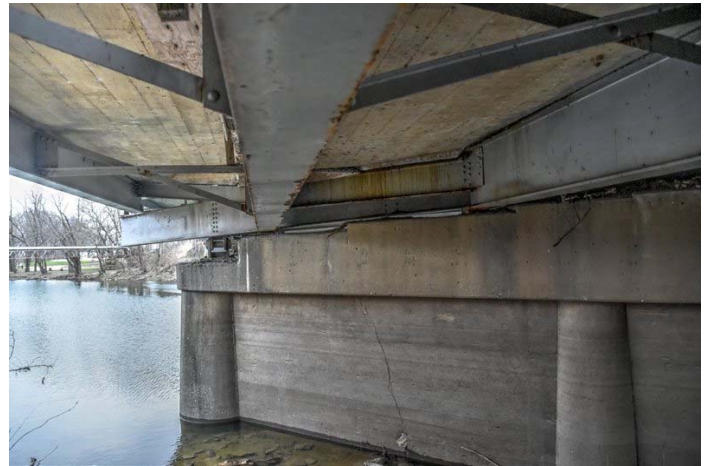
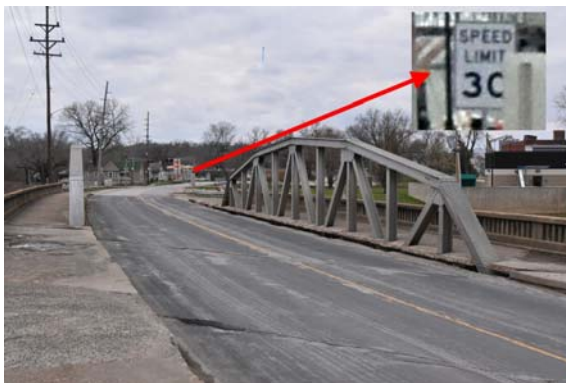
2. In addition to skew, this bridge is situated on a curve in the road and the bridge is designed with superelevation to allow traffic to safely navigate the curve at higher speeds. Superelevation is rare among bridges of this era, and it also represents an increased engineering and fabrication effort. Like skew, superelevation has design and fabrication challenges including but not limited to diaphragm placement, floor beam placement, bracing placement, pier design, etc. The adjacent photo shows the stepped design of the pier, which provides the foundation for a superelevated superstructure.

3. The combined additional engineering effort of unusual skew and curved/superelevation design suggests this bridge may be one of the most complex short-span truss bridges ever designed by the Missouri State Highway Department. Therefore, it should be considered to have HIGH historic significance on the state level. As such, it is my strong belief that extraordinary efforts to avoid adverse effect must be undertaken for this bridge, and any proposed adverse effect to this bridge will warrant unusually high levels of mitigation. See adjacent photo showing skewed, curved, superelevated design.

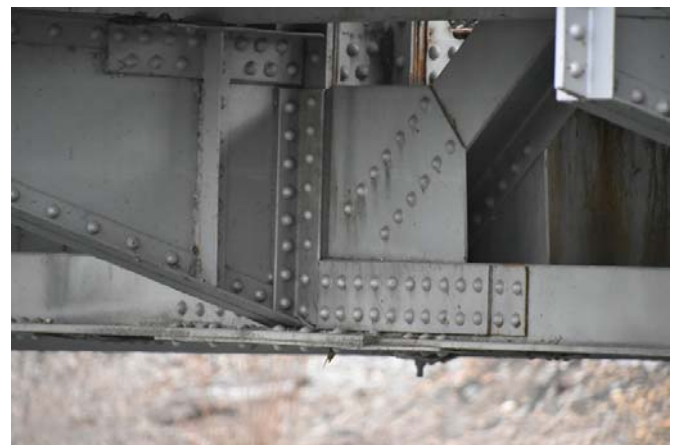
5. The truss of this bridge is in outstanding, excellent condition and repairs needed appear to be minor. Many far more deteriorated truss bridges have been rehabilitated across the country. If the overall rating is poor for this truss it is painfully obvious that such a rating would be due to small isolated areas. The overall truss again in excellent condition. Even lower chord connections (typical condition shown in adjacent photo) which are typical trouble spots are in GREAT condition!
