NEW YORK STATE BARGE CANAL, PARK AVENUE LIFT BRIDGE
(Erie Canal, Park Avenue Lift Bridge)
Park Avenue
Brockport
Monroe County
New York

WRITTEN HISTORICAL AND DESCRIPTIVE DATA

HAER No. NY-477

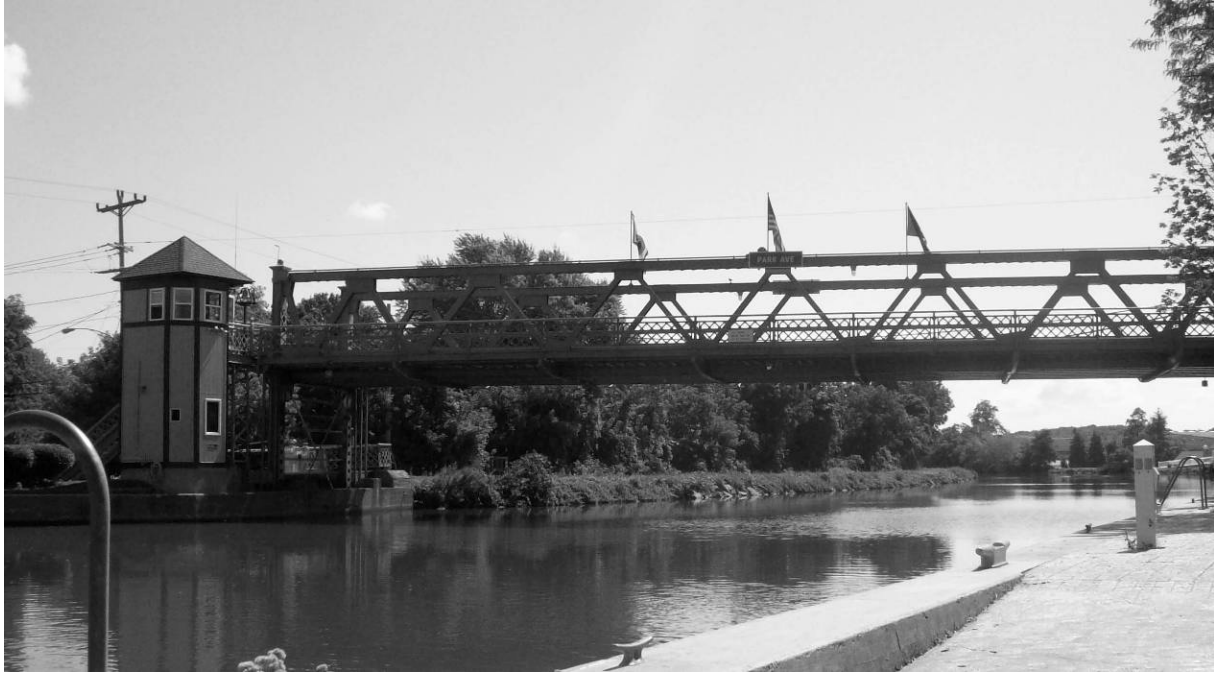
Image 1: Park Avenue Lift Bridge in raised position. Field photograph taken by HAER recording team, summer 2009.

Description: The sixteen vertical-lift bridges on the Erie Canal are Warren pony trusses raised by an electrically-driven system of cables, counterweights, and sheaves. As described in the New York State Barge Canal National Register nomination, “the moveable truss is supported by vertical lifting frames at either end. When the bridge is ‘down’ the lifting frames retract into the pits” located behind the bridge abutments. “The bridge is raised by cables that run from fixed anchor points at the top of the pits, down around sheaves at the bottom of the lifting frame, back up to sheaves at the top of the pit, and down to cast concrete counterweights. When the counterweights sink into the pits...the cables pull the lifting frames upward by the sheaves at their lower corners.” Each bridge has a control tower, with the motors and gearing generally located in the pit nearest to the tower.¹

The vertical-lift bridge carries Park Avenue over the Erie Canal.² The steel Warren pony truss has an open-grate deck. The abutments are concrete. Steel stairways at either end of the west side of the bridge provide access to the pedestrian walkway on the bridge, which is separated from the roadway by steel lattice. The machinery pits are covered with cross-hatch plates. The bridge is in good condition.

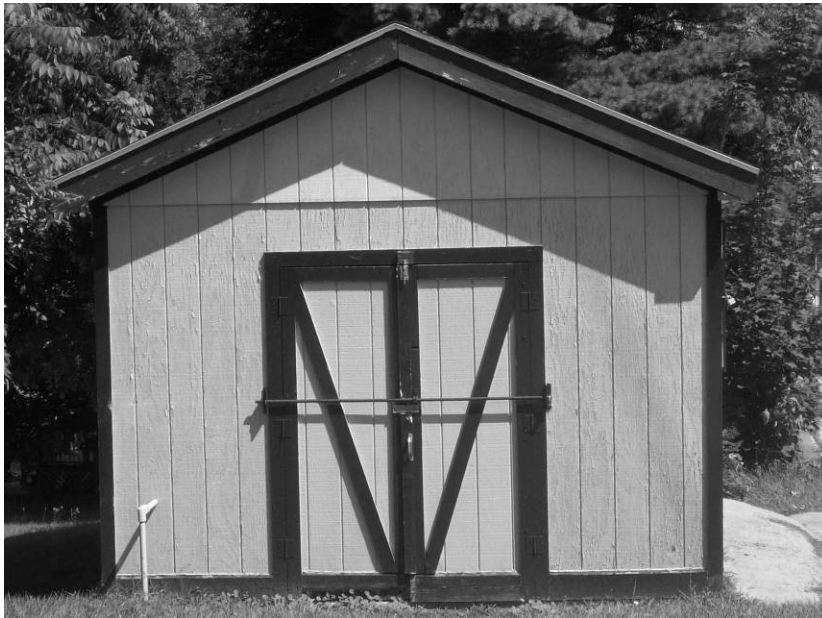
Image 2: Storage shed. Field photograph taken by HAER recording team, summer 2009.

Near the tower is a storage shed. The frame building with vertical-board siding is on a concrete foundation. The gable-front roof is covered with asphalt shingles, and there are one-over-one-

light vinyl windows with steel mesh coverings and a vertical-board paneled door. The shed is in good condition.
