OHIO DEPARTMENT OF TRANSPORTATION
HISTORIC BRIDGE SURVEY REPORT

SFN #: 7000243 County: RICHLAND Municipality: BELLVILLE
NR Rec: Eligible Previous Inventory/Date: FIRST INVENTORY, 1981 Status: Reserve

ODOT District: 03 Owner: STATE Lat/Long: 40.372400 / 82.304200
Location: 5.32 MILES N OF KNOX CO UTM:
Feature On: SR 13 (MAIN STREET)
Feature Intersected: CLEAR FORK CREEK
Type: THRU TRUSS Design: PARKER (RIVETED)
Material: STEEL
Railing Type: METAL PANEL RAILINGS
Spans: 1 Overall Length: 146 ft. Out to Out Width: 34.9 ft. Roadway Width: 30 ft.
Year Built: 1938 Alteration (Date): 1977, 1999 Source: ODOT Inspection Files
Designer/Builder OHIO STATE HIGHWAY DEPT/MT VERNON BRIDGE CO

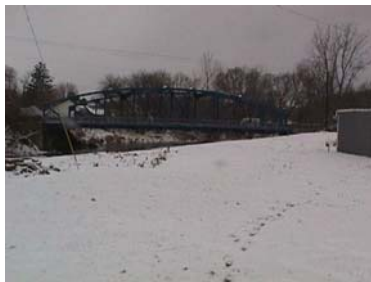
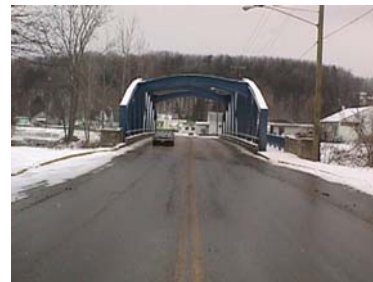
The skewed, 1 span, 146'-long, riveted Parker thru truss bridge has built-up chords and rolled I section web members. There is slightly arched upper lateral bracing at the five interior panel points of the five panel bridge. The end posts are vertical, not sloped, as is characteristic of most Parker trusses of this period. The gusset plates have been shaped to have curvilinear edges, rather than straight edges, giving them a "webbed" appearance. The bridge has rolled floorbeams, stringer, and a concrete deck. The cantilevered sidewalks are supported on built-up brackets and finished with standard decorative metal-panel railings. The stone-faced U-shaped wingwalls are completed by random ashlar parapets.
