Sproules Bridge

(Amaranth Structure No. 13)

General Information	Physical Details
Bridge No. A2	Type: Concrete Bowstring Arch
Ownership: Township of Amaranth	Span: Single
Construction Date: 1912	Dimensions: 3.9m Width
Water Crossing: Willow Brook	Materials: Reinforced Concrete

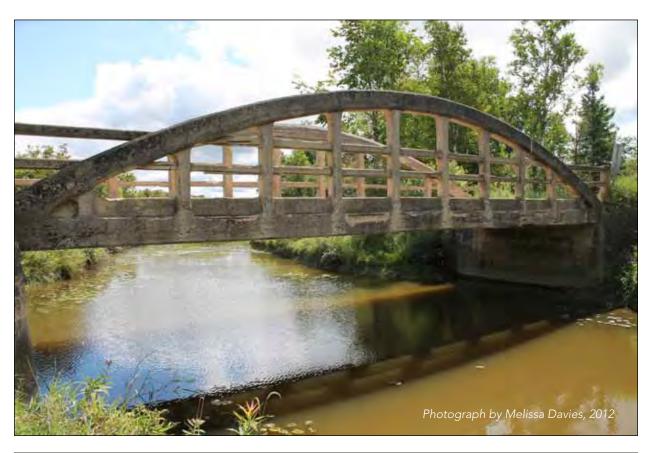
While of a basic type, there is considerable variety among bowstring truss structures. Sproules Bridge has relatively small arches and its concrete trusses and railings are uniquely thin. Concrete railings flank each arch of the bridge and end with a decoratively topped post. The thin board finish is still visible in the concrete and a plaque appears to be missing from the bridge.
