Dufferin Bridge No. 10

(Southgate Bridge No. S1)

General Information	Physical Details
Bridge No. MC1	Type: Through Truss
Ownership: County of Dufferin Township of Southgate	Span: Single
Construction Date: 1920	Dimensions: 25.6m x 6m (LxW)
Water Crossing: Grand River	Materials: Steel, Timber, Concrete

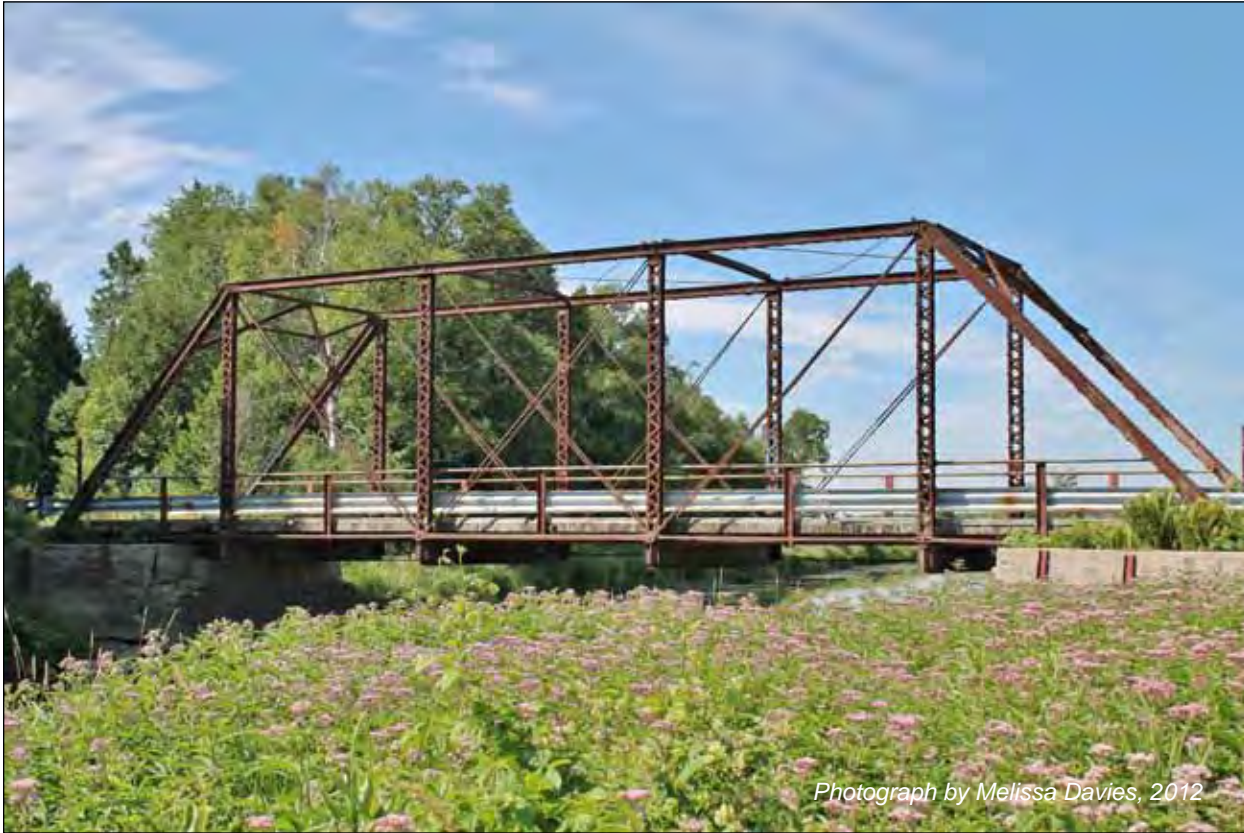
Photograph by Melissa Davies, 2012

Dufferin Bridge No. 10 is a truss frame structure with a timber deck and curb. It is supported by seven longitudinal and four transverse riveted steel I-beams. Remnant abutments from a previous structure remained on either side of the current bridge and they were incorporated into the newer abutments, although they bear no weight.
