Historic Register Report

Historic Name: Monroe Street Bridge

NATIONAL REGISTER OF HISTORIC PLACES
INVENTORY -- NOMINATION FORMSEE INSTRUCTIONS IN *HOW TO COMPLETE NATIONAL REGISTER FORMS*
TYPE ALL ENTRIES -- COMPLETE APPLICABLE SECTIONS**1 NAME**

1. SITE I.D. NO										HAER INVENTORY										Historic American Engineering Record Department of the Interior, Washington, D.C. 20240									
2. INDUSTRIAL CLASSIFICATION Bridges, Trestles, and Aqueducts										3. PRIORITY 1										4. DANGER OF DEMOLITION? (SPECIFY THREAT) <input type="checkbox"/> YES <input checked="" type="checkbox"/> NO <input type="checkbox"/> UNKNOWN									
ARCH: concrete										5. DATE 1909-11										6. GOVT SOURCE OF THREAT OWNER ADMIN									
City Designation Number: 371001001										7. OWNER/ADMIN City of Spokane										9. OWNER'S ADDRESS West 221 Wall Street Spokane, Washington

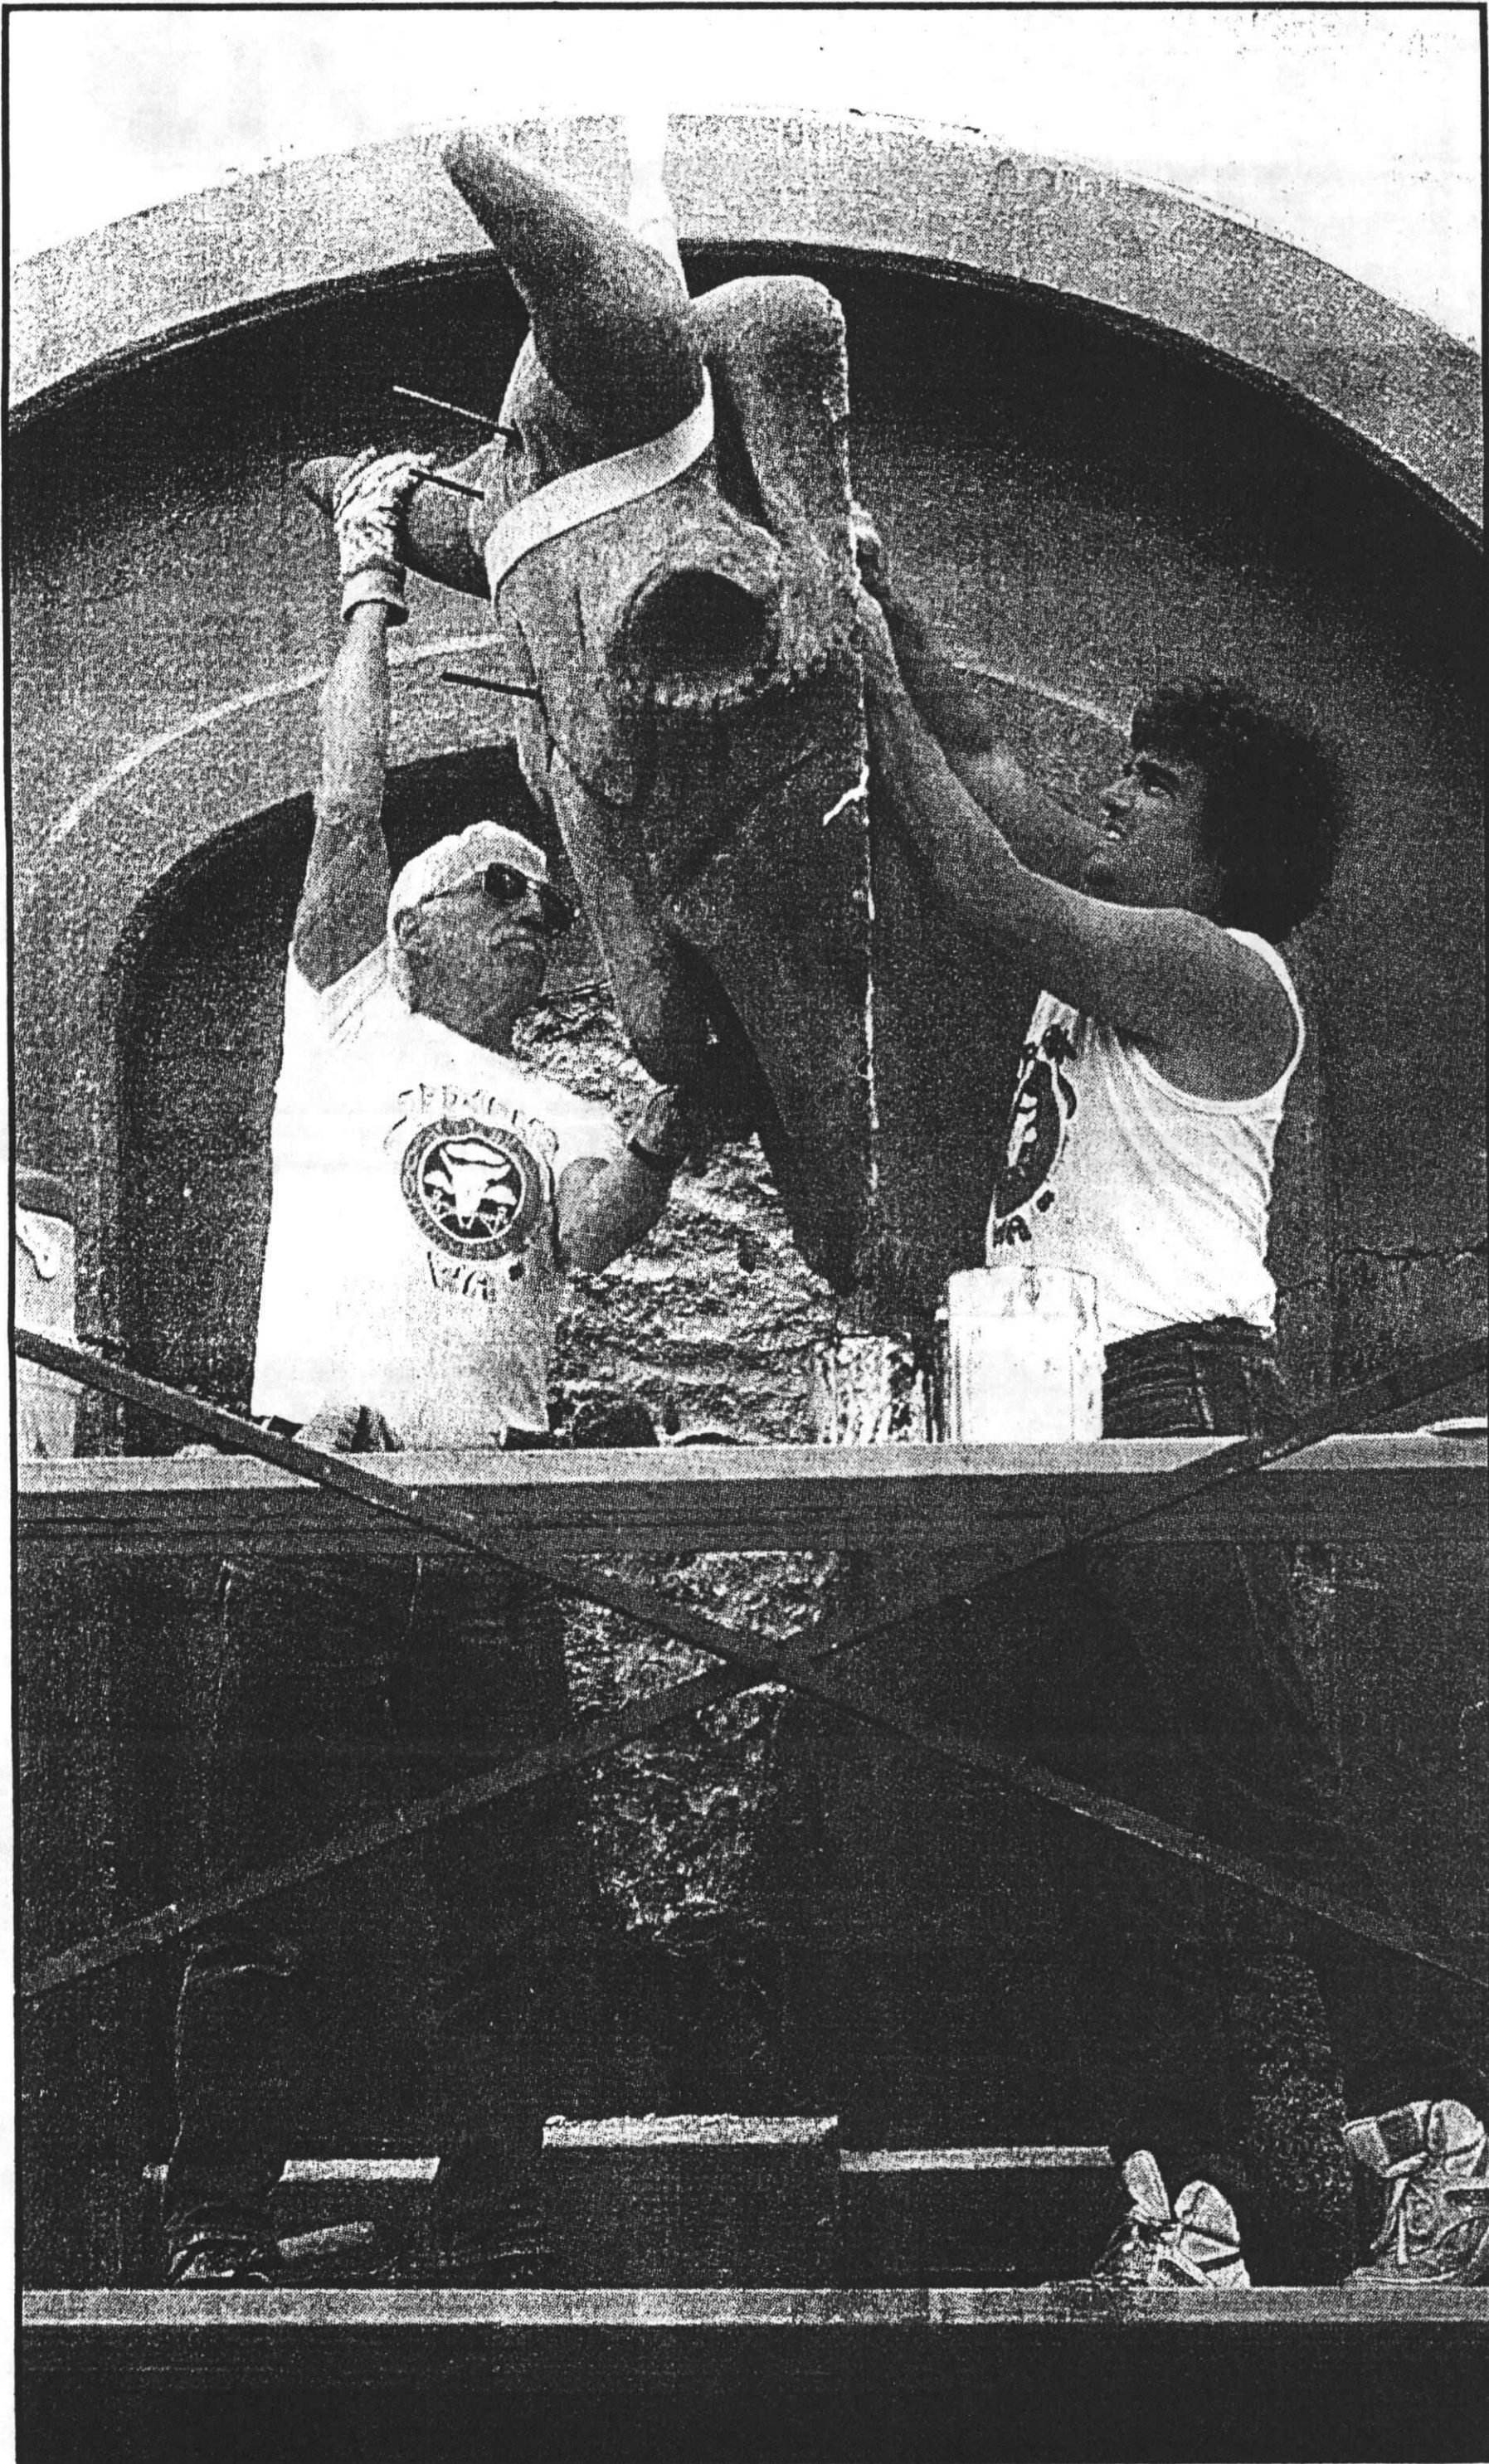
Staff photo by Shawn Jacobson

HEAD'S UP. City employee Jack Fruit helps sculptor Don Rodgers prepare a new buffalo skull for attachment to the Monroe Street Bridge Tuesday afternoon. A truck struck the original skull. Rodgers made a mold from another of the bridge's skulls last year.

The bridge is in excellent condition for weight bearing capacity. Its initial design for street cars has provided a strength more than equal to the present four lane traffic. The only serious structural damage to the bridge in its history occurred when a direct collision removed three rail sections over the 120 foot south arch. Replacement was possible by constructing a mold from another portion of the railing.
