Johnson Street Bridge Condition Assessment Report

EXECUTIVE SUMMARY

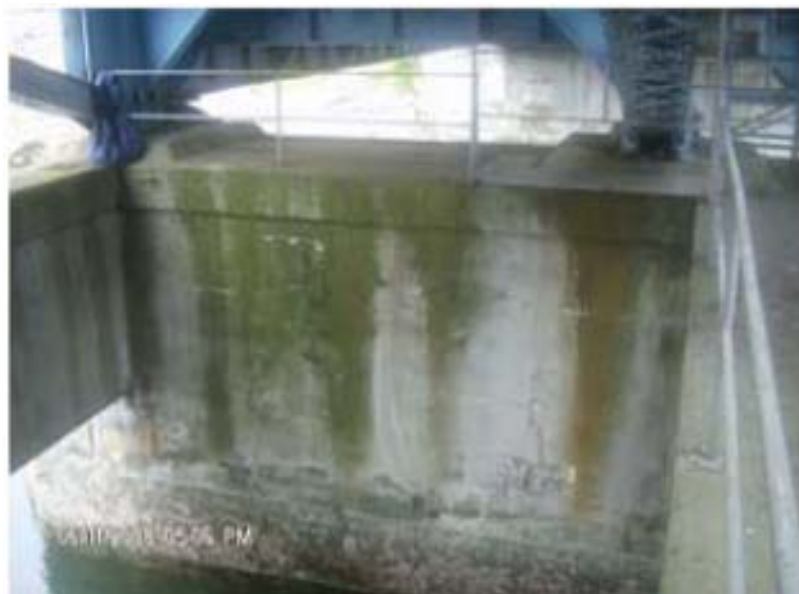
Figure 3.3.2 –Pier 3, West face showing minor cracking and efflorescence

It was noticed that the north east bearing on Pier 3 has reduced anchor bolt stiffeners, so it should be noted that thorough cleaning and a weld repair to replace the existing stiffeners should be carried out.

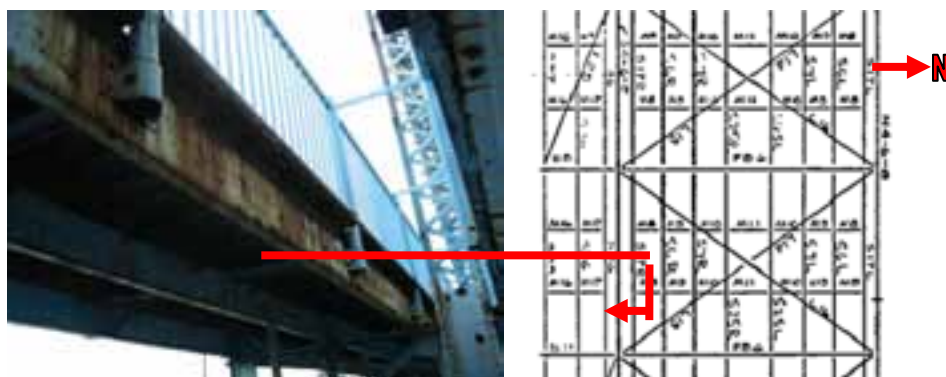
Corrosion and section loss in the deck beams for the road and pedestrian walkways were observed, see **Figure 3.3.10** and **Figure 3.3.11**. It appears that run-off from the deck passes through the open steel grid and gets trapped along the top flanges and the bottom flanges of the supporting beams. Consequently, extensive corrosion has developed on the flanges, webs and rivets on a majority of the beams underneath the lift span, see **Figure 3.3.12**. The webs on the beams in this span have also experienced up to 60% or more paint loss.

Figure 3.3.11 – Girder under pedestrian walkway, North face

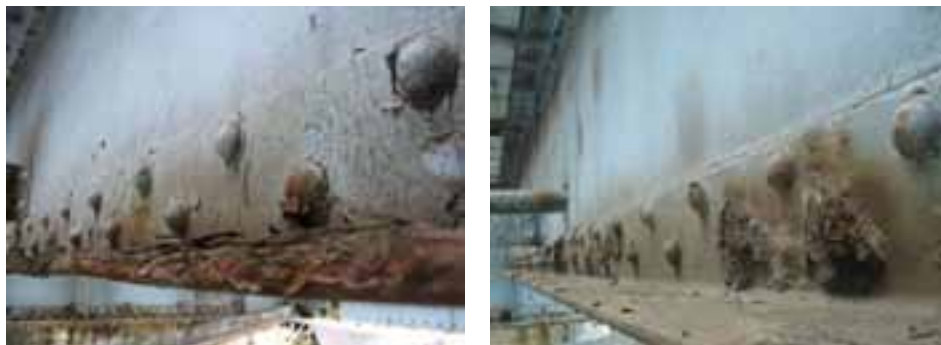
Figure 3.3.12 – Typical corroded bottom flange and rivets on floorbeam

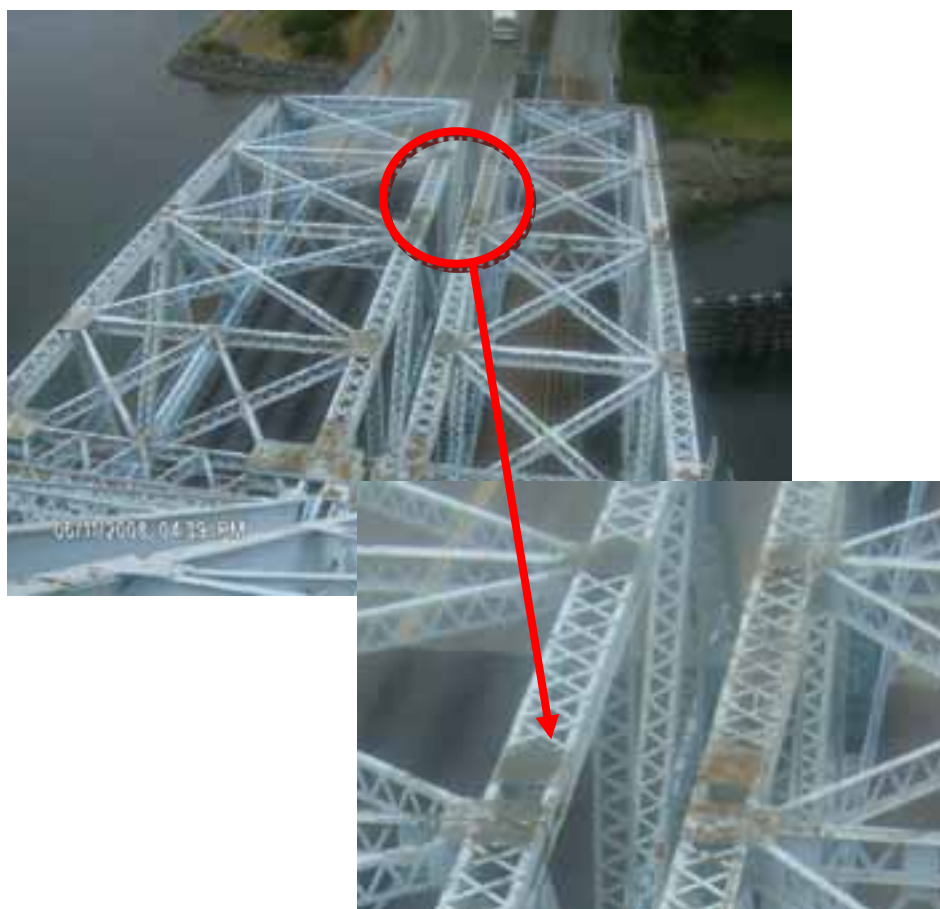
Figure 3.3.13 shows the aerial view of the lift span. There is minimal corrosion on upper lateral bracing. However, the horizontal gusset plates have extensive corrosion and should be cleaned or restored, as the paint has failed there.

Figure 3.3.13 – Aerial view of lift span, (looking west)

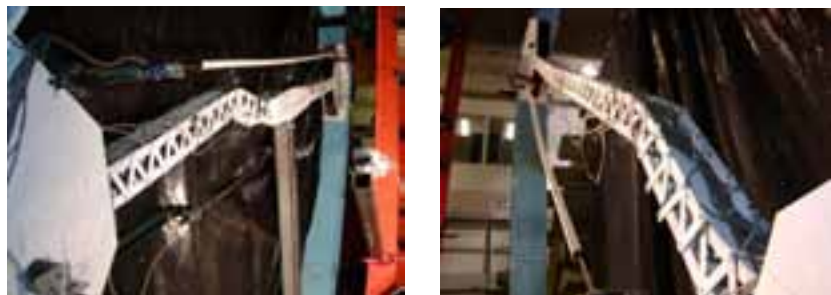
- The bridge was not designed to any seismic standard;
- Reinforcement details in Piers P2 and P3 could result in brittle failure;
- Laced, built-up, riveted members perform poorly under seismic loads (see **Figure 4.5** that shows the result of tests carried out for the Bay Bridge seismic retrofit);

Figure 4.5 – Photographs of Failures in Laced Members Caused by Cyclic Loads

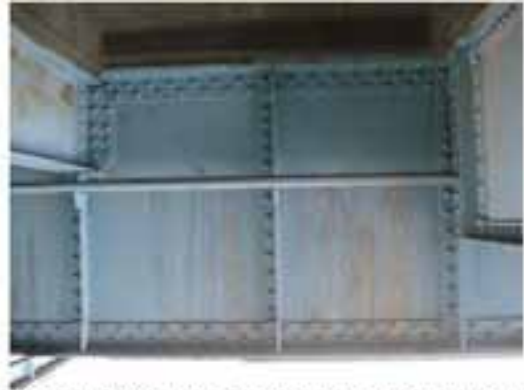
Span 1 - South Side, North Face Built Up Panel
Top Lateral Bracing
Lift Truss

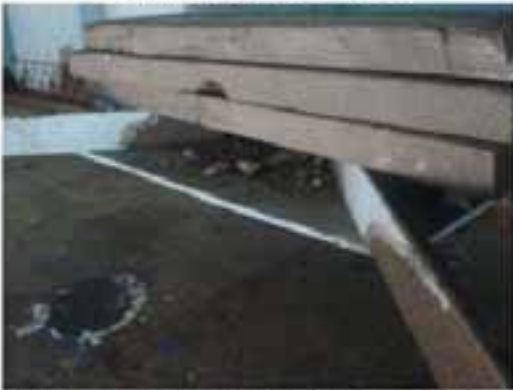
Span 1 - Lateral Bracing Connection
Top Lateral Bracing
Lift Truss
Starting East Working West

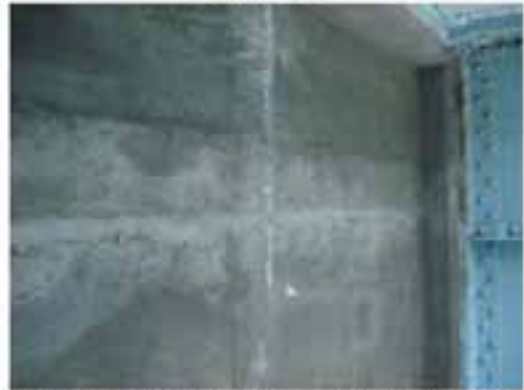
Span 1 - Efflorescence on Soffit
Top Lateral Bracing
Lift Truss
Starting East Working West

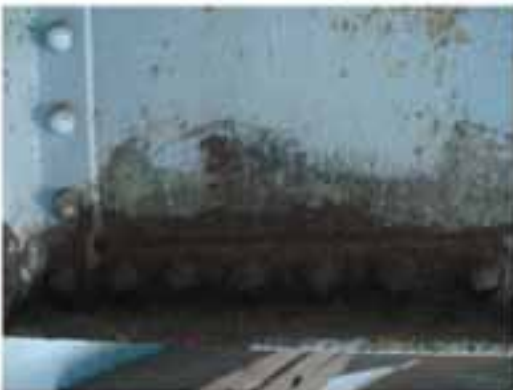
Span 1 - Corrosion on Bottom Flange and Rivets
Top Lateral Bracing
Lift Truss

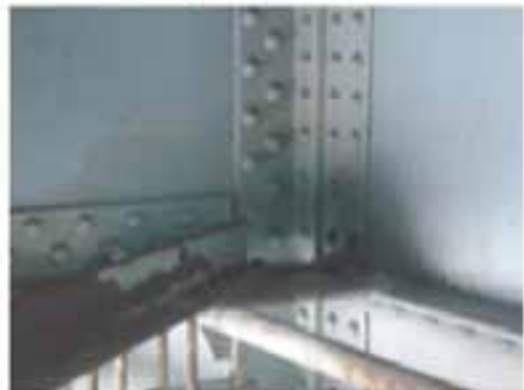
Span 1 - Lateral Bracing Connection
Top Lateral Bracing
Lift Truss
Starting East Working West

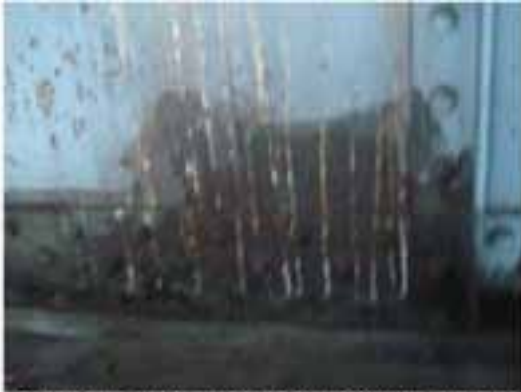
Span 1 - Paint Loss and Corrosion on Bottom FlangeTop Lateral Bracing Lift Truss

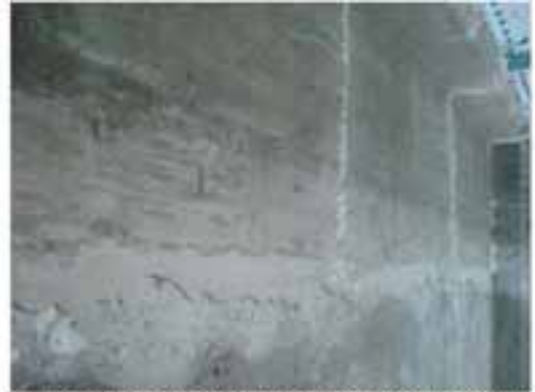
Span 1 - Efflorescence on Concrete SoffitTop Lateral Bracing Lift Truss Starting East Working West

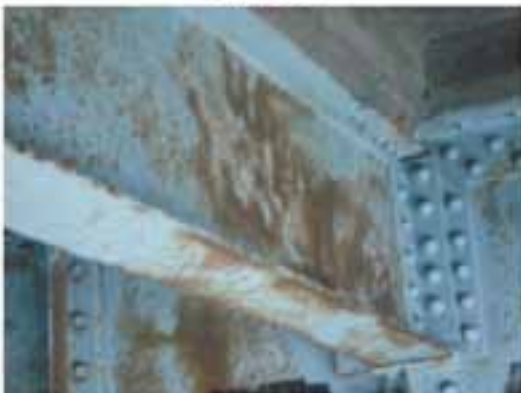
Span 1 - Paint Loss and Corrosion on Floor BeamTop Lateral Bracing Lift Truss

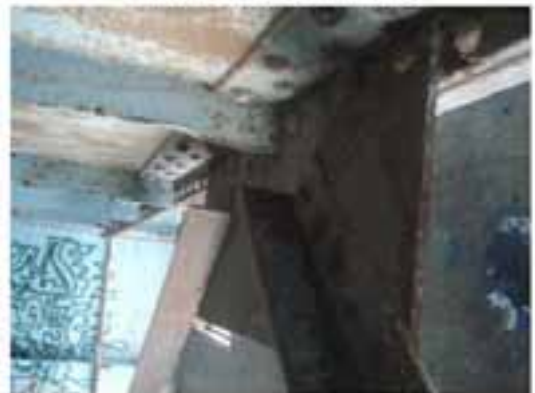
Span 1 - Corrosion on Lateral Bracing Connection PlateTop Lateral Bracing Lift Truss

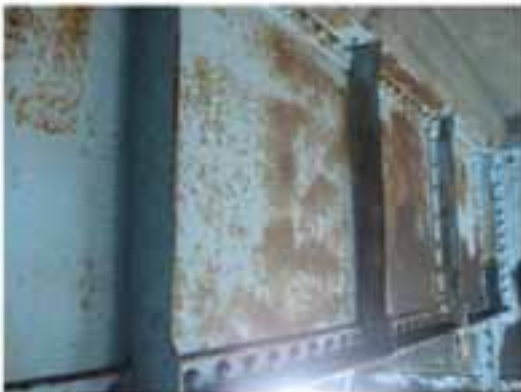
Span 1 - Corrosion on Built-Up Web PanelsTop Lateral Bracing Lift Truss Starting East Working West

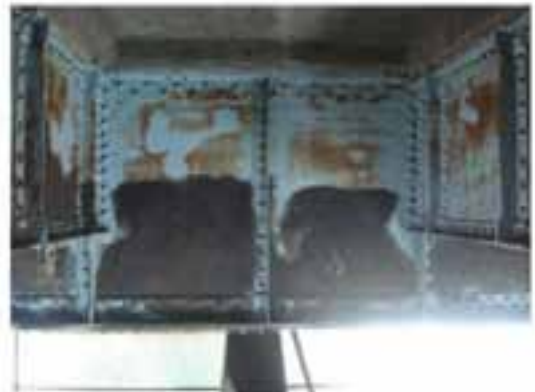
Span 1 - Corrosion on Web of Built-Up MembersTop Lateral Bracing Lift Truss

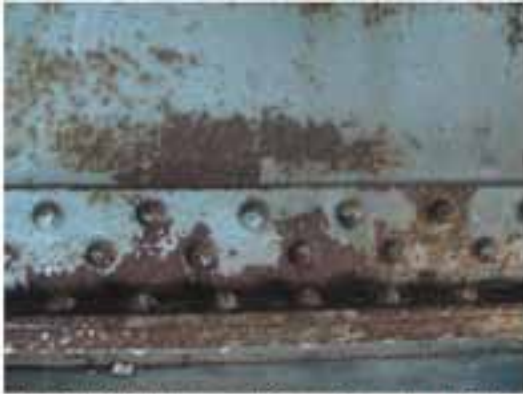
**Span 1 - Typical Paint Loss and Corrosion along Bottom Flange
of Beams Top Lateral Bracing
Lift Truss**

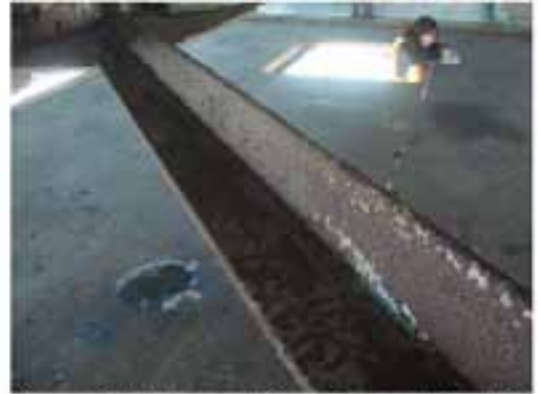
**Span 1 - Severe Paint Loss and Corrosion on Lateral Bracing Top
Lateral Bracing
Lift Truss**

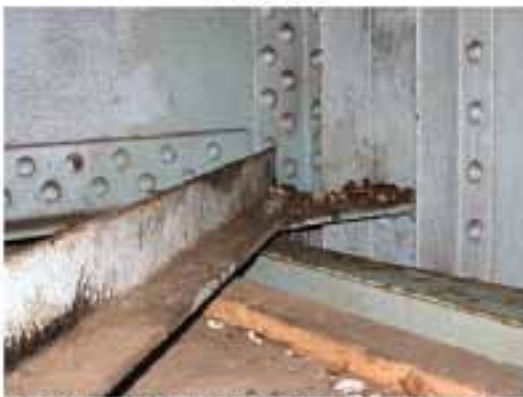
**Span 1 - Debris Build Up at Lateral Bracing Connection, Paint
Loss and Corrosion Top Lateral Bracing
Lift Truss**

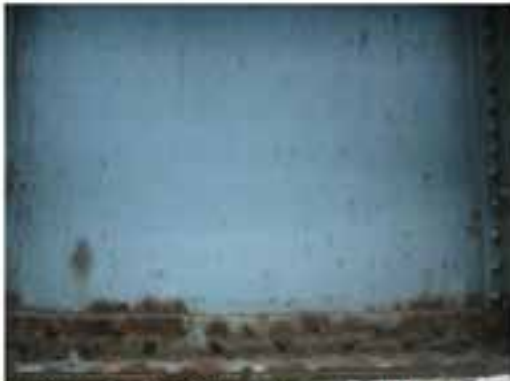
Span 2 - Corrosion on Bottom Flange and Rivets Top Lateral
Bracing
Lift Truss

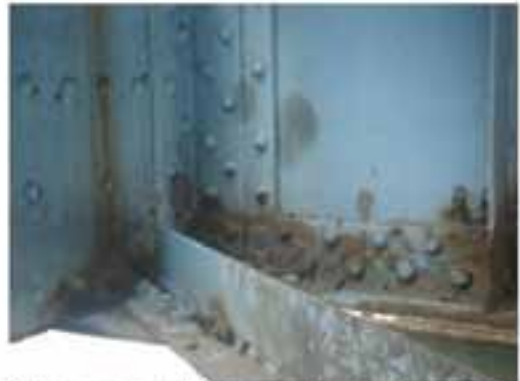
Span 2 - Corrosion on Rivets and Bottom Flange Top Lateral
Bracing
Lift Truss

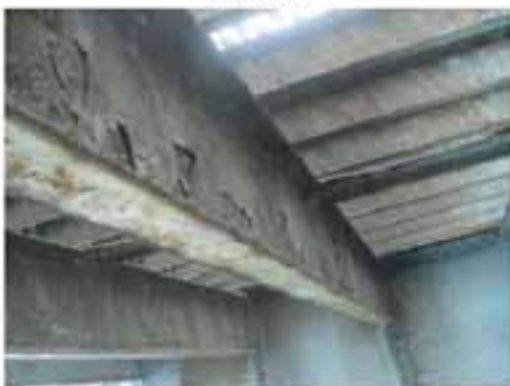
Span 2 - Paint Loss on Web Top Lateral Bracing
Lift Truss
Starting East Working West

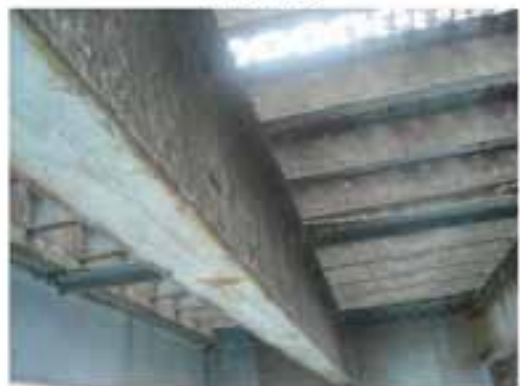
Span 2 - Pain Loss on Web Top Lateral Bracing
Lift Truss
Starting East Working West

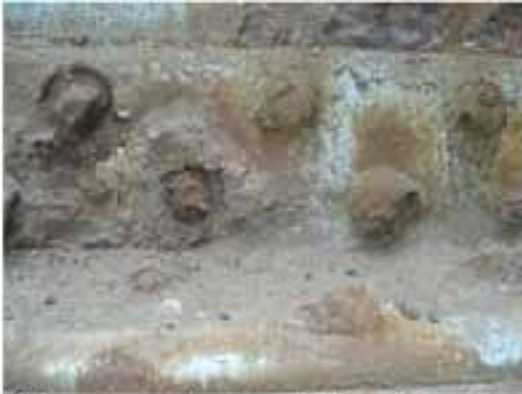
Span 2 - Corrosion on Rivets and Bottom Flange Top Lateral Bracing Lift Truss

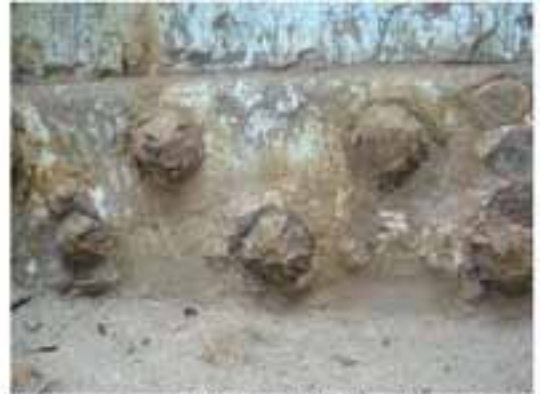
Span 2 - Corrosion on Rivets and Bottom Flange Top Lateral Bracing Lift Truss

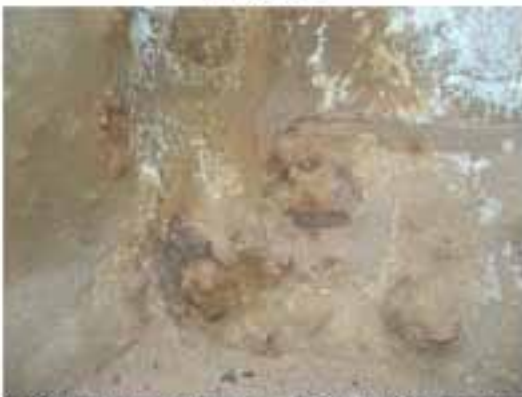
Span 2 - Corrosion on Rivets and Bottom Flange Top Lateral Bracing Lift Truss

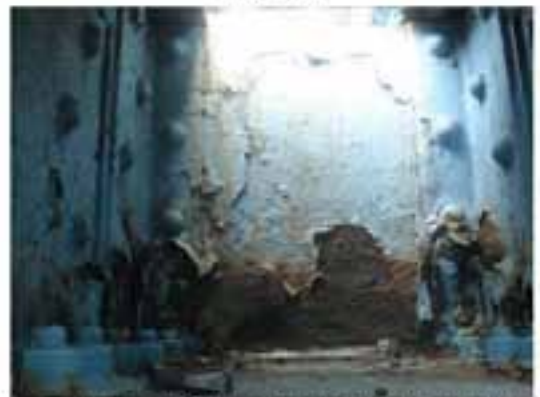
Span 2 - Paint Loss and Corrosion inside Built Up Members Top Lateral Bracing Lift Truss

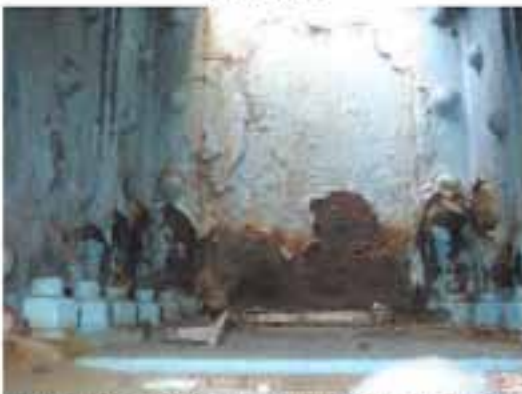
Span 2 - Pain Loss and Corrosion inside Built Up Members Top Lateral Bracing Lift Truss

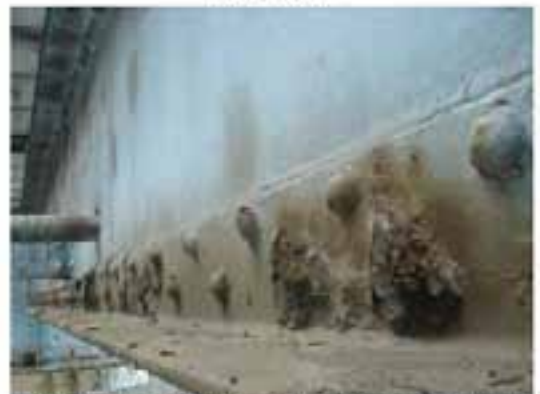
Span 2 - Corrosion on Rivets and Bottom Flange Top Lateral Bracing Lift Truss

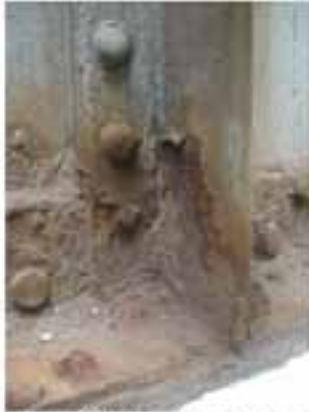
Span 2 - Corrosion on Rivets and Bottom Flange Top Lateral Bracing Lift Truss

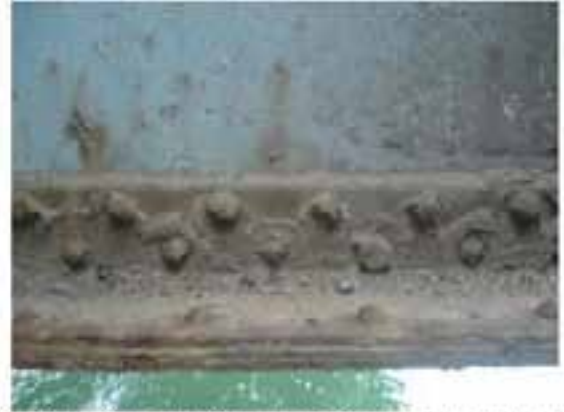
Span 2 - Corrosion on Rivets and Bottom Flange Top Lateral Bracing Lift Truss

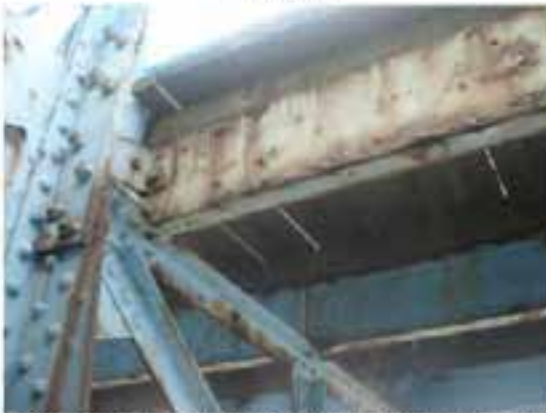
Span 2 - Corrosion Along Sidewalk Top Lateral Bracing Lift Truss Starting East Working West

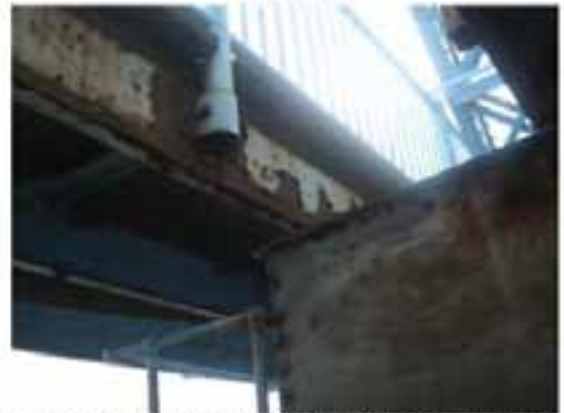
Span 2 - Corrosion Along Sidewalk Top Lateral Bracing Lift Truss Starting East Working West

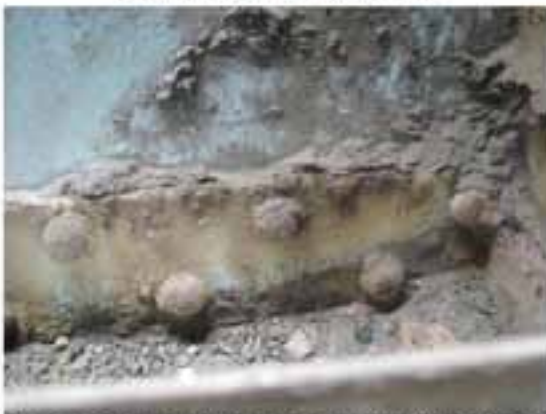
Span 2 - Corrosion on Rivets and Bottom Flange Top Lateral Bracing Lift Truss

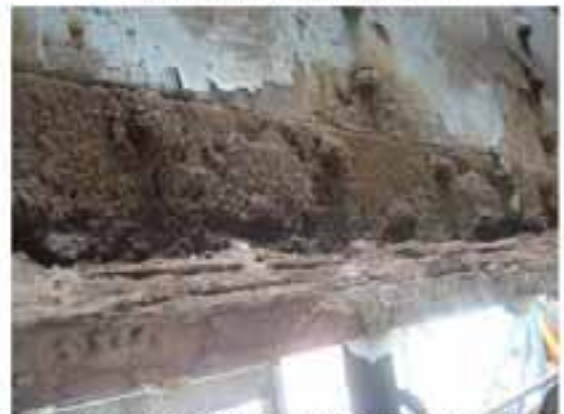
Span 2 - Corrosion on Rivets and Bottom Flange Top Lateral Bracing Lift Truss

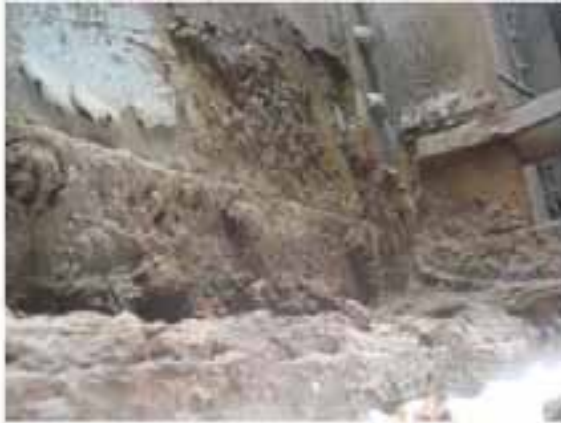
**Span 2 - Corrosion on Rivets and Bottom FlangeTop Lateral
Bracing
Lift Truss**

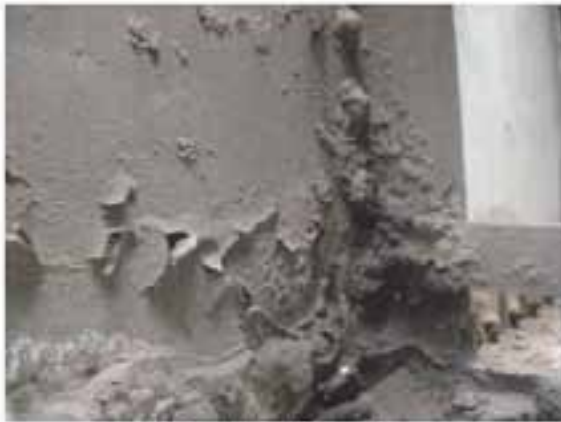
**Span 2 - Corrosion on Rivets and Bottom FlangeTop Lateral
Bracing
Lift Truss**

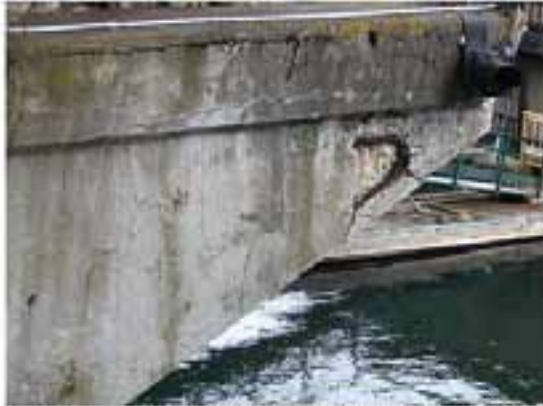
**Span 2 - Exposed Rebar on Pier Top Lateral Bracing
Lift Truss
Starting East Working West**

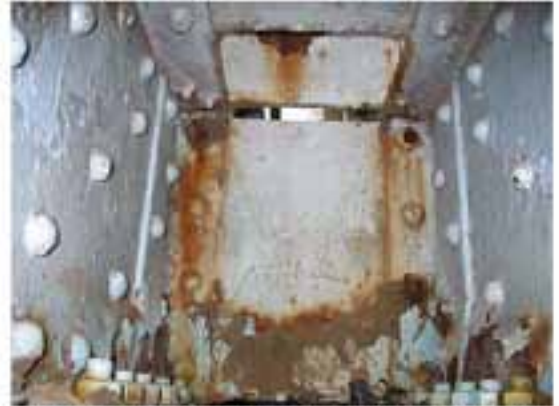
**Span 2 - Corrosion inside Built Up Member Top Lateral Bracing
Lift Truss
Starting East Working West**

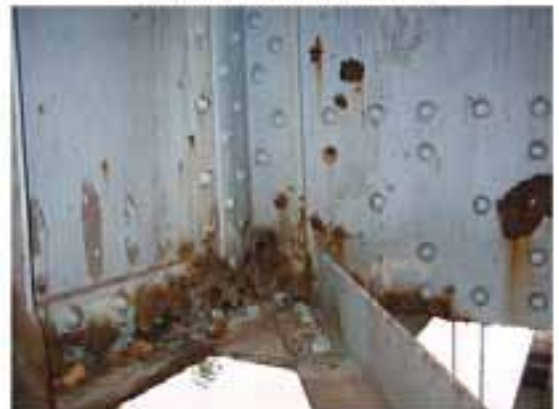
**Span 2 - Corrosion on Rivets and Bottom Flange Top Lateral
Bracing
Lift Truss**

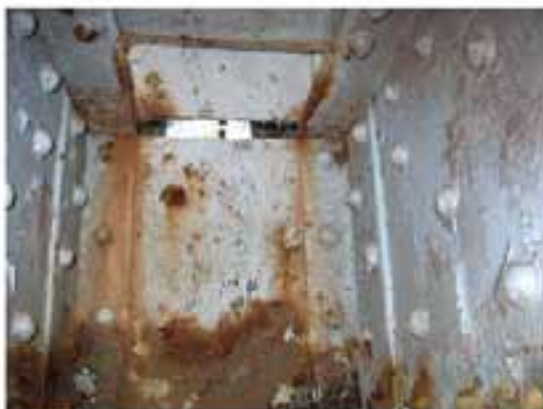
**Span 2 - Corrosion on Rivets and Bottom Flange Top Lateral
Bracing
Lift Truss**

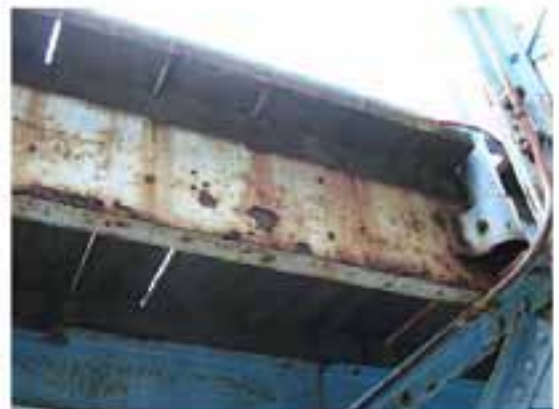
**Span 2 - Corrosion inside Built Up Member Top Lateral Bracing
Lift Truss
Starting East Working West**

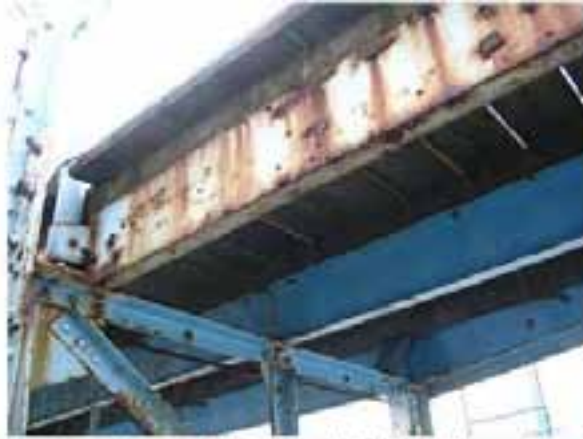
**Span 2 - Corrosion Along Edge of Walkway Top Lateral Bracing
Lift Truss
Starting East Working West**

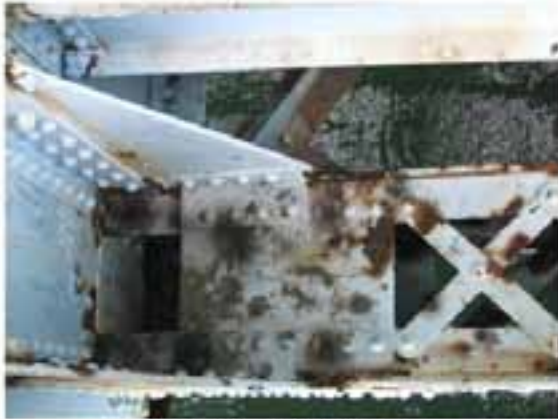
**South Side - Sout Face
Member to Member Connections
Starting East Working West**

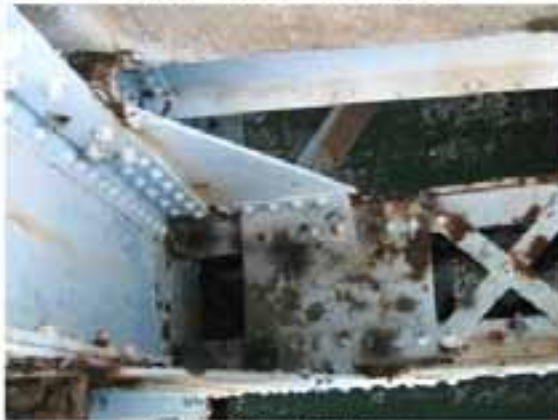
**South Side - Sout Face
Member to Member Connections
Starting East Working West**

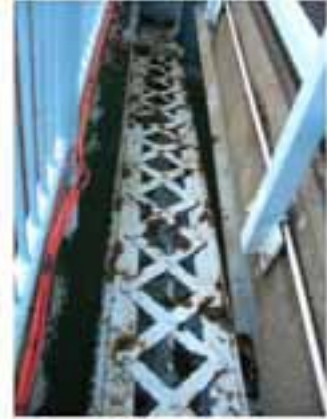
**South Side - Sout Face
Member to Member Connections
Starting East Working West**

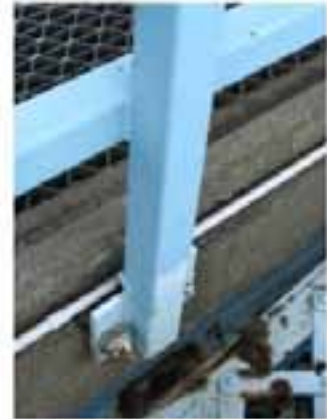
**South Side - Sout Face
Member to Member Connections
Starting East Working West**

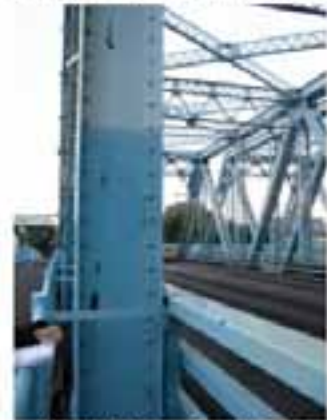
**South Side - Sout Face
Member to Member Connections
Starting East Working West**

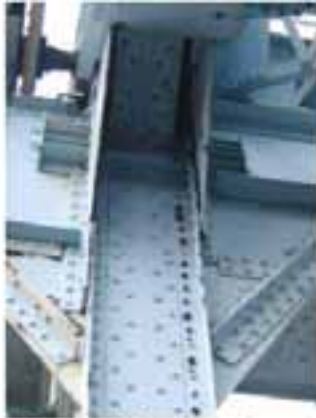
**South Side - Sout Face
Member to Member Connections
Starting East Working West**

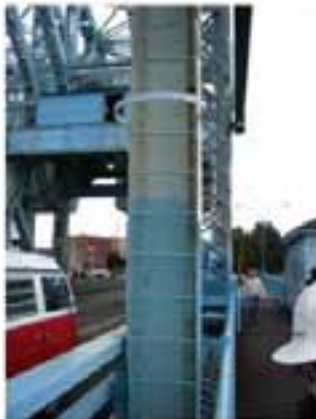
**South Side - Sout Face
Member to Member Connections
Starting East Working West**

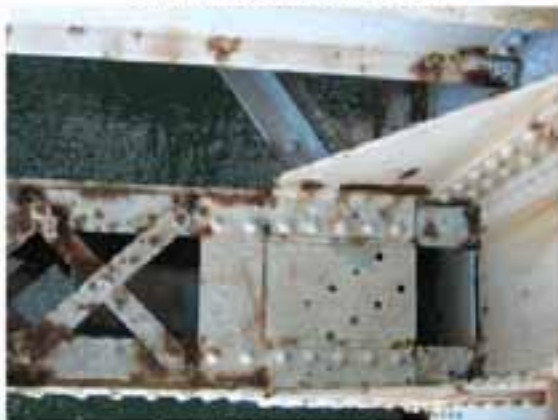
**South Side - Sout Face
Member to Member Connections
Starting East Working West**

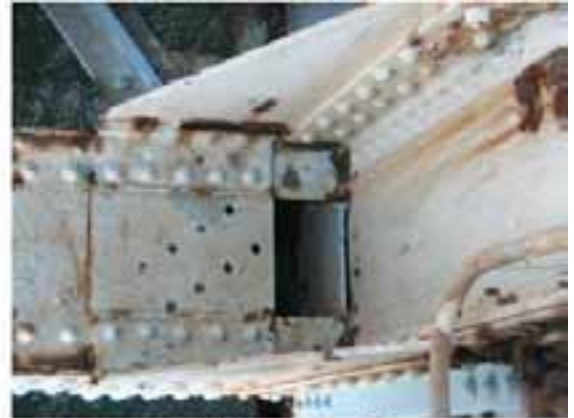
**South Side - Sout Face
Member to Member Connections
Starting East Working West**

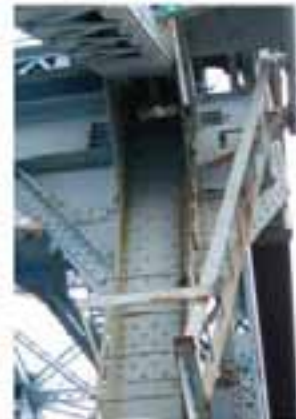
**South Side - Sout Face
Member to Member Connections
Starting East Working West**

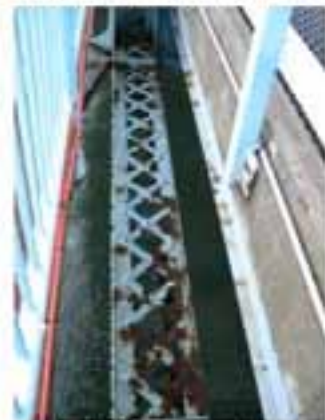
**South Side - Sout Face
Member to Member Connections
Starting East Working West**

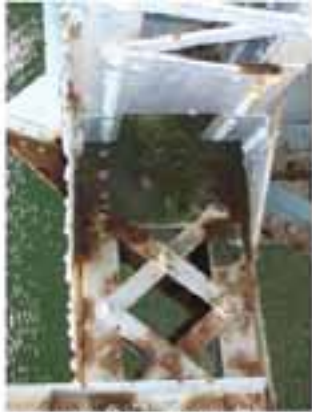
**South Side - Sout Face
Member to Member Connections
Starting East Working West**

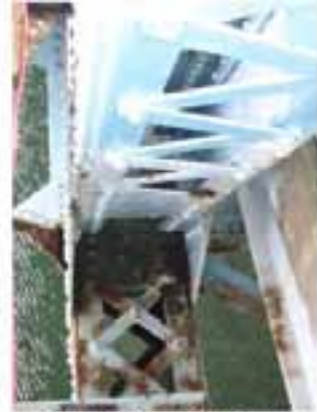
**South Side - Sout Face
Member to Member Connections
Starting East Working West**

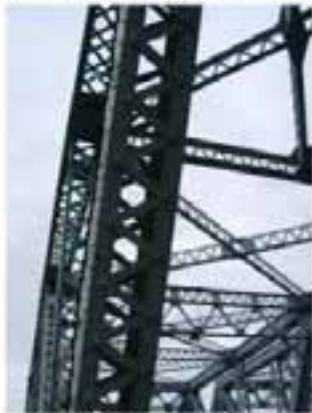
**South Side - Sout Face
Member to Member Connections
Starting East Working West**

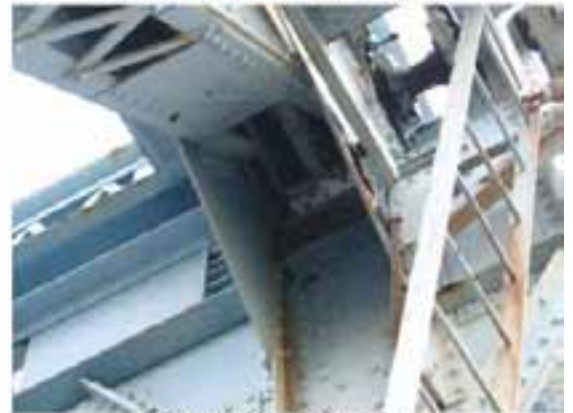
**South Side - Sout Face
Member to Member Connections
Starting East Working West**

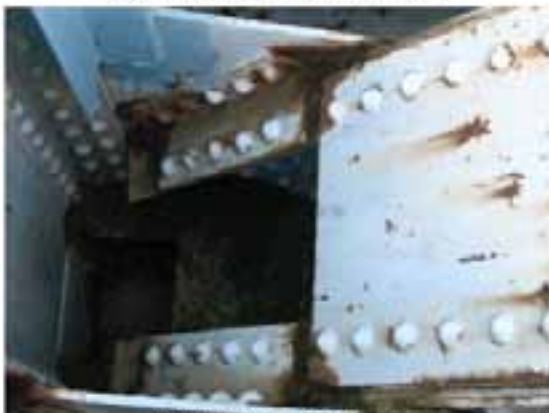
**South Side - Sout Face
Member to Member Connections
Starting East Working West**

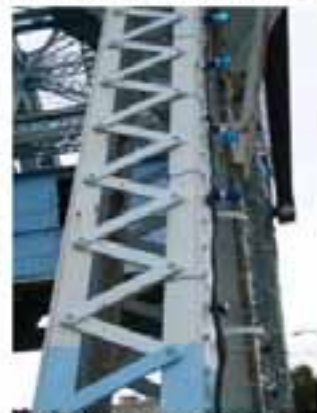
**South Side - Sout Face
Member to Member Connections
Starting East Working West**

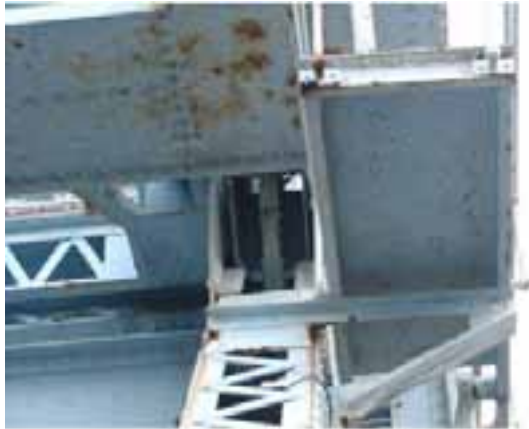
**South Side - Sout Face
Member to Member Connections
Starting East Working West**

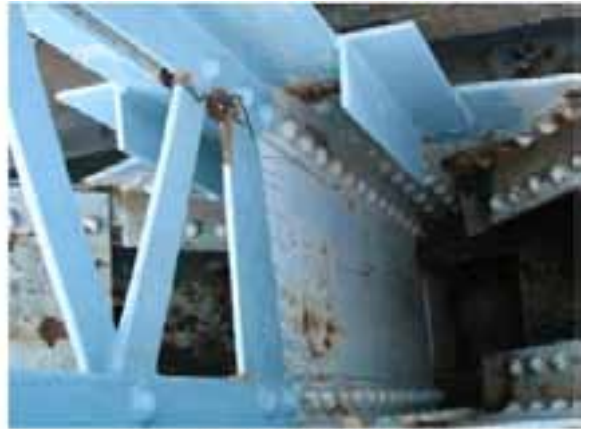
**South Side - Sout Face
Member to Member Connections
Starting East Working West**

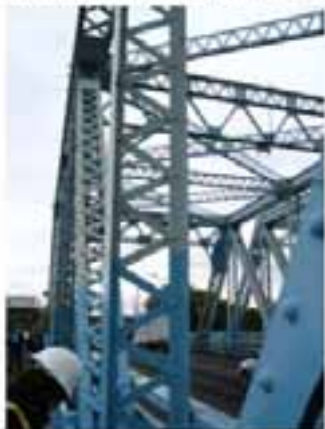
**South Side - Sout Face
Member to Member Connections
Starting East Working West**

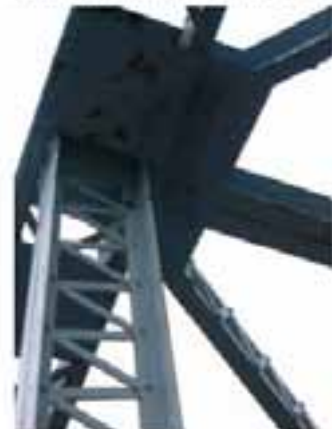
**South Side - Sout Face
Member to Member Connections
Starting East Working West**

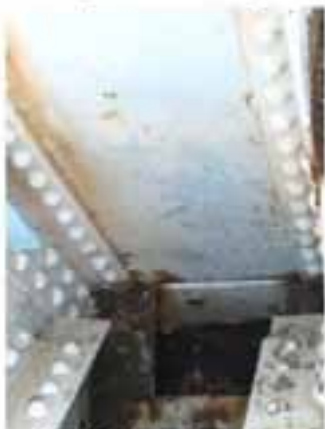
**South Side - Sout Face
Member to Member Connections
Starting East Working West**

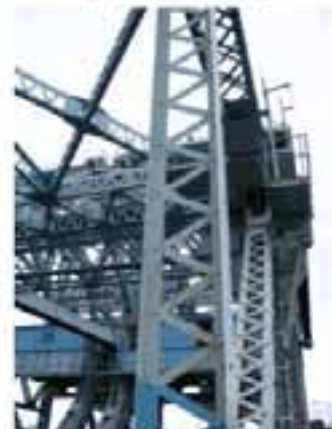
**South Side - Sout Face
Member to Member Connections
Starting East Working West**

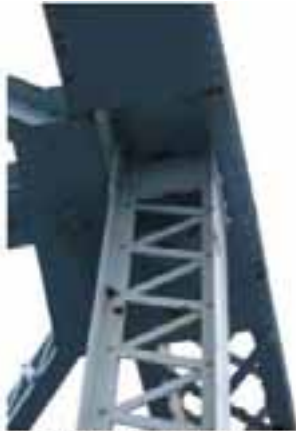
**South Side - Sout Face
Member to Member Connections
Starting East Working West**

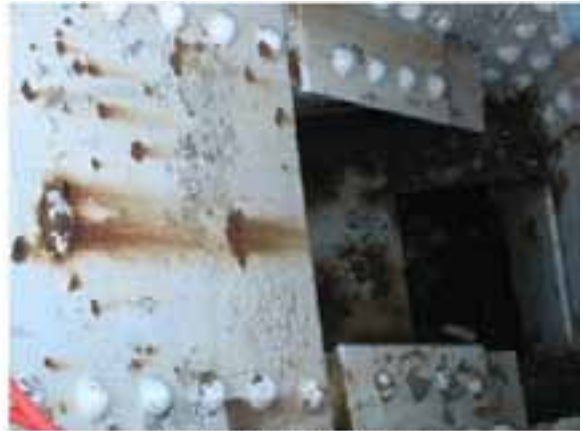
**South Side - Sout Face
Member to Member Connections
Starting East Working West**

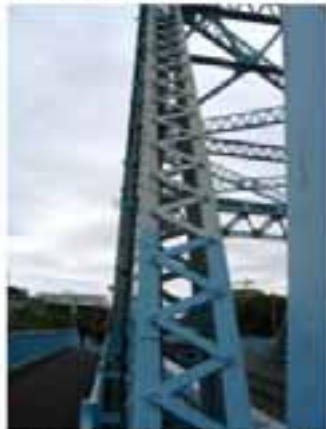
**South Side - Sout Face
Member to Member Connections
Starting East Working West**

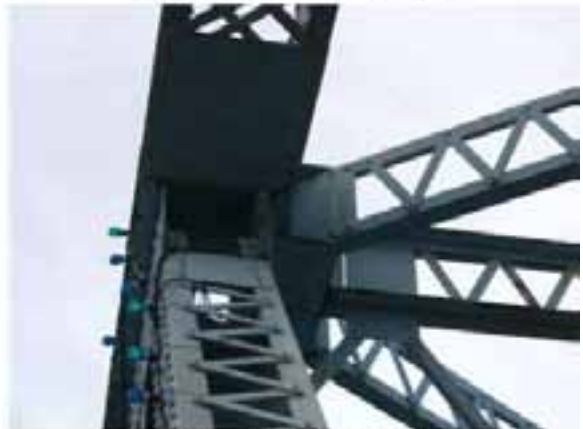
**South Side - Sout Face
Member to Member Connections
Starting East Working West**

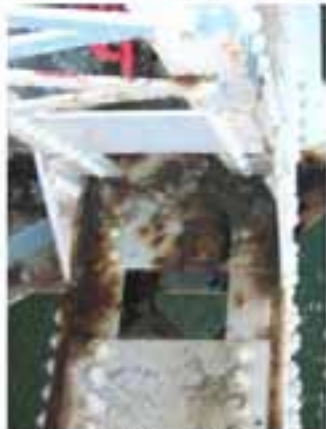
**South Side - Sout Face
Member to Member Connections
Starting East Working West**

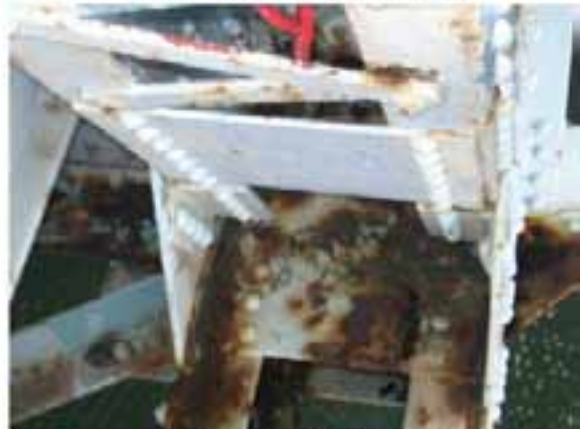
**South Side - Sout Face
Member to Member Connections
Starting East Working West**

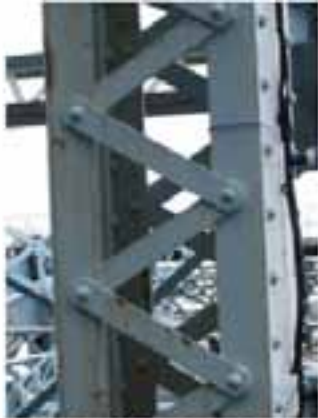
**South Side - Sout Face
Member to Member Connections
Starting East Working West**

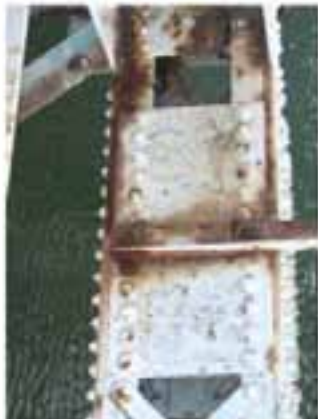
**South Side - Sout Face
Member to Member Connections
Starting East Working West**

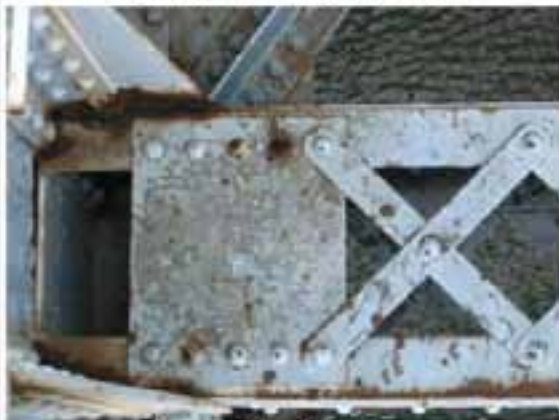
**South Side - Sout Face
Member to Member Connections
Starting East Working West**

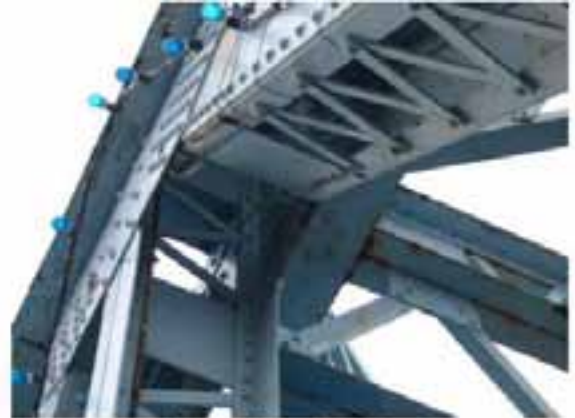
**South Side - Sout Face
Member to Member Connections
Starting East Working West**

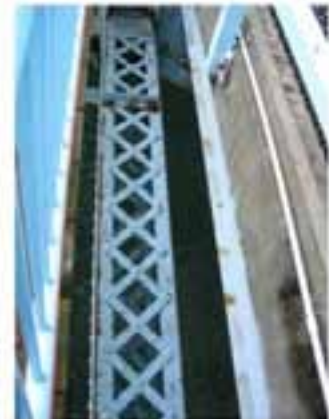
**South Side - Sout Face
Member to Member Connections
Starting East Working West**

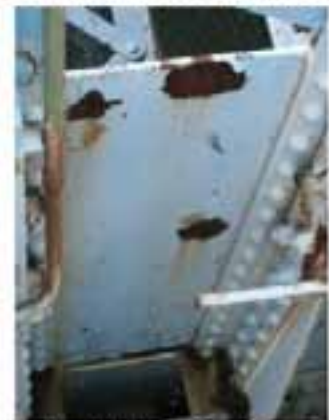
**South Side - Sout Face
Member to Member Connections
Starting East Working West**

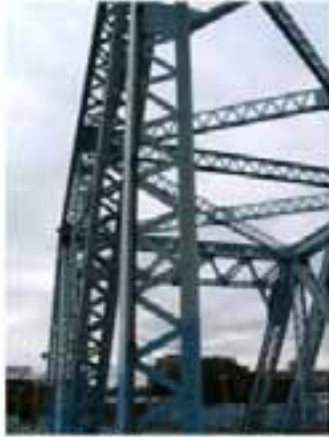
**South Side - Sout Face
Member to Member Connections
Starting East Working West**

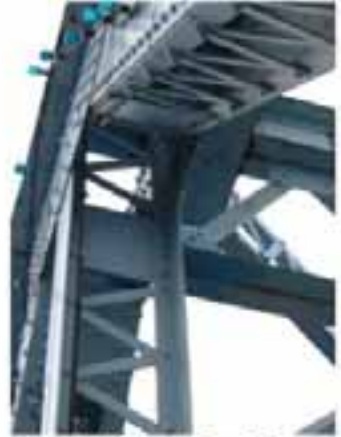
**South Side - Sout Face
Member to Member Connections
Starting East Working West**

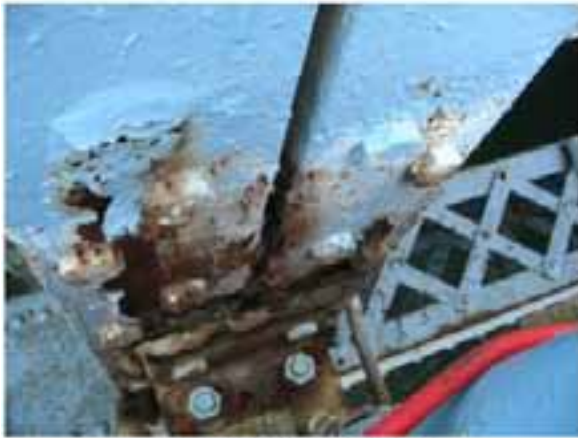
**South Side - Sout Face
Member to Member Connections
Starting East Working West**

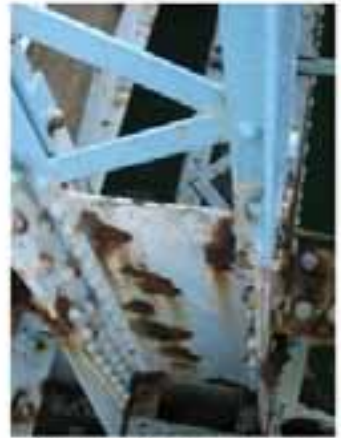
**South Side - Sout Face
Member to Member Connections
Starting East Working West**

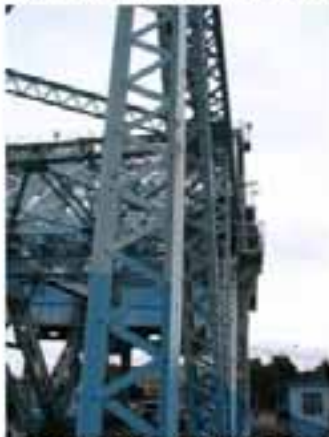
**South Side - Sout Face
Member to Member Connections
Starting East Working West**

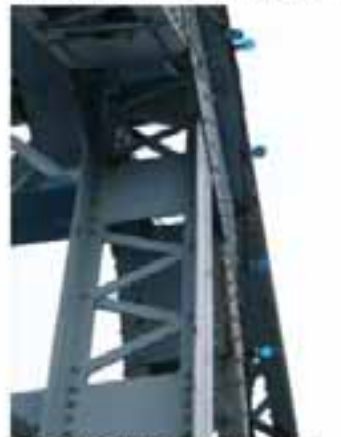
**South Side - Sout Face
Member to Member Connections
Starting East Working West**

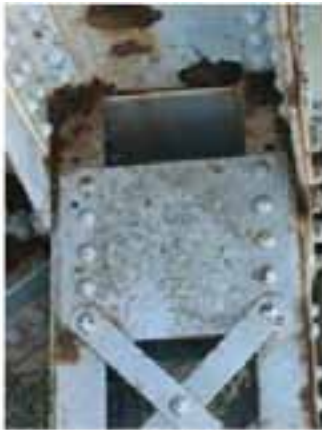
**South Side - Sout Face
Member to Member Connections
Starting East Working West**

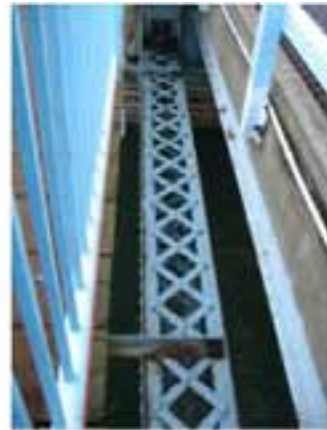
**South Side - Sout Face
Member to Member Connections
Starting East Working West**

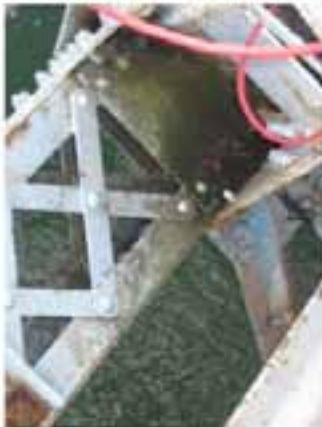
**South Side - Sout Face
Member to Member Connections
Starting East Working West**

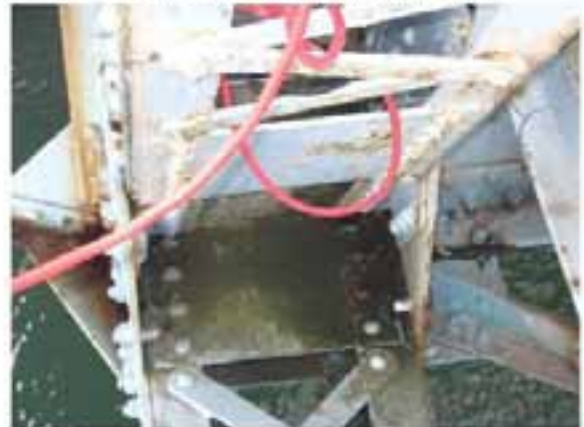
**South Side - Sout Face
Member to Member Connections
Starting East Working West**

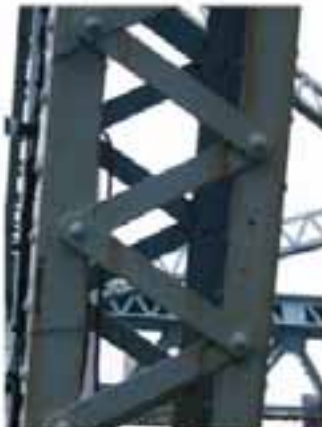
**South Side - Sout Face
Member to Member Connections
Starting East Working West**

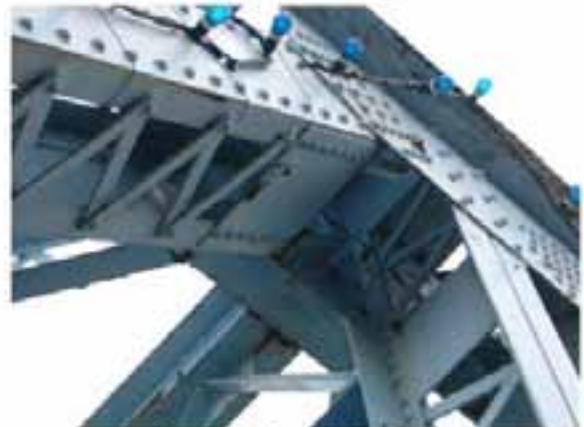
**South Side - Sout Face
Member to Member Connections
Starting East Working West**

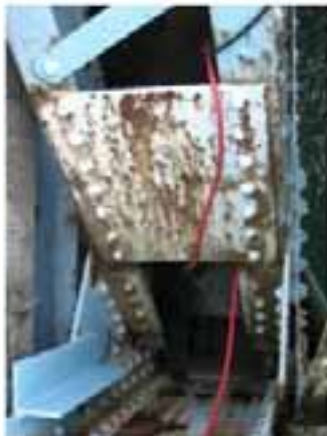
**South Side - Sout Face
Member to Member Connections
Starting East Working West**

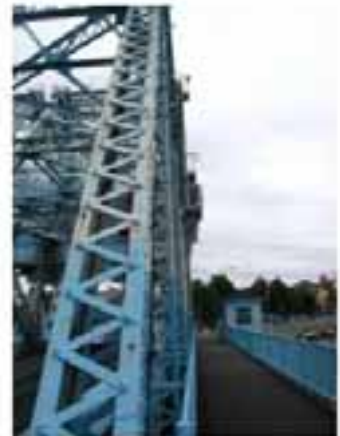
**South Side - Sout Face
Member to Member Connections
Starting East Working West**

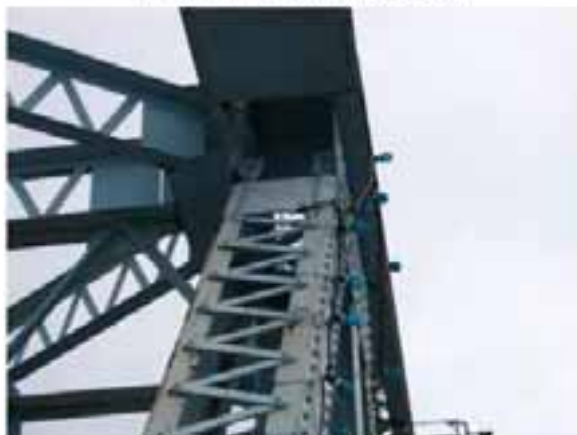
**South Side - Sout Face
Member to Member Connections
Starting East Working West**

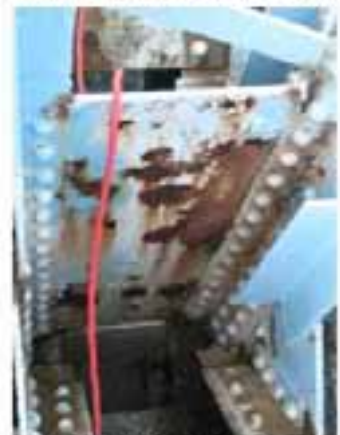
**South Side - Sout Face
Member to Member Connections
Starting East Working West**

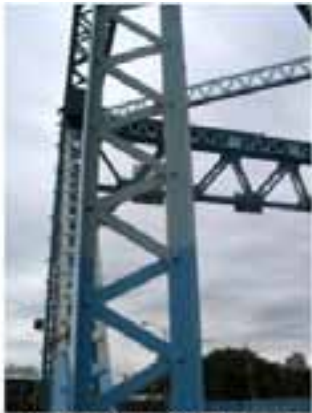
**South Side - Sout Face
Member to Member Connections
Starting East Working West**

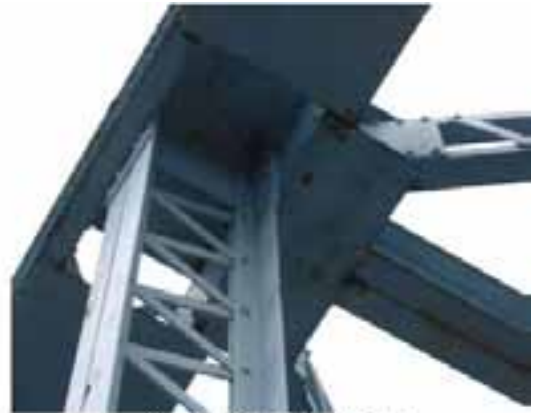
**South Side - Sout Face
Member to Member Connections
Starting East Working West**

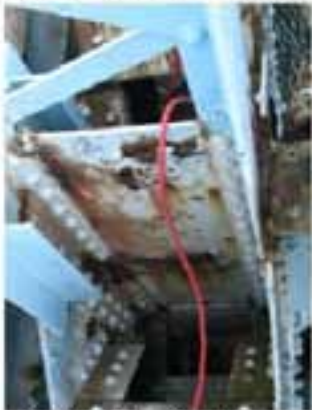
**South Side - Sout Face
Member to Member Connections
Starting East Working West**

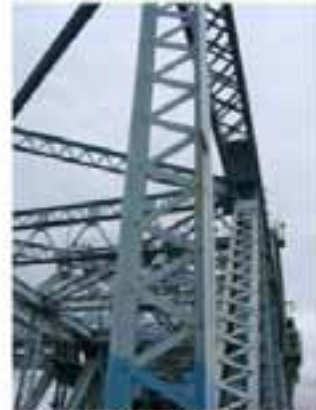
**South Side - Sout Face
Member to Member Connections
Starting East Working West**

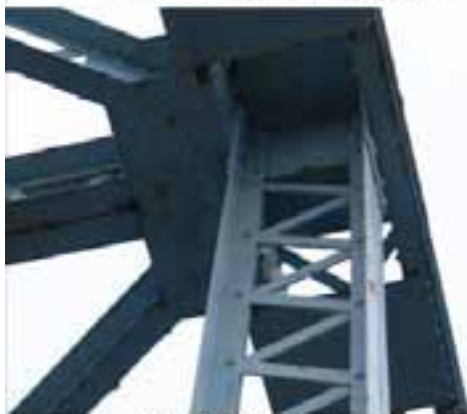
**South Side - Sout Face
Member to Member Connections
Starting East Working West**

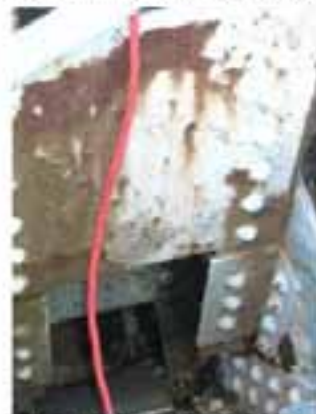
**South Side - Sout Face
Member to Member Connections
Starting East Working West**

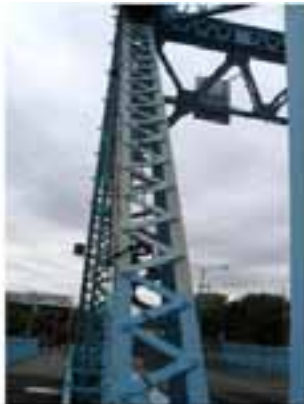
**South Side - Sout Face
Member to Member Connections
Starting East Working West**

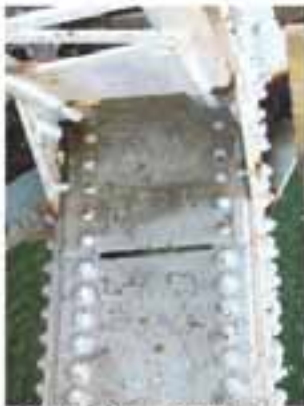
**South Side - Sout Face
Member to Member Connections
Starting East Working West**
