Johnson Street Bridge Condition Assessment Report

EXECUTIVE SUMMARY

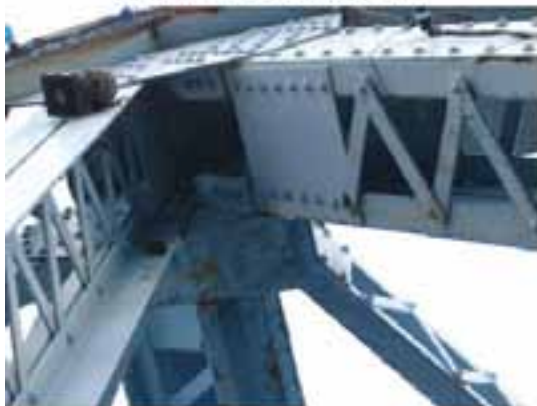
**South Side - Sout Face
Member to Member Connections
Starting East Working West**

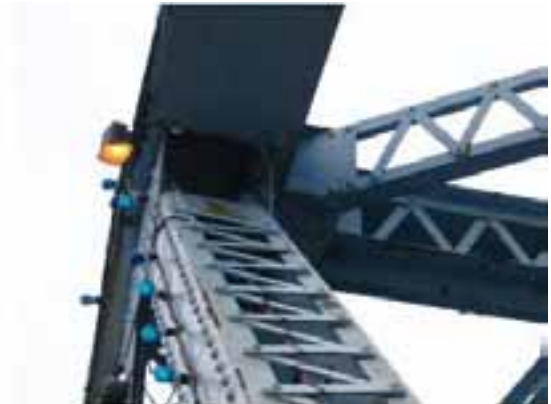
**South Side - Sout Face
Member to Member Connections
Starting East Working West**

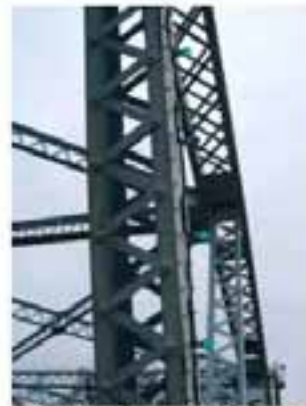
**South Side - Sout Face
Member to Member Connections
Starting East Working West**

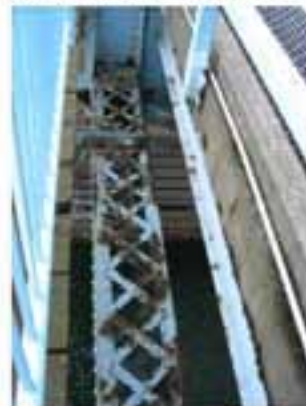
**South Side - Sout Face
Member to Member Connections
Starting East Working West**

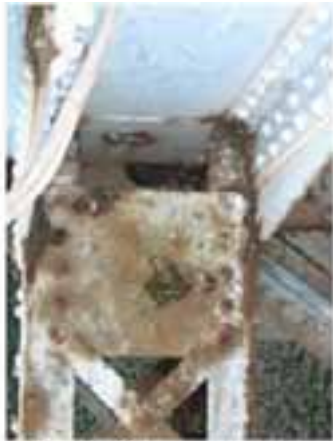
**South Side - Sout Face
Member to Member Connections
Starting East Working West**

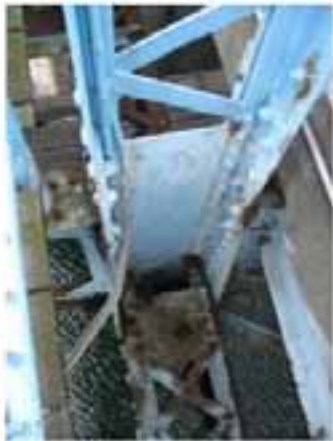
**South Side - Sout Face
Member to Member Connections
Starting East Working West**

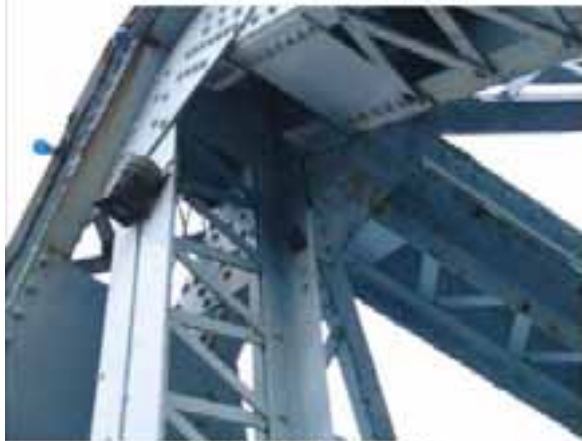
**South Side - Sout Face
Member to Member Connections
Starting East Working West**

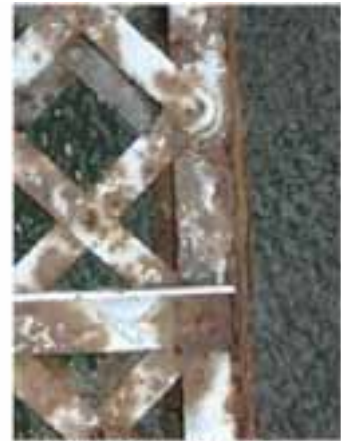
**South Side - Sout Face
Member to Member Connections
Starting East Working West**

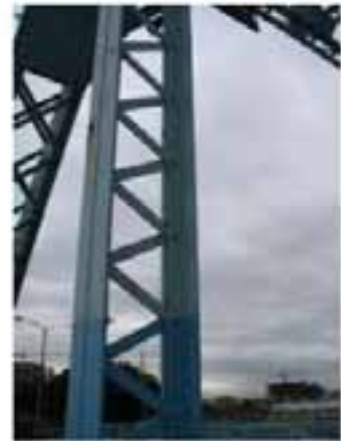
**South Side - Sout Face
Member to Member Connections
Starting East Working West**

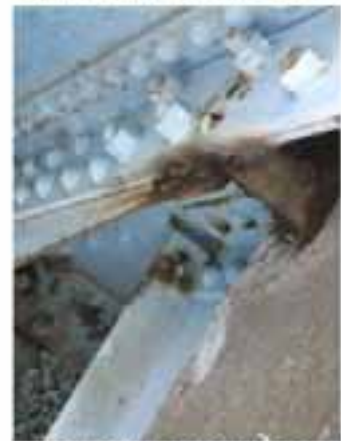
**South Side - Sout Face
Member to Member Connections
Starting East Working West**

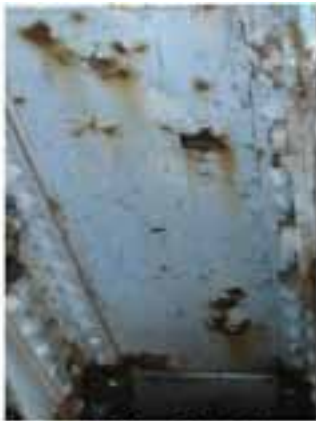
**South Side - Sout Face
Member to Member Connections
Starting East Working West**

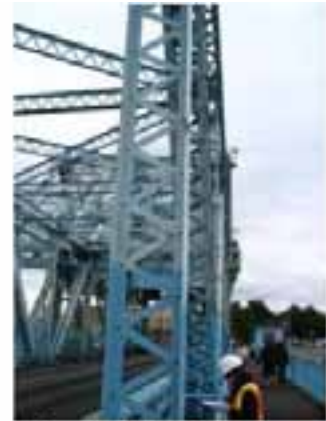
**South Side - Sout Face
Member to Member Connections
Starting East Working West**

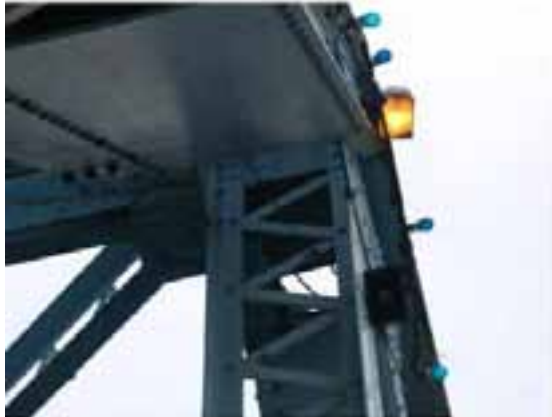
**South Side - Sout Face
Member to Member Connections
Starting East Working West**

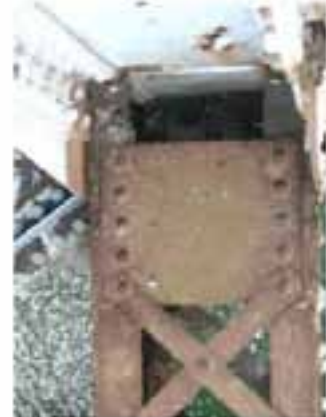
**South Side - Sout Face
Member to Member Connections
Starting East Working West**

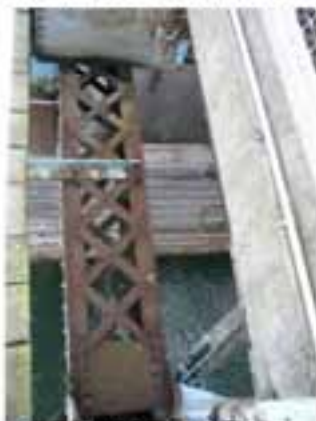
**South Side - Sout Face
Member to Member Connections
Starting East Working West**

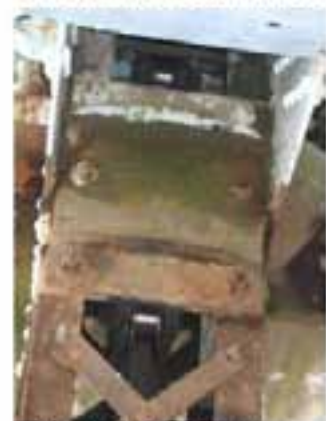
**South Side - Sout Face
Member to Member Connections
Starting East Working West**

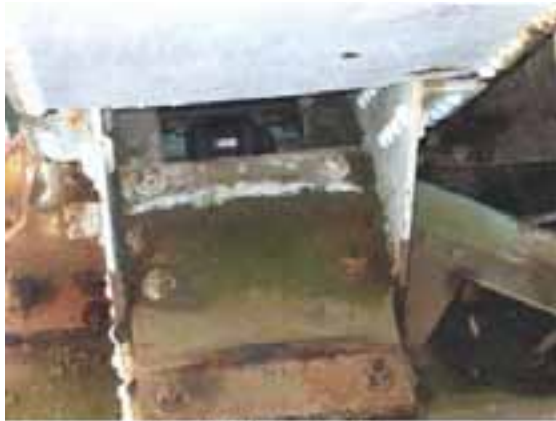
**South Side - Sout Face
Member to Member Connections
Starting East Working West**

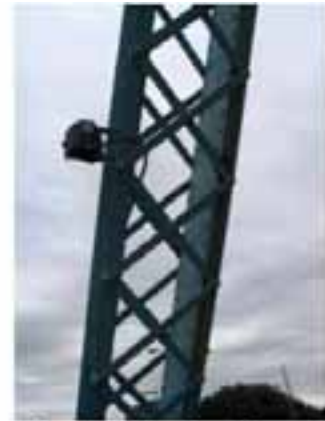
**South Side - Sout Face
Member to Member Connections
Starting East Working West**

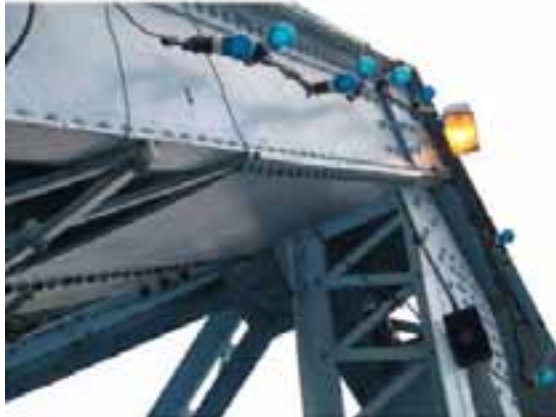
**South Side - Sout Face
Member to Member Connections
Starting East Working West**

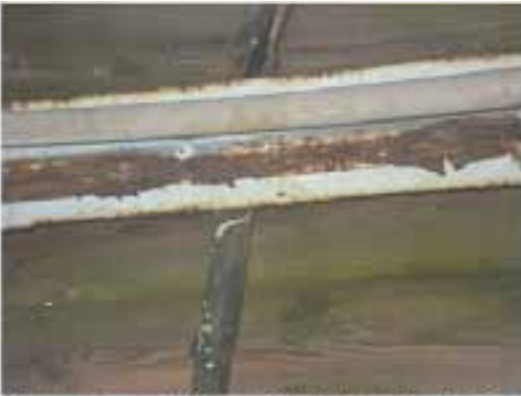
Span 3 - Corrosion on Walkway Cantilever MemberTop Lateral
Bracing
Lift Truss

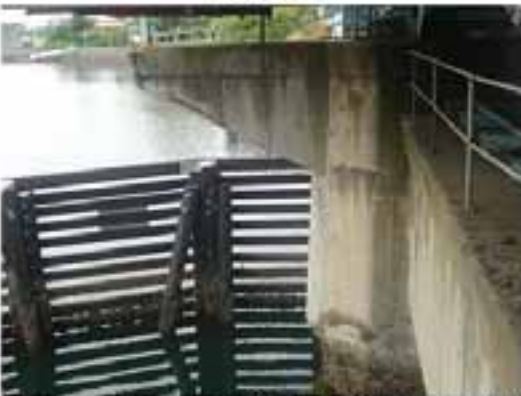
Span 3 - Exposed Rebar and Spalling Concrete on Pier 2Top Lateral Bracing
Lift Truss

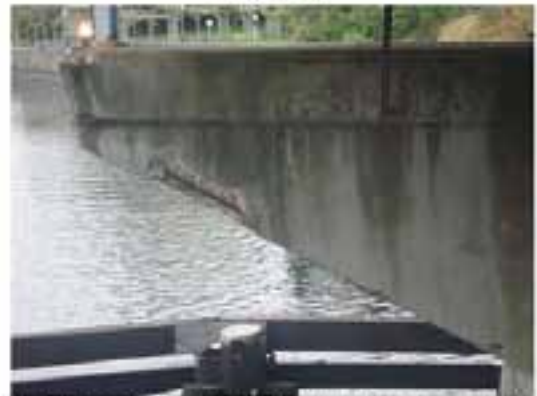
Span 3 - Exposed Rebar and Spalling Concrete on Pier 2Top Lateral Bracing
Lift Truss

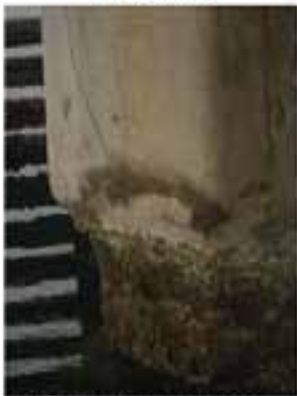
Span 3 - Spalling Concrete on Pier 2Top Lateral Bracing
Lift Truss
Starting East Working West

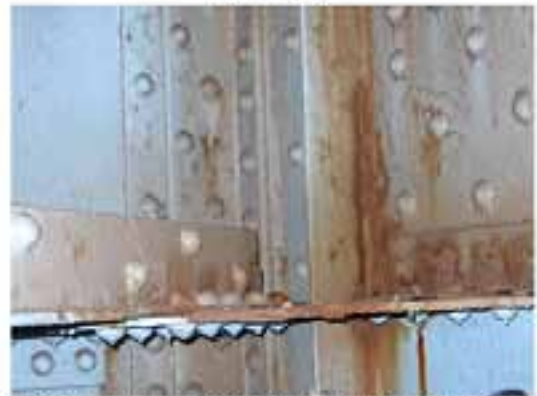
Span 3 - Corrosion on Rivets and Bottom FlangeTop Lateral
Bracing
Lift Truss

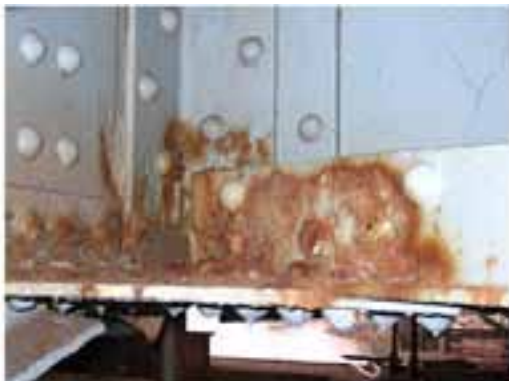
Span 3 - Corrosion on Rivets and Bottom Flange
Top Lateral
Bracing
Lift Truss

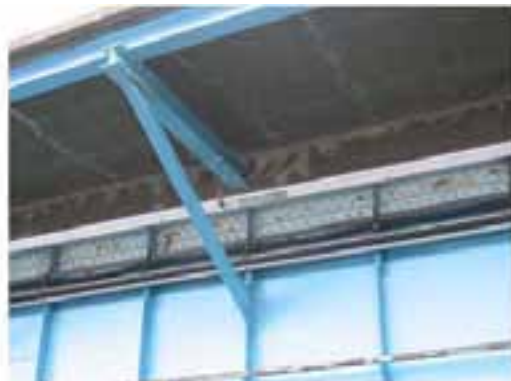
Span 3 - Efflorescence Under Pedestrian Walkway
Top Lateral
Bracing
Lift Truss

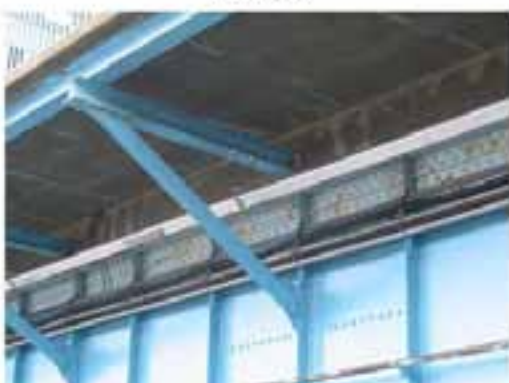
Span 3 - Efflorescence Under Pedestrian Walkway
Top Lateral
Bracing
Lift Truss

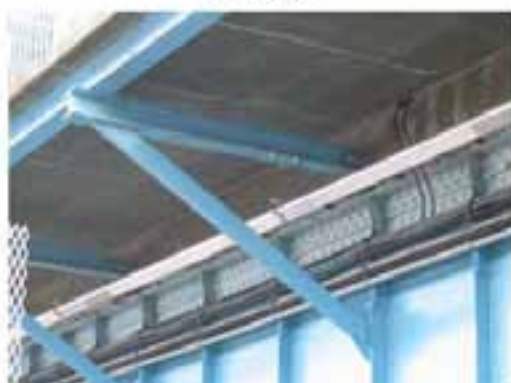
Span 3 - Efflorescence Under Pedestrian Walkway
Top Lateral
Bracing
Lift Truss

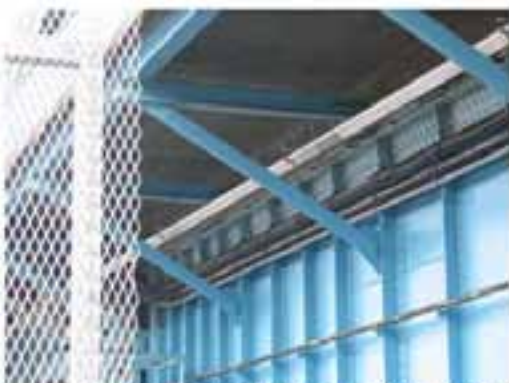
Span 3 - Efflorescence Under Pedestrian Walkway
Top Lateral
Bracing
Lift Truss

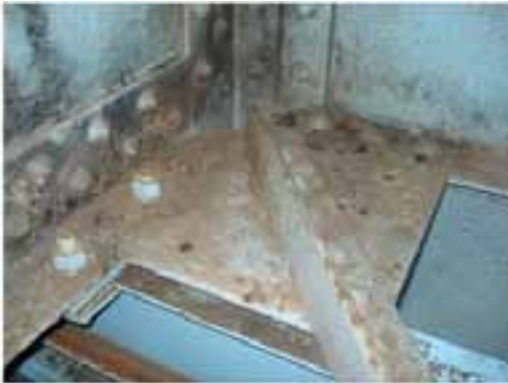
Span 4 - Dirt Build Up on Connection Plate Top Lateral Bracing
Lift Truss
Starting East Working West

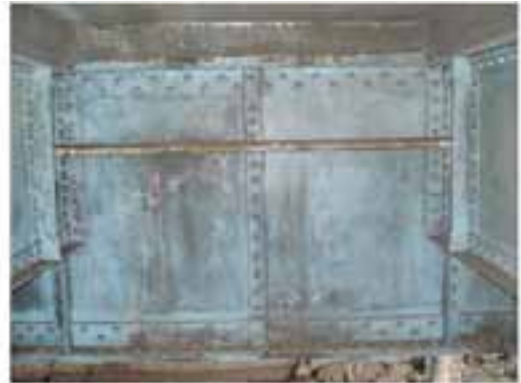
Span 4 - Dirt Build Up on Bottom Flange Top Lateral Bracing
Lift Truss
Starting East Working West

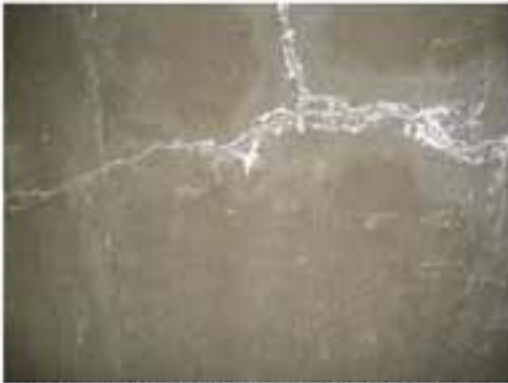
Span 4 - Efflorescence on Concrete Soffit Top Lateral Bracing
Lift Truss
Starting East Working West

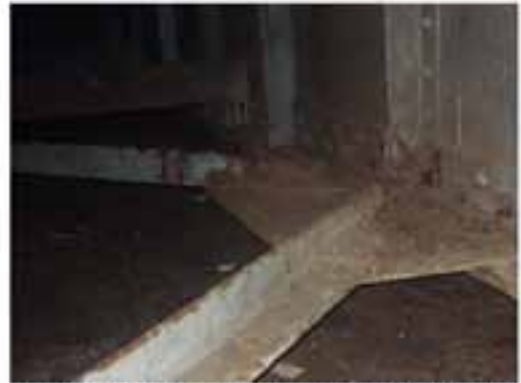
Span 4 - Dirt and Corrosion on Lateral Bracing Connection
Plate Top Lateral Bracing
Lift Truss

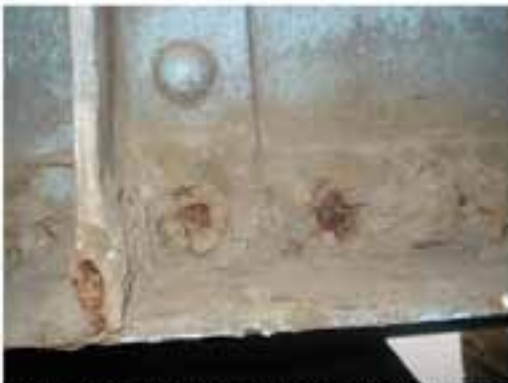
Span 4 - Rivets Worn Away, Corrosion and Paint Loss Top Lateral
Bracing
Lift Truss

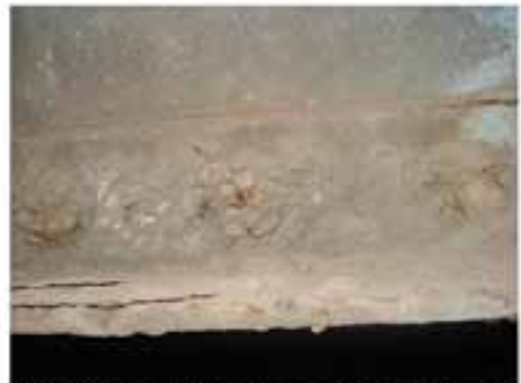
Span 4 - Rivets Worn Away, Corrosion and Paint Loss Top Lateral
Bracing
Lift Truss

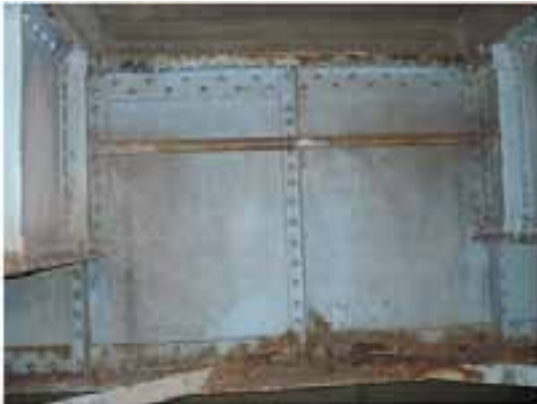
**Span 4 - Corrosion at Lateral Bracing Top Lateral Bracing
Lift Truss
Starting East Working West**

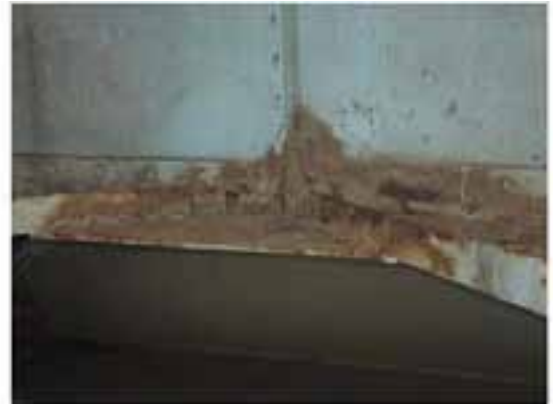
**Span 4 - Corrosion at Lateral Bracing Top Lateral Bracing
Lift Truss
Starting East Working West**

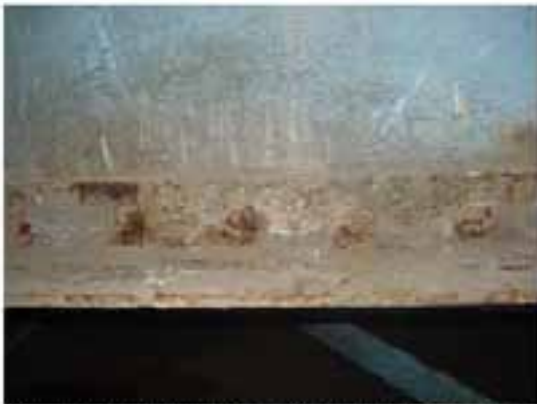
**Span 4 - Rivets Worn Away, Corrosion and Paint Loss Top Lateral
Bracing
Lift Truss**

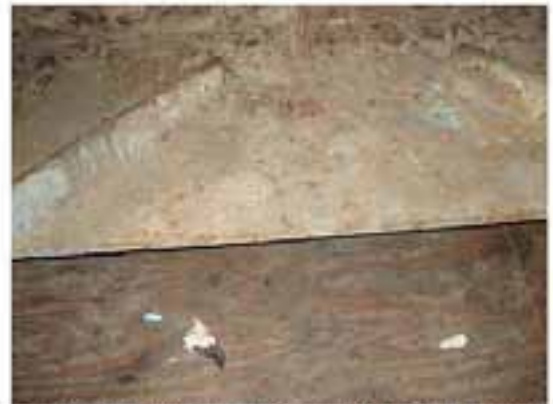
**Span 4 - Paint Loss at Lateral Bracing Plate Top Lateral Bracing
Lift Truss
Starting East Working West**

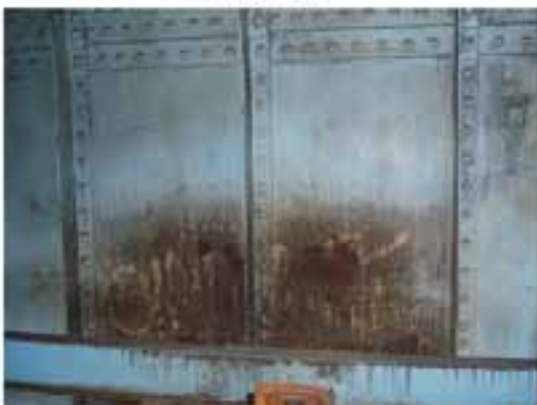
**Span 4 - Paint Loss and Corrosion on Web of Built Up
Member Top Lateral Bracing
Lift Truss**

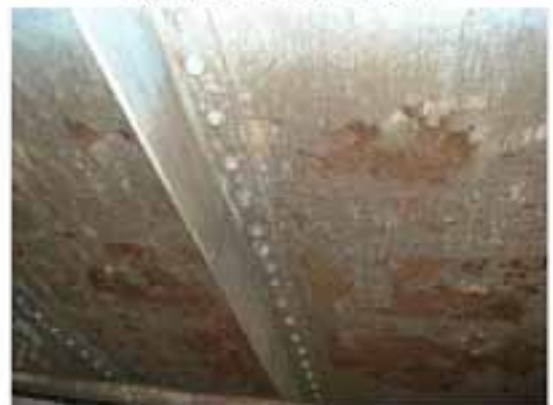
**Span 4 - Paint Loss and Corrosion on Web Top Lateral Bracing
Lift Truss
Starting East Working West**

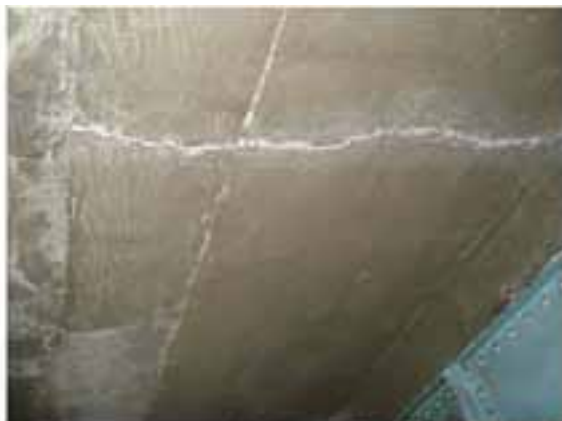
**Span 4 - Efflorescence on Concrete Soffit Top Lateral Bracing
Lift Truss
Starting East Working West**

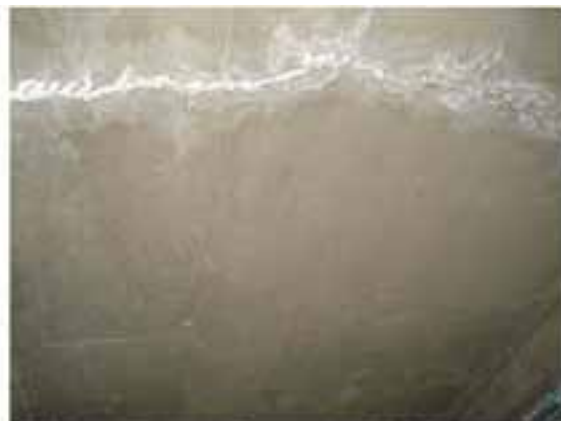
**Span 4 - Efflorescence on Concrete Soffit Top Lateral Bracing
Lift Truss
Starting East Working West**

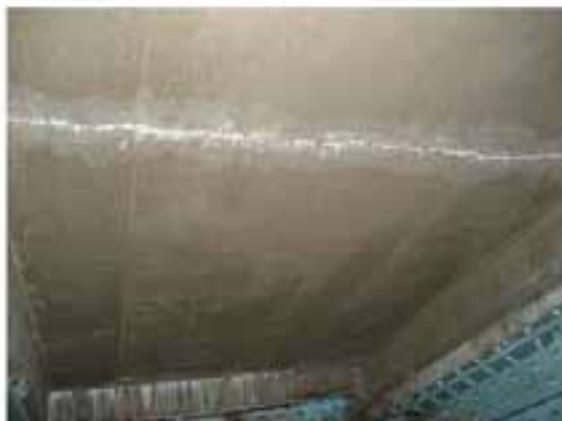
**Span 4 - Efflorescence on Concrete Soffit Top Lateral Bracing
Lift Truss
Starting East Working West**

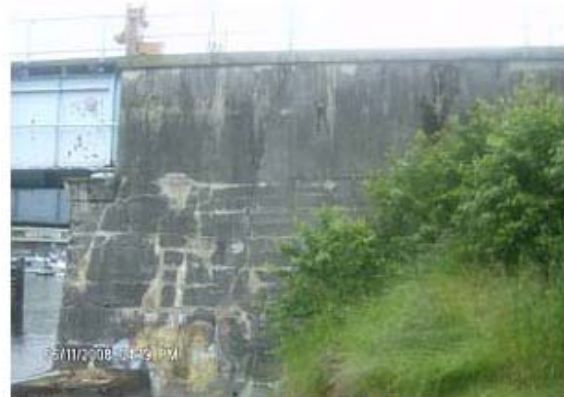
HPIM3957.JPG
P004 - West Abutment 1 - North Wing Wall - 2 mm Vertical Crack Full Height - Minor Cracking and Efflorescence - No Spalling

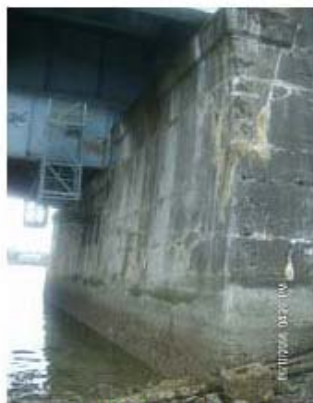
HPIM3958.jpg
P005 - West Abutment 1 - Minor Cracking and Efflorescence - No Spalling

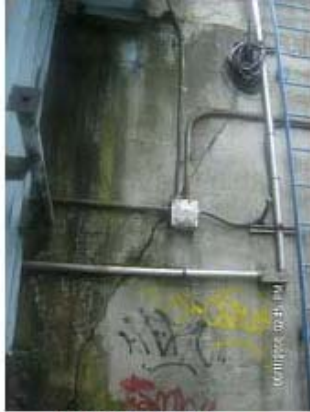
HPIM3910.jpg

P007 - West Abutment 1 - Wide Diagonal Crack (4 mm) in Backwall Between Railway and Roadway Bridges Almost to Waterline

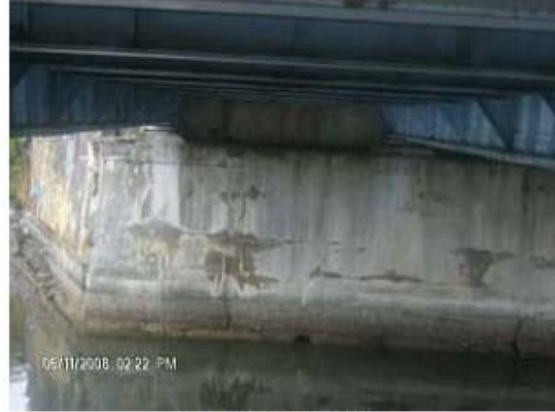
HPIM3884.JPG

P008 - East Abutment 2 - Minor Cracking, Efflorescence and Moisture Staining - Bearing Seat OK

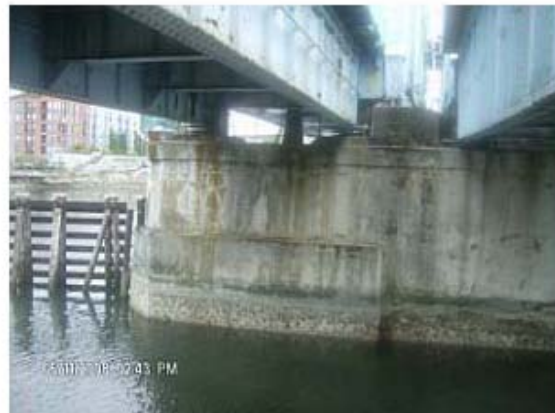
HPIM3908.JPG

P012 - Concrete Pier 1 - North Face - Minor Cracking and Efflorescence But No Spalling

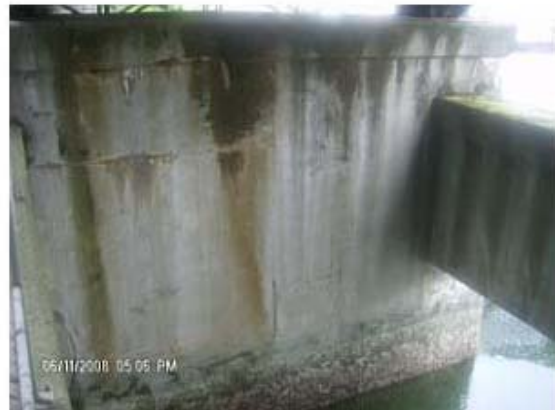
HPIM3990.JPG

P016 - Concrete Pier 2 - East Face - 2 mm Horizontal Crack Along Construction Joint - Moisture Staining and Efflorescence

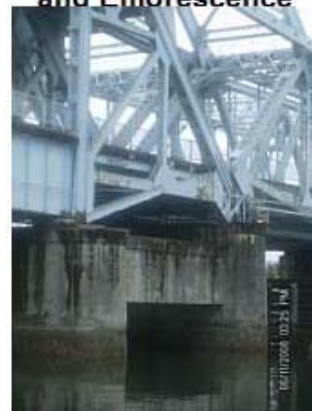
HPIM3931.jpg

P018 - North Side of Span 3 - Piers 2 and 3 Connected with 2 Concrete Strong Beams Above Waterline

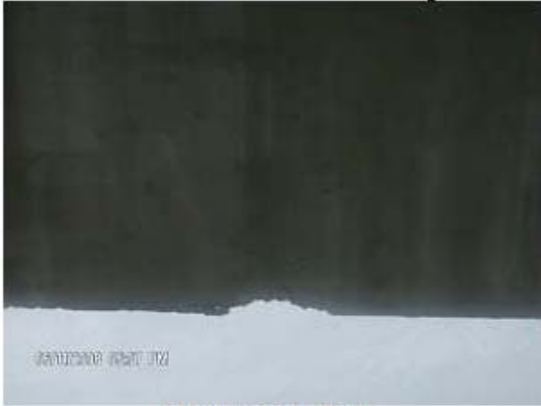
HPIM3991.JPG
P019 - North Strong Beam Between Piers 2 and 3 - 10 cm x 40 cm Spall Bottom of Beam

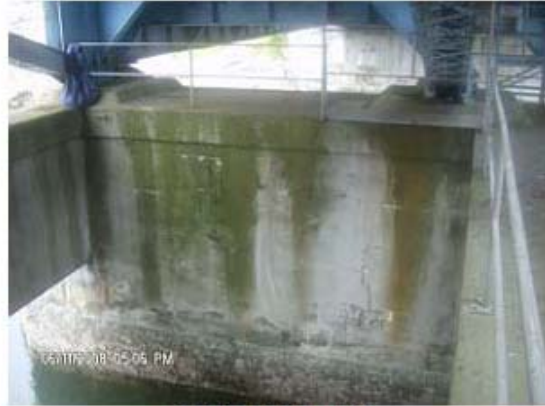
HPIM3989.JPG
P020 - Concrete Pier 3 - West Face - Minor Cracking and Efflorescence But No Spalling and Bearing Seats are Good

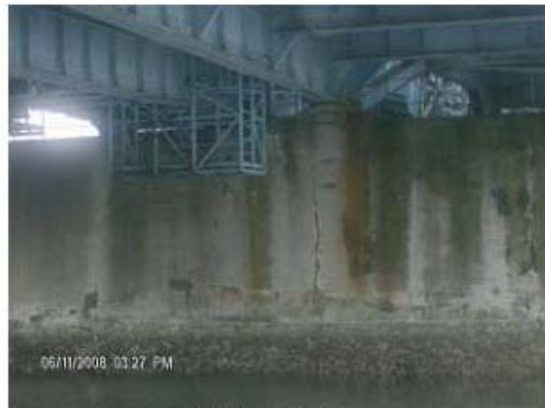
HPIM3934.jpg
P022 - North Face of Pier 3 - 1 mm Vertical Crack Below Railway Bridge South Bearing

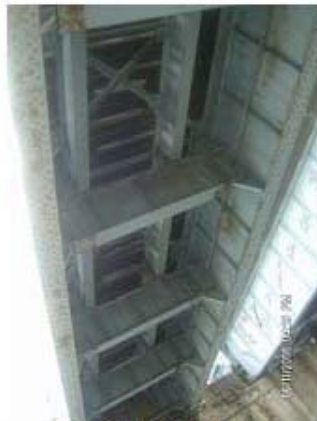
HPIM3959.jpg
P027 - West Approach Span 1 - Floor System - Stringers and Floorbeams Replaced Since Initial Construction

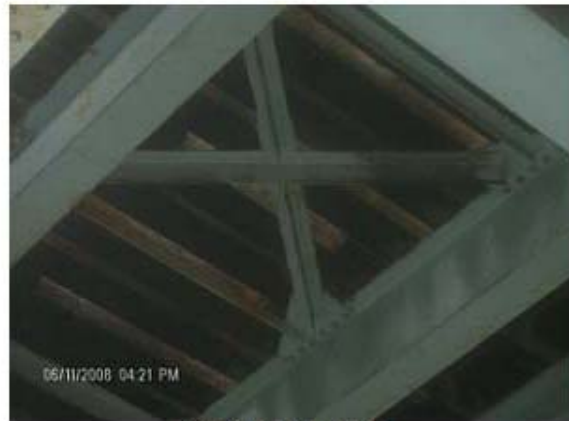
HPIM3960.JPG
P028 - West Approach Span 1 - Floor System - Bolted Connections - Bracing Replaced Since Initial Construction

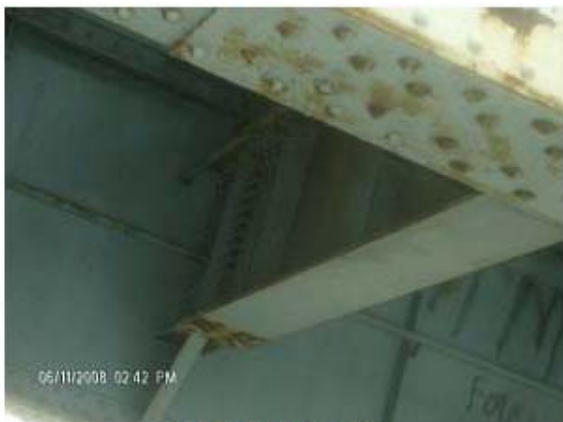
HPIM3907.JPG
P029 - West Approach Span 1 - Floor Beam 1 - Bolted Connections

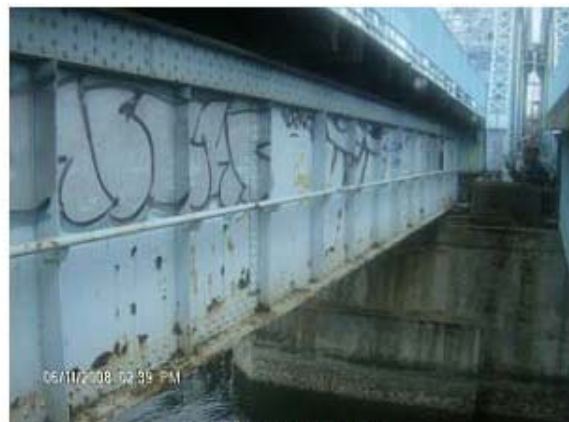
HPIM3902.JPG
P030 - West Approach Span 1 - South Main Girder

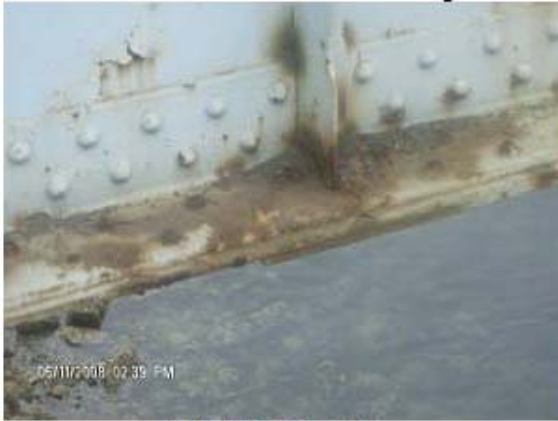
HPIM3903.JPG

P031 - West Approach Span 1 - Debris Buildup on South Main Girder

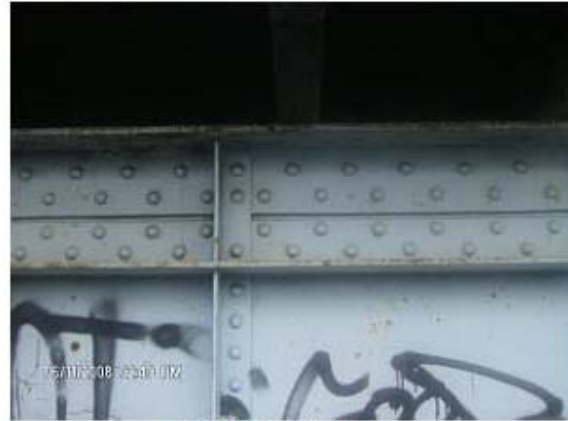
HPIM3904.JPG

P032 - West Approach Span 1 - Top Flange and Shelf Angle on South Main Girder

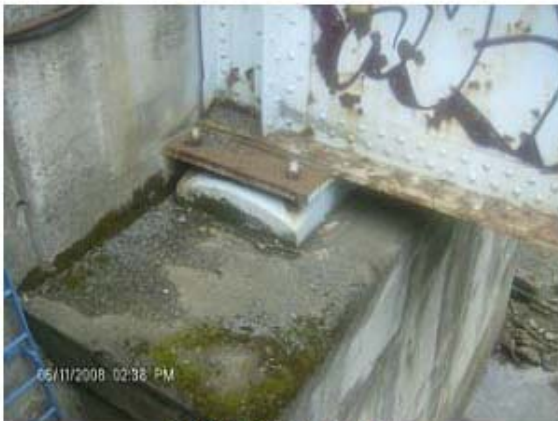
HPIM3901.JPG

P033 - West Abutment 1 - South Fixed Bearing for Span 1

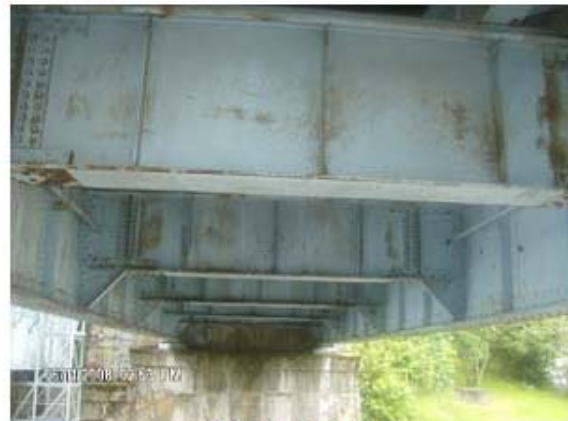
HPIM3913.JPG

P034 - West Approach Span 1 - Floor Beams - Looking West

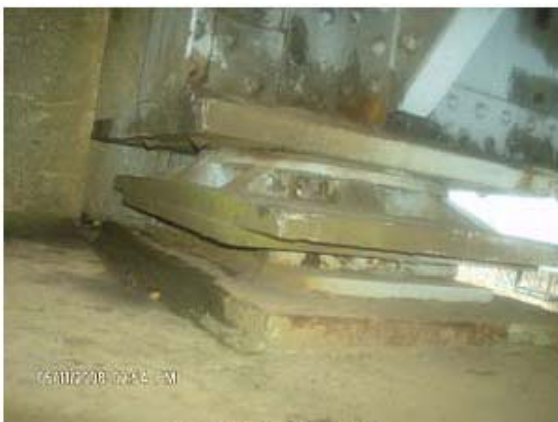
HPIM3914.JPG

P035 - Pier 1 - South Expansion Bearing for Span 1

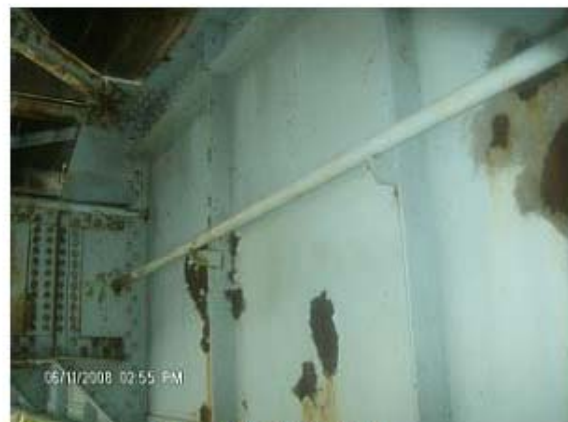
HPIM3916.JPG

P036 - Span 1 - North Main Girder

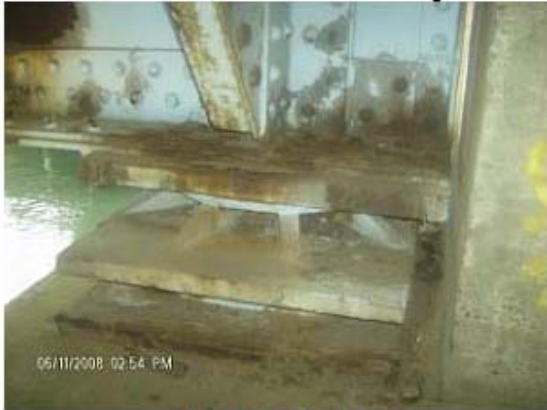
HPIM3915.JPG
P037 - Pier 1 - North Expansion Bearing for Span 1

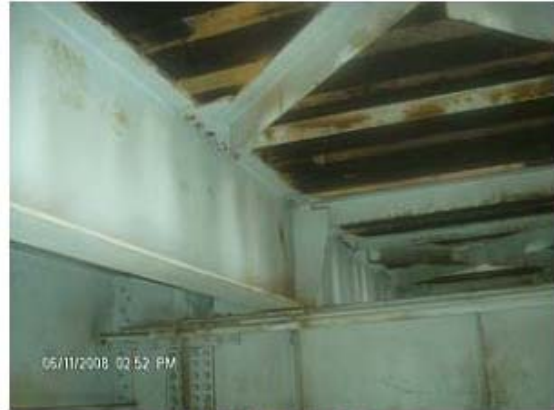
HPIM3911.JPG
P038 - West Approach Span 1 - 2 Stringers Above Floorbeams - Bolted Connections

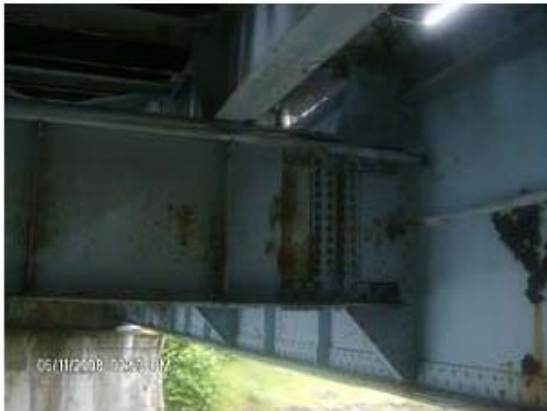
HPIM3912.JPG
P039 - West Approach Span 1 - Floor Beam 1 - Bolted Connection to North Main Girder

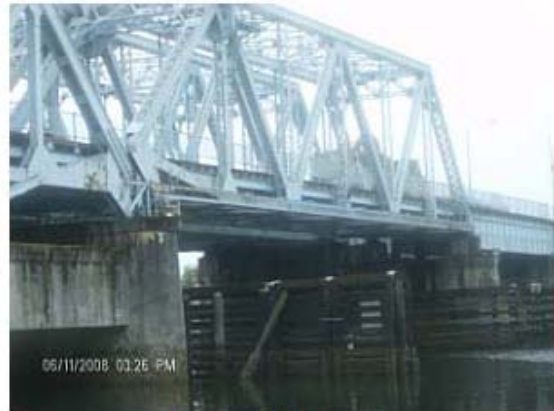
HPIM3932.JPG
P040 - North Side of Through Truss Lift Span 2

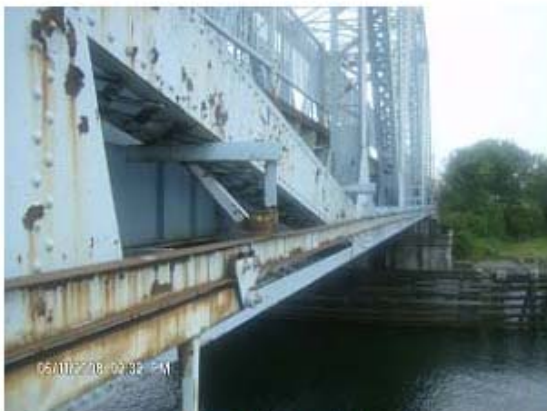
HPIM3900.JPG
P041 - Lift Span 2 - North Bottom Chord

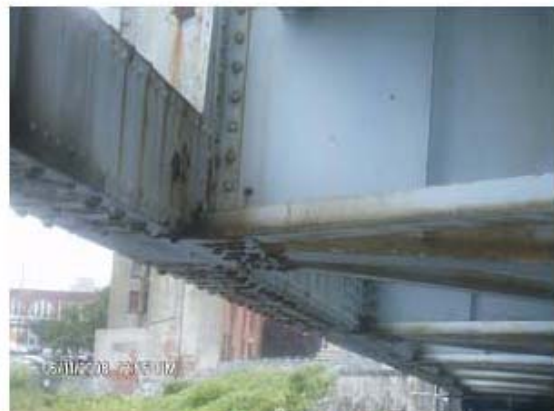
HPIM3918.JPG
P042 - Lift Span 2 - North Bottom Chord

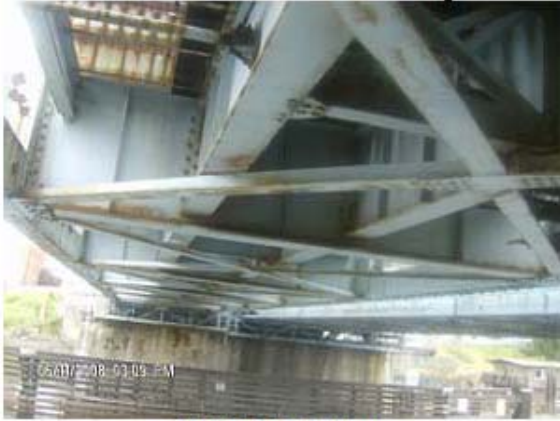
HPIM3923.JPG

P043 - Lift Span 2 - Floor System is in Good Condition with Updated Stringers, Floor Beams and Bracing Since Initial Construction

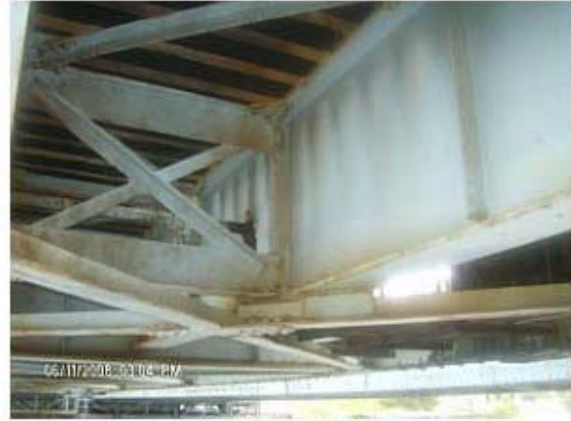
HPIM3922.JPG

P044 - Lift Span 2 - South Main Stringer in Panel 1 - Bolted Connections

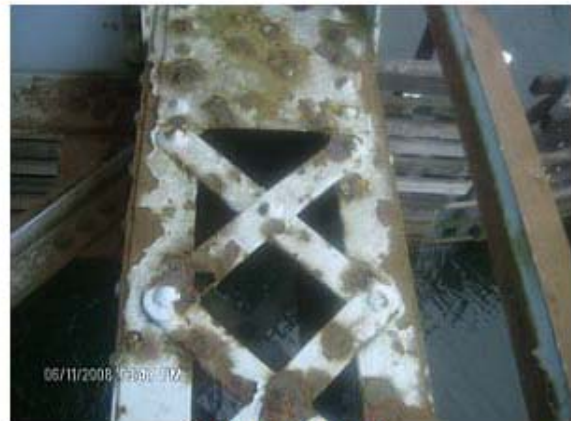
HPIM3945.JPG

P046 - Lift Span 2 - North Bottom Chord in Panel 1 - 1 Holed Lacing Member

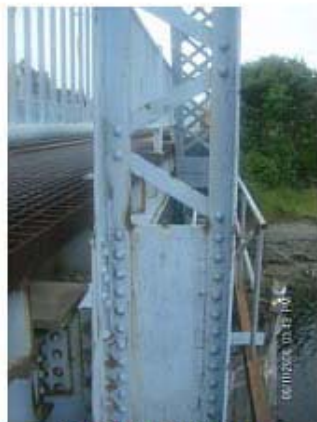
HPIM3946.jpg

P047 - Lift Span 2 - North Vertical Hanger - End of Panel 1 - 10 mm Pack Rust Between Angles

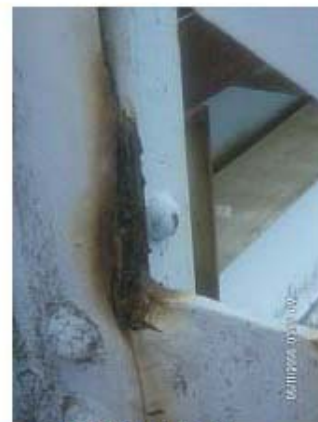
HPIM3947.jpg

P048 - Lift Span 2 - North Vertical Hanger - End of Panel 1 - 10 mm Pack Rust Between Angles

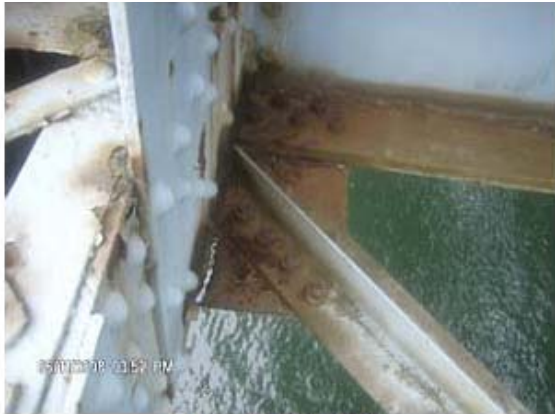
HPIM3948.JPG

P049 - Lift Span 2 - North Horizontal Gusset Plate Holed Along Bottom Chord at End of Panel 2

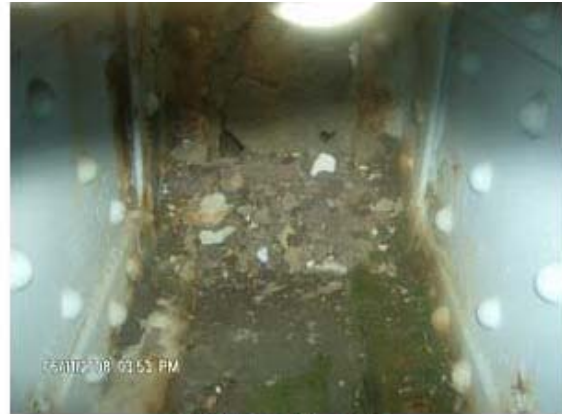
HPIM3949.JPG

P050 - Lift Span 2 - Debris Buildup Inside of Bottom Chord at Verticals - Typical

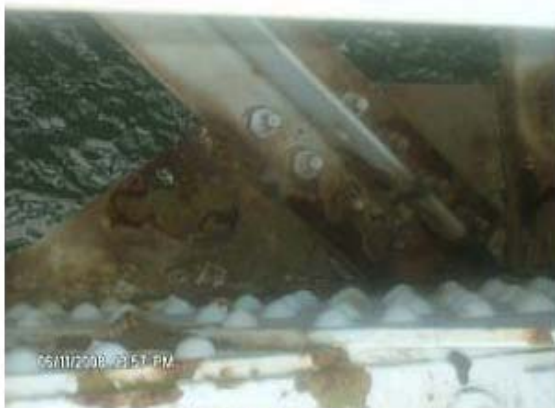
HPIM3950.JPG

P051 - Lift Span 2 - North Horizontal Gusset Plate Holed at Beginning of Panel 6

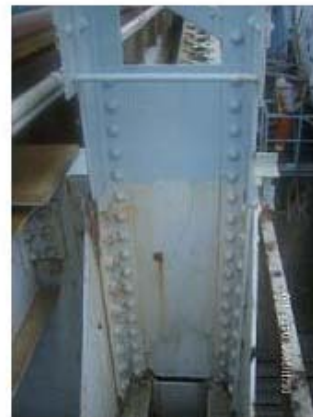
HPIM3954.jpg

P052 - Lift Span 2 - South Vertical Hanger - End of Panel 5 - 10 mm Pack Rust Between Angle and Vertical Gusset Plate

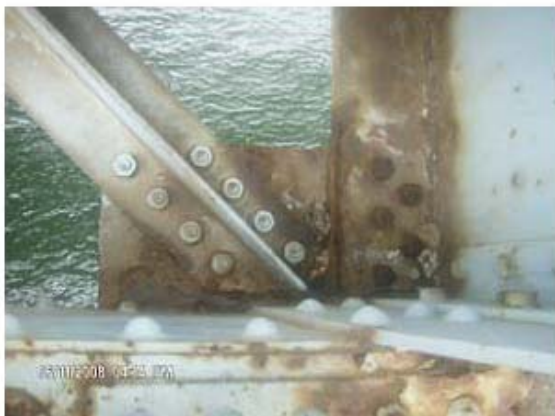
HPIM3955.JPG

P053 - Lift Span 2 - South Horizontal Gusset Plate at End of Panel 1 - Pitted up to 3 mm But Not Holed

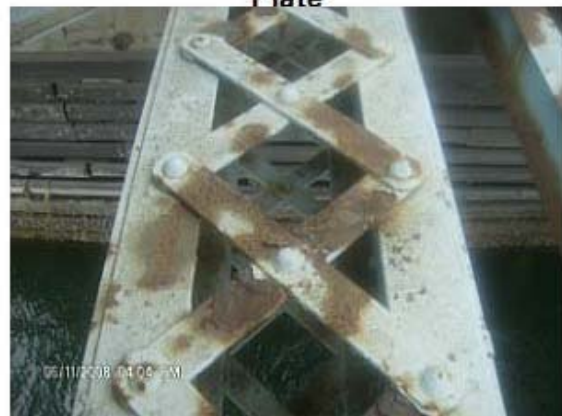
HPIM3953.JPG

P054 - Lift Span 2 - South Bottom Chord of Panel 5 - Approx 5% of Lacing Members are 10% Reduced

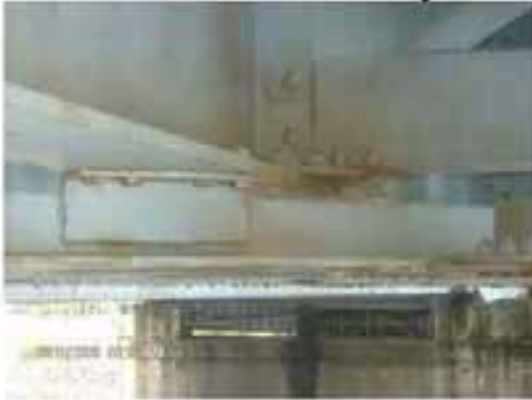
HPIM3995.JPG

P055 - Lift Span 2 - Panel 6 - Lower Sway Braces are Welded and Bolted

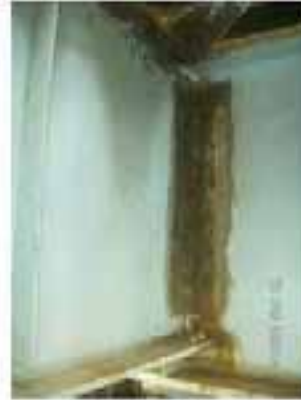
HPIM3996.jpg

P056 - Lift Span 2 - Typical Main Stringer Floorbeam Connections are Bolted - Floor System Has Been Replaced Since Initial Construction in 1923

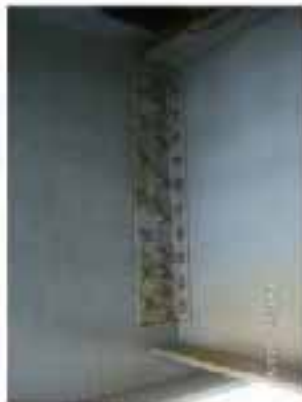
HPIM3997.jpg

P057 - Lift Span 2 - Typical Main Stringer Floorbeam Connections are Bolted - Floor System Has Been Replaced Since Initial Construction in 1923

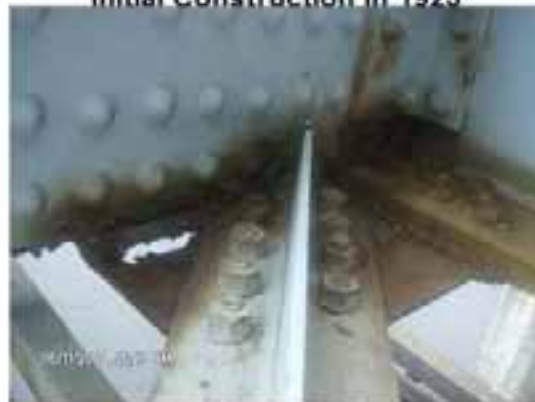
HPIM3998.JPG

P058 - Lift Span 2 - Holed Gusset Plate - Southwest Corner of Panel 5

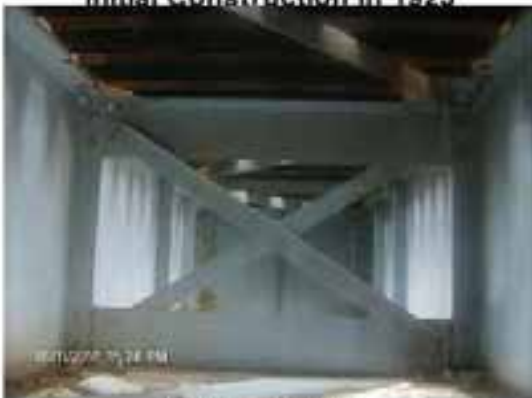
HPIM3999.JPG

P059 - Lift Span 2 - Vertical Cross Bracing Between Main Stringers - Middle of Panel 5 - Bolted and Welded - Typical

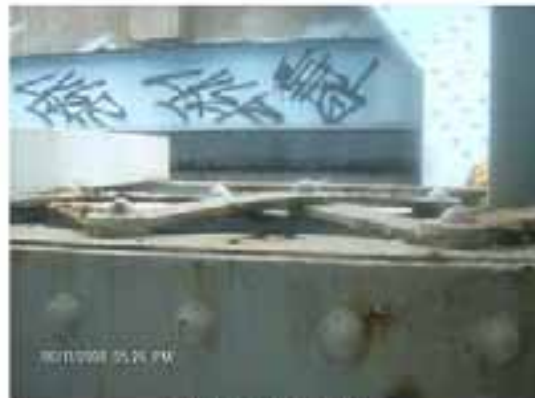
HPIM4000.JPG

P060 - Lift Span 2 - South Bottom Chord - Minor Bowing of Lacing Members

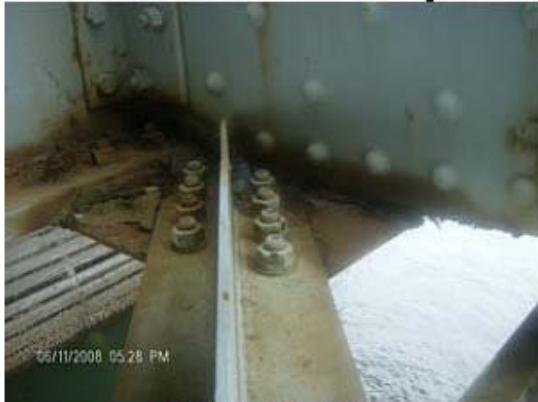
HPIM4001.JPG

P061 - Lift Span 2 - Horizontal Gusset Plate 4 mm Reduction Groove Along Bottom Chord - Southeast Corner of Panel 4

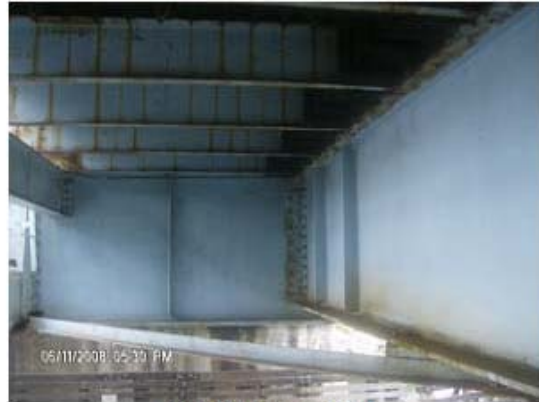
HPIM4002.JPG

P062 - Lift Span 2 - Welded Stiffeners in Stringers and Floorbeams - Typical

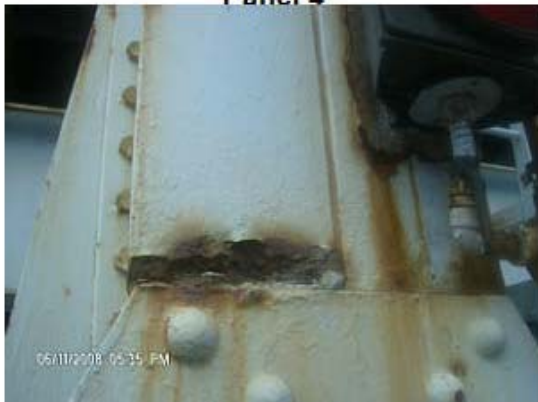
HPIM4006.JPG

P063 - Lift Span 2 - South Vertical at East End of Panel 3 - One Leg of Angle Has Reduction Groove with 50% Section Loss and Holed

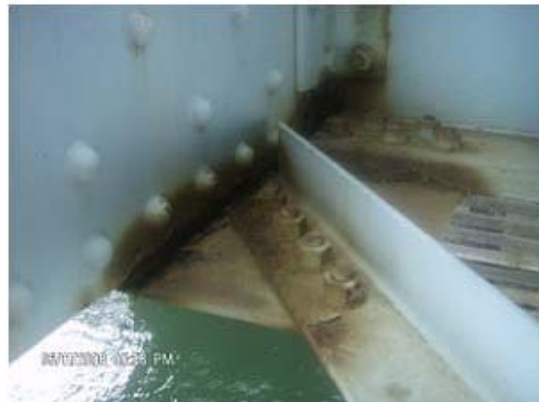
HPIM4007.JPG

P064 - Lift Span 2 - Horizontal Gusset Plates - Reduction Grooves Along Bottom Chords are Typical

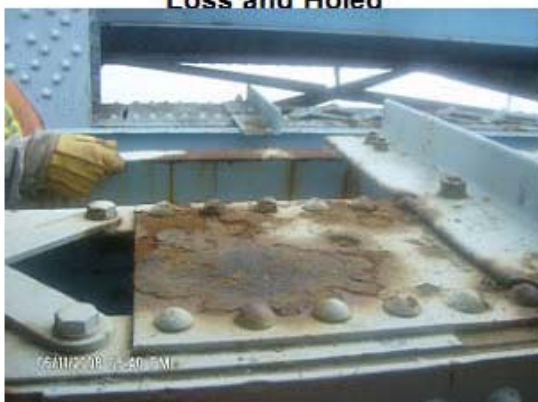
HPIM4008.JPG

p065 - Lift Span 2 - South Bottom Chord in Bay 2 - Horizontal Top Plate is Holed

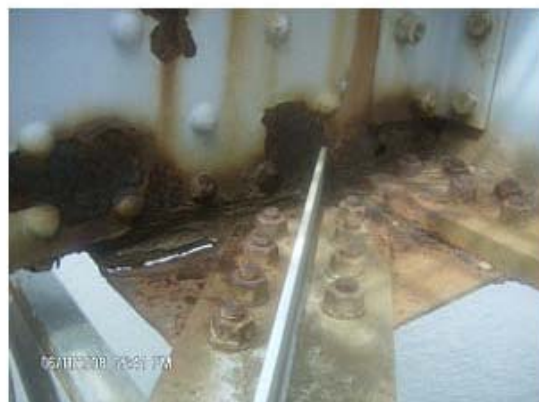
HPIM4009.JPG

P066 - Lift Span 2 - Horizontal Gusset Plate Holed Along Bottom Chord - Northeast Corner of Panel 2

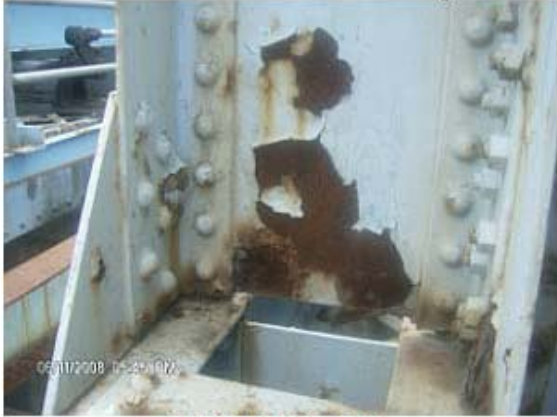
HPIM4010.JPG
P067 - Lift Span 2 - South Hanger at End of Panel 1 - Lower Vertical Plate is Pitted 10 mm

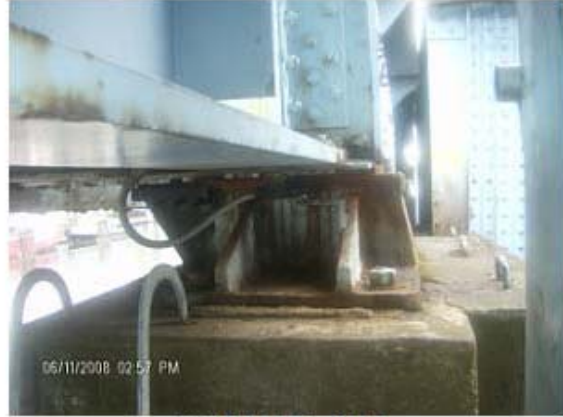
HPIM3919.JPG
P068 - South Rest Bearing on Pier 1 for Lift Span 2

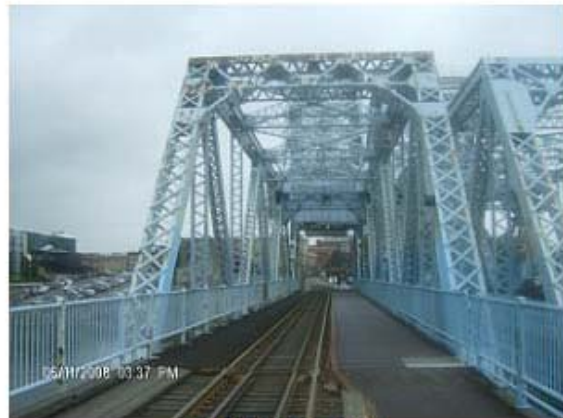
HPIM3920.JPG
P069 - North Rest Bearing on Pier 1 for Lift Span 2

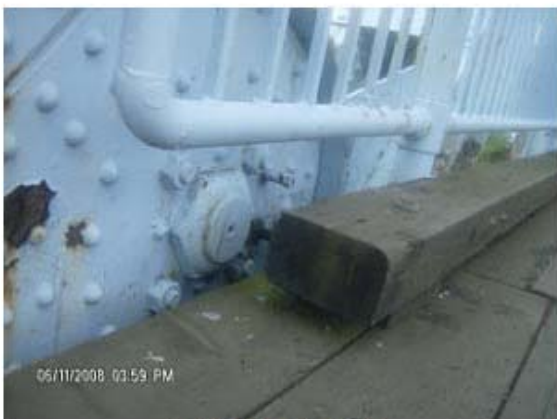
HPIM3944.JPG
P070 - Lift Span 2 - West Portal - No Collision Damage

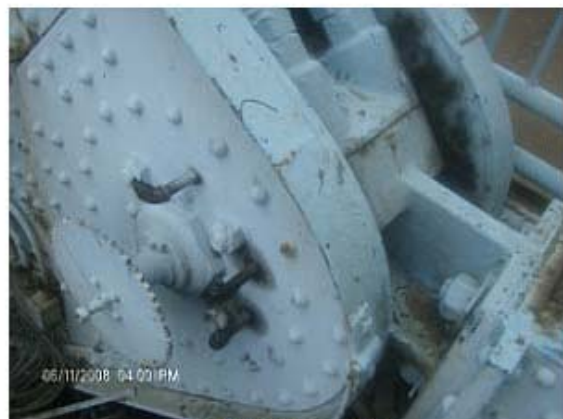
HPIM3951.JPG
P071 - Lift Span 2 - North Lower Pin at Pier 2

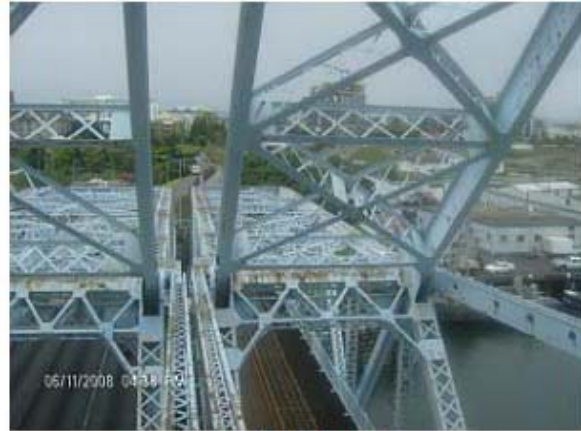
HPIM3963.JPG
P073 - Lift Span 2 - East Portal

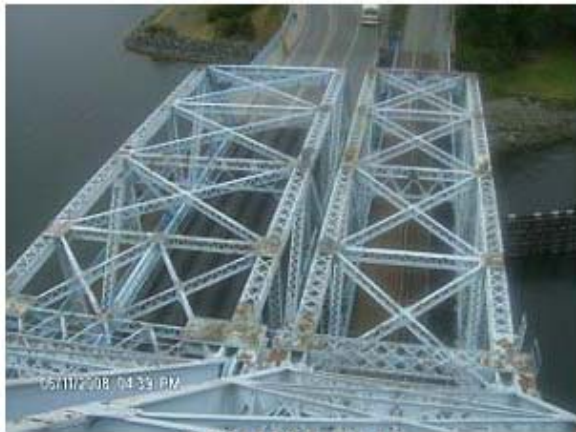
HPIM3970.JPG
P074 - Lift Span 2 - Overhead Bracing

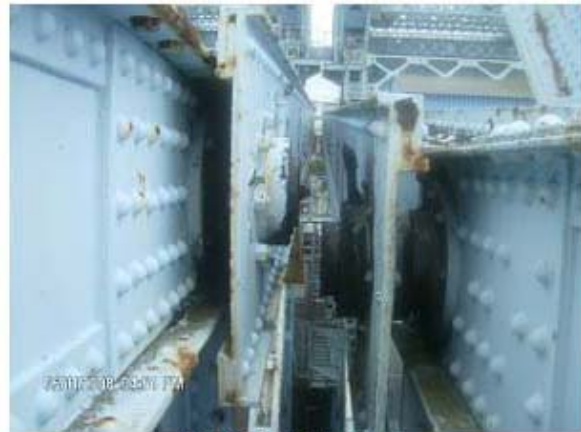
HPIM3972.JPG
P075 - Lift Spans - Top Chords and Overhead Bracing
