Johnson Street Bridge Condition Assessment Report

EXECUTIVE SUMMARY

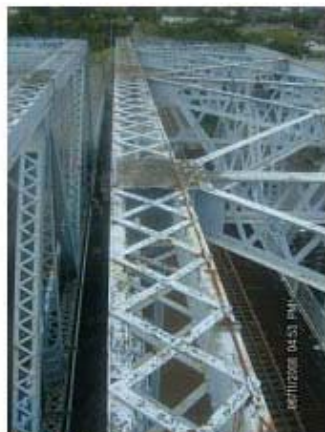
HPIM3981.JPG
P076 - Between Bridges - Lift Span 2 - Pins - Top of East Portals

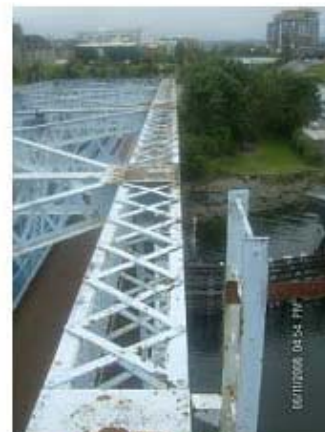
HPIM3982.jpg
P077 - Lift Span 2 - South Top Chord

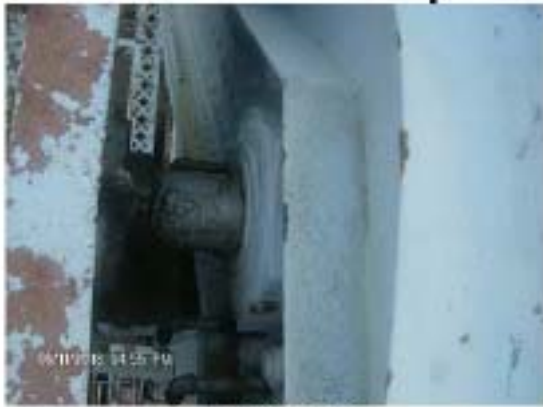
HPIM3984.jpg
P078 - Lift Span 2 - Top North Chord

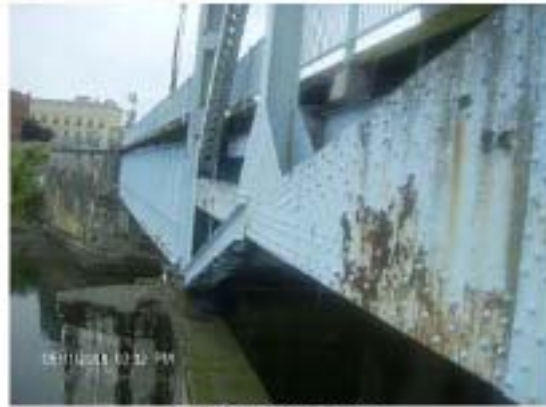
HPIM3985.JPG

**P079 - Lift Span 2 - North Pin at Node 9 -
Top of East Portal**

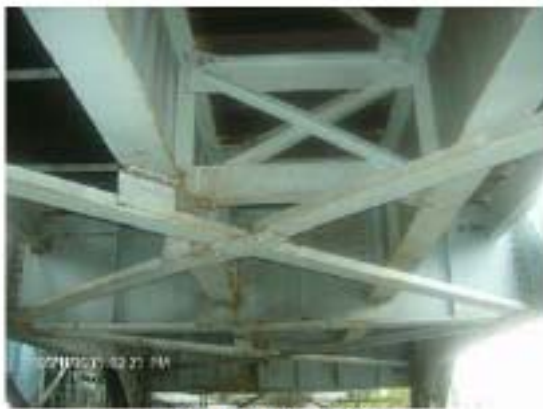
HPIM3899.JPG

P080 - Spans 3 and 4 - North Side

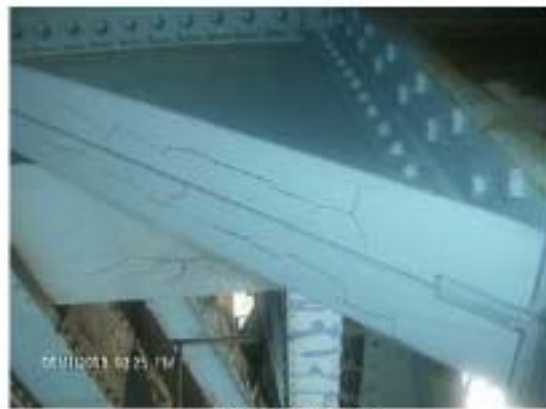
HPIM3885.JPG

**P081 - Span 3 - 2 Large Stringers Below
Track, 2 Small Stringers at Cantilevers**

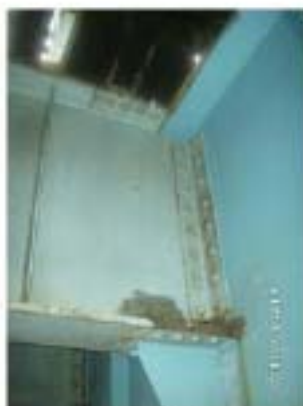
HPIM3889.JPG

**P082 - Span 3 - Shrinkage Cracks in
Paint System**

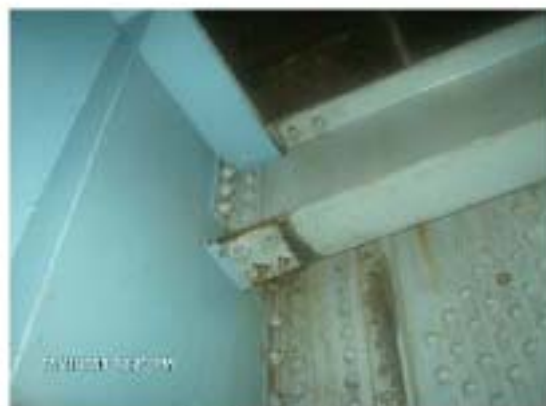
HPIM3887.jpg

**P083 - Span 3 - South Main Stringer
Connection to Floor Beam 0 - Bolted
Connections Typical**

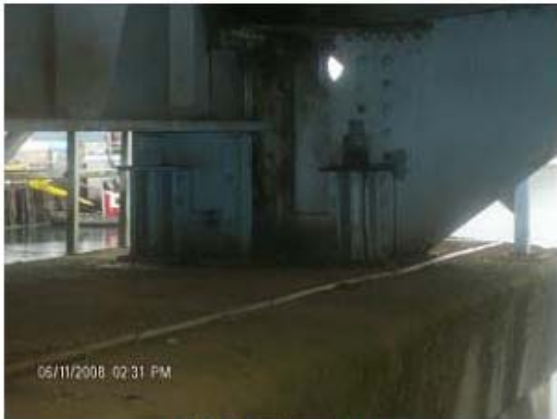
HPIM3888.JPG
P086 - Pier 3 - South Bearings - North Side

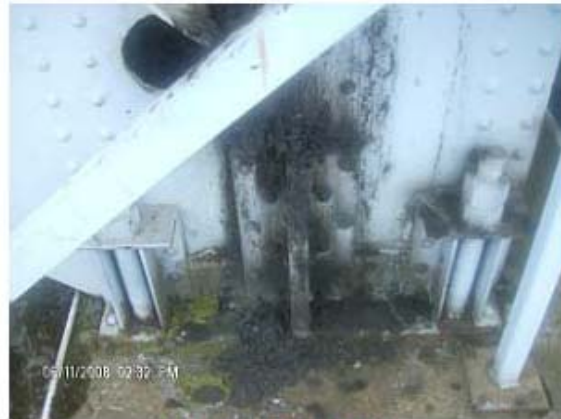
HPIM3896.JPG
P087 - Pier 3 - South Face of North Bearings

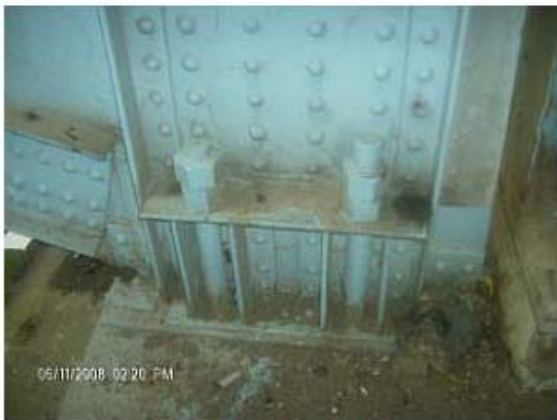
HPIM3898.JPG
P088 - Pier 2 - North Side of North Bearings

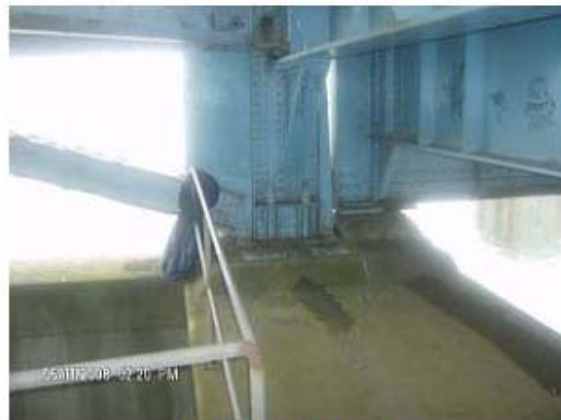
HPIM3880.JPG
P089 - Pier 3 - South Bearing for Span 3

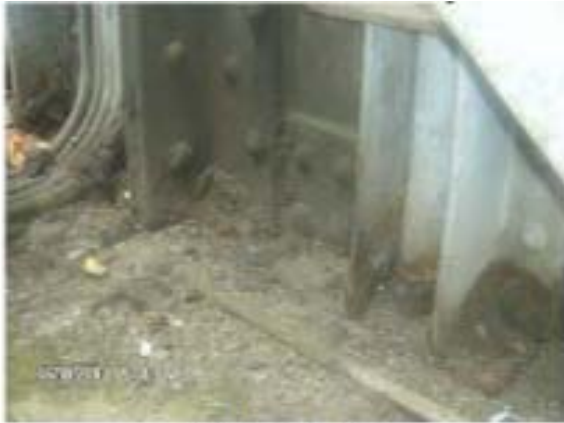
HPIM3879.JPG
P090 - Pier 3 - North Bearings for Spans 3 and 4

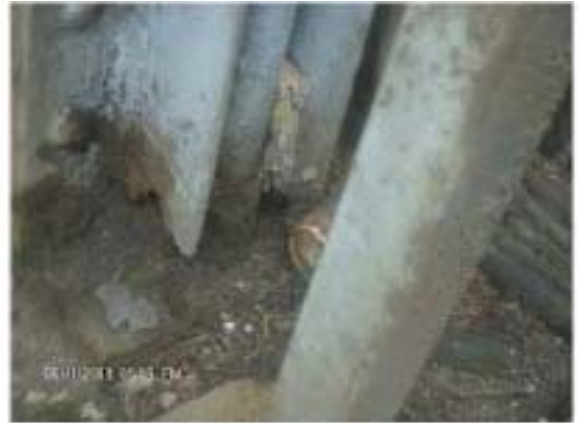
HPIM3992.JPG

P091 - Pier 2 - Span 3 - Section Loss in Anchor Bolt Stiffeners

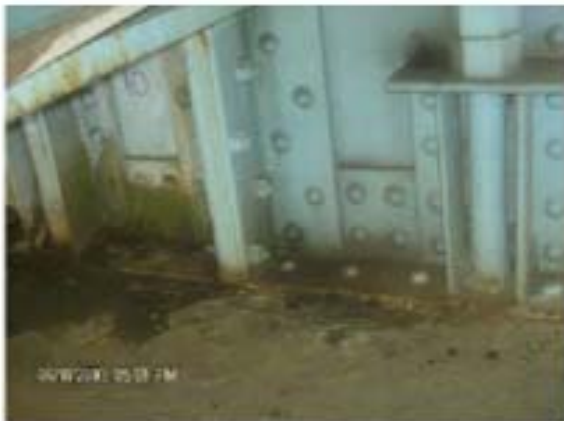
HPIM3993.JPG

P092 - Pier 2 - Span 3 - South Side of South Bearing Holed Anchor Bolt Stiffeners at Mortar Plate

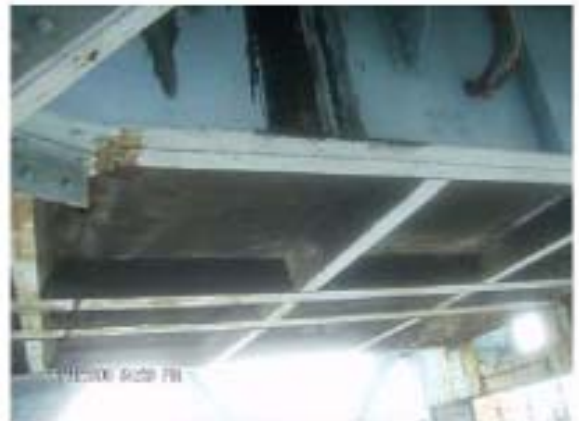
HPIM3994.JPG

P093 - Pier 2 - Span 3 - North Side of South Bearing - Anchor Bolt Stiffeners at Mortar Plate are Not As Bad

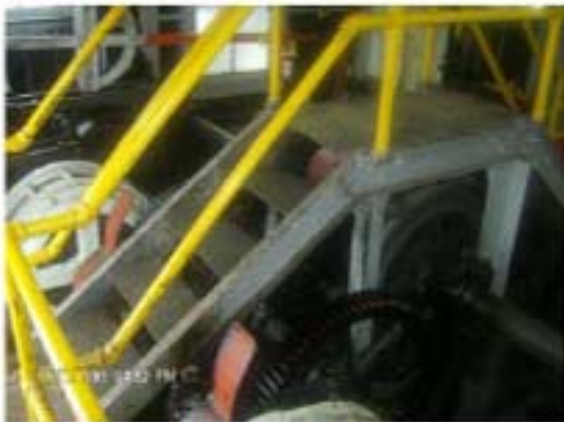
HPIM3962.JPG

P094 - Concrete Floor Soffit - Elevated Mechanical Shed Over Railway Bridge - No Spalling

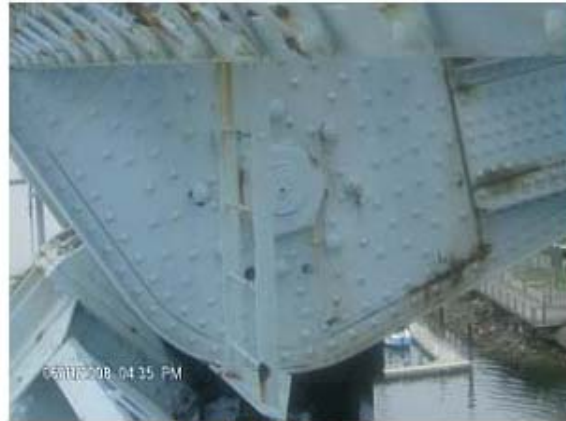
HPIM3967.JPG

P097 - South Trunnion Pin at Node 19

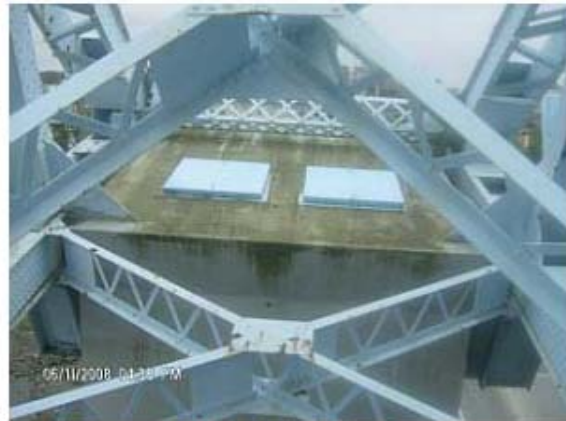
HPIM3969.jpg

P099 - South Counterweight Support Truss

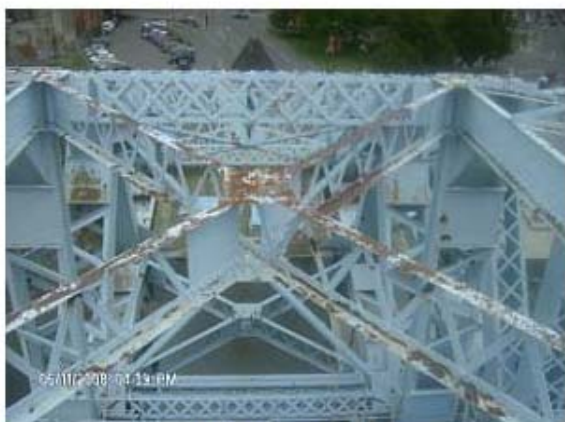
HPIM3971.JPG

P100 - Top of Concrete Counterweight

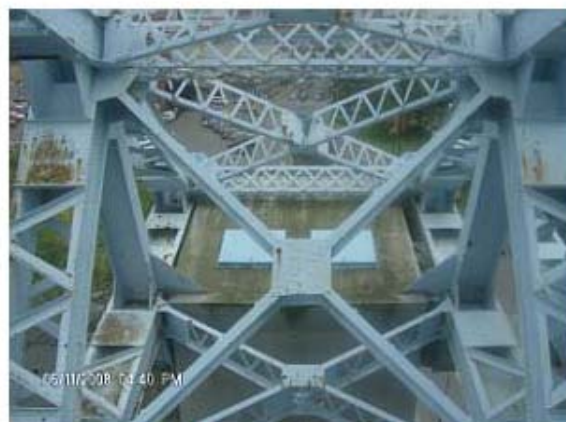
HPIM3973.JPG

P101 - Counterweight Support Truss Over Span 3

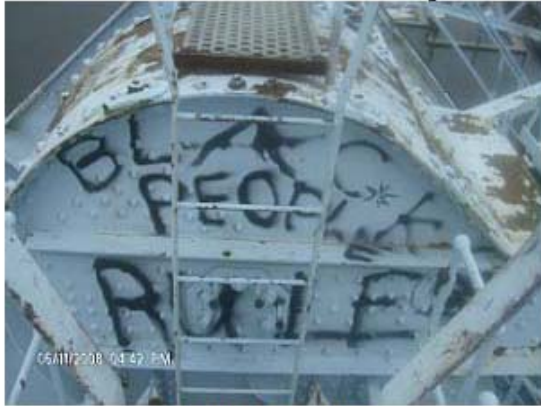
HPIM3974.JPG

P102 - Counterweight Support Truss Over Span 3

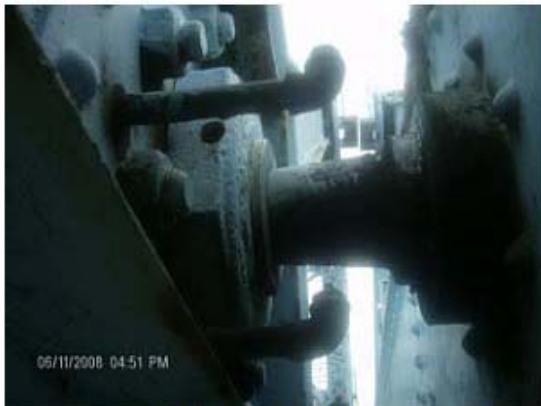
HPIM3978.JPG

P104 - Bascule Drive Struts for Both Bridges

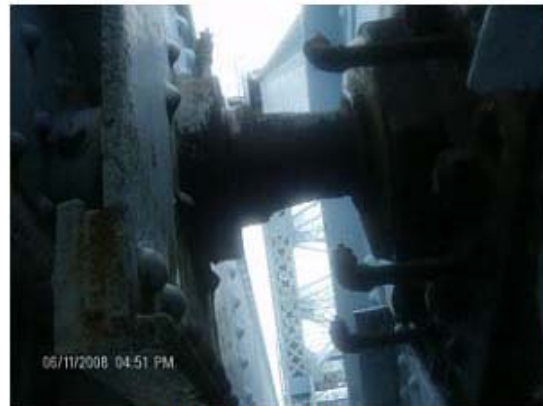
HPIM3979.JPG

P105 - Lift Span 2 - South Pin at Node 9 - Top of East Portal

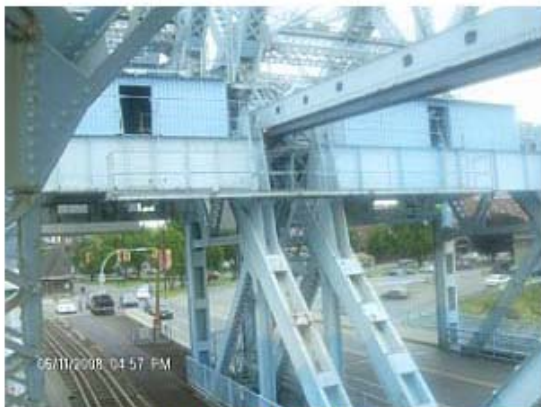
HPIM3980.JPG

P106 - Roadway Bridge - North Pin - Top of East Portal

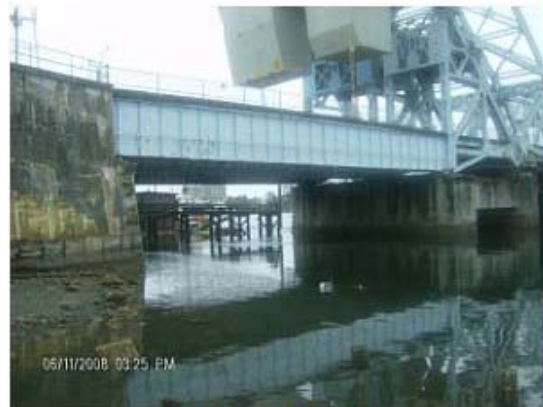
HPIM3986.JPG

P107 - Both Mechanical Sheds Above Span 3

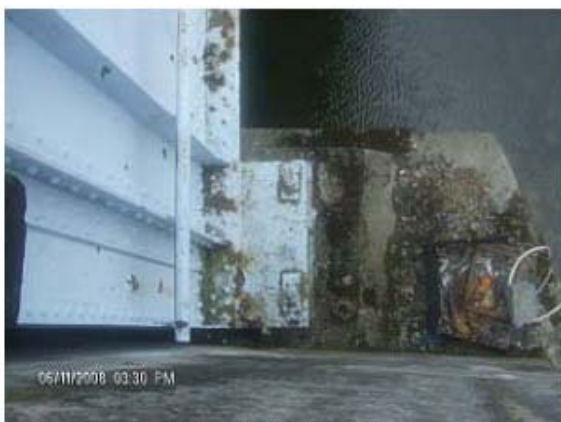
HPIM3987.JPG
P112 - East Approach Span 4 - Sidewalk Supports Between Bridges - Steel Floorbeams with Timber Stringers and Timber Decking

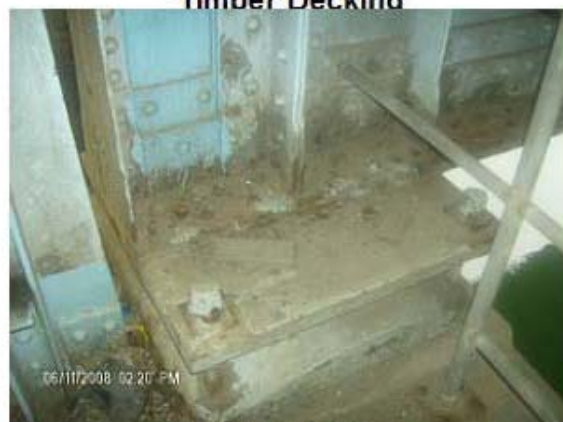
HPIM3936.JPG
P113 - East Abutment 2 - North Bearing and Bearing Seat - 3 mm Pack Rust Between 2 Adjacent Bearing Stiffeners

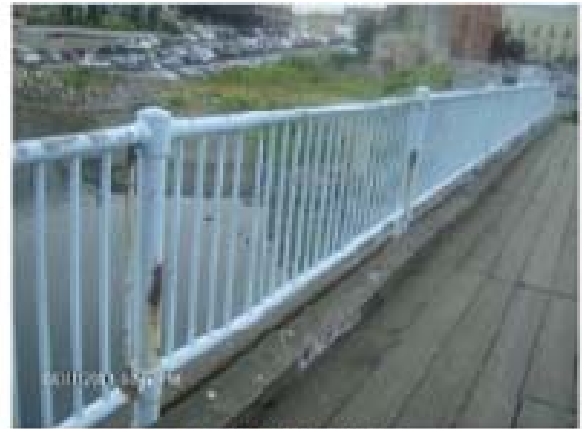
P116 - Track Alignment is Curved in the East Approach Span

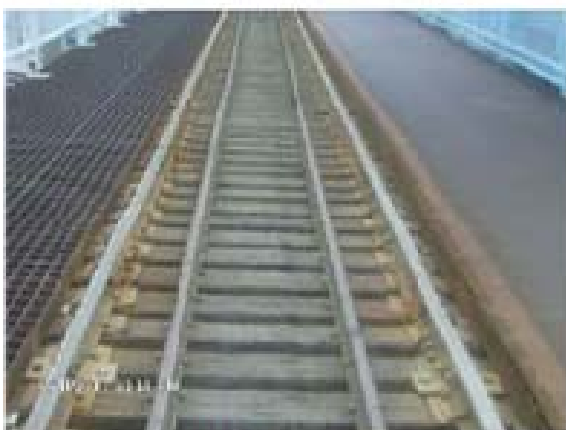
P118 - 65 Span 1 Ties (10' x 12'') - No Rejects

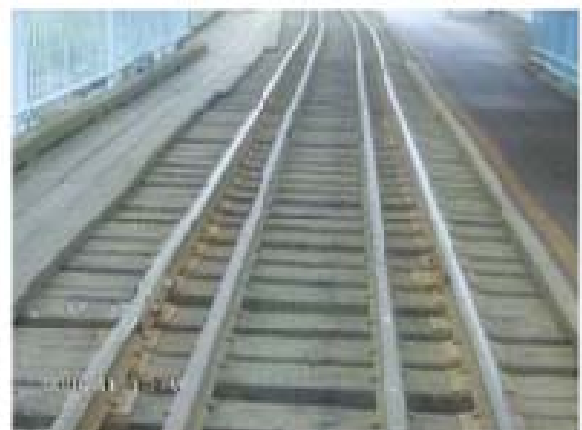
P119 - 147 Span 2 Ties (8' x 12'') - No Rejects

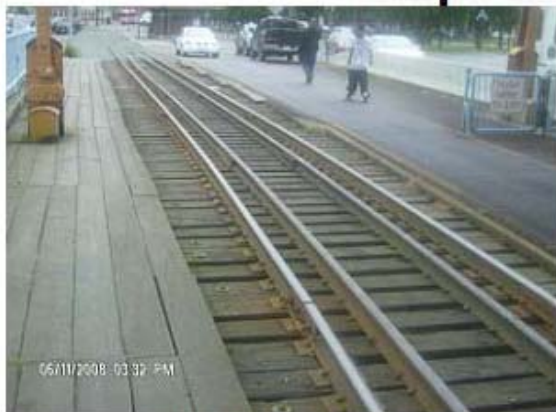
P120 - 51 Span 3 Ties (8' x 12'') - No Rejects

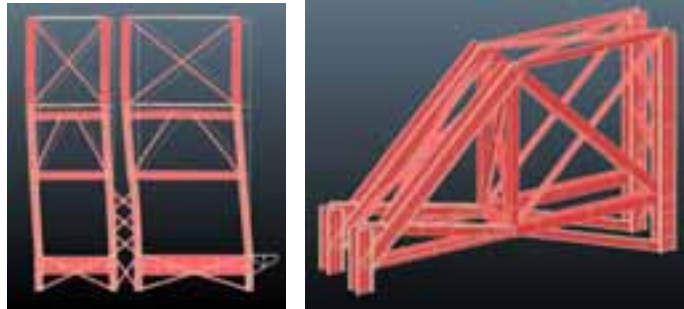
Fig (A-D 2.3) the added members in Alternative 3

All link elements yielded and all main elements remained elastic under the design earthquake, inelastic behavior (damage) is therefore accepted if it does not cause collapse. This eccentric frame is ductile in nature and the damage occurs in designated components.

Fig (A-D 2.3) represents the new added members in this alternative.

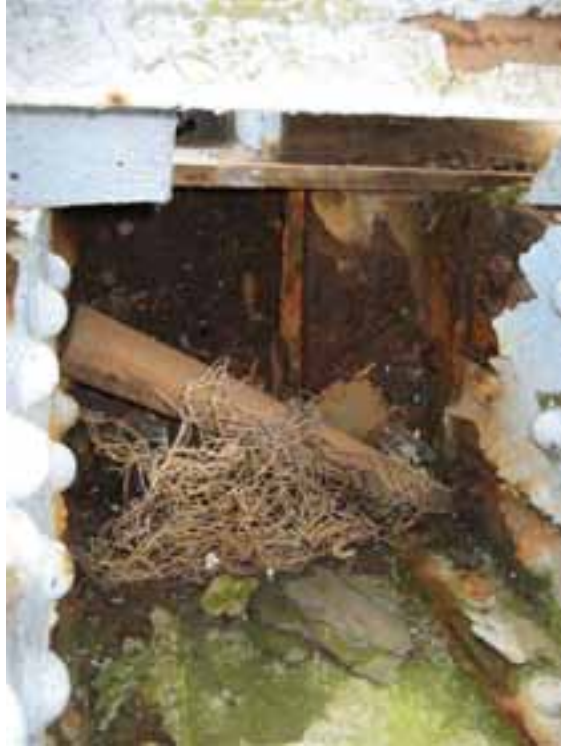
Photo M-5. Highway Bridge, Bearing B16. The upper inboard bearing mounting bolt is located behind the stiffener. Note the accumulated debris and corrosion.

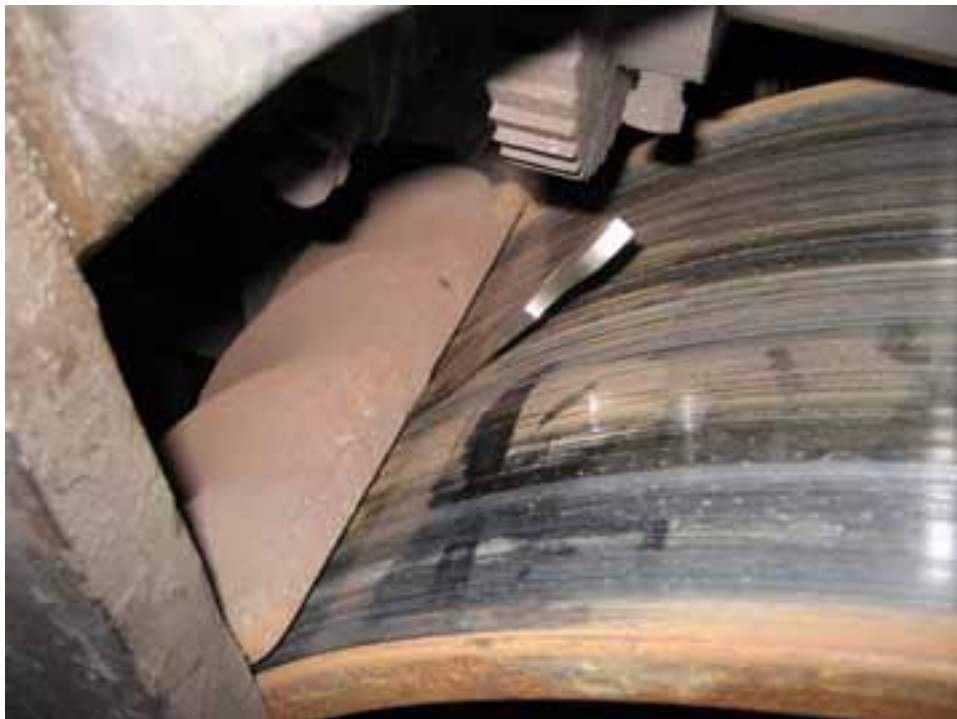
Photo M-10. Railroad Bridge, South Emergency Brake. The taper gage is used to demonstrate clearance between the brake shoe and the brake wheel.

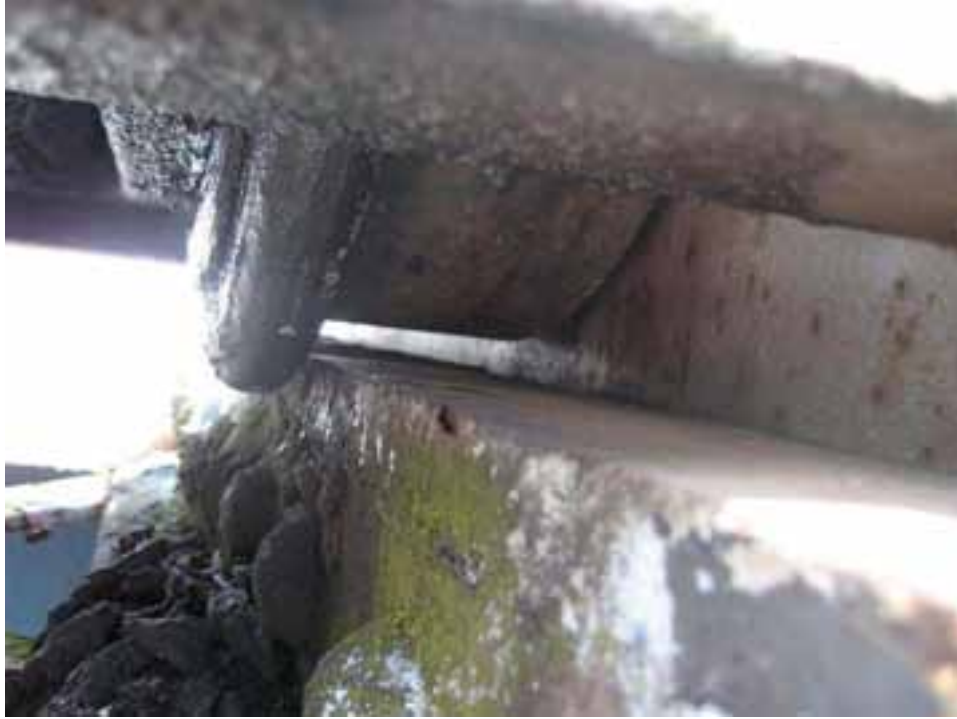
Photo M-19. Highway Bridge, South Operating Strut Upper Outboard Guide Roller. The original drawings indicate a gap of 1/8" at this location. At the time of the inspection the gap measured between 0.350" and 0.475"

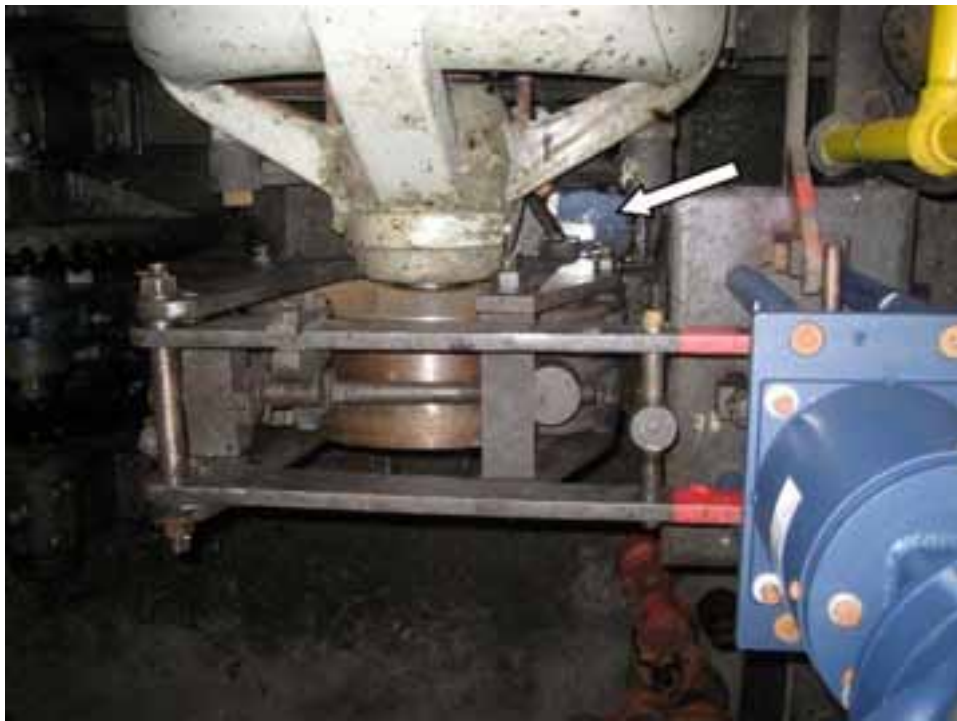
Photo M-20. Highway Bridge, Motor M2. Note the puddle of oil (arrow) between the brake and the motor.

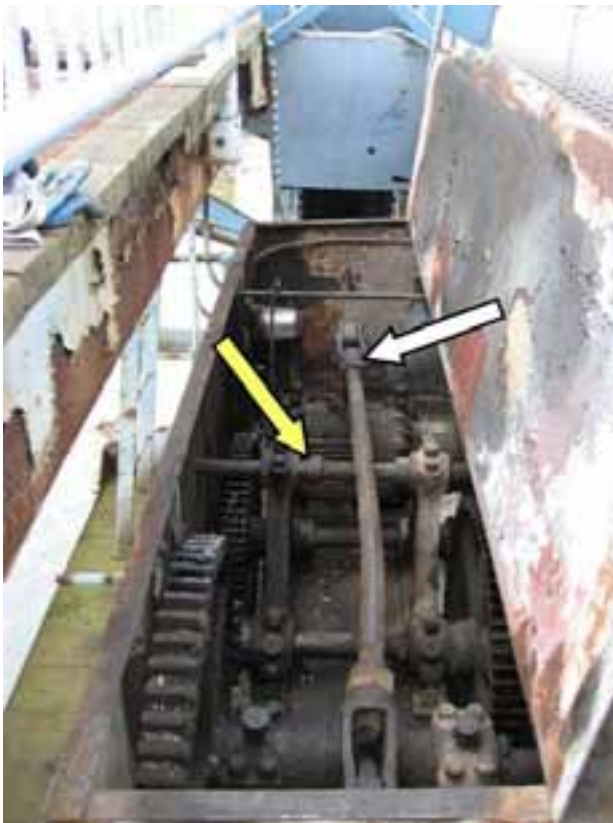
Photo M-30. Highway Bridge, Span Lock Machinery. The nut for the connecting rod (white arrow) is loose, the connecting rod is bent, the thrust collar (yellow arrow) for the hand crank shaft is not properly position and the enclosure is in poor condition.

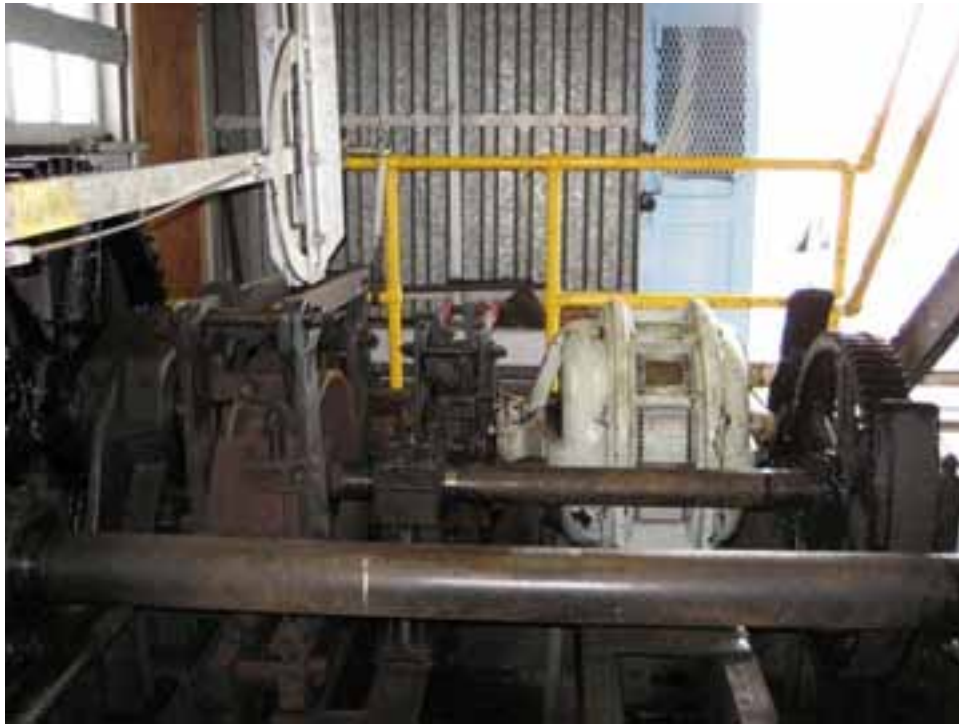
Photo E1.1.1. Highway Machinery Room. Note difficult accessibility of drive motors.

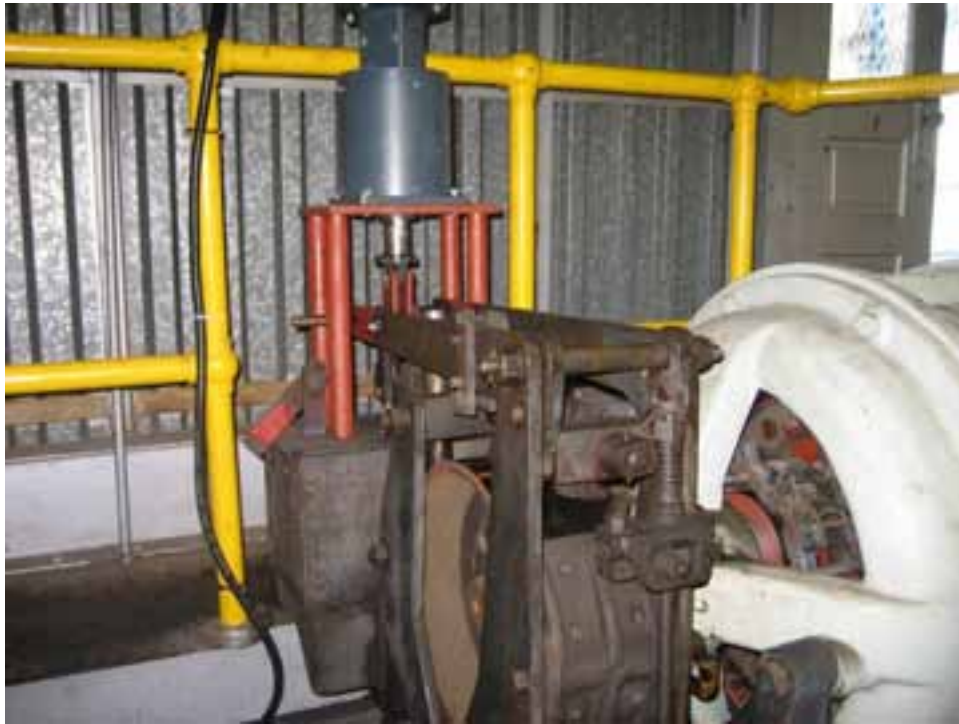
Photo E9. Typical Highway Brakes. Note brakes are not equipped with position limit switches.

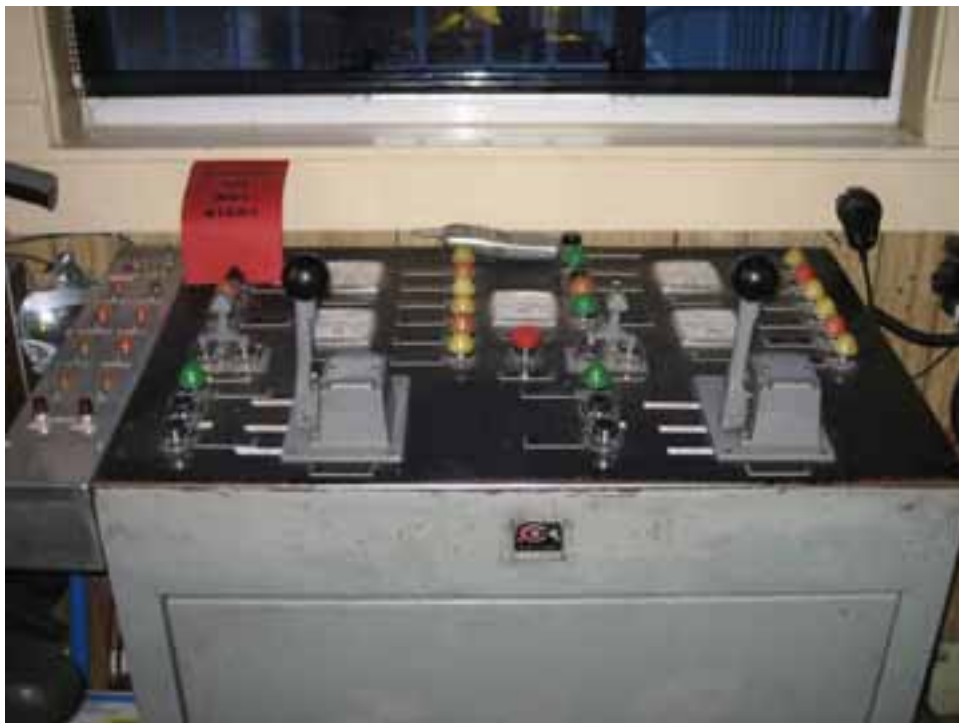
Photo E10. Control Desk. Note age of equipment and indicators.

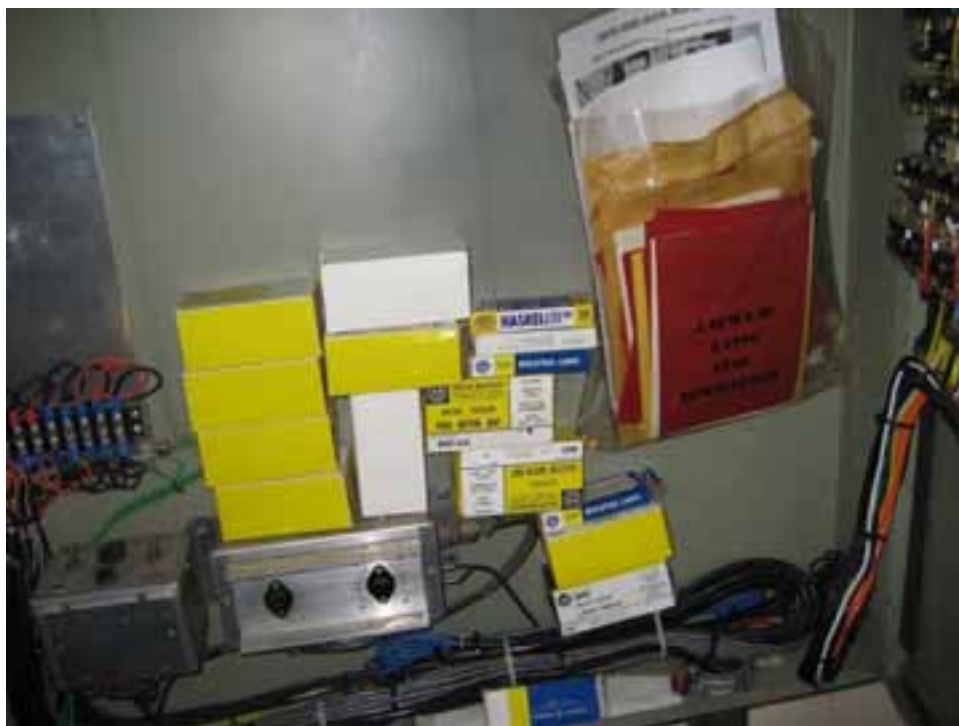
Photo E13. Wall Mounted Control Panel. Note flammable materials being stored in and on equipment inside enclosure.

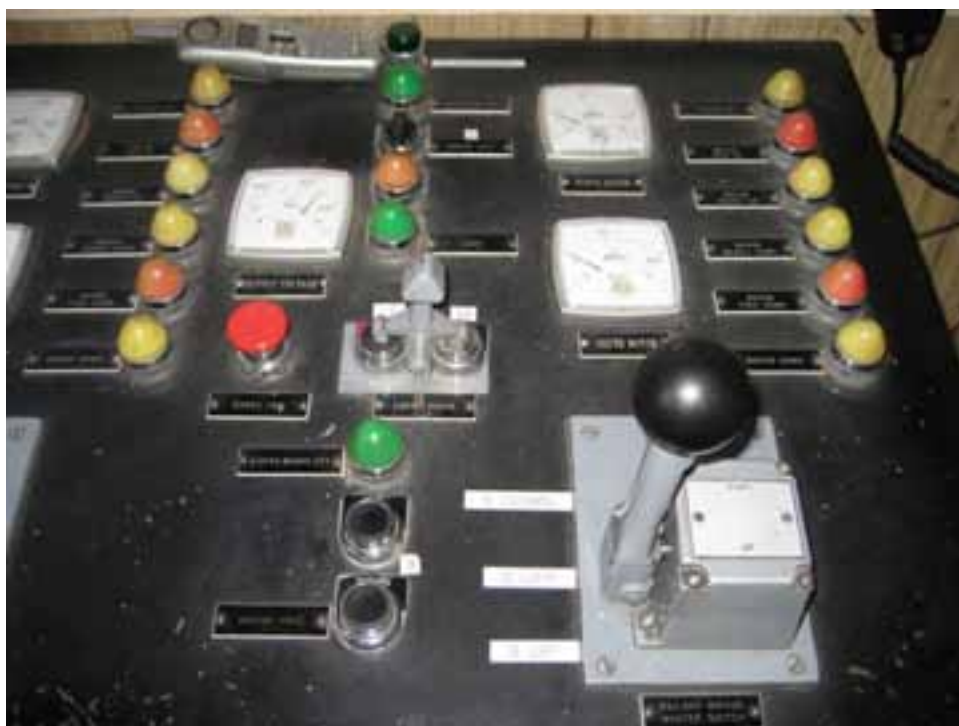
Photo E14. Control Desk. Note drum control switch used for span operation of bridge.

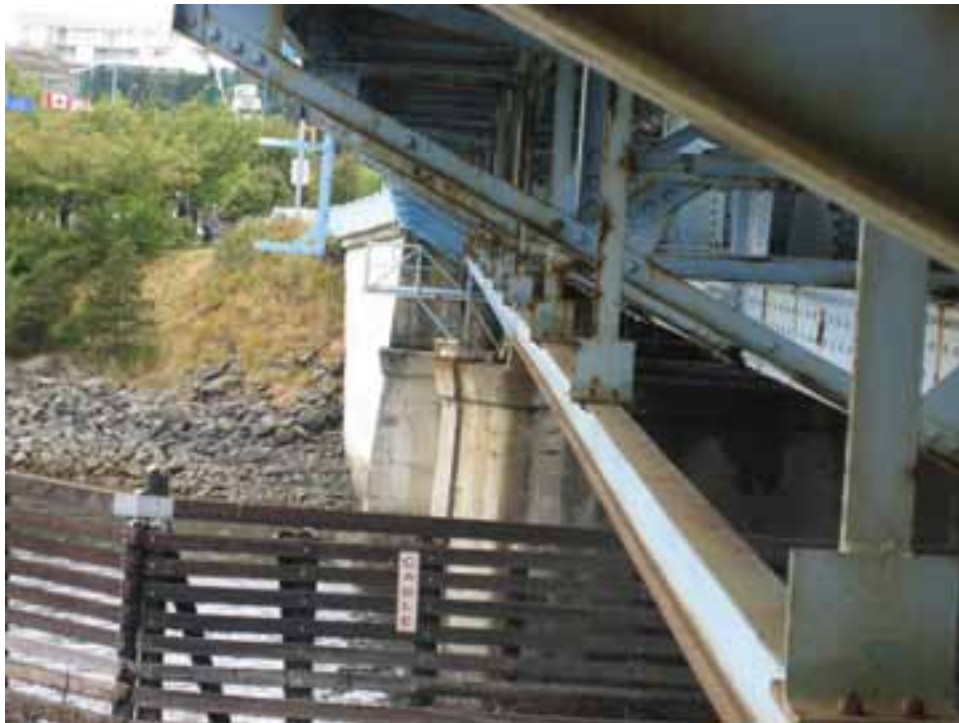
Photo E28. Far Side Submarine Cable Junction Box. Note the location of the junction box that the two submarine cables enter.

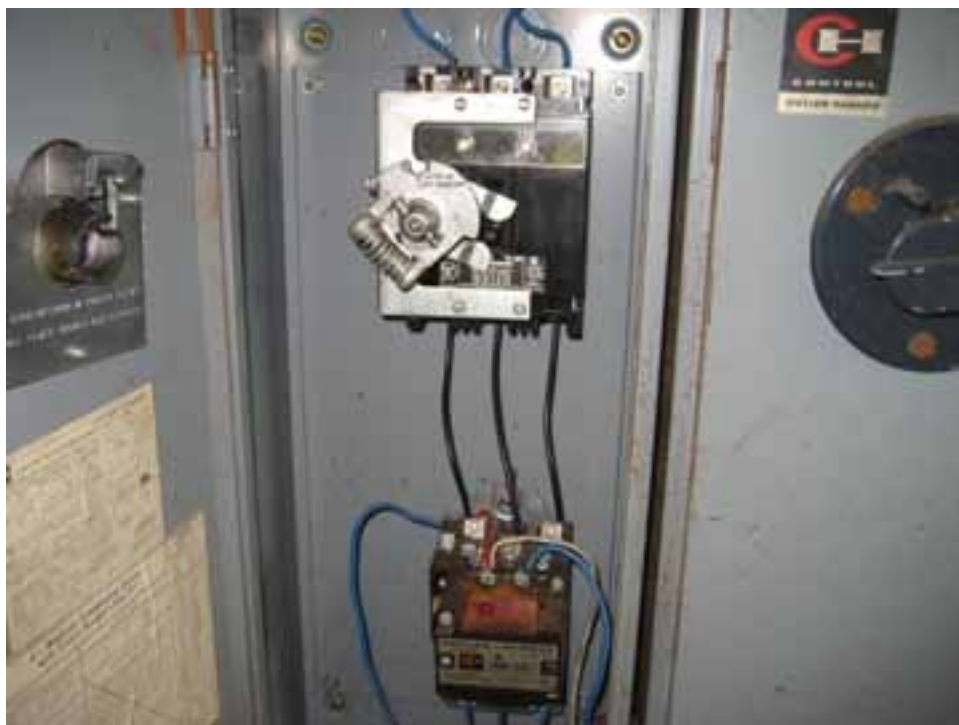
Photo E32. Railway Machinery Room. Note the use of solid conductors in the distribution equipment for power circuits

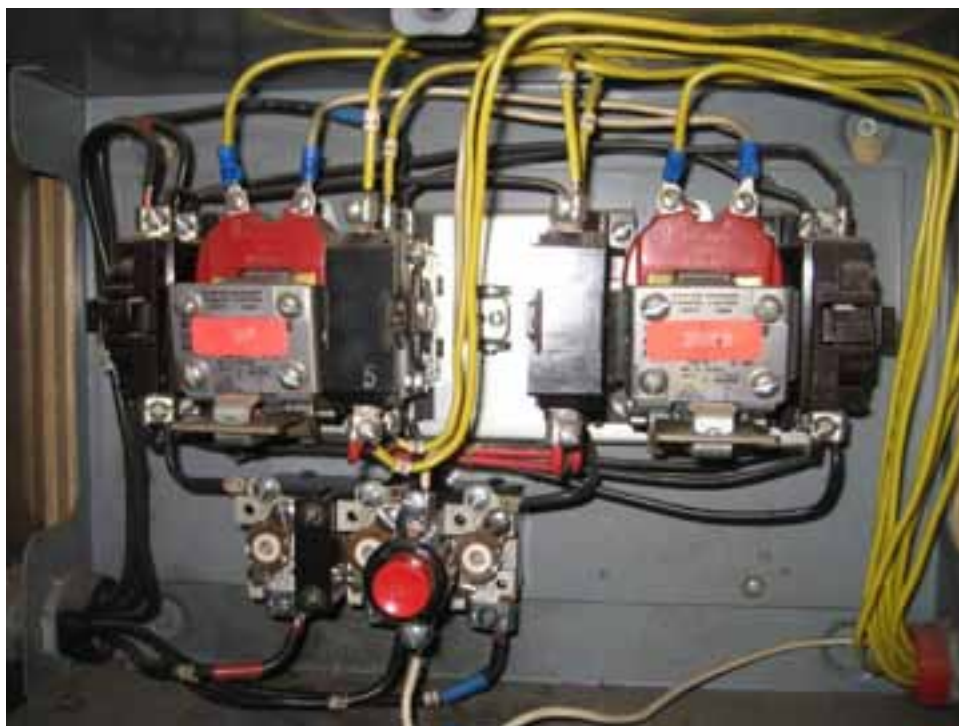
Photo E33. Control House. Note the use of solid conductors in the distribution equipment for power circuits.

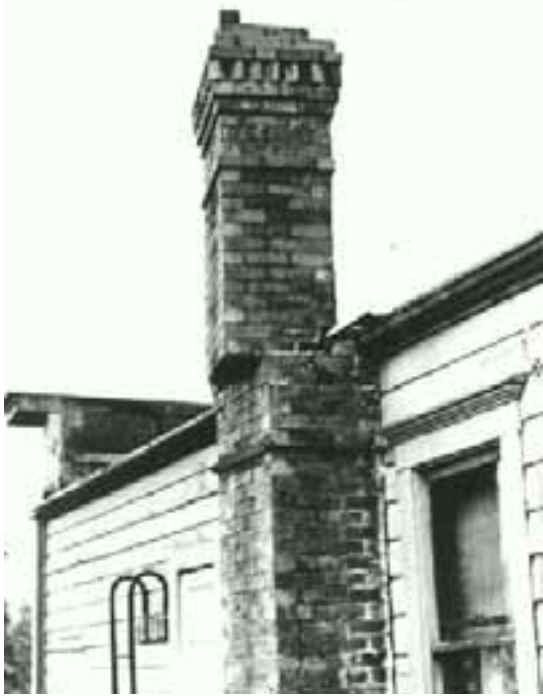
Port Alberni B.C – Chimney Rotation

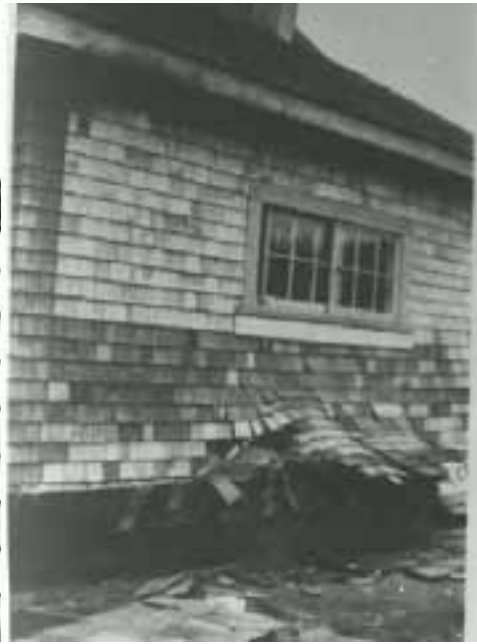
Comox B.C – House Foundation Failure

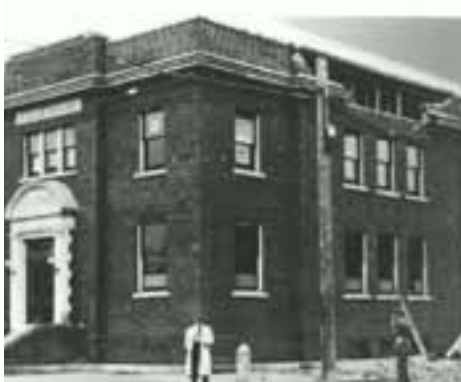
Courtenay B.C – Masonry Failure

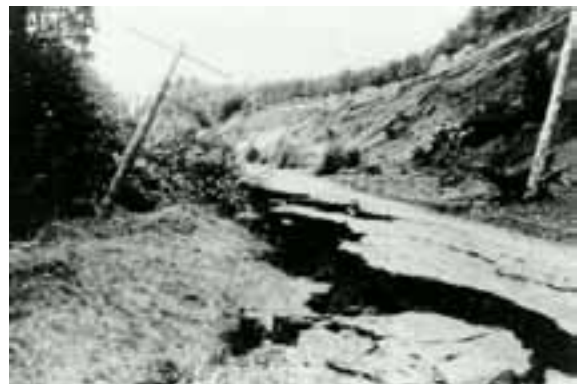
***North of Campbell River B.C
Soil Failure on the Kelsey Bay Highway***
